TECHNICAL REPORT CERC-87-12

# HURRICANE KATE STORM SURGE DATA

**Report 5**

August 1987 Report 5 of a Series

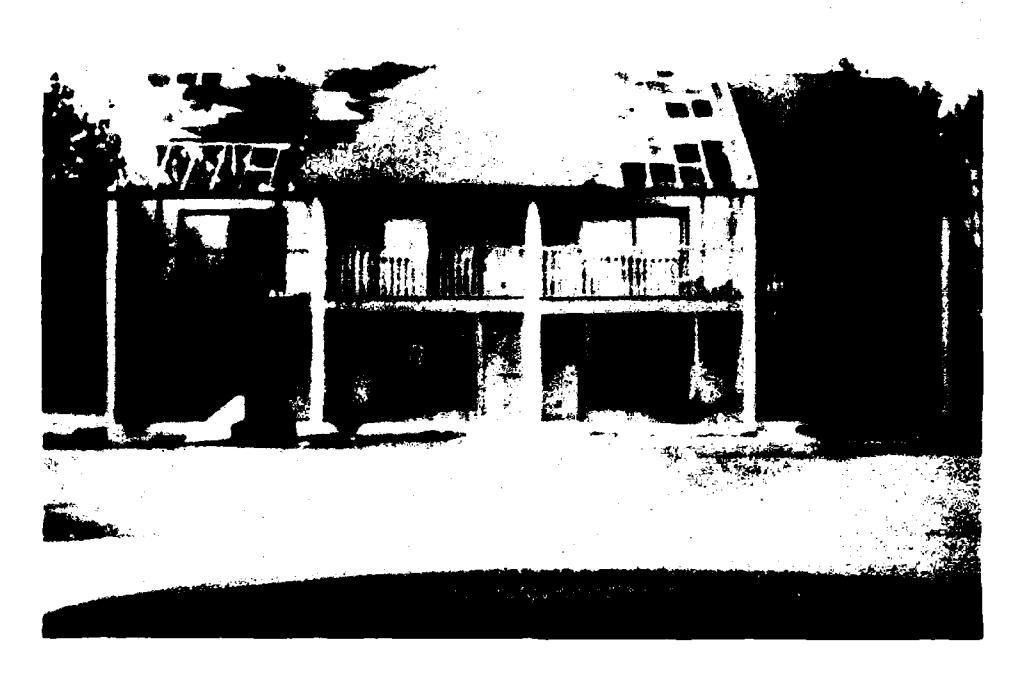
16. Property damage within the park was confined to boardwalks (Photo 6) due to the lack of construction along the beachfront. Farther south at Cape San Blas, there was more extensive damage. Several homes were totally destroyed (Photo 7), and houses that survived were undermined by beach erosion (Photo 8). The surge elevation at this location was approximately at 9 ft. Many of the buildings located far enough from the beach to be protected from surge damage suffered wind damage (Photo 9).

Photo 9. Roof damage, Cape San Blas, Fla.
