HUMAN FACTORS ASSESSMENT: M9 ARMORED COMBAT EARTHMOVER (ACE)

REPORT DOCUMENTATION PAGE		READ INSTRUCTIONS BEFORE COMPLETING FORM
1. REPORT NUMBER ARI Research Note 88-12	2. GOVT ACCESSION NO.	3. RECIPIENT'S CATALOG NUMBER

4. TITLE (and Subtitle) Human Factors Assessment: M9 Armored Combat Earthmover (ACE)		5. TYPE OF REPORT & PERIOD COVERED Final Report February 1983 - December 1985

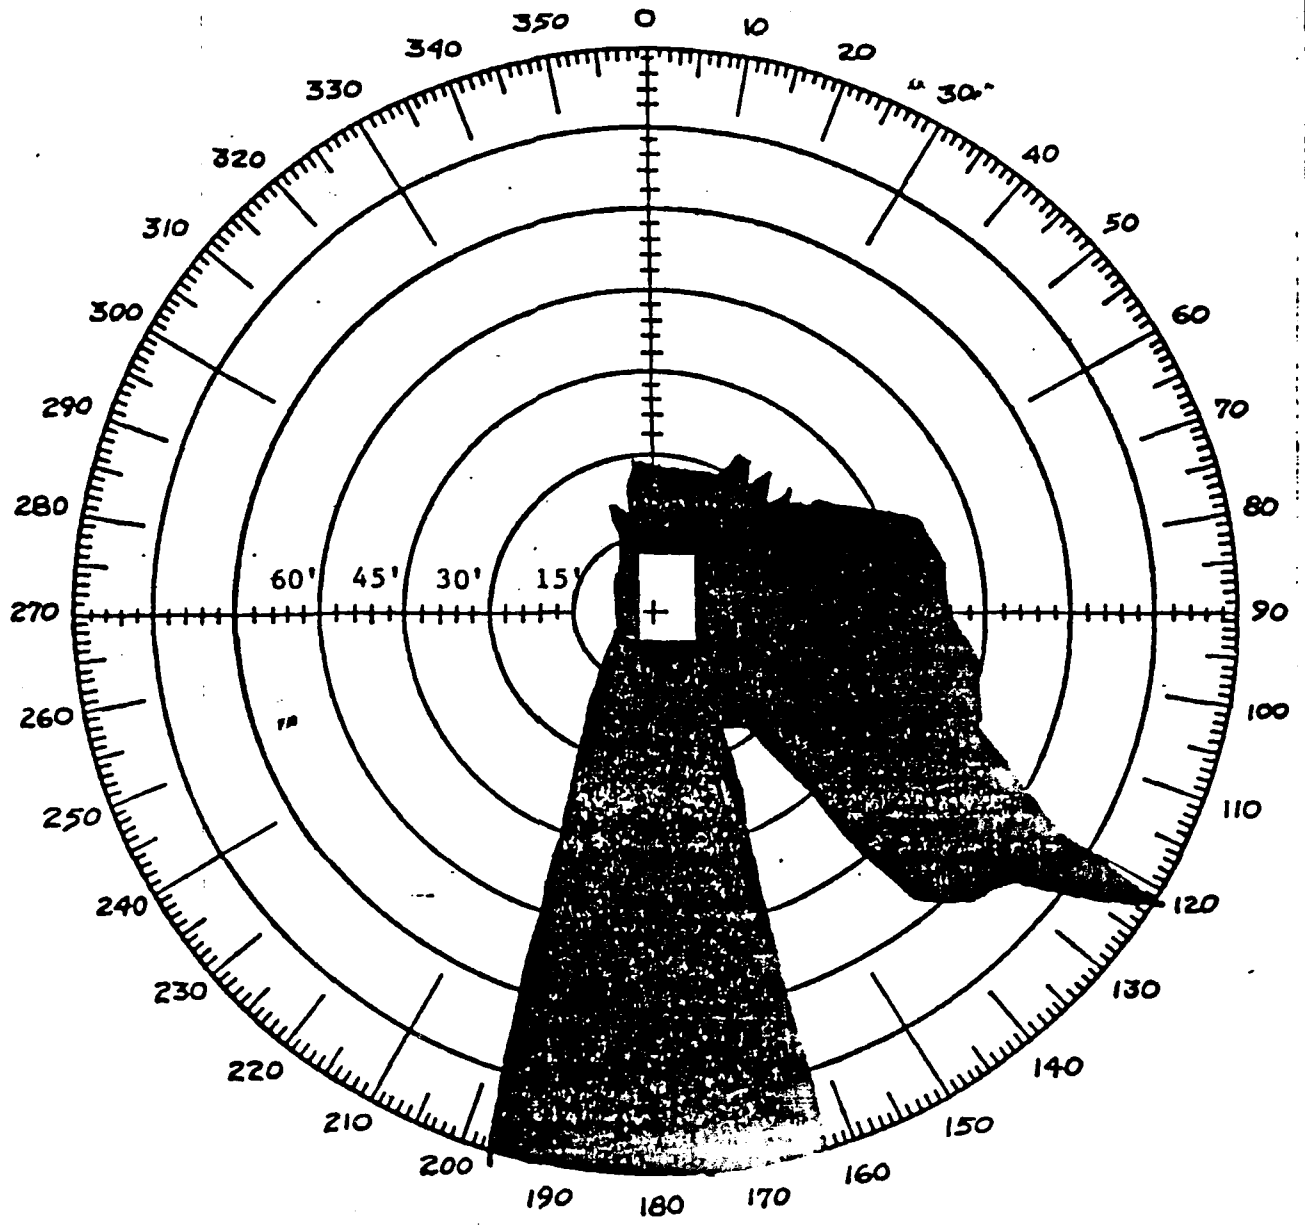
Figure 10. Blade in work position, suspension lowered and tilted forward, hatch open; 5th percentile operator, seated, measured at eye height.

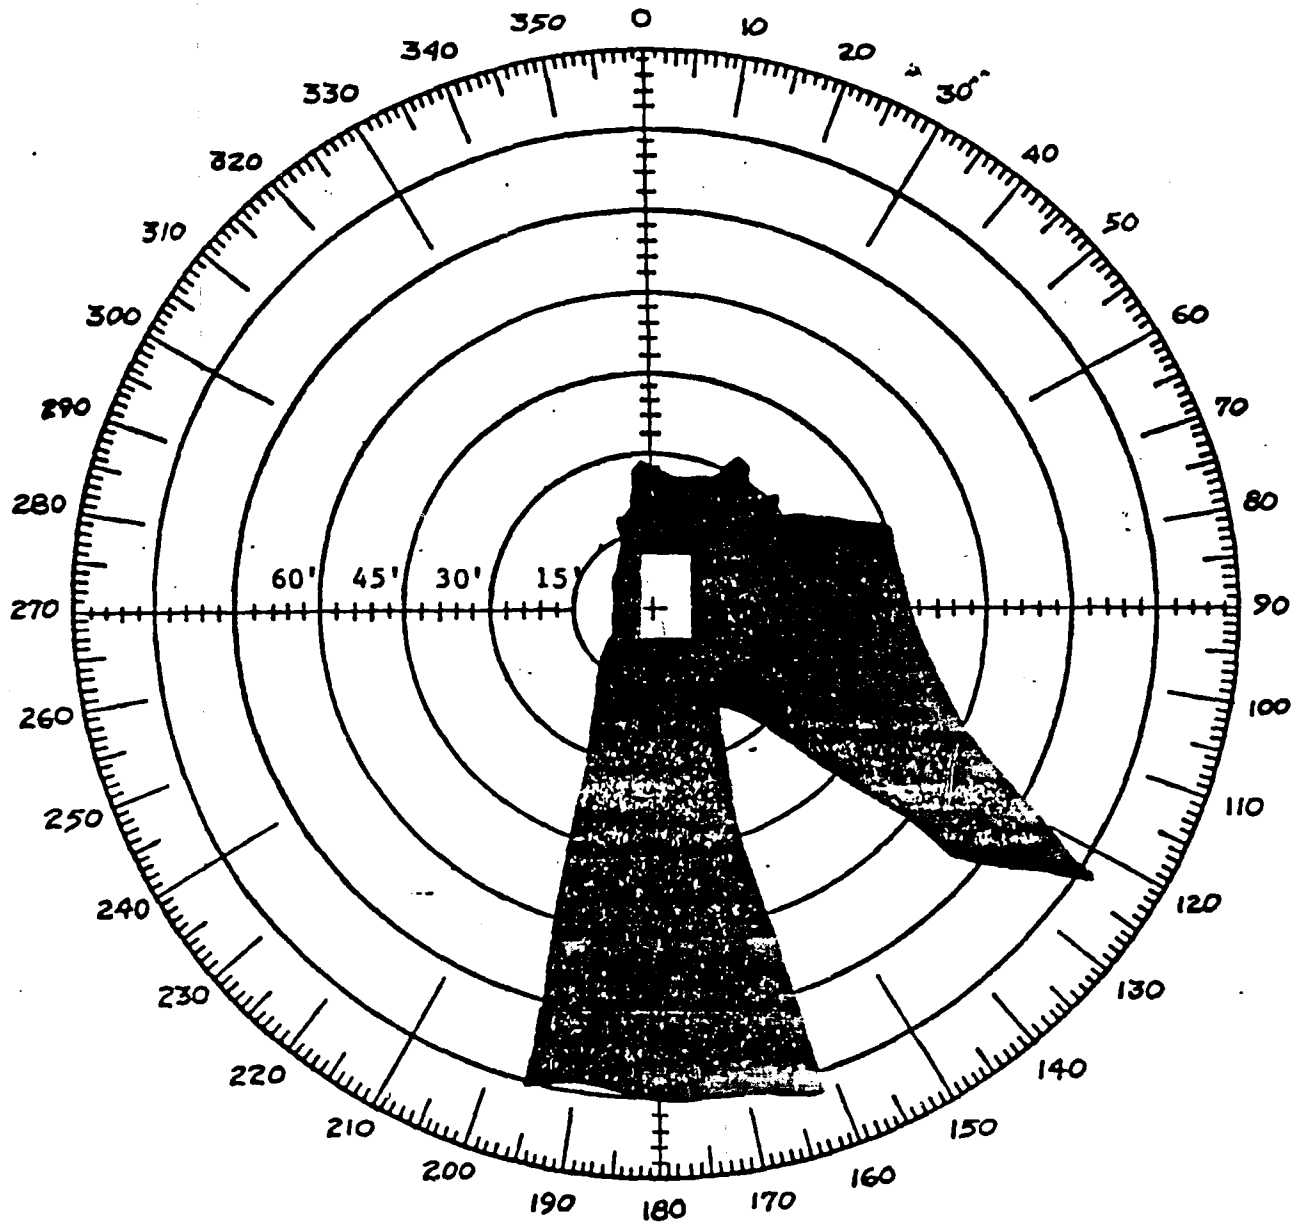
Figure 11. Blade in work position, suspension lowered and tilted forward, hatch open; 95th percentile operator, seated, measured at eye height.

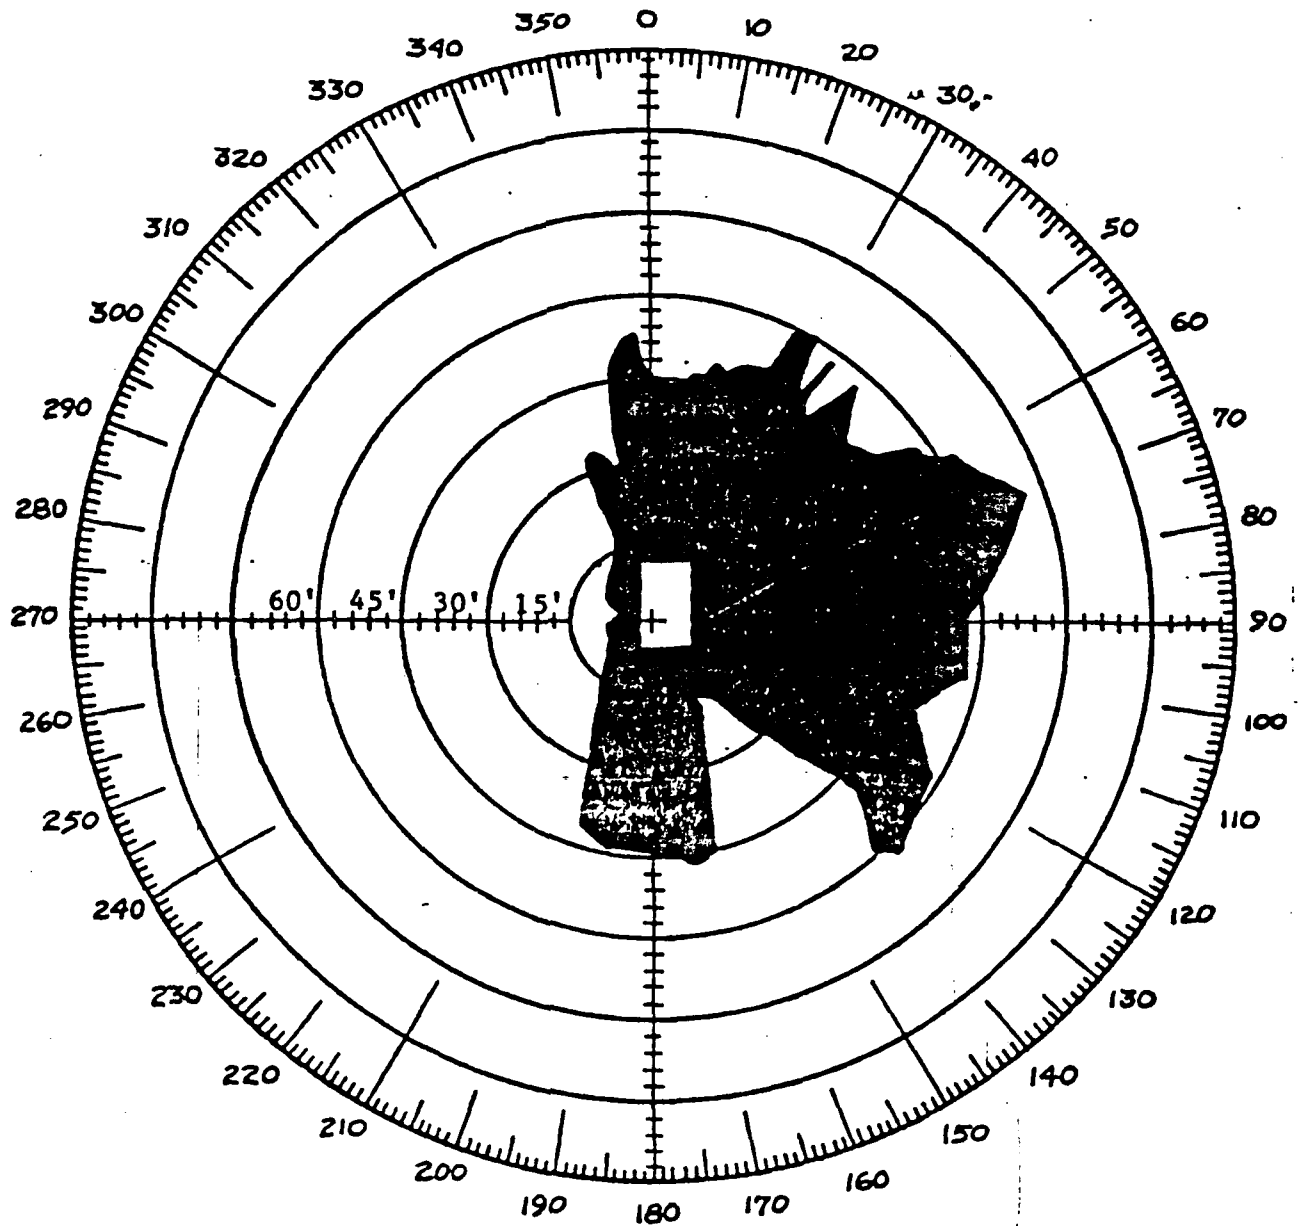
Figure 12. Blade in travel position, suspension lowered and tilted forward, hatch open; 5th percentile operator, seated, measured at eye height.

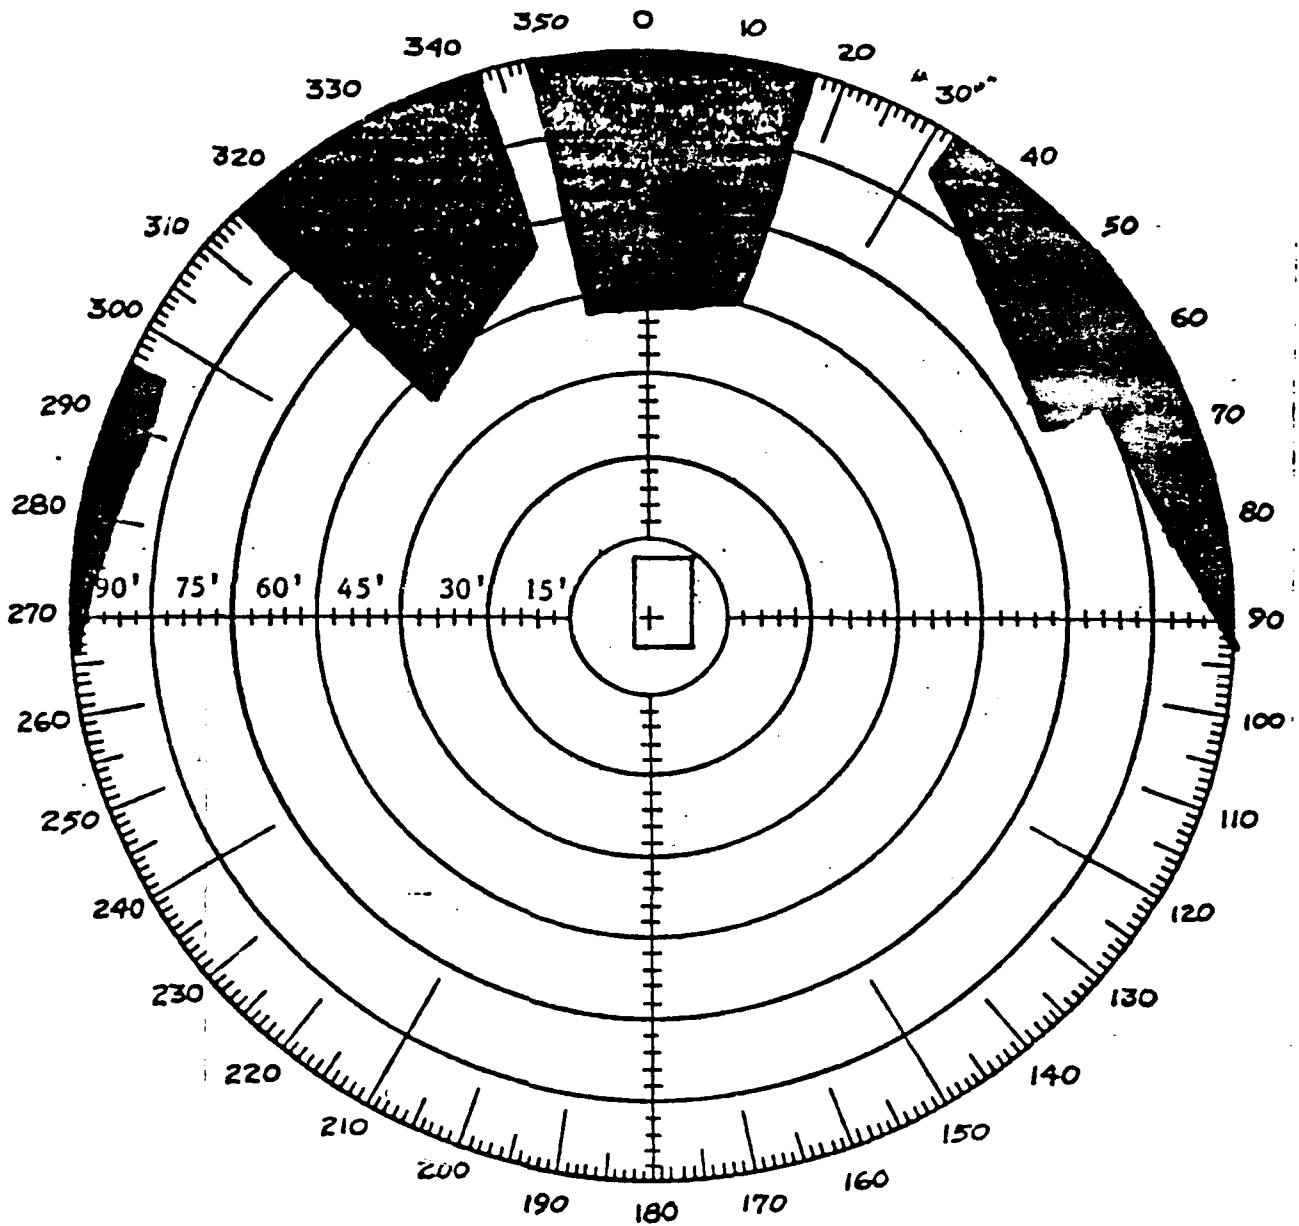
Figure 14. Blade in travel position, hatch closed; 5th and 95th percentile operators, measured at the same eye height.

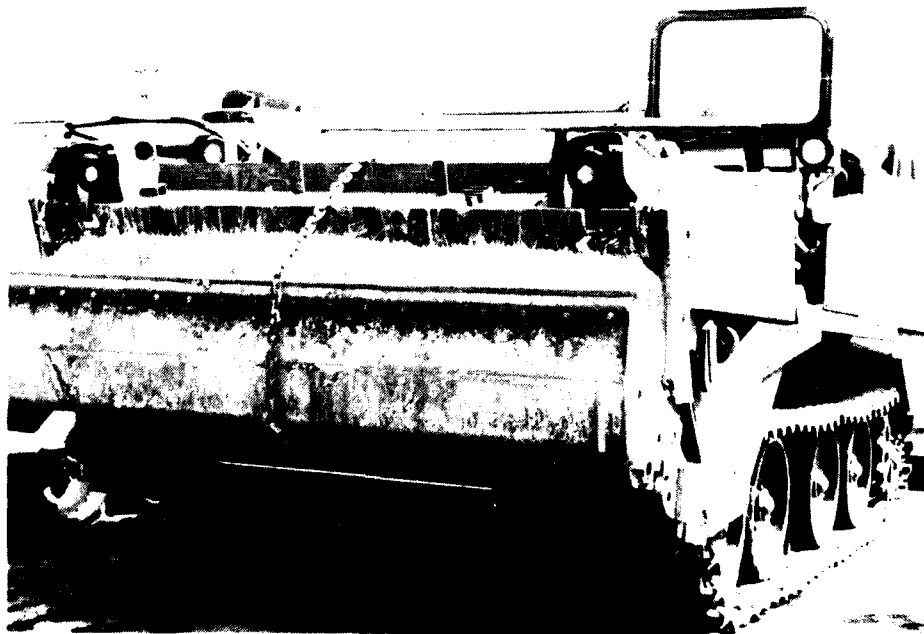
Figure 38. The folded dozer blade and chain position.

An alternative to the procedures involves raising the apron and dozer blade allowing the operator to stand beneath the dozer blade to attach the chain. However, the additional steps add approximately 15 minutes to the 20 to 30 minutes procedure. The additional time results from removing and replacing the apron pins (see Deficiency: Apron and Dozer Blade Lock Pins, pg 64). Moreover, unless the apron is fully raised and locked with its safety pins (making the shackle difficult to reach) the dozer blade and apron could fall on the operator, again as a result of pressure changes in the hydraulic system.

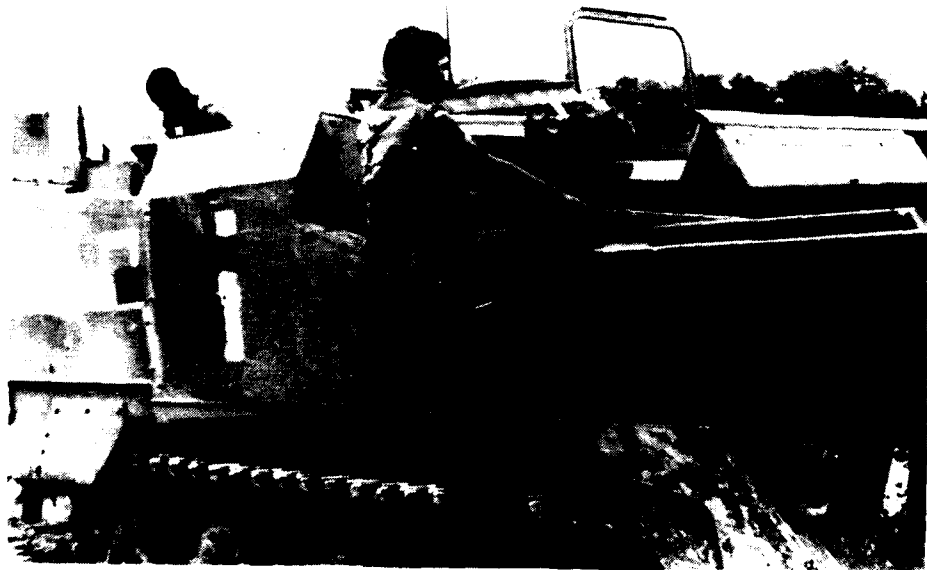
1. The radiator housing. Figure 40 shows an operator trying to step down from the radiator housing.
2. The smoke grenade launcher area including the sloped deck above the tool box.
3. The right and left apron cylinder areas used by personnel to enter or exit the bowl. Figure 41 shows an operator climbing up by the apron cylinder in order to see into the bowl.

Figure 41. The route operators use to climb in and out of the bowl.

Implications for the Operator and the Equipment: Slip and fall accidents are likely, especially when existing steps and handholds are damaged.

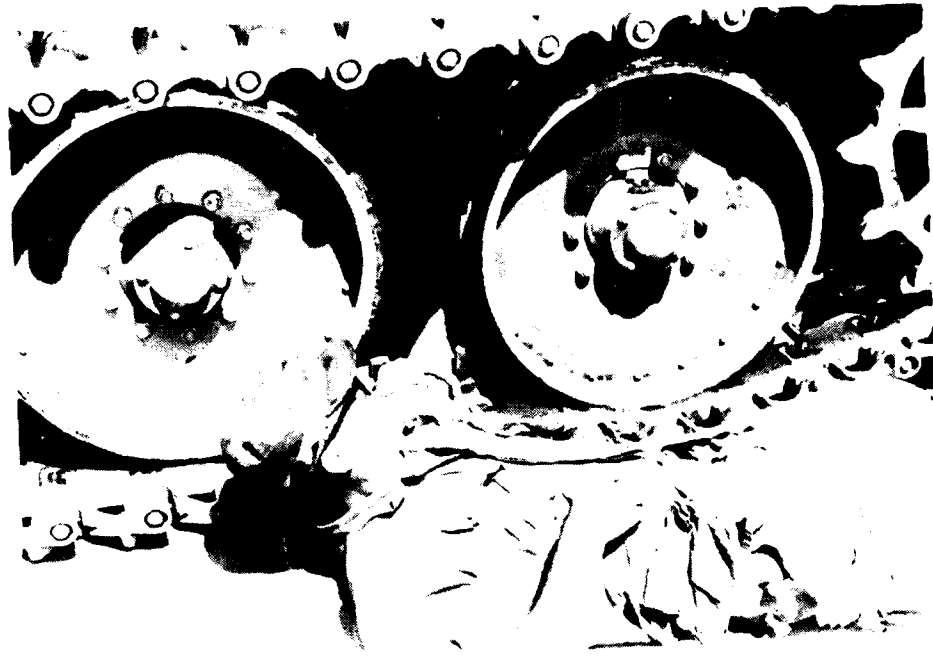
Description of the Safety Hazard: Figure 53 shows a mechanic reaching into the roadwheels in order to hold a dog bone jack in place between the upper and lower portions of the track. Figure 54 shows the dog bone jack.

Figure 53. A mechanic reaching between the roadwheels to position the dog bone jack.

1. Use the hydraulic jack only on hard paved surfaces.
2. Modify the dog bone jack to make it self-standing during positioning of the vehicle. This might be done by adding a hinged bipod to one side of the jack. The bipod would angle outward from the jack and wedge into the ground, creating a tripod of the jack.
