Embankment Criteria,
Performance, and
Foundation Report

Waco Lake
Bosque River, Texas
Brazos River and Tributaries, Texas

SUBJECT: Waco Lake, Texas, Embankment Criteria and Performance Report

EMBANKMENT CRITERIA, PERFORMANCE
AND
FOUNDATION REPORT

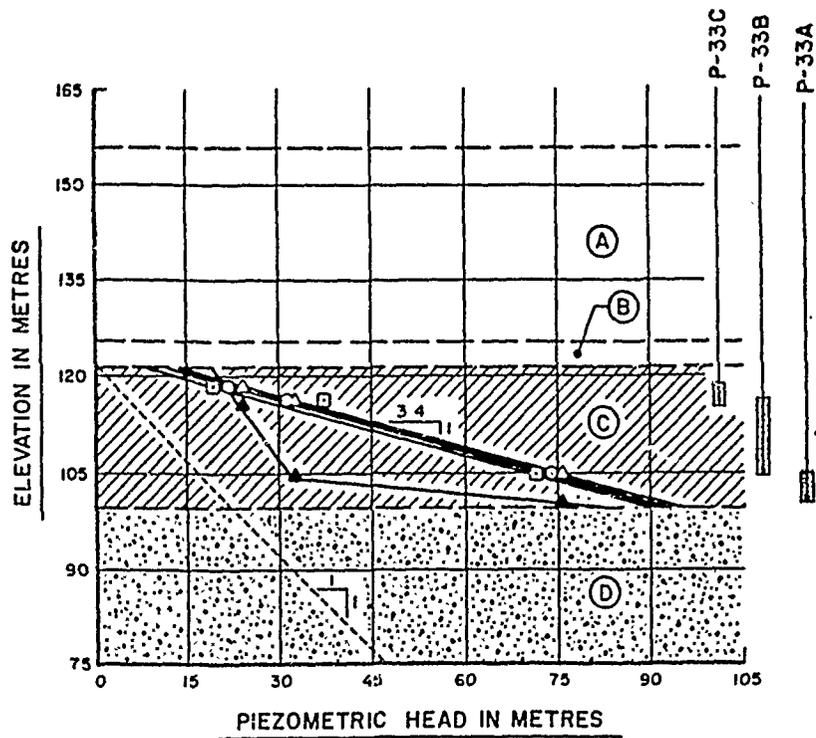
PORE PRESSURE GRADIENT
STATION 55+00, Ⓔ

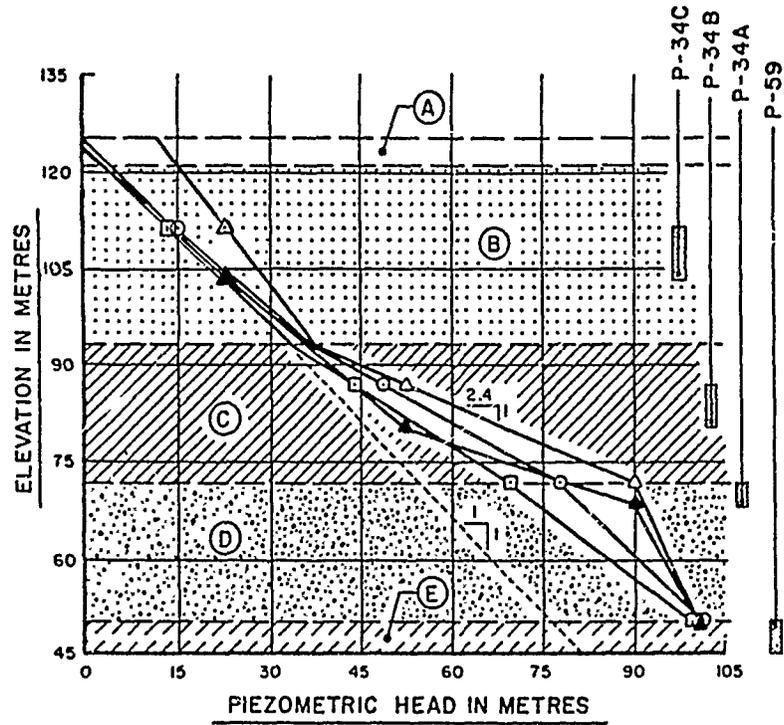
PORE PRESSURE GRADIENT
STATION 52+00, 275m D/S

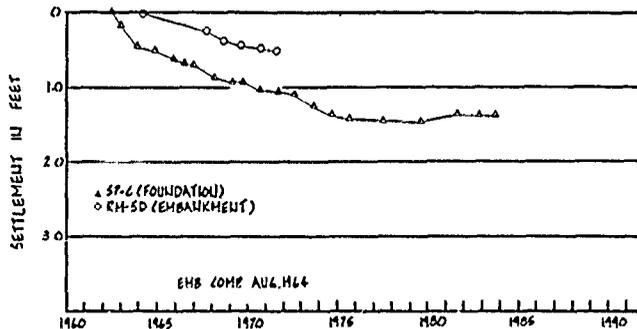
EMBANKMENT AND FOUNDATION
 SETTLEMENT
 STA 55+00, 300US
 FIG. 3

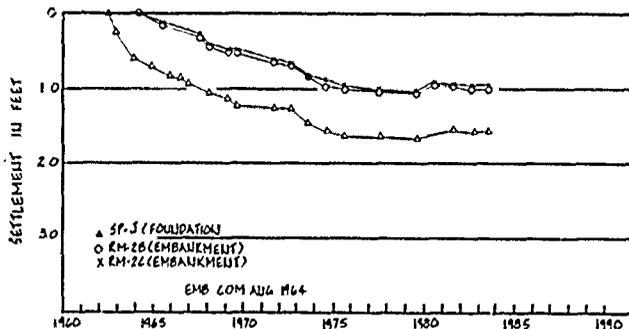
EMBANKMENT AND FOUNDATION
 SETTLEMENT
 STA 55+00, 300DS
 FIG. 4

NOTES:
 SETTLEMENT PLATE D IS SET ON TOP OF SHALE, EL. 395.7,
 SETTLEMENT PLATE K IS SET ON OVERBURDEN, EL. 408.0

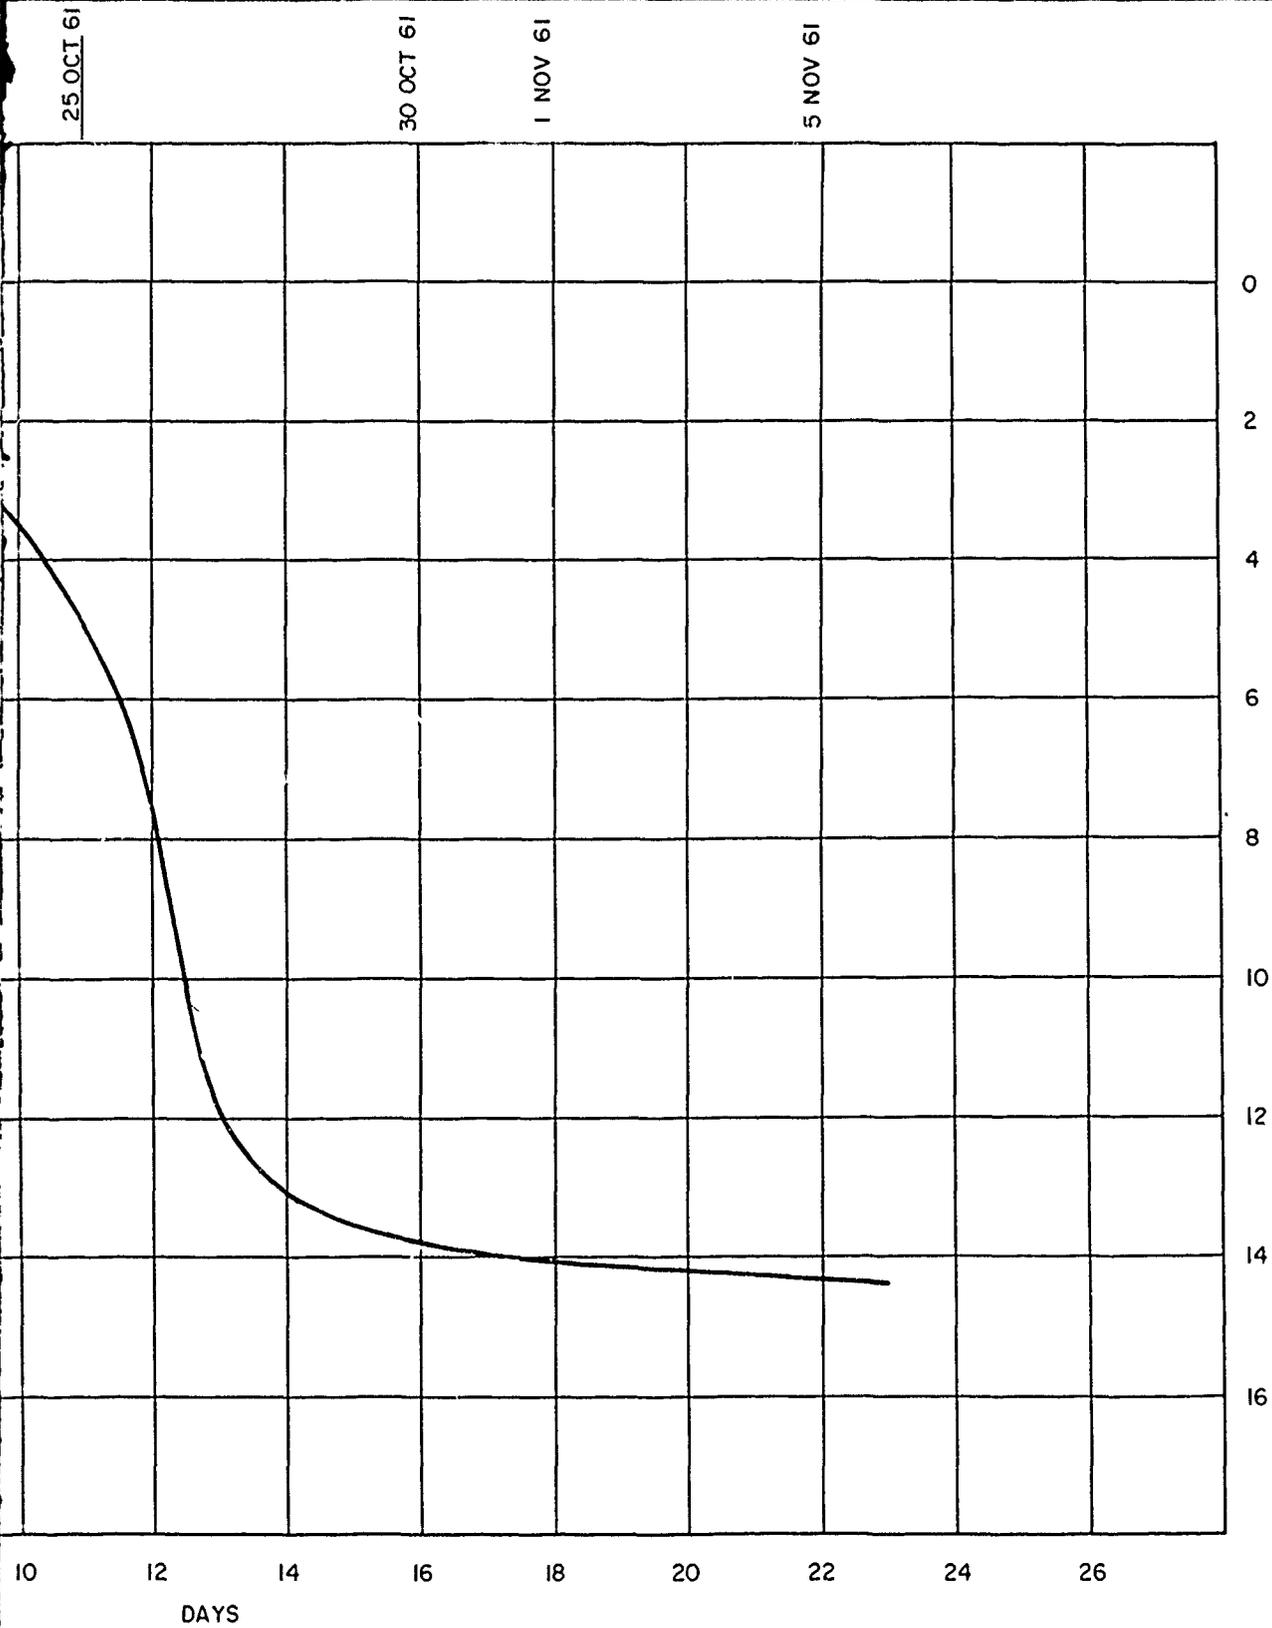
NOTE:
MOVEMENT PRIOR TO 14 OCTOBER 1961
WAS NOT MEASURED.

BRAZOS RIVER AND TRIBUTARIES, TEXAS
 WACO DAM
 BOSQUE RIVER, TEXAS
 RATE OF MOVEMENT
 CENTERLINE POINT
 STATION 55+00
 EMBANKMENT
 SCALES AS SHOWN
 U S ARMY ENGINEER DISTRICT, FORT WORTH JAN 11

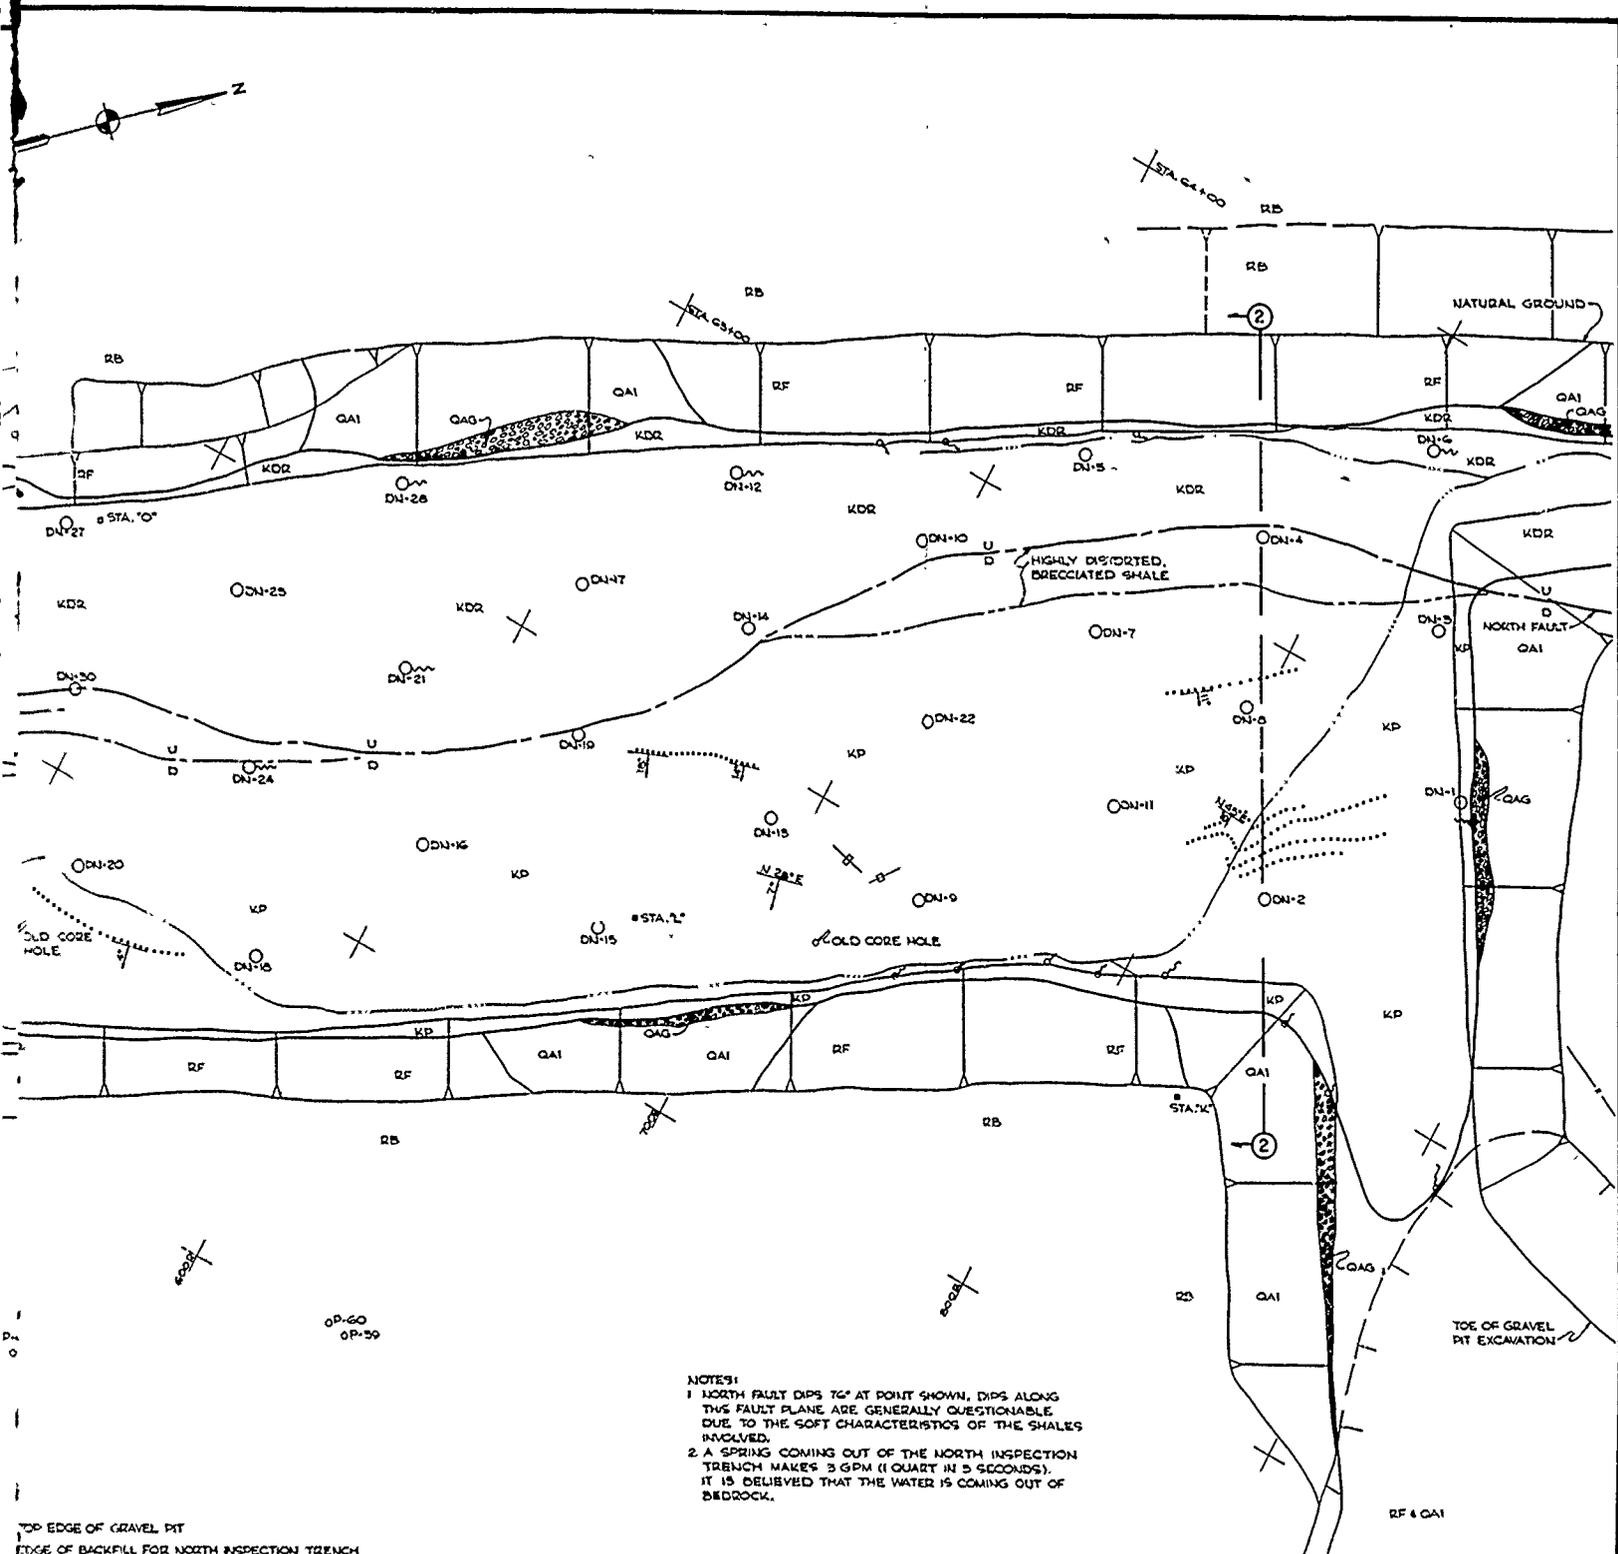
- 1 NORTH FAULT DIPS 76° AT POINT SHOWN, DIPS ALONG THIS FAULT PLANE ARE GENERALLY QUESTIONABLE DUE TO THE SOFT CHARACTERISTICS OF THE SHALES INVOLVED.
- 2 A SPRING COMING OUT OF THE NORTH INSPECTION TRENCH MAKES 3 GPM (1 QUART IN 3 SECONDS). IT IS BELIEVED THAT THE WATER IS COMING OUT OF BEDROCK.

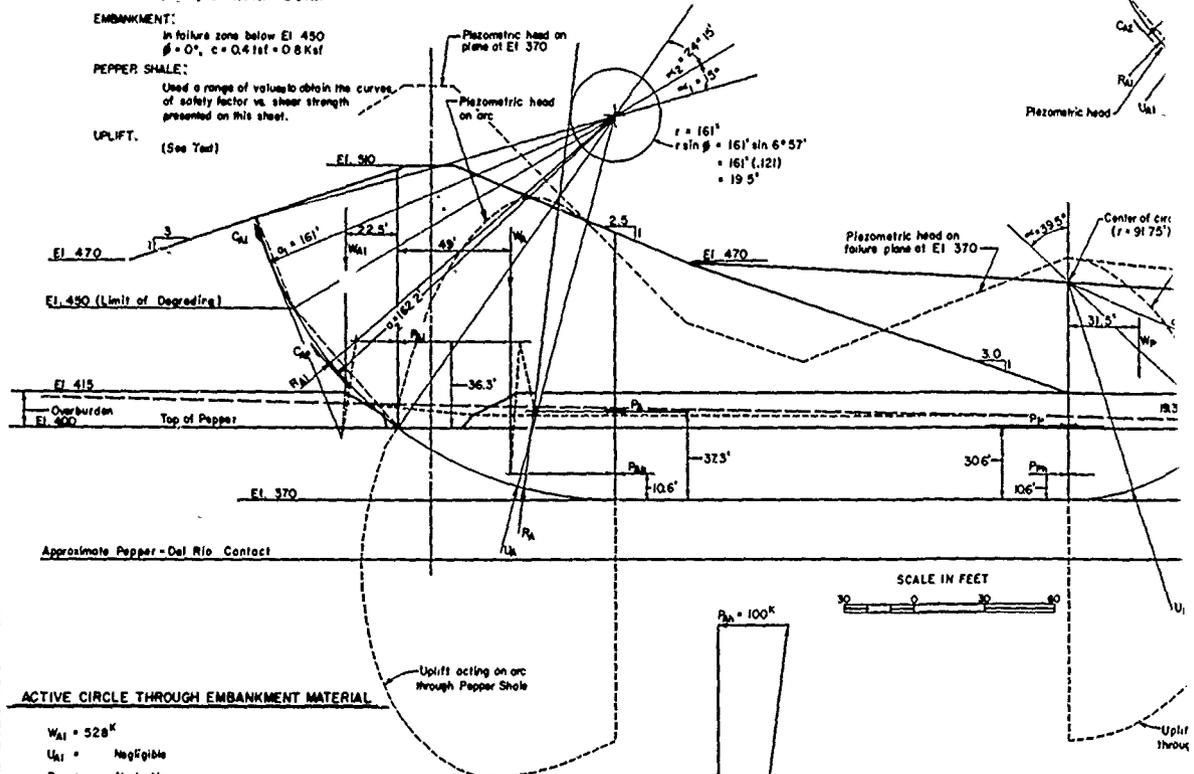
BRAZOS RIVER AND TRIBUTARIES, TEXAS
 WACO DAM
 BOSQUE RIVER, TEXAS
STABILITY ANALYSIS OF REPAIR SECTION
 FOR EXPECTED PORE PRESSURES
 PHI - CIRCLE METHOD
 EMBANKMENT SLIDE AREA - STATION 55+00
 SCALES AS SHOWN
 U.S. ARMY ENGINEER DISTRICT, FORT WORTH JAN. 1963

EMBANKMENT:
 In failure zone below El. 450
 $\phi = 0^\circ$, $c = 0.4 \text{ tsf} = 0.8 \text{ Ksf}$

PEPPER SHALE:
 Used a range of values to obtain the curves of safety factor vs. shear strength presented on this sheet.

$W_{A1} = 528^K$
 $U_{A1} = \text{Negligible}$
 $P_{A1} = \text{Negligible}$
 $L_c = r \sin \frac{\alpha}{2} = 161 \left(\frac{36.3^\circ}{2} \right) = 42.2'$
 $L_c = 2r \sin \frac{\alpha}{2} = 2(161) \sin \left(\frac{36.3^\circ}{2} \right) = 322(.131) = 42.2'$
 $a_1 = r \left(\frac{1}{\cos \frac{\alpha}{2}} \right) = 161 \left(\frac{1}{\cos 18.15^\circ} \right) = 161'$
 $C_{A1} = \frac{c L_c}{\sin \alpha} = \frac{0.8(42.2)}{\sin 36.3^\circ} = \frac{33.8^K}{.59}$

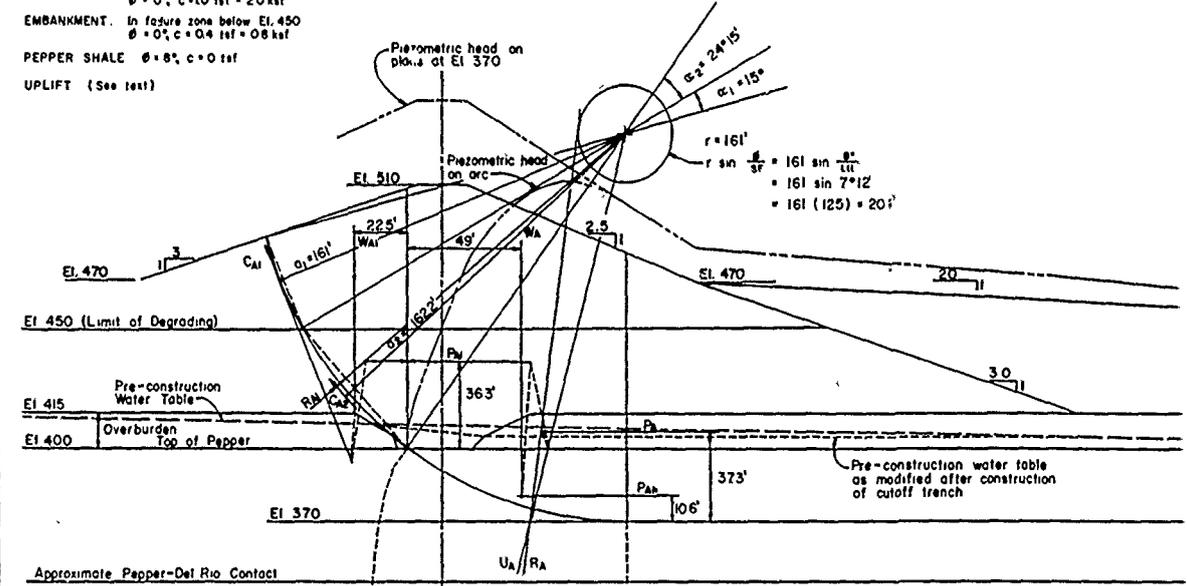
BRAZOS RIVER AND TRIBUTARIES, TEXAS
 WACO DAM
 BOSQUE RIVER, TEXAS
STABILITY ANALYSIS OF REPAIR SECTION
 FOR MAXIMUM PORE PRESSURES THAT COULD OCCUR
 PHI - CIRCLE METHOD
 EMBANKMENT SLIDE AREA - STATION 55+00
 SCALE AS SHOWN

UNIT WEIGHT SOIL = 130 pcf
 UNIT WEIGHT WATER = 62.5 pcf
 SHEAR STRENGTH:
 EMBANKMENT: New construction above
 El. 450, berms, and overburden
 $\phi = 0^\circ$, $c = 10$ tsf = 20 ksf
 EMBANKMENT: In failure zone below El. 450
 $\phi = 0^\circ$, $c = 0.4$ tsf = 0.8 ksf
 PEPPER SHALE $\phi = 8^\circ$, $c = 0$ tsf
 UPLIFT (See text)

$W_{AI} = 528^k$
 $U_{AI} = \text{Negligible}$ } not shown
 $P_{AI} = \text{Negligible}$ } on section
 $L_0 = \sqrt{r^2 - \left(\frac{L_0}{2}\right)^2} = 42.2'$
 $L_c = 2r \sin \frac{\alpha}{2} = 2(161) \sin \frac{15^\circ}{2}$
 $= 322(13) = 422'$
 $q_1 = r \left(\frac{L_0}{L_c}\right) = 161 \left(\frac{42.2}{422}\right) = 161'$
 $C_{AI} = \left(\frac{C}{\sin \alpha}\right) = \frac{20(42.2)}{37} = \frac{84.4^k}{37}$
 $L_0 = \sqrt{r^2 - \left(\frac{L_0}{2}\right)^2} = 68.1'$
 $L_c = 2r \sin \frac{\alpha}{2} = 2(161) \sin \left(\frac{24.29^\circ}{2}\right)$
 $= 322(.210) = 67.6'$
 $q_2 = r \left(\frac{L_0}{L_c}\right) = 161 \left(\frac{68.1}{67.6}\right) = 162.2'$
 $C_{A2} = \frac{C L_c}{37} = \frac{0.8(67.6)}{37} = \frac{84.1^k}{37}$
 P_{AI} = determined from force polygon no 1

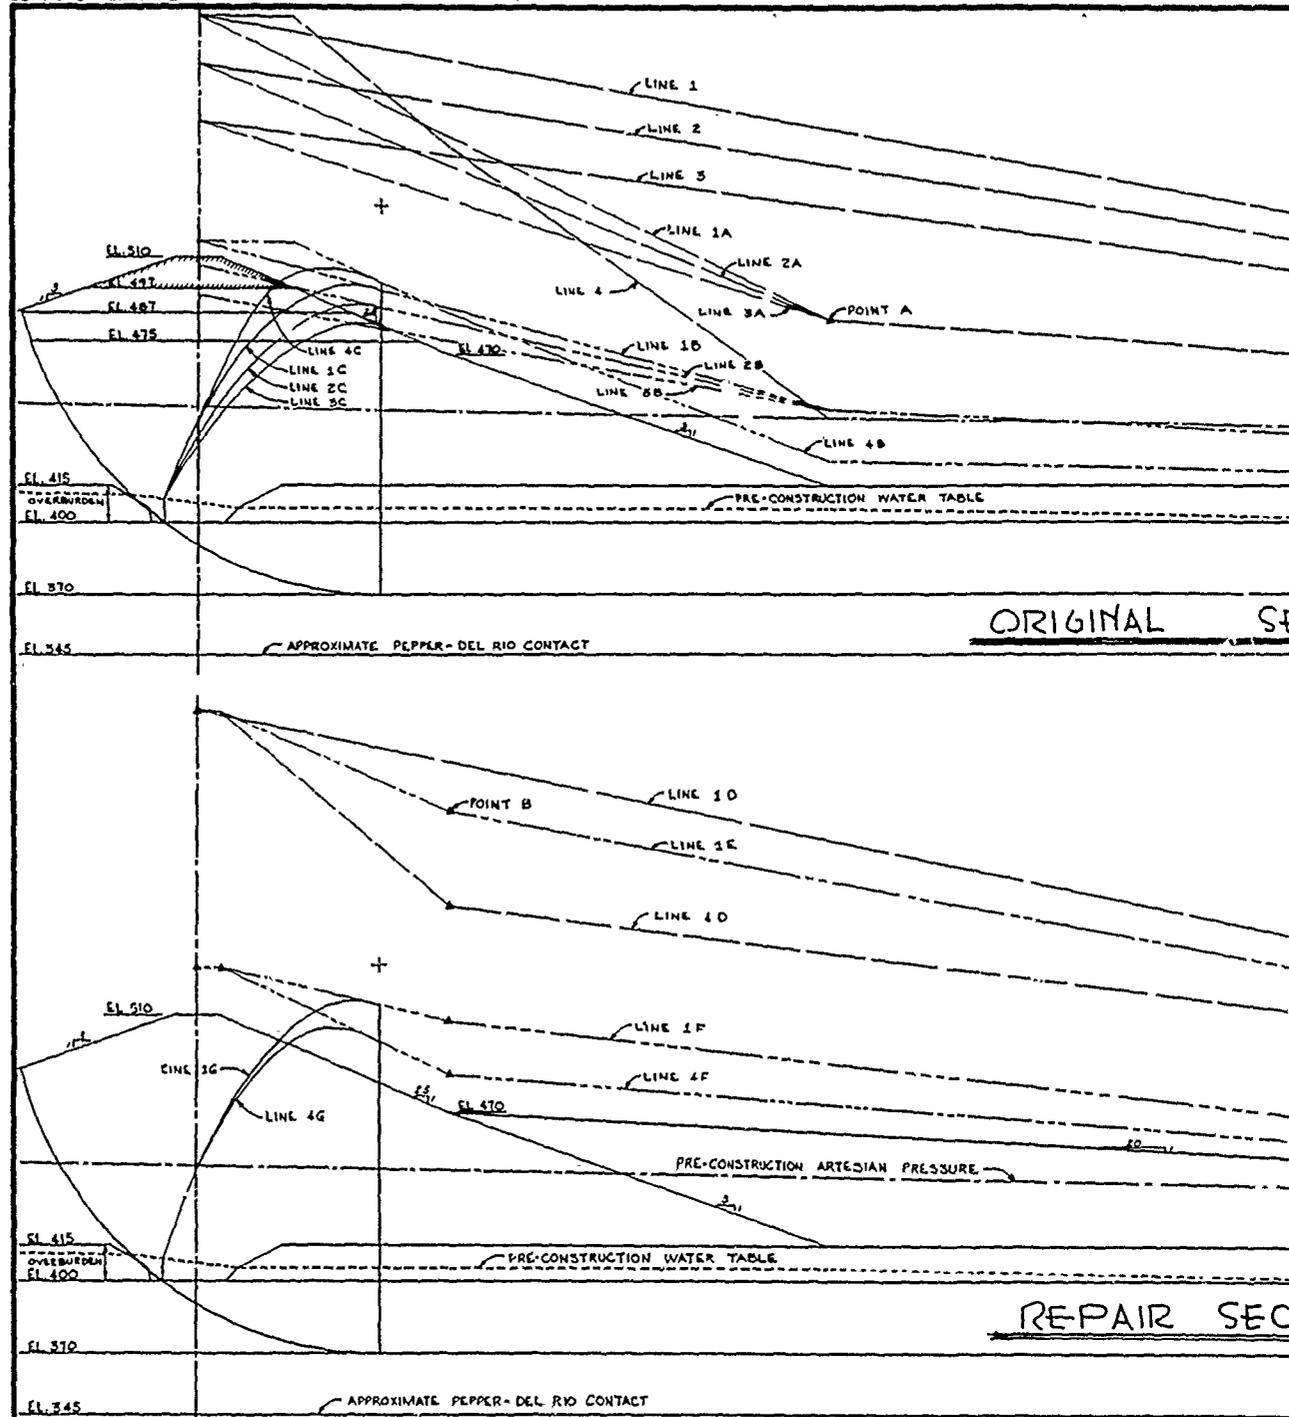
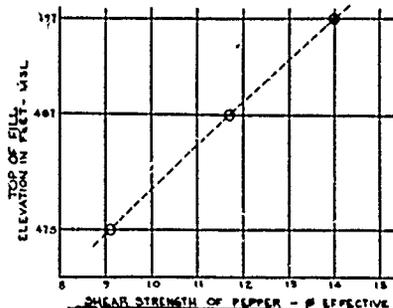
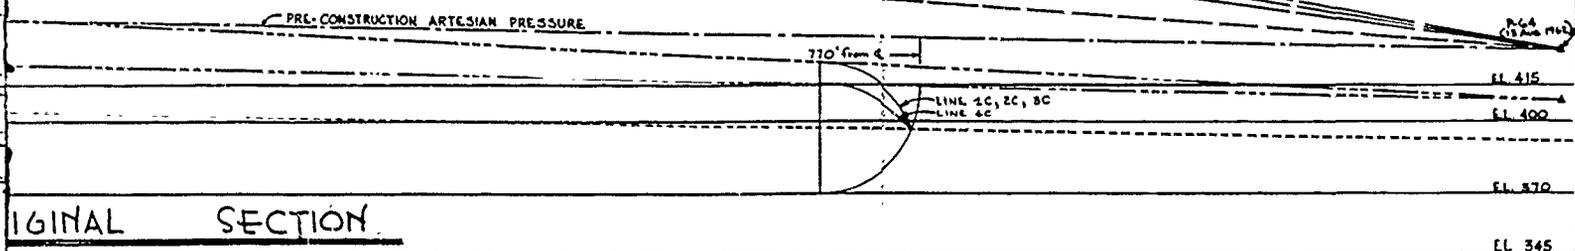
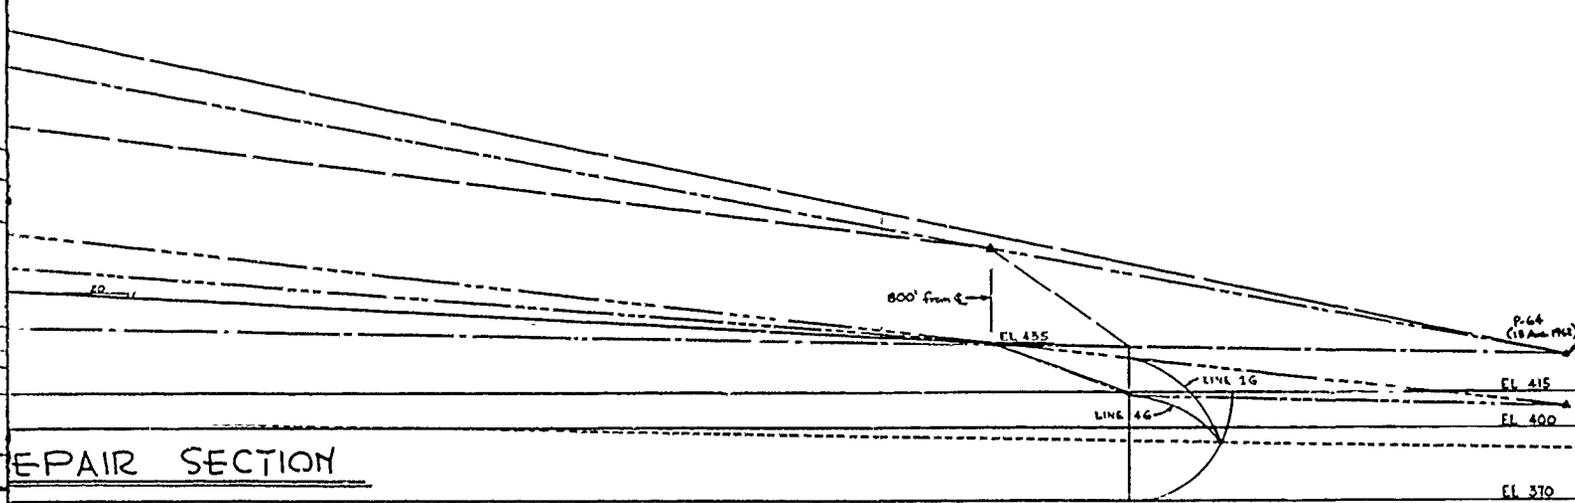
FIGURE 1

1. The slide was analyzed by a simplified procedure for a circular arc plane failure surface to determine the shear strength required for stability (SF=1.0). The shear strength thus determined was applied to the repair section using comparable pore pressure assumptions to determine the safety factor.

2. The slide was analyzed for three elevations for the top of fill to show variation of strength required as construction of fill progressed. The results are summarized in Figure 1. The pore pressures used are identified as line series 1, 2, and 3. The repair section was analyzed using only the shear strength determined from the analysis of the slide with the fill at El. 497, and a safety factor = 1.72 was obtained.

3. The slide was analyzed using pore pressure line series 4, and the shear strength in the Pepper shale was determined to be ϕ (effective) = 9.5 degrees. This value was applied to the repair section and a safety factor = 1.37 was obtained.
