Task Order 2 Enhanced Preliminary Assessment

HAMILTON ARMY AIRFIELD
NOVATO, CALIFORNIA

January 1990

USATHAMA Task Order 2
ENHANCED PRELIMINARY ASSESSMENT REPORT
HAMILTON ARMY AIRFIELD
NOVATO, CALIFORNIA
Contract No. DAAA15-88-D-0007

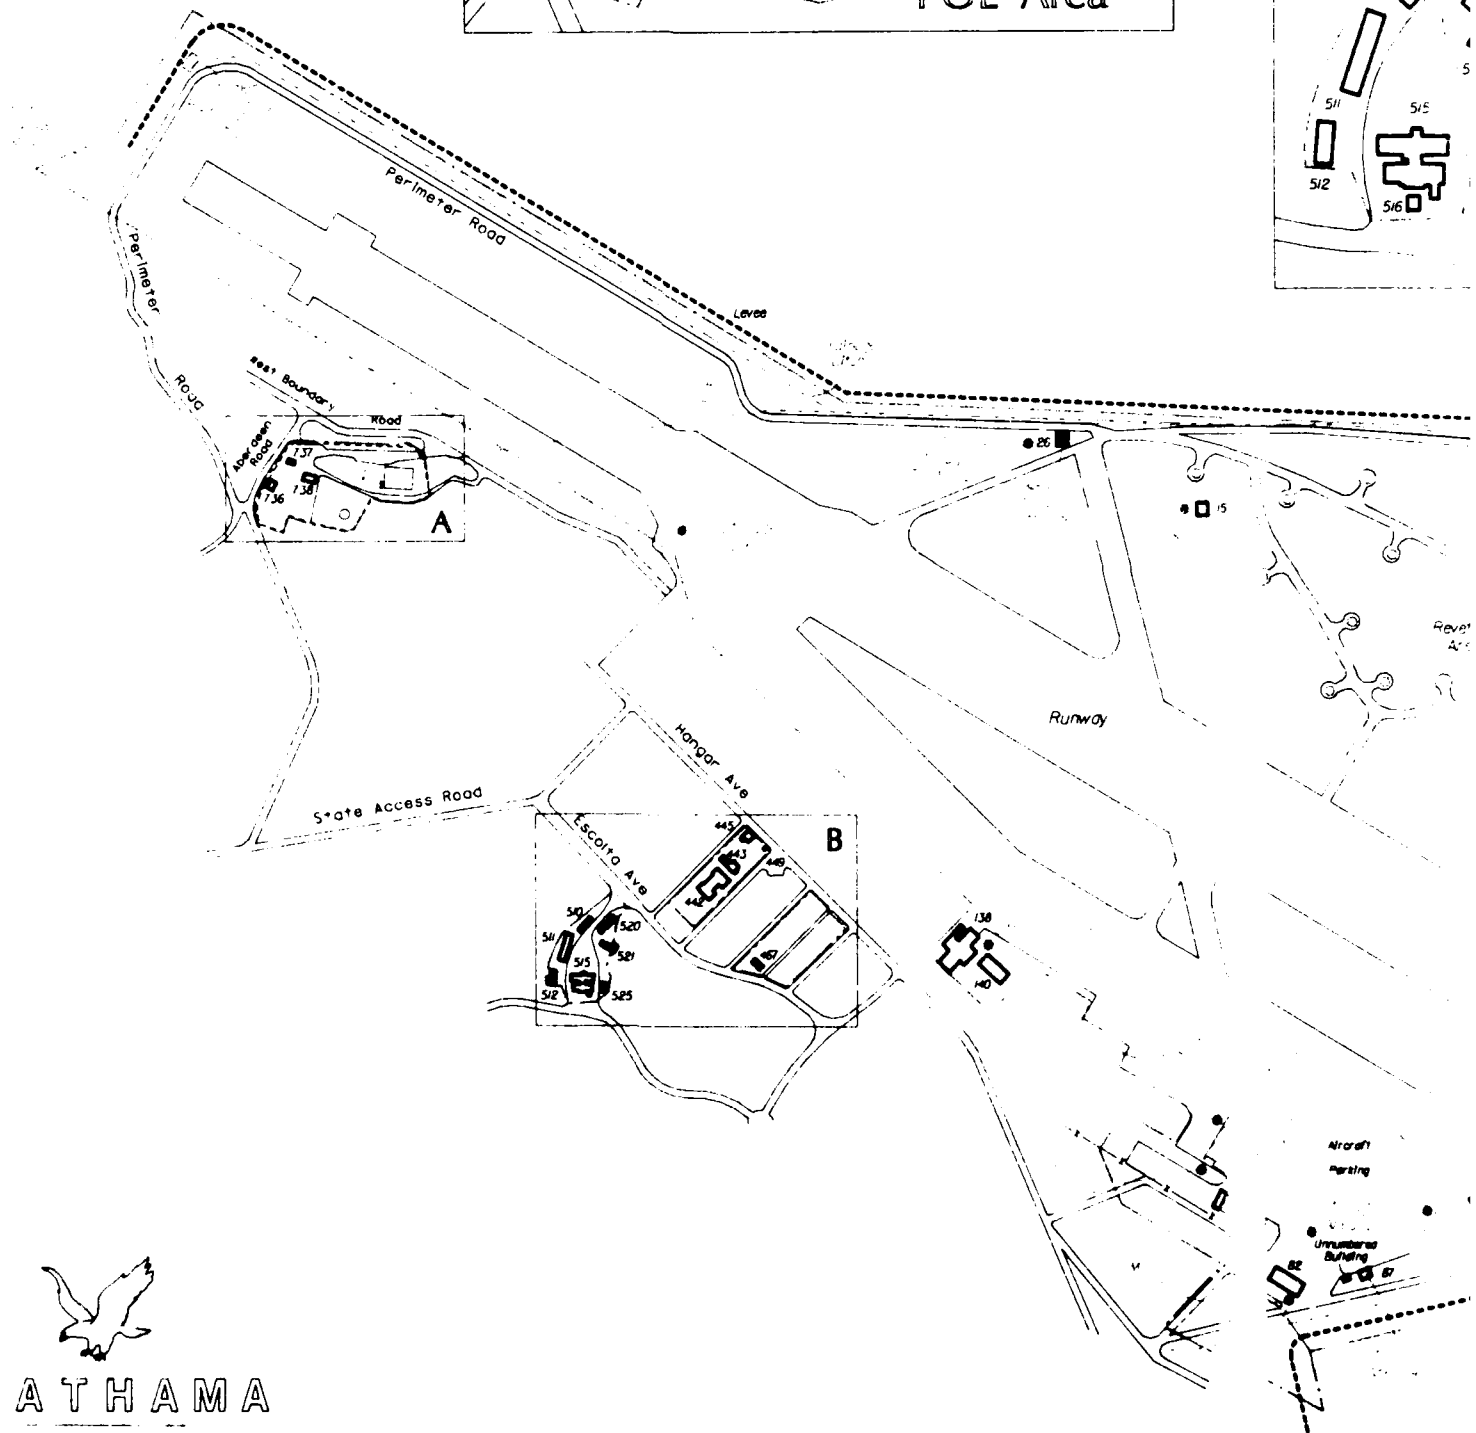
Figure 3-1
Environmentally Significant
Operations

the ground near where they had been used. Reports from HAA personnel indicate that no PCB transformers exist on HAA; however, no documentation or transformer inventory could be found by environmental personnel at The Presidio or Sacramento COE to verify this information [T-1, T-6, T-7]. The exact locations of all transformers within HAA are unknown, and, therefore, are not shown in Figure 3-1.

UST 23 - Several USTs were reportedly located among Buildings 35 through 41 (pump station area, Figure 3-1), but no visible evidence of the tanks was found during the site visit. These tanks may have been removed. There was no information regarding tank size, content, or exact location, but tanks were probably associated with the two generators (Buildings 38 and 40) that powered the pump stations. Those tanks would have contained fuel oil.

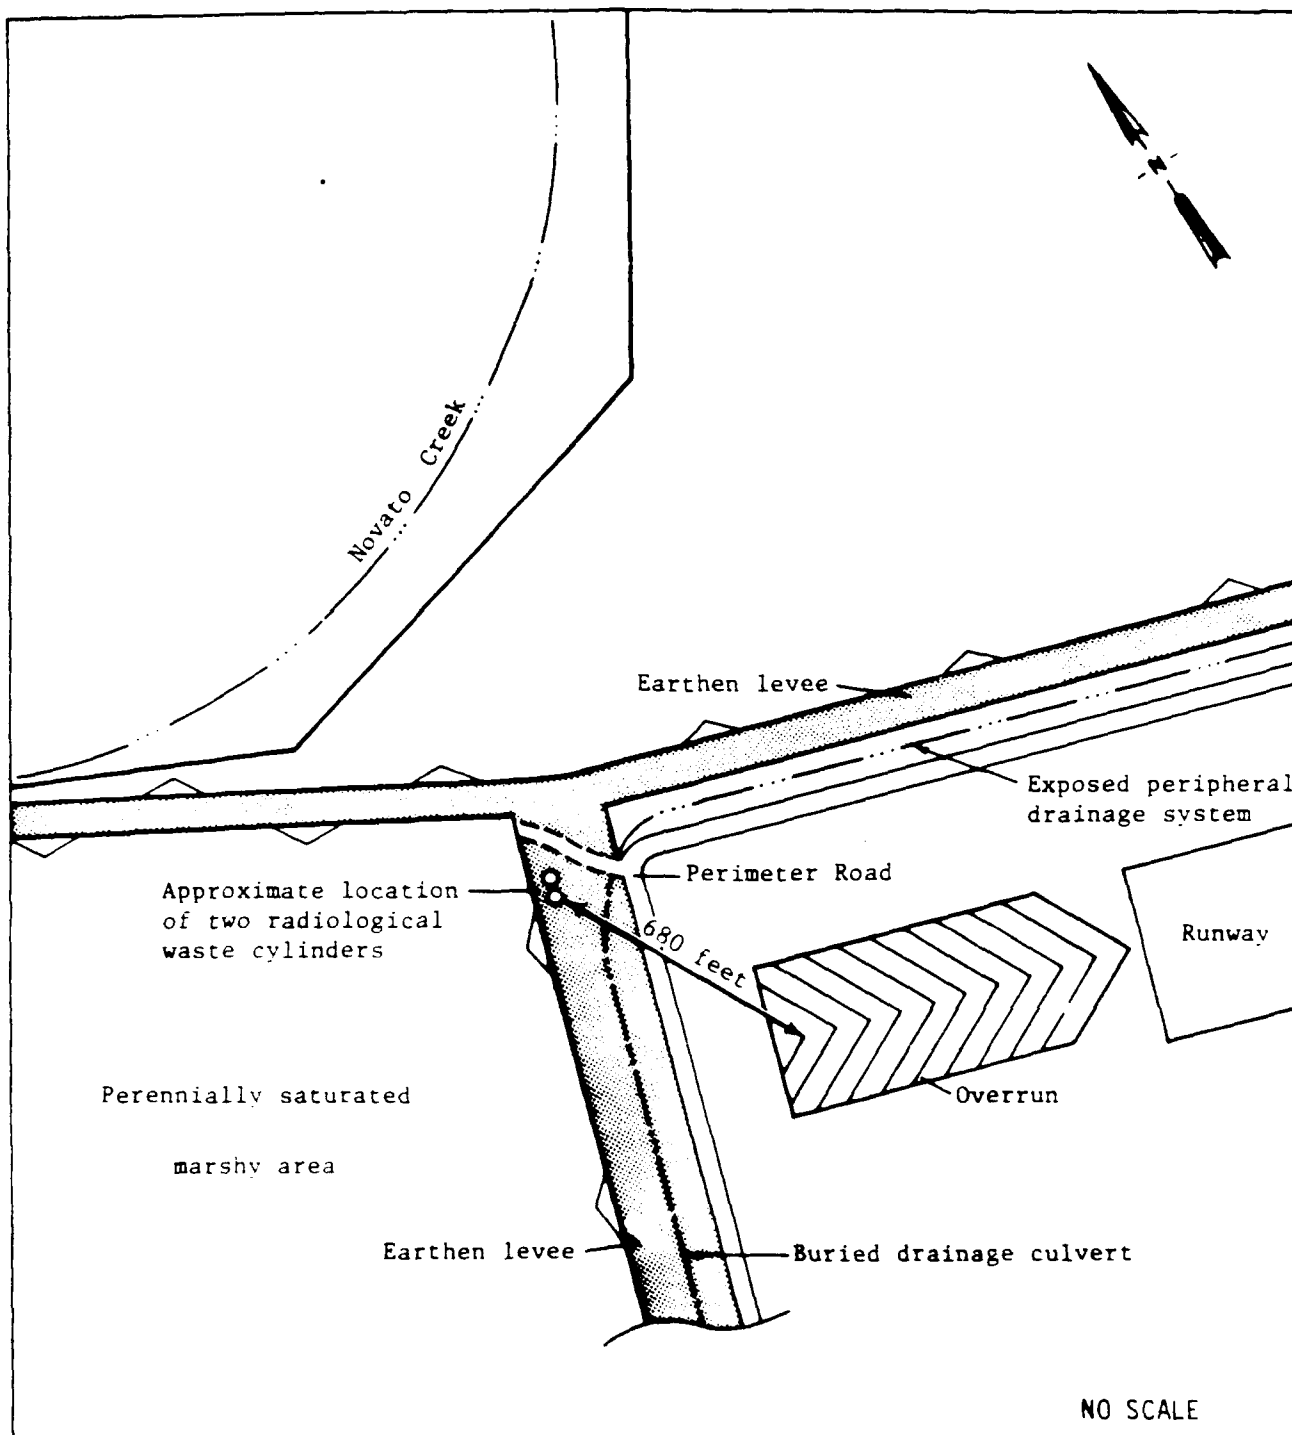
| Project No. 90316A | HAMILTON AFB | Site 6 - Radiological Disposal Site | Figure 7 |

The ground penetrating radar survey covered an area of about 30 feet by 30 feet, which had been cleared of brush in preparation for the survey. Lines were located approximately 4 feet apart. No anomaly which could be considered representative of a cylinder or cylinders was observed in the ground penetrating radar data.

The magnetometer survey located a partially-buried drainage culvert, two partially-buried outfall pipes associated with the base's peripheral drainage system, and two other magnetic anomalies not associated with known
