REPAIR, EVALUATION, MAINTENANCE, AND  
REHABILITATION RESEARCH PROGRAM

TECHNICAL REPORT REMR-CS-30

IN SITU REPAIR OF DETERIORATED CONCRETE  
IN HYDRAULIC STRUCTURES: EPOXY INJECTION  
REPAIR OF A BRIDGE PIER

Prepared for DEPARTMENT OF THE ARMY  
US Army Corps of Engineers  
Washington, DC 20314-1000

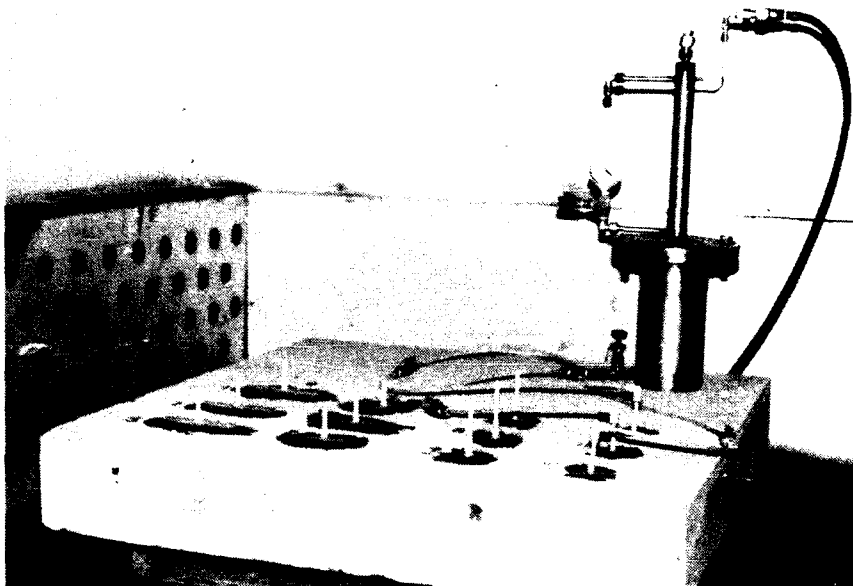
Figure 4. Hydrostatic test set-up used to test injection ports

23. In general, all of the failures resulted from leaks developing around the parameter of the injection port and propagating through the interface of the epoxy seal coat and the injection port. This problem was primarily due to the inability of the epoxy to securely bond to the polyethylene. In no instance did the injection ports physically fail. The results indicate that surface-mounted ports will withstand lower injection pressures than ports mechanically mounted in a drilled port hole. The Lily Injecti-port withstood pressures of 200 to 275 psig when inserted within a drilled port hole, but only 150 psig when surface-mounted. Also, the ability of a surface-mounted port to withstand injection pressures seems to be related to the surface area of the port in contact with the concrete; ports with a larger surface area were able to withstand the least amount of pressure. The surface-mounted Lily Injecti-port withstood the greatest test pressure, 150 psig, while having the least contact surface area,  $0.8 \text{ cm}^2$ . The Type B (refer to Figure 1) surface-mounted port had the greatest contact surface area and withstood the least amount of pressure.

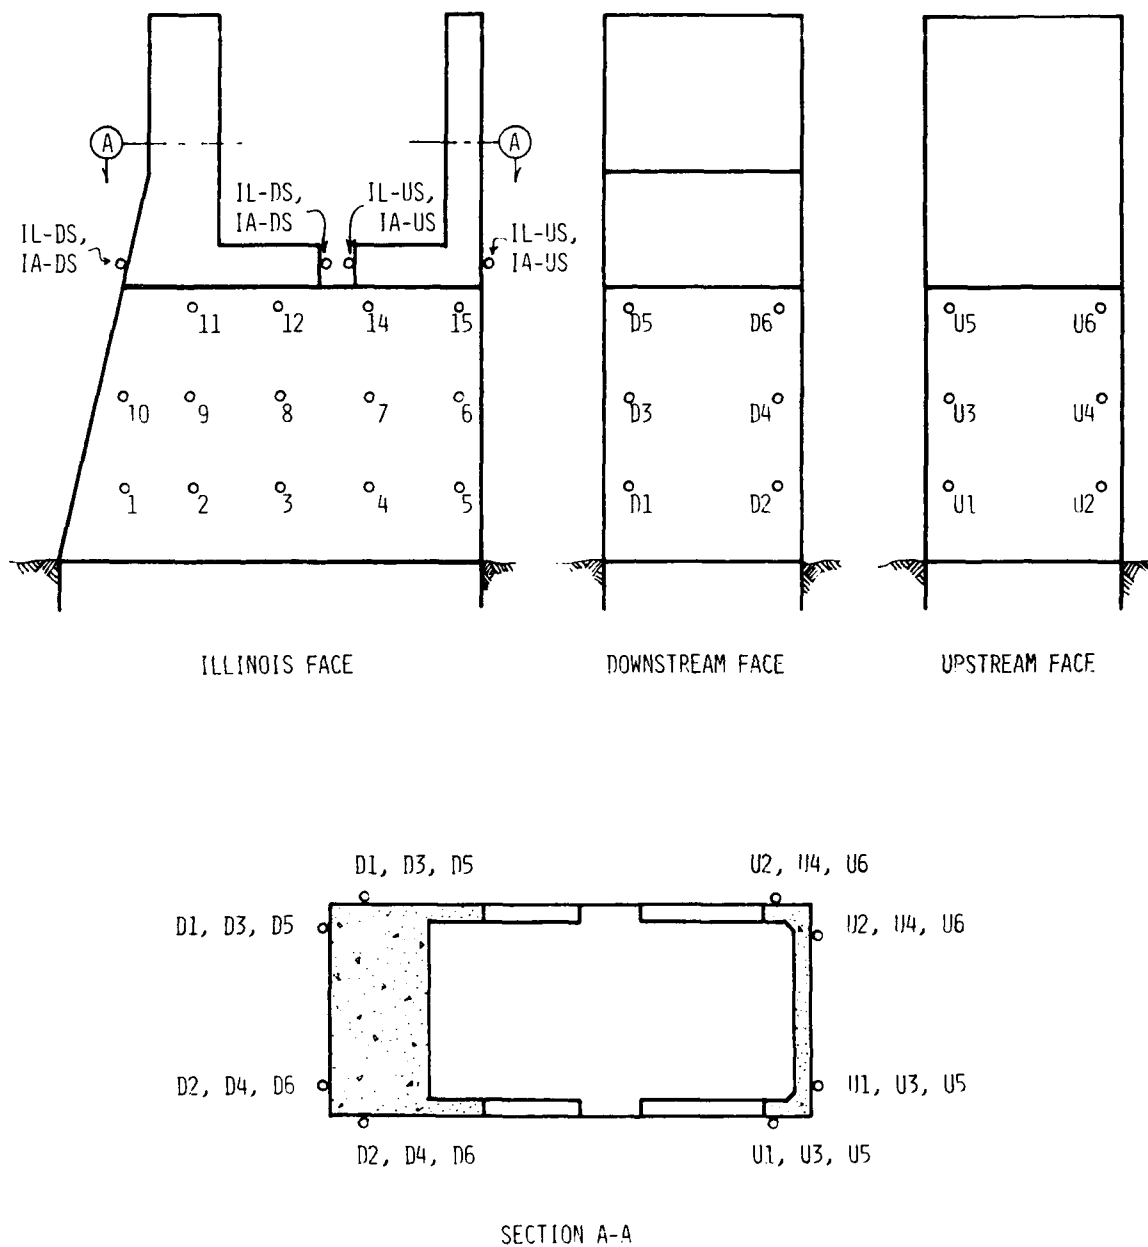
Figure 14. Locations of ultrasonic pulse velocity readings

56. Preliminary PV data were taken between opposite points at 14 locations on the Illinois and Iowa faces of the pier, using the direct transmission method. Readings were also taken diagonally through the corners of the pier using the semi-direct transmission method. The direct transmission method was also used to obtain readings longitudinally through the bridge-bearing seat curtain walls. The general locations of the PV readings are illustrated in Figure 14, and the readings are summarized in Table 3.
