Naval Research Laboratory

NRL Memorandum Report 6861

High Pressure Turbine Blade Life Extension

August 28, 1991

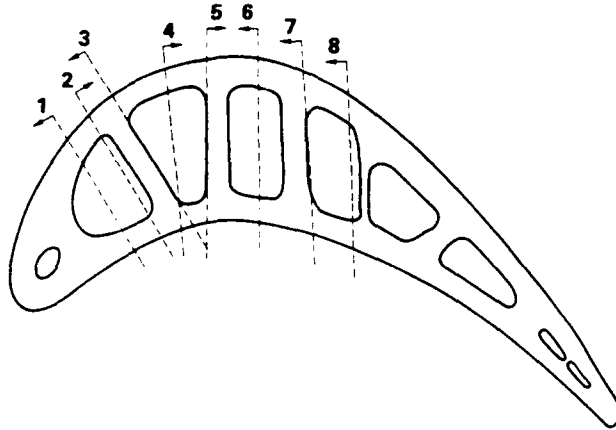
Figure 10. Section views of the microstructure of a DS-R80H blade illustrating the blade-weld interface through the blade cross-section.

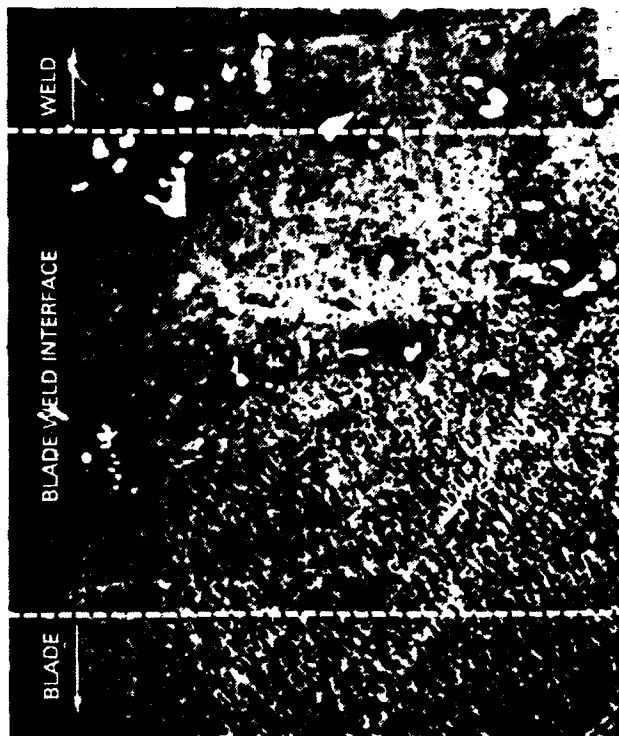
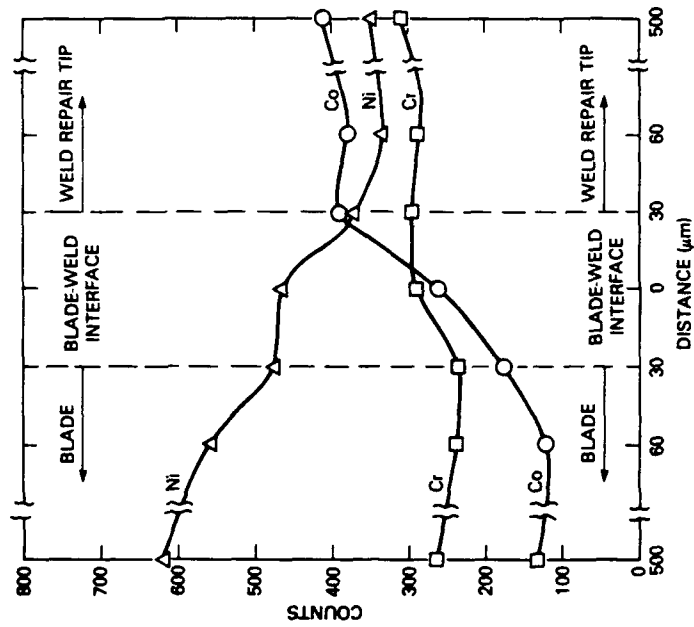
The composition profiles of nickel, chromium and cobalt through the blade-weld interface are shown in Figure 12. The profiles confirm that minimal intermixing of the blade and weld alloys occurred during the tip repair process. Additional detail of the microstructure of the blade/weld interface is illustrated by the TEM micrographs in Figure 13. The micrographs show the change in the microstructure from the blade alloy to the weld as the interface was traversed. The micrographs clearly show the minimal intermixing of the blade and weld alloys which occurred during the blade tip repair process.

Figure 12. Microstructure of the blade-weld interface region and composition profiles detailing the Co, Ni and Cr gradients through the interface.

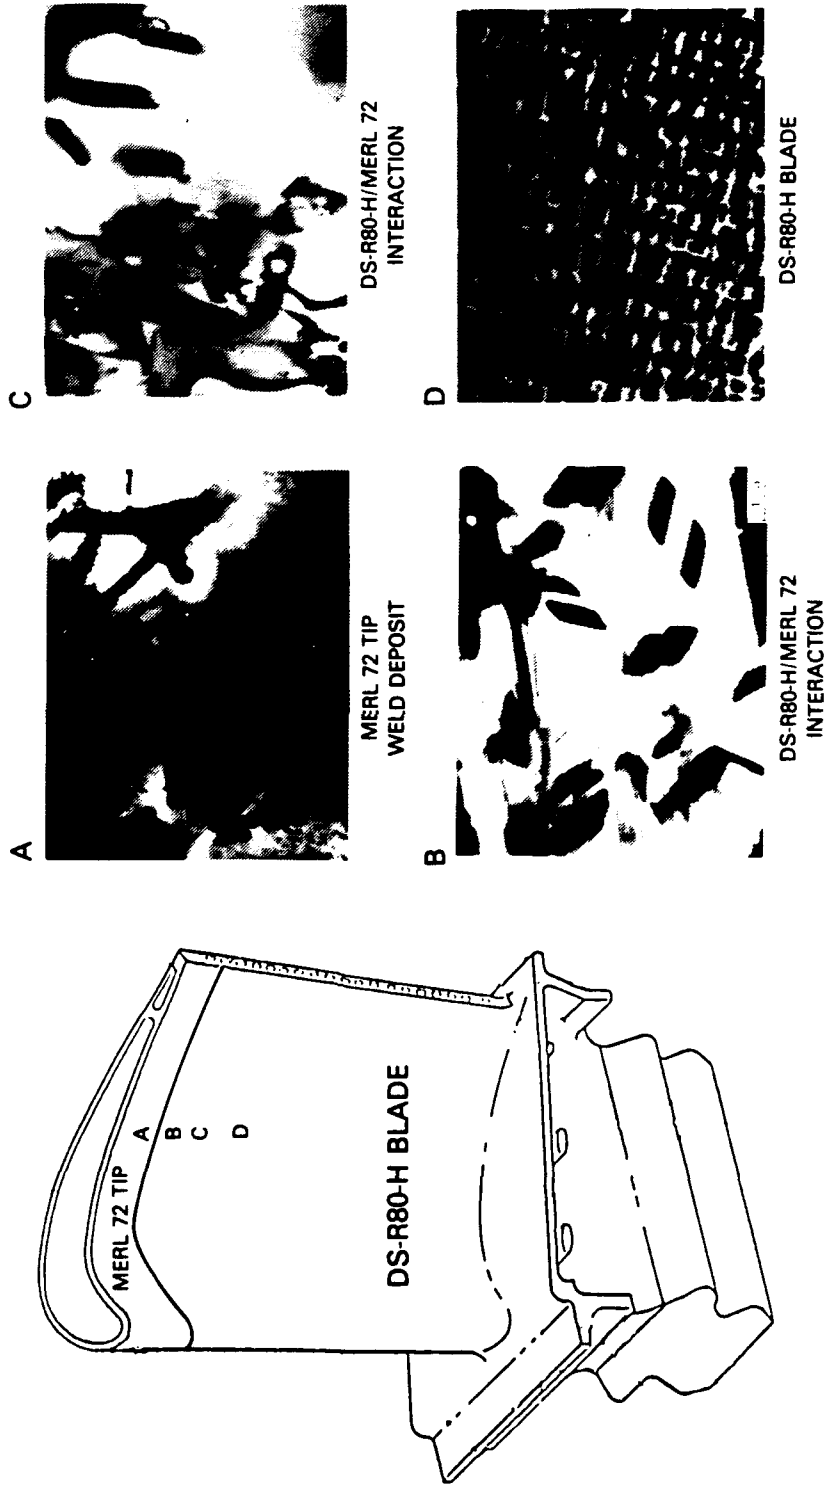
Figure 13. Transmission electron micrographs of the blade-weld interface region showing the change in the precipitate microstructure with location relative to the interface.

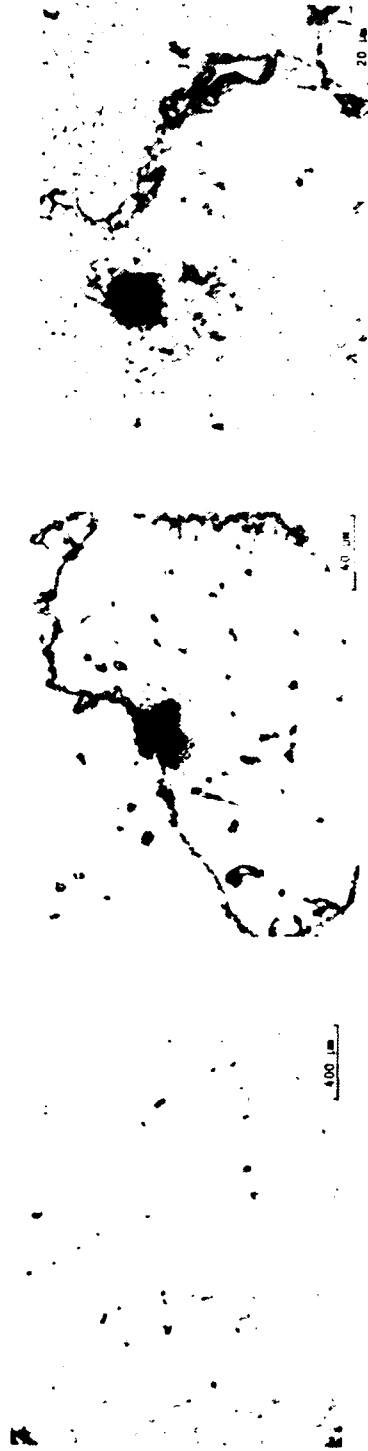
The microstructure of the not-HIP and HIP processed, precipitation heat treated, untested creep-rupture test specimens is illustrated in Figure 23. For both material conditions, the microstructures are seen to be equivalent indicating that HIP processing produced no observable effect on the test specimen microstructure.

Figure 23. Optical microstructure of the not-HIP and HIP processed creep-rupture specimens.

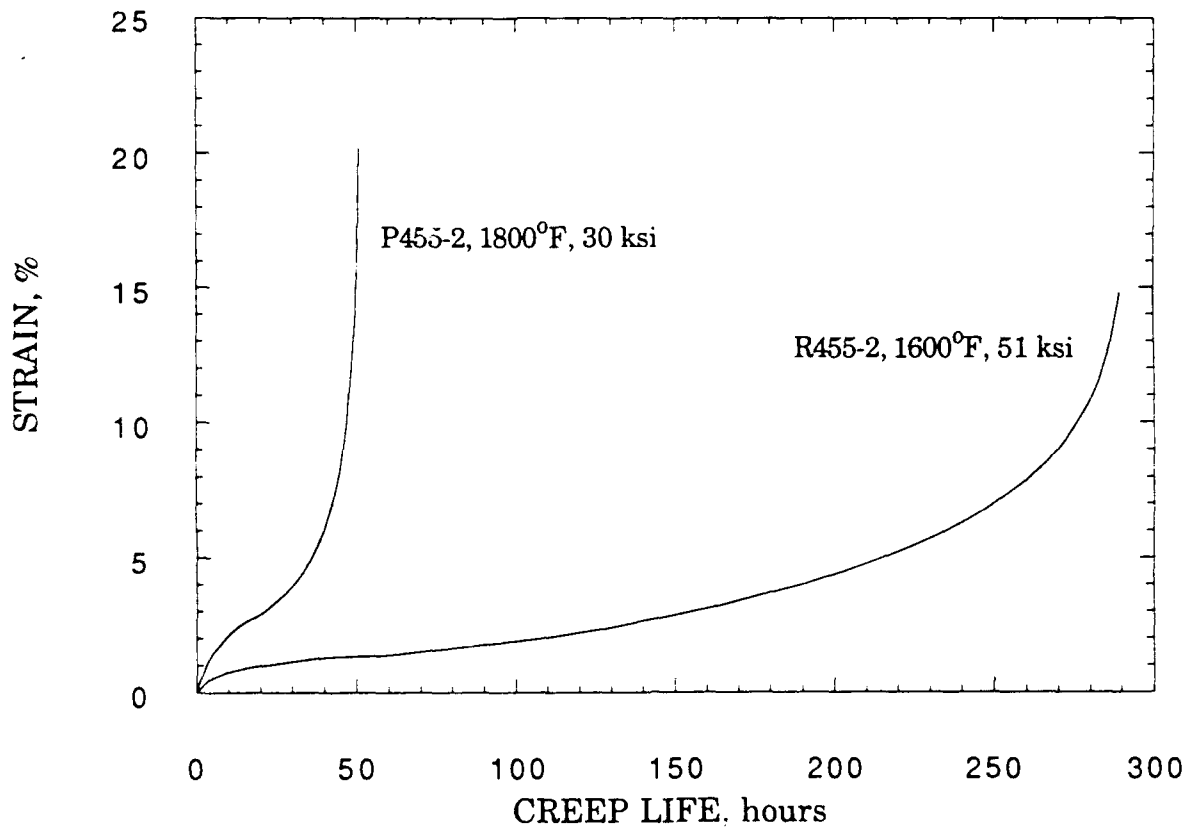
The tensile and creep-rupture test results are summarized in Table 2. The results show that creep ductility increased with increasing test temperature. Typical creep-rupture test results from the DS-R80H specimens, heat treated to include the time at temperature of the coating cycle, are shown in Figure 24 for DS-

Figure 24. Creep-rupture results for not-HIP processed DS-R80H tested at 871 and 982°C.

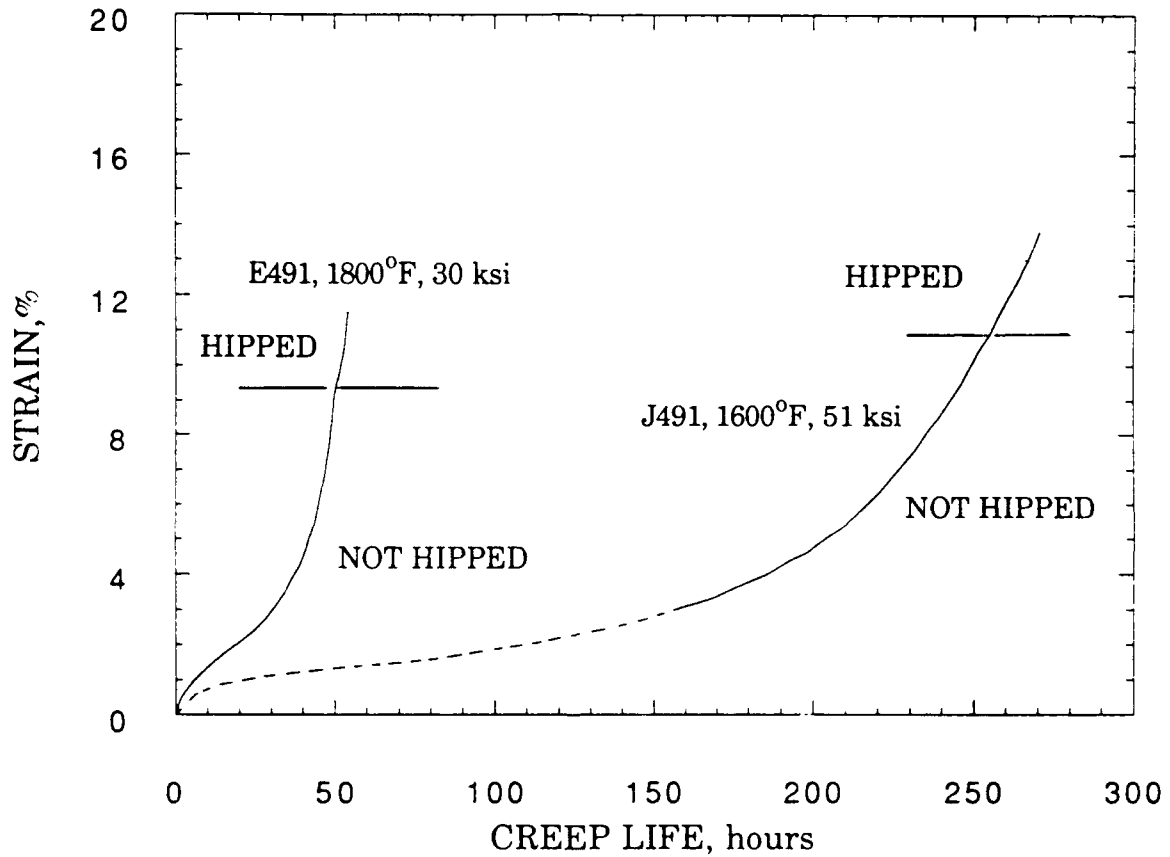
The results in Figure 25 show that the HIP processing provided little change to the creep response of the DS-R80H when compared with the results from the not-HIP processed creep specimens of material 491. As shown in Table 2, the combined not-HIP/HIP processed creep life of specimens of material 491 was slightly reduced from the life of the not-HIP processed specimens tested at both temperatures. In addition, the mid-test application of the HIP and heat treatment cycle reduced the specimen reduction in area and elongation values by approximately 50% when compared with the not-HIP processed condition.

Figure 25. Creep-rupture results for not-HIP processed DS-R80H tested at 871 and 982°C.

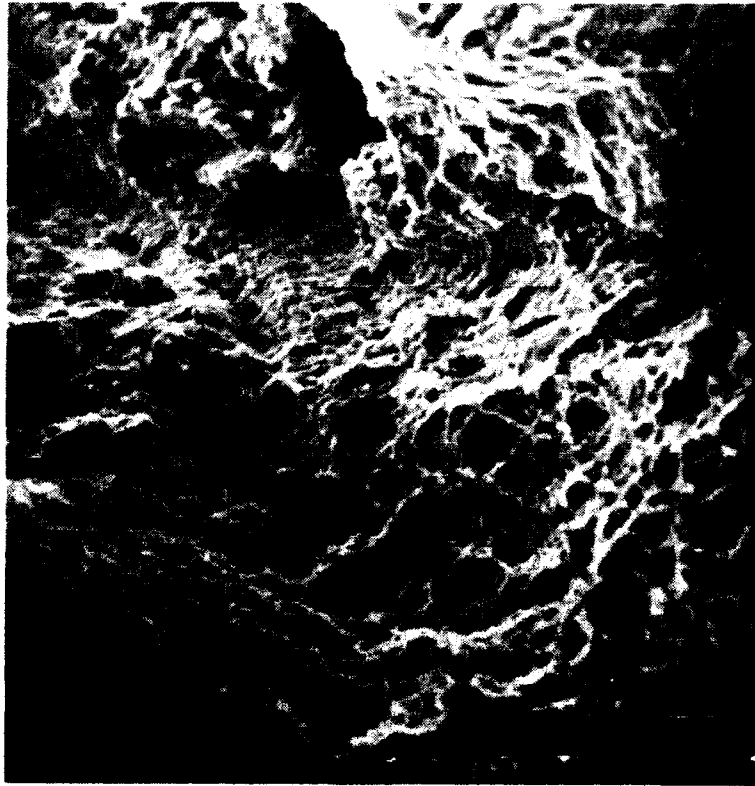
creep life of the MERL 72 was 1.3 hours compared with 289 hours for the DS-R80H. Similar reductions in the creep lives of the MERL 72 occurred at the lower stress levels. The appearance of the fracture surfaces of the MERL 72 creep-rupture specimens is shown in Figure 30. The micrographs show that the fracture surface exhibited microvoid coalescence which was consistent with the high level of ductility observed in the weld material. The results confirm that the weld material exhibited ductility levels consistent with the maintenance of the integrity of the blade/weld interface in the test specimens.

Figure 30. Scanning electron micrographs of the creep fracture surfaces of MERL 72.
