General Document 37

**AIRCRAFT ACCIDENT INVESTIGATION AT ARL  
THE FIRST 50 YEARS**

**J.L. KEPERT**

MARCH 1993

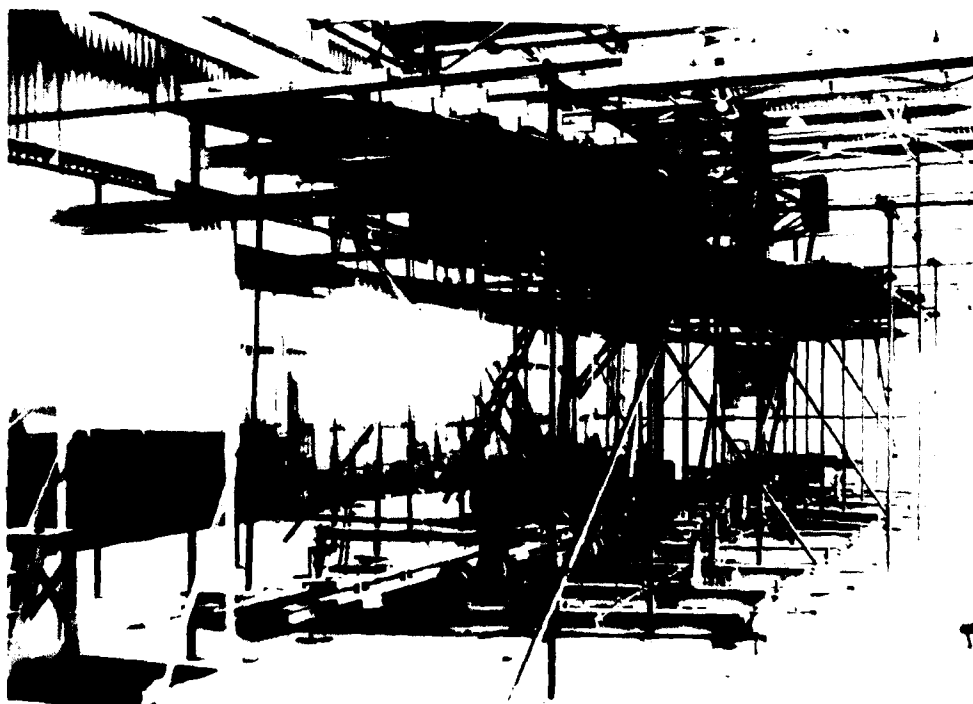
This early work on Anson wing failures generated a comprehensive program of research. The static strength of Anson wings was investigated in a full-scale structural test, Fig. 3. Improved structural analysis techniques were formulated for wooden box beams while the strength and stiffness characteristics of plywood panels and shells were investigated. The ageing properties of UFD were quantified leading, ultimately, to the final grounding, in Australia, of all aircraft constructed with this resin. The effect on bonding strength of extreme temperature and humidity cycles was examined; work which continues to this day in connection with modern fibre reinforced composite materials.

**Fig. 3**      **Anson wing under test. This was the first full-scale wing test to be carried out by ARL**

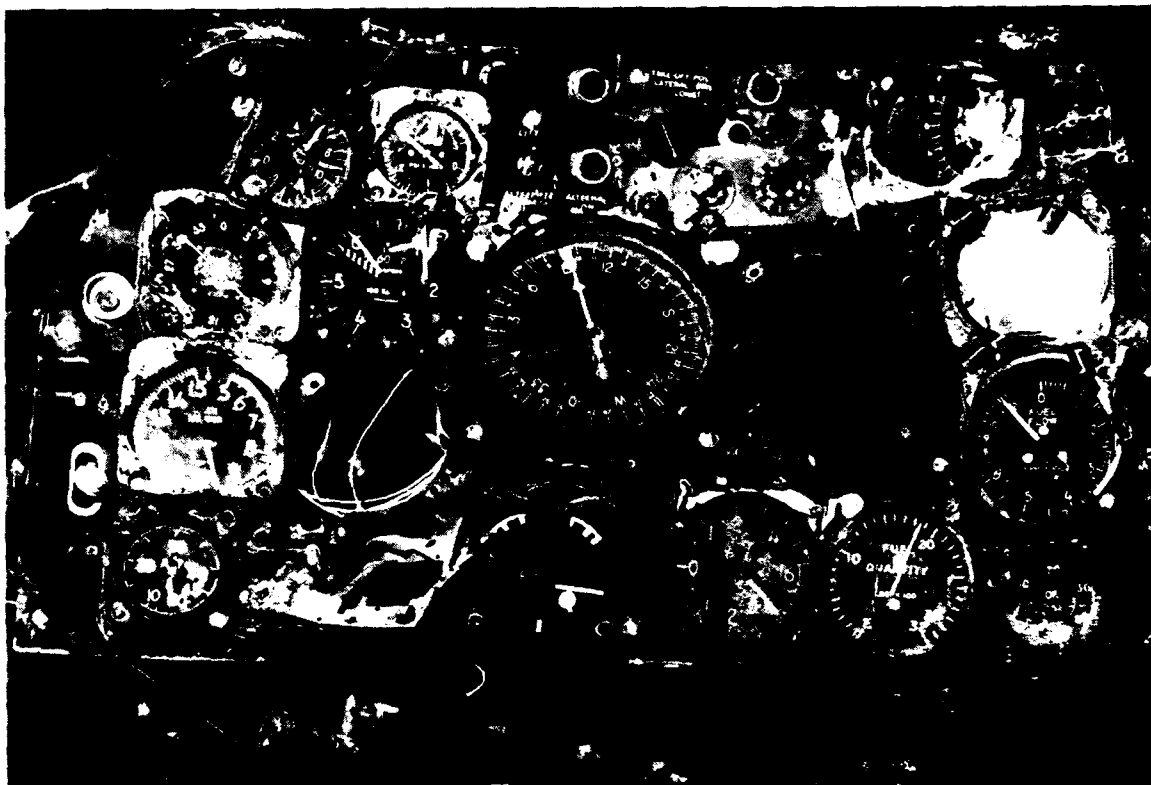
An examination of the instrument panel, Fig. 15, showed that the airspeed indicator and the Mach meter were jammed at readings of 600 knots and 0.96 respectively. Collectively, these indicate an altitude of 3,000 ft for an assumed ambient temperature of 22°C. The recording accelerometer showed a maximum value of +9.1g and a minimum of -4.4g, readings indicative of a violent pitching oscillation. Applied Report 29 concluded that the port wing failed in overload bending when pilot action induced a

divergent short period pitching oscillation at the critical Mach number of 0.96 at an altitude of 3,000 ft.

**Fig. 15**      Instrument panel from A94-360 with Mach meter at left centre

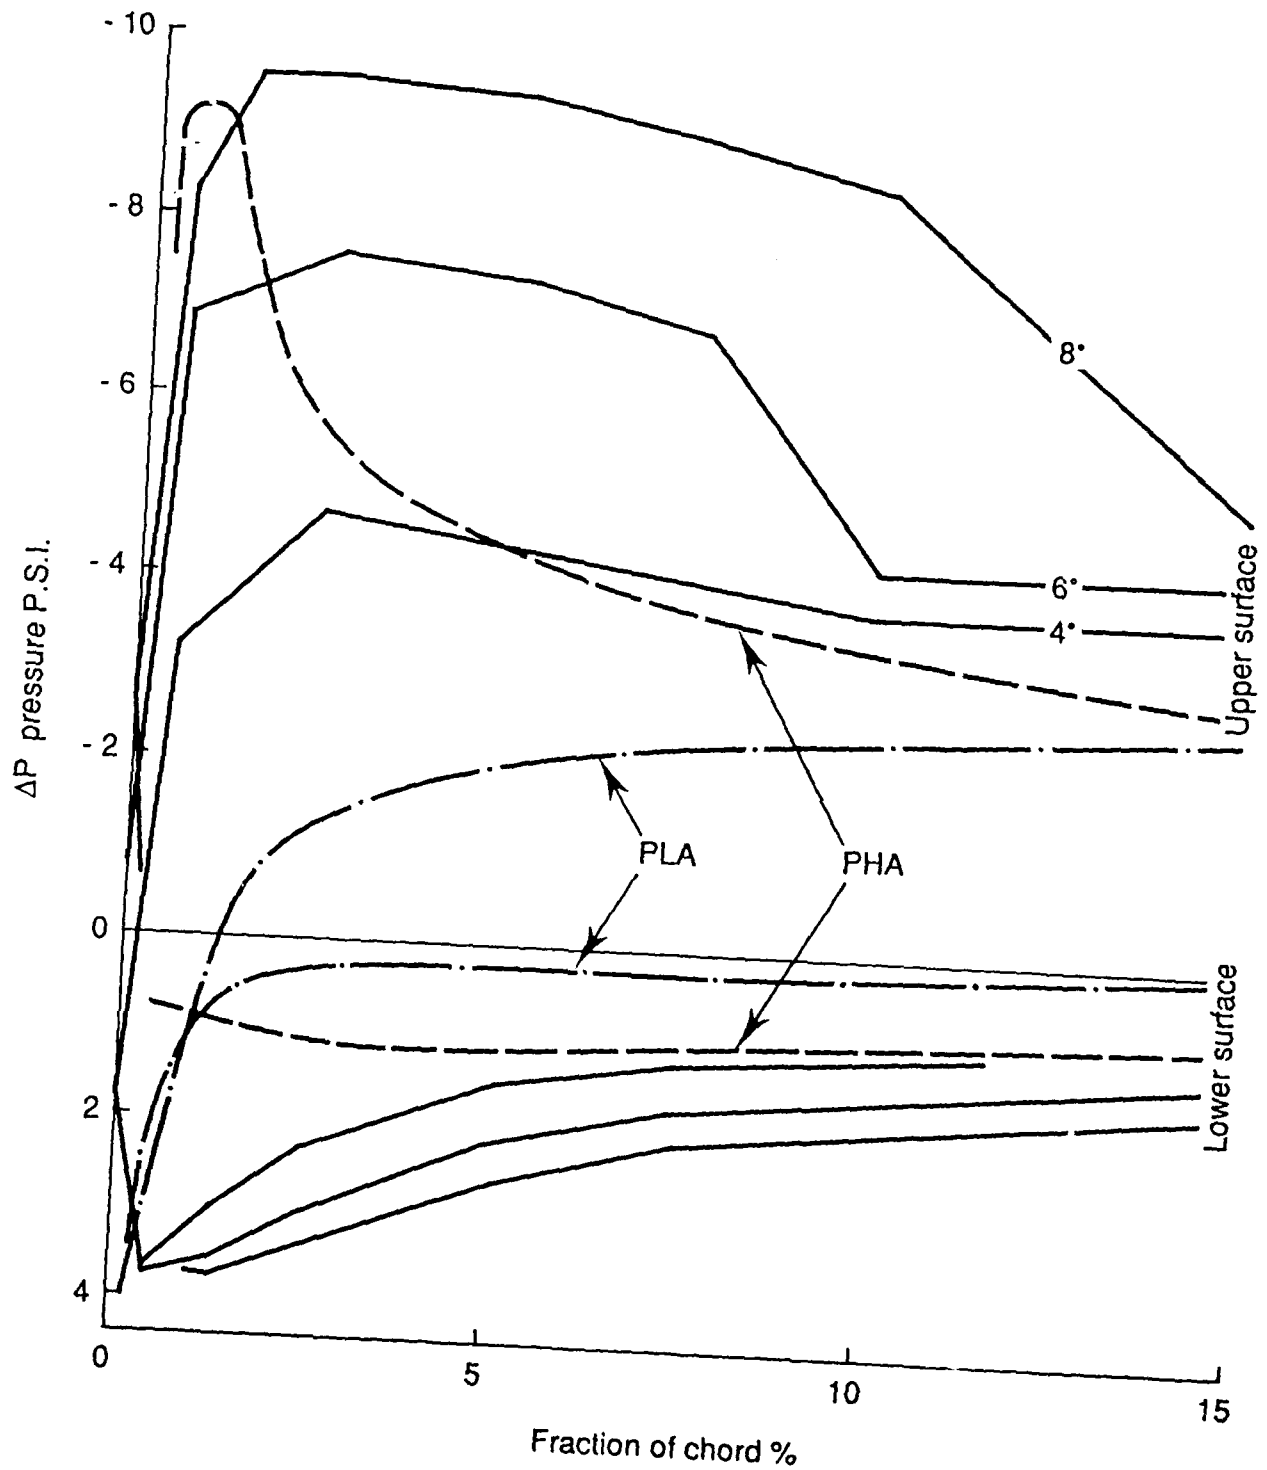
The wind tunnel data from NACA TN3162 show that, with Mach number increasing from 0.52 to 0.62 and  $\alpha$  increasing from  $4^\circ$  to  $8^\circ$ , there is a region where the area of supersonic flow suddenly expands to cover all of the first 15% of chord, i.e. the entire leading edge. The supersonic flow is reflected in the very high suction recorded over the upper surface as shown in Fig. 20 for a Mach number of 0.57. Since A9-754 was flying at 380 KIAS in an ambient temperature of  $28^\circ\text{C}$ , this is the Mach number appropriate to the accident.

For convenience, the pressure distributions for the PHA and PLA (positive low  $\alpha$ ) design cases are also shown in Fig. 20. While these curves are not strictly comparable with the raw two-dimensional wind tunnel data, they are sufficiently compatible to suggest that the total lift load on the leading edge for  $\alpha = 8^\circ$  is roughly double that for the critical PHA design case.

Chordwise pressure distributions at M0.57 for various angles of attack, NACA 64A410 section

A reduction in placard limits was recommended. Lockheed carried out an independent investigation of this accident using a fairly crude finite element model and with aerodynamic loads derived from QUADPAN, an aerodynamics computer code specifically restricted to subsonic flow. They concluded, predictably, that the Orion fully met the design requirements and the accident could not possibly have happened in the way in which it did.

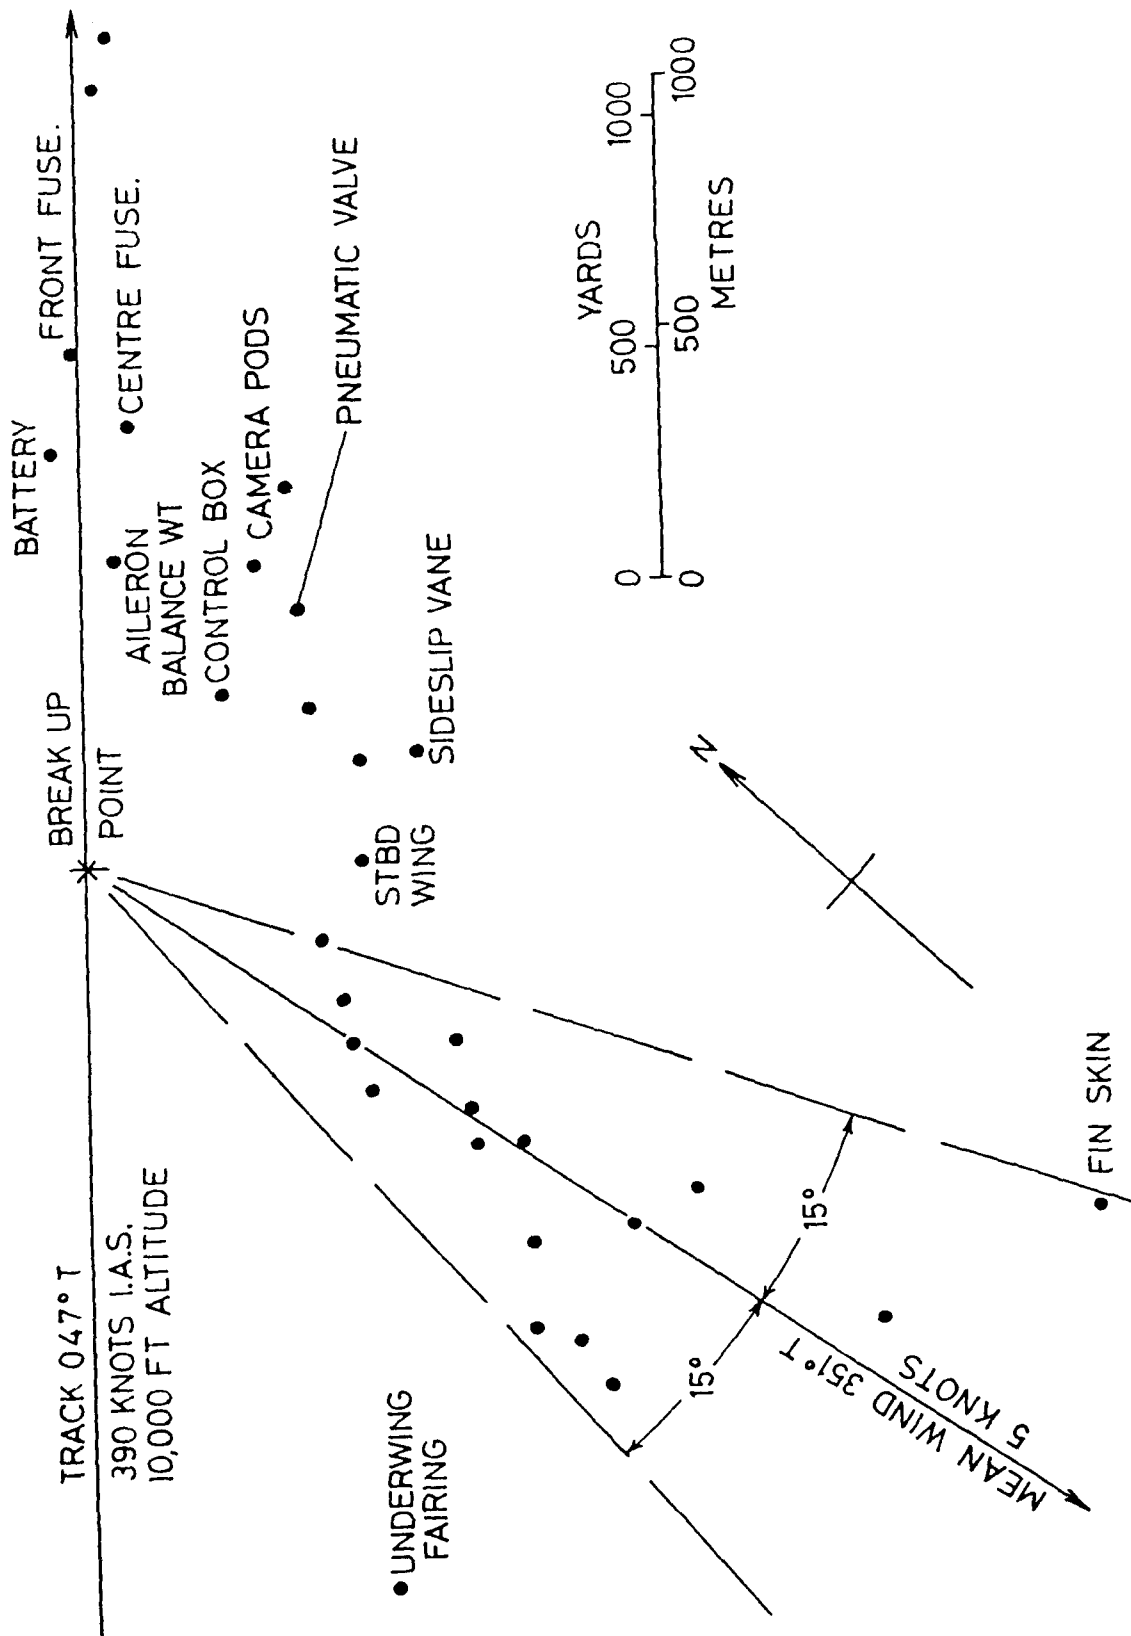
Fig. 34

Jindiviks A92-413 and WRE.493 broke up in flight on 19 February 1965 and 14 March 1968 respectively. Neither of these accidents was investigated by ARL. From an examination of the wreckage layout of A92-413, Fig. 34, the investigating authority concluded that break-up had been initiated by failure of the fin since fin pieces were furthest from the aircraft flight path. Changes to fin manufacturing procedures were recommended. This accident was significant in that it provided the first positive indication that separation of the underwing fairing preceded break-up.

Experience has shown that, following break-up, light wreckage items lose their forward velocity almost immediately and then drift downwind, Structures Note 427. While these items are scattered by turbulence, in most cases they remain within a sector defined by angles of  $\pm 15^\circ$  about the direction of the mean wind and with apex below the point of break-up. If these concepts are applied to Fig. 34, it is clear that the underwing fairing separated some 3.5 - 4.0 sec. before general break-up since it is well back along the flight path from the  $30^\circ$  light wreckage sector. For the fairing to separate in this way, a gross distortion of the fuselage in upwards bending is required.

Jindivik A92-413 Woomera 19 February 1965

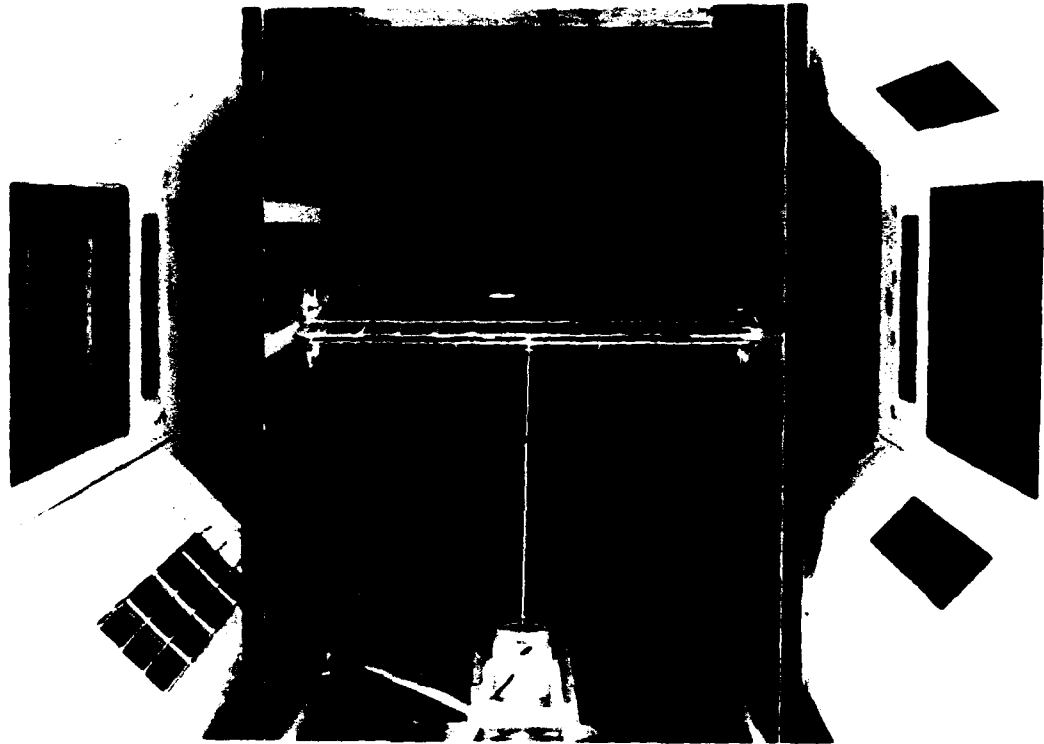
Available unsteady aerodynamic data were considered inadequate for the reliable prediction of the forces acting on a control surface fitted with trailing edge T strips. To obtain better data, a two-dimensional wind tunnel model was prepared by modifying a section of Nomad tailplane and fitting it with 47 pressure tappings enabling the chordwise pressure distribution to be measured. During wind tunnel testing, shakers oscillated the tabs at various frequencies to represent the conditions prevailing during flutter, Fig. 35. Tests were carried out at tunnel speeds of 80 and 100 knots, with and without T strips. The results obtained enabled the preparation of a correction matrix to modify the theoretical pressure distributions so as to agree with measured values.

**Fig. 35** Nomad tailplane under test in the ARL low speed tunnel. Trailing edge T strips were not fitted for this test

Using these ground resonance and wind tunnel test data, the theoretical analysis gave critical flutter speeds within the range 73-132 KEAS depending upon assumptions made with respect to aerodynamic and structural damping. Best estimates of the damping present, and other parameters, gave a most likely flutter speed of 103 KEAS which was in close conformity with the estimated airspeed at the time of the accident. Perhaps the most significant outcome of the theoretical analysis was that it showed the existence of flutter at frequency parameters well above the range normally considered practicable by simplified design criteria such as the Broadbent Criterion. This was the criterion used by GAF to clear the Nomad for test flights. Such criteria are empirically based and can only be relied upon when aerodynamic surfaces are conventional in the sense of past practice.

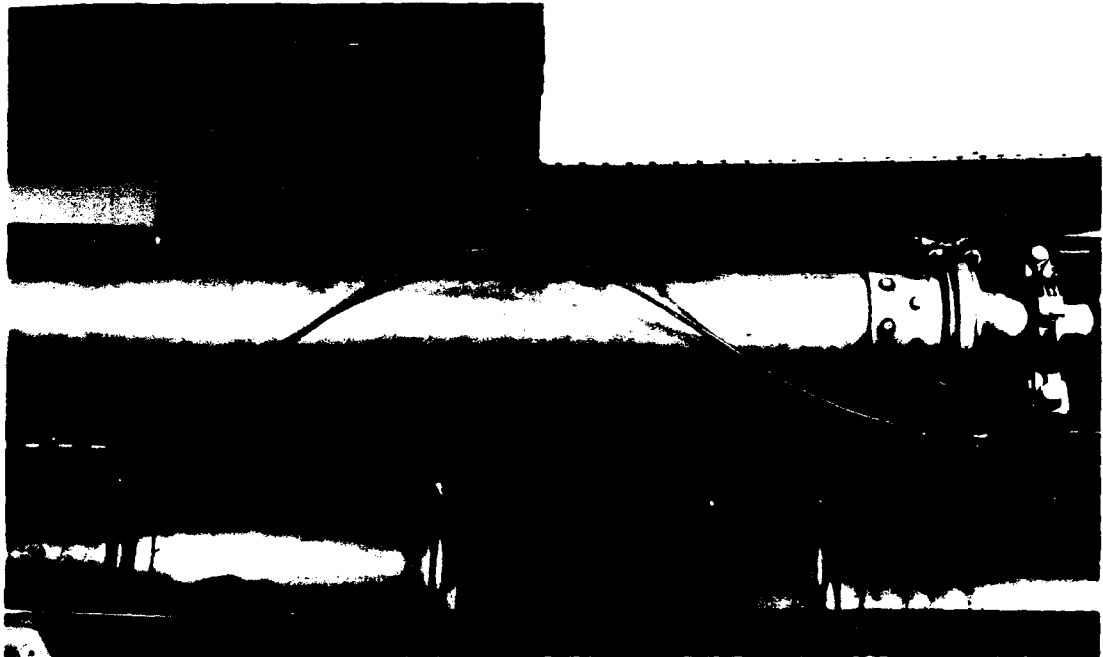
The accident sequence was now clear. A slack cable was simulated in the laboratory, Fig. 48, by allowing a correctly tensioned cable to slip off the quadrant. Vibration tests on the slack cable demonstrated that it would quickly jump over the cable shield and, inevitably, come into contact with rivet heads on the drive shaft, Fig. 49. The friction of this contact would pull the cable into a position where it would be picked up by a coupling bolt, Fig. 50. In consequence, there would be an abrupt application of full left pedal, the tail rotor blades would contact the fin, the aircraft would yaw wildly and violent mast bumping would result. The question was, why did the starboard cable slip off the quadrant?

**Fig. 48**      **Laboratory simulation of slack starboard cable**

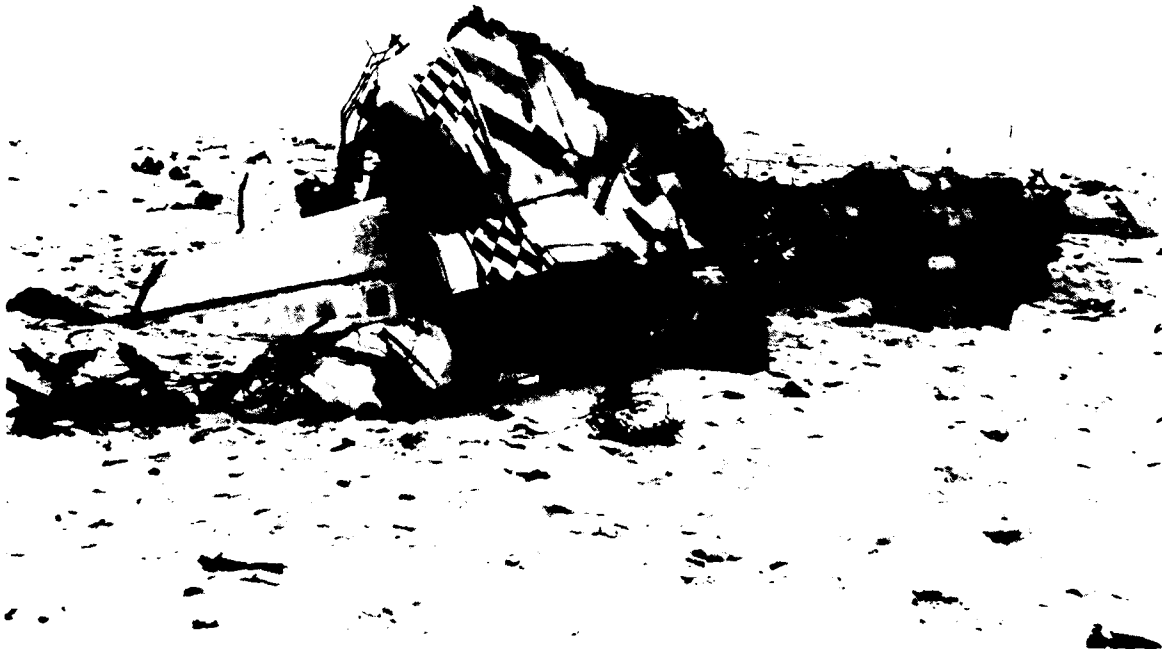
On 10 February 1960, CAC Sabre A94-924 crashed near Williamtown, NSW, Fig 55, after its engine failed at a height of 600 ft. A strip examination of the engine disclosed fatigue failures in the gear teeth of the high pressure fuel pump drive. Four weeks later, Sabre A94-926 suffered a similar fate when it crashed near Williamtown on 7 March 1960 following engine failure at 200 ft, Fig. 56. On this occasion, the engine failure resulted when a distorted and displaced cooling air duct allowed the turbine disc to overheat. The disquieting feature of these two accidents was that in neither case had the pilot attempted to eject; while the canopy had been jettisoned, the ejection seat gun had not fired.

Fig. 55      A94-924 on the beach near Williamtown

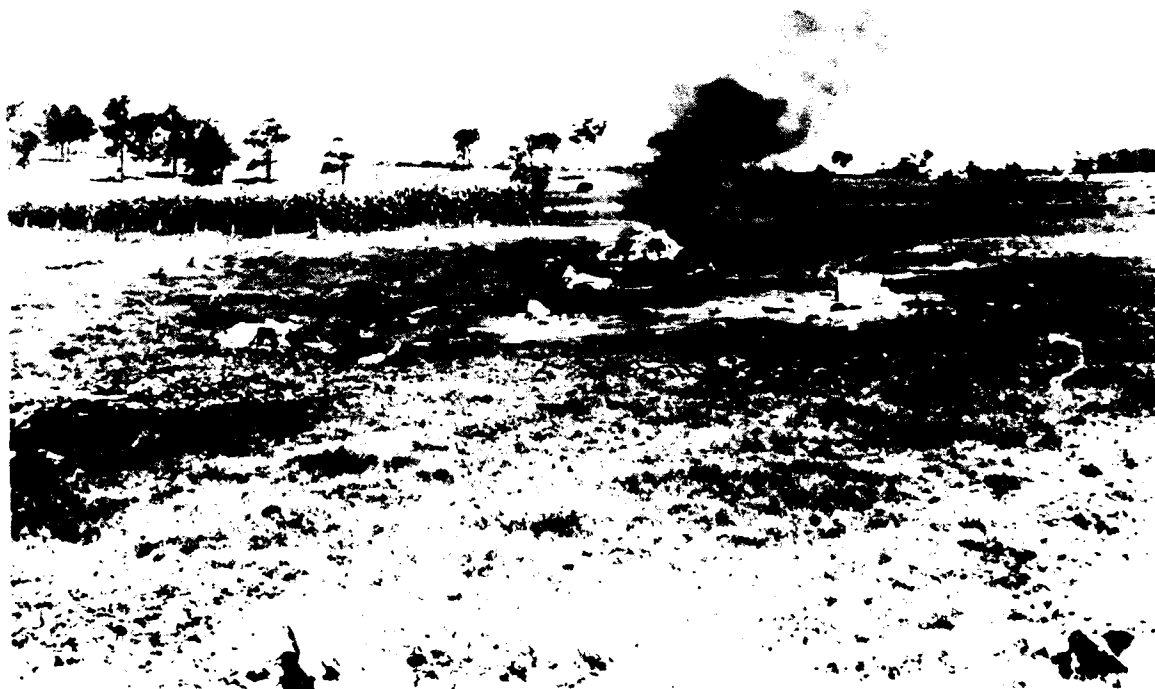
**Fig. 56**      **A94-926 ended its days in a paddock**

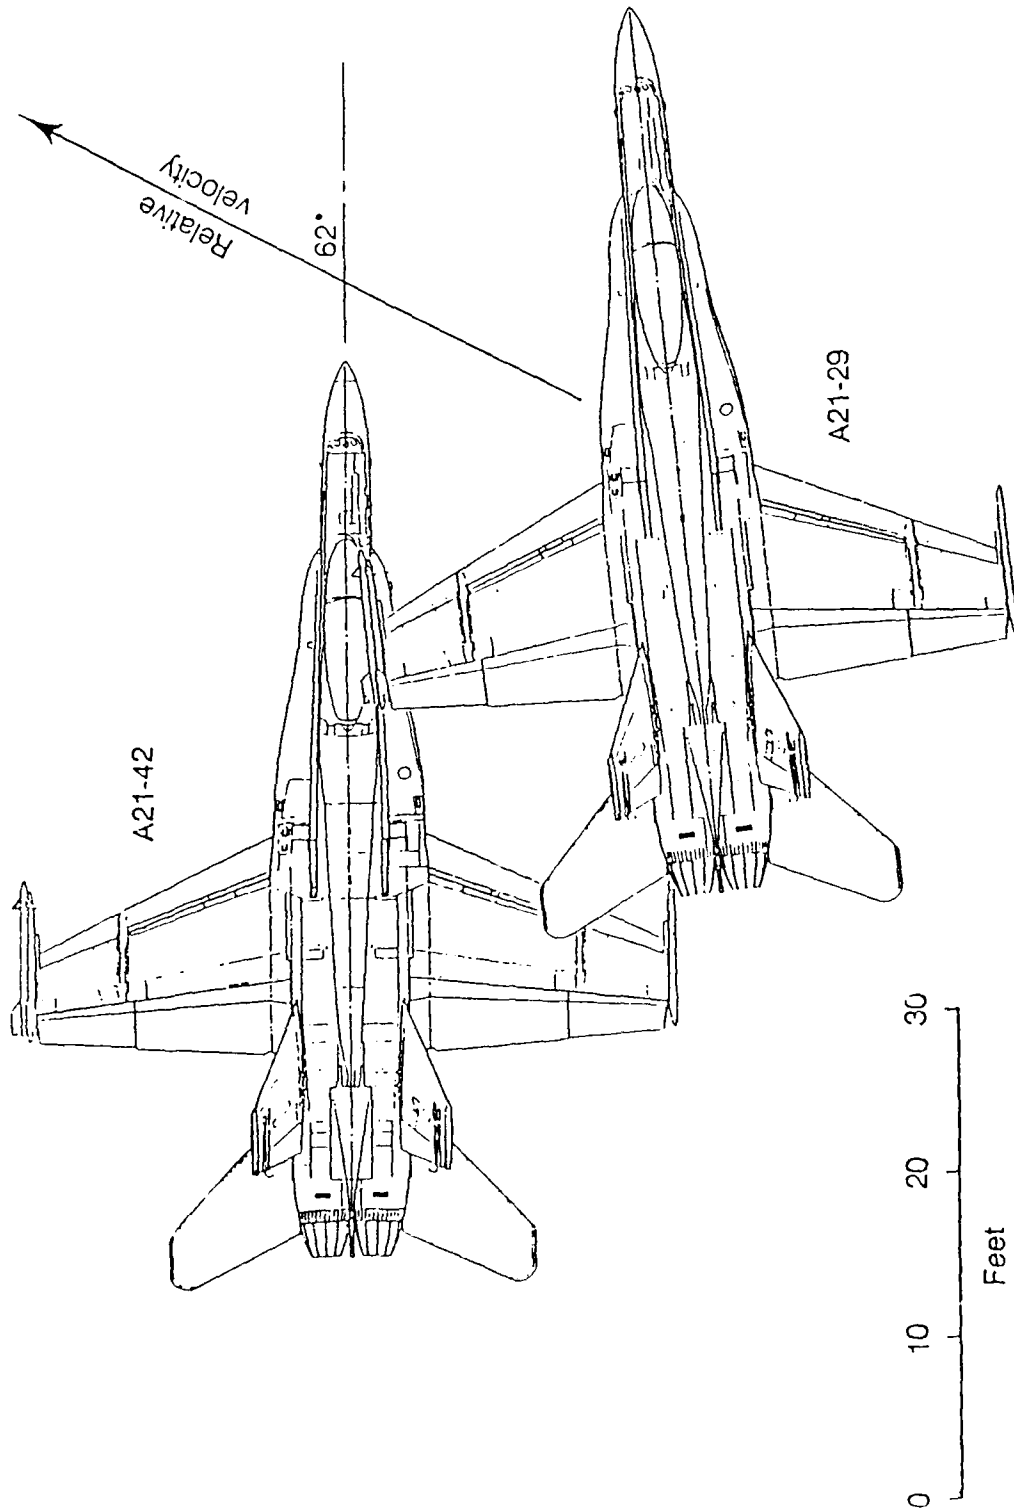
- a. The forward section of the missile on the port wing of 29 impacted the windscreen of 42, Fig. 61. The seeker head, fuze and warhead separated from the missile and the windscreen disintegrated.
- b. The missile motor impacted the canopy which was destroyed. The motor separated from its launcher and struck the pilot's head and the ejection seat.
- c. Simultaneously, the nose of the launcher on the starboard wing of 42 contacted the port jet orifice of 29 causing the launcher to separate.

Reconstruction of the collision geometry enabled the relative velocity vector to be established. As shown in Fig. 61, this was essentially lateral with a magnitude of only 50-55 knots. Under the circumstances, it was not surprising that the pilot of A21-42 failed to see A21-29 nor that he failed to eject.

**Fig. 61**  $t = 0$  the two aircraft at initial contact with the port missile of A21-29 impacting the windscreen of A21-42 and the starboard launcher of A21-42 touching the port jet orifice of A21-29

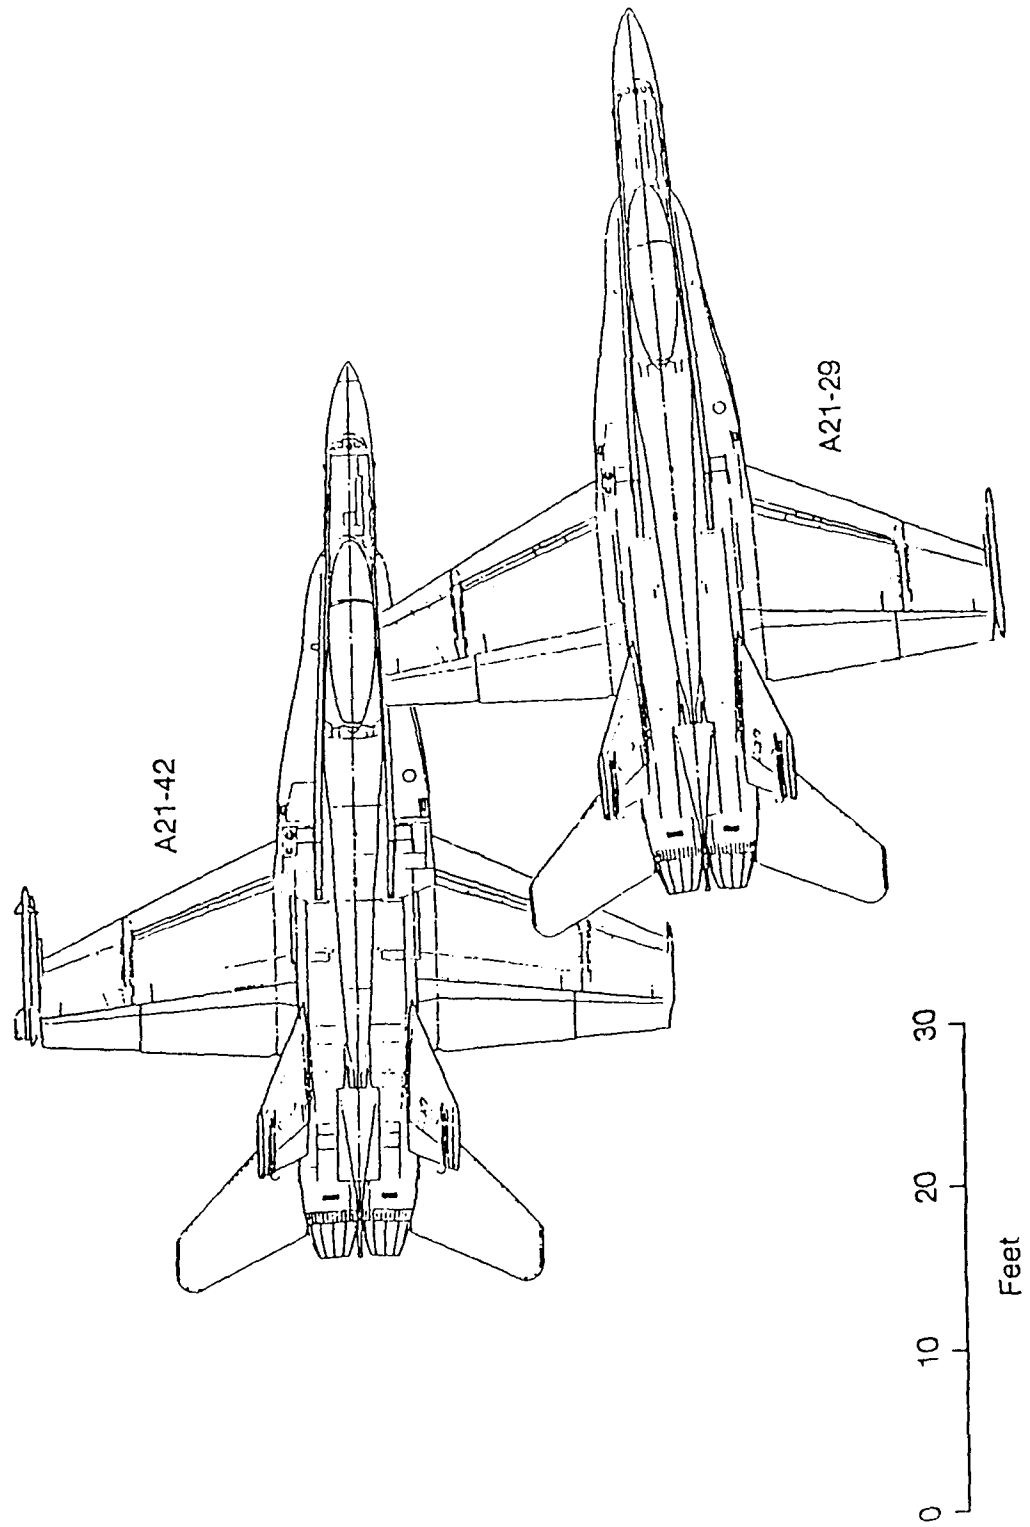
**Fig. 62**  $t = 0.022$  sec following separation of the missile, the port wing of A21-29 penetrates the cockpit of A21-42 while the port tailplane of A21-29 contacts the starboard wing of A21-42

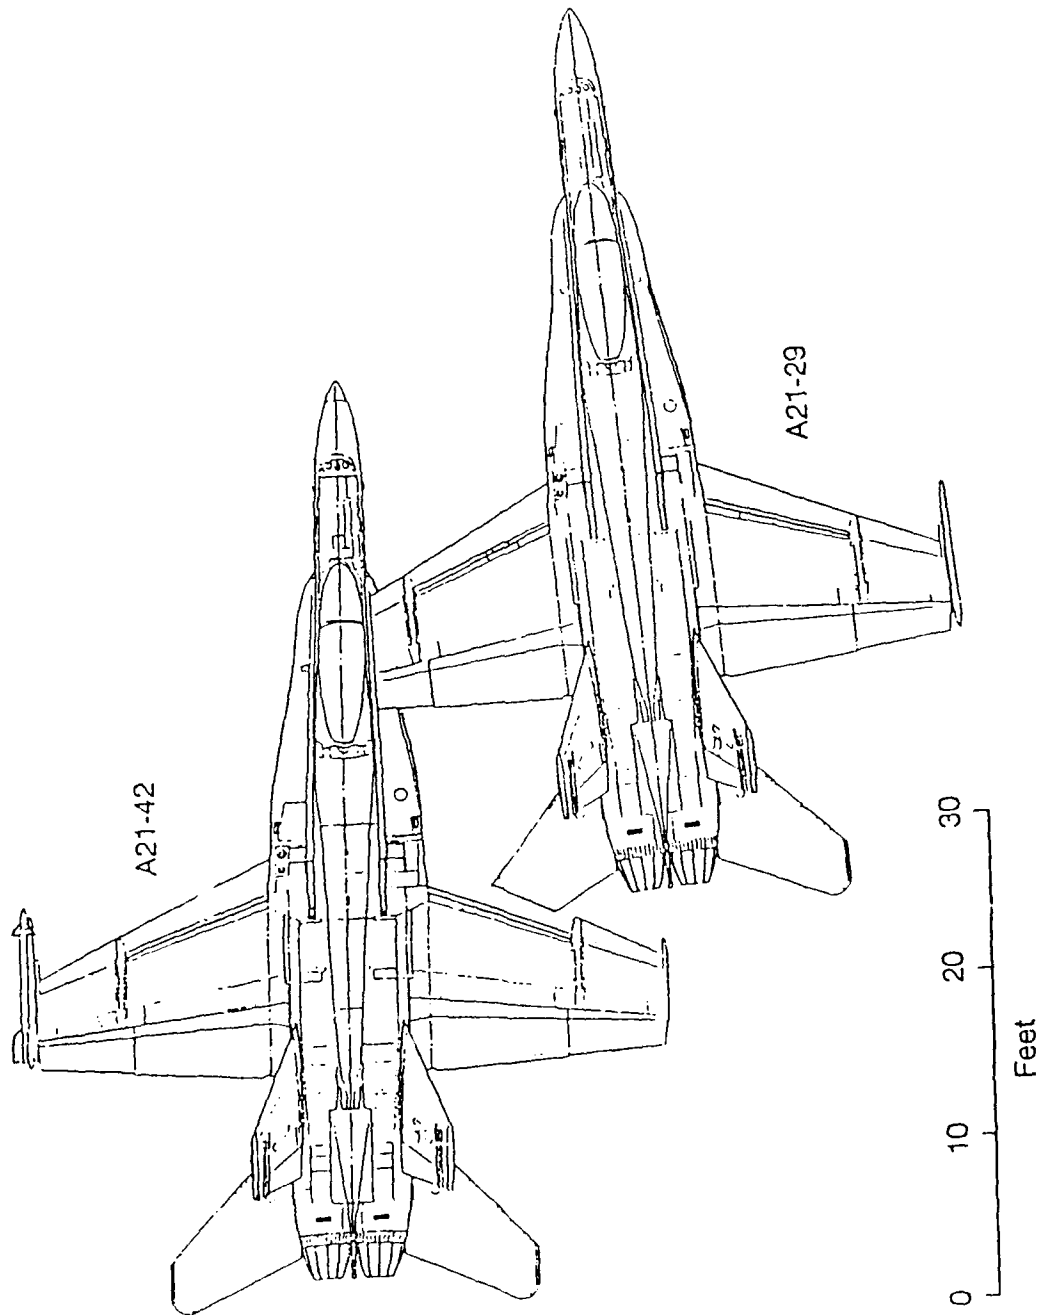
- 
- d. The nose of 29's port launcher contacted the canopy frame just above the cockpit sill and the launcher failed approximately 2 ft aft of the nose.
  - e. The main body of the port launcher passed beneath the cockpit sill cutting through the pilot, destroying the ejection seat and forcing the control column hard left, Fig. 62. The port tailplane of 29 was now in contact with the starboard wing of 42.
  - f. With 42 commencing to roll to port, the port wing of 29 moved progressively downwards to the leading edge extension, disintegrating as it entered the cockpit. Cockpit equipment was forced out of 42 through the port side of the fuselage.
  - g. The starboard leading edge flap separated from 42 while the port tailplane tip was removed from 29, Fig 63.
  - h. After 0.125 seconds, the two aircraft separated with 42 rolling and turning to port before falling into a spin.

Fig. 63  $t = 0.125$  sec the port wing of A21-29 continues to penetrate the cockpit of A21-42; the port tailplane tip of A21-29 breaks off while the inboard leading edge flap separates from A21-42
