LIVE FIRE TEST AND EVALUATION OF M113A3
ARMORED PERSONNEL CARRIER SPALL LINERS (U)

OUSD(A) Log No. S-2/LFT01
1 May 1993

LIVE FIRE TEST AND EVALUATION OF M113A3 ARMORED
PERSONNEL CARRIER SPALL LINERS

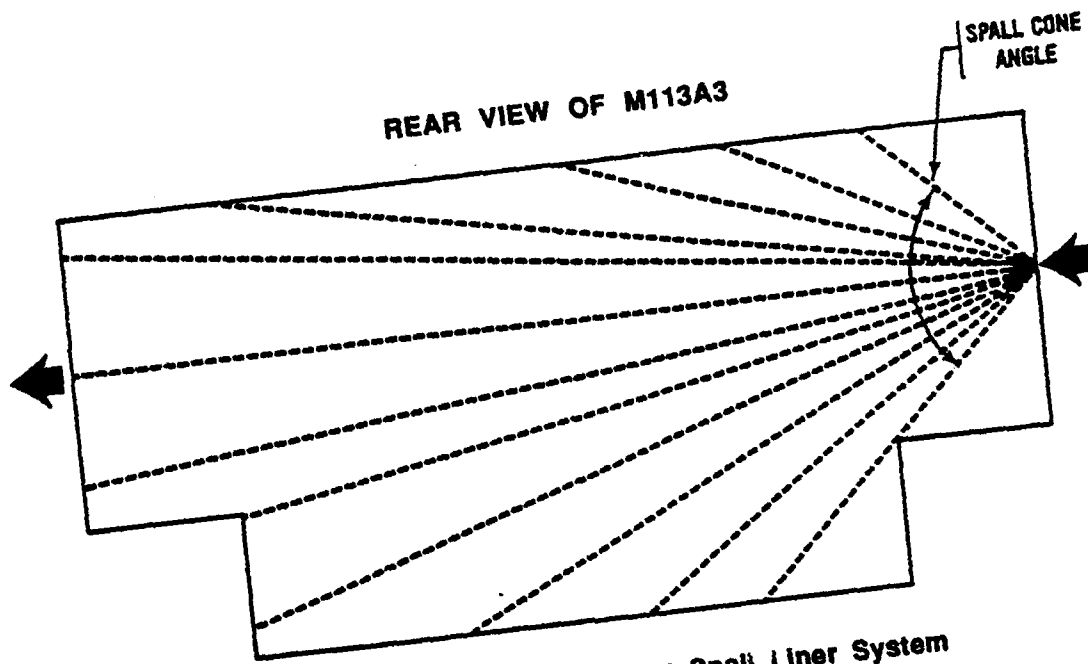
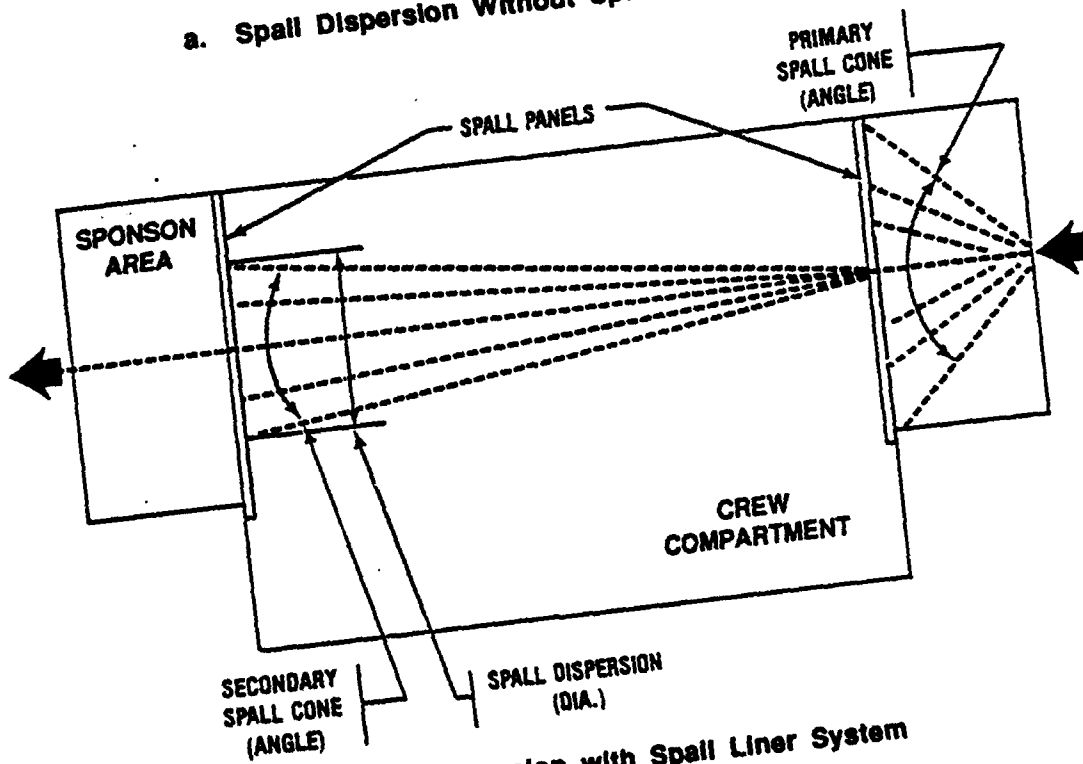
Figure 1. Spall Protection Effectiveness

Although the spall liners are not intended to reduce damage from the main penetrator, they should protect the crew from the spall (see Figure 1), reducing the spall dispersion in the crew compartment. The level of spall protection is measured by the spall cone angle and the number of spall fragments within the cone angle.

a. Spall Dispersion Without Spall Liner System

b. Spall Dispersion with Spall Liner System
