Technical Report REMR-CS-46  
March 1995

## **Repair and Maintenance of Masonry Structures: Case Histories**

*by Edward F. O'Neil*

# Repair and Maintenance of Masonry Structures: Case Histories

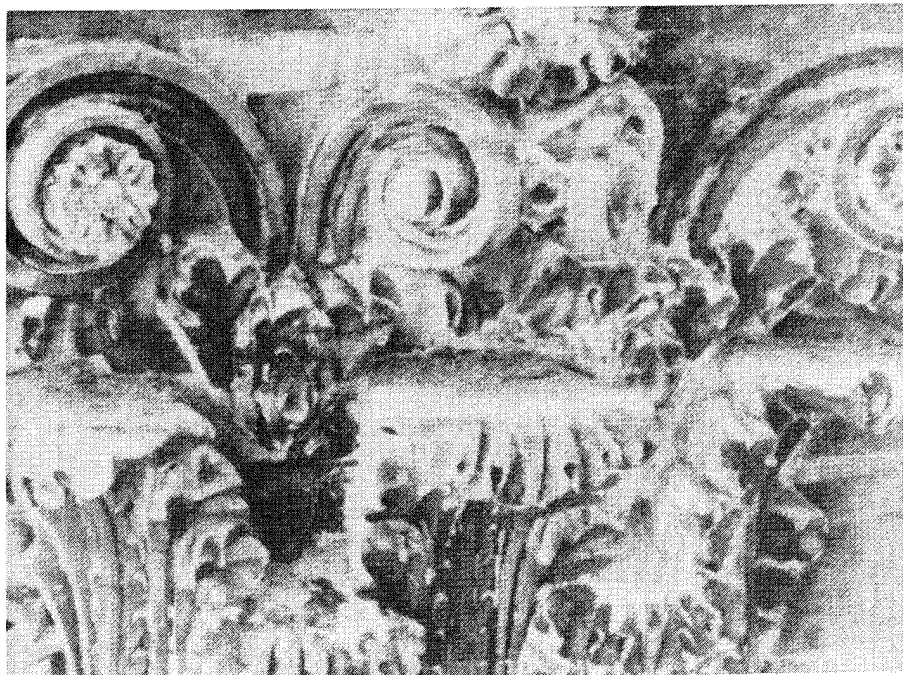
Figure 4. Ornamental detail requiring extra cleaning

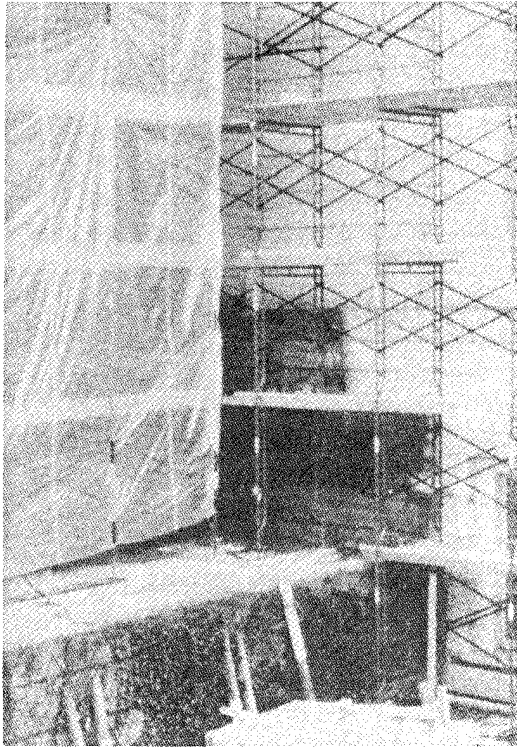
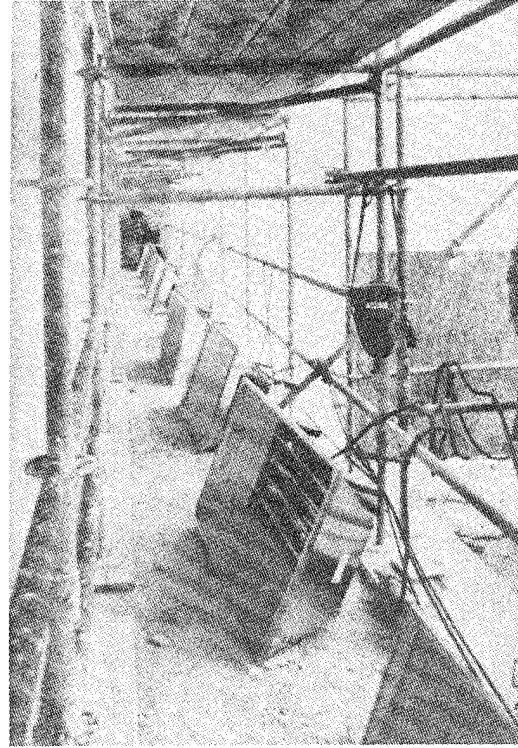
Figure 6. Enclosed scaffolding and heaters

the strengthener was applied, radiant heaters were used near the stone surface at night during the winter. The scaffolding in the area of the work was enclosed with sheets of polyethylene, and the heaters were turned on after the work day was complete, Figure 6. Surface thermometers were installed on the stone and checked each day to make sure that the temperature of the stone was above the minimum 40 °F. The heaters were then disconnected, the polyethylene removed, and the day's work begun.

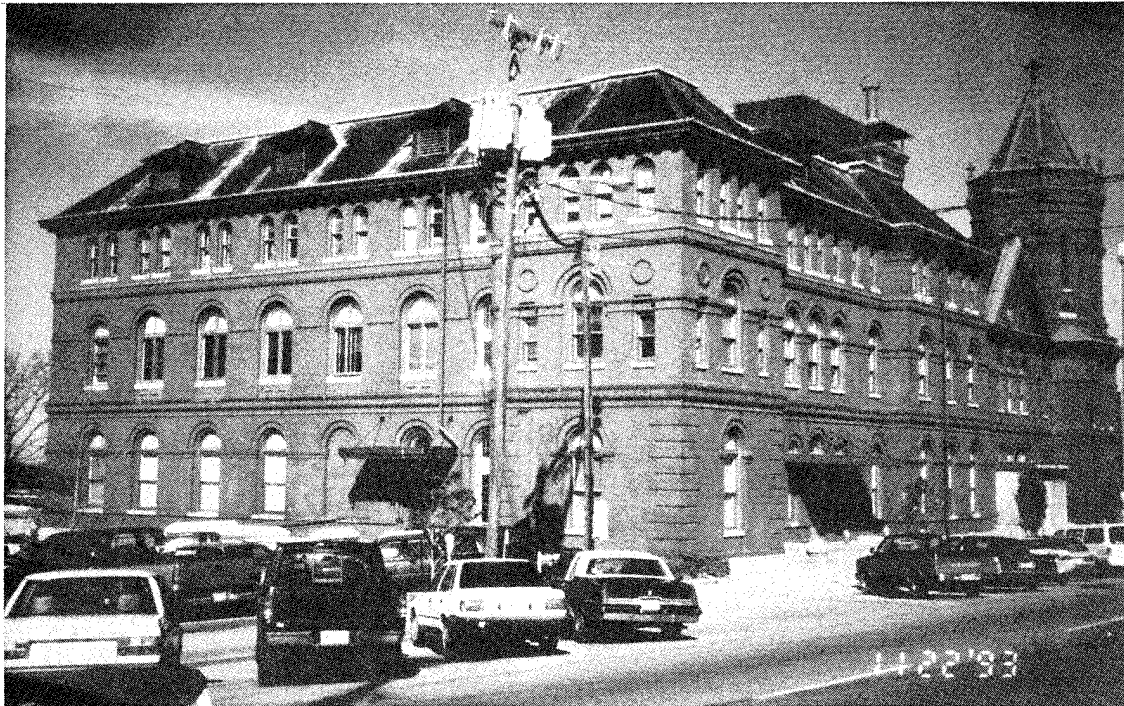
Figure 13. View of cleaned MRC Building

If the above procedure did not clean the surface the first time, it was repeated until the desired result was achieved (Figure 13).

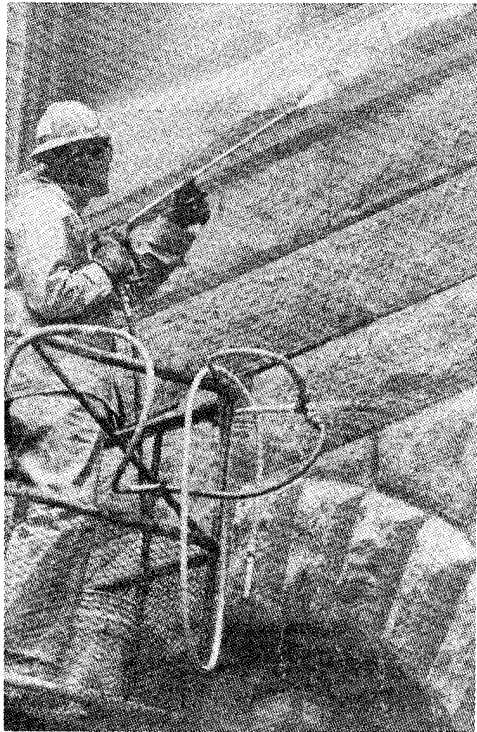
This procedure was used on all the limestone with very good results. Figure 17 shows some of the limestone before and after it had been cleaned. It wasn't until workers began cleaning some of the sandstone sills in Building 108 that there was any problem. The manufacturer of the chemicals used to clean the limestone recommended against using the product with sandstone because it would damage the structure of the stone. A different kind of cleaner was used to clean the sandstone parts of the buildings.

Figure 17. Limestone facade during cleaning

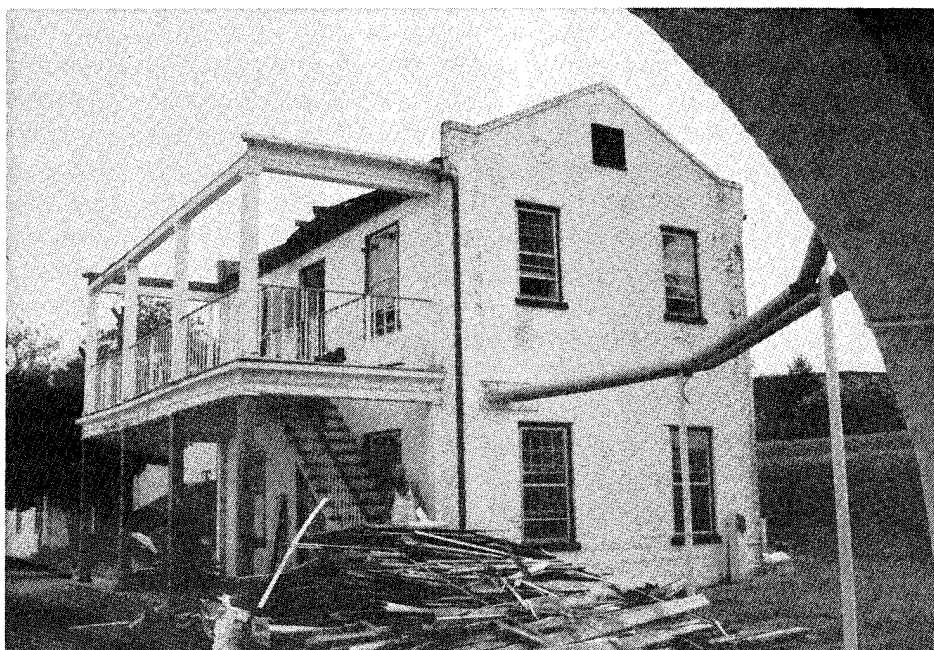
Figure 20. Storehouse showing porch during restoration

The other area of brickwork that had to be renovated was a 1- by 2-ft opening in the end wall of the storehouse that had been cut to allow steam pipes to enter the building (Figure 20.) During the restoration, the steam pipes were removed and the openings closed using the restoration brick and mortar described above.

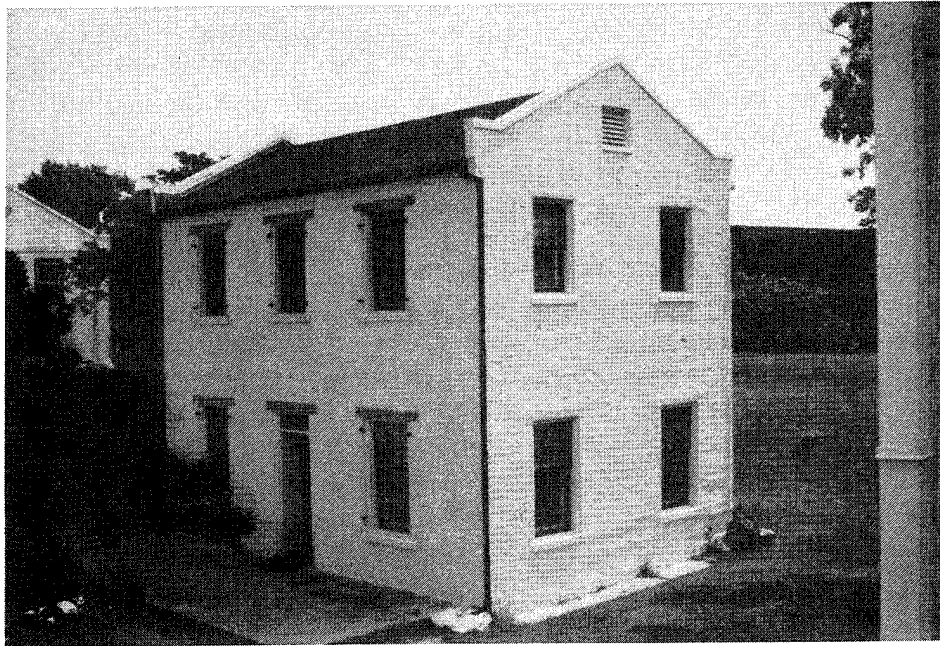
The completed renovation is shown in Figure 21. All renovations are performing well as of this writing. There are no signs of deterioration of the mortar in the joints and the whitewash coat is holding up well. The restoration has returned the building to its appearance in the early 1800's.

Figure 21. Completed restoration of the storehouse

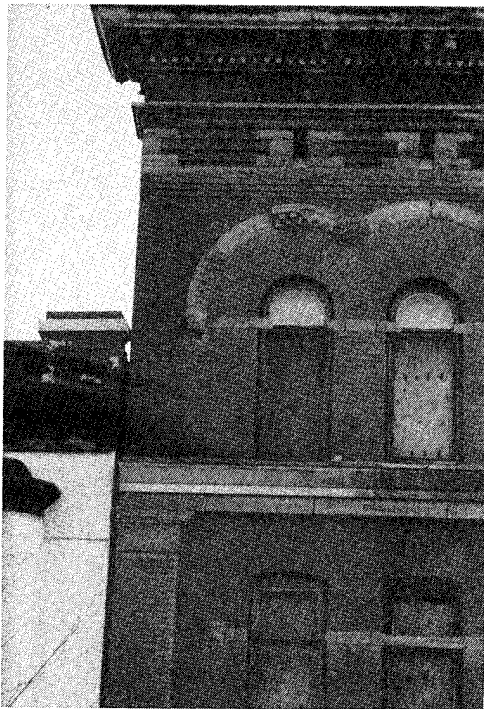
Figure 24. Deteriorated condition of  
windows and sills

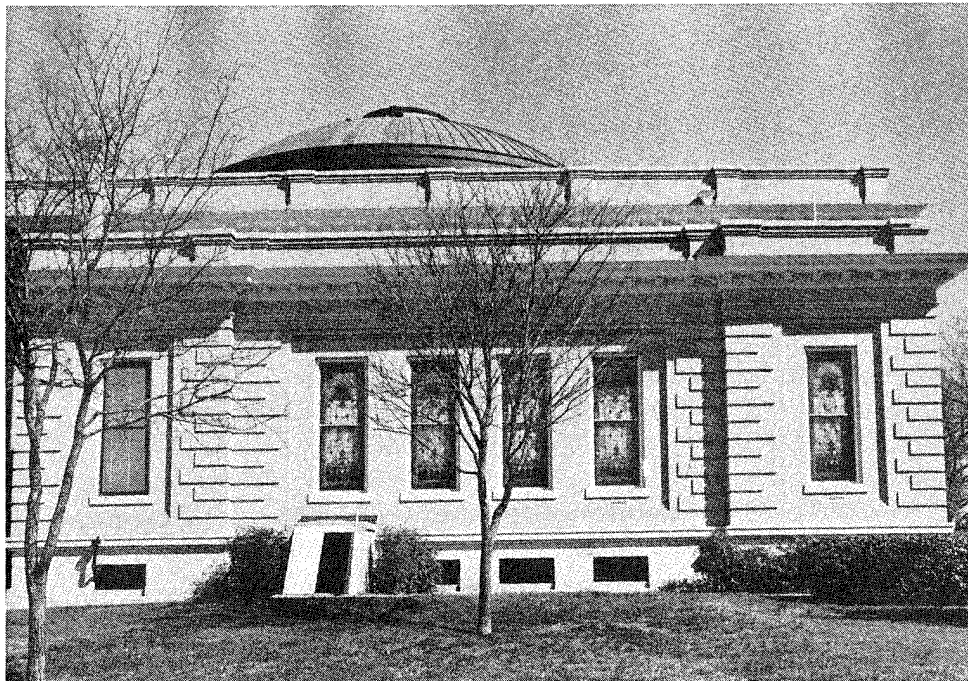
This case study is not only a restoration study, but also a structural study. The original reason for the restoration was to alleviate a problem of cracking in the east and west walls of the central chapel. Cracks in ceiling plaster over one of the wing chapels was the first reason to conduct a survey of the entire building. The building survey showed up a number of other cracks in the walls and the brickwork on the outside of the building. The major cracks were apparent in the east and west walls of the central chapel over the center of the most northern arch windows (Figure 39). The cracks were narrow at their base and became wider as they progressed up the wall. Some of the widest cracks could not be seen from within the chapel itself and had to be viewed from above the inside ceiling of the central dome. These cracks were on the order of inches wide and penetrated completely through the thickness of the wall. This led engineers to suspect that there was differential settlement of the building and that the front and back portions of the building were settling in different directions. A survey of elevations of the building was conducted and it was determined that the south face of the building had settled over 4 in. in relation to the north face.

Figure 38. Elevation of the west facade

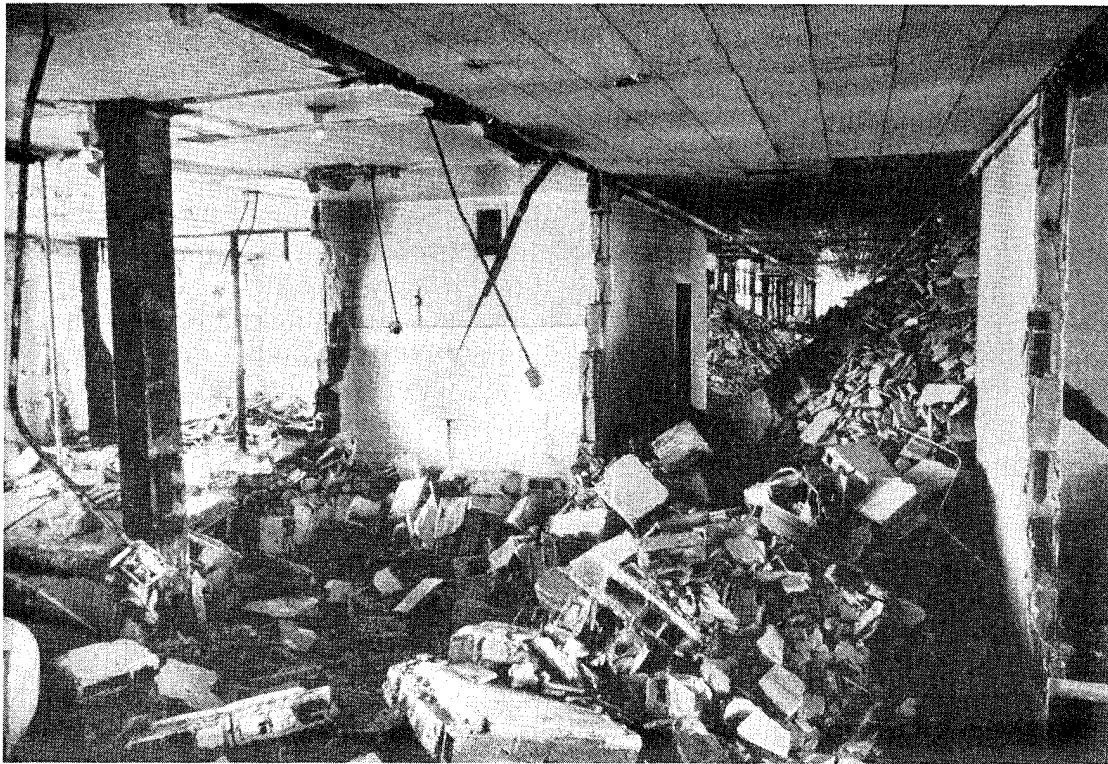
In the initial efforts to renovate the building, many schemes were tried to remodel the existing rooms and corridors for apartment use. It soon became apparent that the existing scheme of rooms would not provide the number of units necessary to financially carry the project. This, coupled with the fact that the interior walls were constructed of hollow clay tile, led to an early decision to demolish all interior walls from the underside of the roof to the basement. Exceptions to this decision were the concrete floors, the exterior walls and the historical rooms. Removal of the hollow clay tile partitions eliminated substantial earthquake hazard, since they will shatter in an

earthquake. Figure 47 shows these tiles during the 1979 renovations. This also reduced the total mass of the building thus lowering the effective earthquake inertia forces.

Figure 47. Clay tile partition rubble from 1979 renovations

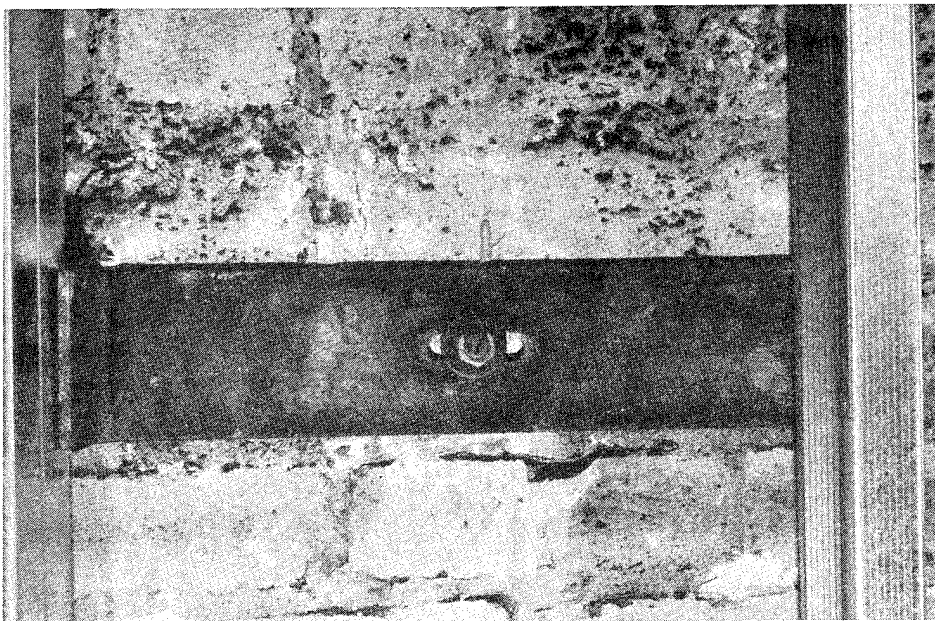
Tests were conducted to determine the strength of the epoxied bolts in the brick. Prior to the actual use of this system, three anchors were epoxied into brick test panels and were loaded to failure. One failed at 7,500 lbf, and the other two at 9,000 lbf, with all failures occurring in the anchor, not in the brick or in bond between the brick and the anchor. There were 4,900 bolts used in the wall renovation, and 520 of these bolts were subjected to pullout

Figure 49. Detail of basketing anchor

testing. The anchors were loaded to a magnitude of 1,000 lbf and held at that level for 1 min. Only 34 anchors failed the proof loading.

To effect this type of performance, the decision was made to provide a basketing system to stabilize the brick walls after cracking occurred. The system devised was incorporated into the new wall furring which was applied to the interior of the steel frames of the exterior walls. Figures 48 and 49 show some of the system details. Heavier structural studs were mixed in with the basic stud furring system. These heavy structural studs were spaced to allow wall anchors to be secured at approximately 3 ft on center in both vertical and horizontal directions. The wall anchors were 1/2-in.-diam bolts long enough to extend from the structural studs through the two interior wythes of the exterior wall and into the face brick. The bolts were inserted into the wall through holes drilled into the brick to a depth including partial penetration in the face brick. They were then anchored to the brick with polyester-resin epoxy cartridges.

To complete the anchorage of the wall, the bolts were then attached to plates which spanned between adjacent structural studs. The stud system then provided a positive anchorage detail to the floor framing above and below. Thus, the exterior wall system was reinforced with steel studs having the capacity to brace the walls against out-of-plane forces after failure of the brick. The system was intended to hold the brick in place, reduce the potential falling hazard, and use the crushing of the brick (during an earthquake) for its energy absorbing value.

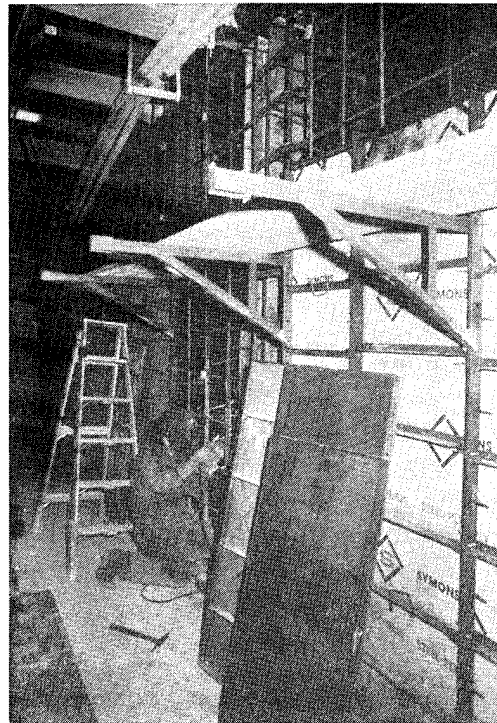
Figure 50. Forming for interior shear walls

Reinforcement of the exterior brick walls was important to the performance of the building in an earthquake, but it was only part of the story. To provide additional strength and ductility to resist major earthquakes, a new system of reinforced concrete shear walls was designed to be added around the stair and elevator shafts (Figure 50). This system, well distributed around the building in the upper stories, was supplemented by additional shear walls from the second floor down to the foundations.

The new shear wall systems also worked well within the confines of the existing structural framing system. The walls were tied into steel floor beams which served as collectors to deliver diaphragm forces, and into the steel columns, which acted as chord members to resist the tension and compression due to the cantilever action of the wall. Nelson studs were required to be added to the existing structural steel members to develop the forces. The new walls were reinforced for the shear stresses as well as to resist net tension forces at the steel columns to supplement the capacity of the column splices. The most critical aspect of the design of the new shear walls was the overturning effect. Although the interior stresses within a shear wall were readily accommodated, it was necessary to mobilize enough gravity load in the walls to enable them to resist overturning. To accomplish this, the

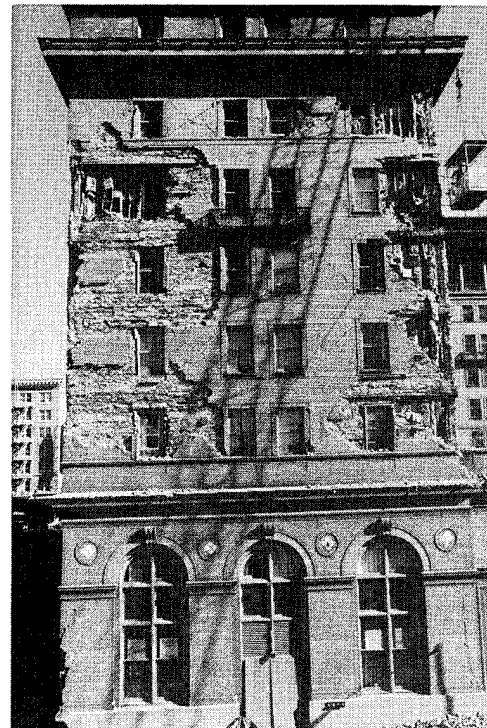
Although the 1989 Loma Prieta earthquake did no damage to the integrity of the structure, there was considerable architectural damage to the exterior brick masonry walls and to a number of apartments. Substantial amounts of brick had fallen to the street from the southwest corner of the building, exposing some of the apartments and the steel framing (Figure 51). With the engineers working to determine the extent of the damage, it was soon learned that the damage was not structural and that except for 30 apartments, the remaining 185 units could continue to be occupied while the repairs to the remaining units were conducted.

The most evident and significant damage sustained by the hotel was the cracking of the exterior brick walls. Although they are not load-bearing walls, the brick walls are the stiffest elements in the building and resisted the main thrust of the earthquake force. The walls are infill brick supported on the structural steel frame, and therefore the damage did not affect the vertical load-carrying capacity of the building. The damage to the brick was manifested as diagonal (X) cracks in the wall piers with virtually no cracking in the horizontal spandrels. Reference to Figure 51 shows this X cracking between bays of windows.

The most severe brick damage took place on the Thirteenth Street end of the Harrison Street wing of the building. There were cracks over 1/2 in. wide, with complex fracturing through the entire thickness of this wall. There were also areas where the face brick had fallen and other areas where it was loose.

Figure 51. Damage to southwest facade after removal of loose brick

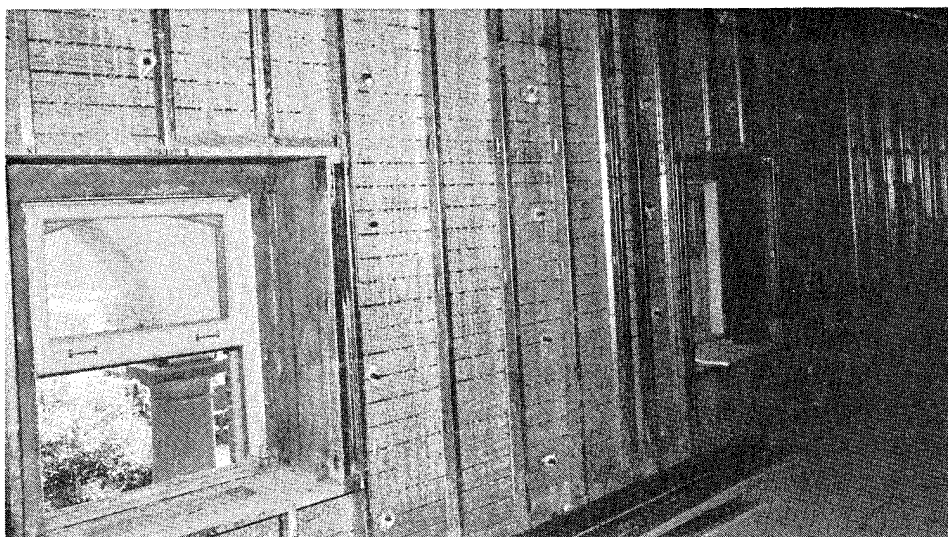
Figure 53. Strengthening of typical upper floor walls

In the first-story historic spaces, the strengthening walls are being located behind the existing historically sensitive wall surfaces to keep the architecture of the space clean (Figure 52). In the upper stories, Figure 53, the additional wall thickness will encroach into the living spaces and the units will be remodeled. Because of the tight spaces in which to work in pouring the new concrete shear walls against the existing brick and the limited amount of work space, the contractor devised an ingenious forming system. Stay-in-place formwork was used and held in place by metal studs that were in turn supported by steel dowels which were carefully placed and epoxied into the facing brick. The studs not only supported the forms but became the method of anchoring the brick to the new concrete walls. The studs were stiffened by wood blocking at each stud and laterally supported by walers. This method allowed for observation of the pour through the formwork and greatly simplified and accelerated the process. The metal studs that remained in place were used as furring for the interior finishes so there were no forms to remove, only the wood blocking and walers.
