# Mark 20 Category II/III Instrument Landing System Operational Test and Evaluation, Functional and Performance Test Report

October 1995

DOT/FAA/CT-TN95/44

U.S. Department of Transportation  
Federal Aviation Administration

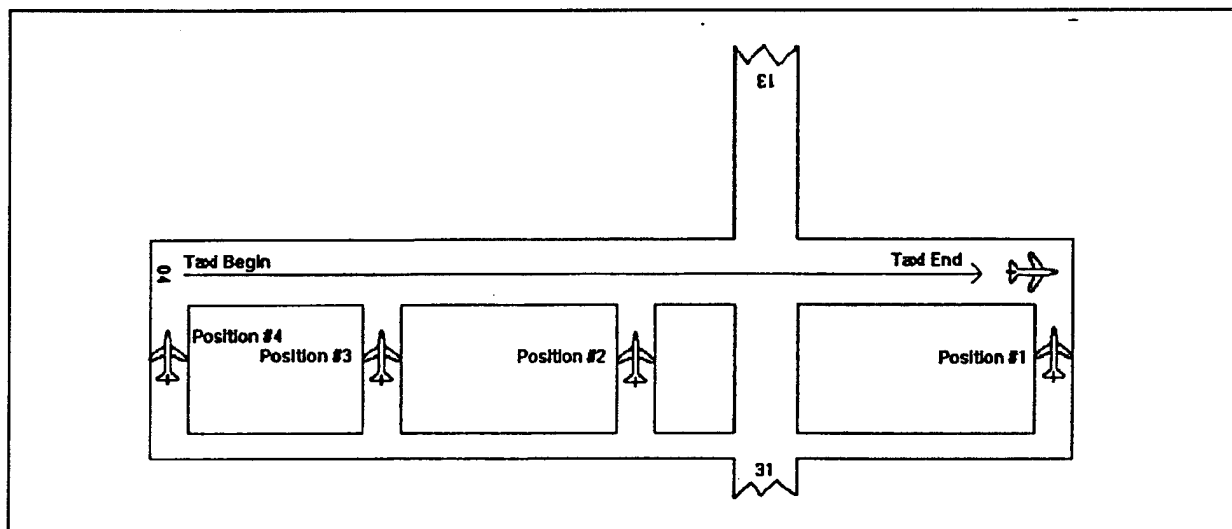
FIGURE 3. LOCATIONS OF B727 WHILE AIRBORNE LOCALIZER APPROACH AND FAR FIELD MONITOR DATA WAS COLLECTED

Localizer approach data was collected by a Convair 580 with a Boeing 727 (B727) located at various test locations along the runway, including the ILS critical area. An approach was flown and airborne data collected while the B727 taxied from the threshold to the stop end of runway 04. A handwritten log was generated to note the time that the B727 had arrived or departed a test location. The test locations are shown in figure 3. The recorded DDM measurements for each FFM are plotted versus time and compared to flight measurements collected while the B727 was located at that position. Any abnormal disturbances discovered in the airborne data that is caused by the presence of the B727, should also be detected by the FFM in higher than normal DDM readings and the appropriate indication at the RSIU.

Table 6 indicates the position of the B727 during testing. Figures 10 and 11 contain DDM values measured by each FFM versus time. FFM 1 is located at the inner marker and FFM 2 at the middle marker. The data collected indicate that minimal interference was detected by the FFMs. The large DDM spikes at 0921.45 and 0954.38 are when the B727 was at the stop end of runway 04 and turning to face the taxiway. The spikes, however, were not of sufficient magnitude to put the FFM into alarm. (The FFM alarm settings were set to  $\pm 0.009$  DDM and the spikes were only -0.004 and -0.005 DDM for FFM 1 and 2, respectively.) Airborne data collected indicates that no effect on provided guidance was caused by the presence of the B727 in positions 1, 2, 3, or 4 (figure 3).

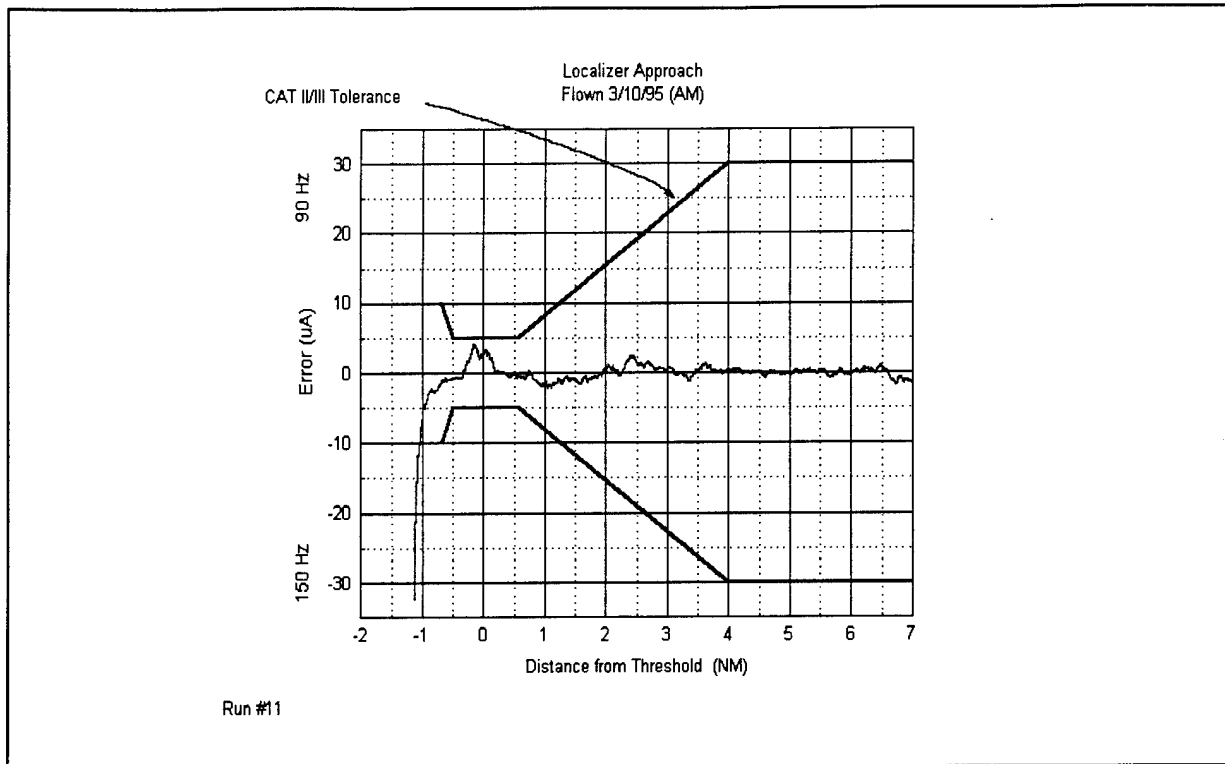
FIGURE 4. LOCALIZER APPROACH GUIDANCE ERROR PLOT

FAA Technical Center flight evaluations met CAT II/III flight inspection criteria. Figure 4 shows a localizer approach. Figure 5 shows a localizer orbit. Figure 6 shows a glide slope approach. Figure 7 shows a glide slope level run.
