NASA Contractor Report 178246

## Test Results for Composite Specimens and Elements Containing Joints and Cutouts

P. T. Sumida, R. C. Madan, and A. V. Hawley

Douglas Aircraft Company  
McDonnell Douglas Corporation  
Long Beach, CA 90846

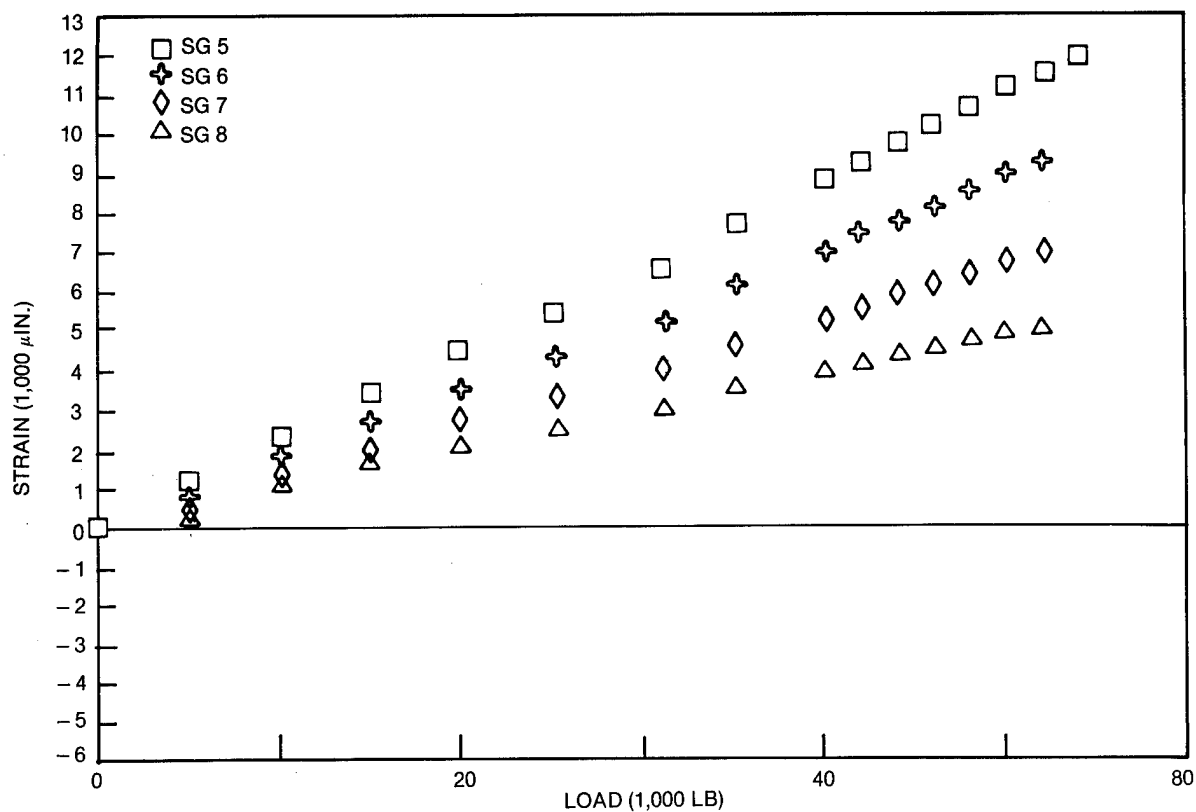
Figure 5-23. Typical Strain Gage Data for Tension Cutout Panel (-501)

The baseline panel (-501) was the only one to buckle in opposite directions at the top and the bottom of the cutout. This is illustrated in Figure 5-22 by the asymmetry of the photoelastic fringe pattern at 31 kips. Although difficult to discern, the top of the cutout buckled toward the camera, producing tensile strains on the surface being viewed, which subtract from the membrane compressive strains to produce a black, or zero-principal-strain, region. Likewise, the buckle at the bottom of the cutout is away from the camera, producing bending strains which add to the compressive membrane strains. Typical plots of strain gage and photoelastic data are shown in Figures 5-23 and 5-24.

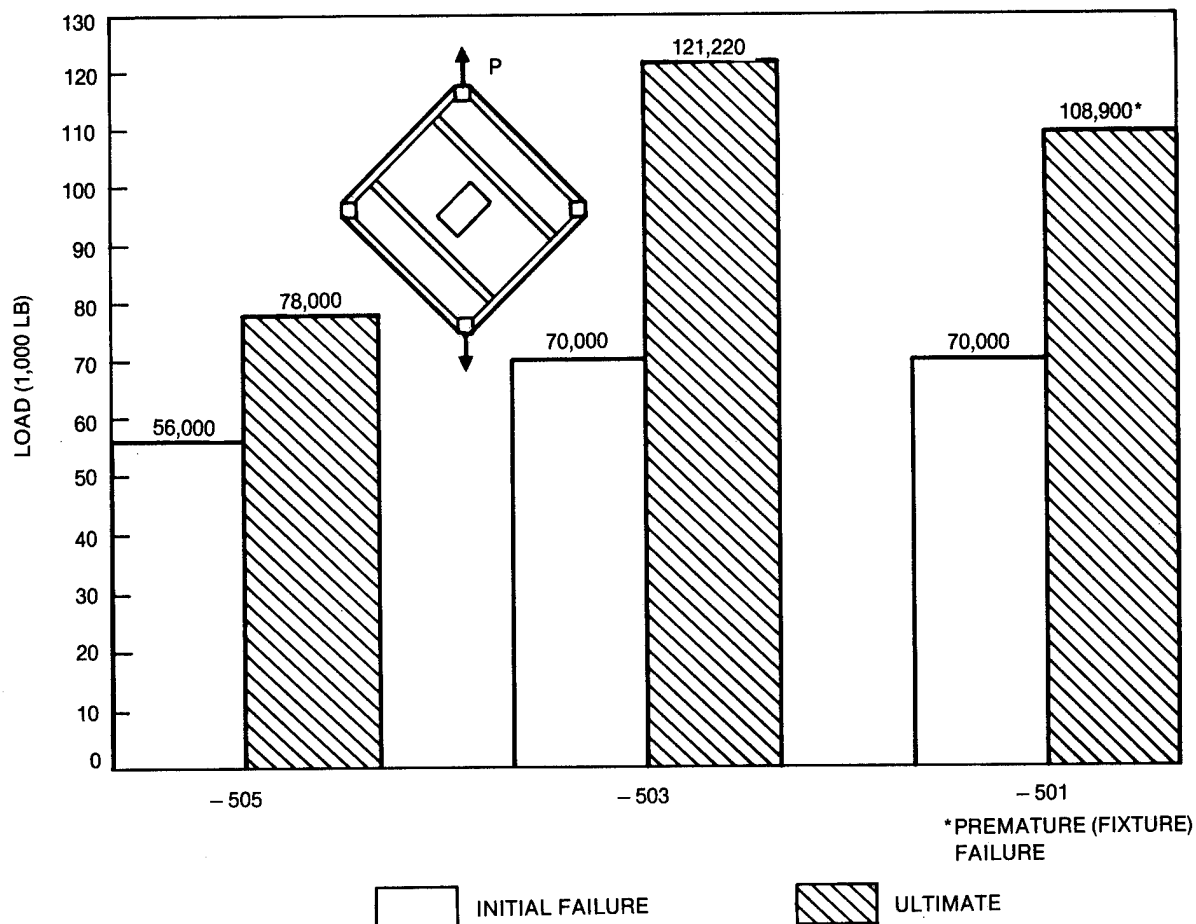
**Figure 5-25. Failure Loads for Group B Shear Cutout Panels**

A summary of the failure loads for the shear panel tests is given in Figure 5-25. All three panels failed initially at the top and bottom corners of the cutout. These localized failures did not result in the collapse of the panels, however. As indicated, the ultimate failure of the -505 panel was precipitated by a partial failure of the picture frame load introduction fixture. Strain gage data indicated that the panel was close to failure before this occurred.

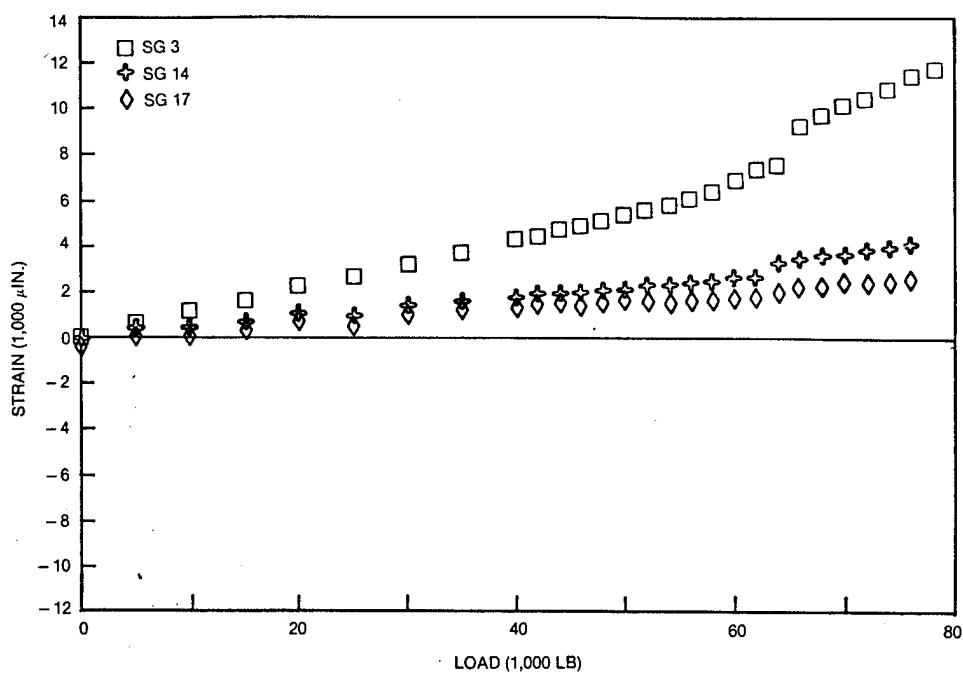
**Figure 5-27. Strain Gage Data at Top Corner of Shear Panel Cutout (-501)**

A sketch of the failed baseline panel (-501) is included as Figure 5-26. Strain gage data (Figure 5-27) taken at the top corner indicate a moderate change in slope at about 30 kips and a marked nonlinear behavior beginning around 50 kips. While holding the load at 56 kips, a loud noise was heard, and while holding at 58 kips, a drastic drop in measured strain at the top corner ( $-9,830$  to  $-2,632$   $\mu\text{in./in.}$ ) was observed. Inspection of the test article revealed delaminations at the cutout on both compression diagonals (top and bottom corners). As the load was increased, these delaminations were observed to progress toward the intersections of the stiffeners. Panel failure occurred while holding at 78 kips. Ultimate failure appears to have resulted from the stiffeners having disbonded from the panel, thus effectively eliminating the last remaining load path for the diagonal compression load.

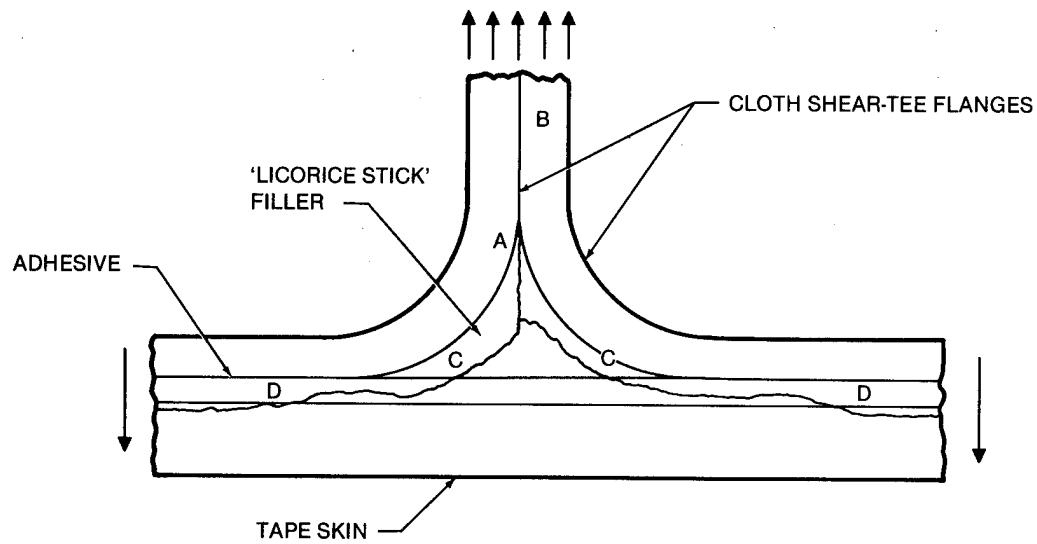
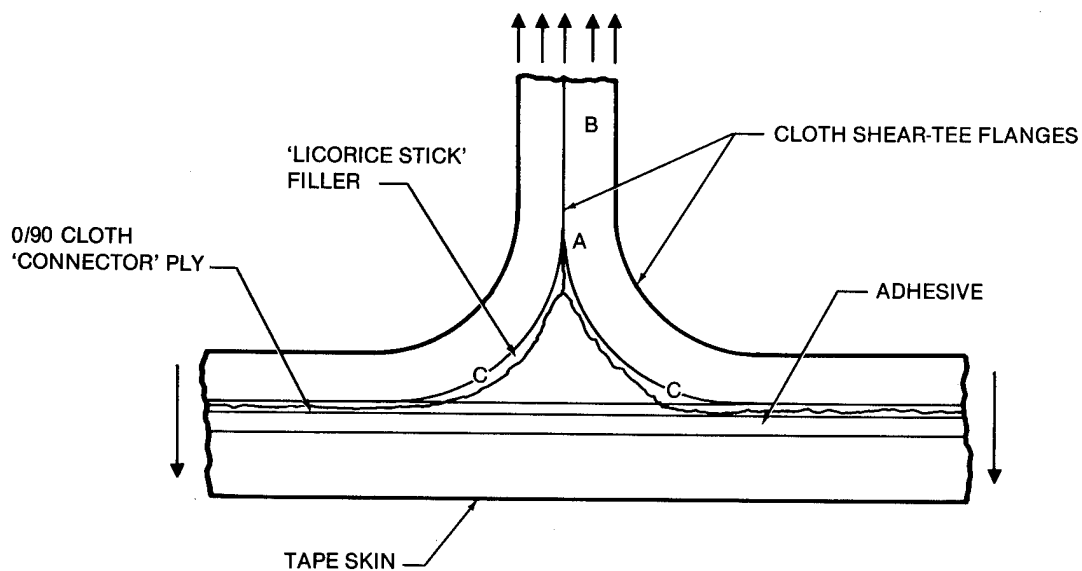
Figure 5-30. Apparent Failure Sequence for Shear-Tee Pull-Off Specimens

Six configurations of the shear-tee/skin intersection were examined. The results of these tests are summarized in Table 5-3. The -503, -509, and -511 configurations all yielded similar results, indicating that neither the alternate adhesive nor the presence of the imbedded hoop plies in the skin had a significant effect on the pull-off strength. The gradual tapering of the shear-tee flange (-505) did, however, result in a noticeable increase in the pull-off load (up to about 425 lb/in.). The worst performers were the -501 and -507 configurations (at about 250 lb/in.), indicating that either adding a ply to connect the tee flanges or thinning/softening the tee as a whole can reduce the pull-off strength dramatically. Figure 5-30 depicts what is thought to be the failure sequence for the shear-tee pull-off specimens. During testing, a loud sound was heard at anywhere from 10 percent to 40 percent of the ultimate failure load (depending on the configuration). As the load continued to increase, a crack was sometimes visible in the region from A to C. These cracks are thought to have originated in the vicinity of A and tended to spread both upward toward B and through the filler material toward either of the C points. Eventually, the cracks would reach a critical length and the specimens would fail suddenly. Examination of the failed specimens revealed adhesive on both the (now separated) tee and skin elements in areas to either side of center. This indicates a cohesive bondline failure in this area (corresponding to the area between points C and D. To either side of this region, there is very little adhesive visible; instead, 0-degree strands are observed on both elements, indicating an interlaminar failure in the first ply of the skin. The -501 specimens, however, showed no sign of any adhesive or 0-degree tape on the failure surface. Instead, there was the very distinct pattern of the 0/90-degree cloth, indicating an interlaminar failure in the tee assembly.

Relating the apparent failure sequence back to the specimens provides some insight into their relative performance. The -503, -509, and -511 specimens all had identical tee elements. Apparently, neither the alternate adhesive, nor the increased stiffness of the skin under the tee, had any significant effect on the peel stress at point C once the crack had propagated to that point. The higher strength of the -505 configuration was likely due to a reduction in this peel stress, effected by the tapered flanges flexing with the

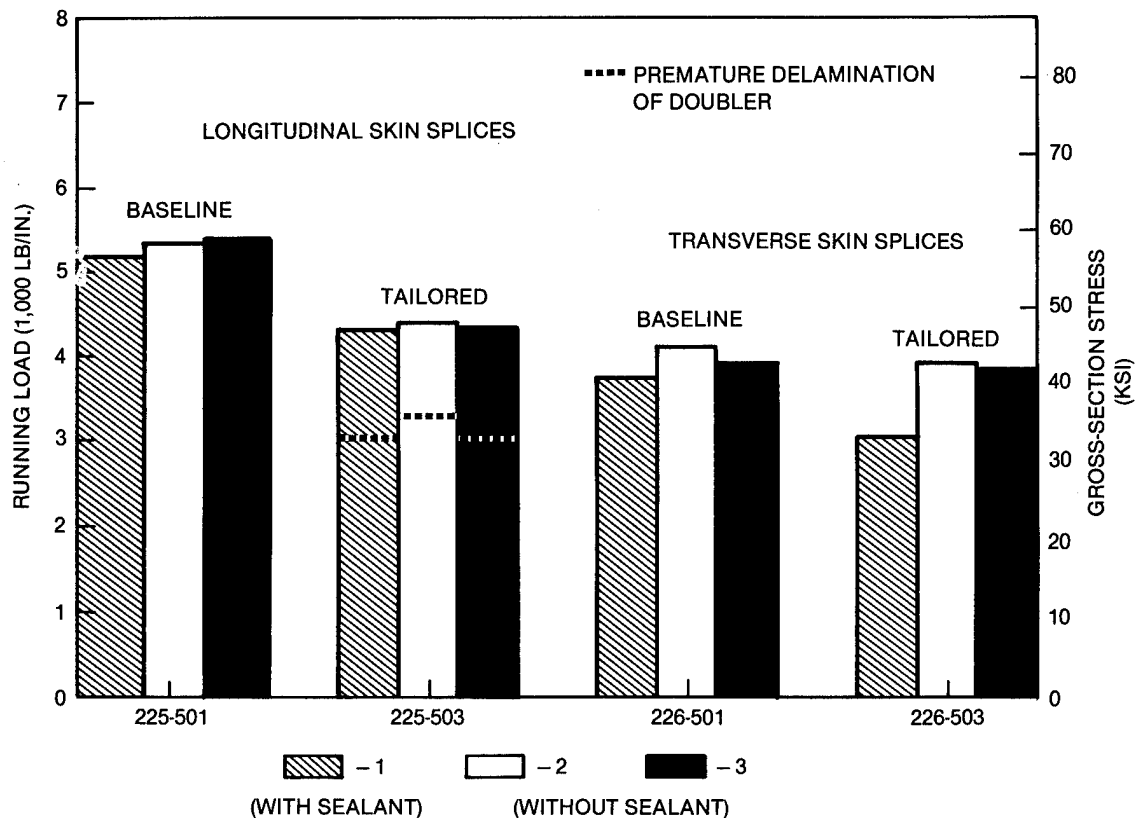
**Figure 5-31. Failure Loads for Group C Skin Splice Specimens**

The results of the skin splice tests are summarized in Figure 5-31. All of these specimens were fabricated from the basic skin laminate (0.0684 inch nominal thickness) to which four plies of 45 were added at the splice region to yield the reinforced skin laminate (0.0912 inch nominal thickness). Gross-section stresses are based on the built-up thickness. Gross-section strains can be obtained by dividing by measured modulus of elasticity for lay-up No. 2 (7.96 Msi). The first replicate of each of the skin splice configurations was tested with faying surface sealant while the second and third were tested without. The presence of the sealant had little effect on the strength of the longitudinal skin splices. The strengths of the transverse splices were more noticeably affected (reduced) by the presence of the sealant. This reduction is generally attributed to the increased eccentricity of these single-shear joints due to the added thickness of the sealant.

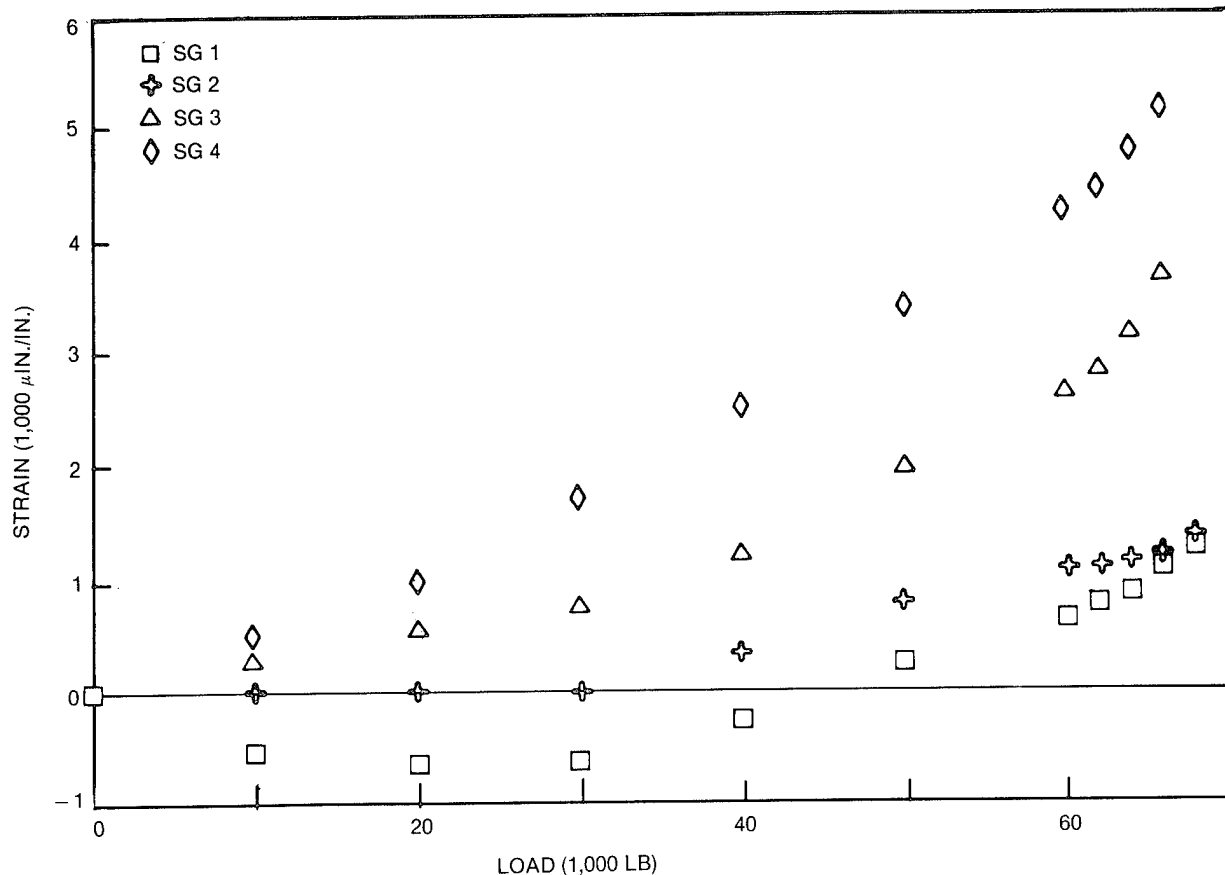
Figure 5-36. Transverse Skin/Longeron Splice Typical Strain Gage Data (Tension)

Strain gage data taken in the vicinity of the splice was noticeably nonlinear. This geometric nonlinear behavior (a result of the eccentricity of the single-shear skin splice) is especially notable in the data from strain gage No. 1 (Figure 5-36). This gage, located in the center of the skin-splice plate, initially read negative even though the applied load was tension. The strain readings leveled off quickly, however, and eventually became positive at about 45 kips. Considerable local bending of the skin and skin-splice members was also visually confirmed during the test. Although not visually detectable, the strain gage data also indicated a degree of eccentricity in the longeron splice, with the strains generally higher in the L-member than in the Z.

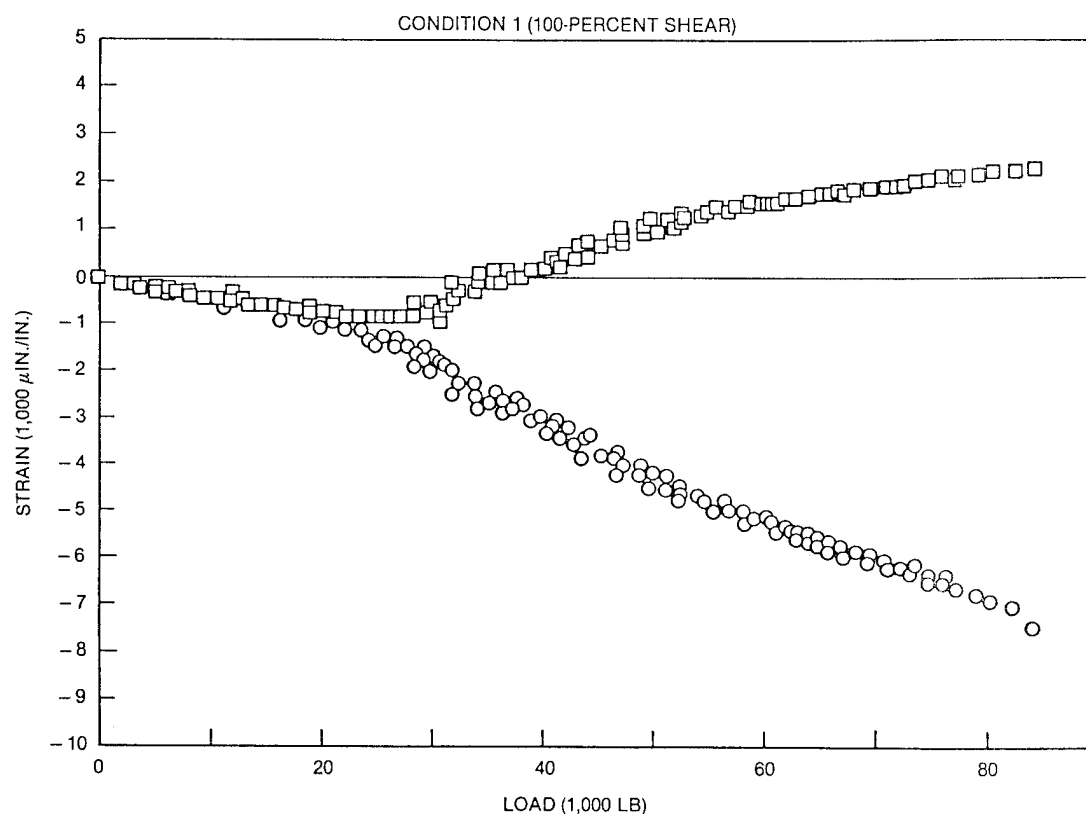
**Figure 5-45. Postbuckling Response of Transverse Skin Splice Panel (Shear)**

Strain gage data for this specimen (see Figure 5-36) provided information concerning skin buckling and the behavior of the transverse splice. The continuously read data for the shear-only conditions (discussed above) are presented in Figure 5-45. The data and the failure load of 84.1 kips suggest a post-buckling ratio for this panel of between 2.5 and 3.0 (depending on the choice for the initial buckling load). Strain gage data from the small skin bay just above the splice (strain gages No. 5 and 6) indicate a small amount of curvature, which suggests a very shallow buckle present here also. (Skin thickness in this bay was nominally 0.0912 in.). Strain gages at the joint indicated behavior similar to that of the two-stiffener transverse splice panel loaded in compression (i.e., nearly equal strains in the Z and L splice members, and tensile strains on the inside surface of the skin splice plate). The strains at the joint were generally quite low due primarily to the fact that the highest compression load applied was 75 kips, corresponding to a running load of about 1,800 lb/in. (this to be contrasted with the failure load of the two-stiffener panel of 3,336 lb/in.).

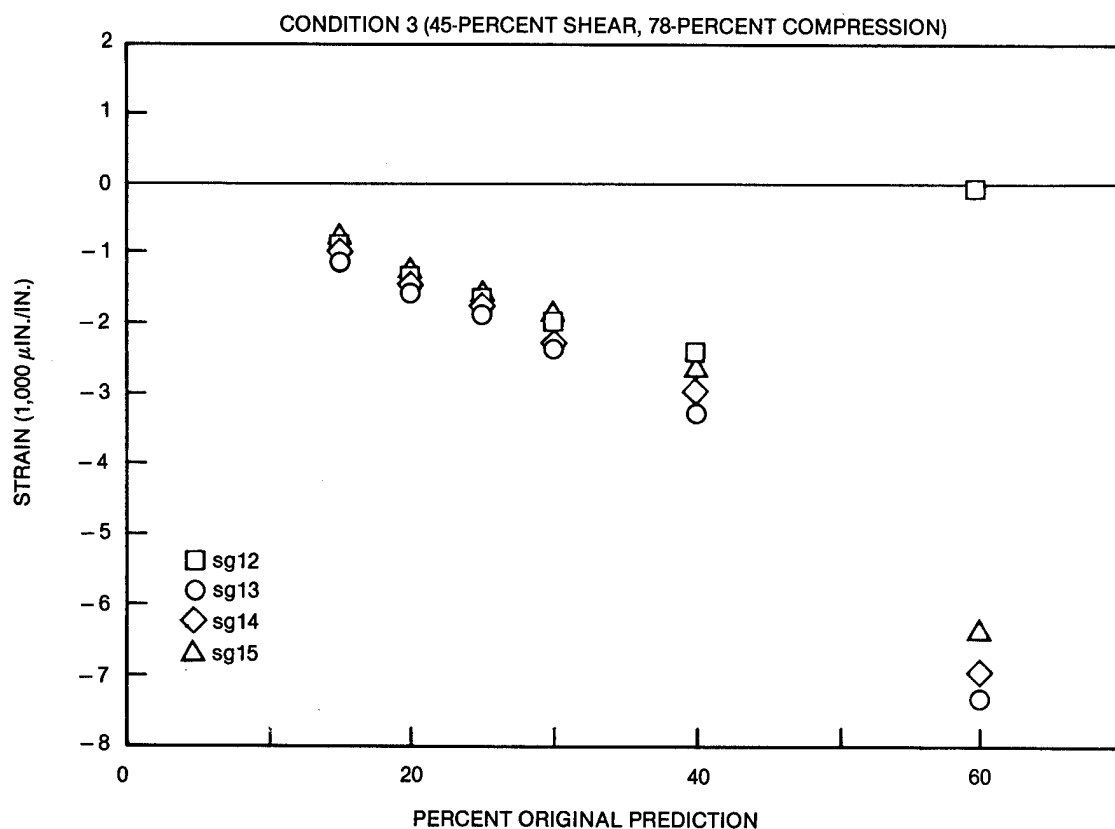
**Figure 5-51. Selected Strain Gage Readings for Window Belt Panel**

The strains recorded by the gages above and below the cutout remained relatively linear, and were (expectedly) higher for the shear dominated load cases. Those recorded by the gages along the left and right edges were likewise highest for the compression-dominated conditions. There was a noticeable nonlinearity in these data, indicative of either a redistribution of load in the panel, or bending along the cutout. The data from strain gages No. 12 through 15 are the most interesting. The gages located at the lower right-hand corner of the lower cutout (see Figure 5-46) showed the presence of high-compression loads for the shear-dominated conditions. Significant bending was indicated at this location by the difference in the readings from the back-to-back strain gages. These readings were also the most obviously nonlinear. The most dramatic example of this behavior is evidenced in the plot for these gages for Condition 3 (included here as Figure 5-51). It would appear from the severity of the bending indicated at this condition for the 60-percent load series, that a failure at or close to this area had already occurred. However, there was no damage to the skin in this region.

Strain gages at the upper right-hand corner of the lower cutout in Figure 5-46 also displayed a nonlinear characteristic with a moderate amount of bending. These strains were tensile for the shear-dominated conditions and compressive for the compression-dominated conditions. Although a skin failure is indicated at these gages in Figure 5-50 (the upper left corner of the lower cutout), the measured strains were quite low just prior to the collapse of the panel. This adds credence to the observation made from the videotapes that this side of the panel was not involved in the initial failure.
