Technical Report HL-96-18  
September 1996

# Channel Stability Study, Flamingo Wash, Las Vegas, Nevada

by *Ronald R. Copeland, Lisa C. Hubbard*

Prepared for U.S. Army Engineer District, Los Angeles

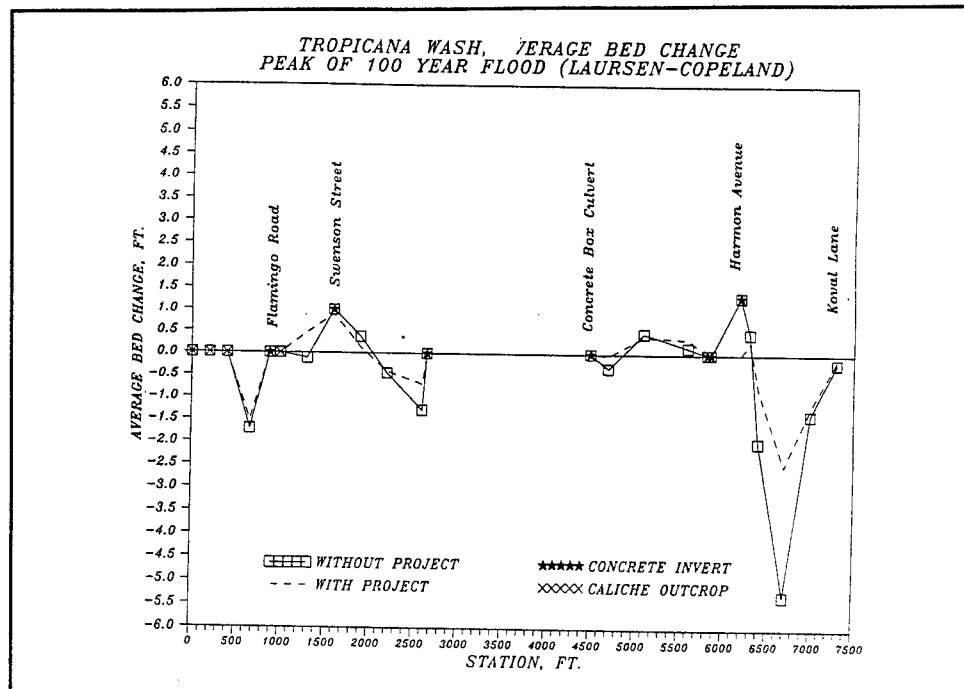
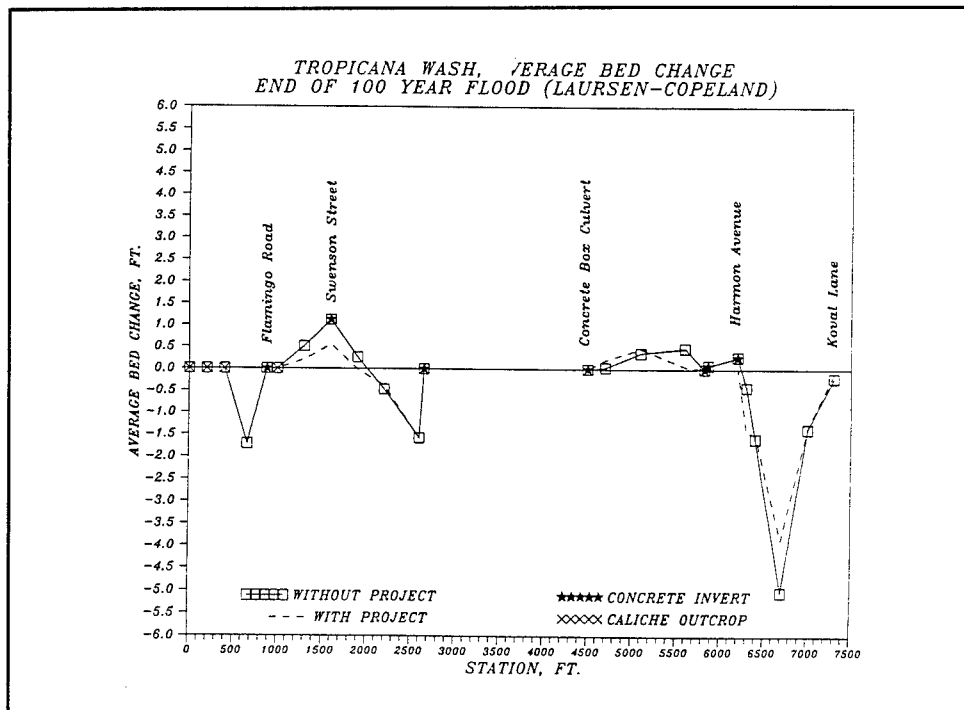
Figure 33. Calculated average bed changes, Tropicana Wash stations 0+00 to 73+00

Average bed elevation changes were calculated for the with-project one-percent-chance exceedance hydrograph and the without-project one-percent-chance exceedance hydrograph. Conditions at the peak of hydrograph are shown in Figures 33a-37a; and conditions at the end of the hydrograph are shown in Figures 33b-37b. Results are also tabulated in Tables 1 and 2. In most reaches, most of the calculated degradation occurred on the rising limb of the hydrograph, so that there was typically little additional degradation after the peak discharge. Typically, zones of degradation occurred downstream from culverts and concrete channel reaches. Aggradation frequently occurred downstream from degradation reaches or just upstream from culverts. In general, aggradation and degradation are significantly less severe for the with-project condition. It can be inferred that decreasing the aggradation and degradation potential will also decrease channel instability.

Outflow from the proposed dam will discharge into Tropicana Wash just downstream from Koval Lane. Due to upstream diversions, the total volume of water flowing through Tropicana Wash will increase with the project, even though the peak discharges will be less. This increase in flow volume has the potential for increasing degradation. In addition, the project will reduce sediment supply to Tropicana Wash, which could further increase the potential for degradation. This reach is therefore a relatively sensitive reach. Significant degradation was calculated on Tropicana Wash downstream from Koval Lane for both with- and without-project conditions and both at the peak and at the end of the flood hydrograph. Interestingly, calculated erosion was less for the with-project condition, even though sediment inflow into Tropicana Wash was eliminated by the project. At the peak of the flood hydrograph, deposition was calculated on Tropicana Wash at Harmon Avenue where the channel size is significantly reduced. Downstream from Harmon Avenue, through the grass-lined reach 2, channel bed elevation changes are relatively small on Tropicana Wash. Some degradation occurs in the channel as it exits the culvert downstream from Paradise Road, but the degradation is limited by caliche outcrops. Degradation potential is high on Tropicana Wash downstream from Flamingo Road, but caliche outcrops will tend to hold the

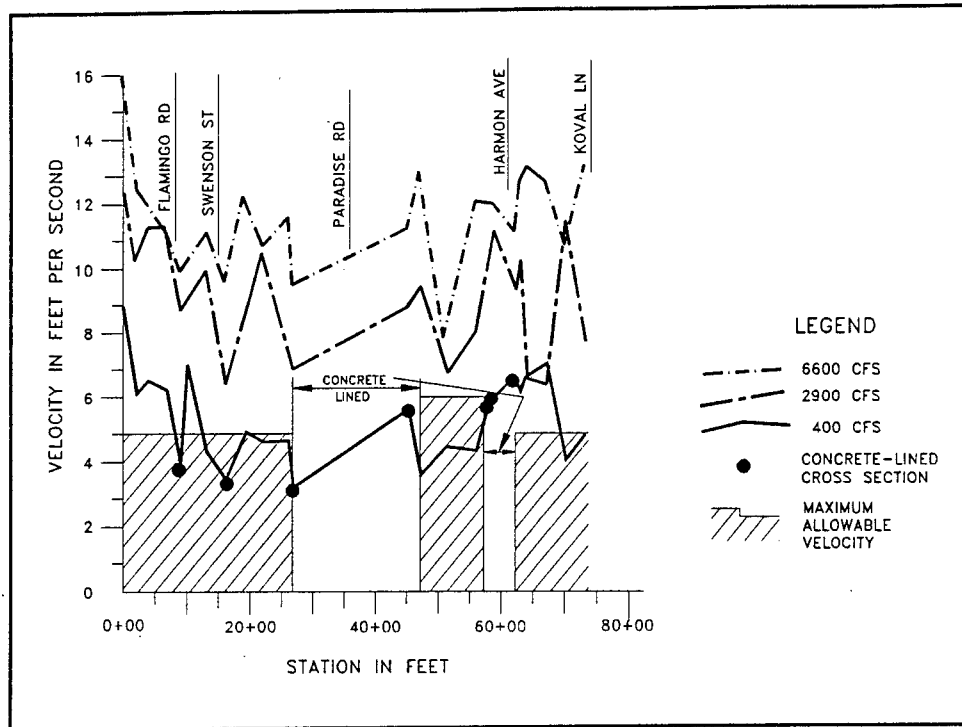
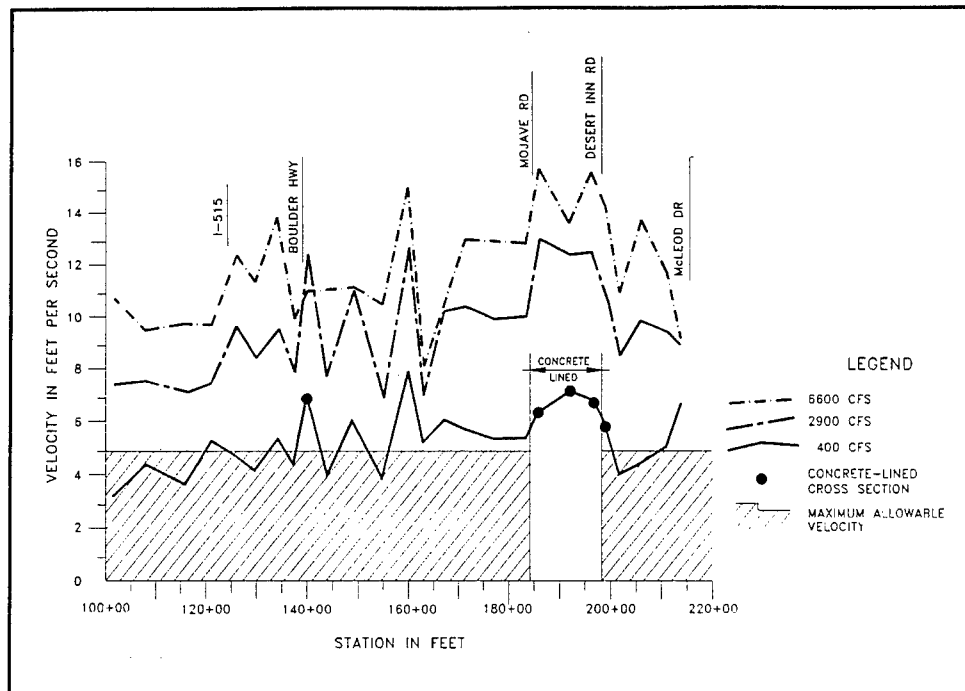
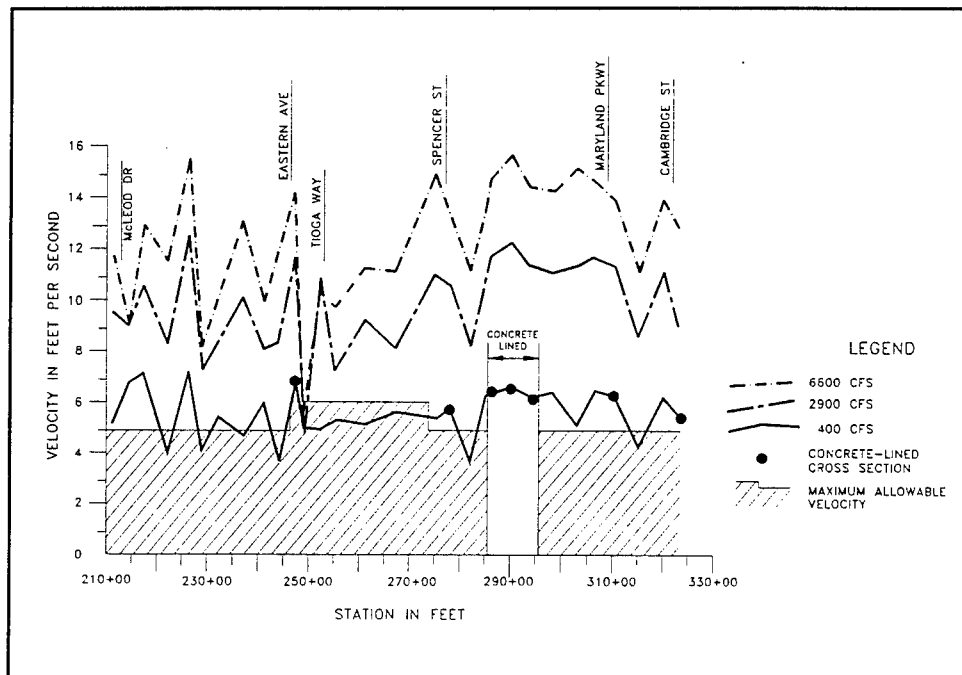
Average channel velocities were calculated for the with-project one-percent-chance exceedance peak discharge of 6,600 cfs, the ten-percent-chance exceedance peak discharge of 2,900 cfs, and 400 cfs, which is the discharge that carries the most sediment during the with-project one-percent-chance exceedance hydrograph. Channel velocities were calculated using the initial channel geometry from the HEC-6W numerical model. These are compared in Figures 41-44 with allowable velocities of 6 ft/sec in grass-lined channels and 5 ft/sec in unlined channels. No consideration is given in this preliminary evaluation for existing rubble riprap or concrete-lined side slopes, because the bed is left unprotected. Caliche outcrops were not given consideration because the banks are left unprotected. Maximum permissible velocities would be less in reaches with significant channel curvature. Maximum permissible velocities would be greater if sufficient caliche deposit control can be confirmed.

The comparison confirms the conclusions reached in the channel inventory - that during major flood peak discharges, the existing channel is unstable in all reaches unless the channel is fully concrete-lined. At 400 cfs, the maximum allowable velocity is exceeded at about 40 percent of the cross sections. The grass-lined and fully concrete-lined reaches would be considered stable at this lower discharge. At a discharge of 400 cfs, the maximum allowable velocity is generally not exceeded in the unlined channel downstream from Boulder

Highway to Las Vegas Wash, except for the reach just downstream from Lamb Boulevard.

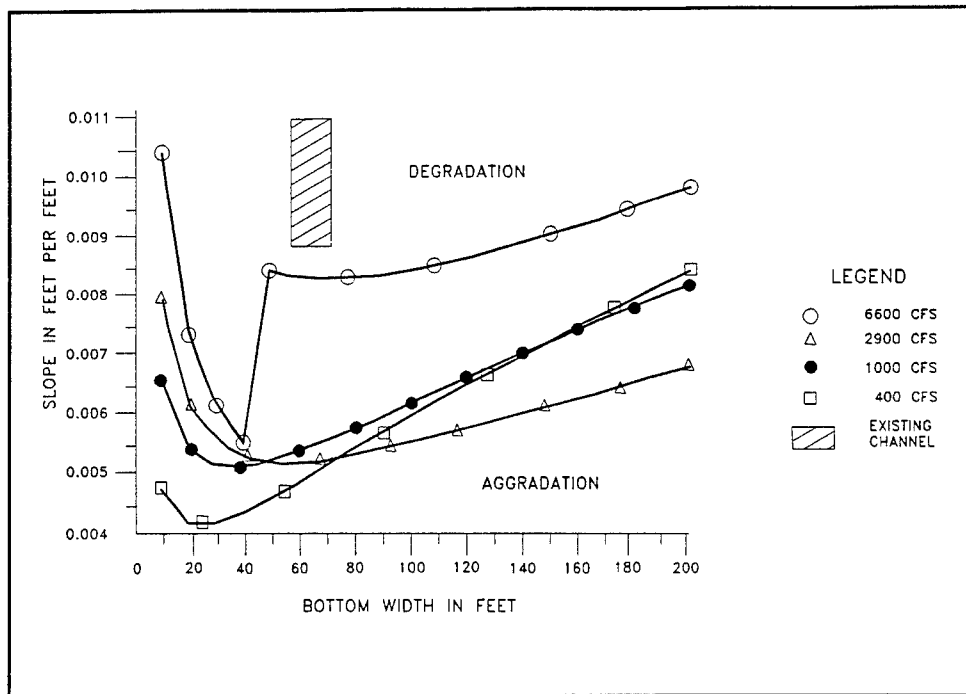
Figure 45. Channel stability curve - Flamingo Wash, Reach 13

The first reach downstream from reach 11 was a concrete-lined channel and required no analysis. The next reach, reach 13, between Mojave Road and Vegas Valley Drive, was a graded trapezoidal channel with a cut low-flow channel. The stable channel analytical method was applied to this reach to obtain a preliminary design estimate of stable channel dimensions. The proposed channel design was a trapezoidal channel that retained the unlined 1V:3H side slopes, which were assigned a roughness coefficient of 0.040. The stable channel calculations were made using the hydraulic design package SAM. The calculated stable channel design curves are shown in Figure 45. Also shown on this figure are the base width and slope ranges of the existing channel. The existing channel dimensions plot well above the stability curves for all discharges, indicating an existing channel regime subject to degradation. Since the existing channel passes through a residential neighborhood, it would be difficult to widen the channel. Therefore, retaining the existing channel base width of about 60 ft, a design channel slope of 0.0050 is obtained from the stability curves for 2,900 cfs. The estimated design slope is about 50 percent of the existing channel slope. An 11-ft drop would be required through the 2000-ft-long reach to attain this slope. Calculated water depth at 2,900 cfs is 5.8 ft, average channel velocity is 6.4 ft/sec, and the composite roughness coefficient is 0.046. This high roughness coefficient is the result of bed-form roughness calculated by the Brownlie equations. The discontinuity in the stability curve for 6600 cfs is due to transition from upper regime plane bedforms to lower regime dune bedforms.

The stable channel method only provides for sediment transport capacity through the reaches. In all the reaches studied herein, the calculated channel velocity was higher than the maximum permissible velocities. Therefore, bank protection would be required for all these stable channel designs.

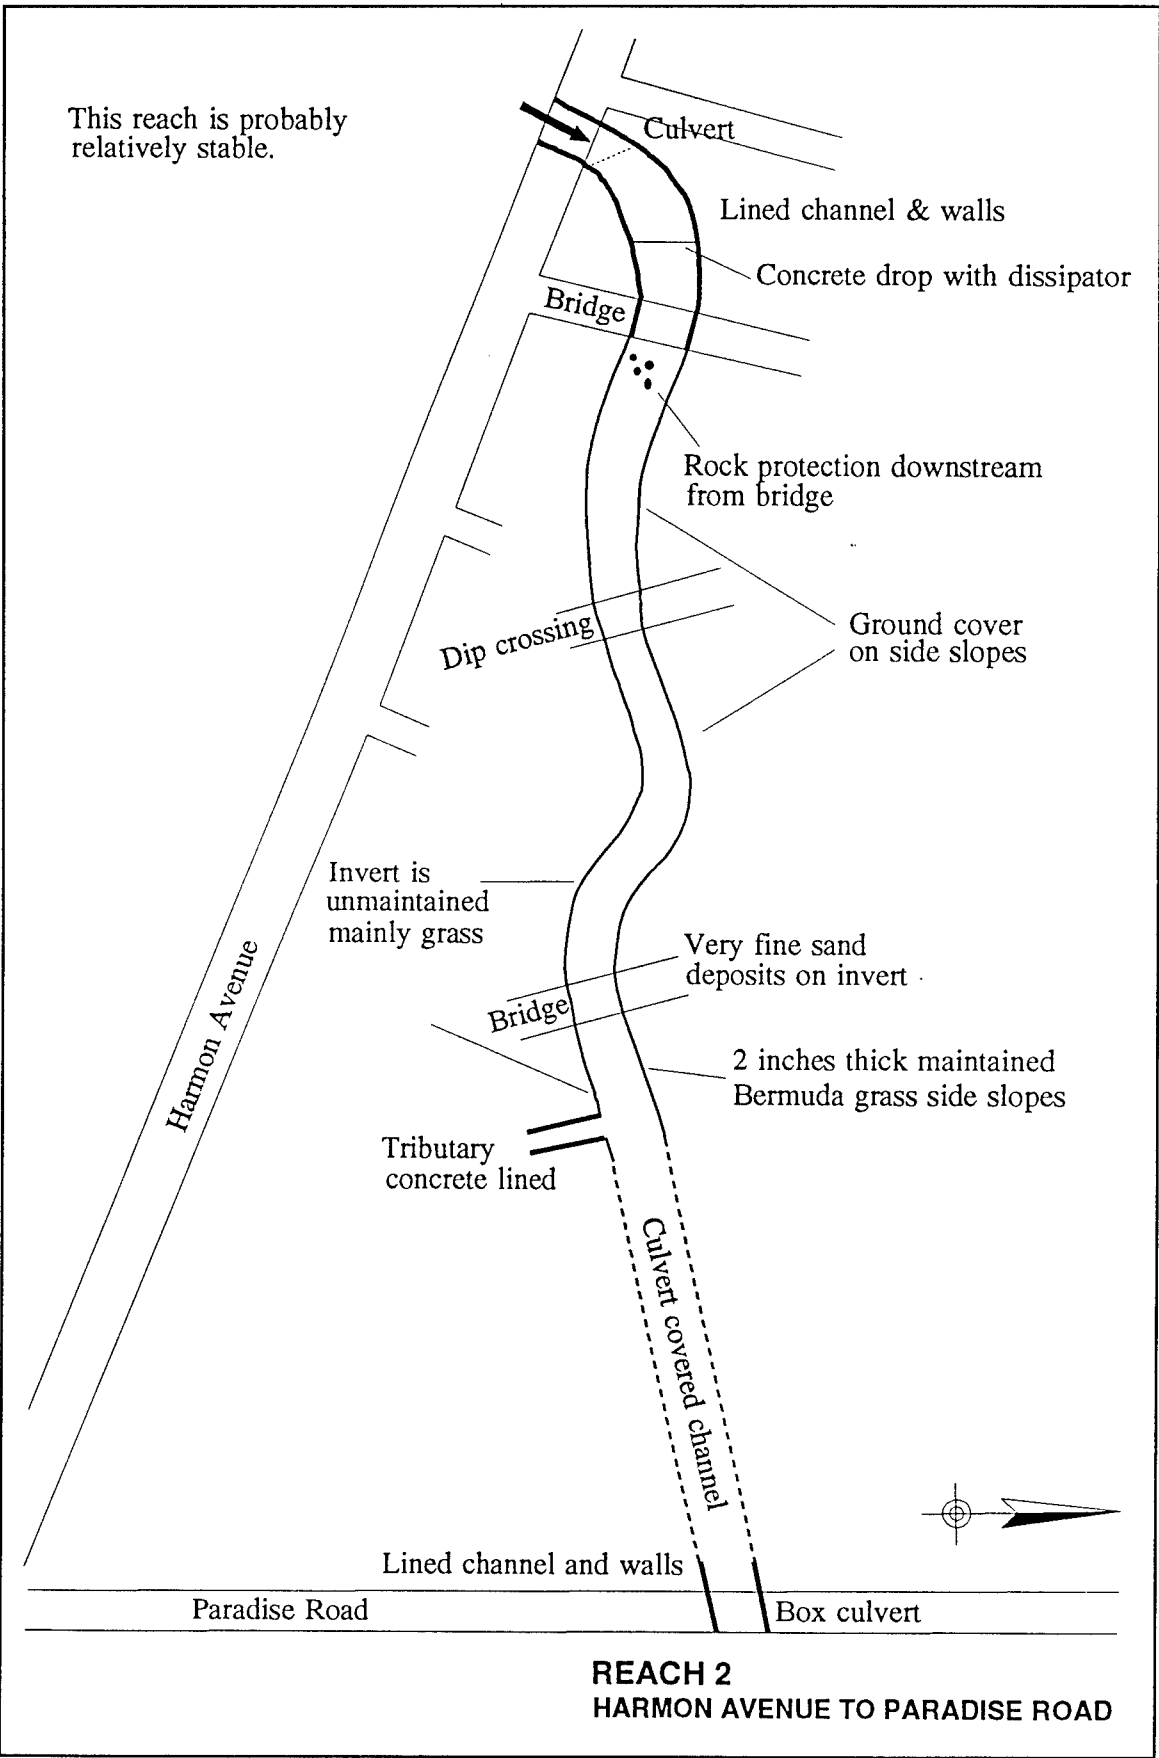
Plate 4

Downstream from Harmon Avenue, for about 150 ft, the channel was concrete-lined. At the end of the concrete-lined channel there was a 3- to 4-ft drop structure and an energy dissipator (Figure 2). Downstream from the dissipator the channel was grass-lined. Low vegetative ground cover was maintained on the side slopes between a driveway bridge, located about 250 ft downstream from Harmon Avenue, and a point 900 ft downstream from Harmon Avenue (Figure 3). Downstream from that point, both the invert and side slopes were grass-lined. Most of the grass in the channel was well maintained in August 1994, but there were a few spots where it had died and bare ground was exposed. Underneath the driveway bridge there were large cobbles and boulders that looked like they had been positioned to hold the low-flow channel. A paved dip road crossing was located about 600 ft downstream from Harmon Avenue. The grass-lined channel runs into a concrete multi-bay culvert which is located 1400 ft downstream from Harmon Avenue. The features described for reach 2 are shown in Plate 4.

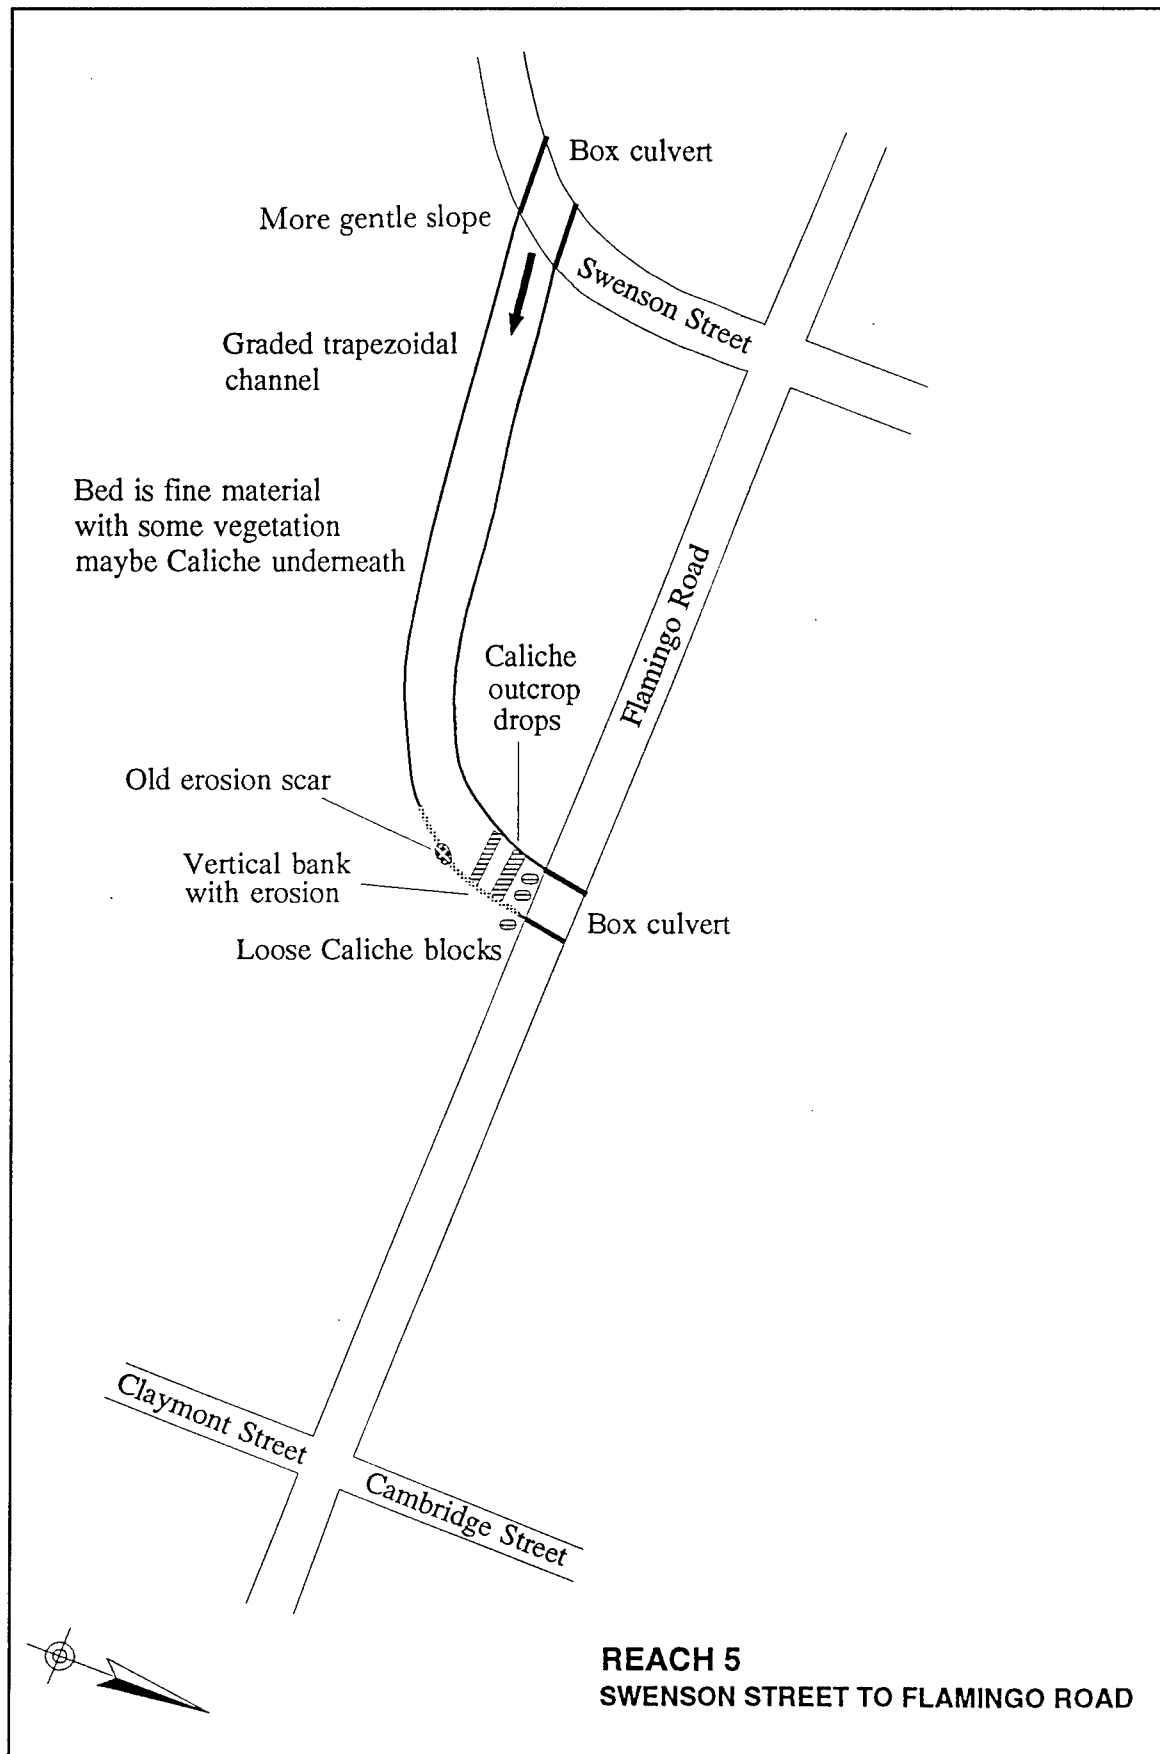
At Flamingo Road the channel entered a triple concrete-box culvert. Sloping pier noses should decrease the potential for floating debris build-up at the culvert entrance. Sediment deposits were observed in the culvert during the August 1994 field reconnaissance. About 6 to 12 inches of broken caliche and mud had deposited in the left bay. At the culvert exit, downstream from Flamingo Road, the natural channel bed was about 1 ft lower than the concrete invert. Plate 6 is a plan view sketch of the features in this reach.

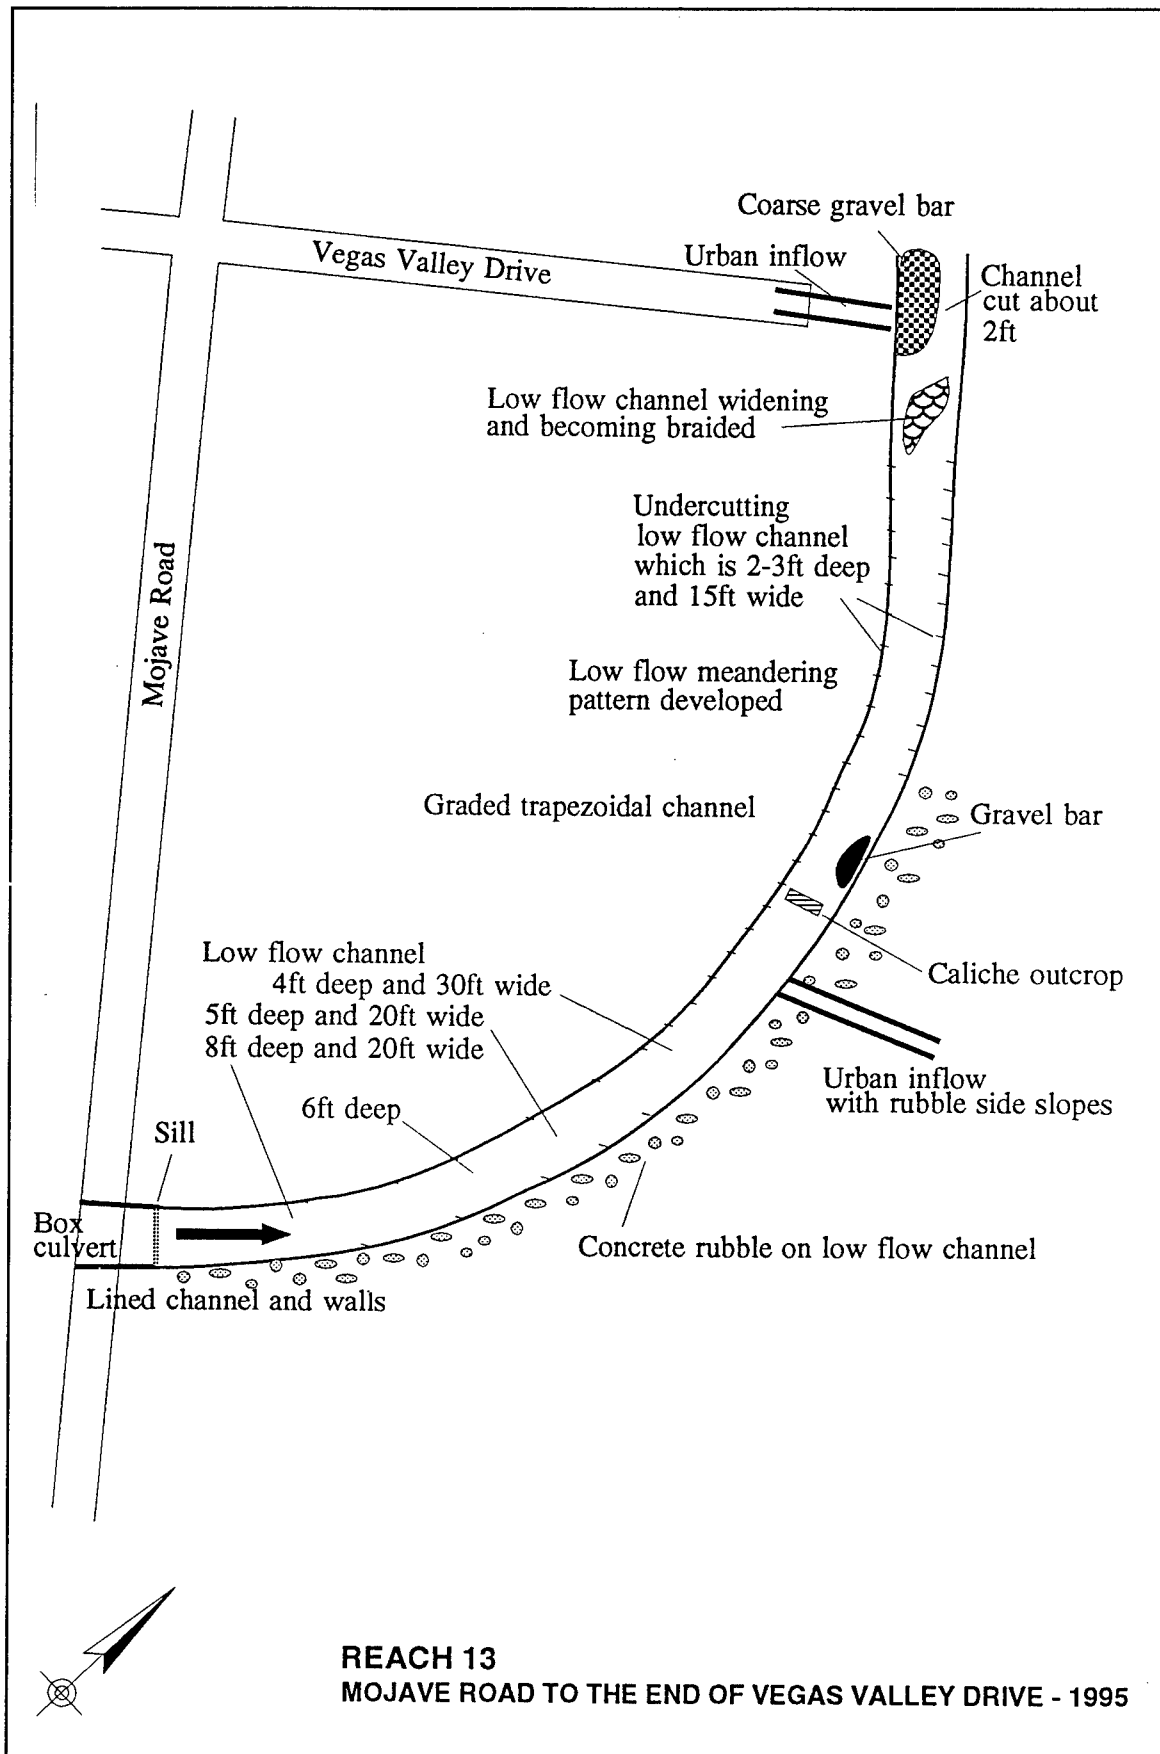
Downstream, towards Vegas Valley Drive, the low-flow channel widened and became shallower. The bed seemed to consist of a gravel mobile armor layer, and the bank material was unconsolidated. The notes in Plate 12 point out the variability of the low flow channel in this reach.
