RECONNAISSANCE REPORT OF DAMAGE TO HISTORIC MONUMENTS IN CAIRO, EGYPT FOLLOWING THE OCTOBER 12, 1992 DAHSHUR EARTHQUAKE

**Reconnaissance Report of Damage
to Historic Monuments in Cairo, Egypt
Following the October 12, 1992 Dahshur Earthquake**

Technical Report NCEER-93-0016

August 19, 1993

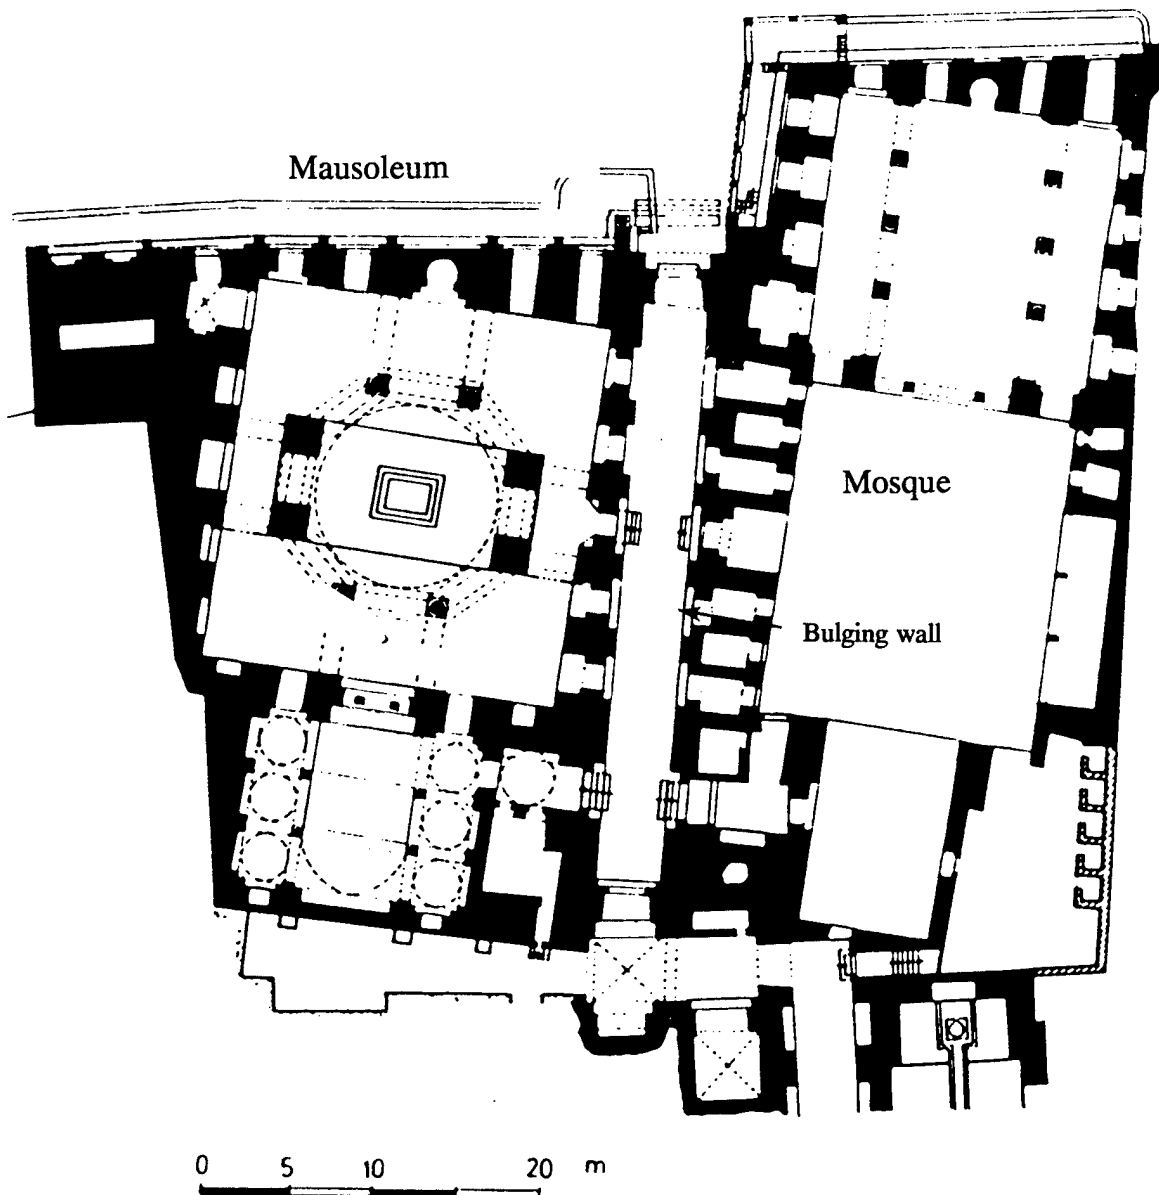
FIGURE 4-19 Floor plan of Mosque and Mausoleum of al-Mansūr Qala'ūn (Creswell 1959)

This mausoleum was in poor structural condition and incurred moderate damage to numerous architectural and structural elements on the exterior and interior. A floor plan of the total complex is shown in figure 4-19 and views of the monument are shown in figures 4-20 through 4-22. It was particularly difficult to ascertain the extent of recent

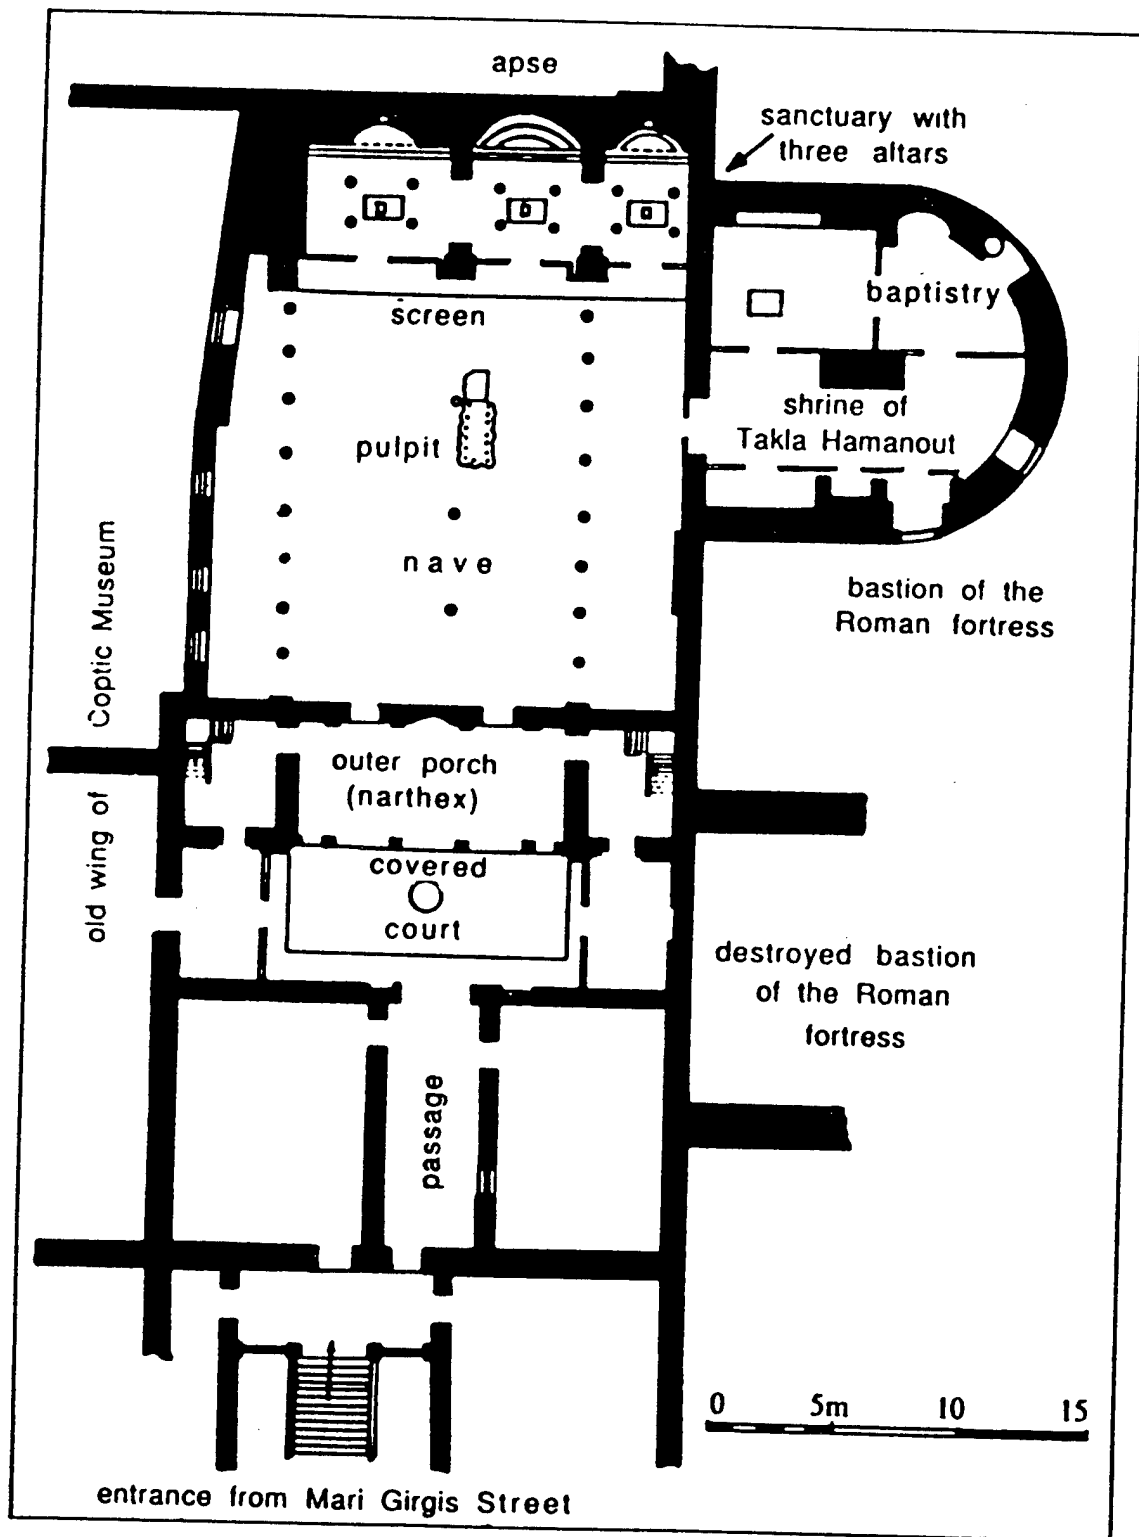
FIGURE 4-38 Floor plan of el-Moallaqa Church (Kamil 1990)

The structural foundations of el-Moalloqa Church rest on the open-air remains of the west gate of The Fortress of Babylon, in particular two bastions (see previous discussion about Coptic Museum). Palm wood joists span the bastions and other massive foundation walls. The church maintenance people reported that for the past eight years about 1.5 m of standing water has been present at the base of the foundation walls. Increased moisture in this trapped airspace has been absorbed into the ancient palm wood. Consequently, the palm wood, already over 2000 years old⁺⁺, is deteriorating more rapidly and can now be dug into easily with a fingernail. A contractor was in the basement shoring arches in the foundation walls at the time of the team's visit.

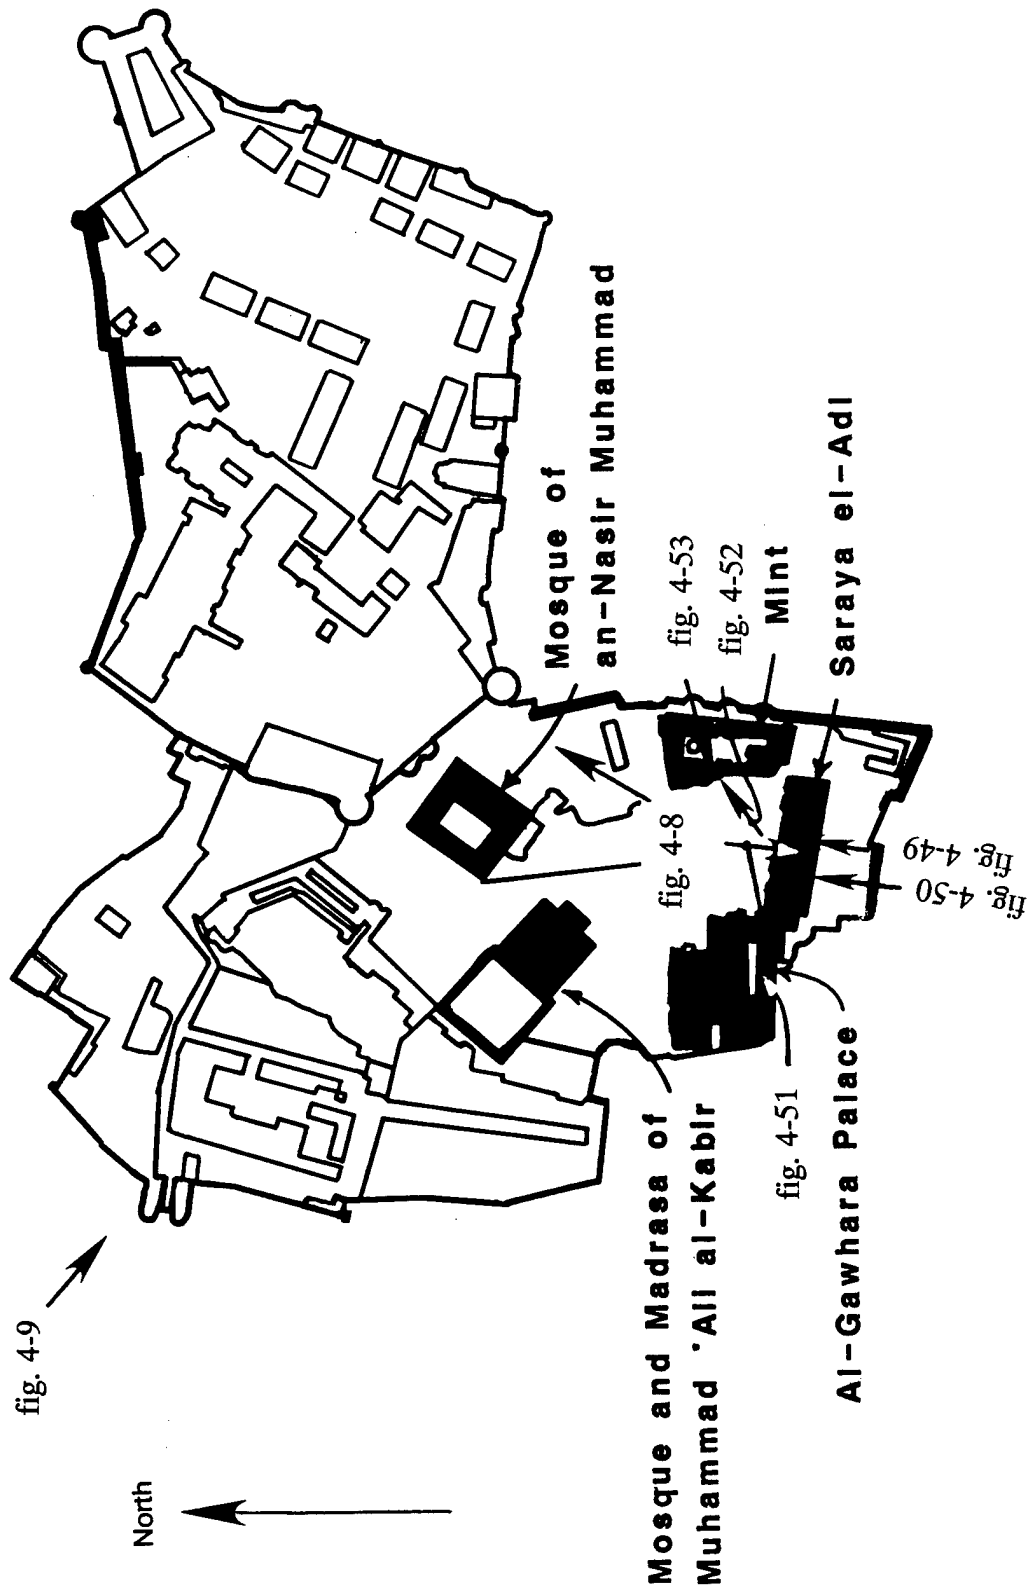
FIGURE 4-48 Map of Citadel (adapted from Egyptian Association of Friends of Antiquities 1980)

The two most recent monuments with severe damage are located at the Citadel. These are the Saraya el-Adl and the Mint. A more detailed map of the Citadel is provided in figure 4-48. The Saraya el-Adl was the location of the court proceedings. This skeleton of a building is adjacent to, and the east of, the el-Gawhara Palace at the Citadel. It is a two-story structure (although only a facade exists on the front of the second floor) built with the European style favored at the time. Timber and mortar construction of the walls is visible in the remains of wall burnt in a fire. The primary components of the earthquake motions appear to have been in the out-of-plane direction.
