Technical Report CHL-97-5 March 1997

Monitoring Completed Navigation Projects Program

# Burns Harbor, Indiana, Monitoring Study

## **Volume I: Overview of Approach and Results**

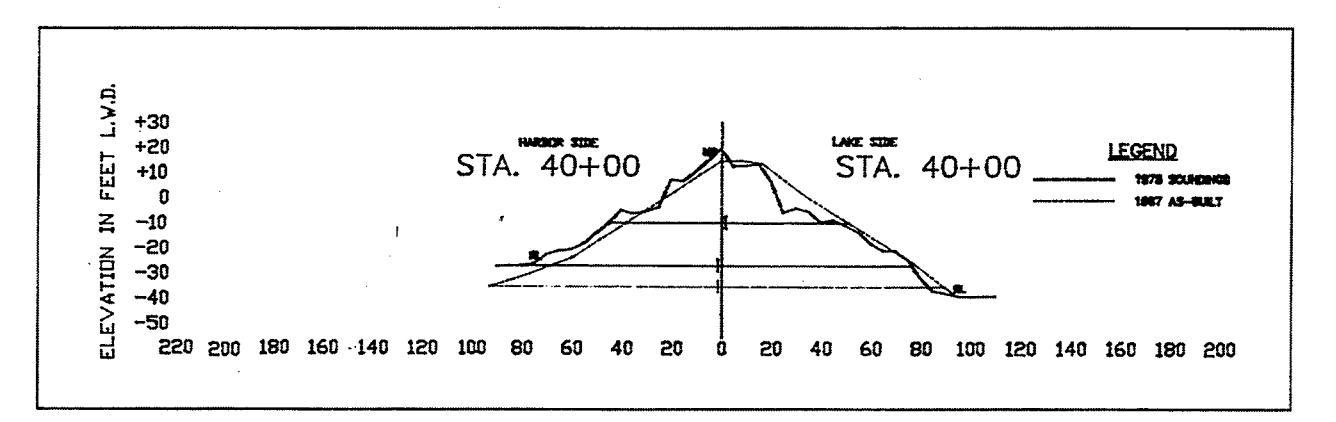
Figure 11. Typical as-built cross section

**Cross-section surveys.** All surveys were digitized and analyzed using AUTOCAD to allow intercomparisons and volumetric computation (Figure 11). These values were used in the cross section and stability analyses below.

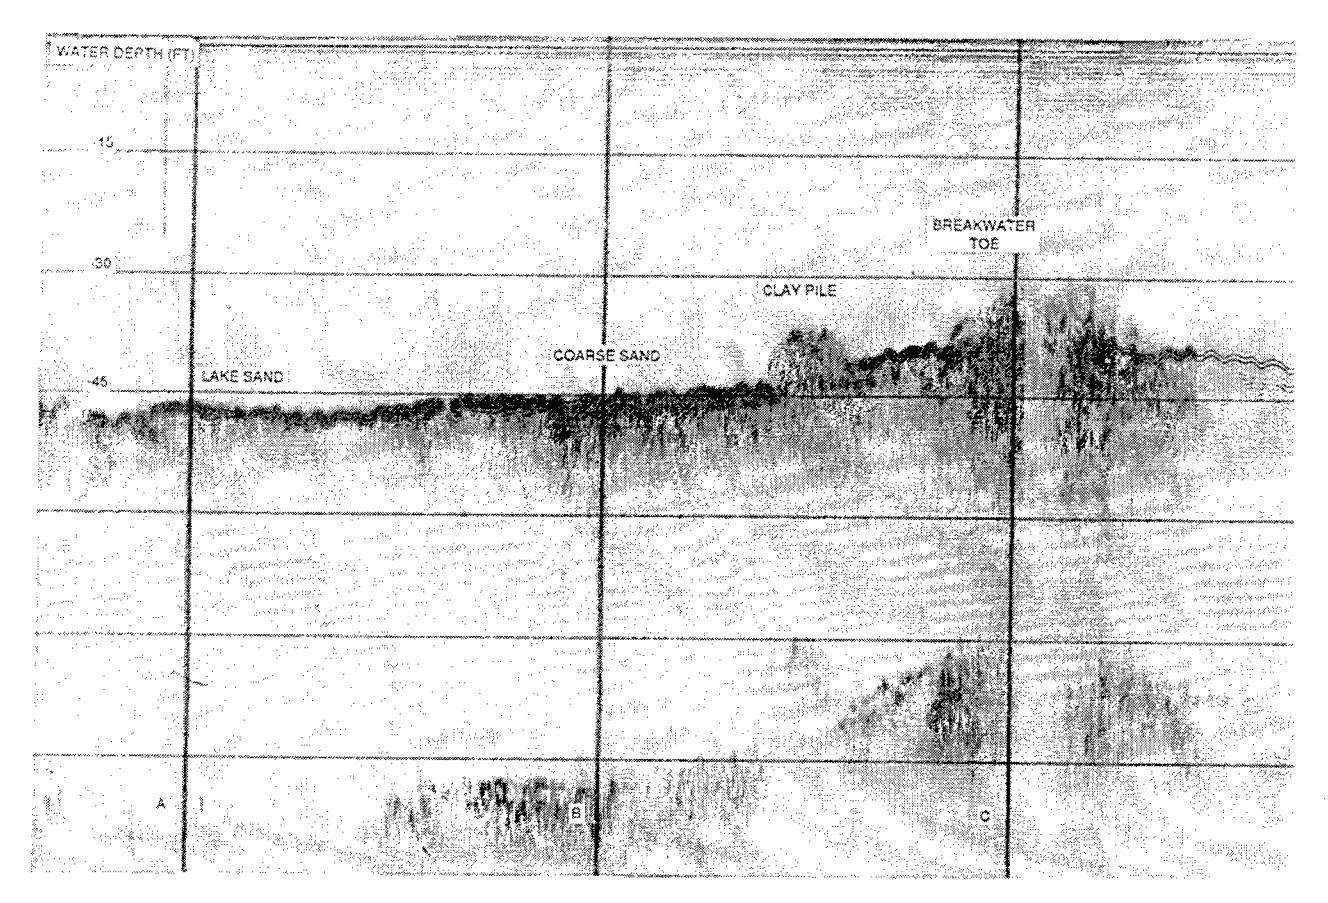
Figure 22. Subbottom sonar sonogram, line 25L

**Subbottom sonar surveys**. Track lines 16L, 25L, and 33L are shown on Figure 18 with hash marks labelled at corresponding fix marks (A, B, C,...) on the SBS sonograms to identify the features. Figure 22 is the sonogram of line 25L. The shallow relief of the coarse sand deposit, the abrupt outline of the clay mound, and the beginning of the breakwater slope are easily identifiable. Some layering is discernible in the sediments away from the structure.

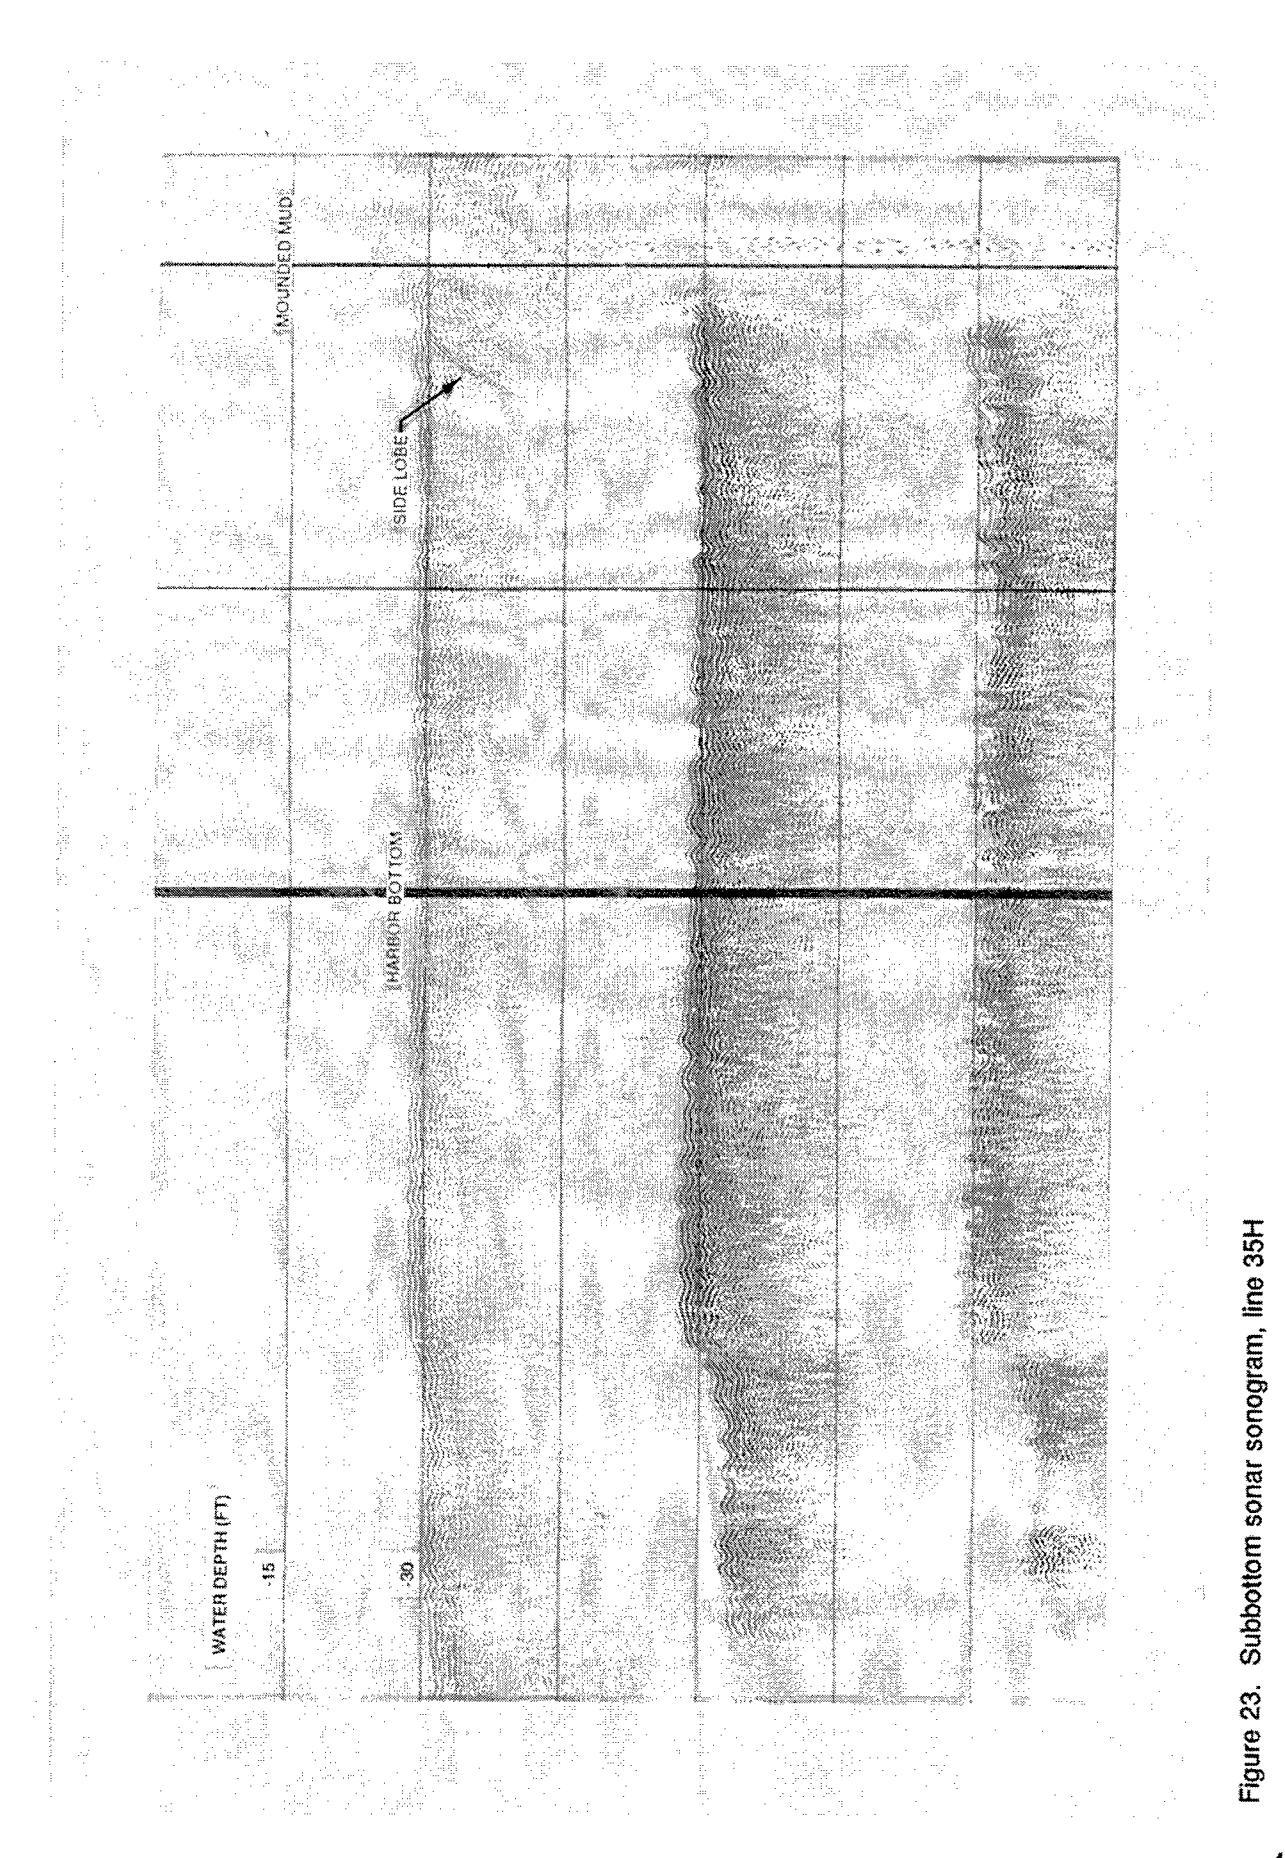
On the harborside, the SBS confirms the featureless bottom seen on the SSS sonogram. Figure 23 is the line 35H. The faint return from the soft clay as it slopes upward to about -20 ft is barely visible at the right end. Its shape is inconsistant with sedimentation due to material settling from above. There is no evidence of a distinct hard return as would be caused by armor stone below this slope. The curved reflection labeled "sidelobe" comes from strong reflections from the armor off to the side of the transducer as it approaches the structure.

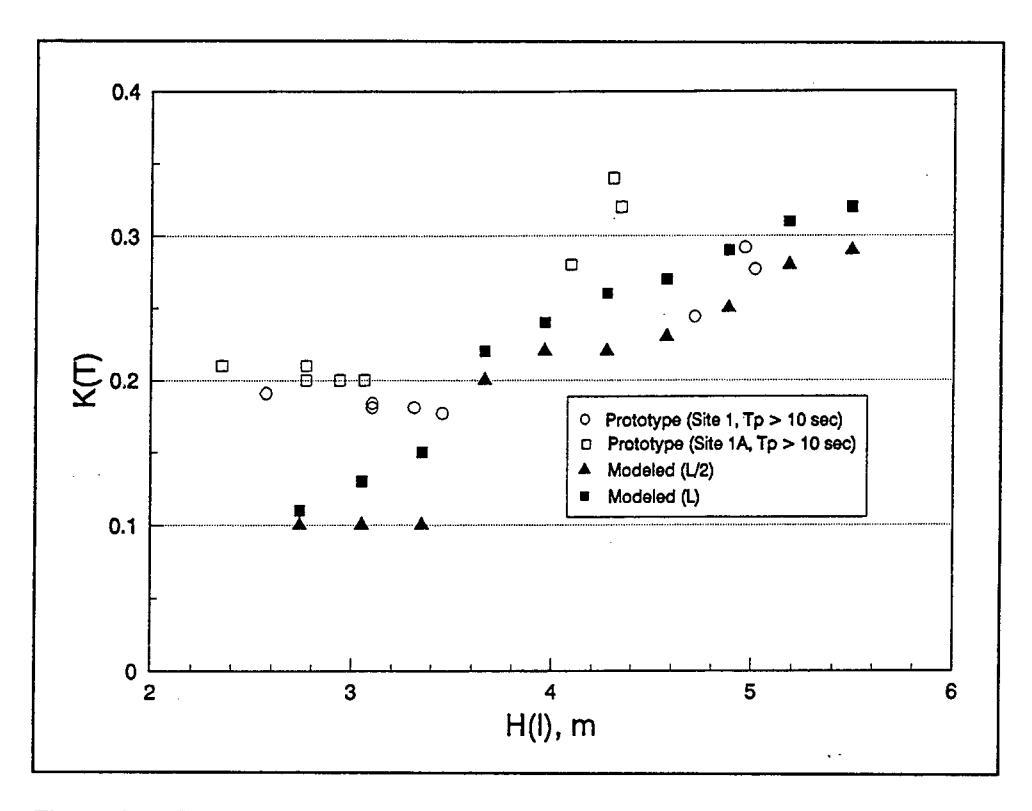
Figure 34 is a comparison of the prototype and the 2-D model transmission coefficients. The prototype data ranged from 4.1 to 11.6 sec, but only those prototype waves with periods greater than 10 sec, comparable to the 11-sec model waves, are plotted. The 2-D model measured wave transmission at two

The model significantly underpredicted transmission for waves below 3 m, regardless of whether the reflected waves are included. Long-period waves below 3 m are transmitted through the structure without overtopping, and are strongly influenced by the structure's porosity. Results of later research showed that the core material in scaled physical models should be oversized relative to the linear scaling relationship to compensate for viscosity effects (Keulegan 1973). The core material in the 1966 study was sized linearly, like the cover layers, and underprediction may result from the effect of the increased viscous drag, relative to the prototype, at these scales.

Figure 34. Prototype and modeled transmission coefficient K(T) versus incident significant wave height when  $T_P > 10$  sec

The model data show an abrupt discontinuity around 3.5 m. It is near this point that the model study indicated overtopping occurred. It seems likely the additional energy coming over the model structure caused the increase in total transmittance. There is not as obvious a jump in the prototype data, though it could be argued that an increase in the rate of transmittance occurs between 3 and 4 m. It is likely that this corresponds to the onset of significant

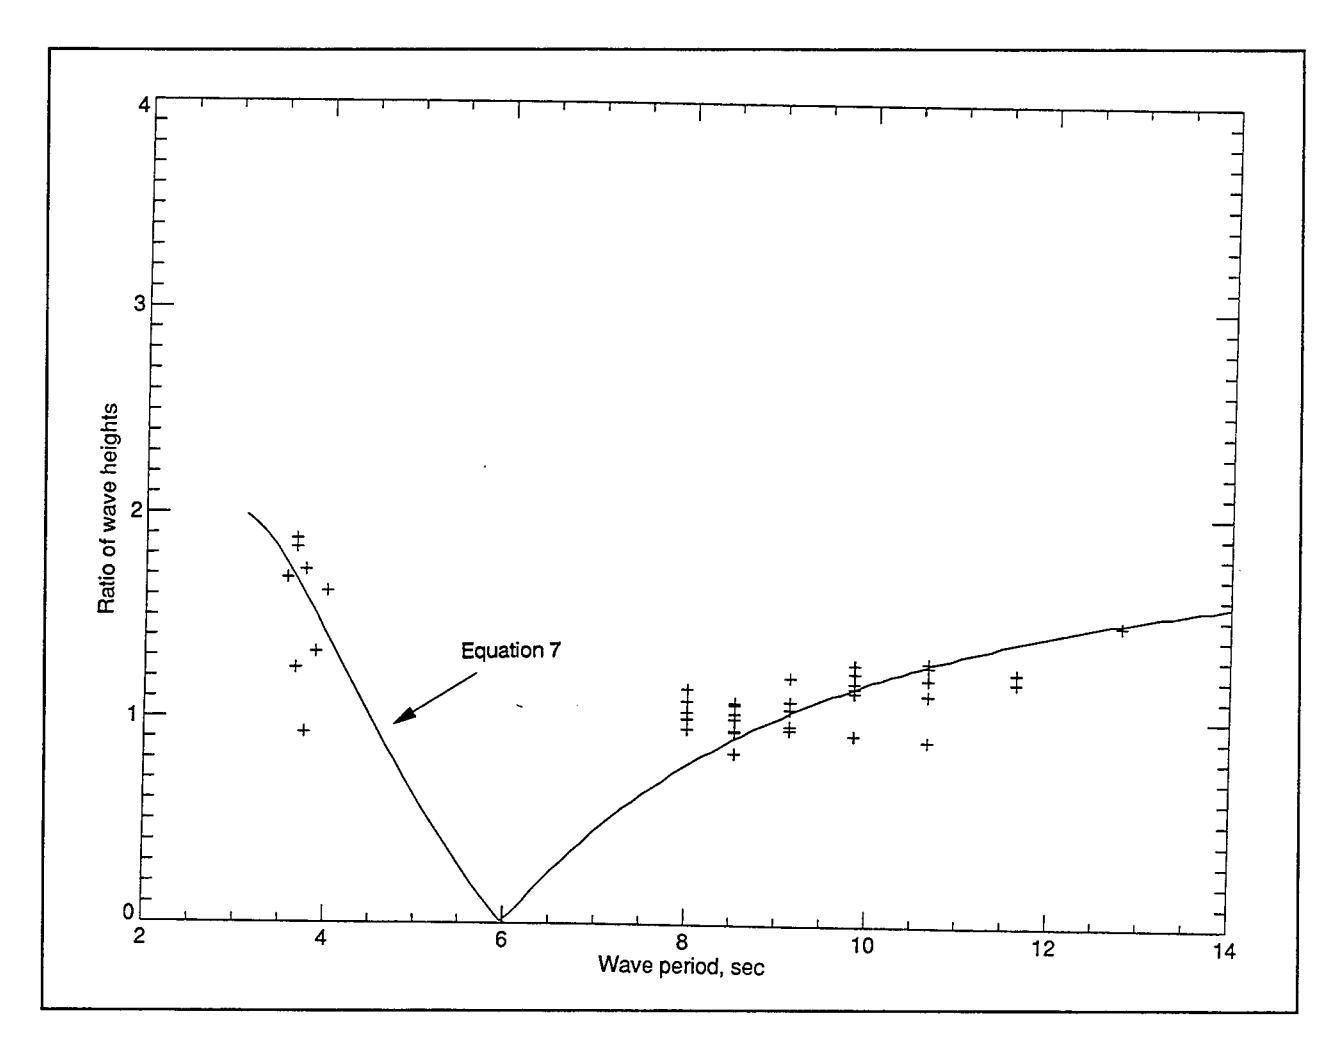
Figure 35 is a plot of the ratio of measured wave heights at Site 3 to Site 2 against the peak period data at Site 2. Equation 7 is also plotted on Figure 35 for x = 45 ft, the distance of Site 3 from the front of the grain dock. L was estimated from the linear shallow-water approximation for a depth of 30 ft. For example, for 6.7 ft, the highest wave measured at Site 3, Equation 7 predicts an incident wave of 4.8 ft, which agrees well with the 4.7-ft wave height

Figure 35. Ratio of significant wave height (Site 3 to Site 2) versus peak period (Site 2)

measured at Site 2 at the same time. This indicates wave conditions at the grain dock result from complete reflection of energy transmitted through the breakwater.

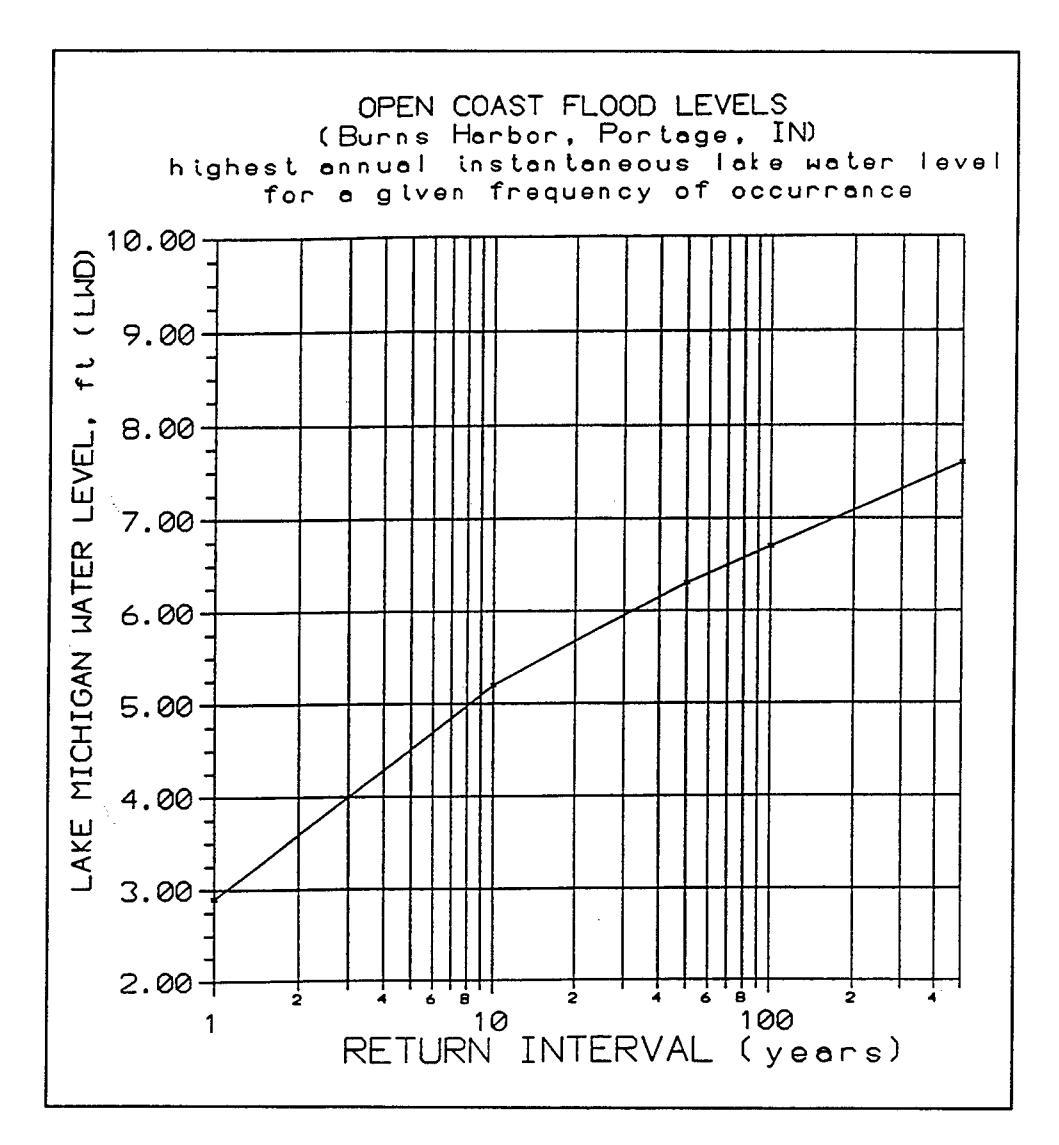
Water level extremal analysis. Either an extremal analysis or a frequency distribution analysis is suitable for the measured water level record, because the time series is nearly continuous, and over-sampled relative to the rate of change of the lake levels. Figure 36 (from the extremal analysis) plots water levels versus return interval for the Calumet Harbor gages as taken from a study conducted by the Detroit District.

Figure 36. Return interval versus water level
