Technical Report REMR-CS-60
September 1998

Repair, Evaluation, Maintenance, and Rehabilitation Research Program

Performance Criteria for Concrete Repair Materials, Phase II Field Studies

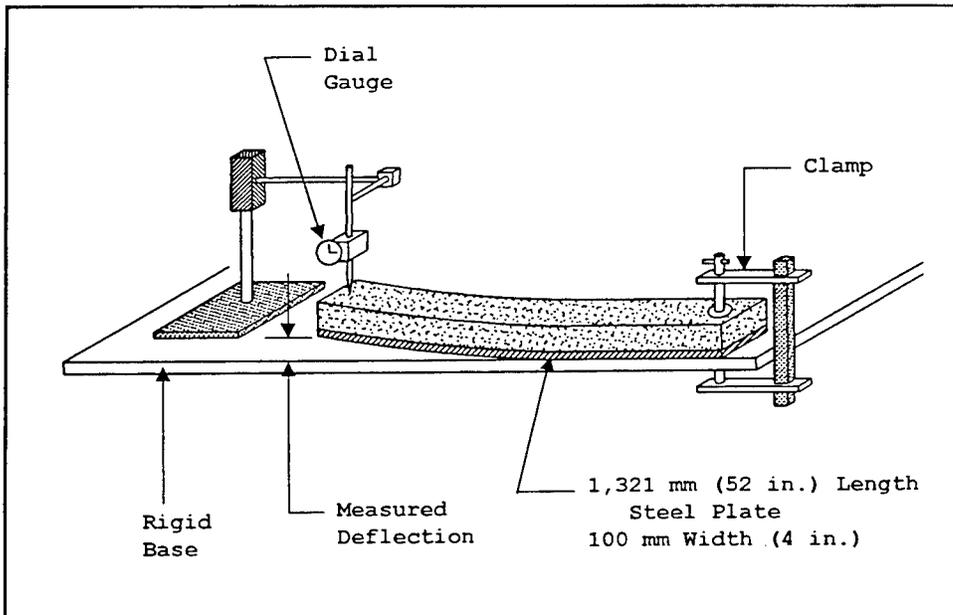
Figure 18. Schematic of restrained volume change strain/stress indicator (SPS Plate Test)

As previously shown in Figure 18, the SPS Plate Test specimen is a beam that is fixed at one end and free to move at the other end. As the material expands or contracts in response to moisture and temperature changes, the free end deflects accordingly. The initial deflection measurements were made after completion of curing, and subsequent measurements were made periodically during the monitoring period. Detailed results of the SPS Plate Test are presented in Appendix B and summarized in Table 10.
