ESL-TR-91-13  
VOL II

**EXPEDIENT REPAIR OF STRUCTURAL  
FACILITIES (ERSF) - VOLUME II: ERSF  
SYSTEM REQUIREMENTS AND USERS  
GUIDE**

**JULY 1991**

**FINAL REPORT**

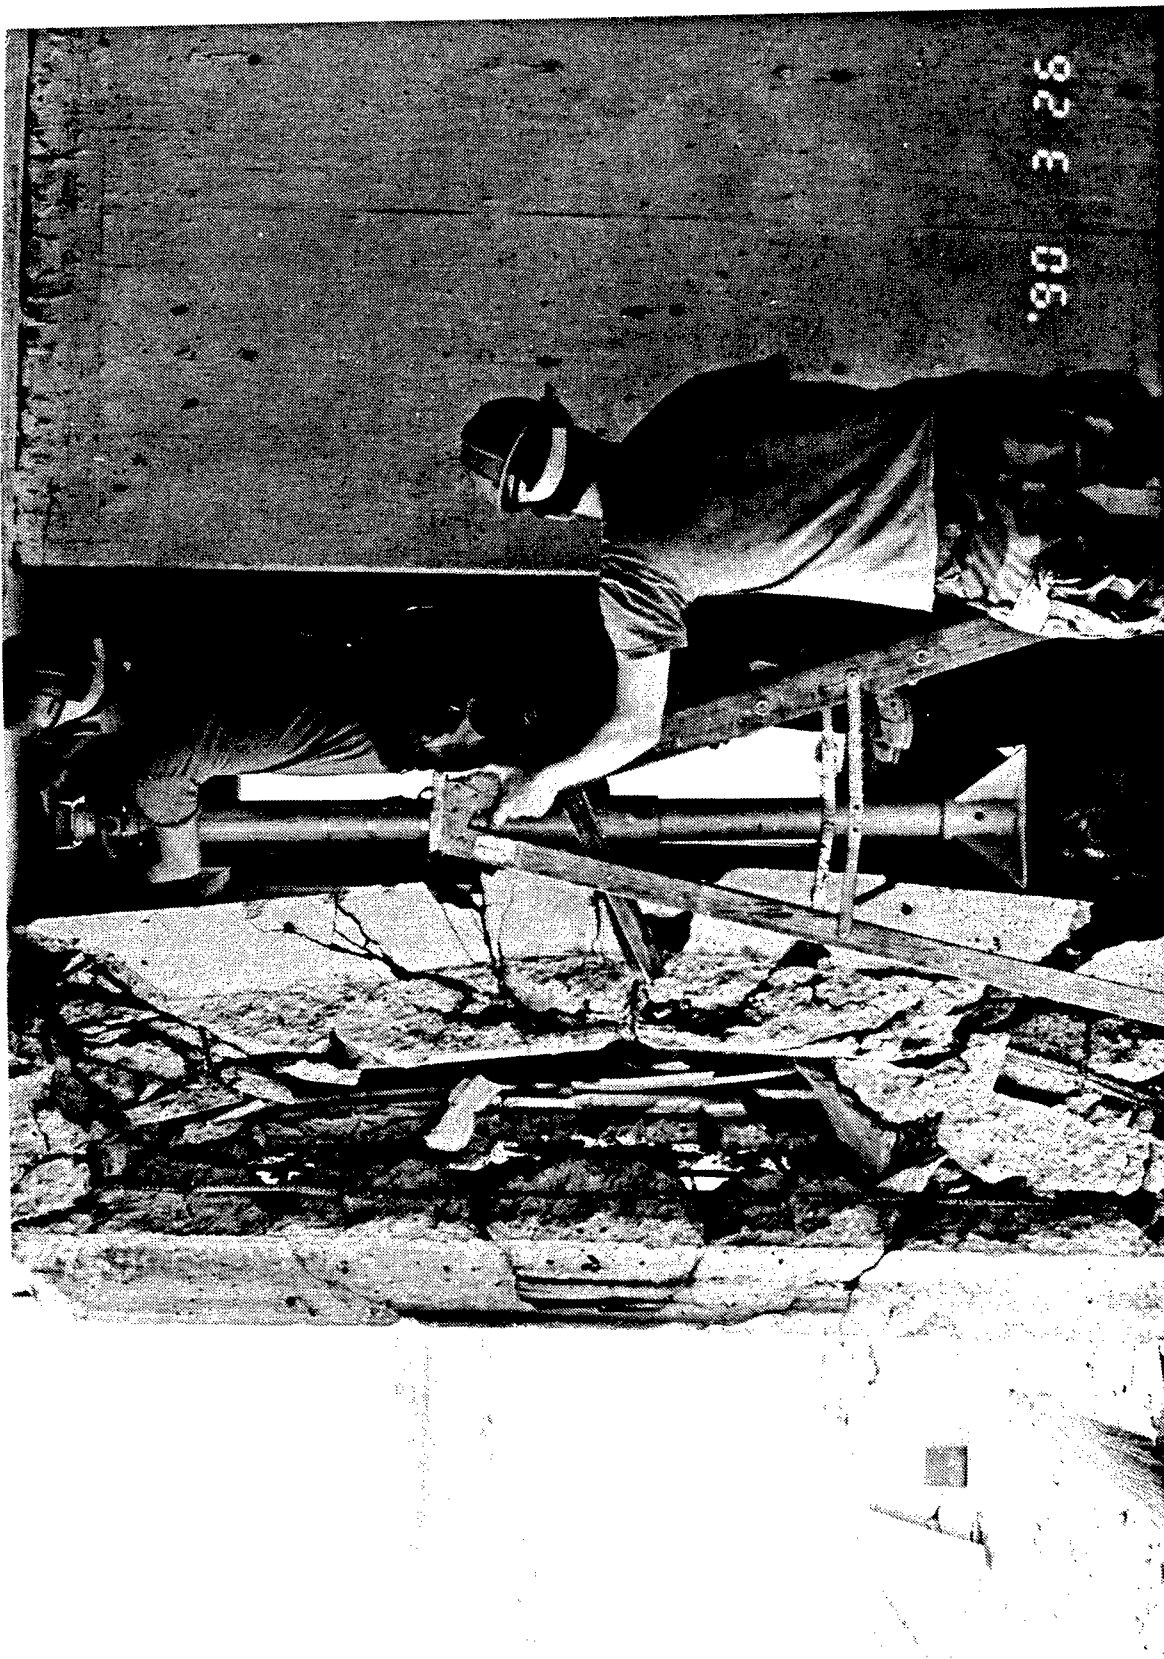
Figure 51. Placing Shoring Jack Next to Destroyed Column.

(3) Third, the height of the shoring jack when fully extended was not long enough for the top of the jack to come in contact with the bottom of the roof beam when the base of the jack was placed on the floor. Consequently, the base of the jack had to be placed on wood blocks (cut up railroad ties) to obtain the required height. Using the blocks increased repair time and reduced the stability of the jack. Additionally, during this test sequence, only two wood blocks were used under the jack, and as a result, the jack had to be fully extended to come in contact with the roof beam, which increased repair time and reduced jack stability.
