# AFRL-ML-WP-TR-1998-4191

# CUT PROGRESSION DURING DYNAMOMETER TESTING OF FOREIGN OBJECT DAMAGED TYPE VII EXTRA HIGH PRESSURE AIRCRAFT TIRES SAE PAPER 912155

# Cut Progression During Dynamometer Testing of Foreign Object Damaged Type VII Extra High Pressure Aircraft Tires

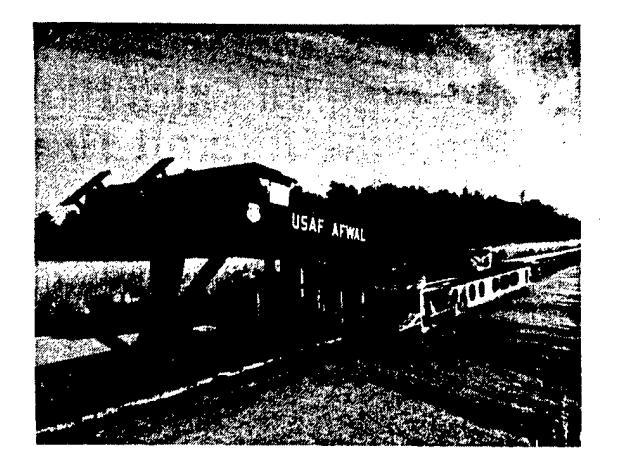
FIGURE 1 - TIRE CUTTING TEST VEHICLE

TIRE CUTTING TEST VEHICLE - The Tire Cutting Test Vehicle (TCTV) at Lakehurst was used for a test of debris lofting, with an F-4 nose landing gear in place. That fixture was replaced with one that supported an F-16 main landing gear wheel assembly (see Figure 1). The following elements were varied on the test tire, the TCTV, and what the tire passed over:

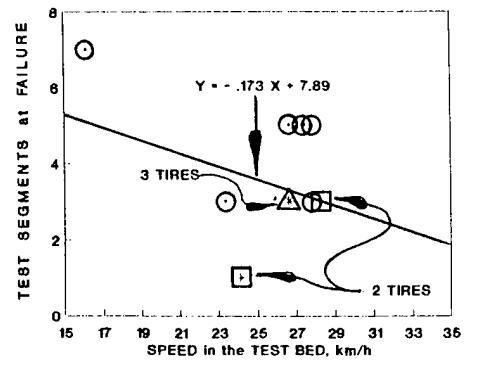
The number of dynamometer segments run at

tire failure is presented in Figure 12. On the dynamometer, 69% of the tires failed on or before TTO 2, Test Segment 3. The negative slope indicates more damage occurred at higher track speed, which resulted in a shorter life on the dynamometer. This curve compliments the information in Figure 9.
