NAVAL AIR WARFARE CENTER AIRCRAFT DIVISION  
PATUXENT RIVER, MARYLAND

REPORT NO: NAWCADPAX/TR-2000/59

### **BREAKDOWN OF PRESERVATIVE FLUID MIL-PRF-46170 IN AIRCRAFT HYDRAULIC SYSTEMS**

29 March 2001

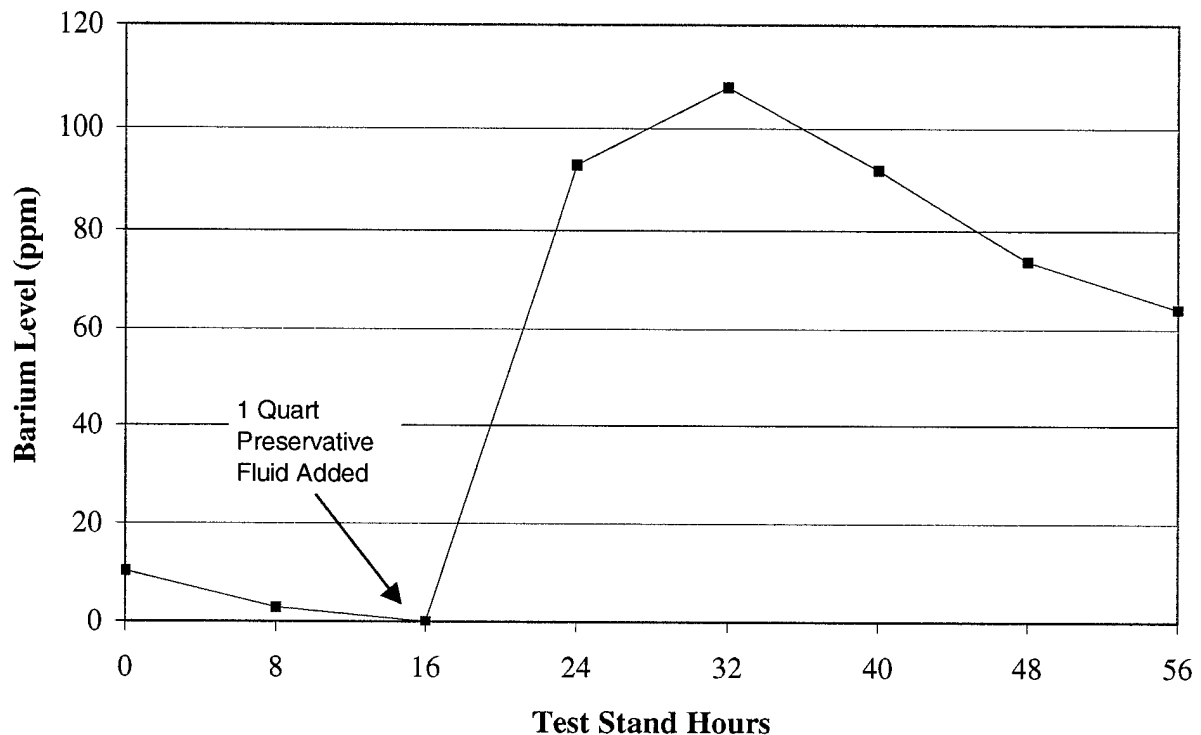
**Figure 2: Fluid Barium Level Versus Time**

Fluid temperature was maintained at 215°F and the first 2 days of testing were performed without preservative fluid to ensure a clean system. Filter loading for the first 2 days was minimal. Note that fluid barium level was reduced from 13 ppm to 0 ppm in the first 16 hr of testing as residual preservative was removed from system fluid.

The beginning of the third day, 1 qt of preservative fluid was added after 16 hr of operation (shown in figure 2). The rate of filter loading significantly increased after adding the preservative fluid. The level of residual preservative in fluid was steadily reduced as organic material was collecting on the filter.

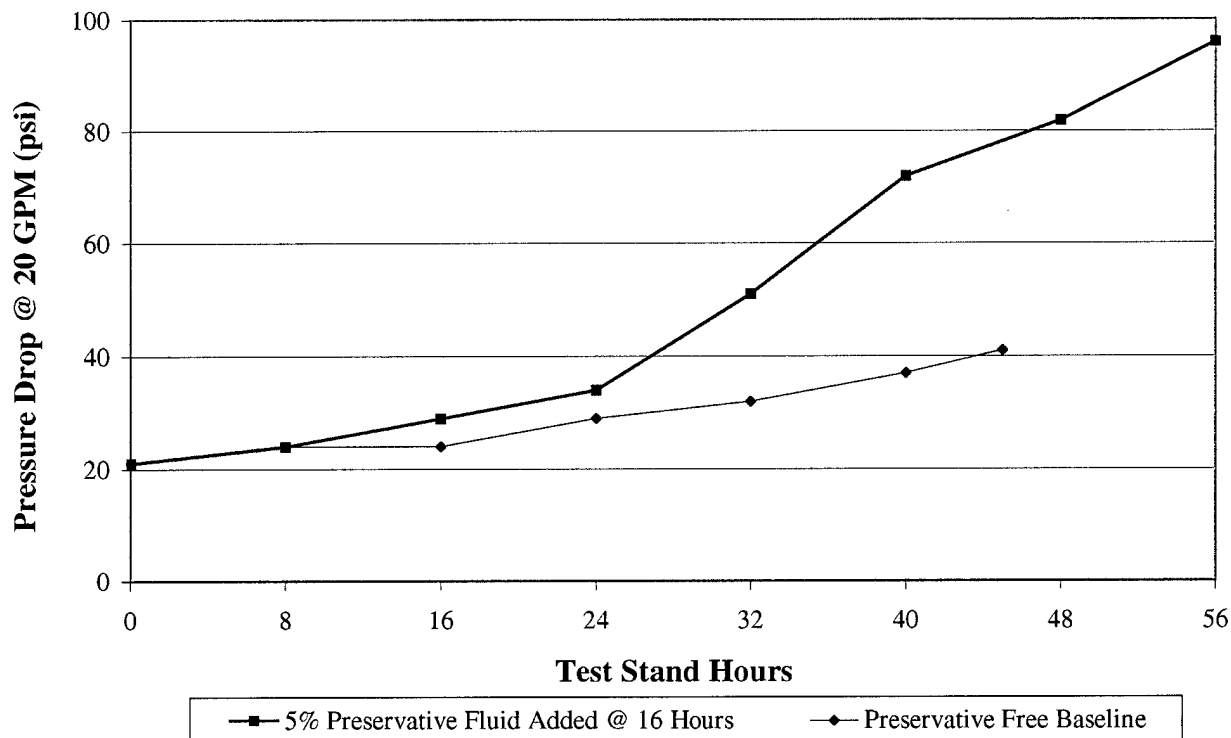
Figure 3: Filter Element Pressure Drop Versus Time

Additionally, baseline testing was performed with 100% hydraulic fluid to quantify the effects of preservative on filter clogging. Baseline testing with low levels of preservative showed minimal filter loading for the first 45 hr of testing (figure 3).

System baseline testing had progressed to 45 hr with minimal filter loading when an abrupt increase in pressure was observed. Inspection of the system identified a rupture in the heat exchanger that was adding large amounts of water to system fluid.
