**(CAVITATION DAMAGE OF MECHANICAL  
PUMP IMPELLERS OPERATING IN  
LIQUID METAL SPACE POWER LOOPS)**

*by R. S. Kulp and J. V. Altieri*

Prepared under Contract No. NAS 3-2541 by  
PRATT & WHITNEY AIRCRAFT DIVISION  
UNITED AIRCRAFT CORPORATION  
Middletown, Conn.

NATIONAL AERONAUTICS AND SPACE ADMINISTRATION

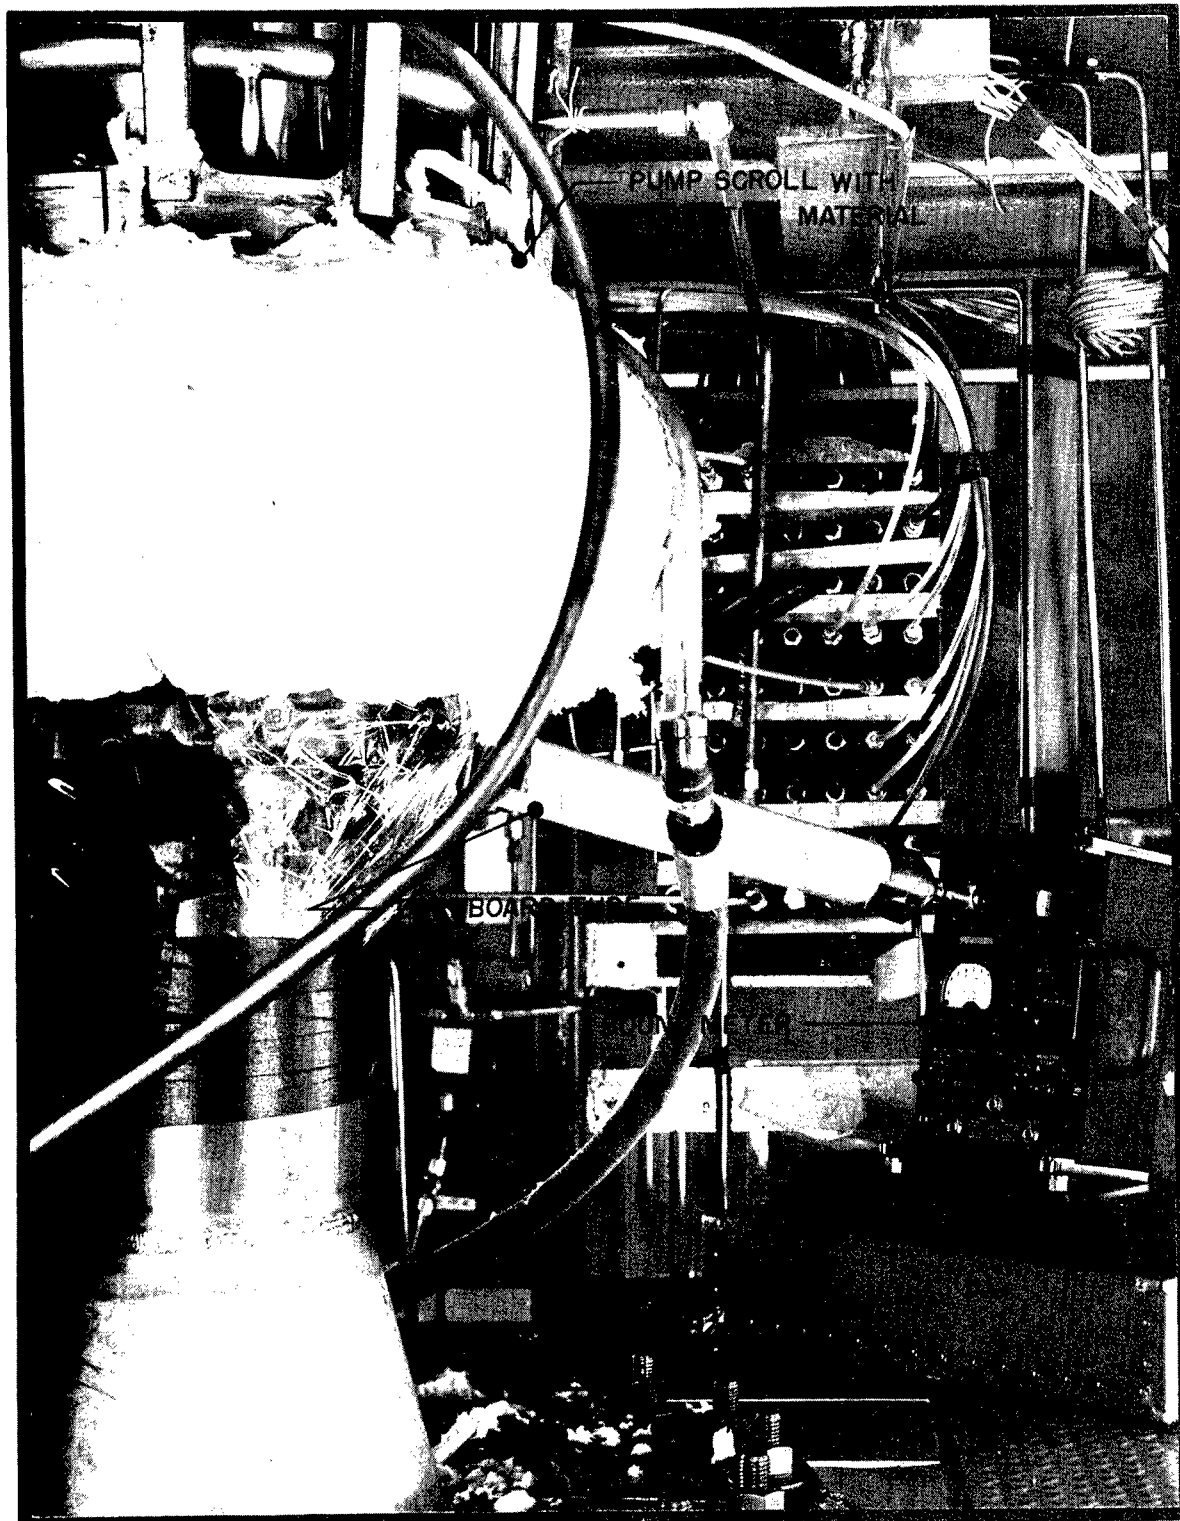
FIG 39

attempt to record useful sound data. Further definition of the impeller noise was obtained by placing a cardboard tube over the microphone and inserting the end of the tube in a hole cut through the insulation under the pump scroll (Fig. 39). The sound pattern thus obtained is given in Fig. 40.

SETUP FOR SOUND READINGS IN WATER PUMP TEST STAND

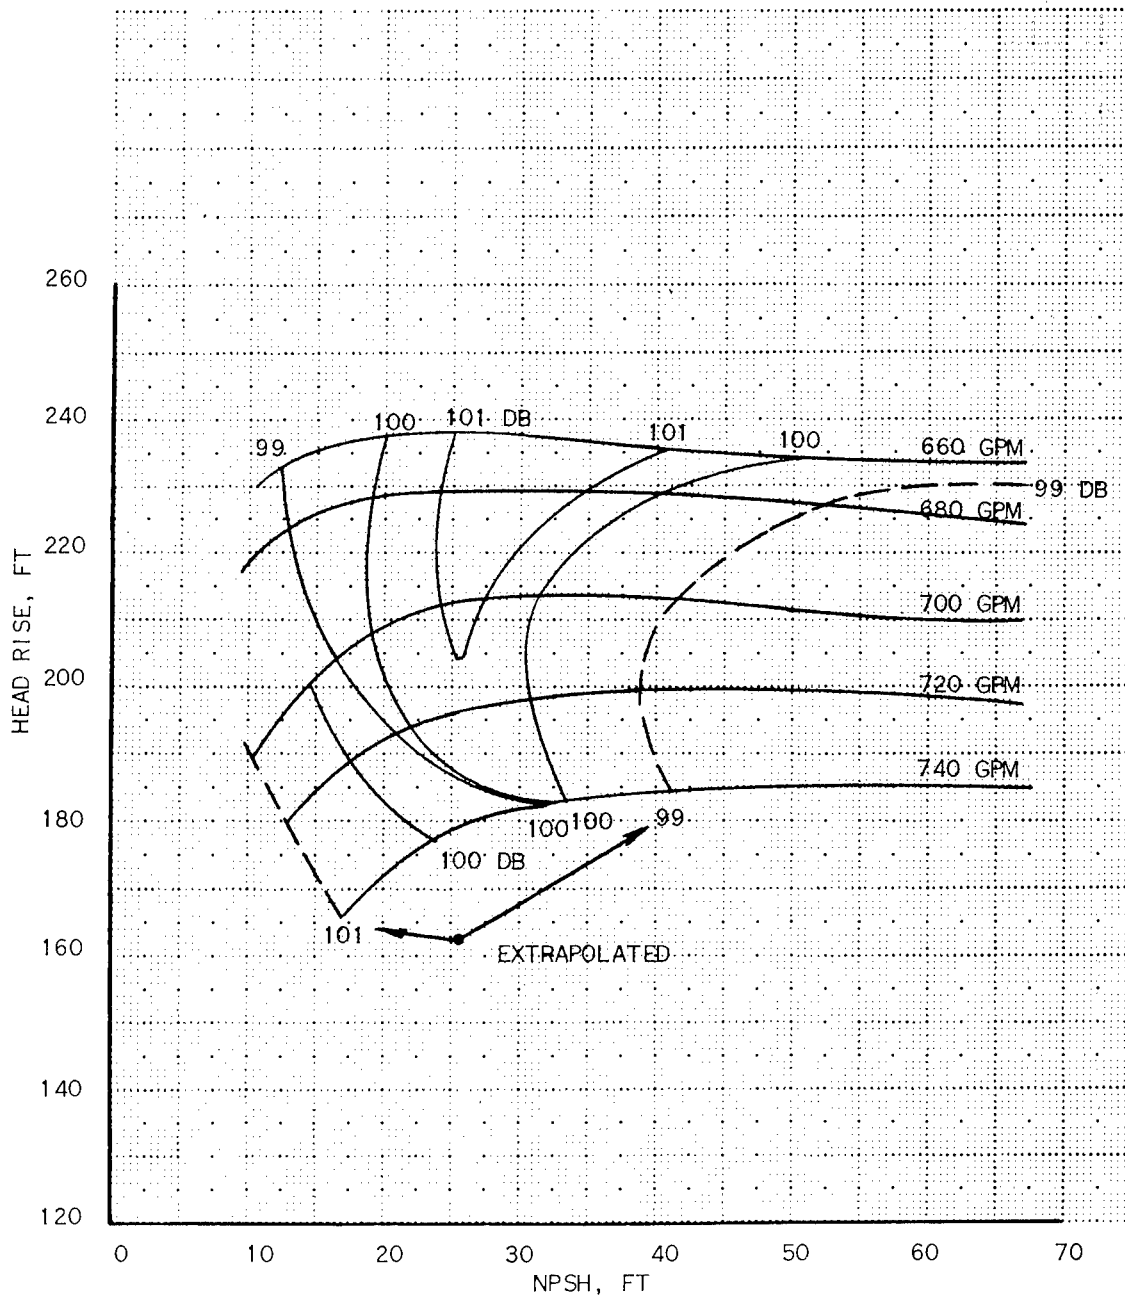
FIG 40

# CROSS PLOT OF NOISE AND CAVITATION PERFORMANCE FOR THE TURBOPUMP WATER TEST

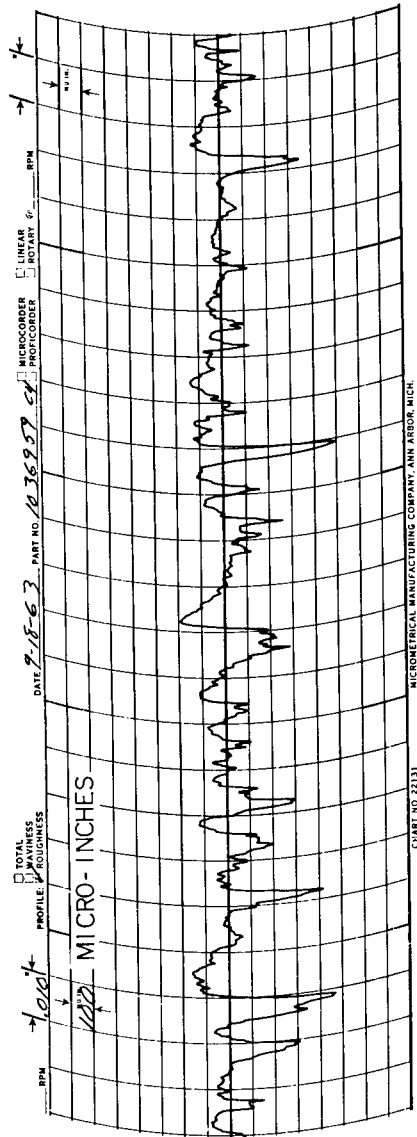
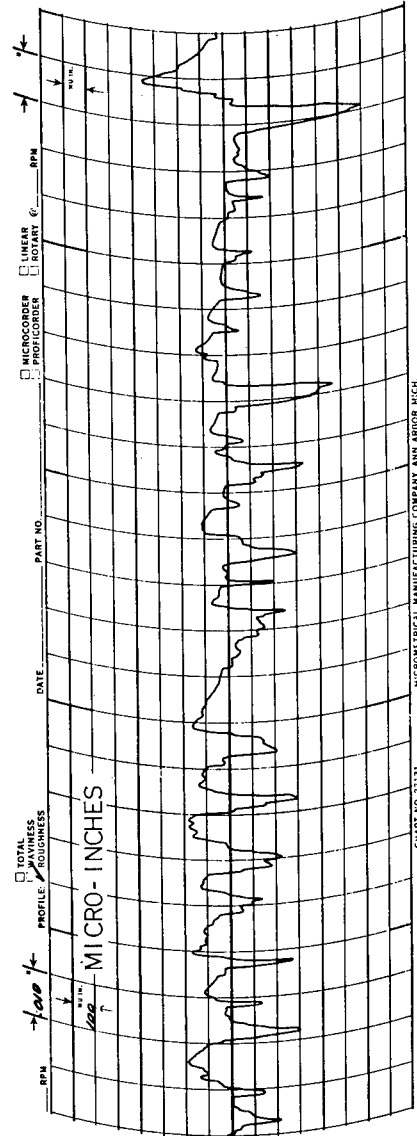
# SURFACE ROUGHNESS MEASUREMENTS COMPARED AFTER WATER TEST BLADE 2, STATION 6, PRESSURE SIDE

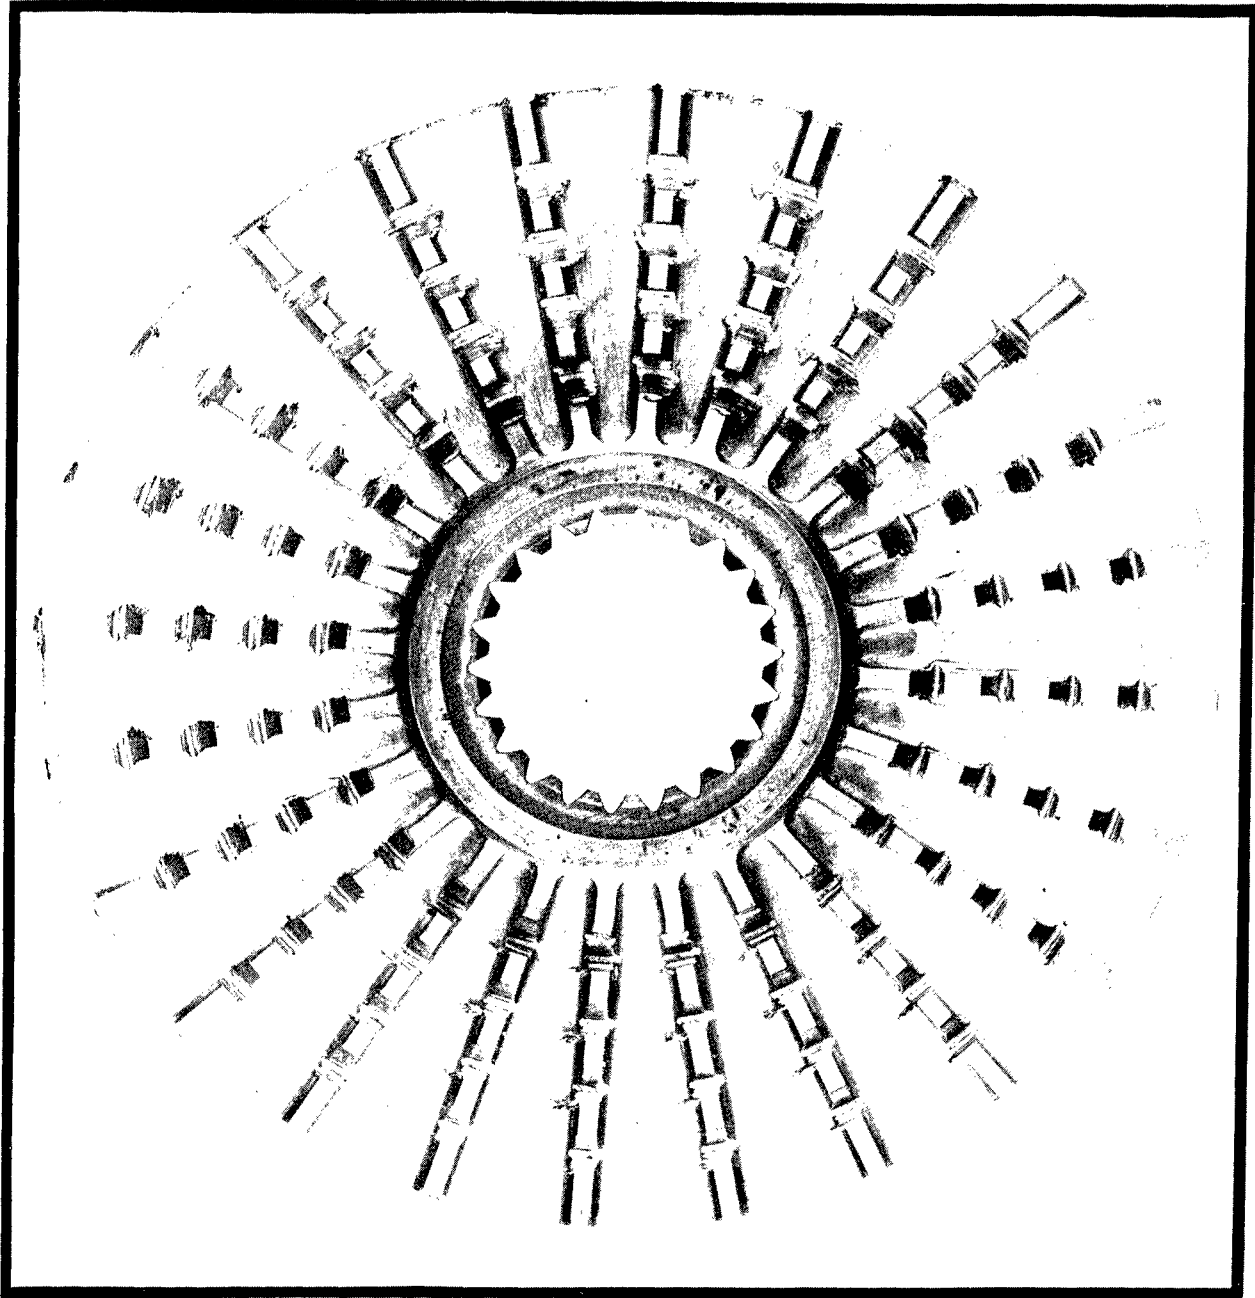
FIG 52

LOWER DYNAMIC SEAL (POSTTEST)

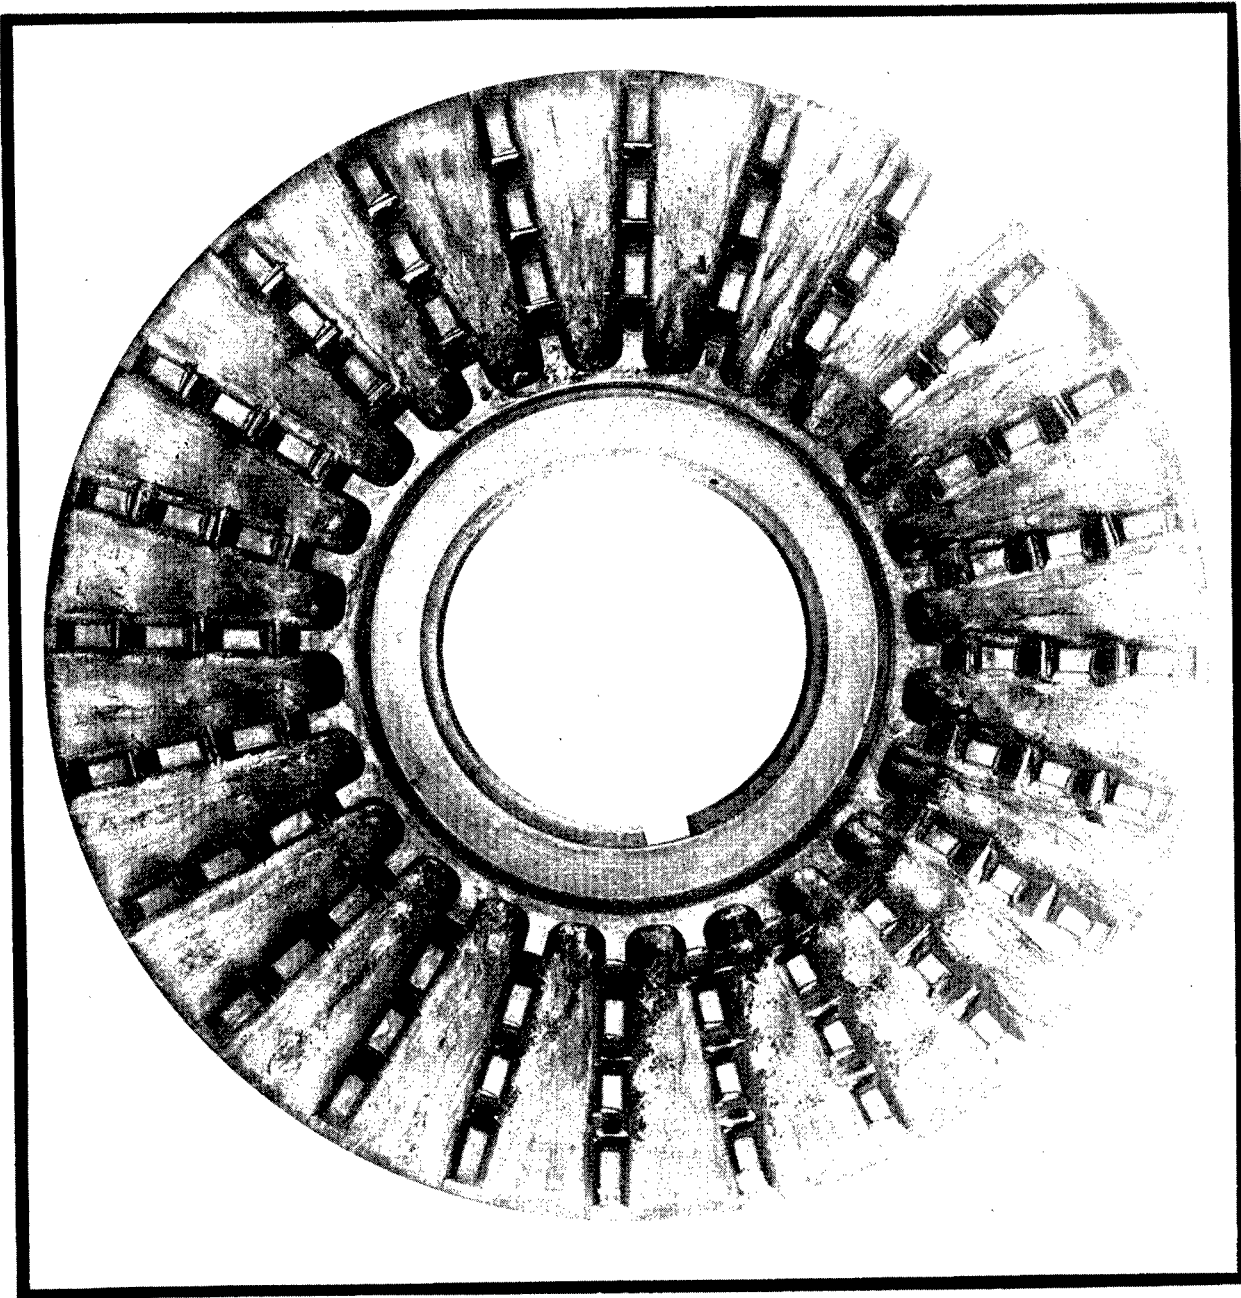
FIG 53

UPPER DYNAMIC SEAL (POSTTEST)

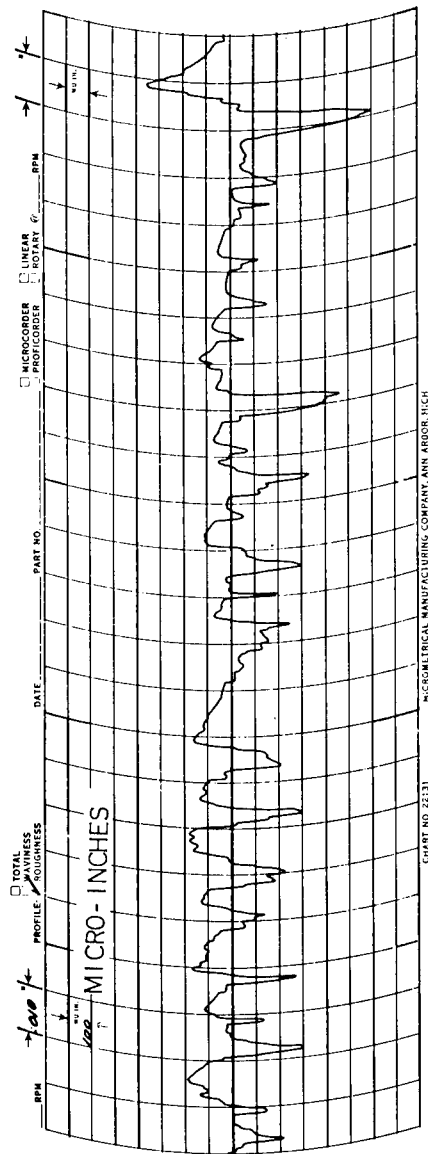
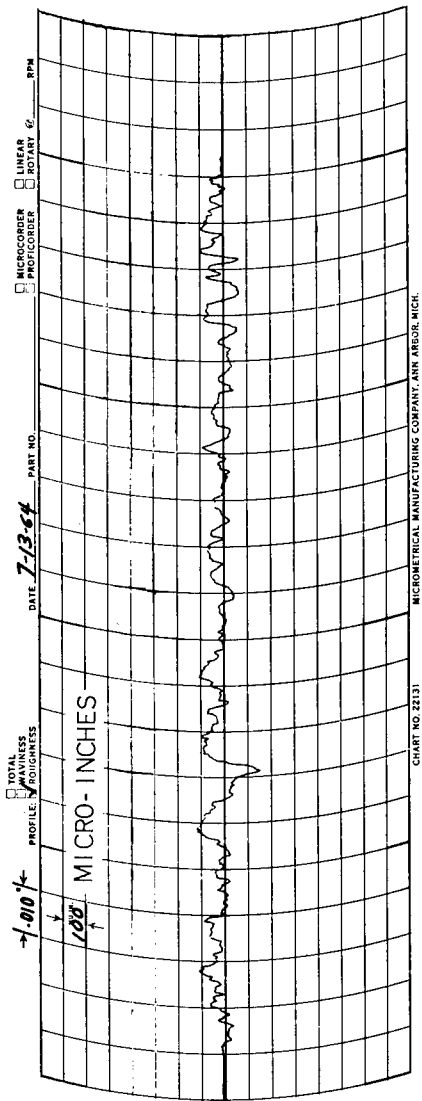
FIG 58

A complete program of inspection was performed on the impeller using all techniques previously noted. The surface roughness measurements made along the same vane stations as those in pretest indicated a slight smoothening of the surface had occurred. This can be seen in the surface roughness traces shown in Fig. 58. This smoothening action was apparently caused by a slight erosive action of the liquid metal.

SURFACE ROUGHNESS MEASUREMENTS COMPARED AFTER  
LIQUID METAL TEST  
BLADE 2, STATION 6, PRESSURE SIDE

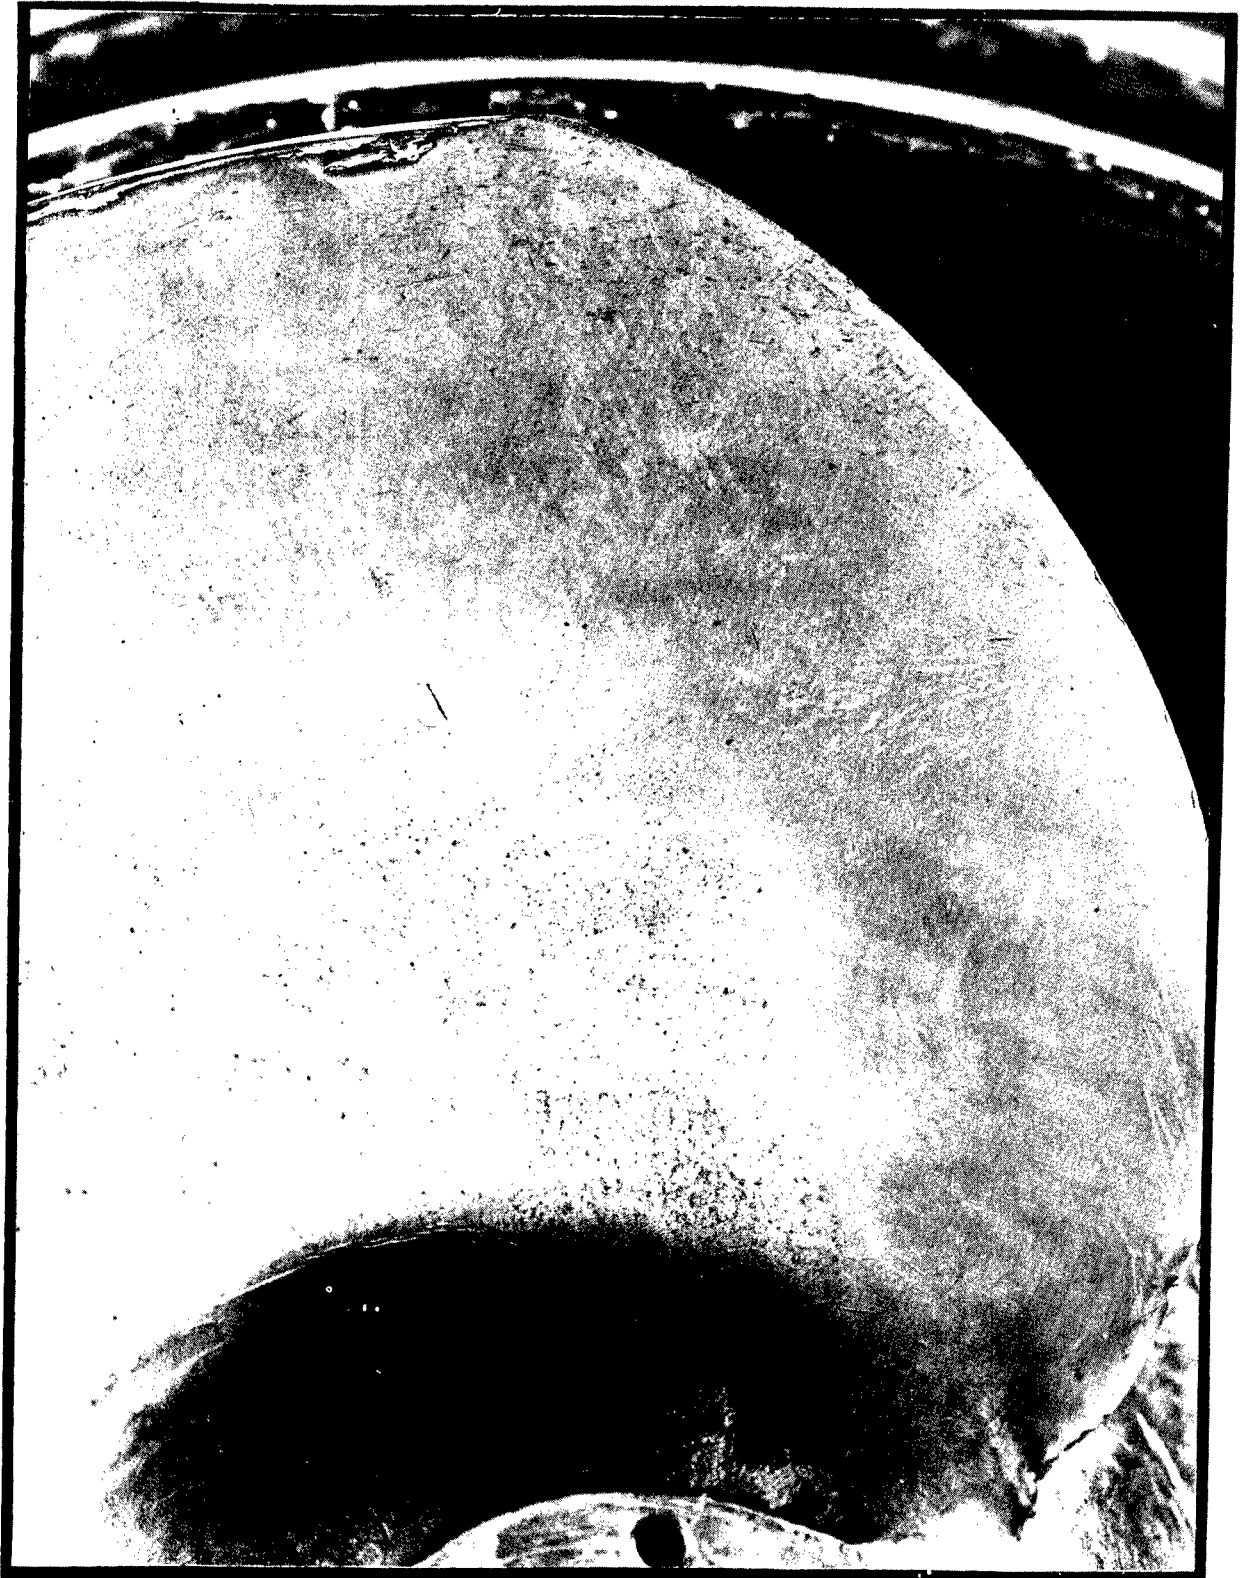
FIG 62

Photographic enlargements were also made of the inlet suction surfaces. A typical photograph is shown in Fig. 62. These photographs were taken at enlargements of two times and four times size and have the potential of enlargement to 20 times size.

POSTTEST VIEW OF RI-7C3 IMPELLER VANE 2 SURFACE

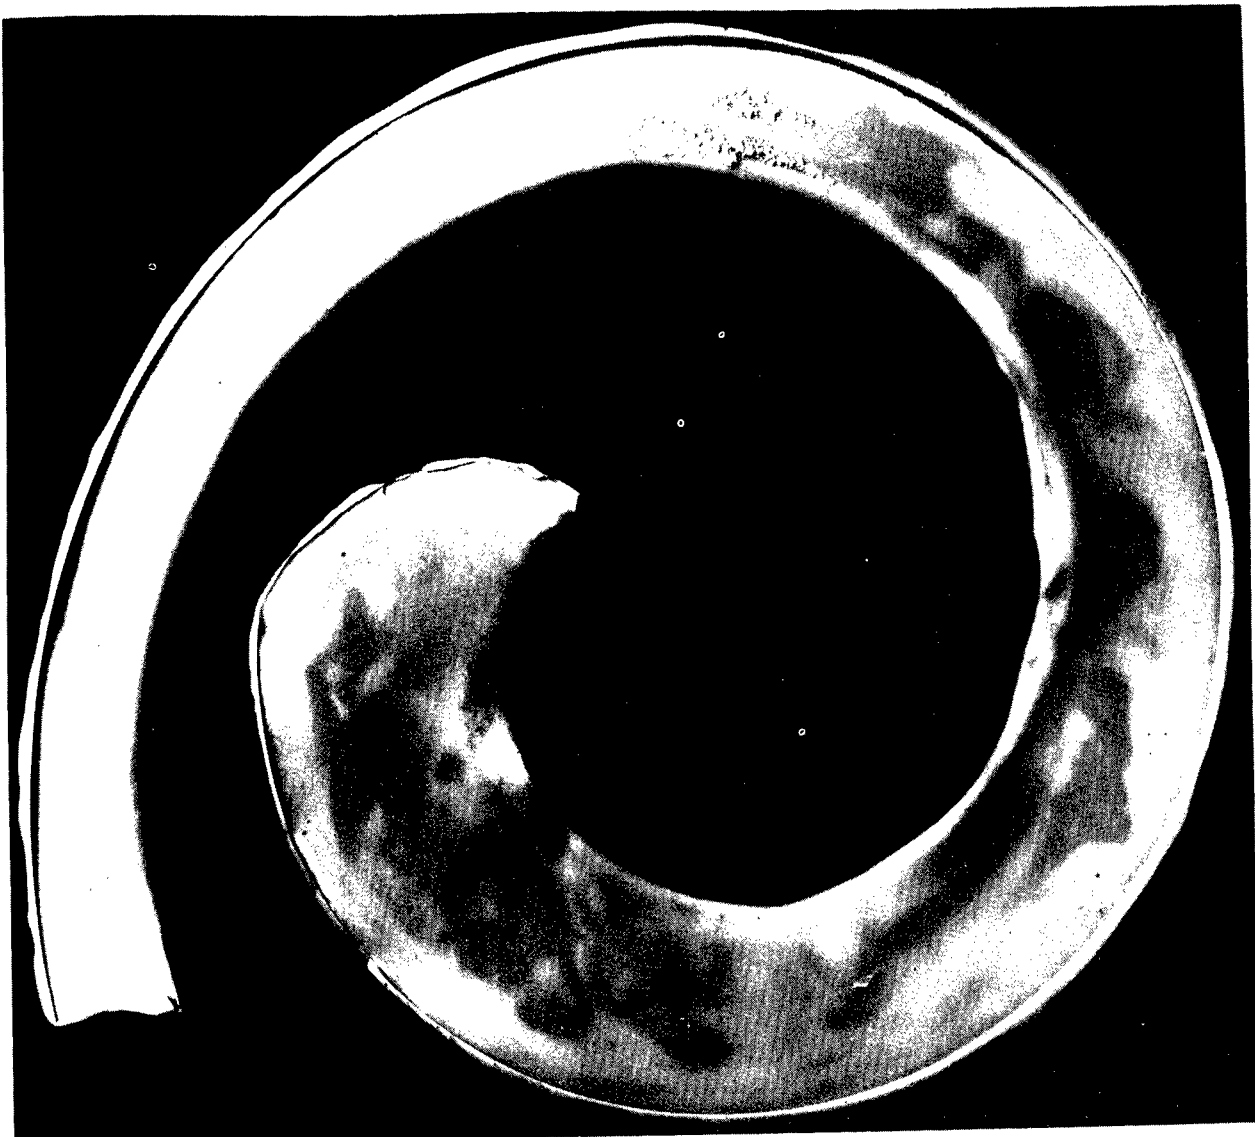
FIG 63

A typical rubber mold is shown in Fig. 63 of the entire pressure surface of vane 2. Fig. 63A is the heavy cavitation damage area of vane 2 photographed at 11X with the mold laid over a sharp edge. Fig. 63B is the rear channel damage of vane 1, photographed by the same technique but at higher magnification (23X). The partial translucence of the rubber material does not allow surface features to stand out in sharp contrast when looking directly at the surface, even under high magnification. The best method of interpreting the rubber molds appears to be the technique employed in photographing.

RUBBER MOLD OF IMPELLER VANE SURFACE AFTER POTASSIUM TEST  
PRESSURE SURFACE OF VANE 2

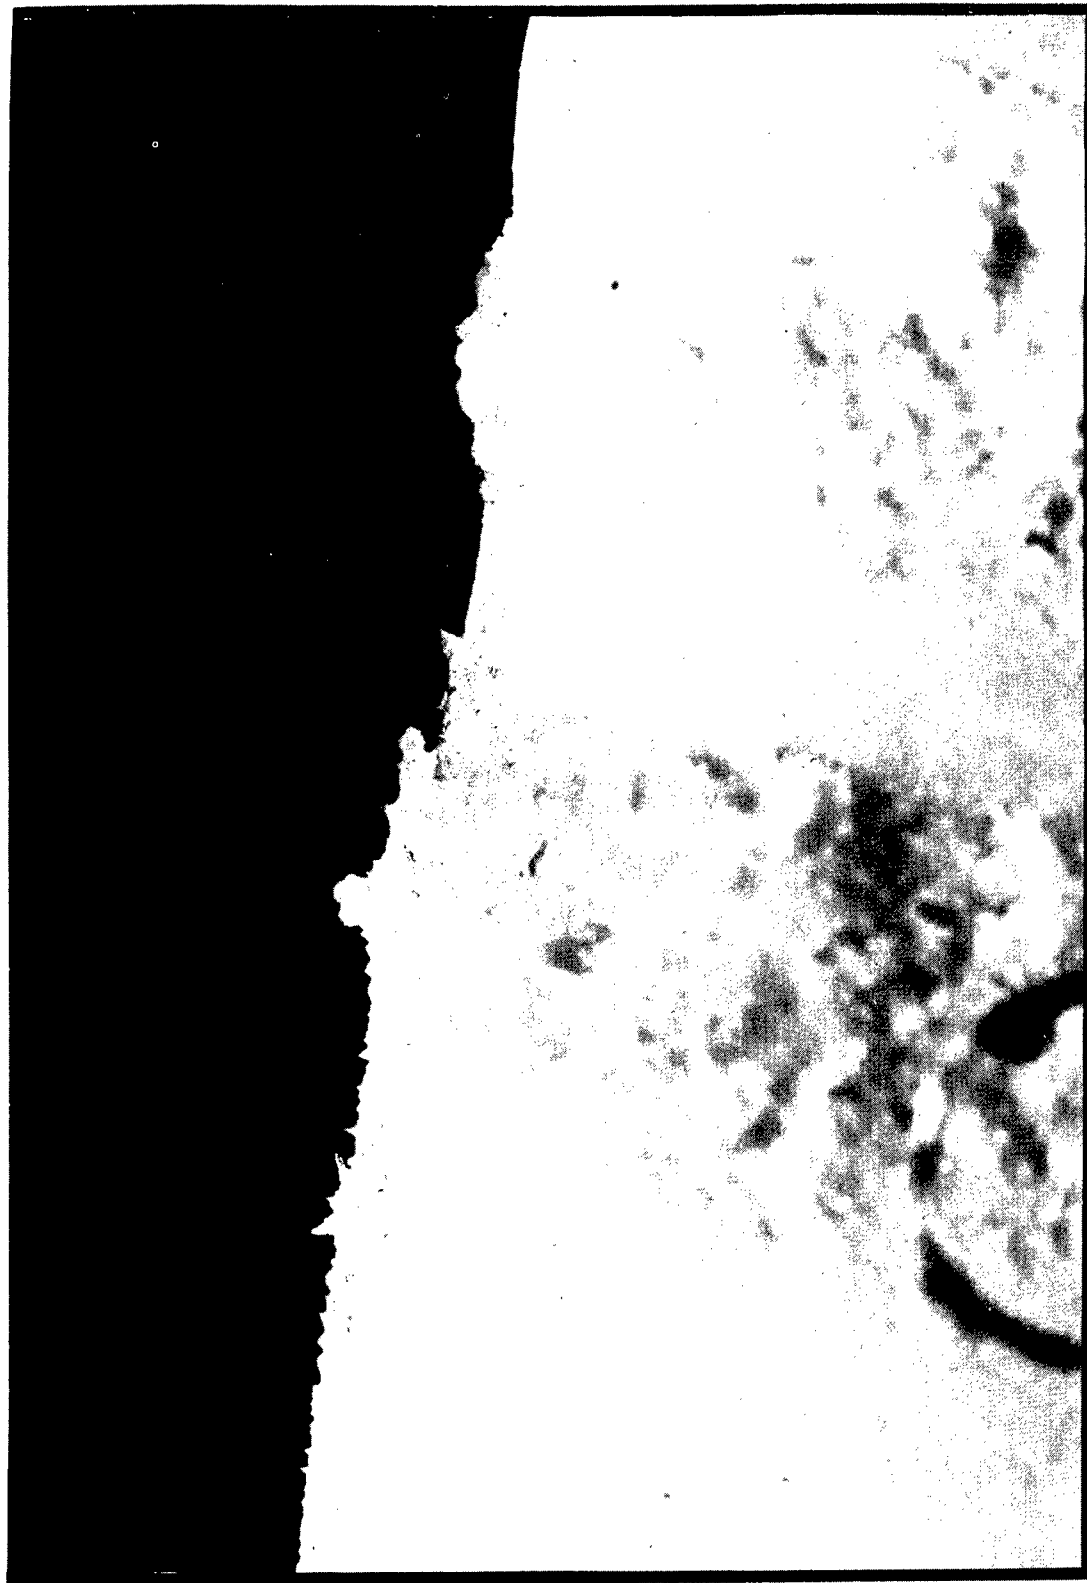
FIG 63A

RUBBER MOLD OF IMPELLER VANE SURFACE AFTER POTASSIUM TEST

PRESSURE SURFACE OF VANE 2

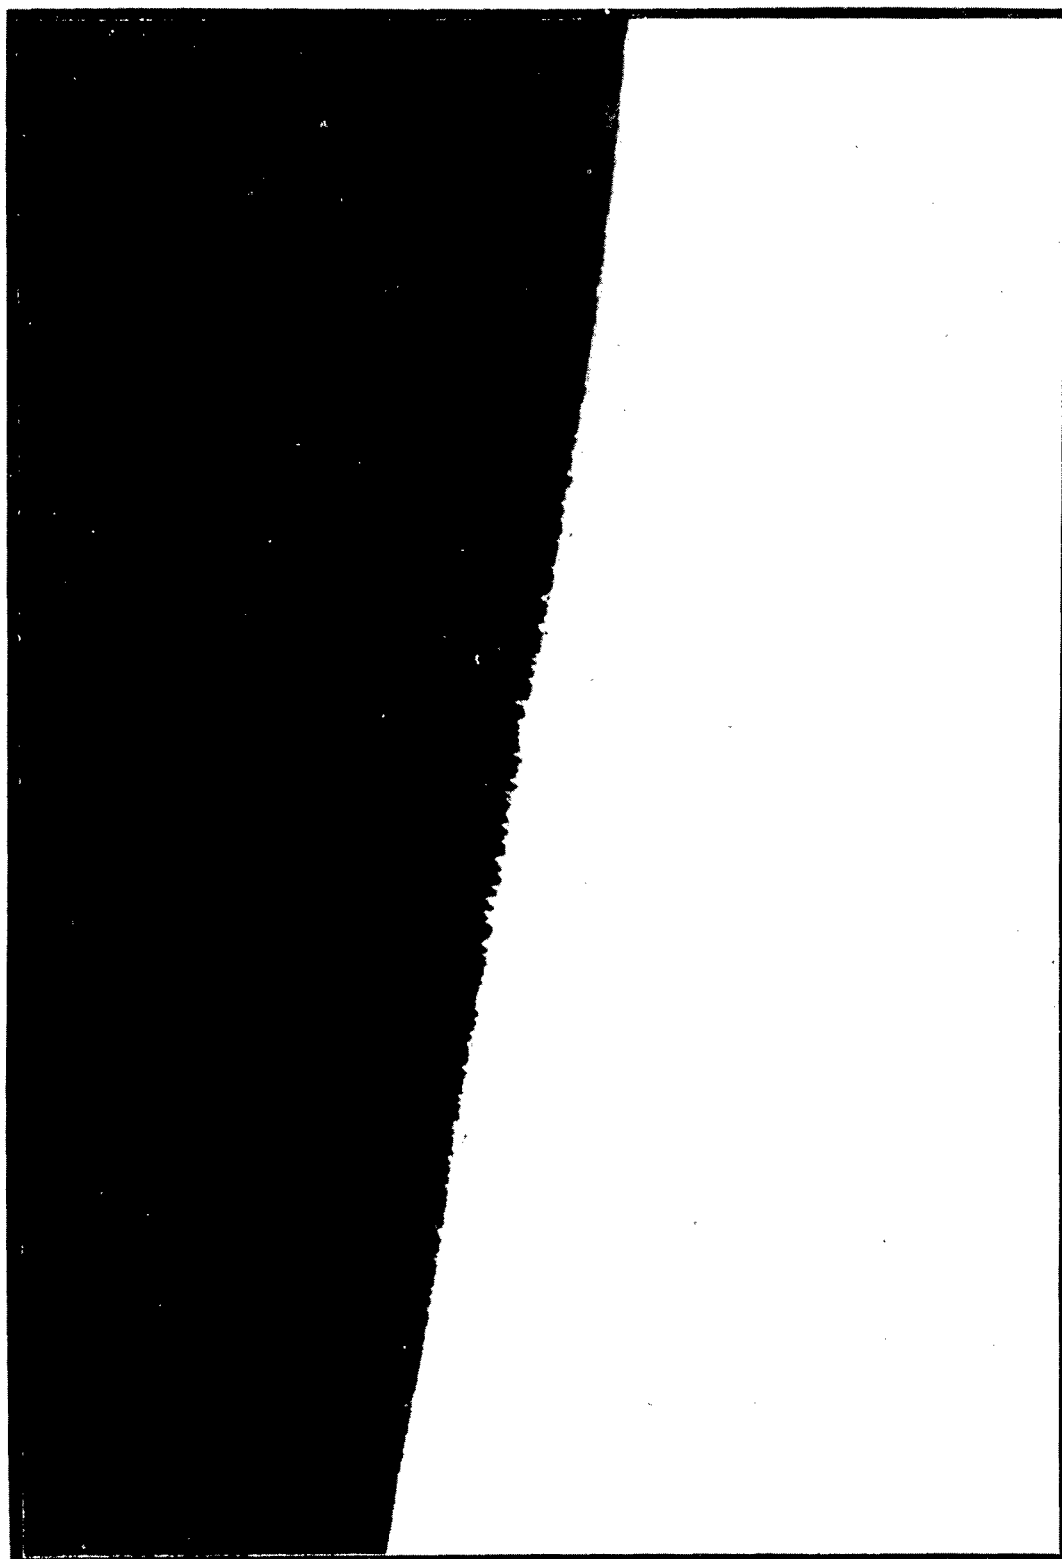
FIG 63B

RUBBER MOLD OF IMPELLER VANE SURFACE AFTER POTASSIUM TEST

PRESSURE SURFACE OF VANE 1

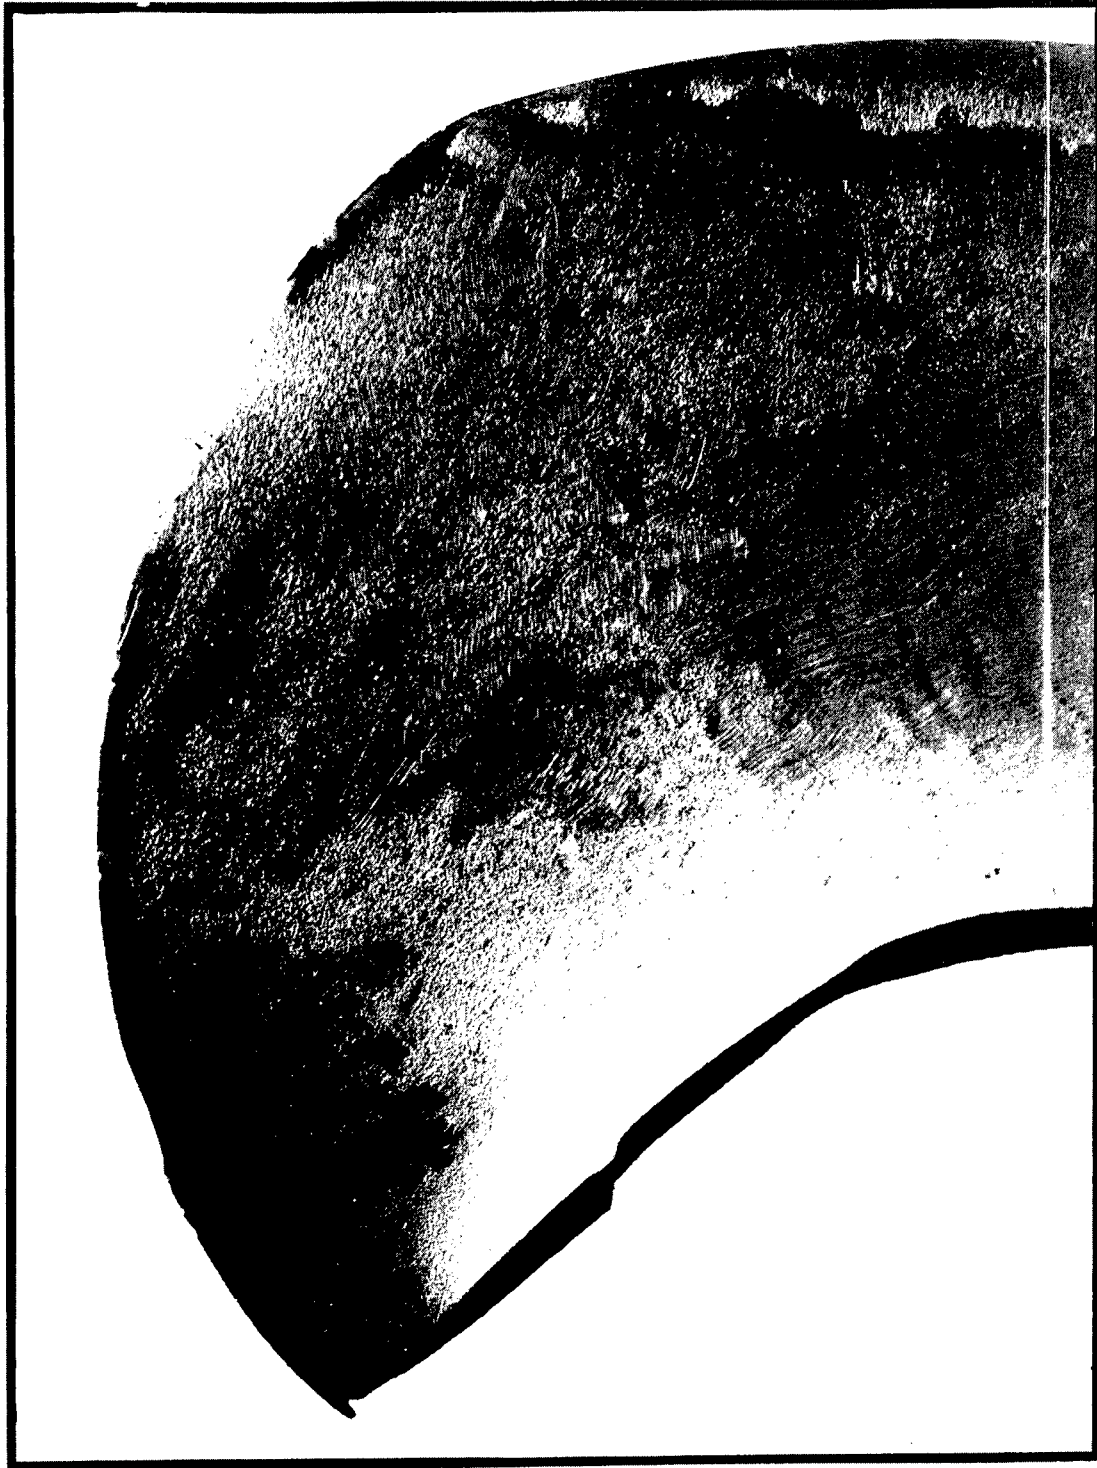
FIG 64

Vane 3 was cut from the inlet of the impeller in order to inspect the pressure surface in more detail. A section of this vane is shown at 3 1/2 magnification in Fig. 64. Small single pits are apparent on the surface in this photograph. These pits are shown at 23 magnification in Fig. 65. A count of pits of all sizes in Fig. 65 shows approximately 30 pits per square inch. A similar examination of pits on the suction surface of the vane showed only two pits per square inch, all occurring within the impeller flow channel. Examination of the area of the impeller vane suction surface as seen when looking directly into the inlet revealed no cavitation pits.

PRESSURE SIDE OF VANE 3 REMOVED FROM IMPELLER

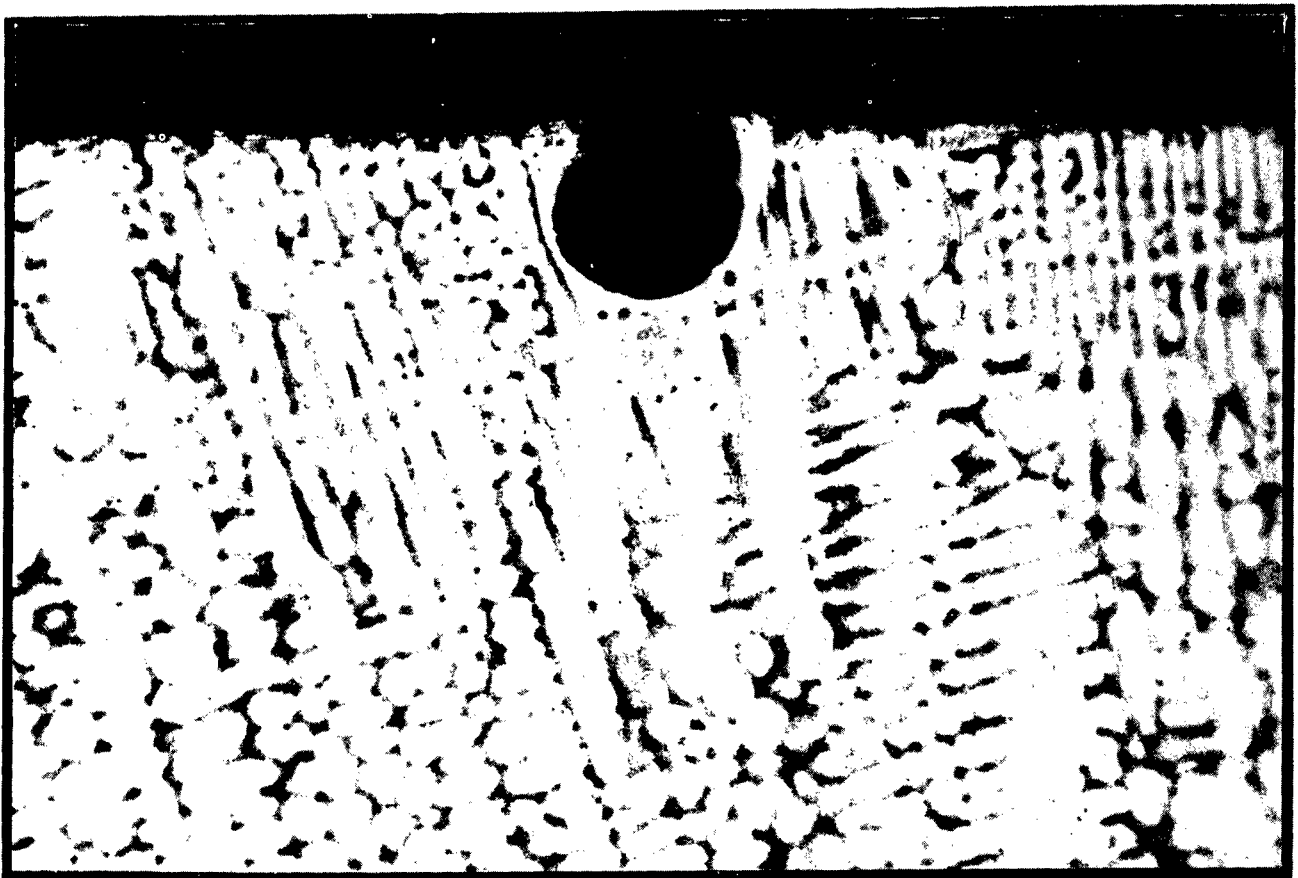
FIG 66

The large pit and one of the smaller ones were sectioned to obtain their profiles. These are shown in Figs. 66 and 67. It is assumed that these pits were caused by a single event, or implosion of one bubble. This assumption is based on the following facts: 1) X-ray revealed no subsurface pockets containing gas which would have blown out under high temperatures, 2) fluorescent inspection revealed no small holes in this area at pretest inspection, 3) the carbide stringers are distorted slightly around the hole, which indicates deformation after solidification of the impeller material, and 4) the surface of the blade, at least one hole diameter either side of the hole, is displaced upwards.

LARGE PIT OF FIG. 65 IN CROSS SECTION

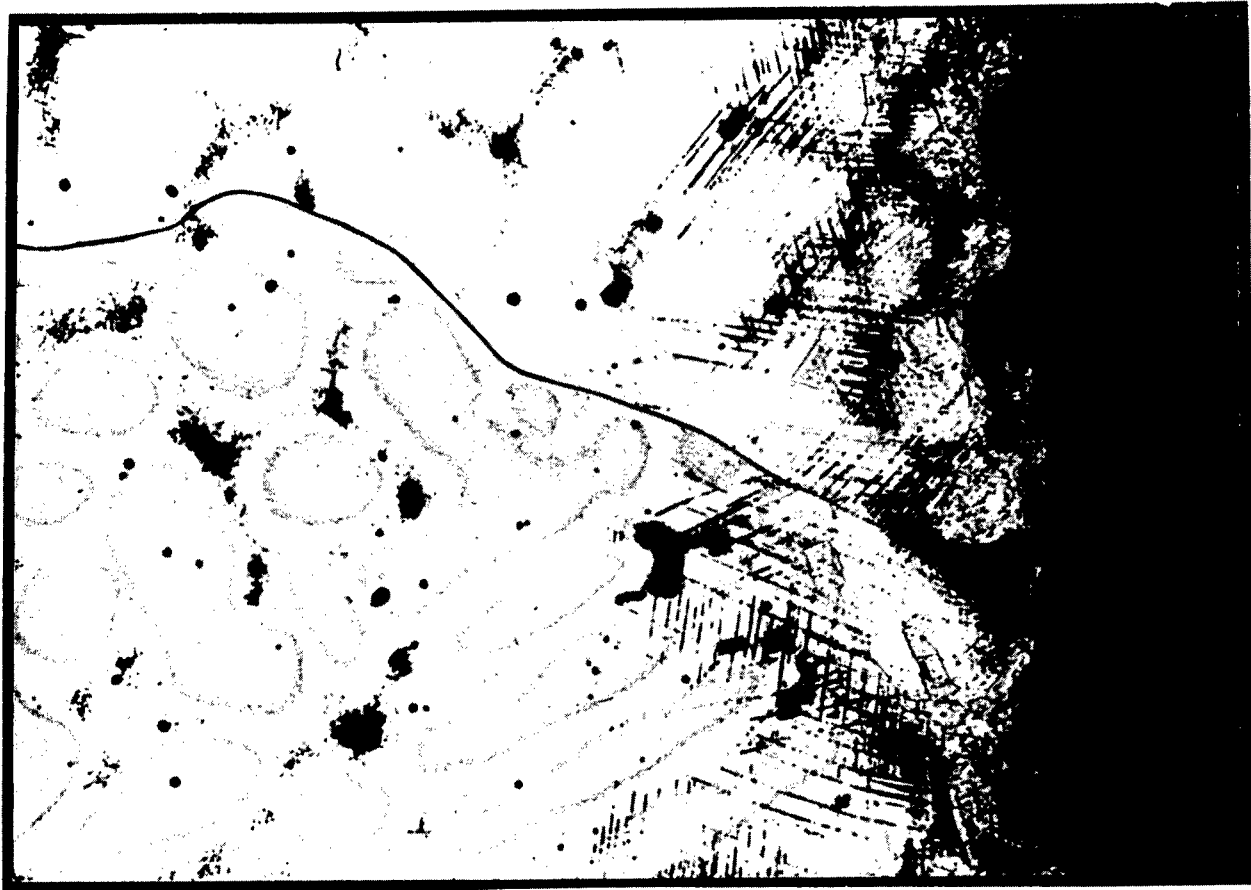
FIG 68

Metallographic examination of the cavitation damage areas in the impeller rear channels was done in an attempt to determine a mechanism of damage. This examination failed to show conclusively any mechanism by which cavitation damage propagates. A microsection of the "as cast" structure is shown in Fig. 68. This figure shows the typical large grain cored microstructure normally associated with cast type 316 stainless steel. Widmanstatten carbide precipitation observable in this figure is typical of all surfaces and results from the casting process. A microsection of post-test material undamaged by cavitation is shown in Fig. 69. The time and temperature effects are noted in the more homogeneous dispersion of the carbide phase throughout the matrix. The light band along the surface is shown at higher magnification in Fig. 70. This band shows a tendency toward recrystallization to extremely small grains with spheroidal carbide precipitation at the grain boundaries. This effect was noted in microsections of deep cavitation damage to exist on all surfaces exposed to the liquid metal.

## PHOTOMICROGRAPH OF PRETEST MATERIAL

CROSS SECTION AREA AT PRESSURE FACE DISPLAYING LARGE GRAINED, CORED, 316 SS MICROSTRUCTURE. WIDMANSTÄTTEN CARBIDE PRECIPITATION IS TYPICAL OF ALL SURFACES AND RESULTED FROM THE CASTING PROCESS. RANDOM RECRYSTALLIZATION CAN BE OBSERVED AT THE SURFACE.

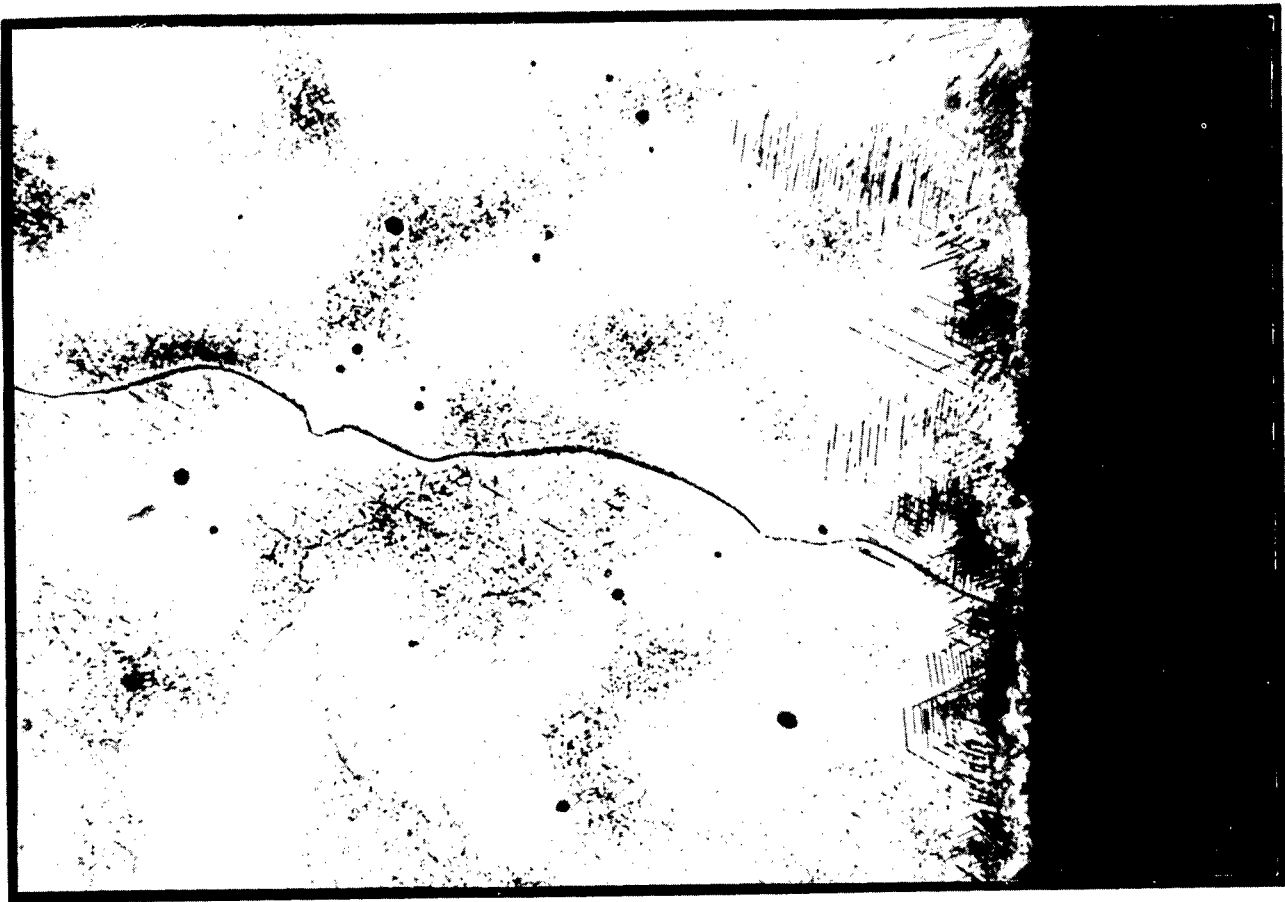
FIG 69

PHOTOMICROGRAPH OF POSTTEST UNDAMAGED MATERIAL

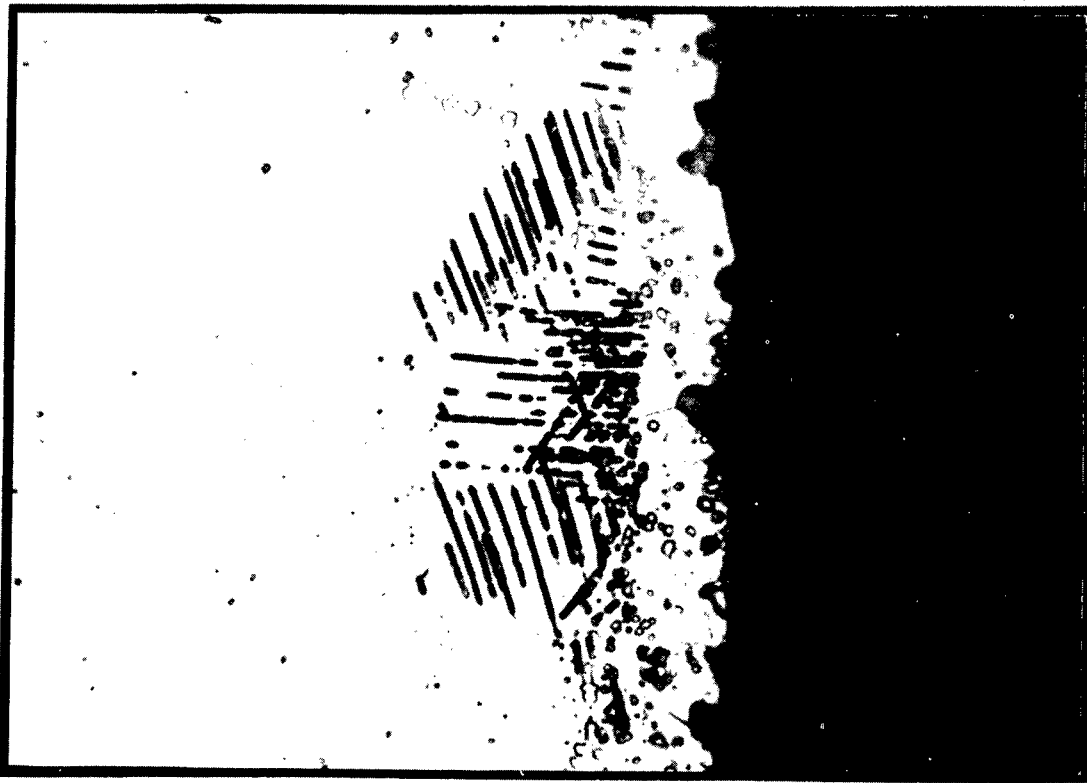
FIG 70

PHOTOMICROGRAPH OF POSTTEST MATERIAL OF FIG. 69 AT HIGHER  
MAGNIFICATION
