ERDC/CERL TR-02-26

Condition Assessment of William Beaumont General Hospital Historic Buildings at Fort Bliss, Texas

Thomas R. Napier and Sheila A. McCarthy

September 2002

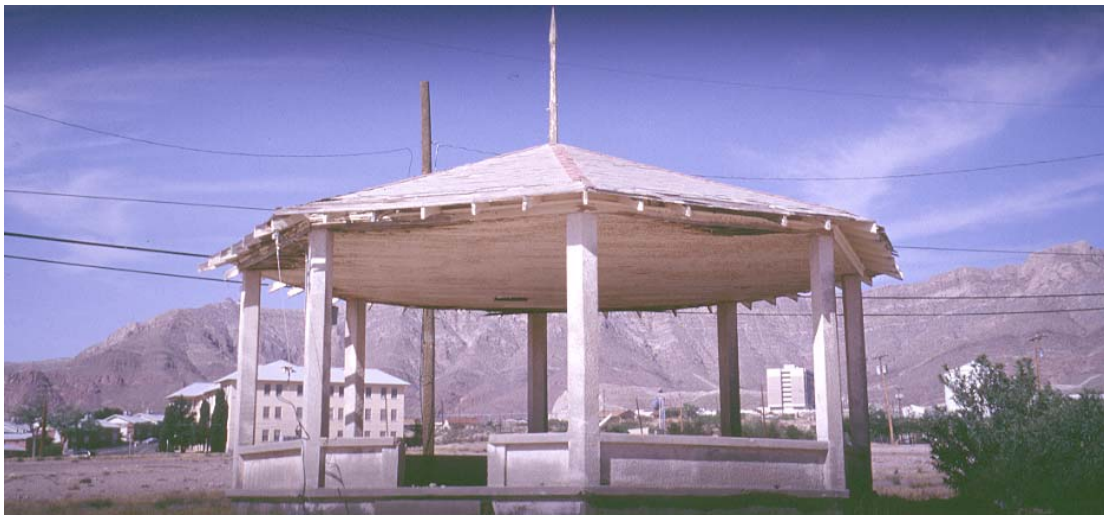
Photograph 1. Exterior photograph of Building 7122 (bandstand).

The bandstand (Photograph 1) is an elevated octagonal, open sided pavilion. It is 12.5 ft in diameter, or 125 sq ft in plan area. The floor slab is roughly 30 in. above grade. The foundation, floor slab, rails, and columns are reinforced concrete. A parged finish (a cementitious finish coating) is applied to the above ground concrete. The roof structure is framed with rafters converging in a point at the roof's center. The bead board ceiling conceals the roof structure. Asbestos shingle was the original roofing material. This roofing remains on the structure. Drawing 1. presents the key plan used in discussion of the structure.

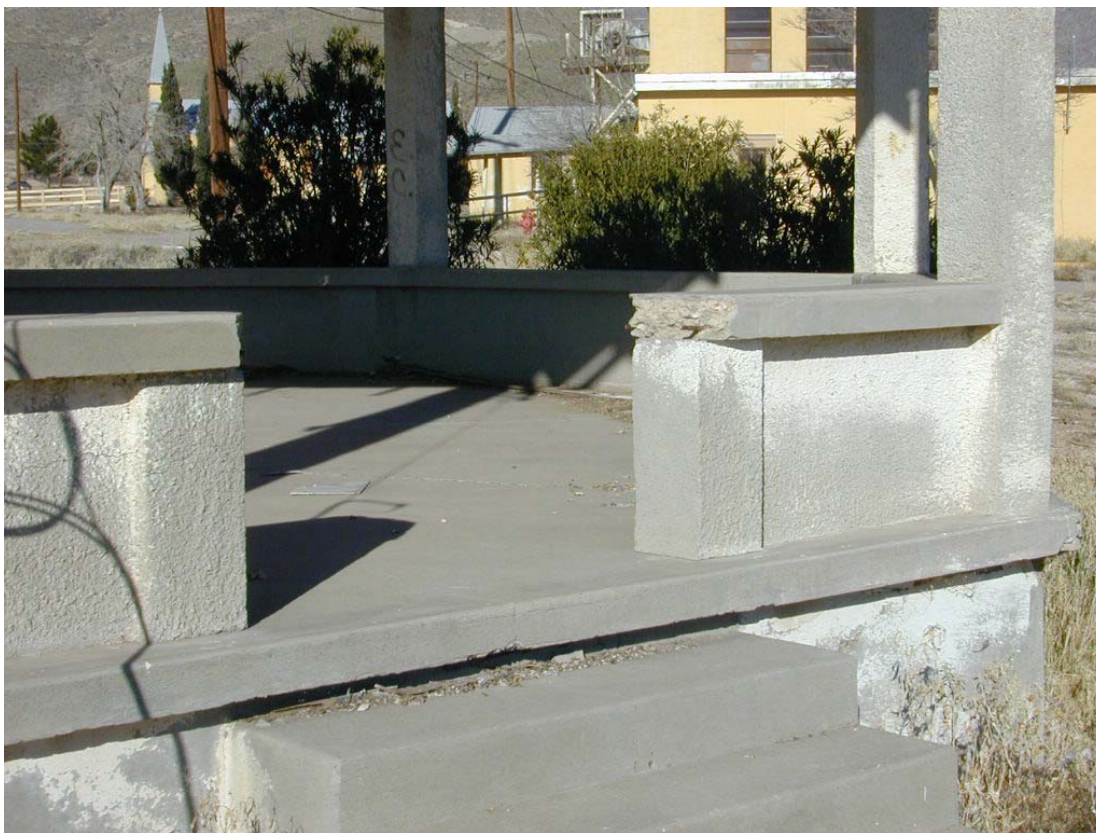
Photograph 4. Detail of bandstand entrance.

The entrance at the southeast side of the bandstand has apparently been enlarged by chopping away at the concrete rail. The edges are rough-cut (Drawing 1, F) and will need to be either ground smooth or patched to remove a hazard and improve appearance (Photograph 4).

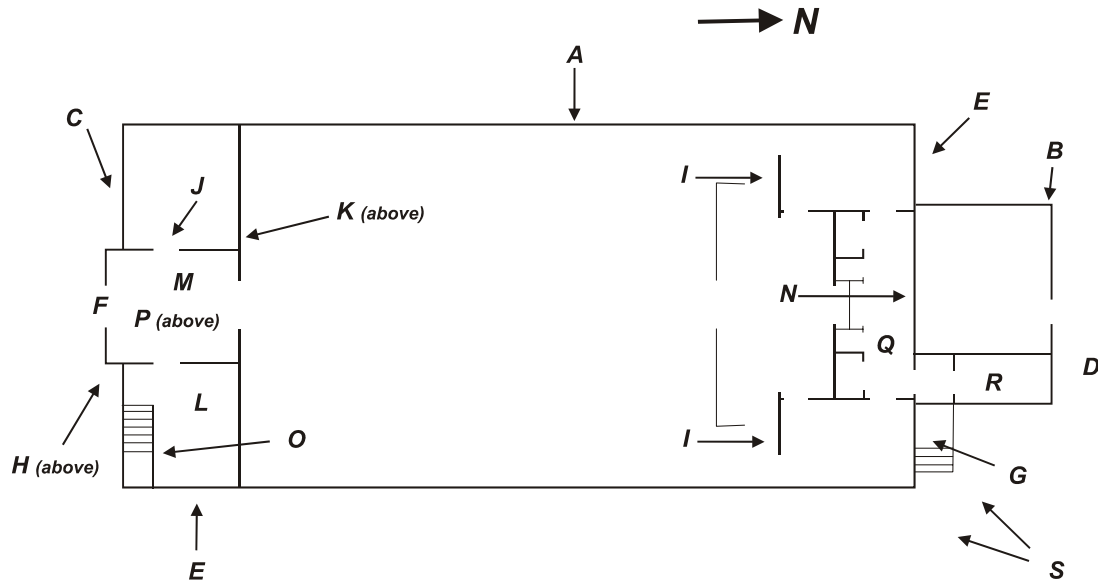
Drawing 2. Building 7151 key plan.

Building 7151 is seriously contaminated by pigeon excrement. Researchers were reluctant to expose themselves to airborne contamination. Therefore, the following observations are made primarily from examination of the building's exterior, with only cursory review of the chapel's interior. Prolonged exposure to the closed interior environment was inadvisable.

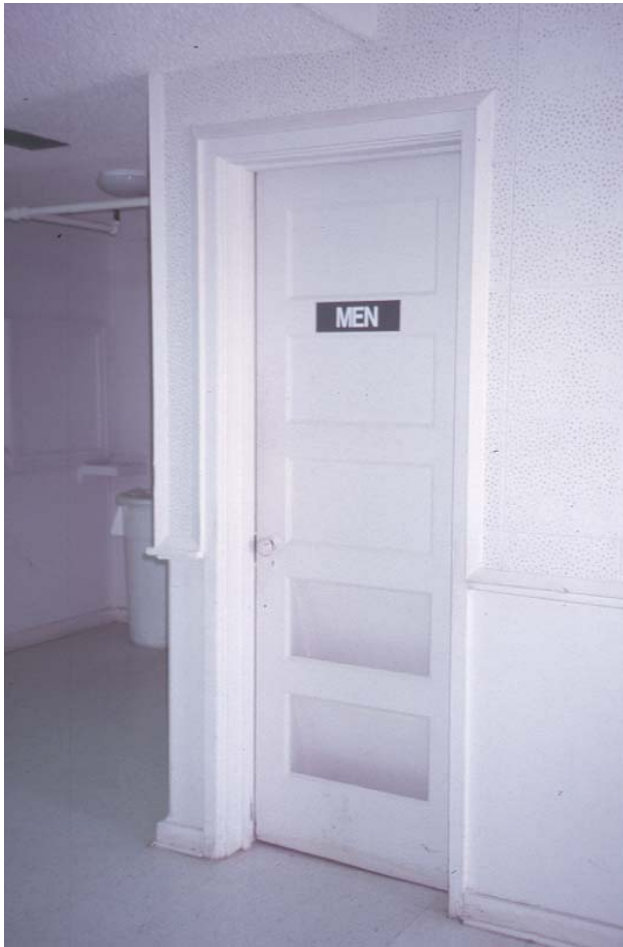
Photograph 18. Theater washroom door vent detail.

All partition construction appears to be sound. Five-panel doors remain in the vestibule and washroom area. An innovative vent detail has been incorporated into the washroom doors (Photograph 18). Also, a new flush metal door is in place adjacent to the stage.

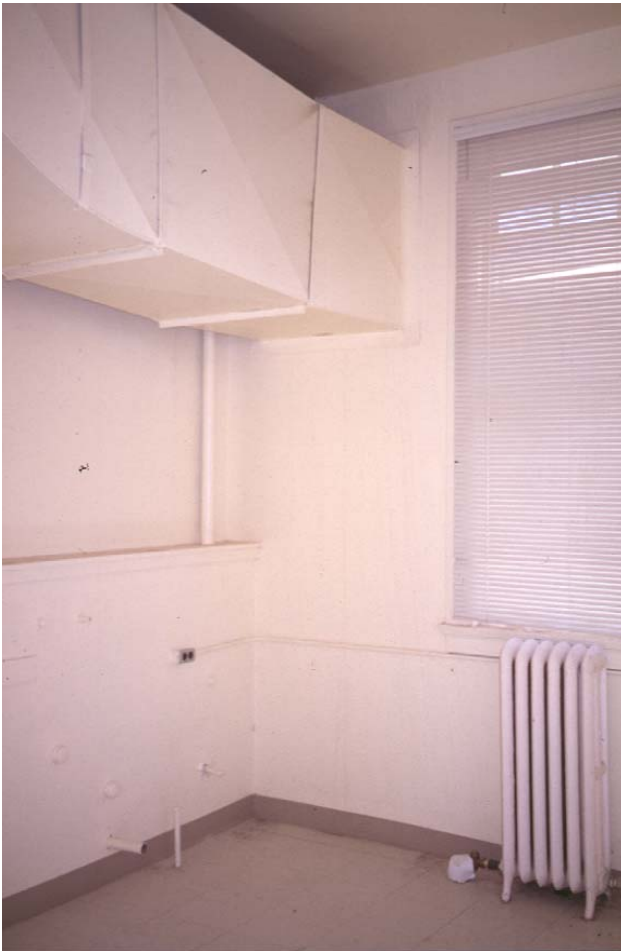
Photograph 50. Building 7157 cooling equipment.

The first floor is serviced by an evaporative cooler located at grade level outside of room 105. A duct enters the room through one window's upper sash, which tees into the supply duct running the length of the building and supplying each room. The second floor is serviced by a cooler mounted on a steel-framed tower at the south end of the building outside of room 202. A duct enters the room through the wall and runs the length of the building, supplying each room. The coolers were installed 5 years ago and are reported by DPW personnel to be serviceable (Photograph 50).

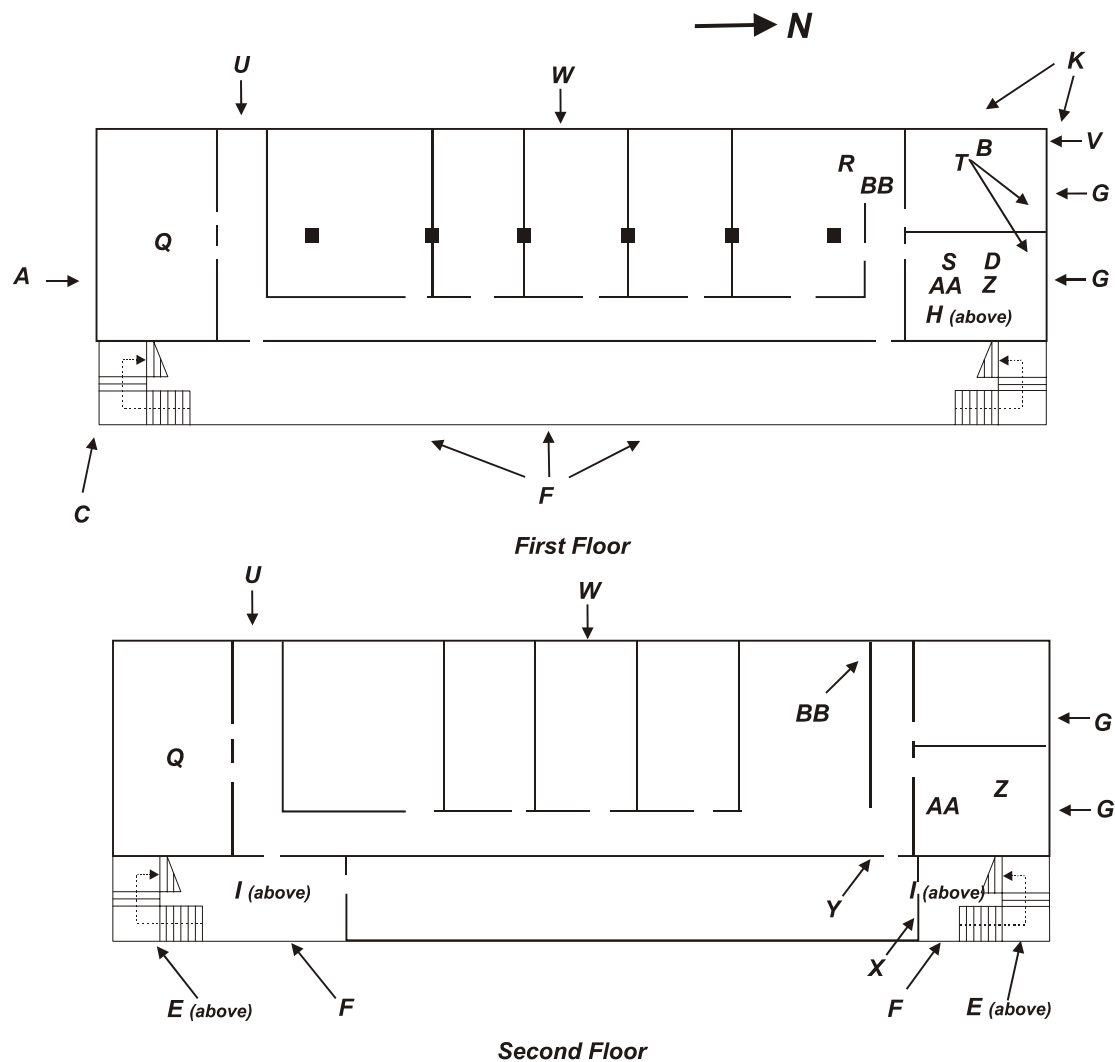
Drawing 6. Building 7158 key plan.

The partitions dividing the two NCO rooms at the south end of the building have been removed at both the first and second floors (Drawing 6, Q). The floor slopes slightly toward the center of the building at the first floor, where the partition was located. However, no excessive deflection or sponginess in the floor was observed at this location.

Similar to Building 7157, there is a low spot in the first floor, in the northwest corner of room 106 (Drawing 6, R). Leakage and water damage is apparent by the buckling in the underlayment. While no other sponginess, deflection, or distress was evident, evaluating the floor framing and subfloor at this location is recommended as part of a reuse design. Several joists had been notched at the bottom (tension) edge for an electrical conduit in the same location in Building 7159. It is possible a similar modification may have also been made in Building 7157 and 7158 as well.

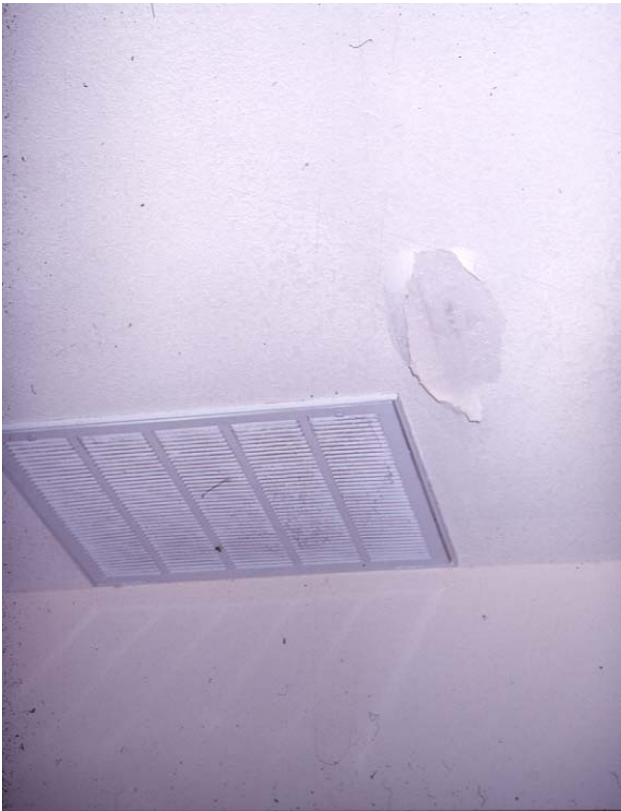
Photograph 66. Water stain on BOQ ceiling.

One water stain occurs in the (living room) ceiling (Drawing 8, F; Photograph 66) directly below the evaporative cooler and diffuser. Leakage from other evaporative coolers suggests this may be a roof leak, or a leak from the cooling equipment. If the cooler is to be removed as part of an adaptive reuse design, the roofing at this area will have to be replaced or repaired. If the cooler is to remain, the integrity of the flashing at the cooler's supporting structure must be verified.

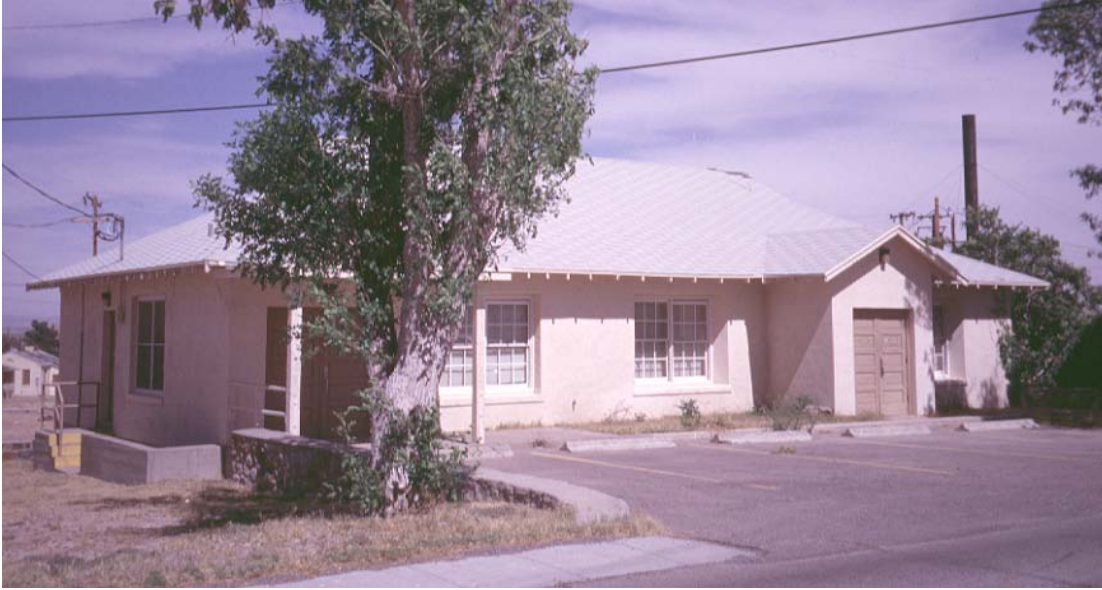
Photograph 68. Exterior slab and parking area at BOQ.

An exterior slab is present at the north end of the west side of the building, adjacent to an entry (Drawing 8, K). Parking is immediately west of the slab at this entry (Photograph 68). The west entries' thresholds are at grade, which are below the grade and paving to the west. Rainwater runoff flows down Beaumont Drive, over the paving, collects against the building, and leaks into the building through the wall and under the door. Water intrusion under the west entry doors and through
