ERDC/CHL CR-06-1

## Chesapeake Bay Breakwater Database Project, Section 227 Demonstration Site: Hurricane Isabel Impacts to Four Breakwater Systems

Final Report

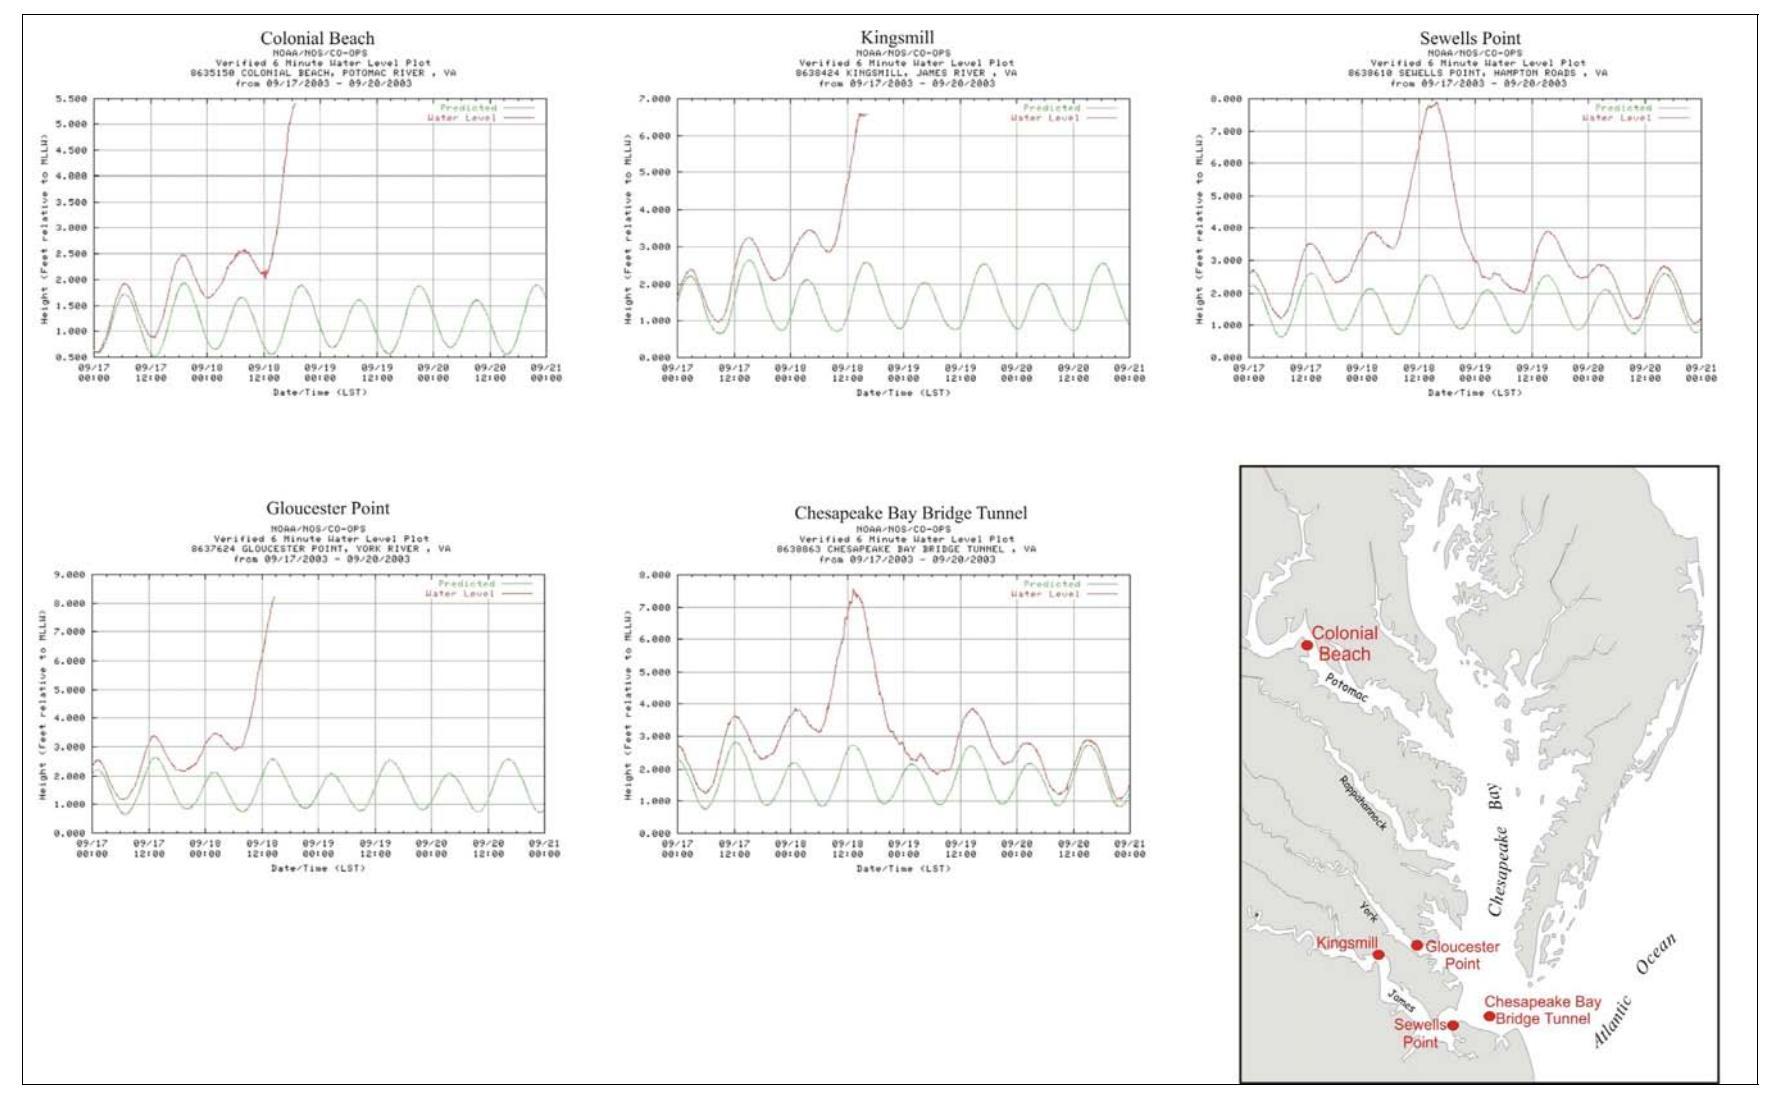
The Kingsmill south-facing shoreline is oriented approximately east-west allowing wind/waves from the southeast, south, and southwest to impact the site. Water levels were measured at Kingsmill by a tide gauge until about 2:30 p.m. on 18 September 2003 (Figure 14). During the storm, the gauge was damaged, and the last reading was about el 6.6 while tide was still rising. Wind and water level data also were measured at Sewells Point, which is about 23 n.m. downriver from the site. Wind speeds at Sewells Point exceeded 72.4 km/hr (45 mph) and remained so from 9:30 a.m. to about 5 p.m., and they reached sustained speeds of over 80.5 km/hr (50 mph) while water levels peaked at about 4 p.m. Kingsmill is located about halfway between Richmond and Norfolk, both of which have longterm wind monitoring stations. Wind data from Richmond shows more persistent winds from the north and northeast through the day on 18 September while Norfolk wind data showed winds more persistent from the east-northeast before they turned east then south. The combination of storm surge and southerly wind/wave climate, as indicated by the survey as the top of the bank scarping, resulted in water levels greater than el +10.2.

Yorktown is located across the York River from VIMS where NOAA maintains the Gloucester Point tide gauge (Figure 14). During Isabel the gauge stopped at about 2:30 p.m. with a reading of about el +8.3 as the tide was still rising. Wind speed measurements at VIMS provided by instruments atop VIMS' Byrd Hall showed that maximum sustained winds on the campus reached 65 mph, with 144.8-km/hr (90-mph) gusts. The barometer bottomed out at 74.1 cm (29.2 in.), with a rainfall accumulation of about 5.6 cm (2.2 in.). At the height of the storm, VIMS' ADCP measured what might be considered a deepwater wave of 1.8 m (6 ft) with a 5 sec period. Still-water level at Yorktown was measured at el 8.6 (mean tide range is 0.7 m (2.4 ft)), and the combination of maximum storm surge and wave runup was measured at about el 12.5. One could infer that there could have been a 1.2 m (4 ft) or greater wave breaking across the breakwater system and into the adjacent infrastructure.

Figure 14. Verified water levels at wave gauges around Chesapeake Bay during the storm and approximate gauge location. From the NOAA Web Site (http://www.co-ops.nos.noaa.gov/)

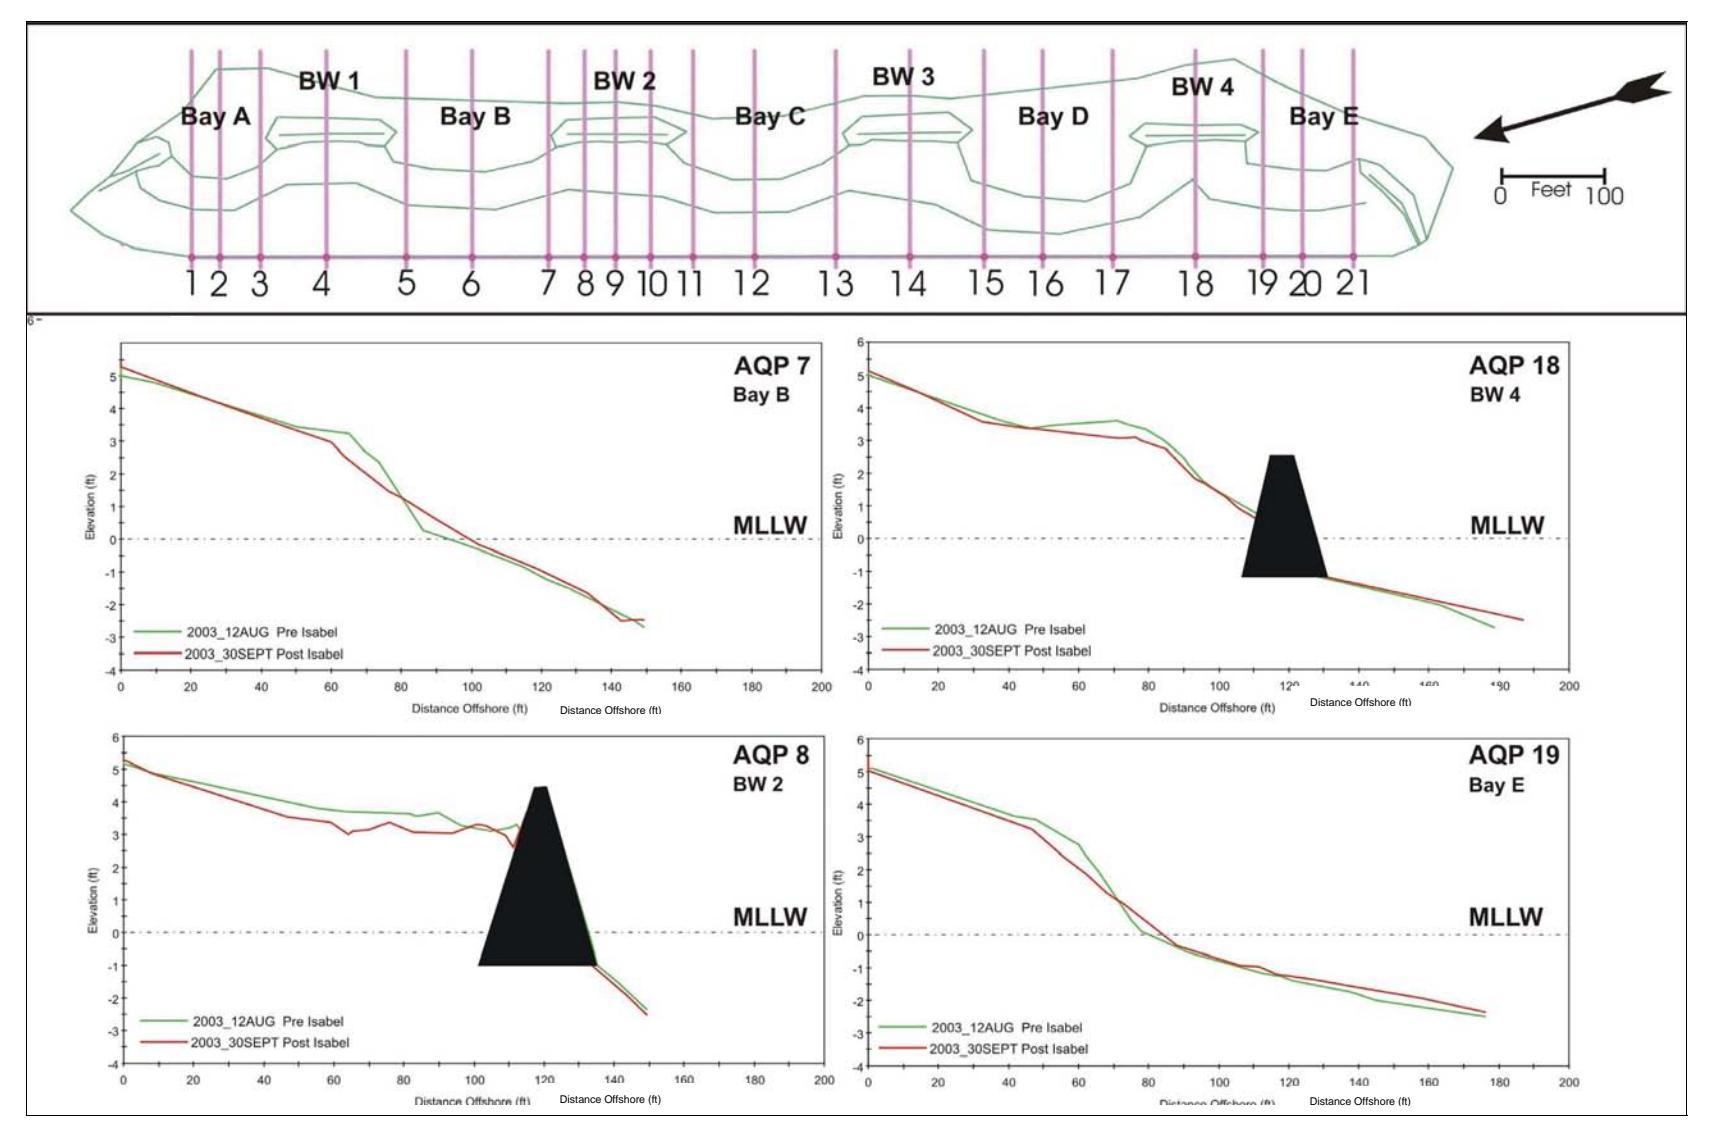
Figure 16. Aquia Landing (AQP) baseline and selected pre- and post-storm cross sections

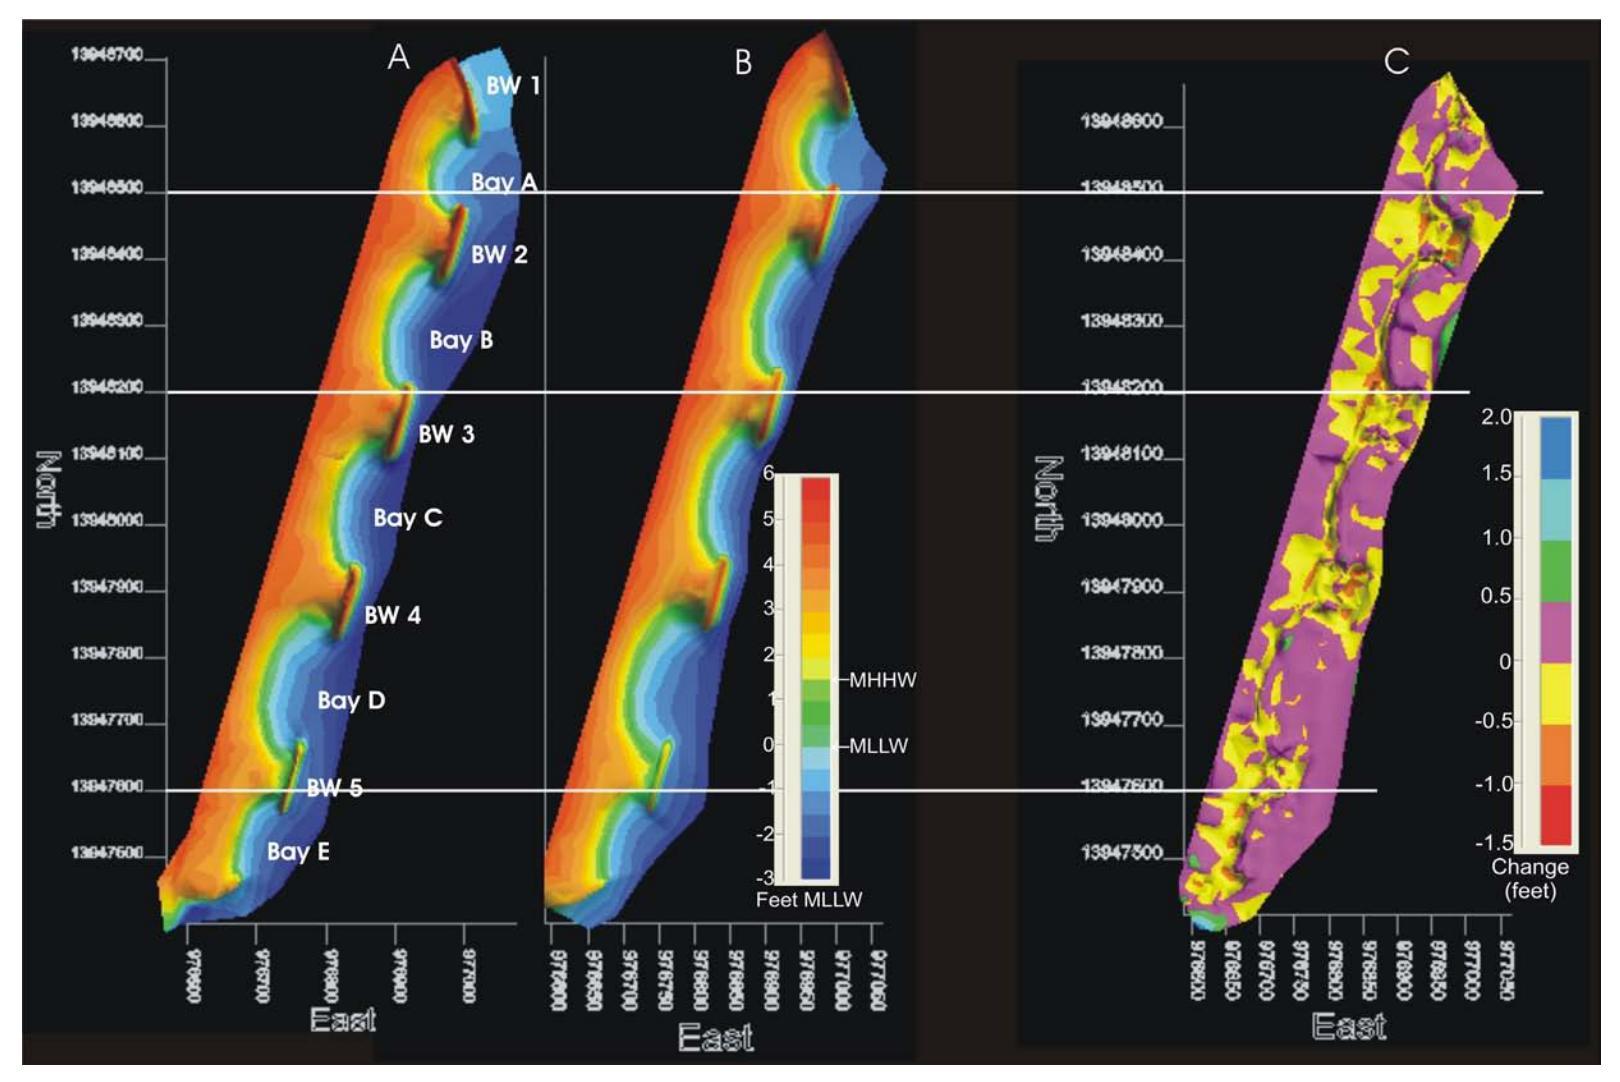
The overall change in topography of the site is shown in Figure 18. The yellow and orange areas on the isopach map indicate decreases in elevation of -0.2 m (-0.5 ft) and -0.3 m (-1.0 ft), respectively (Figure 18c). These areas occur in front and in the lee of each breakwater and along the beach berm zone of each embayment. Overall slight increases in sand elevation are shown in purple (+0.2 m (+0.5 ft) change), which occur intermittently along the backshore of each embayment and green (+0.3 m (+1.0 ft) change), which occur mostly along the very nearshore of each bay. No extreme changes (>0.3 m) (>1 ft) were measured in topography indicating the overall stability of the breakwater system.

Figure 18. Aquia Landing color contour maps for: (a) pre- and (b) post-storm conditions, and (c) isopach map showing elevation changes between surveys

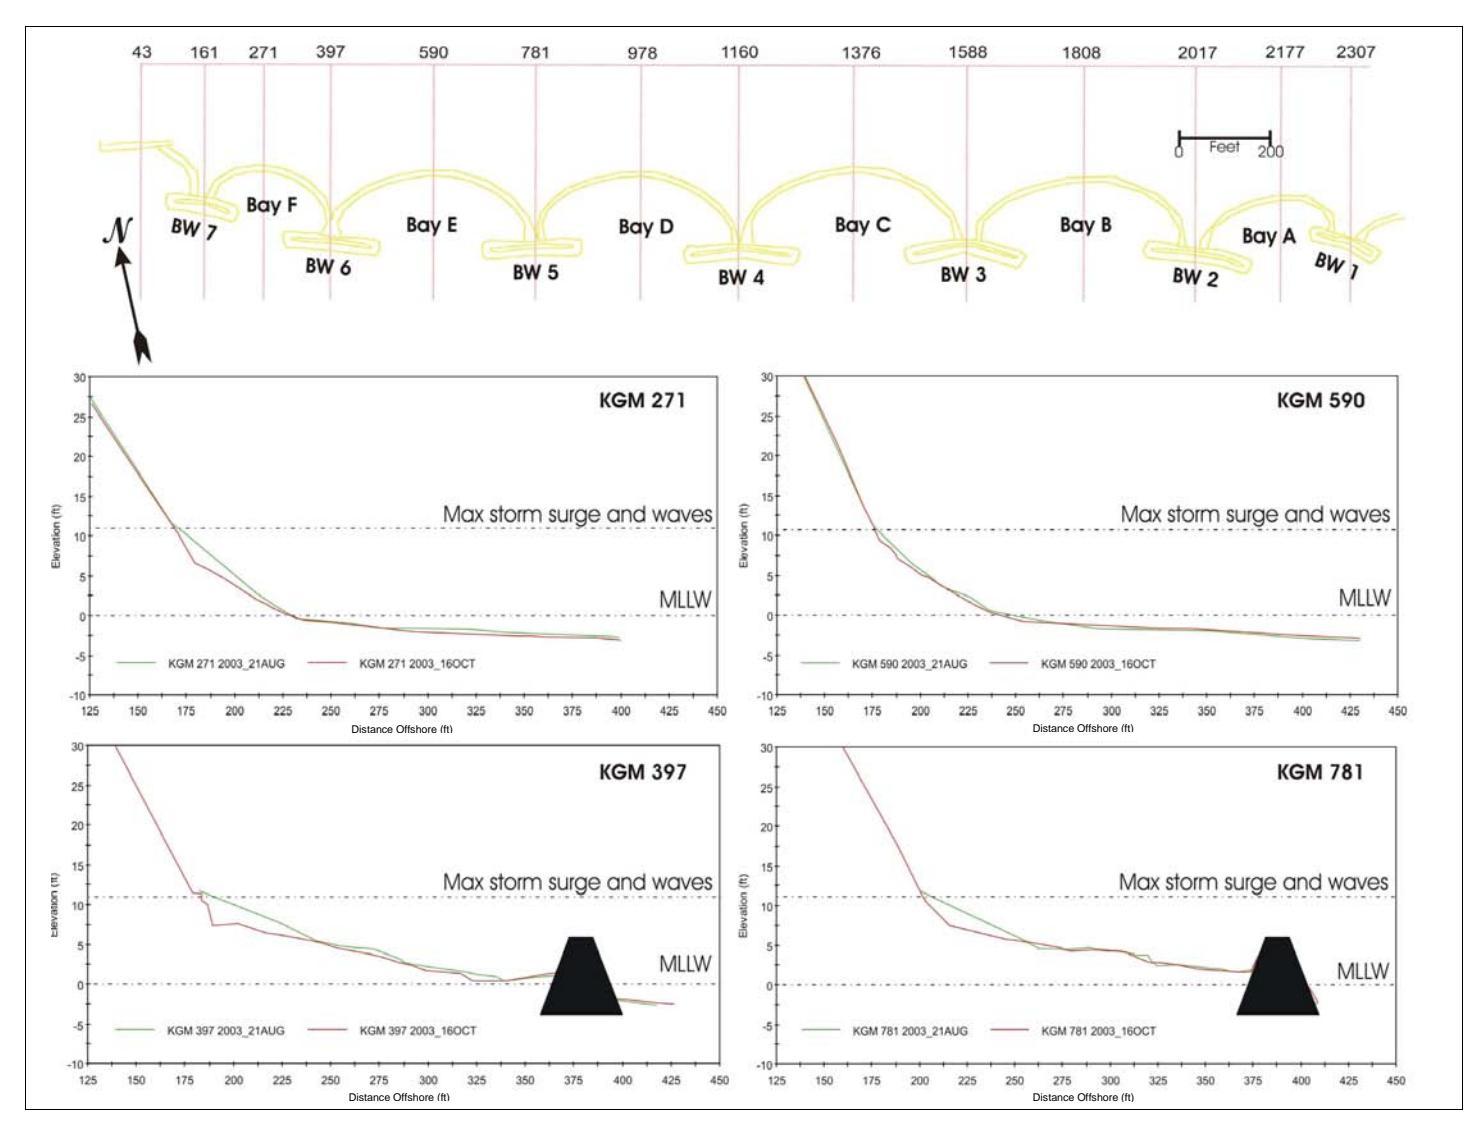
Figure 20. Kingsmill (KGM) baseline and selected pre- and post-storm cross sections

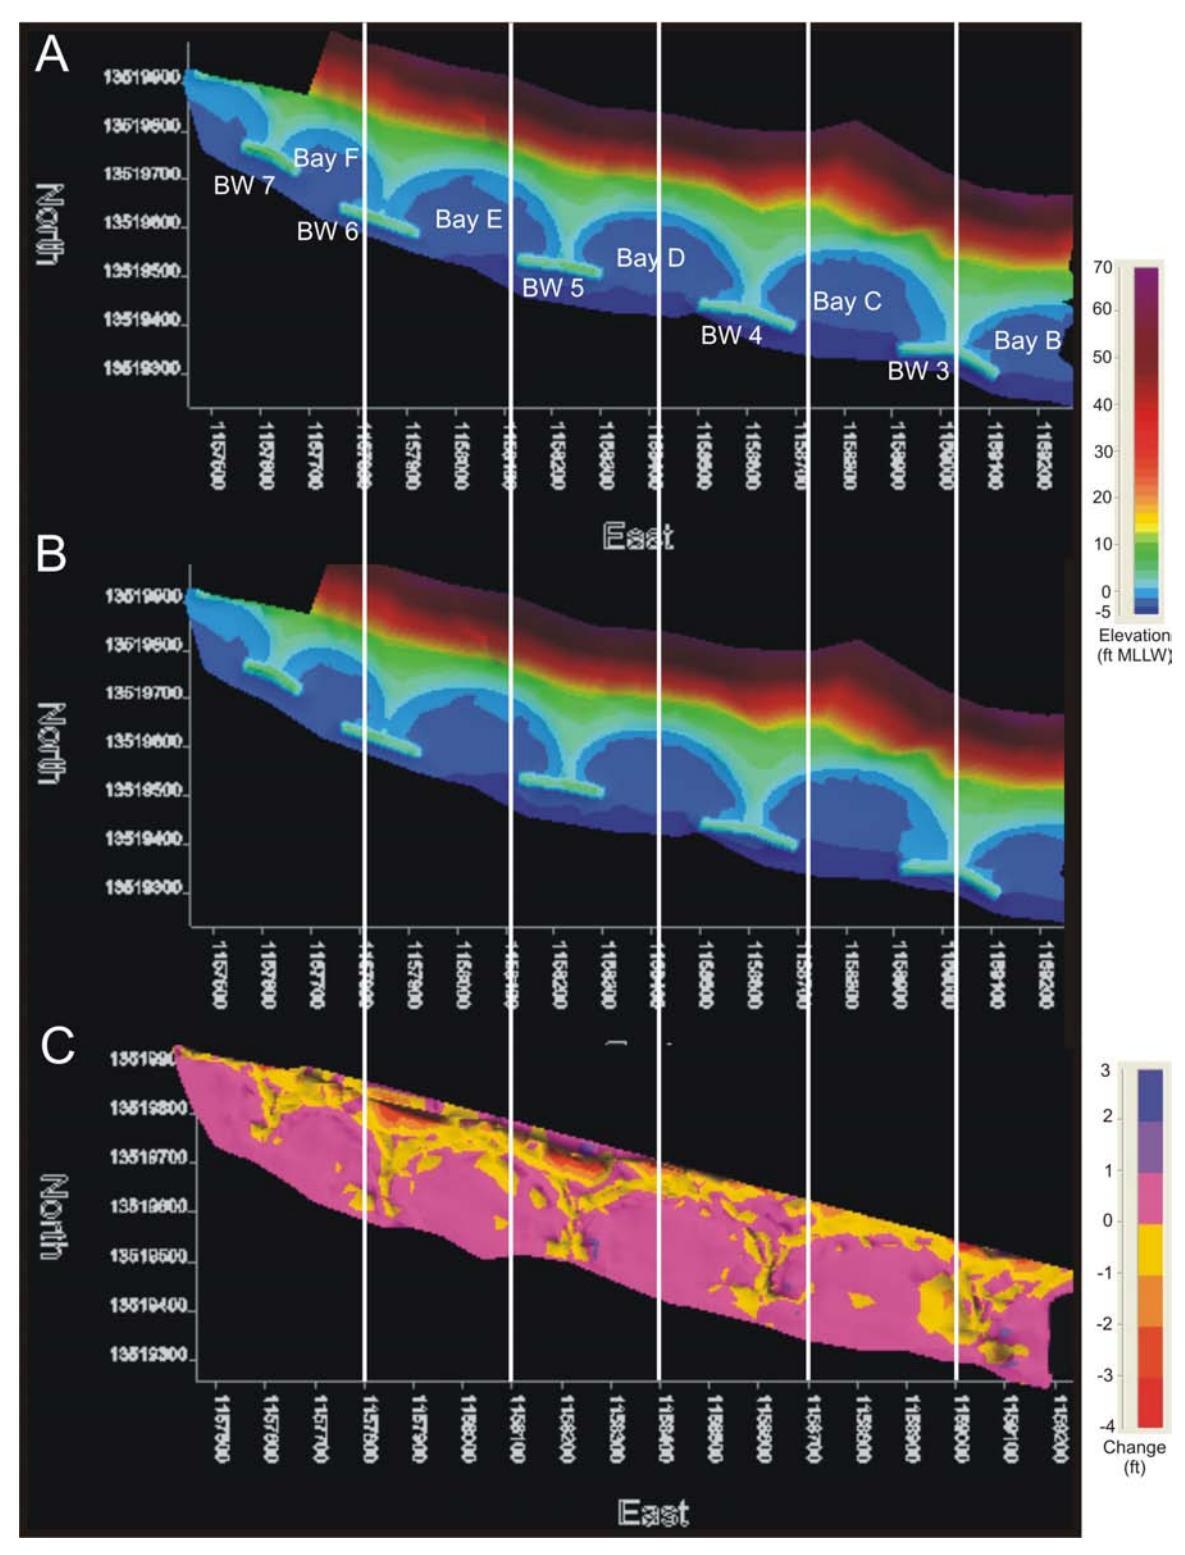
Figure 22. Kingsmill color contour maps for: (a) pre- and (b) post-storm conditions, and (c) isopach map showing elevation changes between surveys

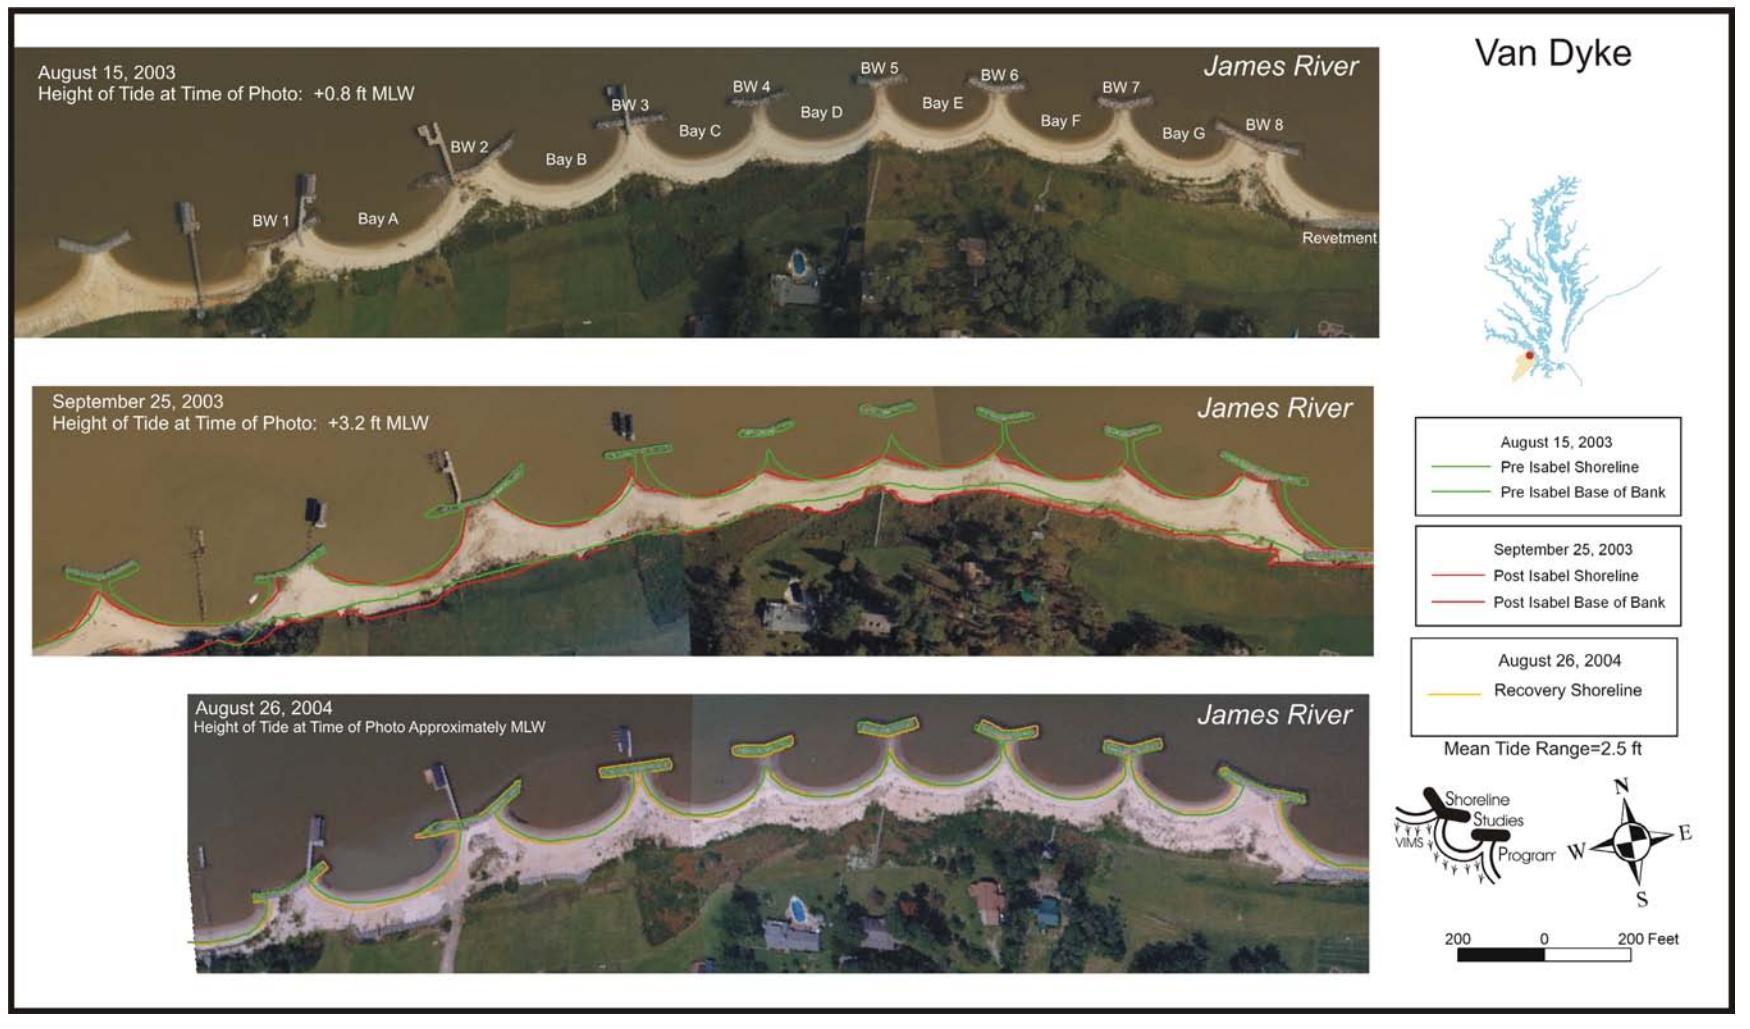
Aerial imagery pre- and post-Isabel shows mostly landward shifts in the positions of both the shoreline and base of bank (Figure 23). Reduction in tombolo size are seen behind BW3, BW4, BW5, BW6, and also BW7, which had the narrowest attachment before the storm. The adjacent BOB along these structures also receded. Significant BOB recession also occurred in Bay A. General BOB stability is seen between BW2 and BW4 as well as between BW7

and BW8. These trends are shown in typical profiles for select bays and breakwaters (Figure 24). The combination of storm surge and wave height exceeded el 11, about 0.9 m (3 ft) higher than project design. Post-storm recovery shows the shore planforms have returned to approximately their prestorm configuration (Figure 23).

Figure 23. Van Dyke low-level pre- and post-Hurricane Isabel and recovery ortho-rectified aerial photographs

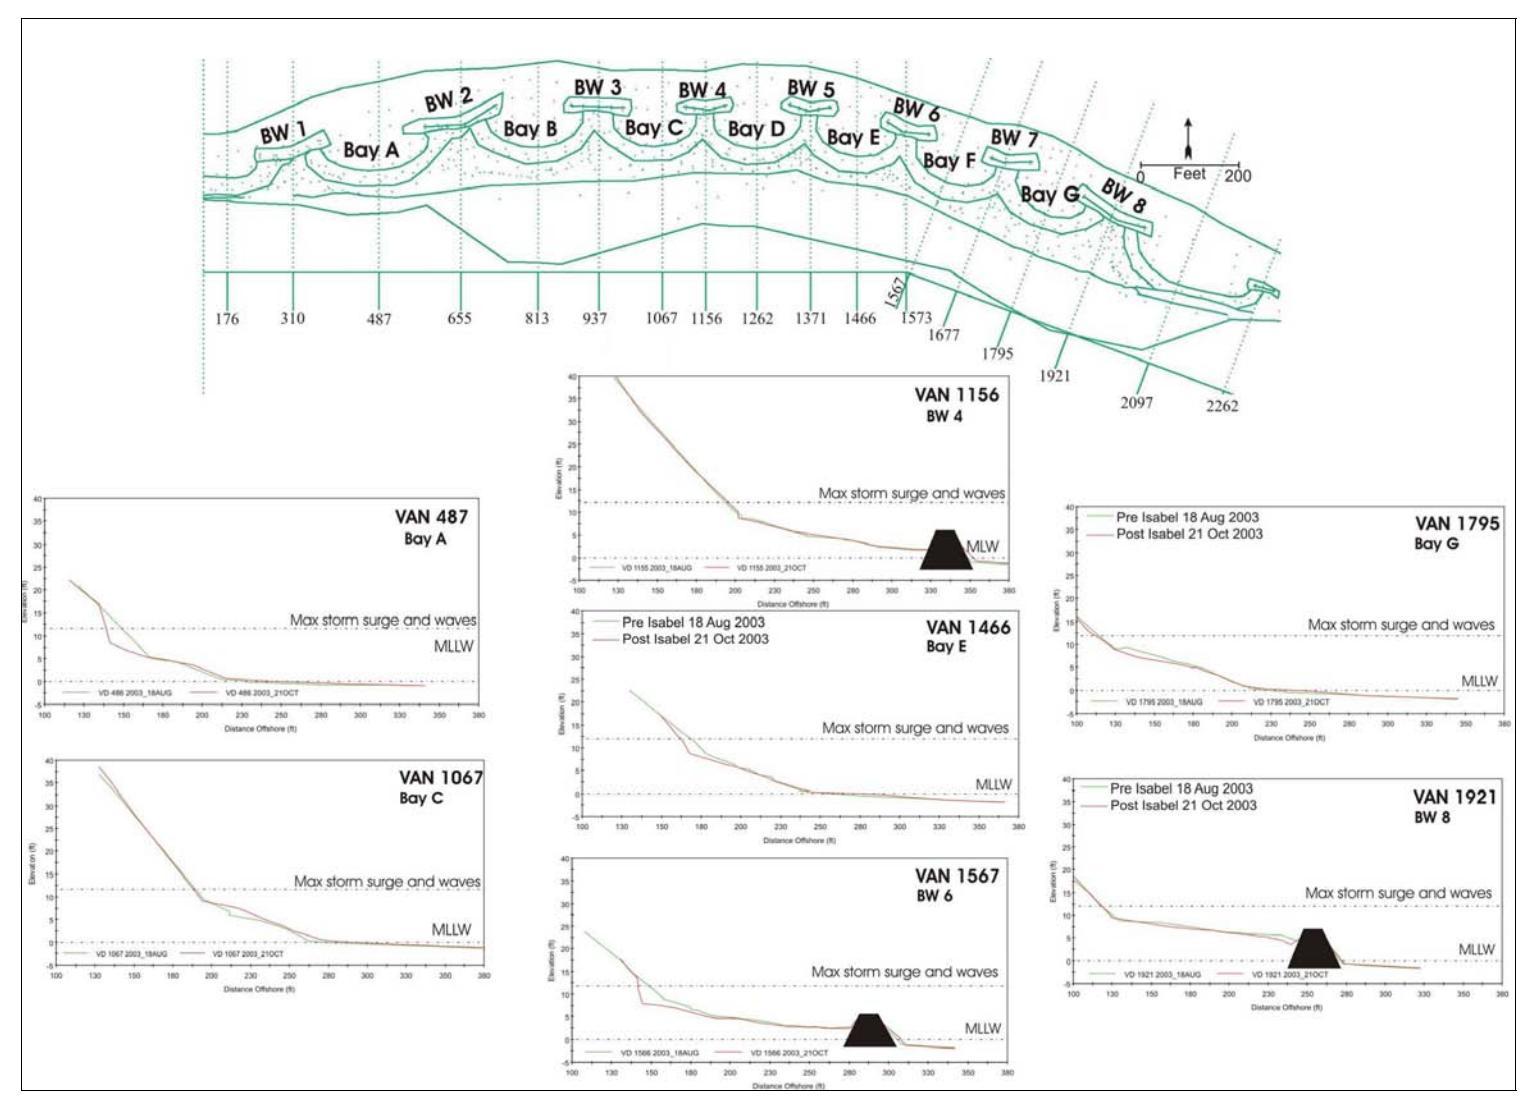
Figure 24. Van Dyke (VAN) baseline and selected pre- and post-storm cross sections

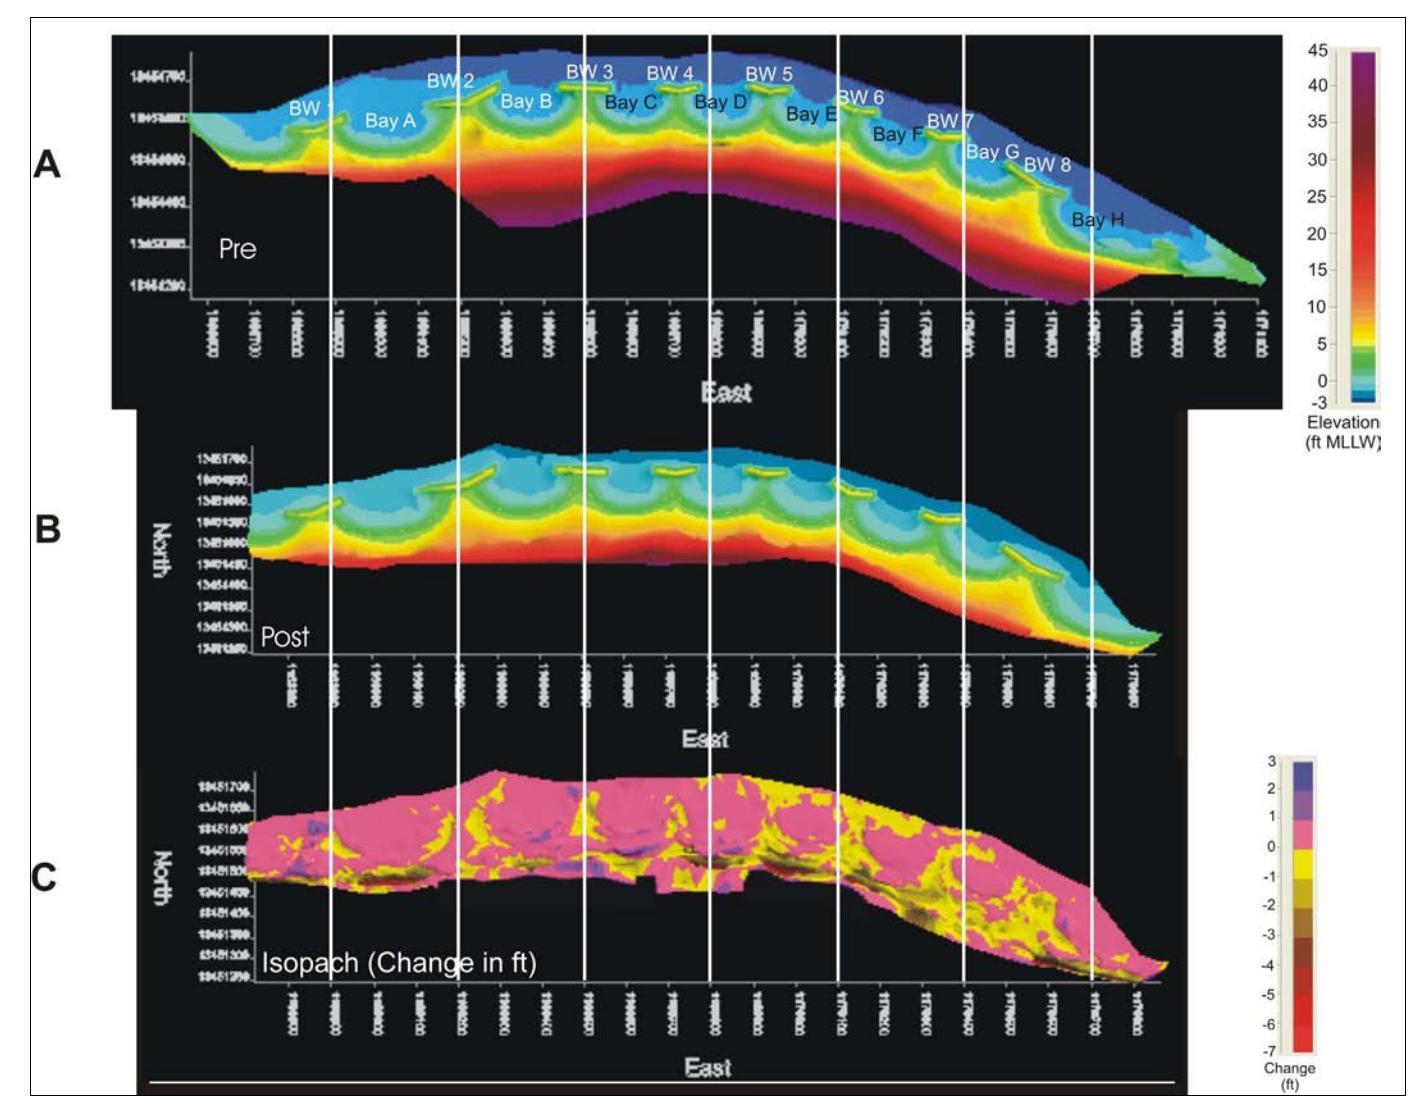
The overall change in topography at this site is seen in Figure 26. Negative topographic changes are evident at each tombolo and around and in front of BW5, BW6, and BW7. Severe land reduction occurs along the aforementioned BOB and along the top of the downriver revetment. Consequent increases or no change in topography are generally greater in the nearshore areas as indicated by the pink patterns (0 m<change<0.3 m) (0 ft<change<1 ft).

Figure 26. Van Dyke: (a) pre- and (b) post-storm color contour maps, and (c) isopach map showing elevation changes between surveys

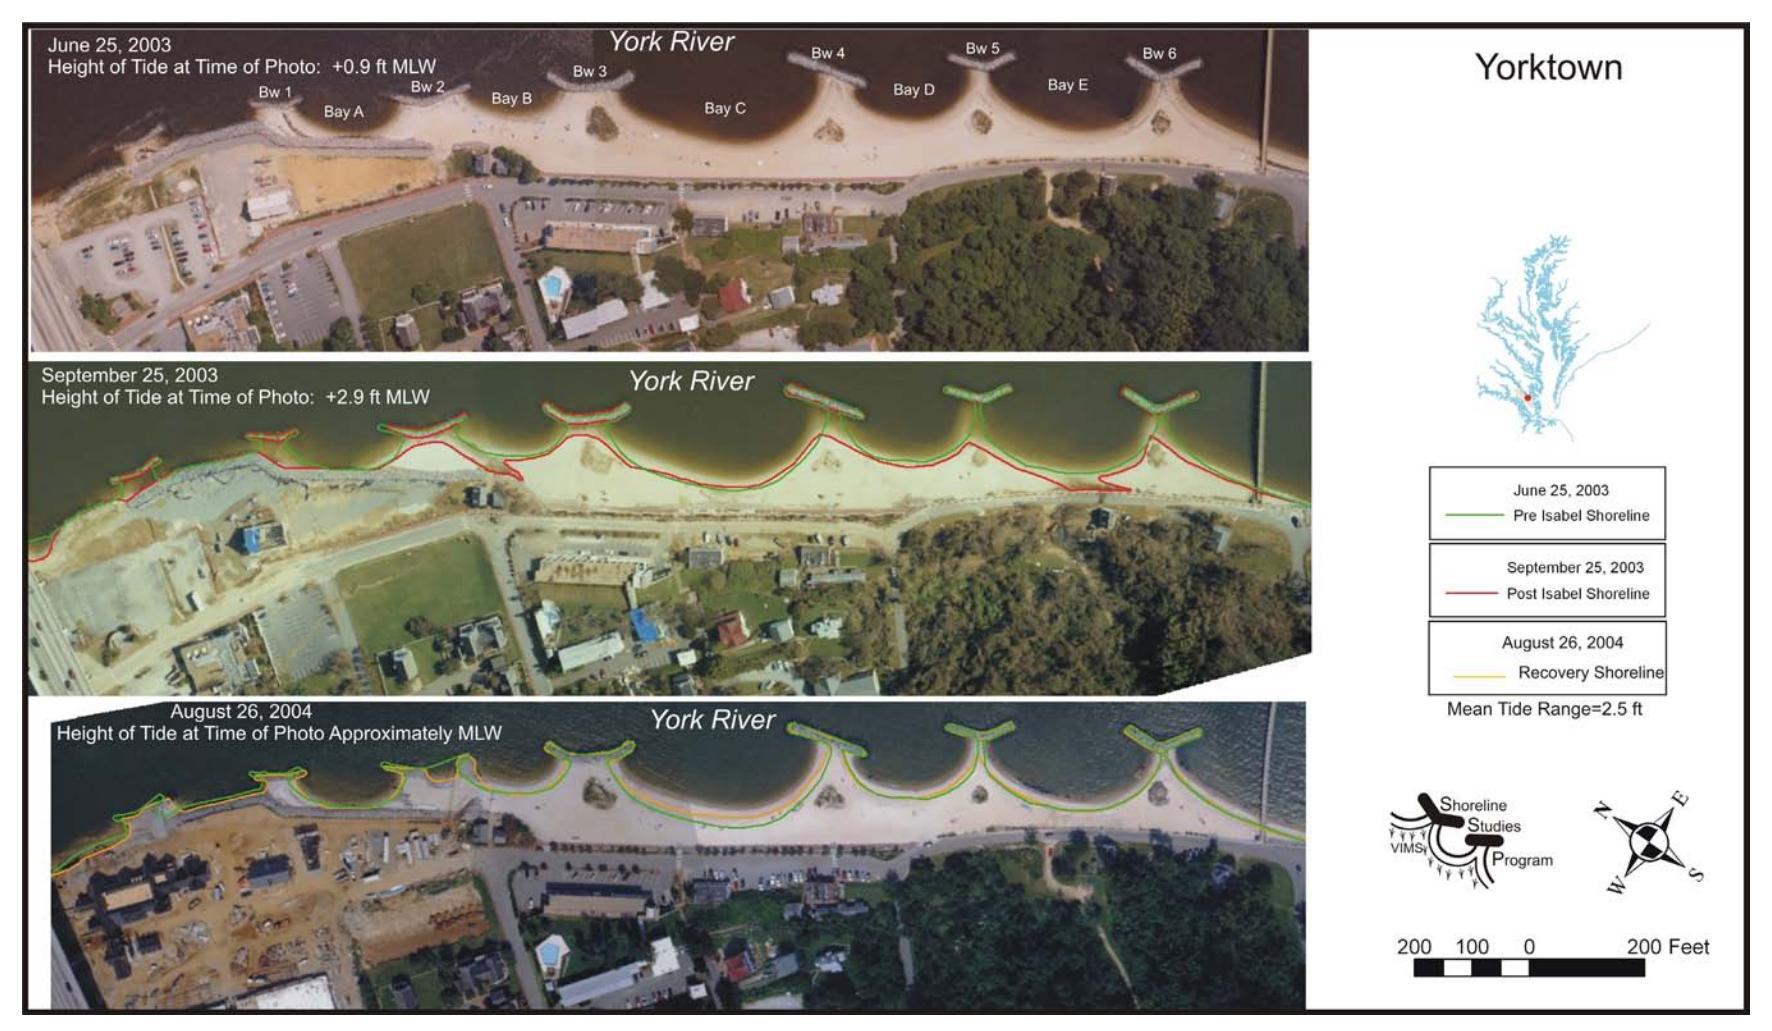
Pre- and post-Isabel low-level aerial imagery show a narrowing of each tombolo and a landward shift of sand behind each breakwater unit (Figure 27). The shoreline position in the two middle and largest embayments showed only slight changes after the storm. Typical profiles show cross-sectional changes as a basic cut and fill in the embayments (Figure 28). Shearing occurred across the top of the tombolos as well. Some sand was lost to the offshore after the storm, but the county filled the beach to its pre-storm profile shortly after the hurricane. Post-storm recovery about 1 year later shows shore planforms to have returned to their pre-storm position. A noticeable shore advance is seen in Bay B and D. Sand was carried into the adjacent street, but recent granite block backstops helped reduce this tendency. These blocks measuring about 0.3 m (1 ft) square, 1.5 m (5 ft) long, and weighing about 907.2 kg (1 ton) were easily shifted around by the storm waves. Several areas of scour occurred along the backshore/ sidewalk/road juncture (Figure 29), but post-storm cleanup and added fill restored the public beach to use by late October 2003. The businesses along the waterfront were severely damaged. It took several months for their rehabilitation due to water damage, but they are presently operating. Figure 30 shows a low backshore along Water Street in Yorktown as well as the storm wrack lines, which are the floating debris accumulated at the limit of high water. At Colonial National Historical Park, just downriver from Yorktown, small rocks from the revetment along the shoreline were scattered on the road, and the adjacent upland bank was severely scarped.

Figure 27. Yorktown low-level pre- and post-Hurricane Isabel and recovery ortho-rectified aerial photographs

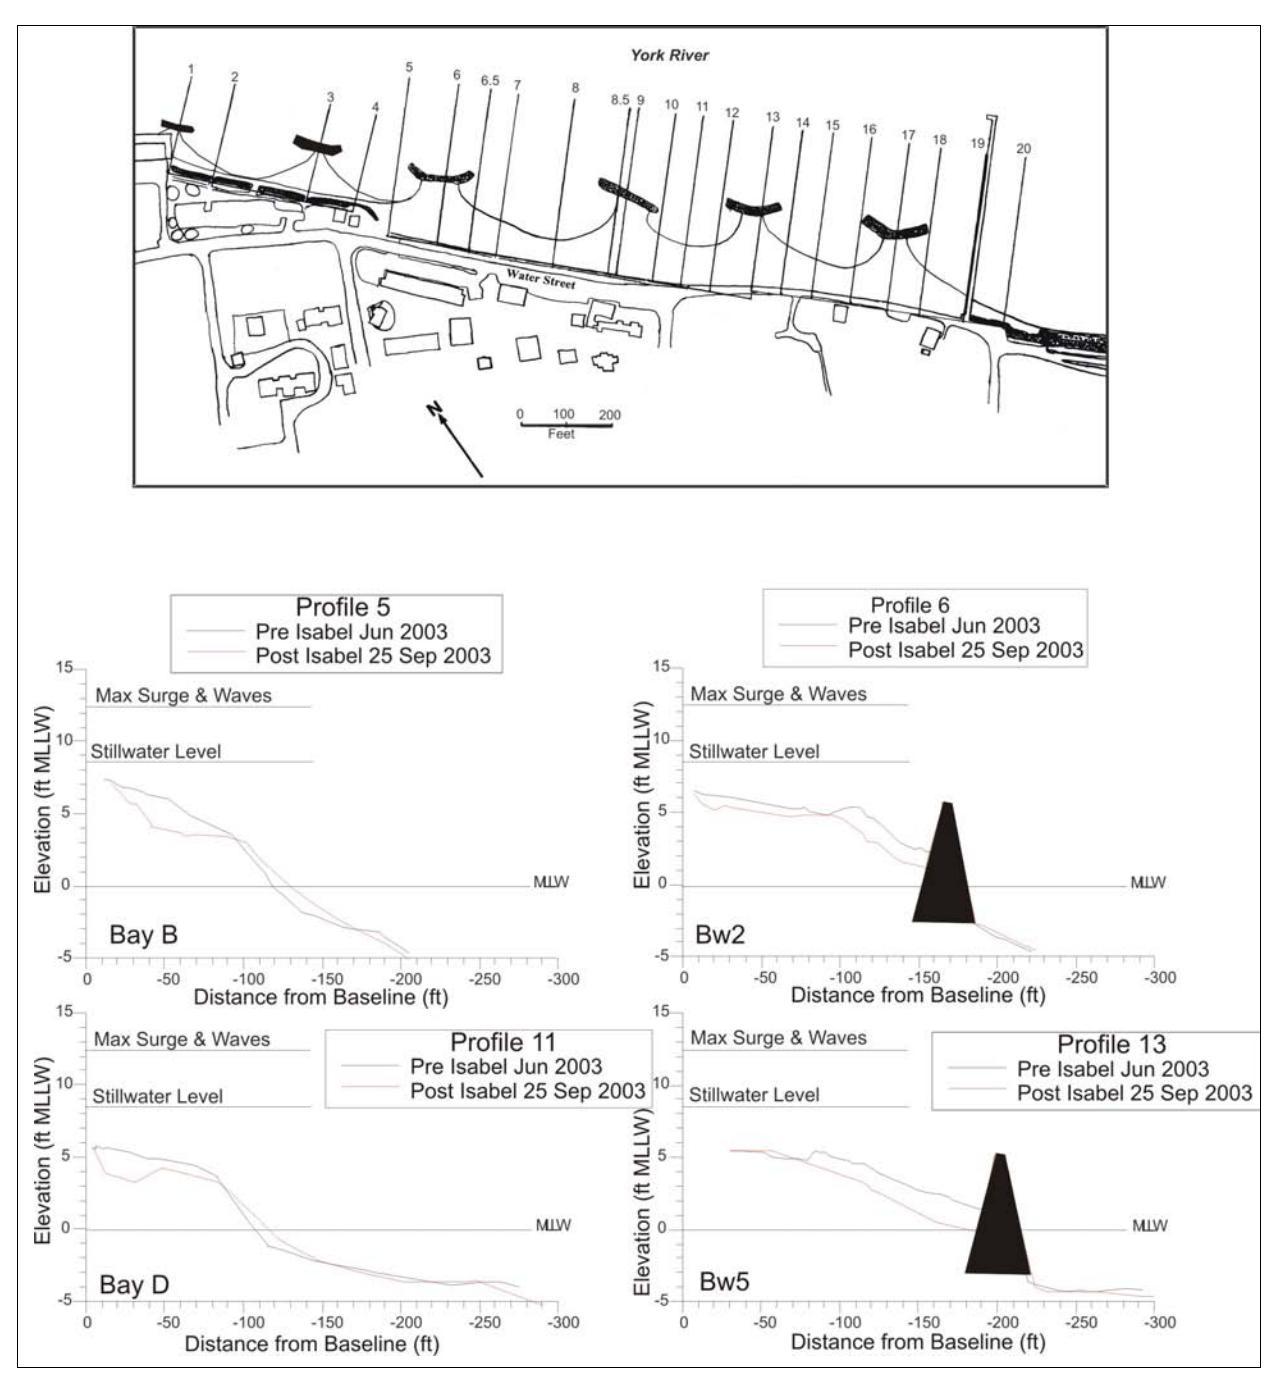
Figure 28. Yorktown baseline and selected pre- and post-storm cross sections

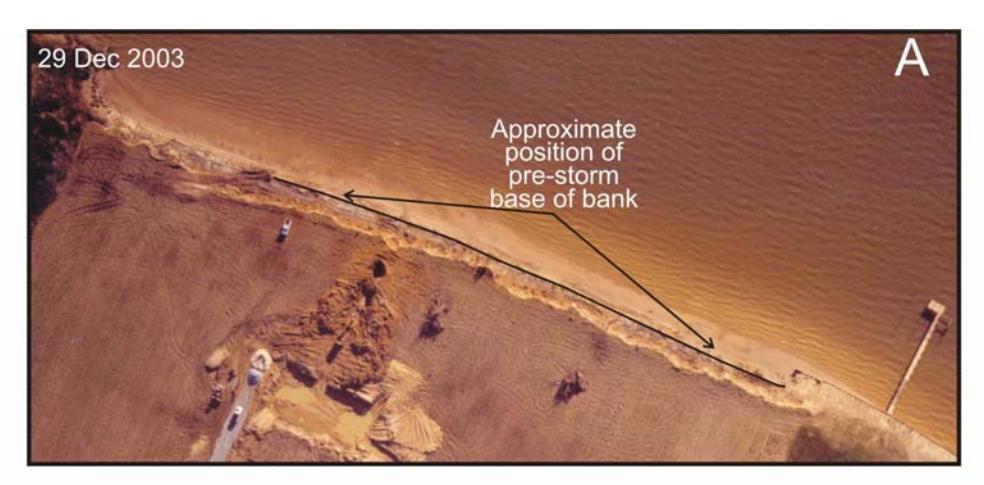
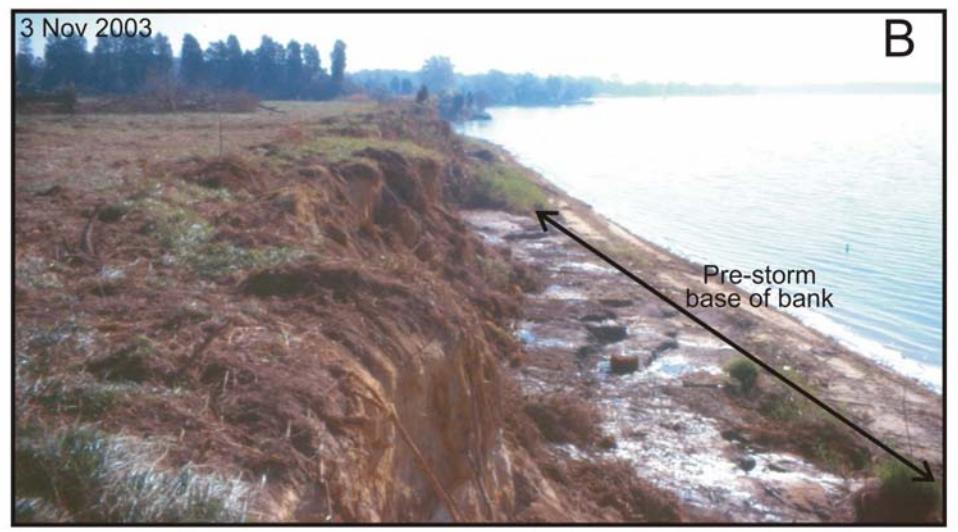
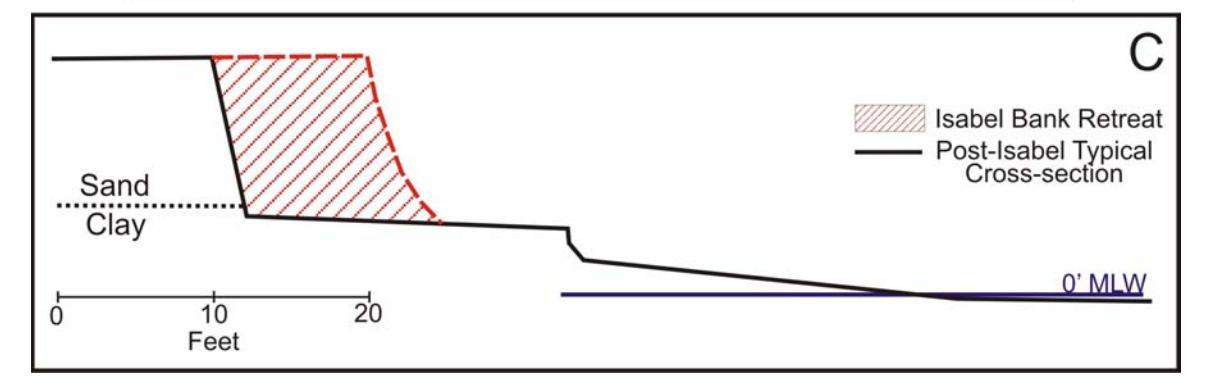
Just downriver at two other sites which had no shore protection system, significant change occurred (Figure 31). Dahlgren is on the south side of the Potomac River just downriver from the Route 301 Potomac River Bridge. Its bank was eroded 4.6 to 6.1 m (15 to 20 ft) threatening upland infrastructure (Figure 32). On the north side of the Potomac River, Lenhart is slated for development. During the storm, its bank retreated 3.0-4.6 m (10-15 ft) (Figure 33).

a. Nonrectified aerial photograph

b. Ground photograph

c. Typical post-storm cross section
