Electrospark Deposition for the Repair of Army Main Battle Tank Components

ARL-TR-3849

July 2006

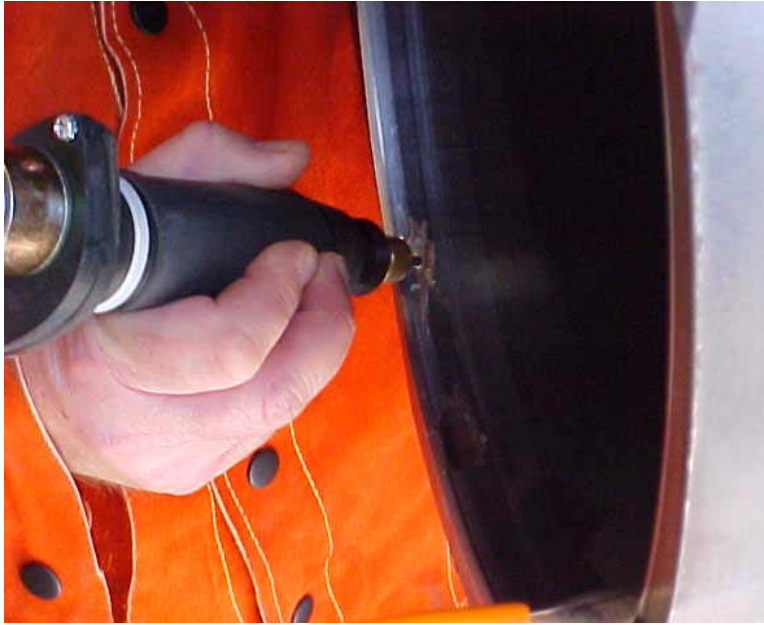
Figure 7. Photo showing ESD torch applying deposit on the inside diameter of a cradle with a rotating electrode.

distortion; shrinkage and high residual stresses can be avoided.² Figure 7 shows the application of an ESD deposit. This provides extremely rapid solidification, resulting in a nanocrystalline structure or, in some cases, an amorphous surface layer that is extremely dense, forming a metallurgical bond to the substrate. The low heat input eliminates deleterious thermal stresses or changes in metallurgical structure, otherwise known as the HAZ, allowing it to be considered for heat-sensitive applications. ESD can be used for applications requiring corrosion and wear resistance as well as the build up of worn or damaged areas on parts. ESD is also an environmentally friendly process, and the deposition of toxic materials can be accomplished with the use of a fume hood to capture any dangerous gases that may evolve. ESD operators require no specialized safety protection other than eyewear and a dust mask in some cases. The only major disadvantage is that the ESD electrode is relatively small (~0.125 inches in diameter), making the repair of large surface areas impractical and expensive.
