ERDC TR-07-10

## **Geologic Setting of Mosul Dam and Its Engineering Implications**

September 2007

Final report

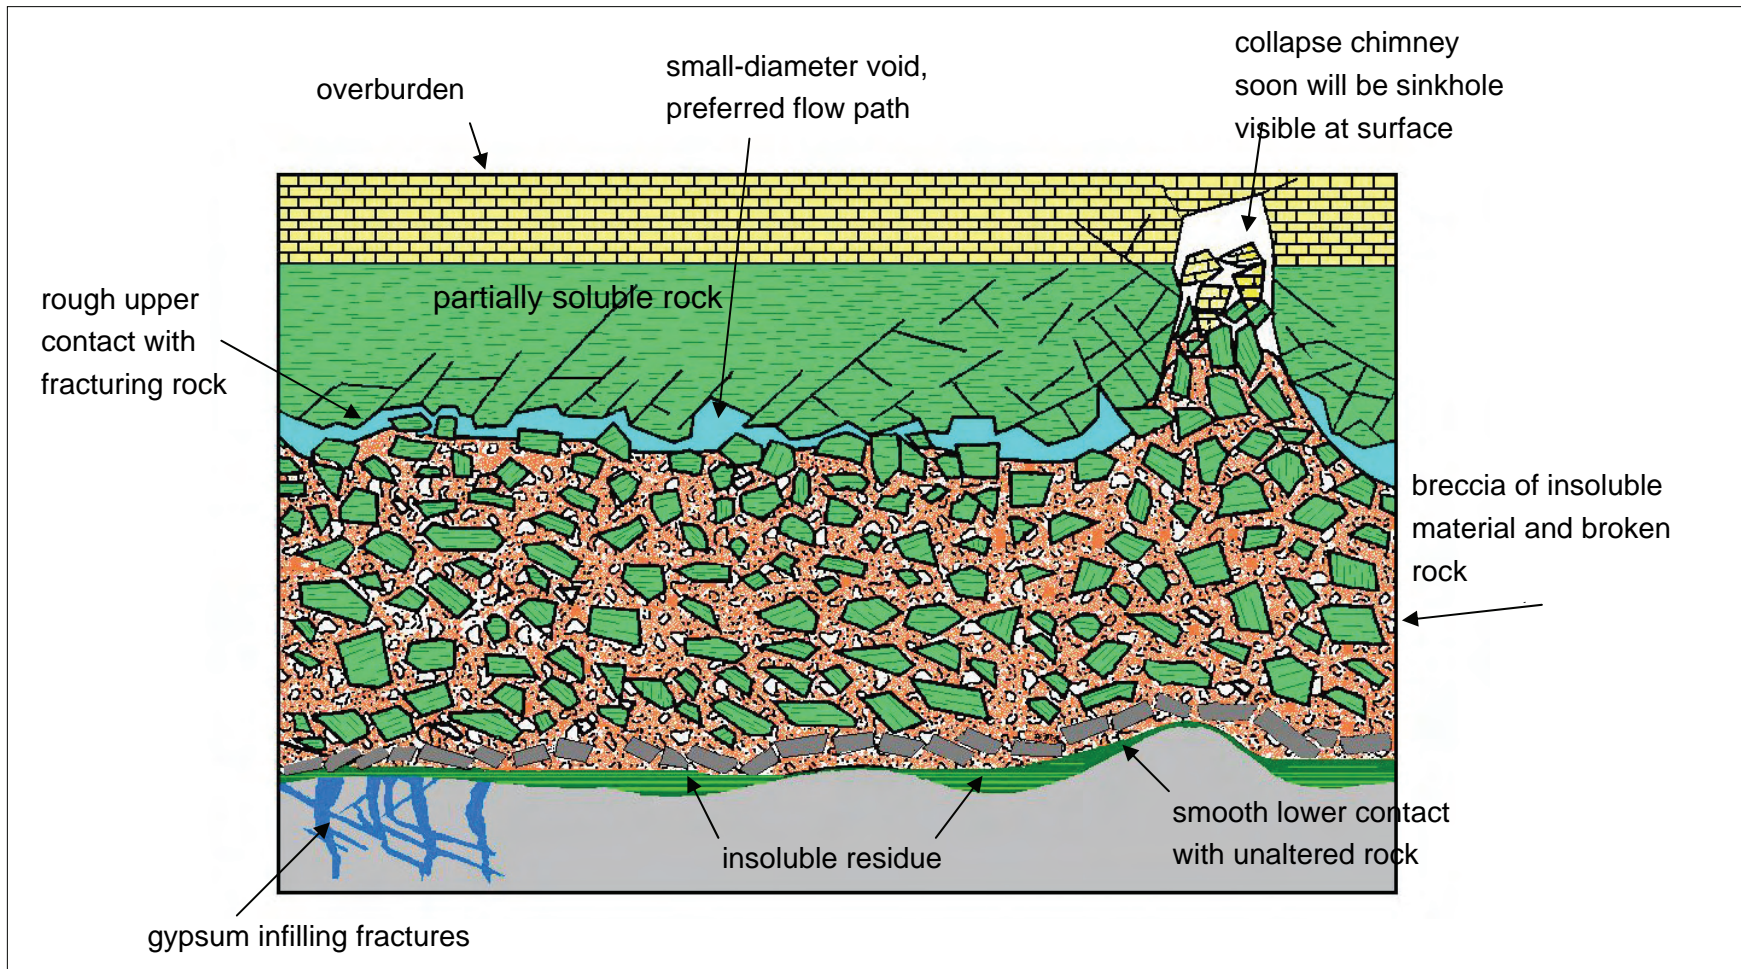
Gypsum breccia layers exist within the Fatha Formation and have proven to be the most problematic rocks in the foundation. Breccia is evidence of a subsurface dissolution zone within a layer of gypsum. Pieces of partially dissolved rock may collect on the floor of a void space as a layer of rubble within. The main breccia body contains fragments or clasts of limestone, dolomite, or larger pieces of insoluble rocks of collapsed material. The upper portion of the accumulation grades upward from rubble to crackle mosaic breccia and then a virtually unaffected competent overburden (Figure 2). Breccia also may form without the intermediate step of an open cavity, by partial dissolution and direct formation of rubble.

Figure 2. Development of breccia within a layer of gypsum (Warren 2006).

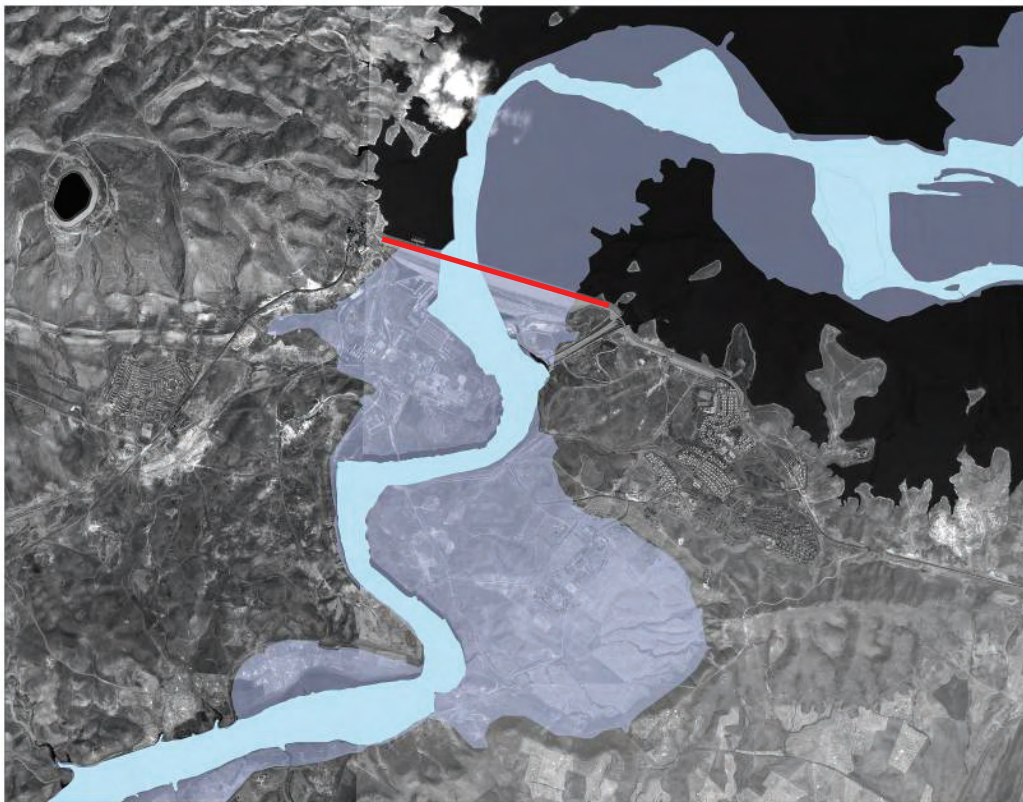
The Tigris River floodplain (Figure 3) in the dam area has been in much the same location since the Pleistocene (1.6 Ma to 10,000 years ago) (Jassim et al. 1999). Over time, the river channel has migrated from east to west as evidenced by the location of old abandoned river terrace deposits primarily on the east side of the river (Jassim et al. 1997). Deposits within the active river channel consist of loosely cemented conglomerates, sands, and marls. Because of their high permeability, these materials would likely be a natural conduit for groundwater. However, large volumes of the terrace gravels were removed during construction. Remaining terrace deposits are not continuous across the dam site and are not in configurations to provide subsurface flow pathways for water from the reservoir.

Figure 3. Pre-dam Tigris River channel (light blue) and floodplain (gray) are shown above Mosul Dam (red line) superimposed on the reservoir (shown in black). The recent Tigris River channel (light blue) and floodplain (gray) continue below Mosul Dam (M. L. Pearson, S. W. Broadfoot, and J. R. Kelley).

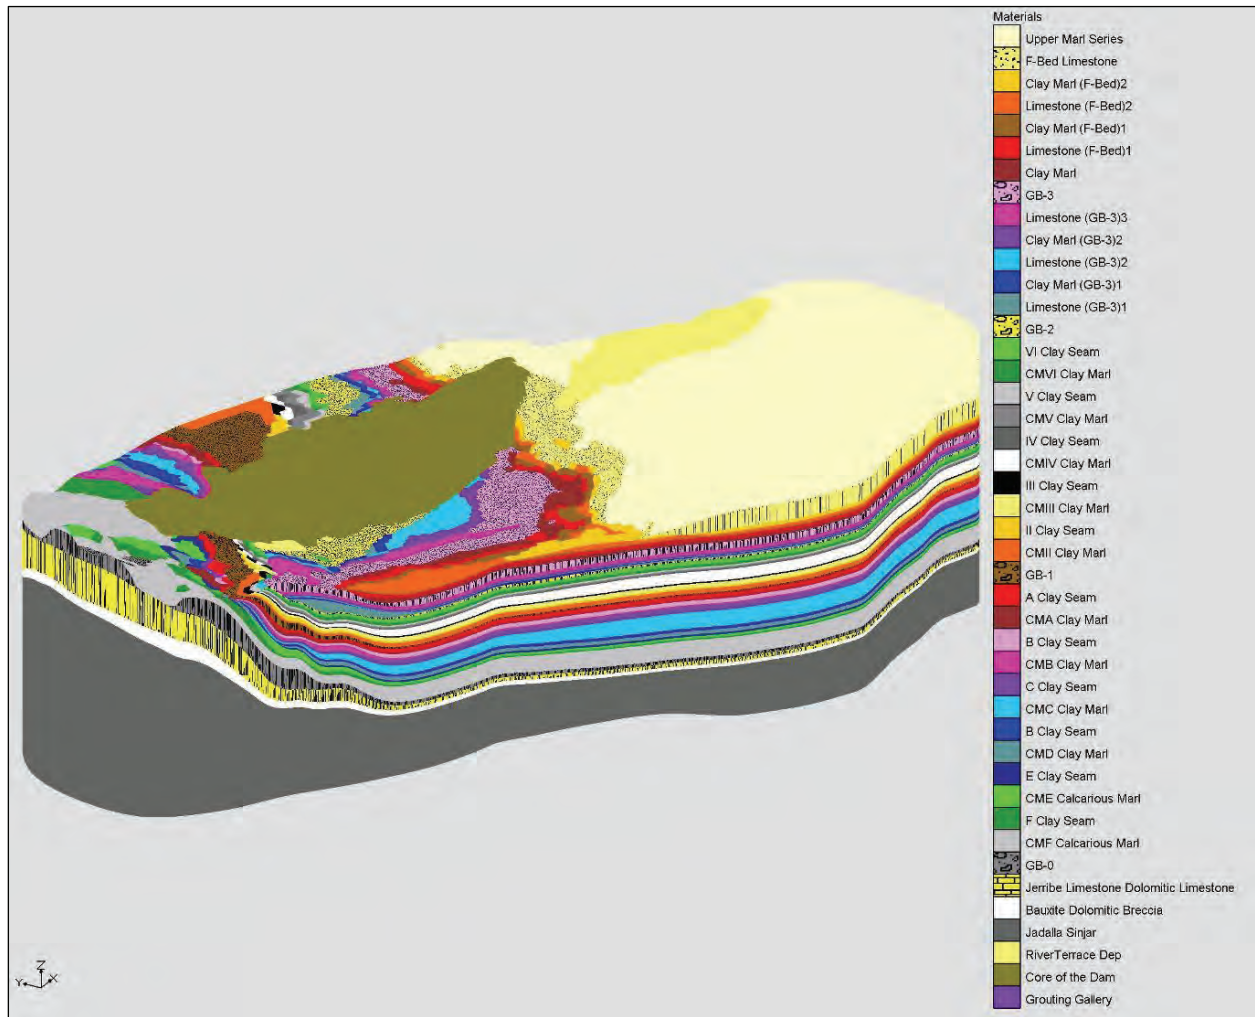
Figure 6. Two-dimensional projection of an oblique view of the 3-D conceptual model, looking upstream from the southwest toward the downstream face of the dam. Broad yellow area is surface expression of southeast-dipping geologic units on the east abutment; contrasting to complex exposed geology of steeply dipping units under the dam and reservoir and on the west abutment, where the Butmah Anticline is the dominant geologic structure. (Figure from ERDC 3-D geologic model in GMS.)

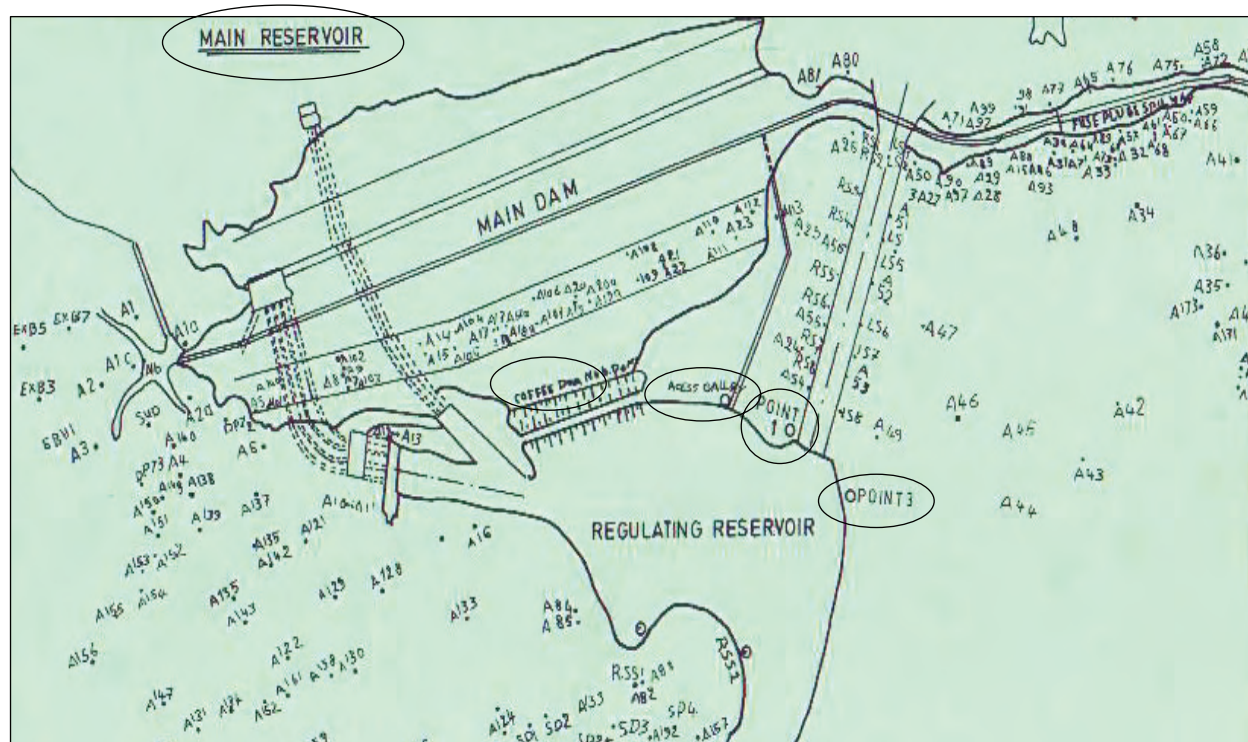
Figure 11. Locations of seepage monitoring and piezometers at Mosul Dam. Note especially Point 1 and Point 3, circled in red to the right-center of the map, corresponding to SP1 and SP3 in the text.
