# HADITHA DAM PERIMETER SECURITY HADITHA, IRAQ

## SUSTAINMENT ASSESSMENT

**SIGIR PA-09-192**  
**APRIL 13, 2010**

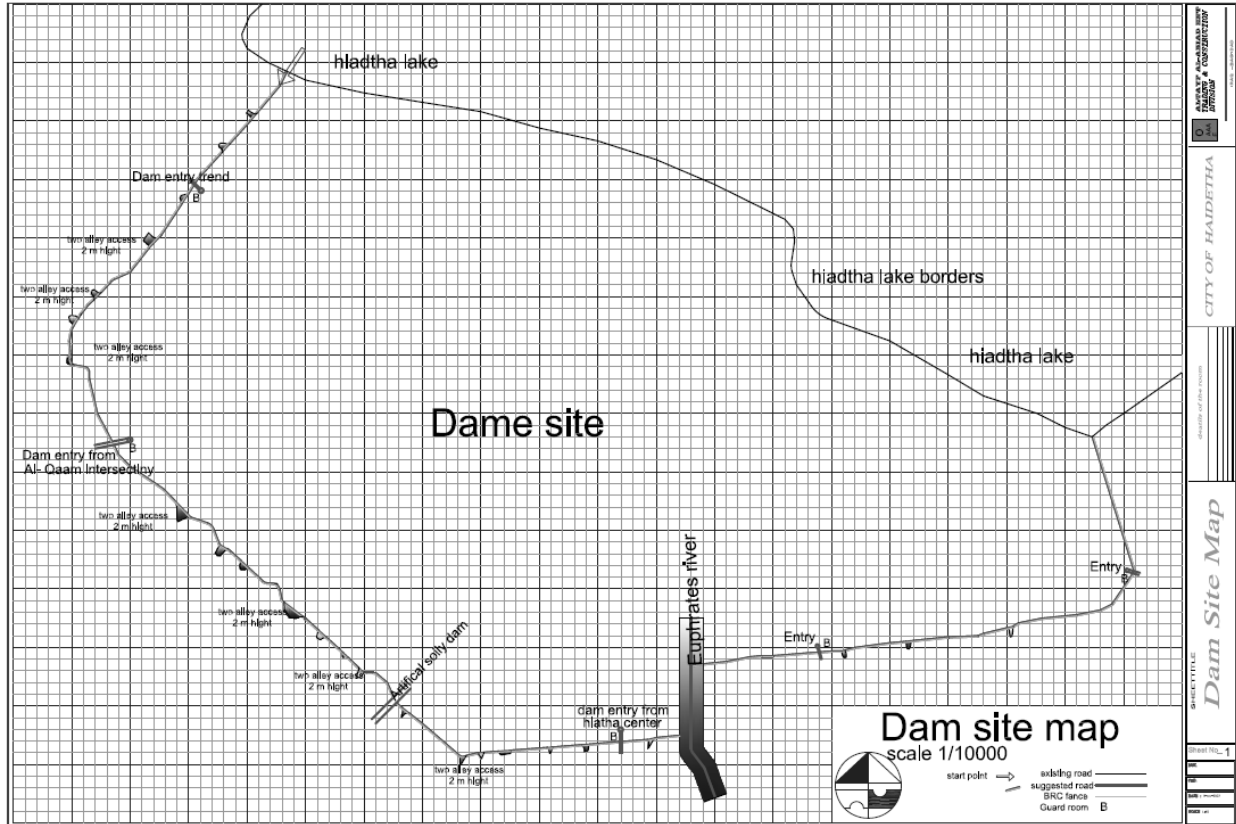
The contractor provided an overall site plan (Figure 1) and profile for the perimeter fence and access drive. The plan and profile were based on topographic information and included physical features of the project area and the proposed improvements.

Figure 1. Haditha Dam perimeter security site plan  
(Courtesy of GRC)

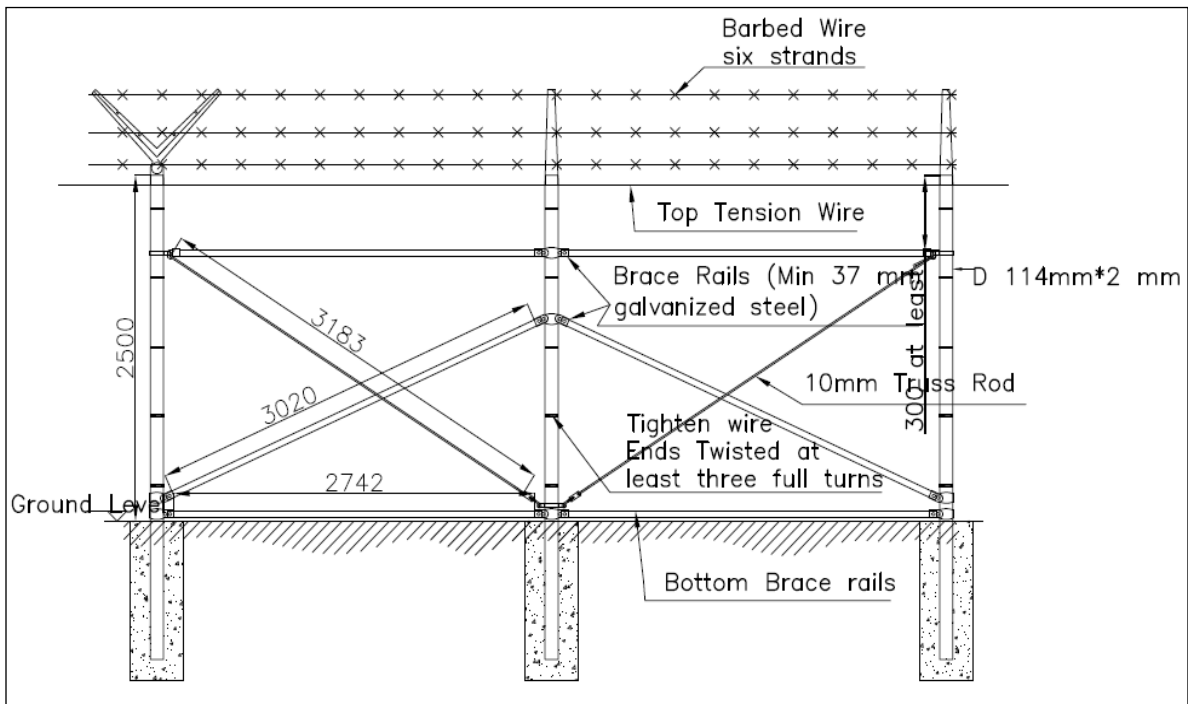
The contractor submitted details in the design drawings for construction of the perimeter fence (Figure 2). These details were based on the standard drawings provided with the contract and provided additional dimensions and details.

Figure 2. Contractor's design of typical fence section  
(Courtesy of GRC)

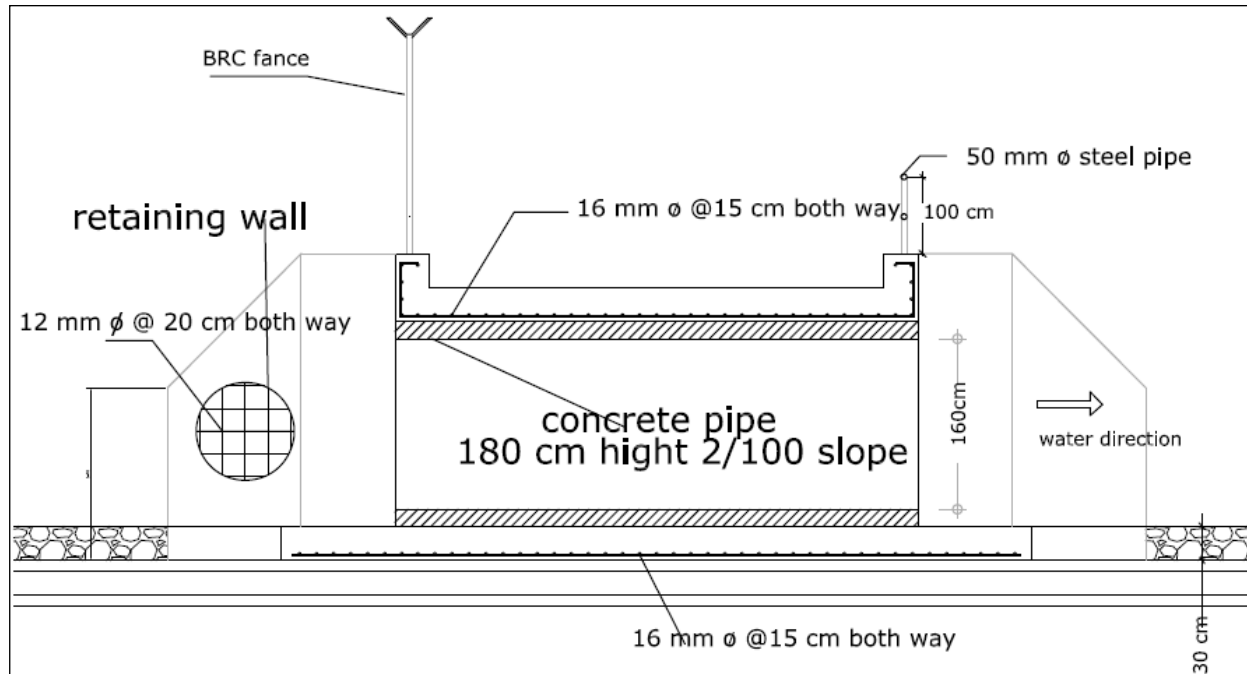
The culvert details provided by the contractor included information for one and two culverts. Also, the details provided information for constructing the fence across the drainage channel. Details of the longitudinal sections of the culverts were provided to show the headwalls, pipe, and fence in relation to the access drive (Figure 3).

**Figure 3. Culvert for access drive**  
(Courtesy of GRC)
