**ASC-TR-2010-5002**

# **THREATS TO AIRCRAFT STRUCTURAL SAFETY, INCLUDING A COMPENDIUM OF SELECTED STRUCTURAL ACCIDENTS / INCIDENTS**

**Engineering Directorate (ASC/EN)  
Aeronautical Systems Center**

**MARCH 2010  
Final Report**

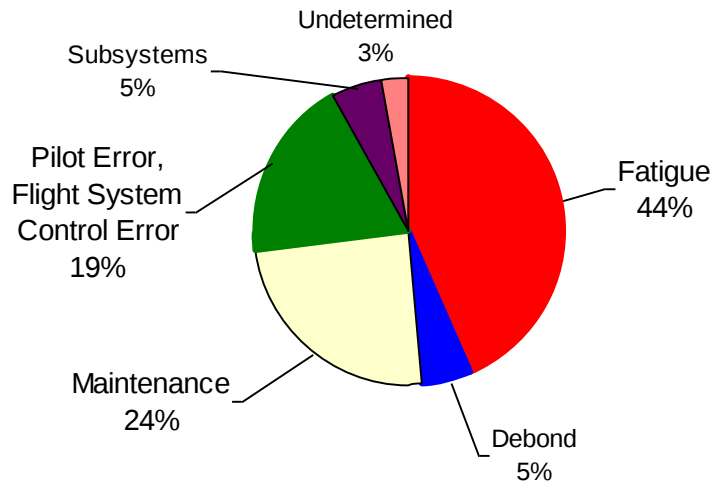
**Figure 2: Percentages Associated with Types of Causes Associated with 37 USAF Structural Failures [29]**

Babish [29] summarized all 37 USAF aircraft losses attributed to structural failures (as defined by the USAF Safety Center) that have occurred to since 1972. Babish determined that seven of the 37 structural failures were attributed to overloads caused by pilot error, flight control system errors or to a combination of these two errors. Figure 2 provides a summary of the percentages of catastrophic aircraft structural failures due to non-combat causes of the 37 aircraft.
