THI QAR VILLAGE ROADS  
SEGMENT 3  
GOVERNORATE OF  
THI QAR, IRAQ

**SIGIR-PA-06-059**  
**OCTOBER 26, 2006**

SUBJECT: Report on Project Assessment of Thi-Qar Village Roads Segment 3 Project,  
Thi-Qar, Iraq (Report Number SIGIR-PA-06-059)

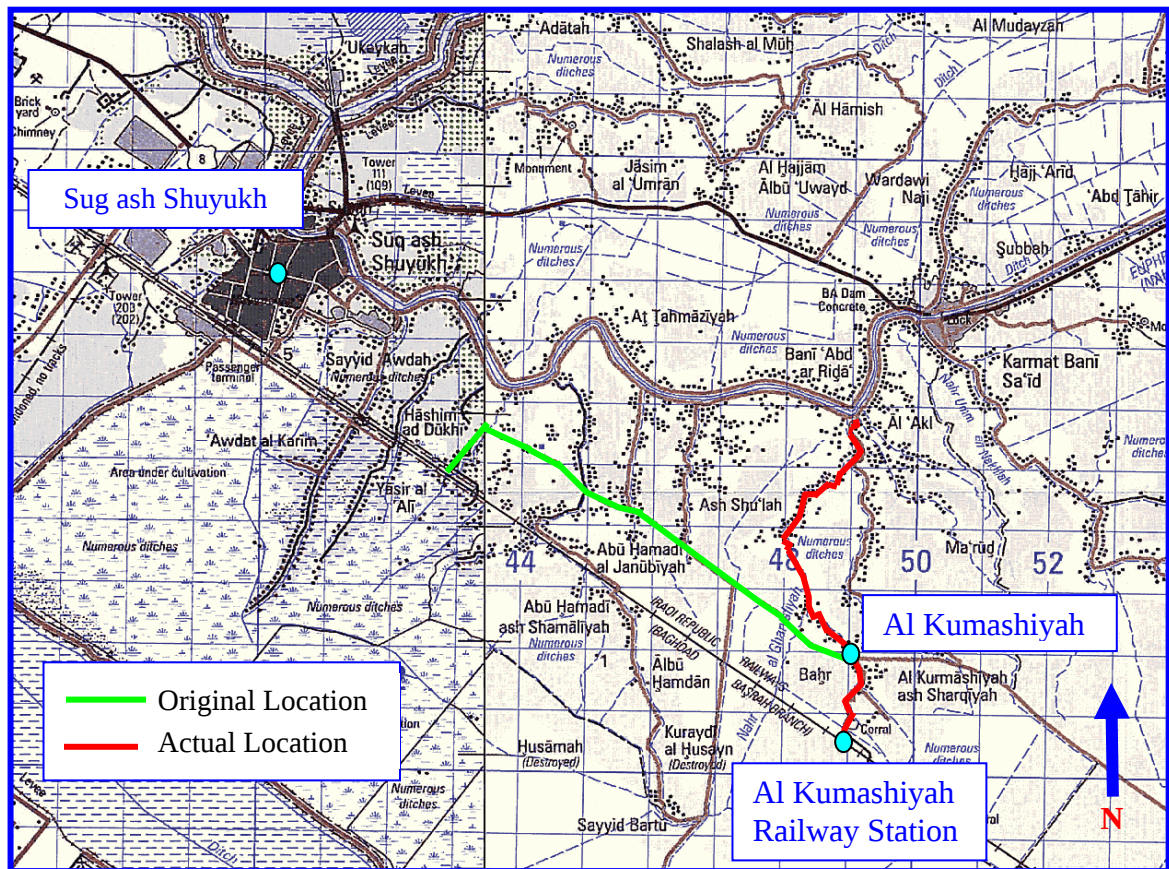
**Figure 1: Thi Qar Village Roads Segment 3 Project**

The grid coordinates provided by the SCRB delineated the alignment shown in red in Figure 1. The new alignment parallels an irrigation canal and runs in a north-south direction. The northern terminus of the road is at the Euphrates River. The road ends in the south at the Al Kumashiyah Railway Station.
