Thule Air Base Airfield White Painting and Permafrost Investigation

Phases I–IV

June 2013

Final report

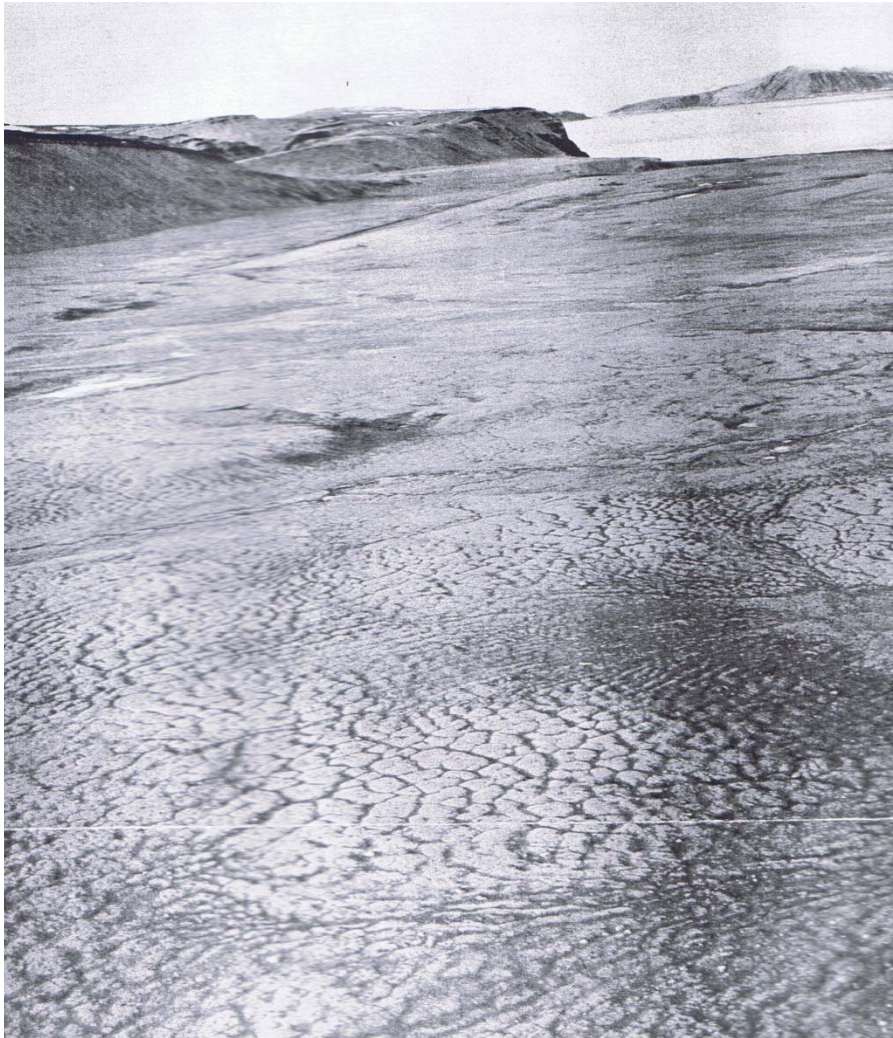
Figure 6. Aerial photo prior to Air Base construction looking southwest. The polygonal ice wedge networks are seen to extensively cover much of the valley.

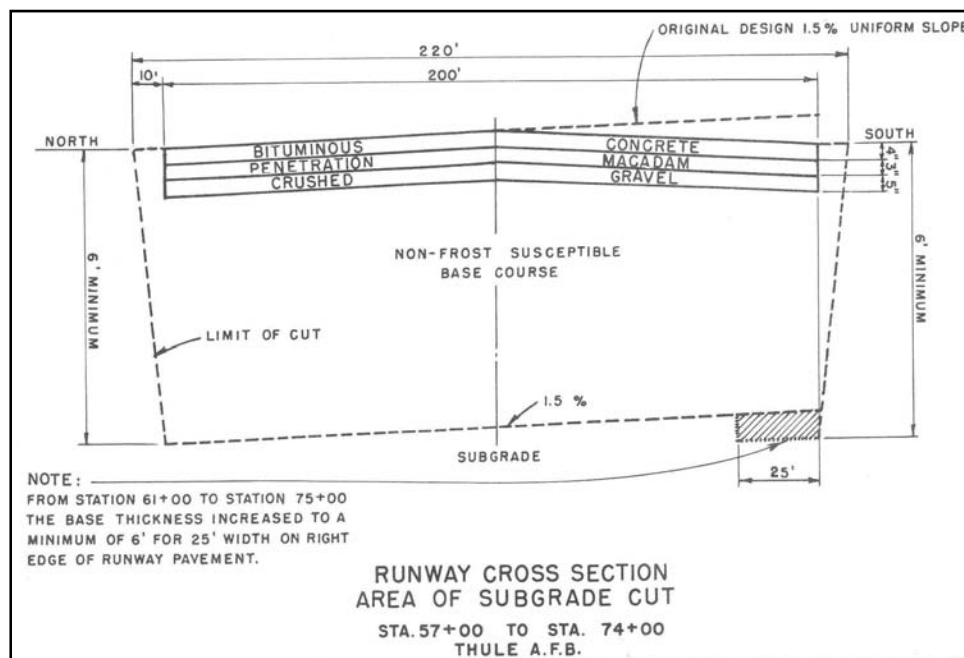
ing the permafrost table and inducing thaw was determined to be 6 ft (Metcalf & Eddy 1956). The 10,000-ft runway was constructed entirely on fill material, with the extreme ends of the runway requiring the greatest amounts, up to 30 ft. A portion of the runway, 1800 ft long, starting at station 50+50 and ending at 70+30, required excavation of a topographic high, resulting in a maximum cut at one location of 13 ft. The mid-point of the topographic high required excavation of diorite bedrock, and the rest of the cut section was excavated in frozen glacial till. The cut portion incorporated the 6 ft of thaw preventative fill as mentioned previously. However, because of design changes in the runway surface during construction, from a transverse slope to a crowned cross section, the resulting thickness from top of runway to bottom of excavation along the southern edge of the cut was reduced to only 3 ft (Fig. 7).

Figure 7. Cross section of the runway cut section from 57+00 to 74+00 showing initial design and mid-construction design change. The box excavation is also shown which was installed from 61+00 to 75+00 along the runway south limit (ACFEL 1955).

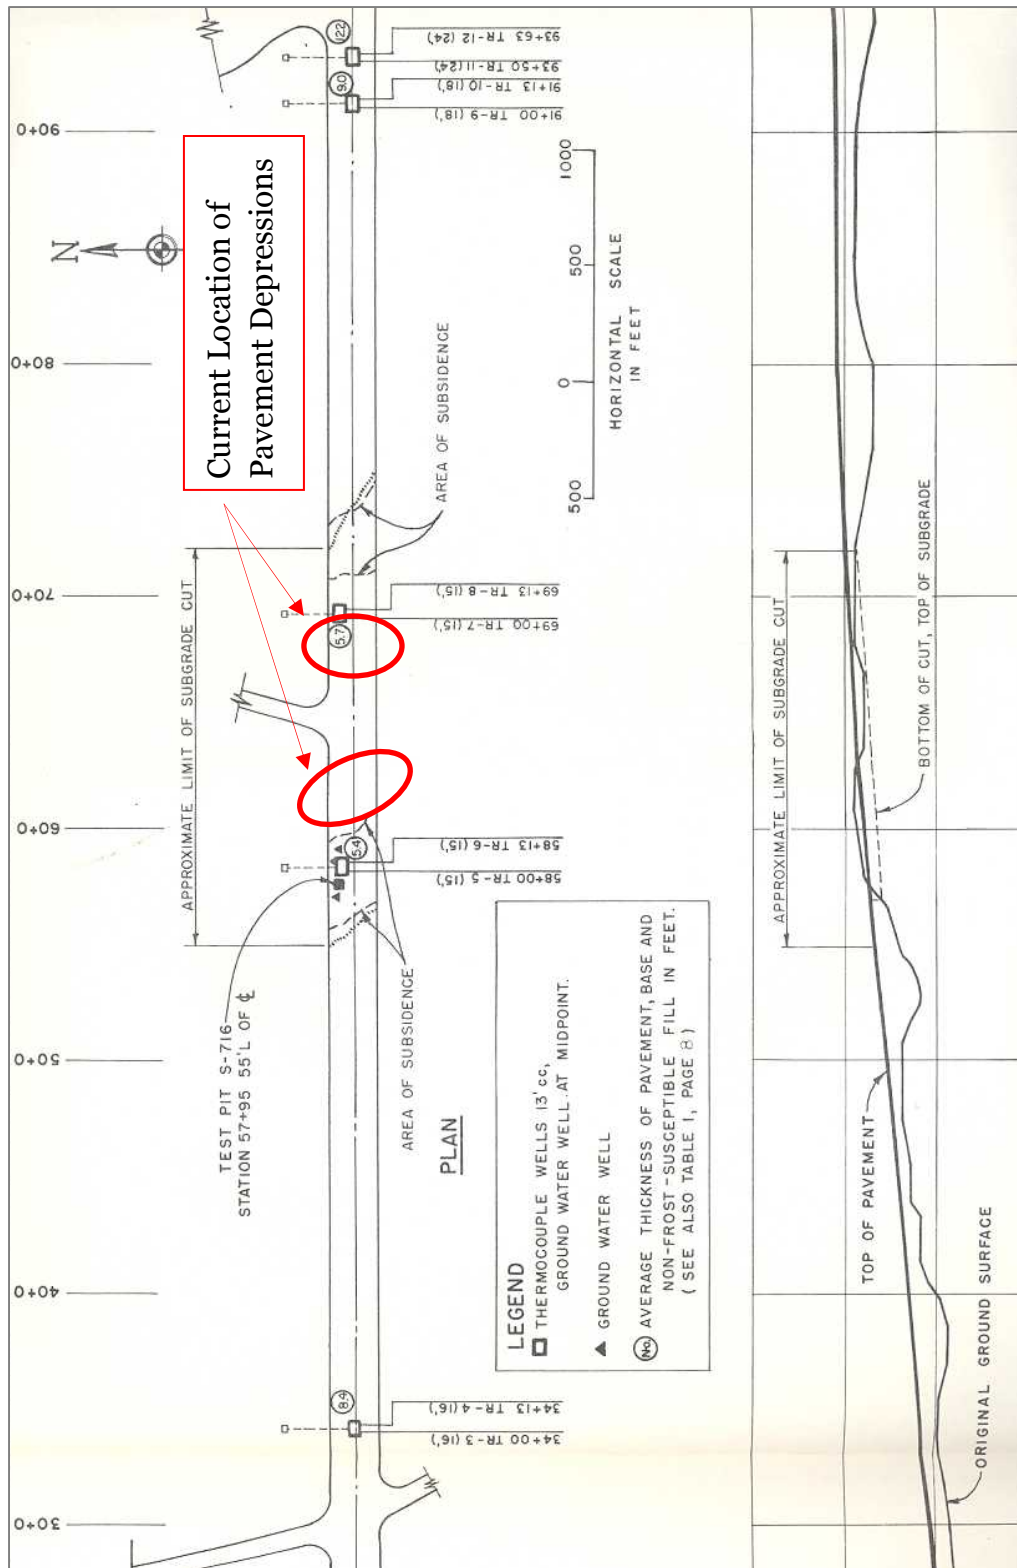
The Arctic Construction and Frost Effects Laboratory (ACFEL) conducted an investigation in 1953 and 1954 to determine the cause of thawing on the runway in the vicinity of existing Taxiway Charlie. Boreholes were drilled and pits hand dug to determine the subsurface conditions. Ice was found at a depth of 6.5 ft at subsidence location 58+00 (TR-5) and at 6 ft at subsidence location 72+00 (TR-7 in Fig. 8). Massive ice in the subgrade was thawing and causing differential settlement because of inadequate thickness of thaw-preventing fill in the runway. Measured thaw depths and numerical analysis conducted during this current study show that 8 to 9 ft of fill material should have been the design standard.

Figure 8. Plan view of depressions and test pits from ACFEL 1955 investigation (ACFEL 1955). Current depression areas are noted.

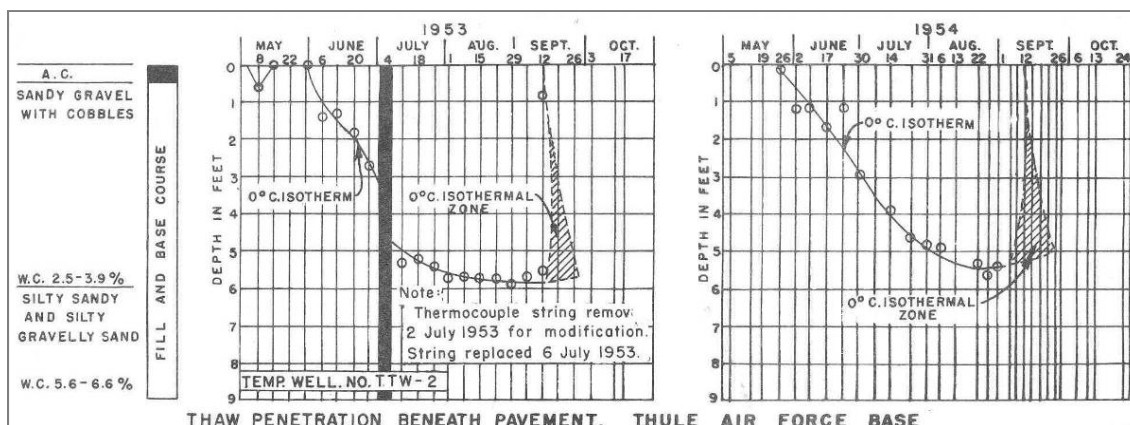
Plots of the depth of thaw under these two areas are compared for two seasons in Figures 9 and 10; the thaw depth was reduced by approximately 2 ft where the pavement was painted white. The thawing index for 1954 was greater than in 1953, but the deeper thaw in 1953 is attributed to heat introduction during excavation of the thermocouple strings, which were replaced in July 1953. Other investigators have confirmed these results (Berg and Aitken 1973). In a more recent study conducted at Kangerlussuaq, Greenland, Jorgensen and Ingeman-Nielsen (2008) used ground-penetrating radar to measure 2.6 ft of decreased thaw depth under white painted asphalt

Figure 9. Temperature profile for two seasons under a white painted asphalt surface (ACFEL 1955). Although 1954 had a higher thaw index, the 1953 thaw depth is deeper owing to excavation for a new temperature measurement string.

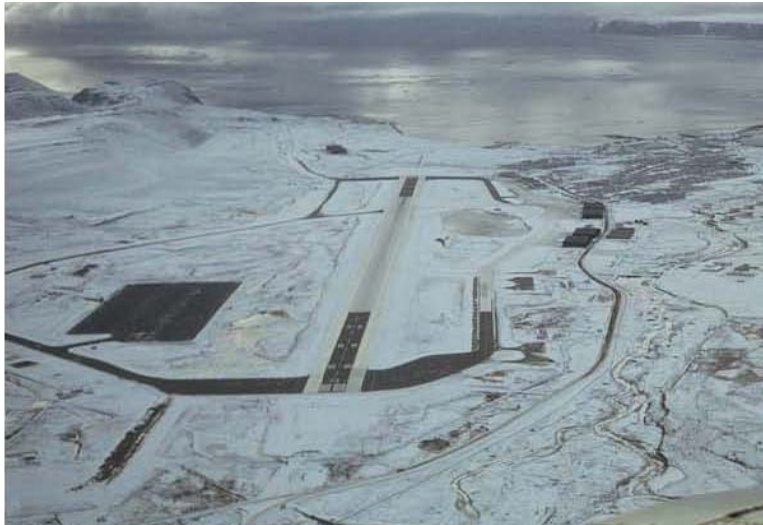
Figure 12. Airfield in September 1975 showing the extent of painting up to that time. The landing zones, 2000 ft from either end of the runway, are not painted nor is the 26 or 08 ends of Taxiway Alpha. This study found there was no information anecdotally, or in the literature, suggesting past thaw depression problems in these areas (Funder 1990).

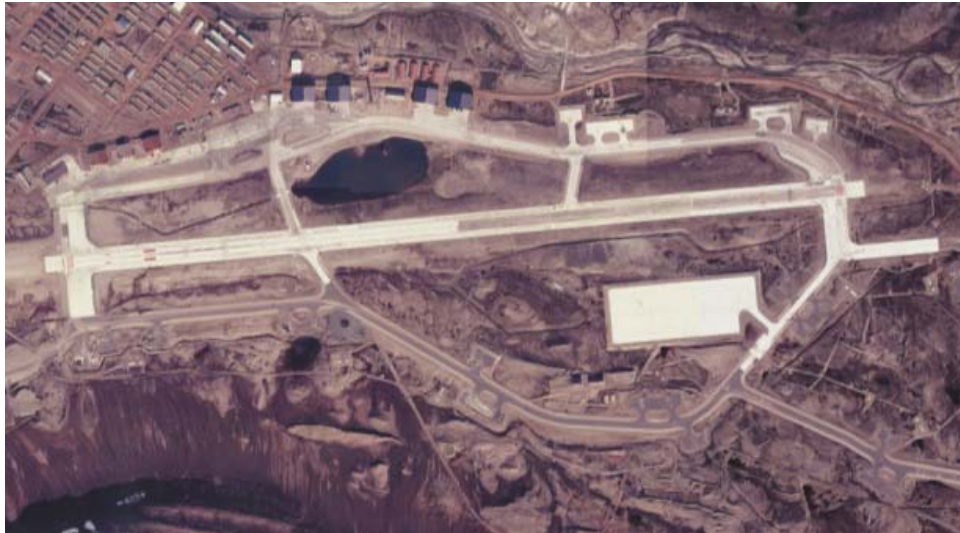
Figure 14. Undated photo of the airfield obtained from Thule personnel. The painting is in process during this photo. It is unknown if the dark pavement from approx. 50+00 to 100+00 is from wear or if milling or some other program is being conducted.

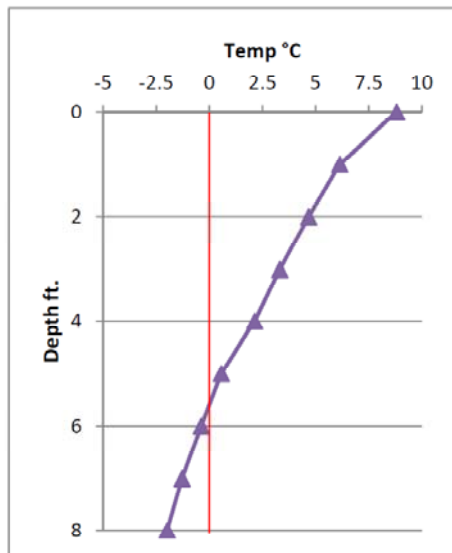
Figure 29. Subsurface temperatures measured at the “White Pavement” site. Measurement taken 11 August 2011 is the deepest thaw obtained for that summer. The albedo was 0.32 and the depth is almost 5.5 ft. This is consistent with the albedo vs. thaw depth presented in this report.

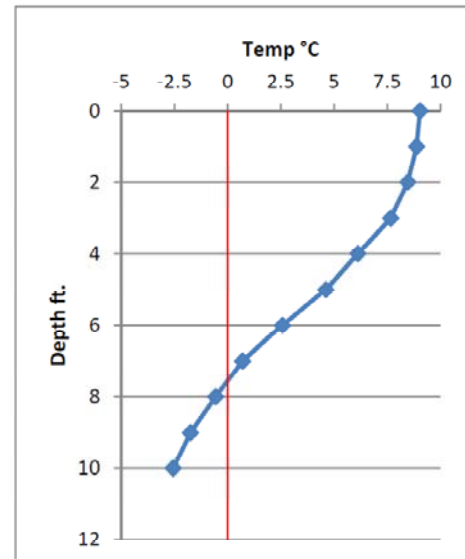
Figure 30. Subsurface temperatures measured at “Black Pavement” site. Measurement taken 11 August 2011 and is deepest thaw obtained for that summer, almost 7.5 ft, which is approximately 1 ft deeper than other measurements in natural colored pavement.

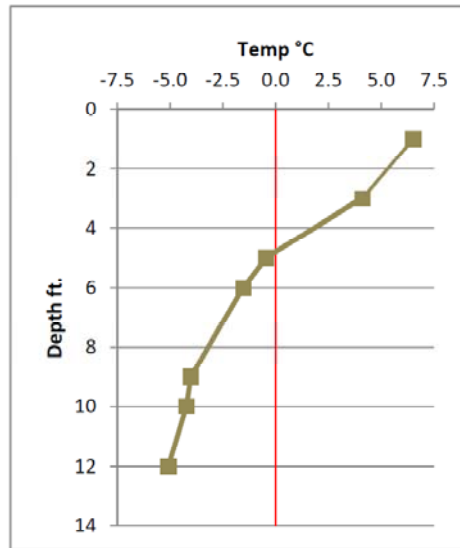
Figure 31. Subsurface temperatures at a permanent station in fill material near the Terminal Operations Building. Measurement was 1 August 2011 and is deepest the thaw obtained for that summer, almost 5 ft, which is consistent with borehole and test pit investigations, and the albedo vs. thaw depth measurements in fill material.

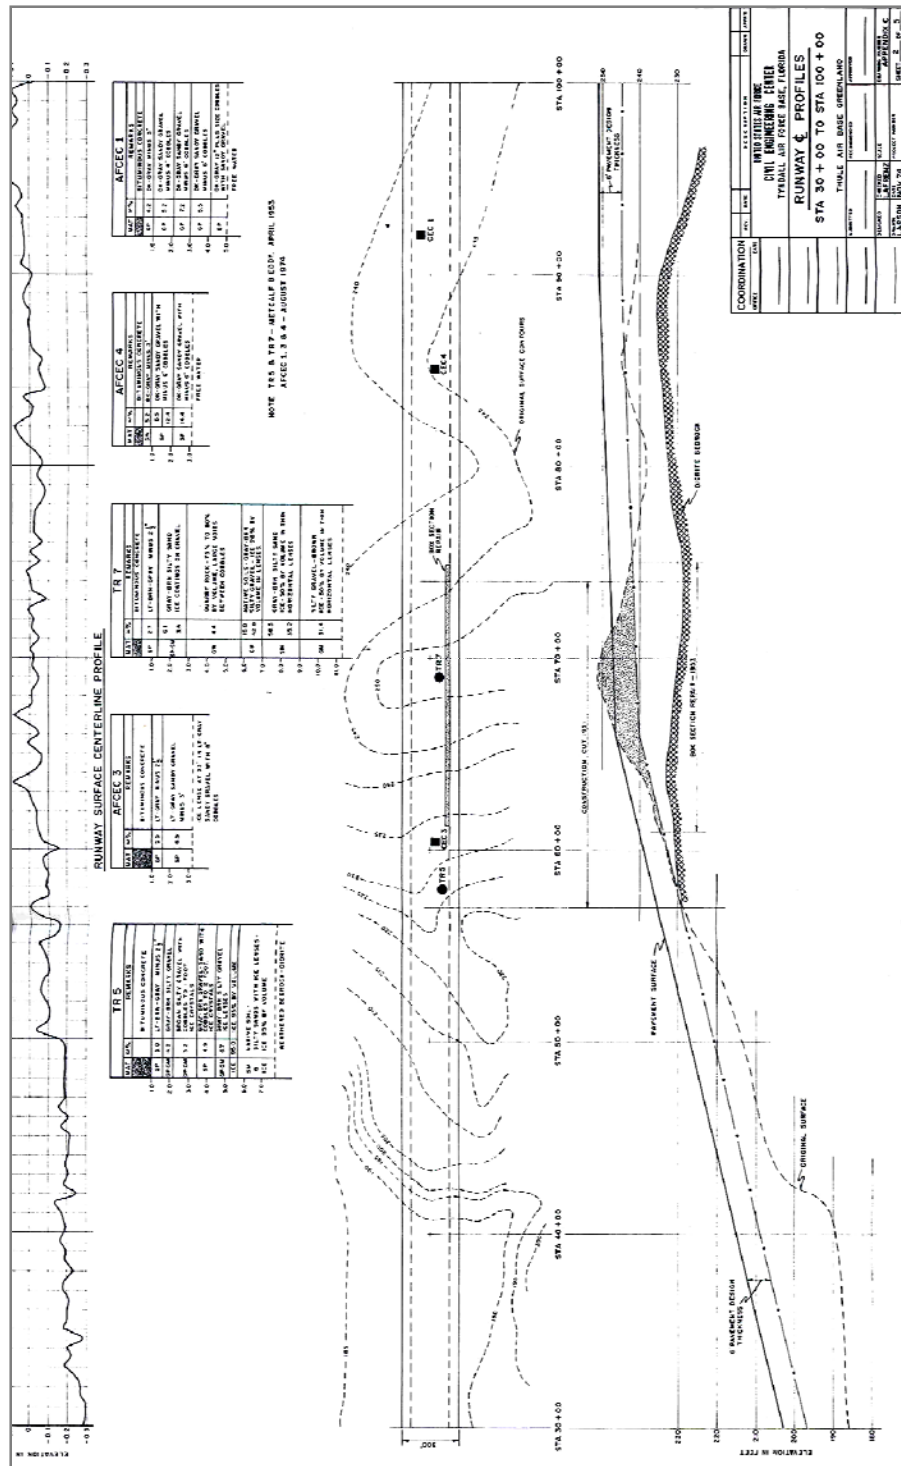
Figure 33. As-built plan provided in the AFCEC (1974) *Pavement Evaluation* report. The original surface before airfield construction is shown and is similar to the ACFEL (1955) report. These differ from the Metcalf & Eddy 1958 drainage report, which shows six cut sections.

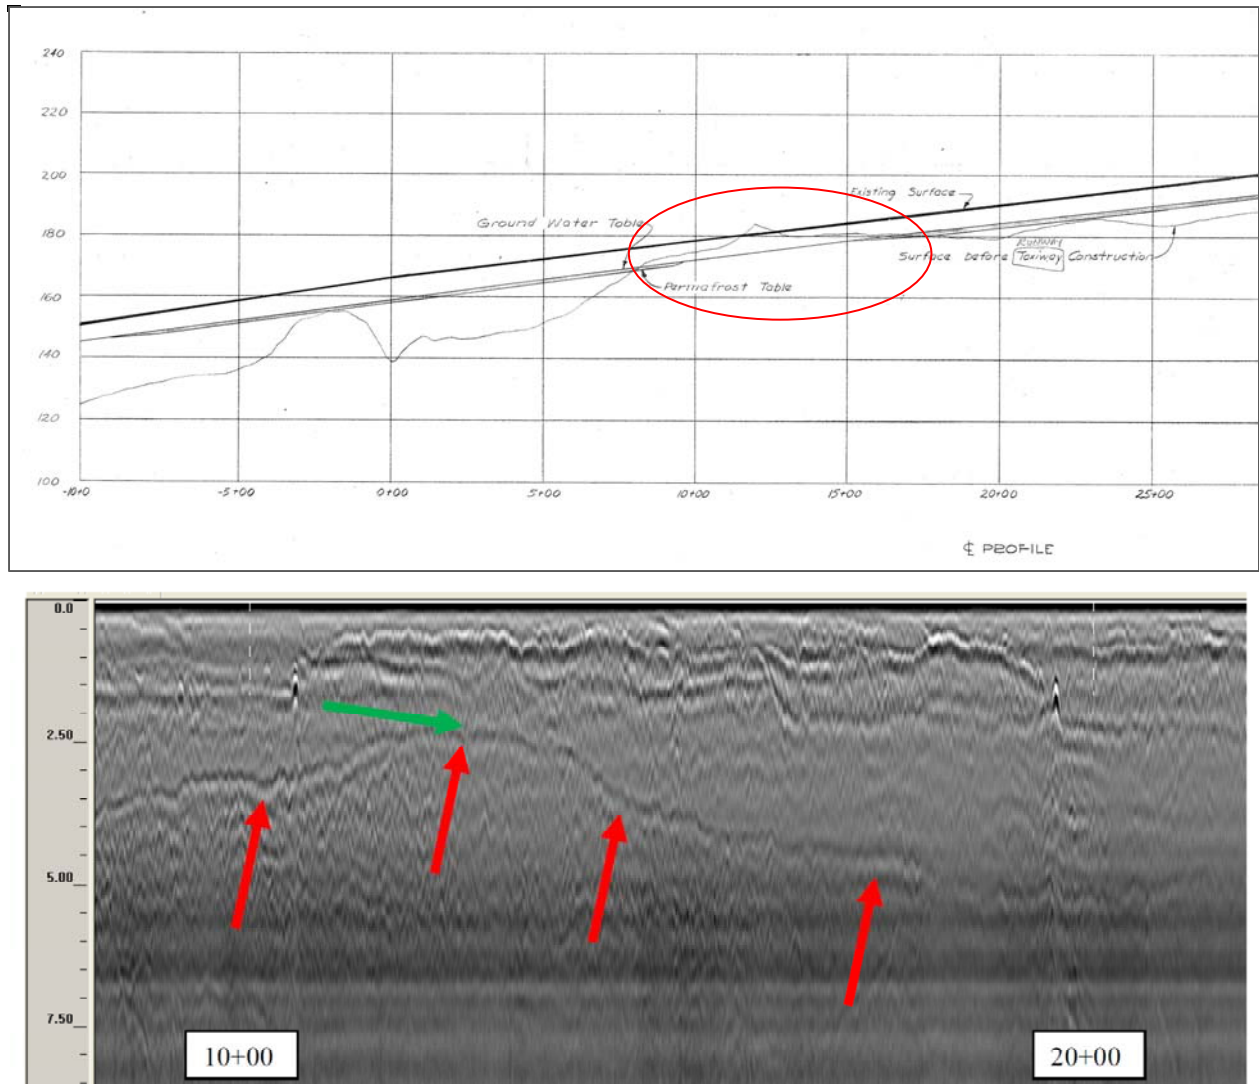
Figure 34. Top: a portion of the runway as-built provided by Metcalf & Eddy. A cut section is shown starting at 5+00 and ending at 17+00. The red oval indicates the location shown in the GPR image in the bottom figure, a portion of a radargram showing the subsurface between 8+00 and 22+00. Survey was taken on the right side of the runway between the centerline and the edge lighting. The rise in topography shown in top drawing is clearly seen at the red arrows. Green arrow indicates location where near surface ice-rich soil may exist at 8.2 ft depth.

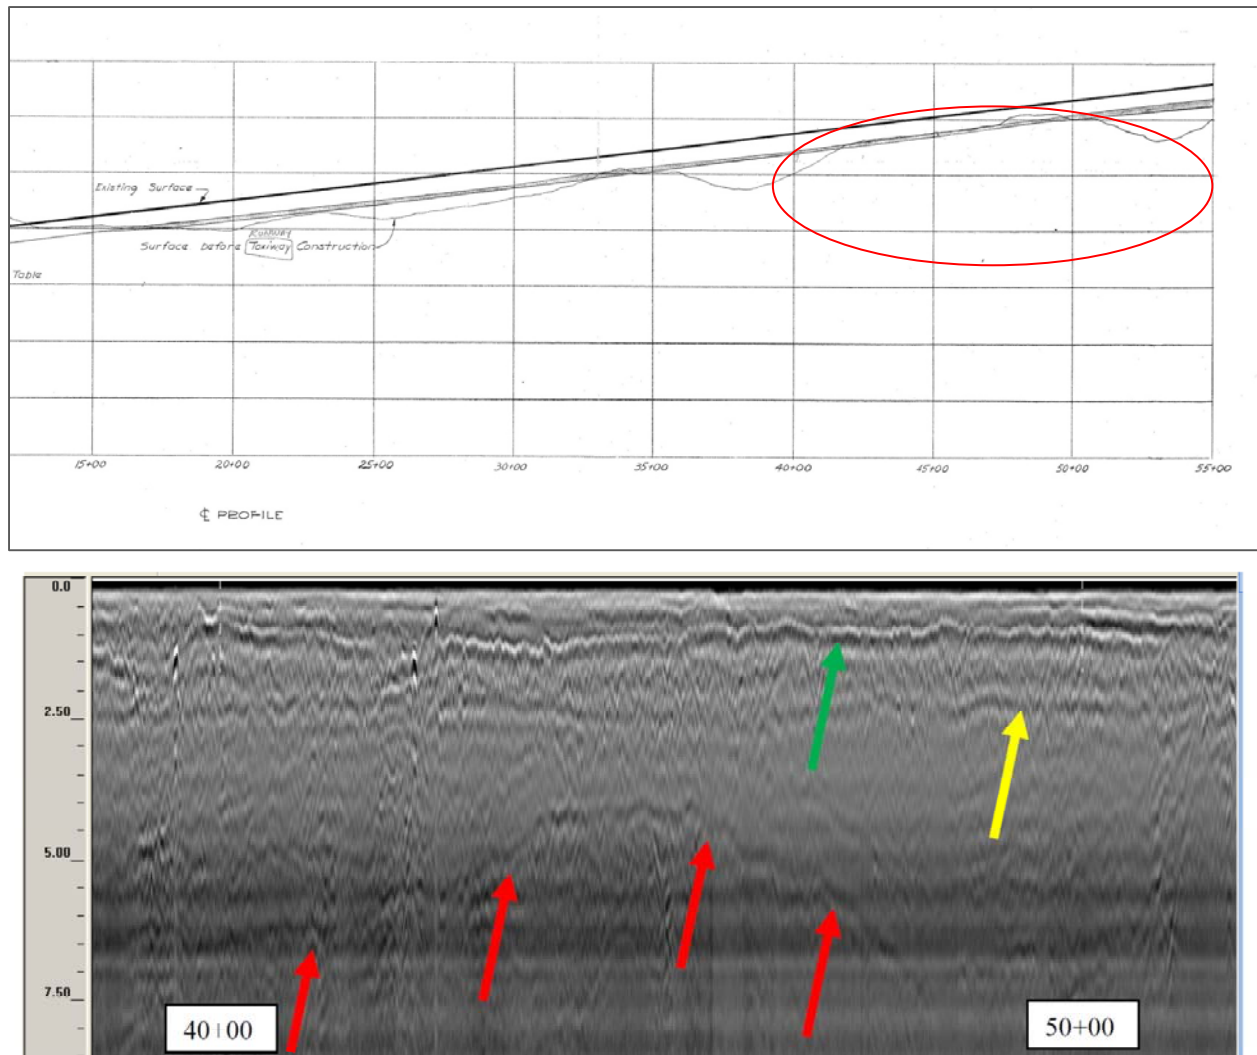
Figure 35. Top: portion of the runway as-built provided by Metcalf & Eddy. A cut section and near-cut section are shown starting at 42+00 and ending at 51+00. The red oval indicates the cut section shown in the bottom figure, a portion of a radargram showing the subsurface between 38+00 and 52+00. This survey was taken on the right side of the runway between the centerline and the edge lighting. The rise in topography shown in the top figure is marked by red arrows. The transitions to multiple lifts of coarser material for the asphalt base course (Fig. 7) are shown by the yellow arrow starting at approximately 8.0 ft. The green arrow indicates a visible strong reflector at the 3-ft depth and this most probably corresponds to the bottom extent of the 1992 repaving subgrade reworking.

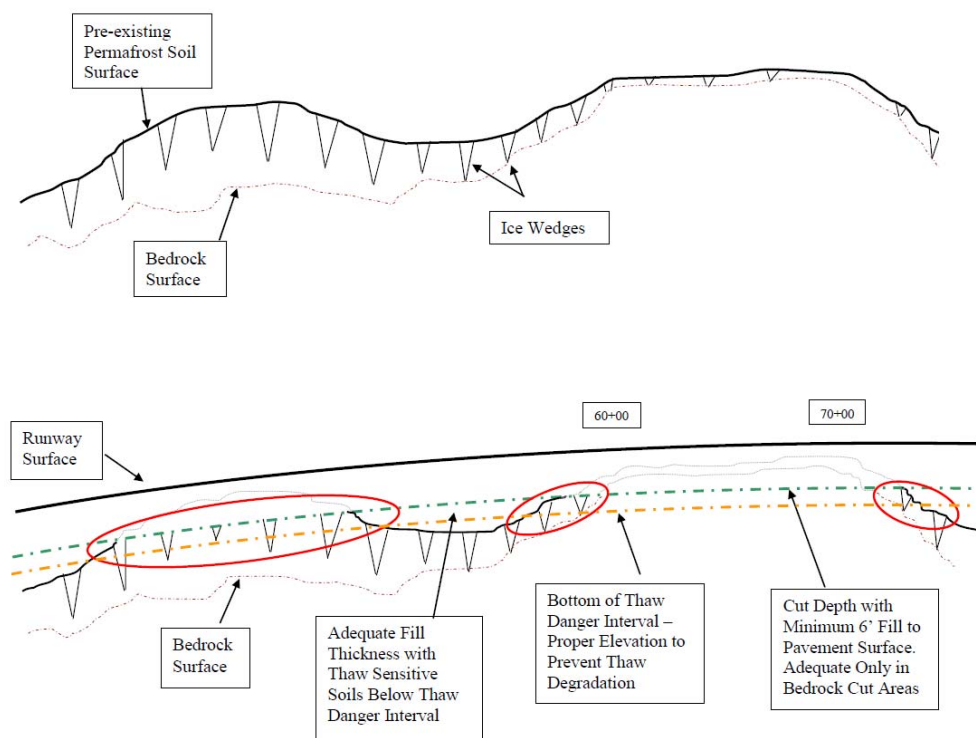
The model is completed with the addition of the accurate cut-and-fill thicknesses over the top of the ice rich native soils. The cut and fill locations indicate where the massive ice and ice-rich soils may be close to the surface and in danger of thaw. As the fill thickness decreases, the native ice-rich terrain surface becomes closer to the man-made surface, within the thaw critical interval. Figure 36 illustrates this general concept. Therefore, if the cut was not substantially deep enough to excavate the entire near surface wedge ice, thaw danger is possible at the margins and surface of the cut areas. However, it is possible that, in some of the cut areas, where shallow bedrock existed, the massive ice was completely removed.

Figure 36. Permafrost terrain conceptual model created for the airfield.

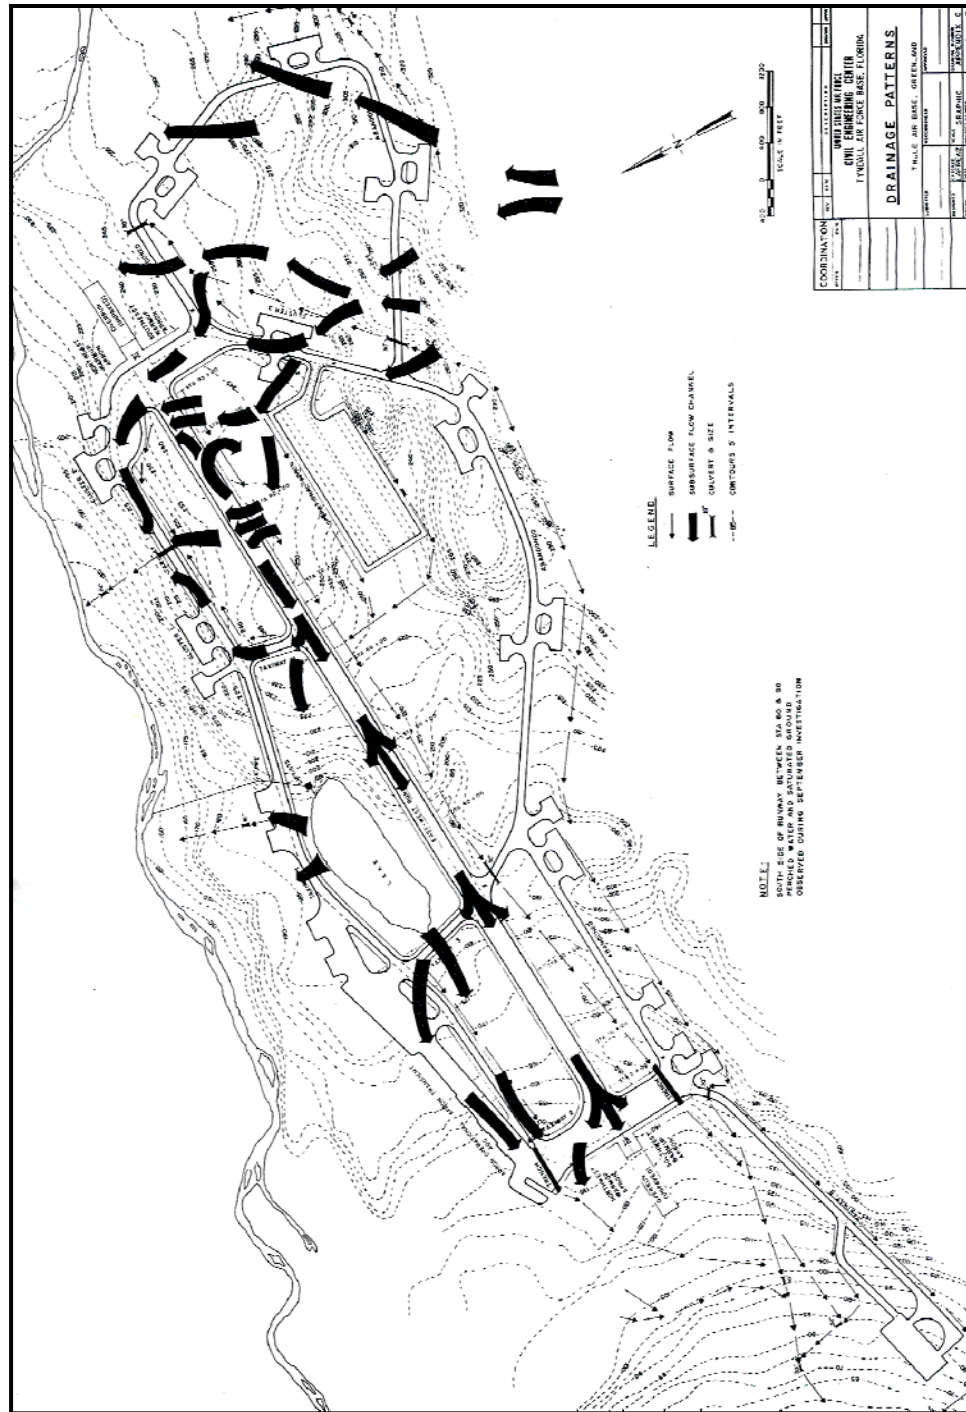
Previous dedicated drainage studies for the airfield (Metcalf & Eddy 1958; Berg 1976) have been conducted. These studies suggest that flow originates from the slopes of South Mountain, with contributions from the area in the direction of DET-1, and then enters the southeast area of the airfield, flowing across the South Loop Taxiway into the runway area. Both studies suggest that the runway and taxiway embankments act as preferential flow paths, and when flow encounters an embankment it migrates longitudinally under its centerline. The studies suggest that a majority of the flow eventually discharges out of the north side of the runway embankment at approximately 80+00 to flow through the culvert under Taxiway Alpha east of Taxiway Charlie (Fig. 39).

Figure 39. Surface water drainage paths and inferred subsurface drainage paths (AFCEC 1974).

Some flow continues to the west into Lake Eddy, under Taxiway Bravo and out under culverts to the west. In 1975, “bird baths” that had developed from 80+00 to 100+00 were suspected to be from groundwater weakened soils. Berg (1976) suggested white painting of this section of the runway; it

was done in 1977. Pavement overlay was done in 1977 and repaving in 1993 and this problem has not returned. The Metcalf & Eddy (1958) study suggests that a spring exists under station 85+00 of the runway with no explanation. A spring migrating through cold, continuous permafrost is very unlikely.

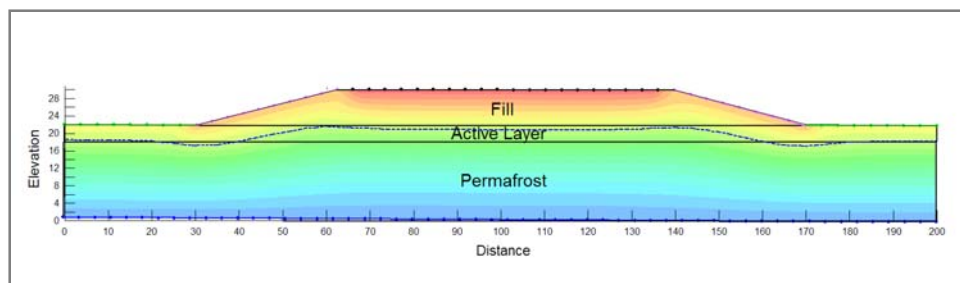
A finite element computer analysis was performed to see if subsurface water could possibly flow down the center of the airfield embankments. An idealized embankment was constructed with a 6-ft gravel fill section overlying a 4-ft active layer, these both in turn overlying an 18-ft thick permanently frozen till. Figure 40 shows that the swales at the transition from the embankment to the native soil grade would be the lowest elevation along the cross section. The top of the permafrost in the embankment will be at a higher elevation than the top of the permafrost in the native material adjacent to it, creating a damming effect that resists groundwater movement from one side of the embankment to the other. Therefore, a more realistic scenario than that suggested by the previous drainage reports is that lateral flow of groundwater under the runways and taxiways is altered or blocked, diverting the groundwater in complicated ways.

Figure 40. Numerical analysis of thaw depth in a 6-ft fill embankment constructed on natural grade. The colors represent end-of-analysis temperatures, with blue the coldest, and red the warmest. The depth of thaw after one season is represented by the blue dotted line. The raised permafrost table into the fill produces swales at the embankment toe and a damming effect that would prevent lateral flow of groundwater from shoulder to shoulder.

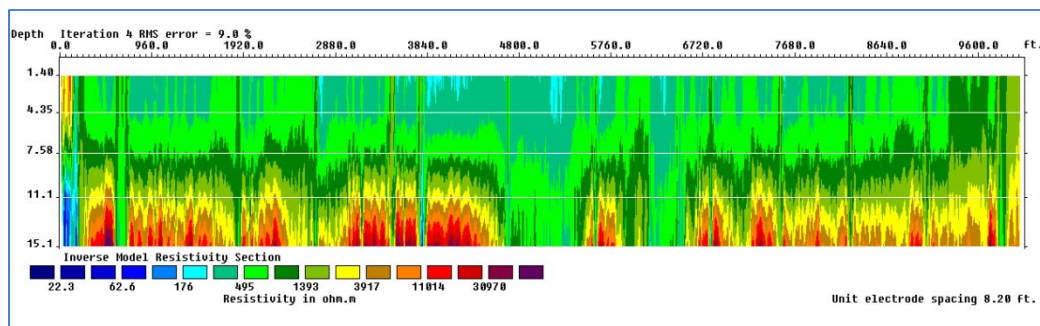
When the validated topographic information for the terrain model was compared to the electrical earth resistivity surveys (CCER), it can be seen that two highly conductive regions exist approximately in the middle of the runway embankment (Fig. 42) at approximately 52+00 and 62+00. These locations correspond to the topographic lows at 52+00 and 62+00. The location at 52+00 is a drainage course that existed prior to construction and would have originated on the south side of the runway at approximately the south shoulder area, extending to the northwest becoming the primary, and possibly only, surface water tributary into Lake Eddy. Sub-

Figure 42. Runway resistivity cross-section from 00+00 to 100+00. The locations of the pre-construction surface drainage feature at ~52+00, and the location of the existing depressions at 62+00 are visible in blue with the lower resistivity (high conductivity). The undulating frozen ground boundary is also clearly defined by the yellow and red shading. (Depth scale is exaggerated in this figure.)

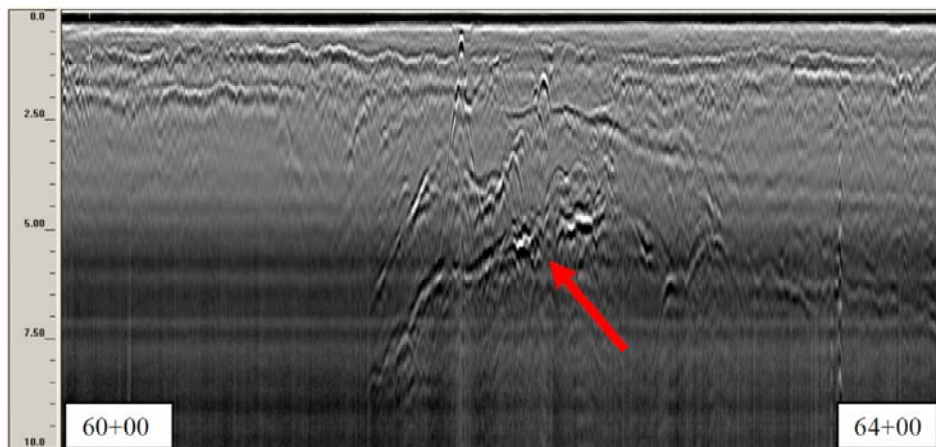
surface flow might now exist at this location under the runway to Lake Ed- dy. However, owing to the extreme climate at Thule, it is rather improb- able this flow is any deeper than the bottom of the seasonal frost. Also, sub- surface flow would pipe material from the embankment, most probably causing larger scale settlement at the surface, and this is not seen. The lo- cation at 63+00 corresponds to a relative low region within the very large cut made from 56+00 to 74+00. The GPR profiles image very sharply dip- ping reflectors in this area, and this also corresponds to the location of the depression at 62+00 to 63+00. (Fig. 43) The bottom of the highly conduc- tive region at 63+00 is 16 ft deep, and this corresponds with the depth of the reflectors in the GPR image at 16 ft.

Figure 43. GPR image showing from 60+00 to 64+00. Isolated reflectors are shown at ~63+00 at a depth of ~16 ft. The bright black-white-black reflectors (red arrow) are typical of the sedimentary bedrock reflections.
