## **Investigation of the Corrosion Mechanism and Determination of the EMS Estimated Service Life at Site 81**

February 2013

Final report

Prepared for U.S. Army Corps of Engineers  
Europe District  
CMR 410, Box 1, APO, AE 09049

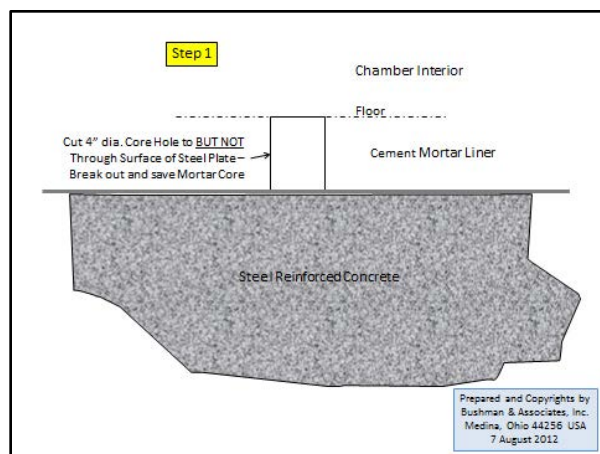
Figure 1. Step 1 of the in-situ LPR corrosion rate measurements.

**Step 1:** Drill 4 in. core through concrete liner to steel plate EMS using diamond core drill (Figure 1).

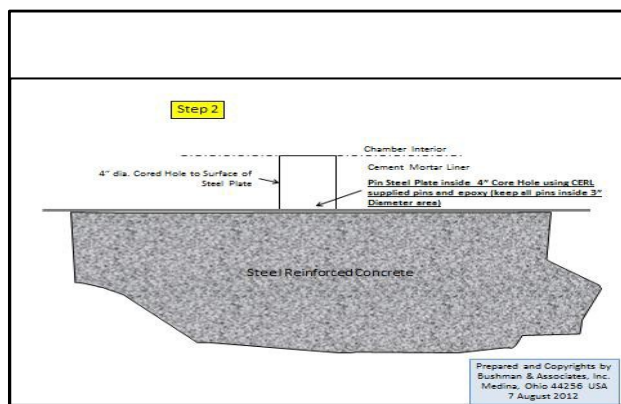
Figure 2. Step 2 of the in-situ LPR corrosion rate measurements.

**Step 2:** Pin EMS steel plate to underlying reinforced concrete with steel bolts inserted through EMS into epoxy-filled holes (Figure 2).

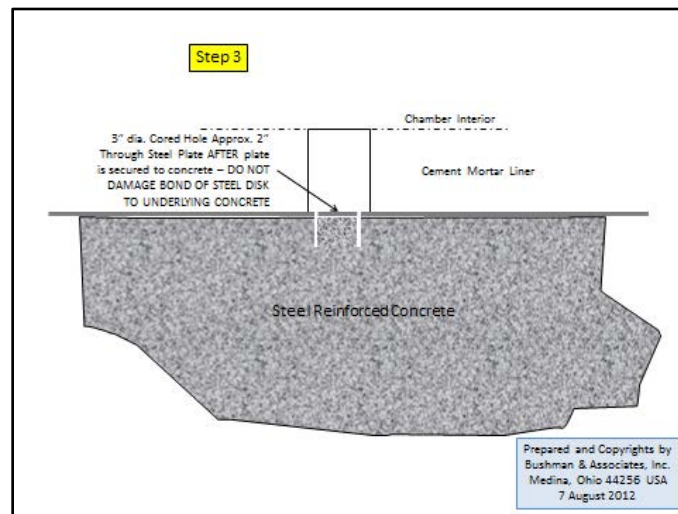
Figure 3. Step 3 of the in-situ LPR corrosion rate measurements.

**Step 3:** After bolt epoxy has cured, use 3 in. diameter diamond-tipped core drill to drill down through steel plate and at least 2 ½ in. into underlying concrete (Figure 3). Be sure drill is centered on the bolts securing the plate to concrete.

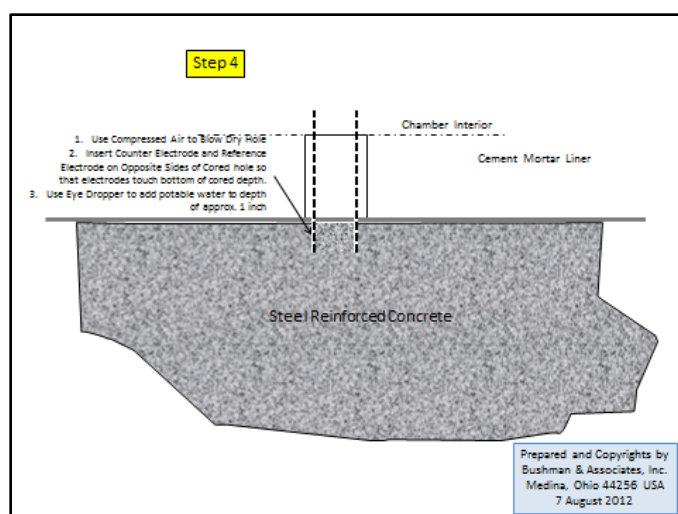
Figure 4. Step 4 of the in-situ LPR corrosion rate measurements.

**Step 4:** Insert precious metal oxide coated counter and reference electrodes into opposite sides of annulus created by 3 in. diameter core hole so that bottom of electrode touches the bottom of cored hole (Figure 4).

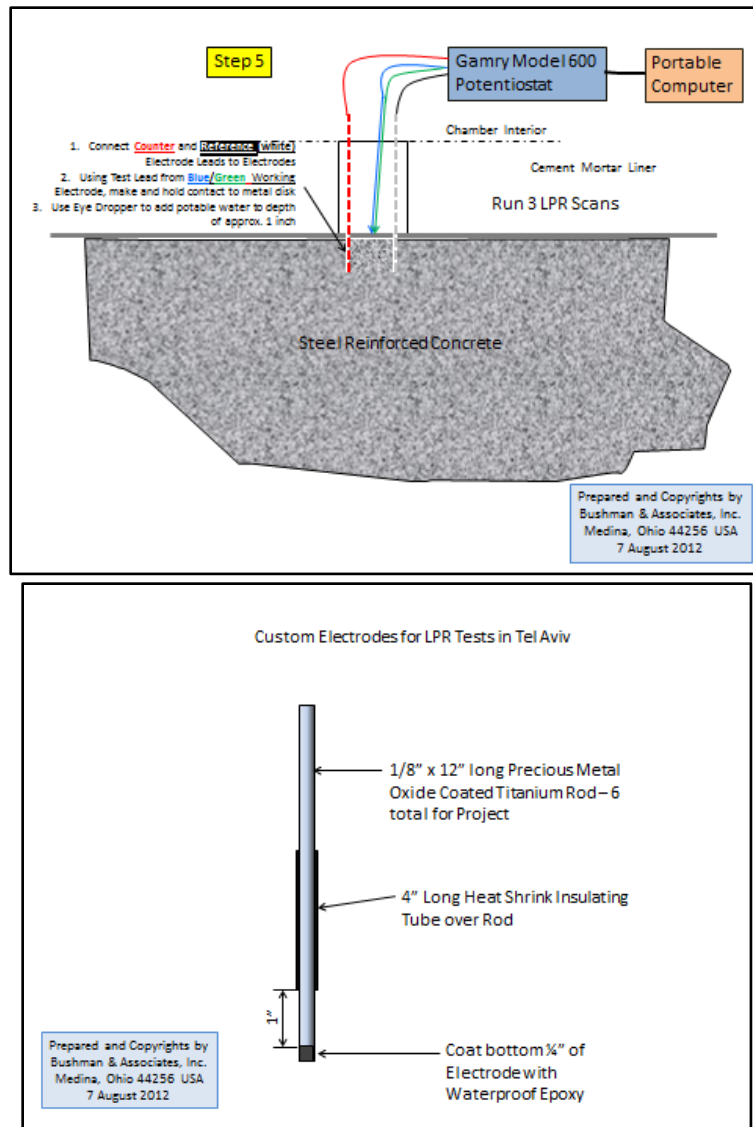
Figure 5. Step 5 of the in-situ LPR corrosion rate measurements.

**Step 5:** Connect Gamry test leads to counter (white lead) and reference electrodes (red lead) and blue/green leads to pointed tool pressed in contact with center disk (working electrode of 3 in. diameter steel EMS disk) (Figure 5). Be sure counter and reference electrode insulated section isolates electrodes from EMS plate.

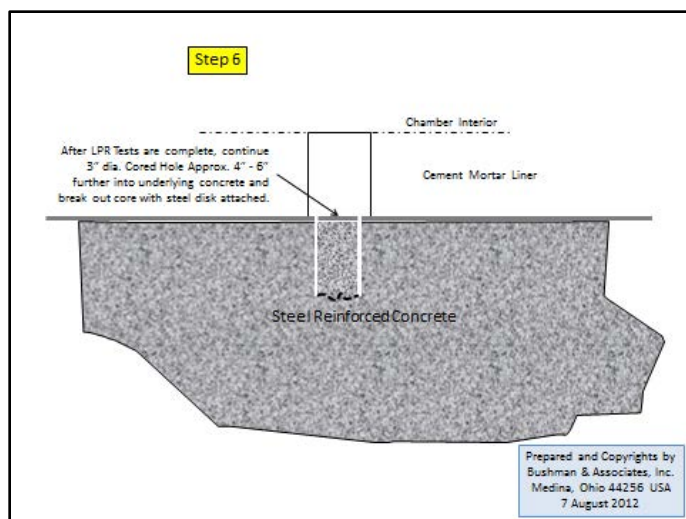
Figure 6. Step 6 of the in-situ LPR corrosion rate measurements.

**Step 6:** After LPR tests are complete (minimum 3 scans per cored hole), continue 3 in. core hole down to minimum 4–6 in. depth below EMS steel plate. Remove the breakout core from hole for future laboratory analysis by ERDC-CERL. After core is removed, detach EMS steel plate from core and exam surface in contact with underlying concrete (including photo

documentation) to define percentage of surface that is suffering corrosion attack (Figure 6).

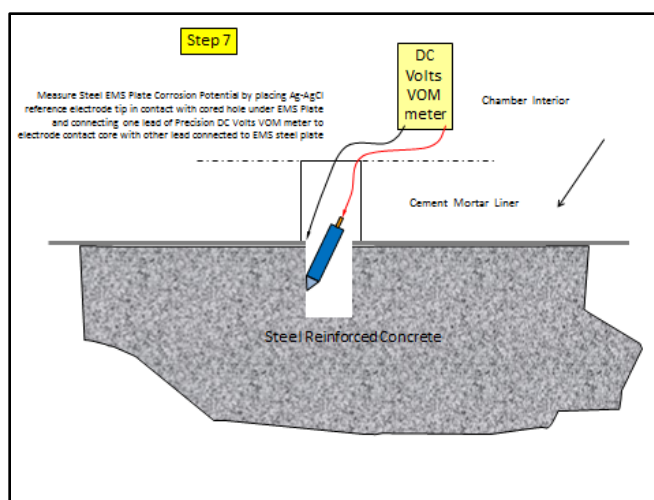
Figure 7. Step 7 of the in-situ LPR corrosion rate measurements.

**Step 7:** Measure steel EMS surface in contact with underlying concrete electrical corrosion potential using 3.5 molar potassium chloride/silver/silver chloride reference electrode and Fluke Model 289 5½ digit precision VOM meter (Figure 7).

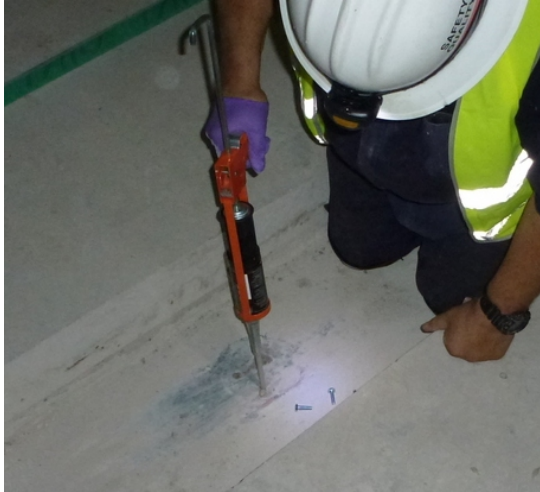
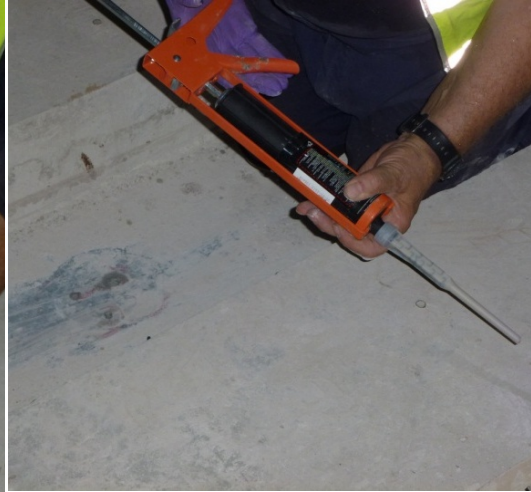
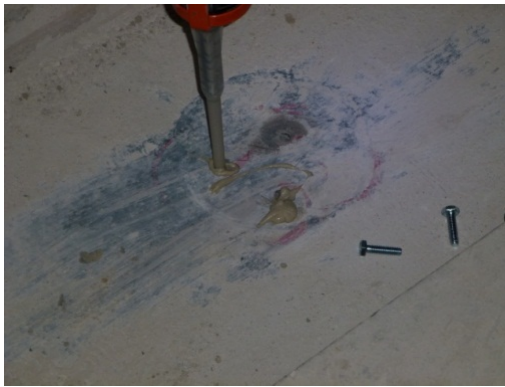
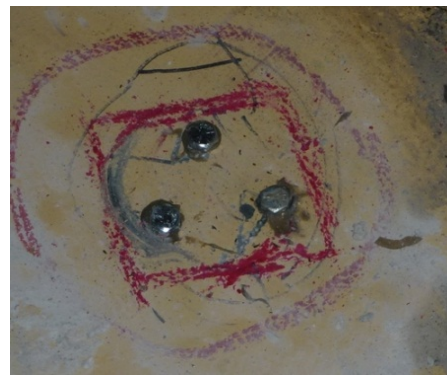
It was then decided that trial LPR scans and concrete moisture tests should be performed at the first two locations to confirm the methodology to be used and to identify any problems. To perform the subsequent LPR testing, it was essential that the steel plate be held firmly in place while cutting through the plate with a core drill. To accomplish this, it was necessary to drill three 5/16 in. (0.8 cm) diameter holes approximately 1.5 in. (3.9 cm) deep through the steel plate on an equilateral triangle spacing to prevent the cut plate from rotating independent of the concrete cylinder as the diamond core bit rotated (see Step 2 of test procedure, Chapter 2). This proved to be extremely difficult as the EMS steel was an extremely hard material. Using drill bits with a titanium coating later improved the time to drill the three holes on each plate. After the three holes were drilled through the electromagnetic field (EMF) plate into the underlying concrete, the holes were first vacuum cleaned, followed by high-pressure air blowing to remove all dust and moisture (although moisture would immediately begin seeping back into these holes at some locations). Immediately following cleaning of each hole, a special caulking gun was placed into each hole; the gun contained two tubes of epoxy components (A & B) with a spiral mixing tip. Sufficient epoxy was injected to barely overflow each hole, immediately after which the steel bolts were firmly inserted flush to the plate in each hole (Figure 11–Figure 14). In most cases, the bolts had to

be depressed several times to displace enough epoxy so that the bolt head was tight to the steel plate.

Figure 11. Epoxy injection overview.

Figure 12. Two-part epoxy-mixing caulking gun.

Figure 13. Close-up photo of epoxy injection.

Figure 14. Close-up photo of holes after final placement of bolts.
