**TECHNICAL REPORT**  
**TR-NAVFAC-EXWC-PW-1303**  
**SEPTEMBER 2013**

**BUILDING INTEGRATED PHOTOVOLTAIC (PV)  
ROOFS FOR SUSTAINABILITY AND ENERGY  
EFFICIENCY**

**ESTCP Number: EW-200813**

**September 2013**

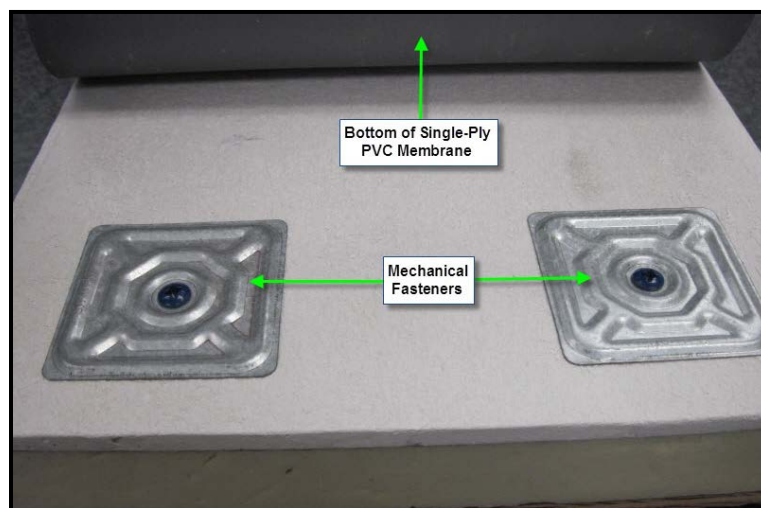
Figure-3 shows the mechanical fasteners that are used to attach the gypsum board and insulation to the roof deck. These fasteners are similar, if not the same, as the ones used in a regular PVC roof. The next layer up is the single-ply PVC membrane and is also visible in that photograph.

Figure-3: The mechanical fasteners under the single-ply PVC membrane

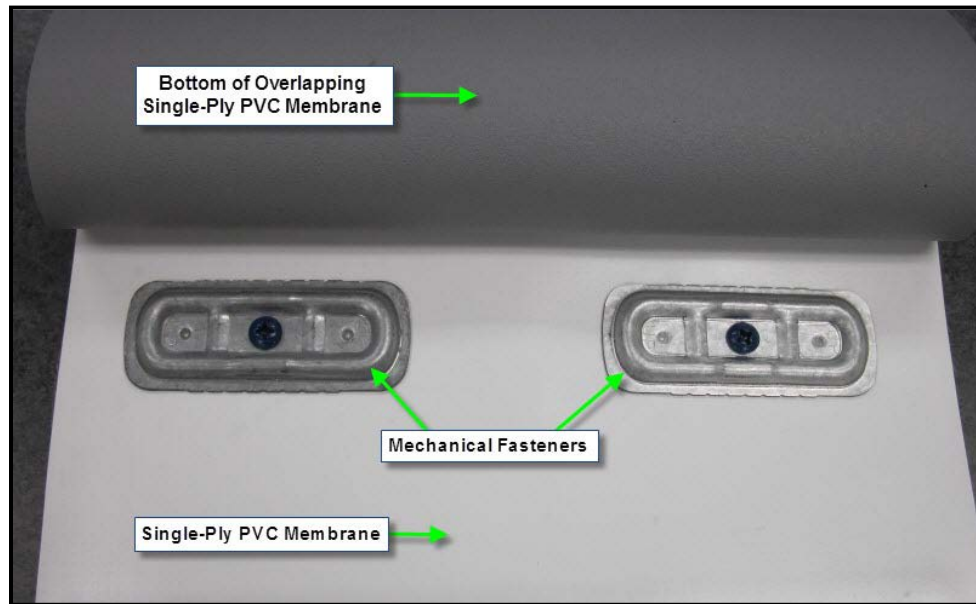
Figure-4 shows the top of the single-ply PVC membrane seen in Figure-3. The mechanical fasteners shown there are used to attach the PVC membrane to the roof components below it. These fasteners are only used along the edges of the PVC membrane sheet. To form a watertight roof, the sheets of PVC membranes are made to overlap so that the top PVC membrane seals off the fasteners below it. The bottom of the overlapping PVC membrane sheet can also be seen in Figure 4.

**Figure-4: The mechanical fasteners holding down the single-ply PVC membrane.**

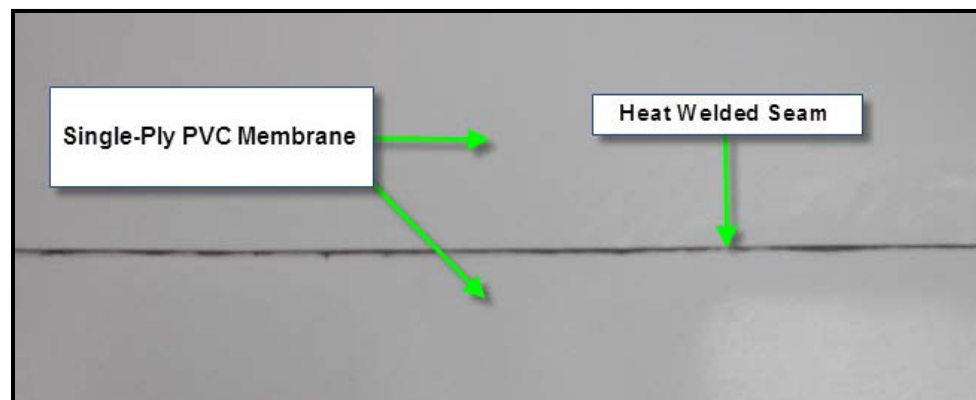
Figure-5 shows the two PVC membrane sheets overlapping and the resulting seam from the heat welding used to form the bond between them. The PVC carrier sheet from the BIPV panel is attached to the PVC membrane using the same held weld process. This completes how the BIPV roof was assembled.

**Figure-5: The overlapping area of single-ply PVC membrane under the BIPV panel.**

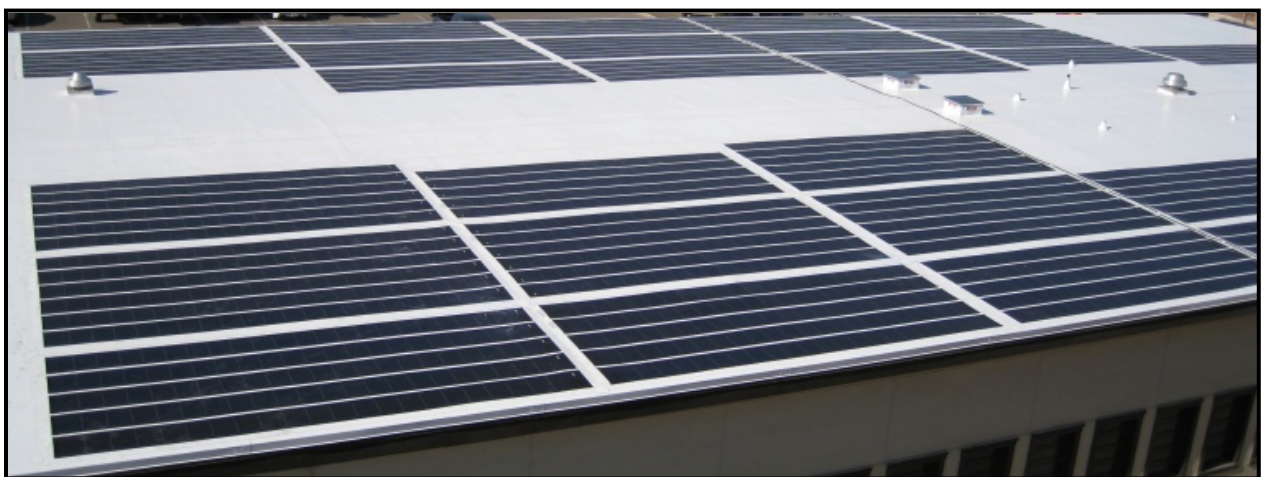
There is no indication that the thermal properties of this roof will be different from that of a new roof, so the BIPV roof system was installed on top of the existing roof. The existing antennae cable was laid across the roof once the BIPV roof was installed and held down by PVC strips so that the cable will not interfere with any of the solar panels or wear out the PVC membrane. The PV laminates cover about 36% of the roof (Figure-14).

**Figure-14: Rooftop photo of Building 228 at Site III (MCAS Yuma) after BIPV installation.**

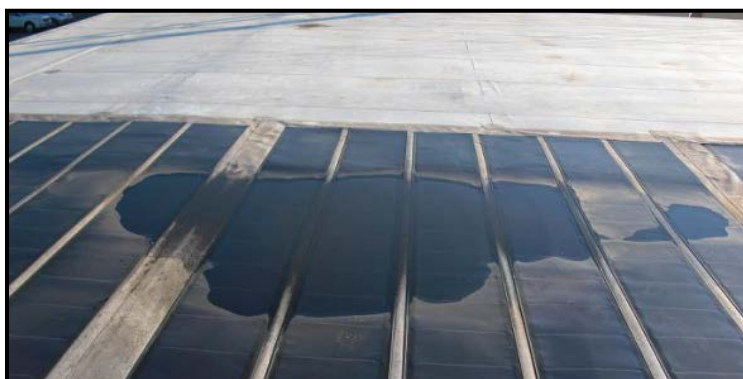
ROOFER EMS survey records for Site II (NAS Patuxent River) are shown Appendix H and the resulting condition indices are shown Table-5. The condition indices were significantly impacted by mold growth on the PVC and a warping dens-deck shown in Figure-28 and water ponding shown in Figure-29. Since mold growth was not present at either Site I (Luke AFB) or Site III (MCAS Yuma), it was once again determined to be worthwhile for the ROOFER survey team to measure the roof reflectance while they were on site (Table-6; Appendix I). Due to a lack of clear skies, a condition necessary for proper roof albedo measurement, only one measurement was acquired for Site II (NAS Patuxent River). In addition, it was impossible to properly measure the albedo of the PV modules due to water ponding. Water ponds also reduce the amount of sunlight the PV modules receive, thus, reduces the PV energy output.

**Figure-29: Significant ponding at Site II (NAS Patuxent River).**

water and the pool of water that is shown in Figure-29. There was a lack of snow events, so snow impacts could not be quantitatively determined, but it is expected that snow retention on the roof will significantly reduce the PV power output more than the water retention.

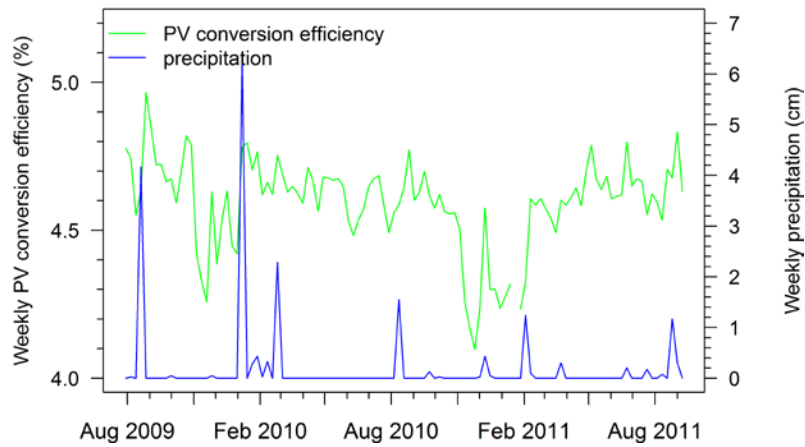
Figure-40: Weekly PV conversion efficiency and precipitation over time at Site III (MCAS Yuma).

Weekly PV conversion efficiency was analyzed to see how it changed over time as it related to precipitation events. Figure-40 shows that each time a major rain event occurred, the conversion efficiency increased temporarily. The improvements were not constant and were likely due to the magnitude of the soiling problem prior to the rainfall.

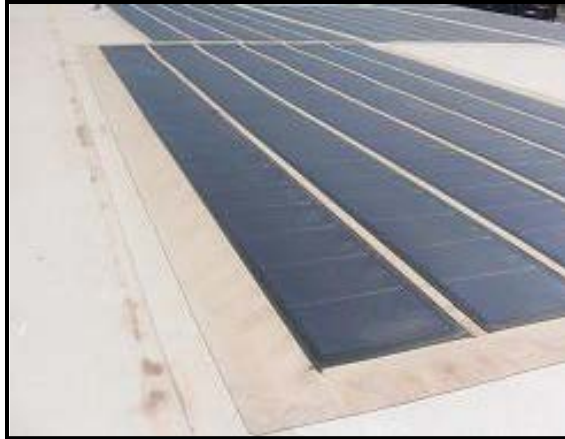
ROOFER results are shown in Table-7 (Appendix J). PV and PVC reflectance results are shown in Tables-8 and -9, respectively (Appendix K). The “with patch” indices are a result of the samples taken from the roof for the laboratory testing discussed later. ROOFER indices without the patch, as if the samples were not taken, were also generated for comparison. October 2011 reflectance values were not attained due to the removal of the ladder needed to safely transport the instrument onto the roof. Since soiling is the largest contributor to reflectivity, visible conditions indicated that the reflectance of the roof had improved in October 2011 when compared to December 2010. This determination is further supported by the PV conversion efficiency analysis, that will be presented in the next section, which shows atypically low efficiency values in Winter 2010. Despite the soiling, the Site III (MCAS Yuma) BIPV roof appeared to have aged the best when compared to the other two sites (Figure-42).

**Figure-42: Photo of Site III (MCAS Yuma) in October 2011, 16 months after installation.**

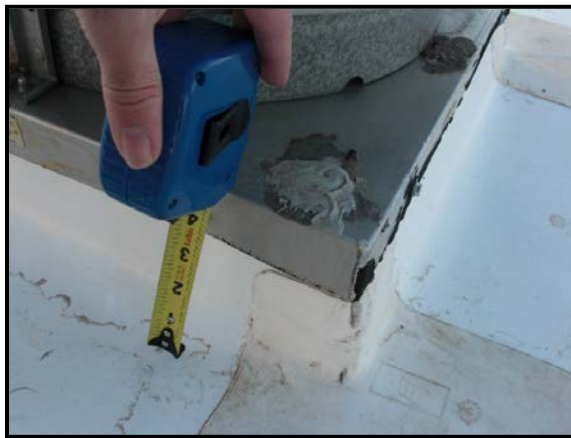
Figures-43 and -44 show the problem with the flashing not exceeding the six-inch height requirement, which reduced the overall FCI. The flashing height requirement is to prevent water penetrating the roof through rooftop equipment, such as exhaust vents.

**Figure-43: Photo of Site III (MCAS Yuma) exhaust vent with insufficient flashing height.**

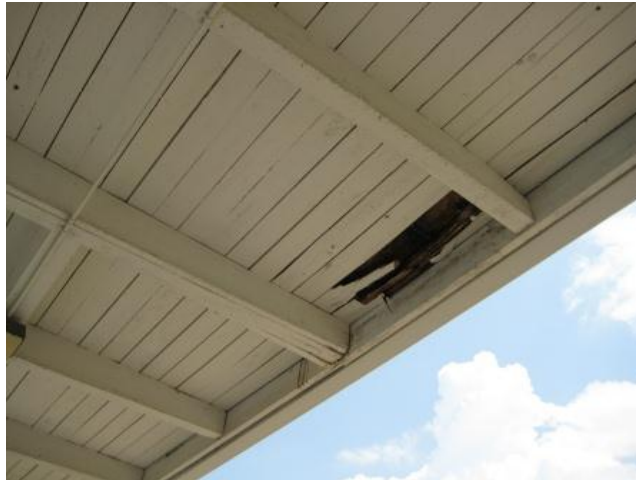
**Figure 3 Building 515 Rotten Section**

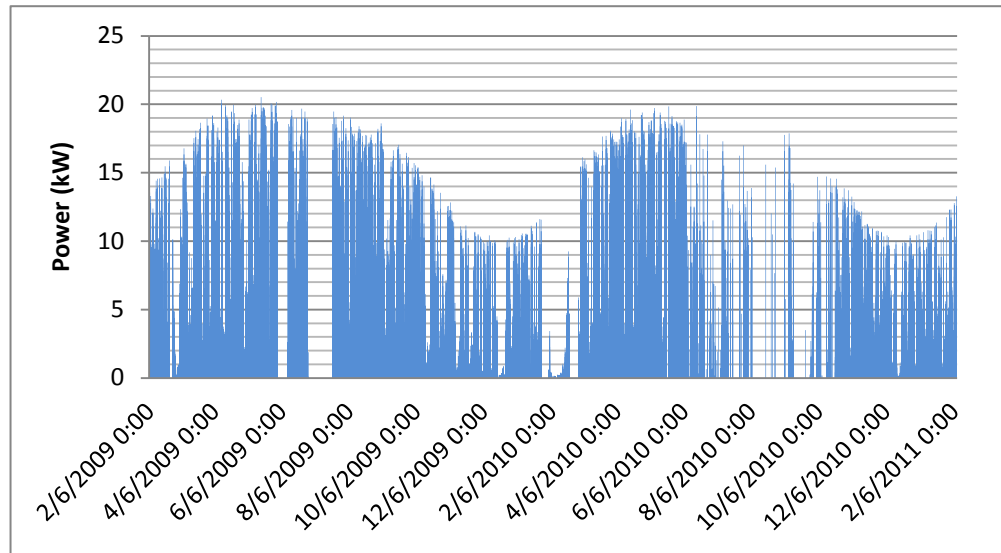
Over the course of the two (2) years of monitoring, the BIPV system produced a peak energy of 20.5 kilowatts, with an average of 6.6 kilowatts (See Figure 6). A total of 61,000 kilowatt-hours of energy was produced throughout the monitoring period. The BIPV is able to support an off-grid load of up to 20 kilowatts, but is best suited for a load of 5.31 kilowatts in that application.

The estimated system performance was 42,787 kWh and the actual system produced 30,500 kWh annually. Annually, the system underperformed design expectations by 28.72%. BIPV system was designed at 34.848 kWp DC. An actual 24.740kWp AC was recorded on July 19, 2010 at 3:00PM. At peak, the BIPV underperformed expectations by 29%. Based on these findings, the de-rating factor is actually 0.63 instead of 0.77. The de-rating factor is the combination de-rating factors that affect each component of the system. More study would be needed to determine which of these de-rating factors actually varied from design conditions.

**Figure 6 Energy throughout Monitoring**

There was no noticeable change in the performance between year one and year two. Periodic cleaning of the PV and additional monitoring could help determine actual preventive maintenance practices.
