**U.S. ARMY CERL LIBRARY  
REPAIR, EVALUATION, MAINTENANCE, AND  
REHABILITATION RESEARCH PROGRAM**

TECHNICAL REPORT REMR-CS-16

# **REPAIR OF DAM INTAKE STRUCTURES AND CONDUITS. CASE HISTORIES**

**January 1988**

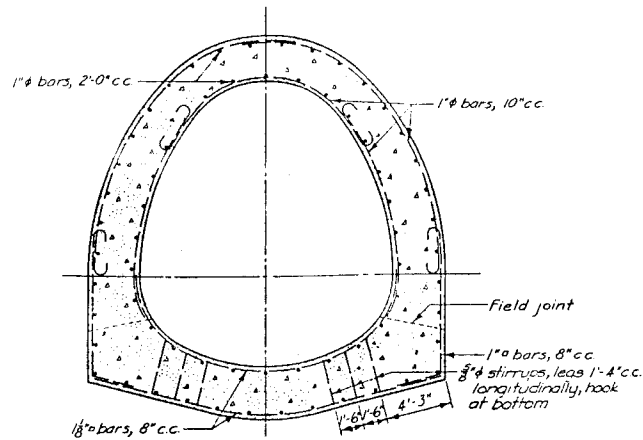
10. It appears that the omission of water stops in the invert is the major contributing factor in the leakage and associated deficiencies observed at the monolith joints of the conduit. During the early operations of the outlet works, leakage was observed at the upstream joints between monoliths 1 and 7. Leakage continued after remedial grouting in 1950 and was accompanied by loss of foundation material and differential movement. Movements of 0.04 ft or greater were reported in 1969 for monolith joints 3/4, 6/7, 9/10, and 10/11. Also reported were spalling and missing filler at various joint locations. Remedial grouting of all conduit joints was performed in 1970. In 1974, a sinkhole developed in the embankment above the downstream end of the conduit near the west edge of the toe road. This sinkhole was cleaned out and backfilled with sandy clay after an investigation concluded that the sinkhole had developed from earlier foundation material losses through openings which were grouted in 1970. Leakage continued and remedial grouting was performed in 1977. In total, leakage has occurred to varying degrees at all monoliths

Figure 1. Typical conduit section, Arkabutla Dam

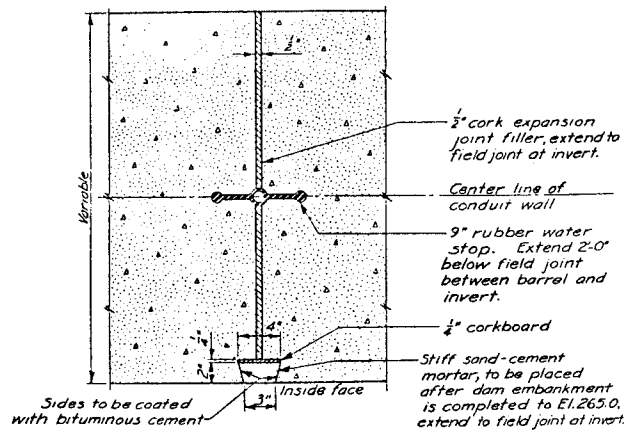
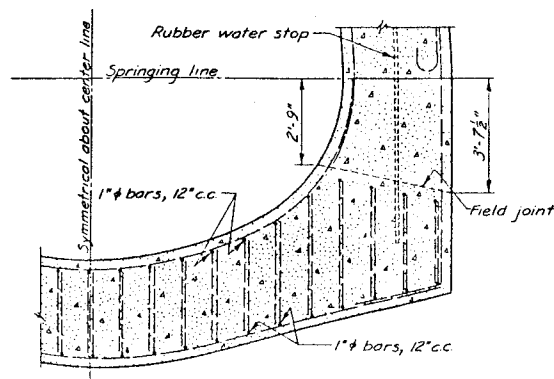
9. Arkabutla Dam was completed in 1943 and is located in northwestern Mississippi on the Coldwater River approximately 12 miles northwest of Coldwater, Mississippi, in the Vicksburg District. The main dam is a rolled earthfill embankment approximately 10,700 ft long with a maximum height of 67 ft above the valley floor. The outlet works is located near the south abutment of the main dam. It consists of reinforced concrete structures that include an approach channel, three-gate control structure, transition, single-barrel conduit, chute, and stilling basin. The conduit is made up of thirteen 25 ft monoliths each having a modified inverted egg-shaped cross section (Figure 1) that is 18.25 ft high and 16 ft wide with a ring thickness of 3 ft at the crown and 3.5 ft at the spring line and invert. The monolith joints of the conduit have 9-in. rubber water stops in the crown and side walls that extend below field joint, but not into the invert (Figure 2).

Figure 2. Waterstop location in joint, Arkabutla Dam

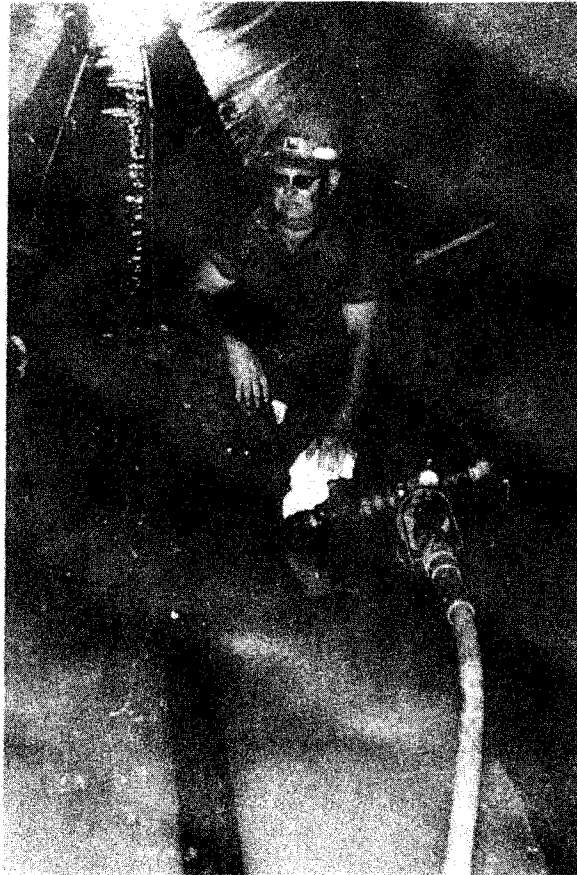
Figure 6. Control valve, Arkabutla Dam, 1977

22. A hydraulically operated dual mixing bin grout machine with a 20-cu-ft sump tank capacity was located on the embankment surface about 20 ft from the right stilling basin wall. Approximately 300 ft of 1-1/2-in. inside diameter hose extended from the grout machine to a set of control valves (Figure 6). An additional 300 ft of the hose was used to complete the loop back to the machine for recirculation of the grout during periods when the grouting operation had to be interrupted. At the control valves, a 50-ft-long, 1-1/2-in. inside diameter line was used to connect to injection ports. Grout pressure was indicated by a gauge at the set of control valves (Figure 6) and a second gauge at the injection port (Figure 7). Lead wool was used to chink grout leaks in the conduit (Figure 8).

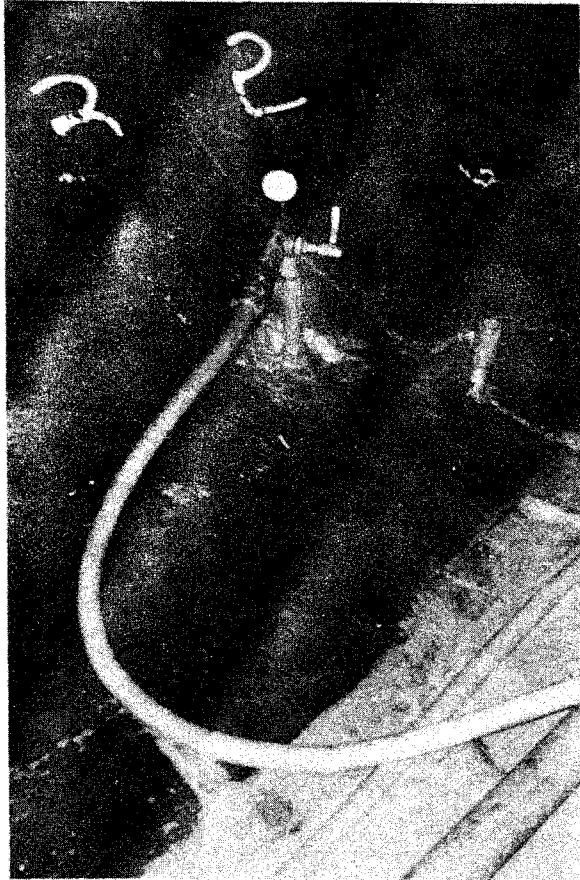
Figure 7. Pressure gauge and cutoff valve, Arkabutla Dam, 1977

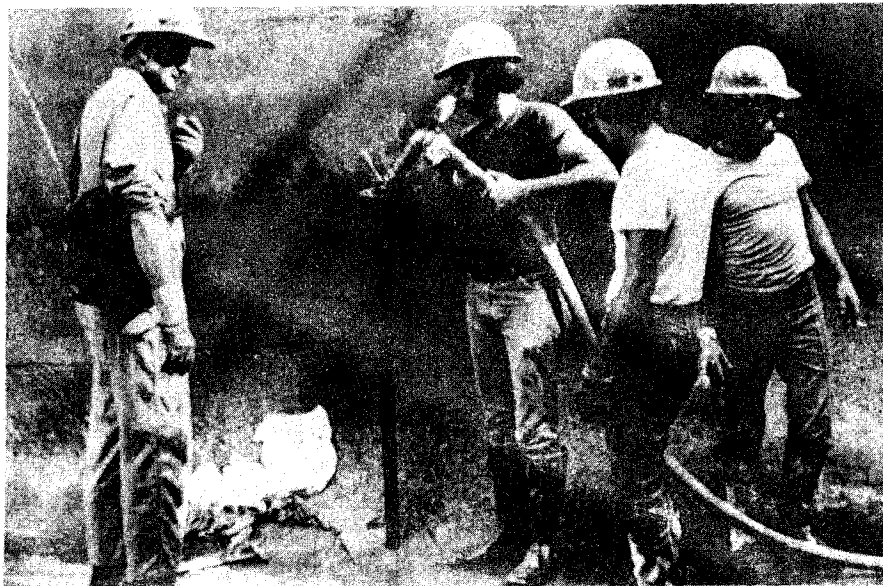
Figure 11. Grouting using standpipe, Arkabutla Dam, 1977

24. At the end of the grouting day, all grouted holes were inspected. Water dripping from a hole when the valve was slightly opened indicated grout had not sealed the leak. A 4-ft-tall standpipe was connected to the hole and filled with 1:1 grout (Figure 11). If water was observed dripping from the top of the standpipe the next day, adjacent ports were cleaned out, jetted with water, and then pressure grouted with a 1:1 mix.

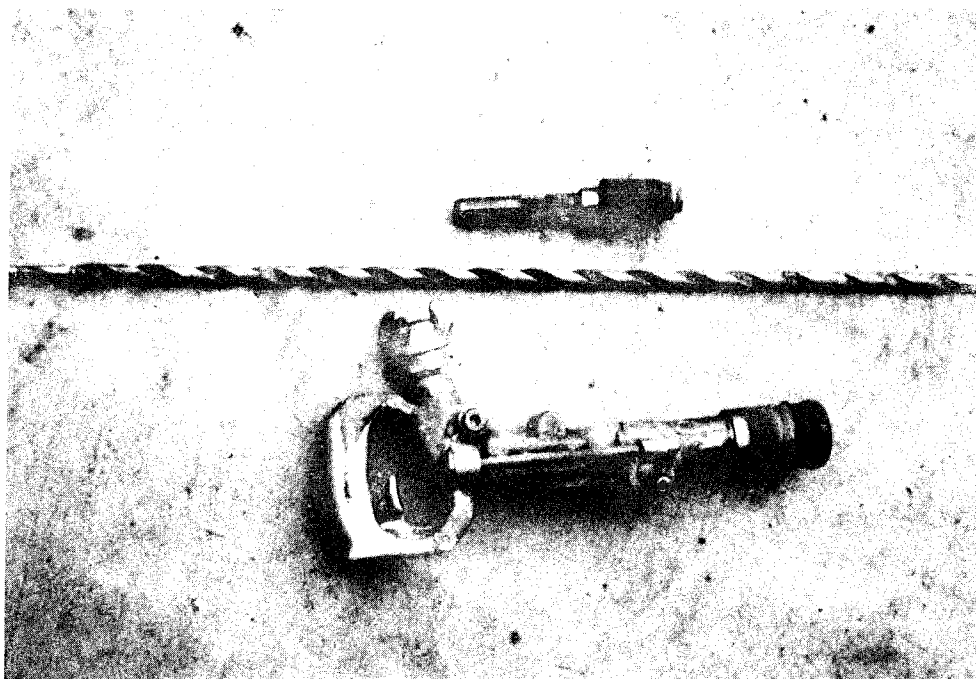
Figure 14. Rotary hammer drill, adapter, and bit, Blakely Mountain Dam, 1986

Five hundred and fifty feet of hose was used to supply air to monolith joint 20/21 where the drilling was started. Two Chicago pneumatic rotary hammer drills, model number 9A, were used to drill the grout holes. The grout holes were 5/8 in. in diameter and were drilled using 18 and 36-in.-long masonry bits that were carbide tipped and had SDS (SR) series shanks (Figure 14).

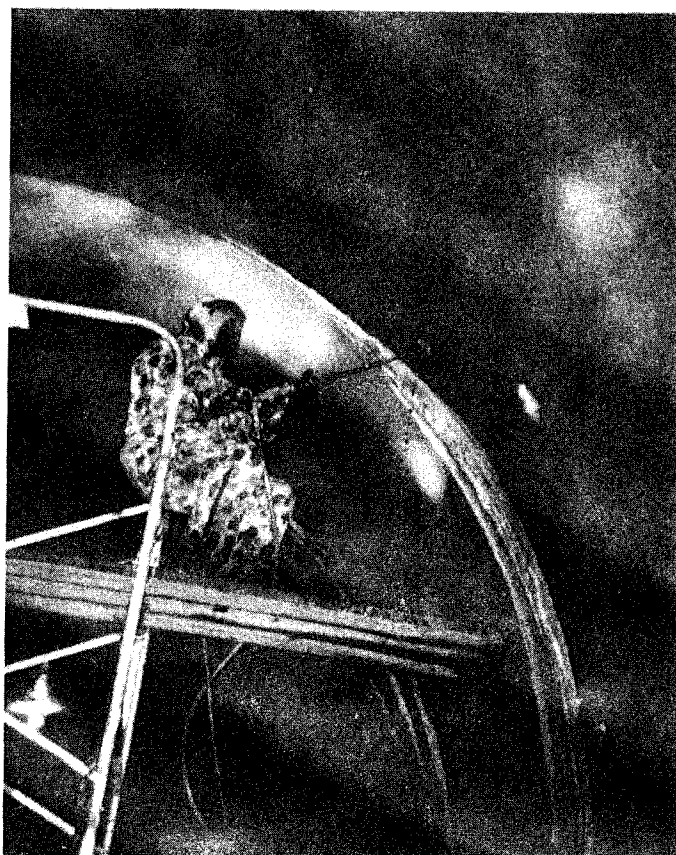
Figure 15. Drilling of grout hole, Blakely Mountain Dam, 1986

73. Holes to be drilled were measured from the center of crown along the tunnel circumference and marked. Drilling of the grout holes (Figure 15) was started on 30 January 1986 at monolith joint 20/21. The joint was weeping at two locations, 9.5 ft right of the centerline of the crown and 5 ft left of the centerline of the crown looking downstream. Five holes were located as follows: 5 ft right (weeping), 7.5 ft right (flowed), 7.5 ft left (flowed), 5 ft left (weeping), and 2.5 ft left (flowed). These grout holes were drilled at a 40- to 45-deg angle to the concrete surface and slanted toward the joint with the holes starting 12 to 16 in. downstream of the joint. The purpose for this was to intercept the joint behind the water stop so that the surface of the joint would not have to be sealed to retain the chemical grout. To drill a 30-in.-deep hole required 45 min to 1 hr. This length of time was required frequent withdrawal of the bit to assist in the removal of the cuttings and the additional effort required to puncture the water stop. Bits were not vented to blow cuttings out of the hole.

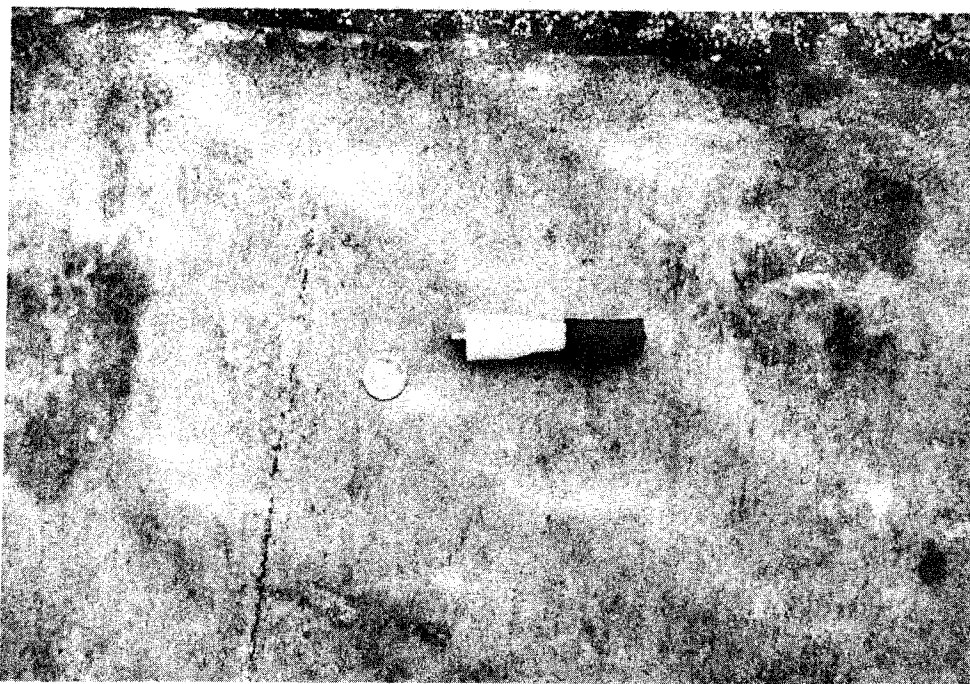
Figure 16. Injection packer, Blakely Mountain Dam, 1986

79. On 3 February 1986, the injection of the chemical grout was begun with a total of 15.0 gal of FLEX 44 and 15.0 gal of TACSS 020 NF being used. Approximately 3.0 gal of each grout were wasted due to loss through joints and loss due to the humid air in the tunnel reacting with the chemical grouts at their exposed surface in opened pails. The grout was injected into the joints and cracks through a packer patented by Avanti International, another chemical grout supplier (Figure 16). These injectors were possibly not the best to use with hairline cracks since they required 400- to 600-psi pressure to open the grease fittings. A modified Graco Airless President Hydra-Spray Pump, capable of spraying heavy viscous materials, was used to inject the chemical grouts (Figure 17). The spray gun modification consisted of a high-pressure pipe cross onto which was connected a dump valve, a 3,000-psi fluid gage, and a 3-ft-long pressure hose with a grease fitting connector (female) on the free end. A ground wire was connected to the pump for a positive ground, in accordance with the pump literature for use with paint. The ground wire for the grout pump was run from the tunnel outlet to monolith 1 and up the intake structure by the project personnel.

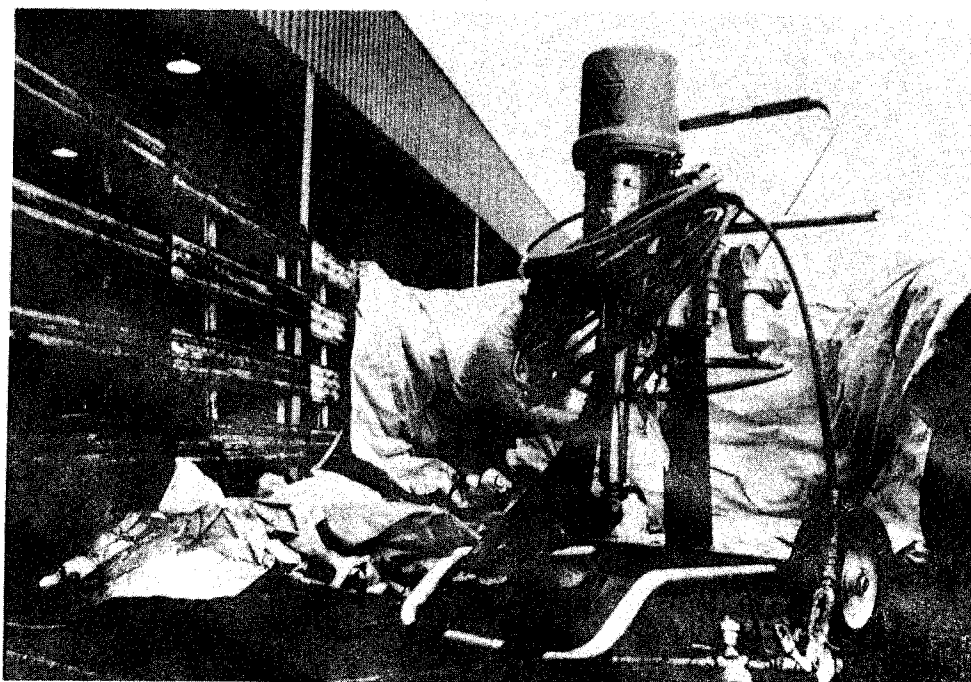
Figure 17. Grout pump, Blakely Mountain Dam, 1986

80. The Graco pump ordered was to have teflon seals substituted for the leather seals in the liquid pump. The pump received did not have the requested seals. As a result, the pump failed causing a loss of 1 day of work while efforts were made to obtain replacement parts. Also, the female connector to the grease fitting had a seal that was not compatible with solvents. The grout crew needed six to eight of these females connectors at the start of the job. One or two connectors were replaced each day depending on how many times the pump was flushed out with a cleaner.

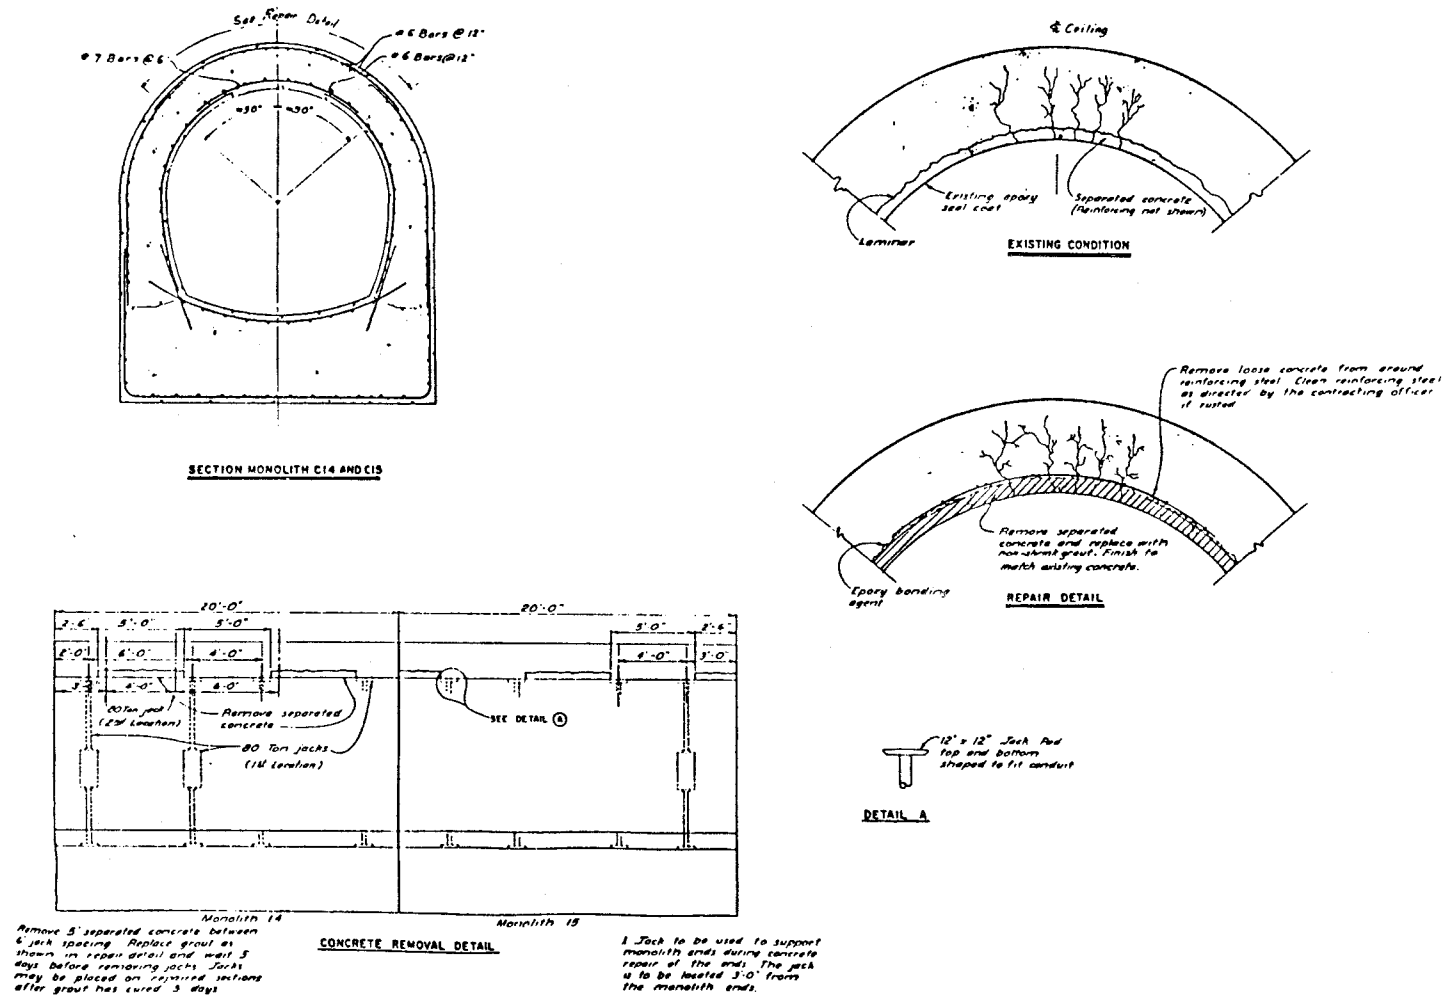
Figure 33. Details of removal and replacement concrete in crown of conduit, Eau Galle Dam

122. In a few of the monoliths containing the most severely delaminated concrete, the damaged concrete in the crown of the conduit was removed and

replaced with a nonshrink grout prior to installation of the steel liner (Figure 33). The work was performed in reaches of 5 ft and required 80-ton jacks at the ends of each reach to support the ceiling during the repair. The specifications for the nonshrink grout required aluminum powder as expansive agent, No. 4 maximum size aggregate, Type III portland cement, and minimum compressive strength of 4,200 psi.

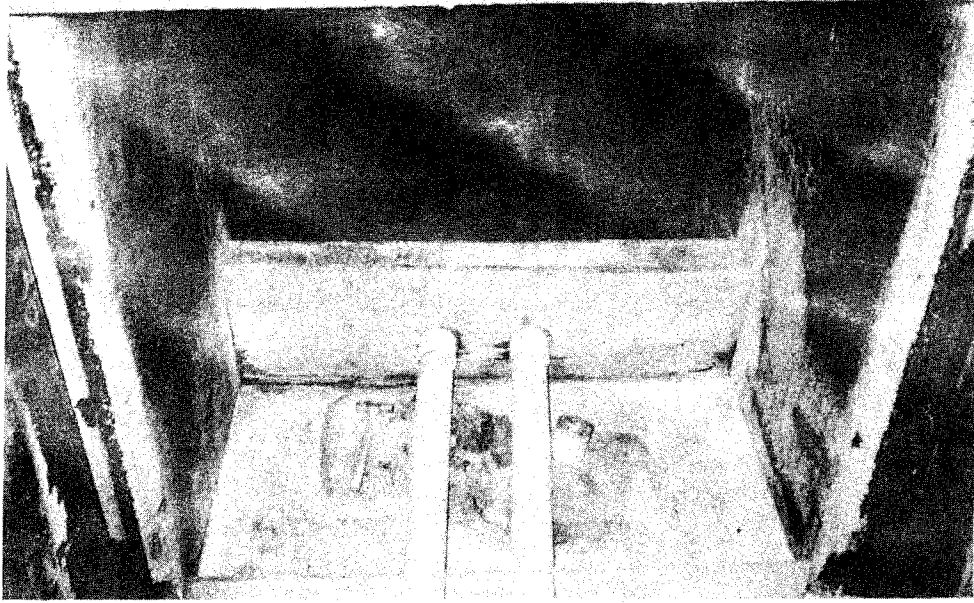
Figure 36. Cofferdam, Isabella Dam, December 1983

145. Cofferdams (Figure 36) were constructed by project personnel upstream and downstream of the work area with two 3-in. PVC pipes between them to keep the water leaking pass the emergency gate from entering the work area. One airbag was installed at the upstream coffer dam to prevent water that was spraying from around the emergency gate from entering the repair area (Figure 37).

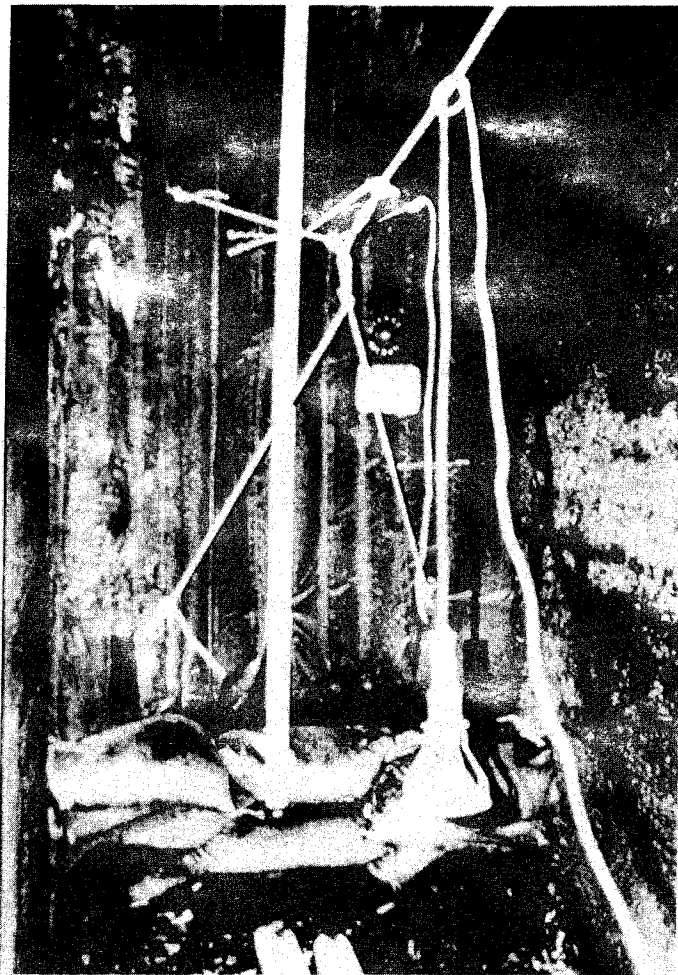
Figure 37. Airbag, Isabella Dam, December 1983

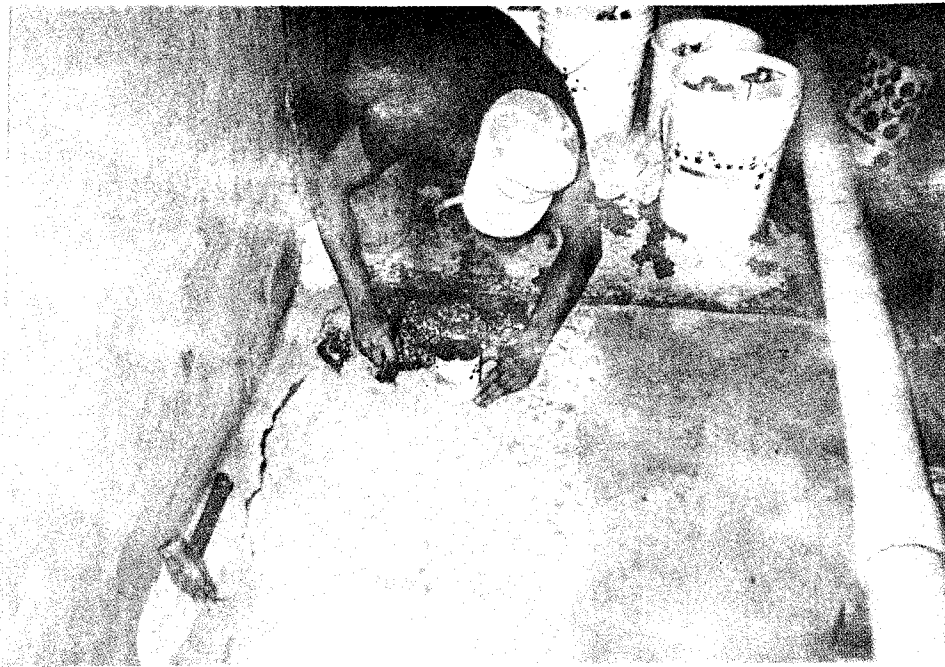
Figure 38. Applying surface conditioner, Isabella Dam, December 1983

148. The large holes in the concrete at the invert and base of the wall were conditioned with Belzona Molecular Magma Conditioner (Figure 38). The

application was done with brushes having half the length of their bristles cut away to increase brush stiffness. Belzona Molecular Magma Fill, a bulk filler material, was mixed and placed into the holes until they were within 1/8 to 1/4 in. of being level with the floor.

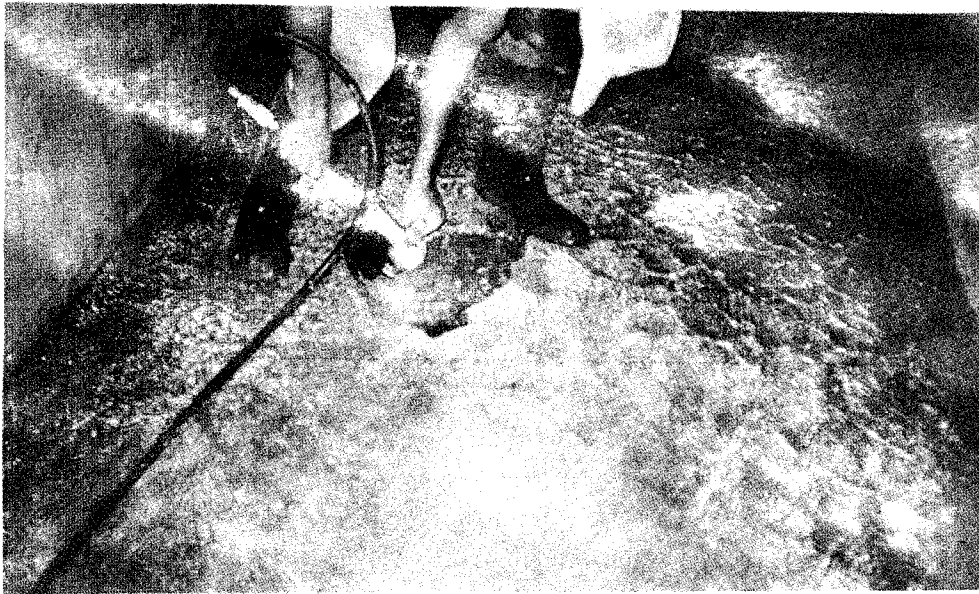
162. A small area of damage (12 by 12 in., 1/4 in. deep) in the concrete at the invert of chamber 2 was repaired underwater using Belzona Underwater Metal. The surface to be repaired was ground using an air grinder (Figure 41). The repair material was placed in the area and worked level with the invert surface (Figure 42).

Figure 41. Underwater grinding, Isabella Dam, September 1984

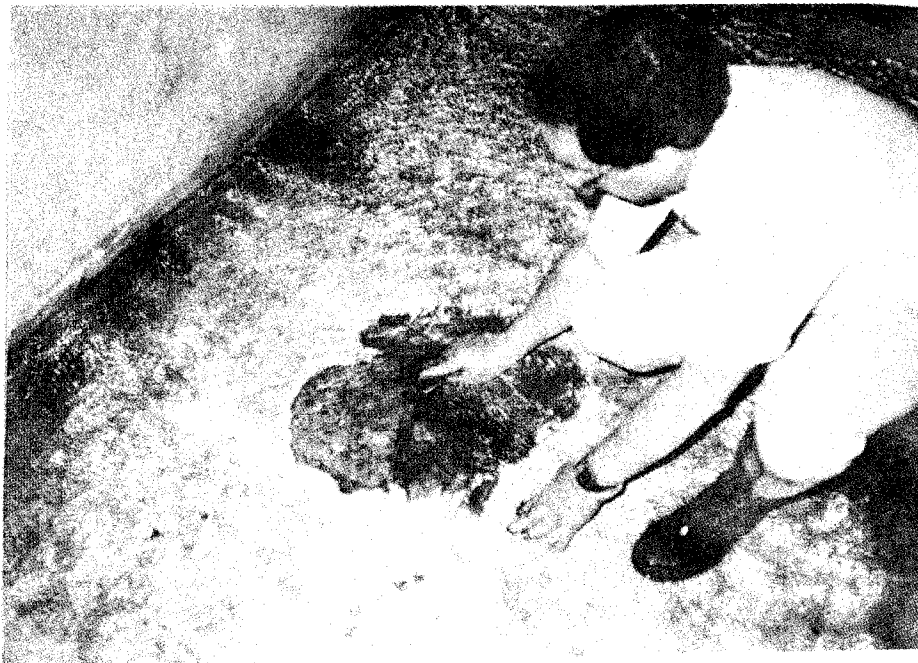
Figure 42. Underwater finishing, Isabella Dam, September 1984

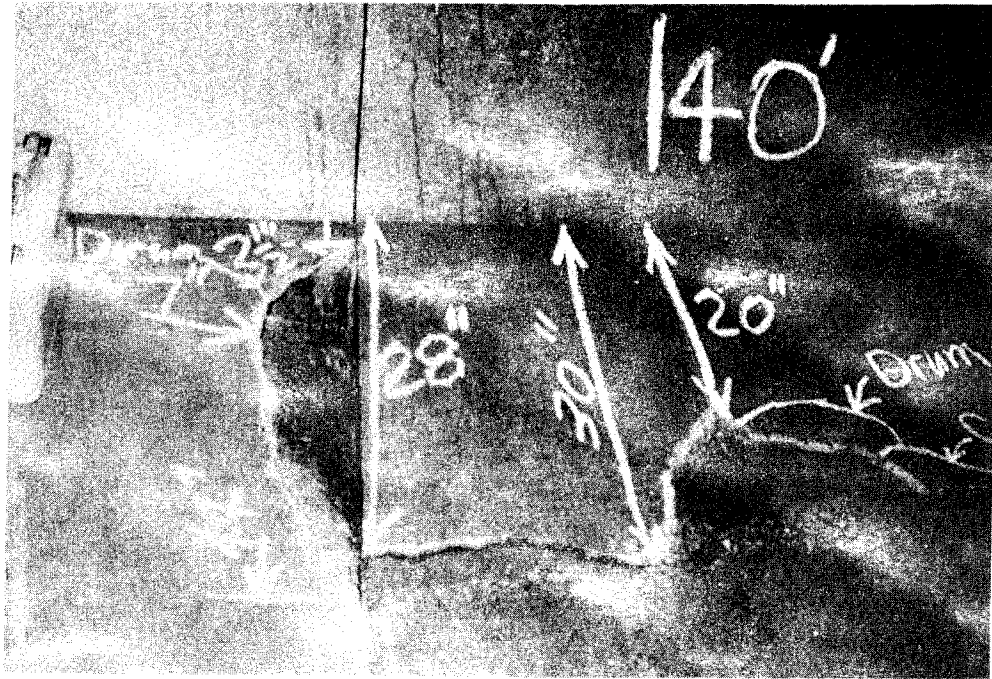
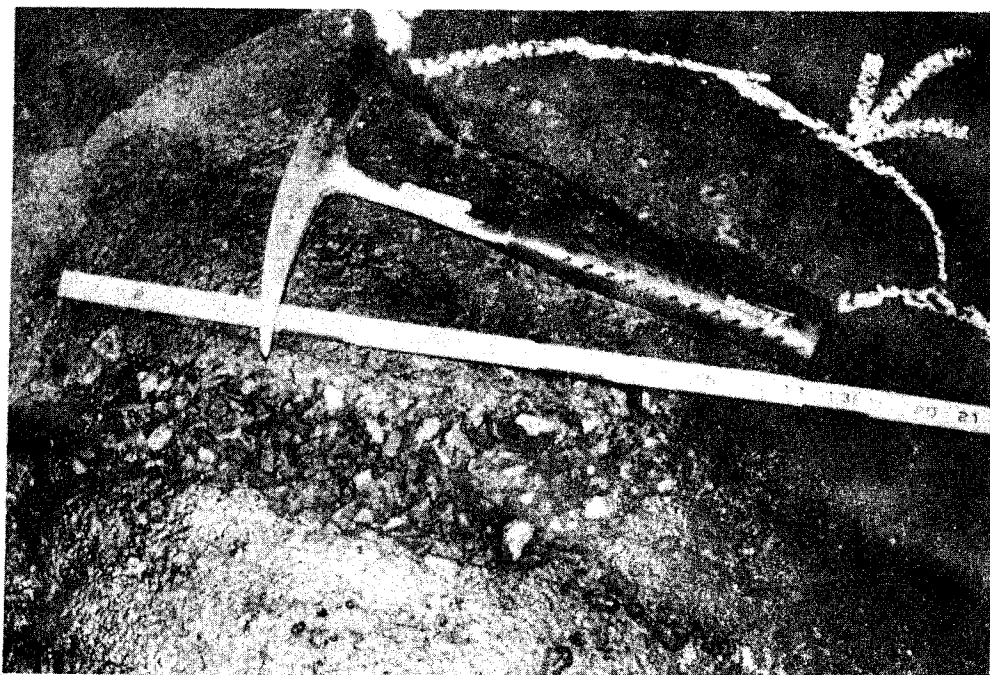
Figure 44. Mortar loss, Milford Dam

189. In 1974, approximately 80 percent of the 3/4-in.-thick epoxy mortar in the invert was missing with delamination evident in some of the areas where the mortar remained. The area of loss was primarily between the service gate steel liner and the construction joint between the tower and first conduit monolith (Figure 44). The epoxy mortar on the walls was intact and appeared sound (no drumming was detected when tapped with a hammer). It was suspected that the loss of epoxy mortar was the result of strains caused by differences in thermal expansion between the epoxy mortar and concrete and strains caused by cavitation forces produced by the high discharges that occurred in the spring of 1973.

a. Downstream end of passage

b. Closeup

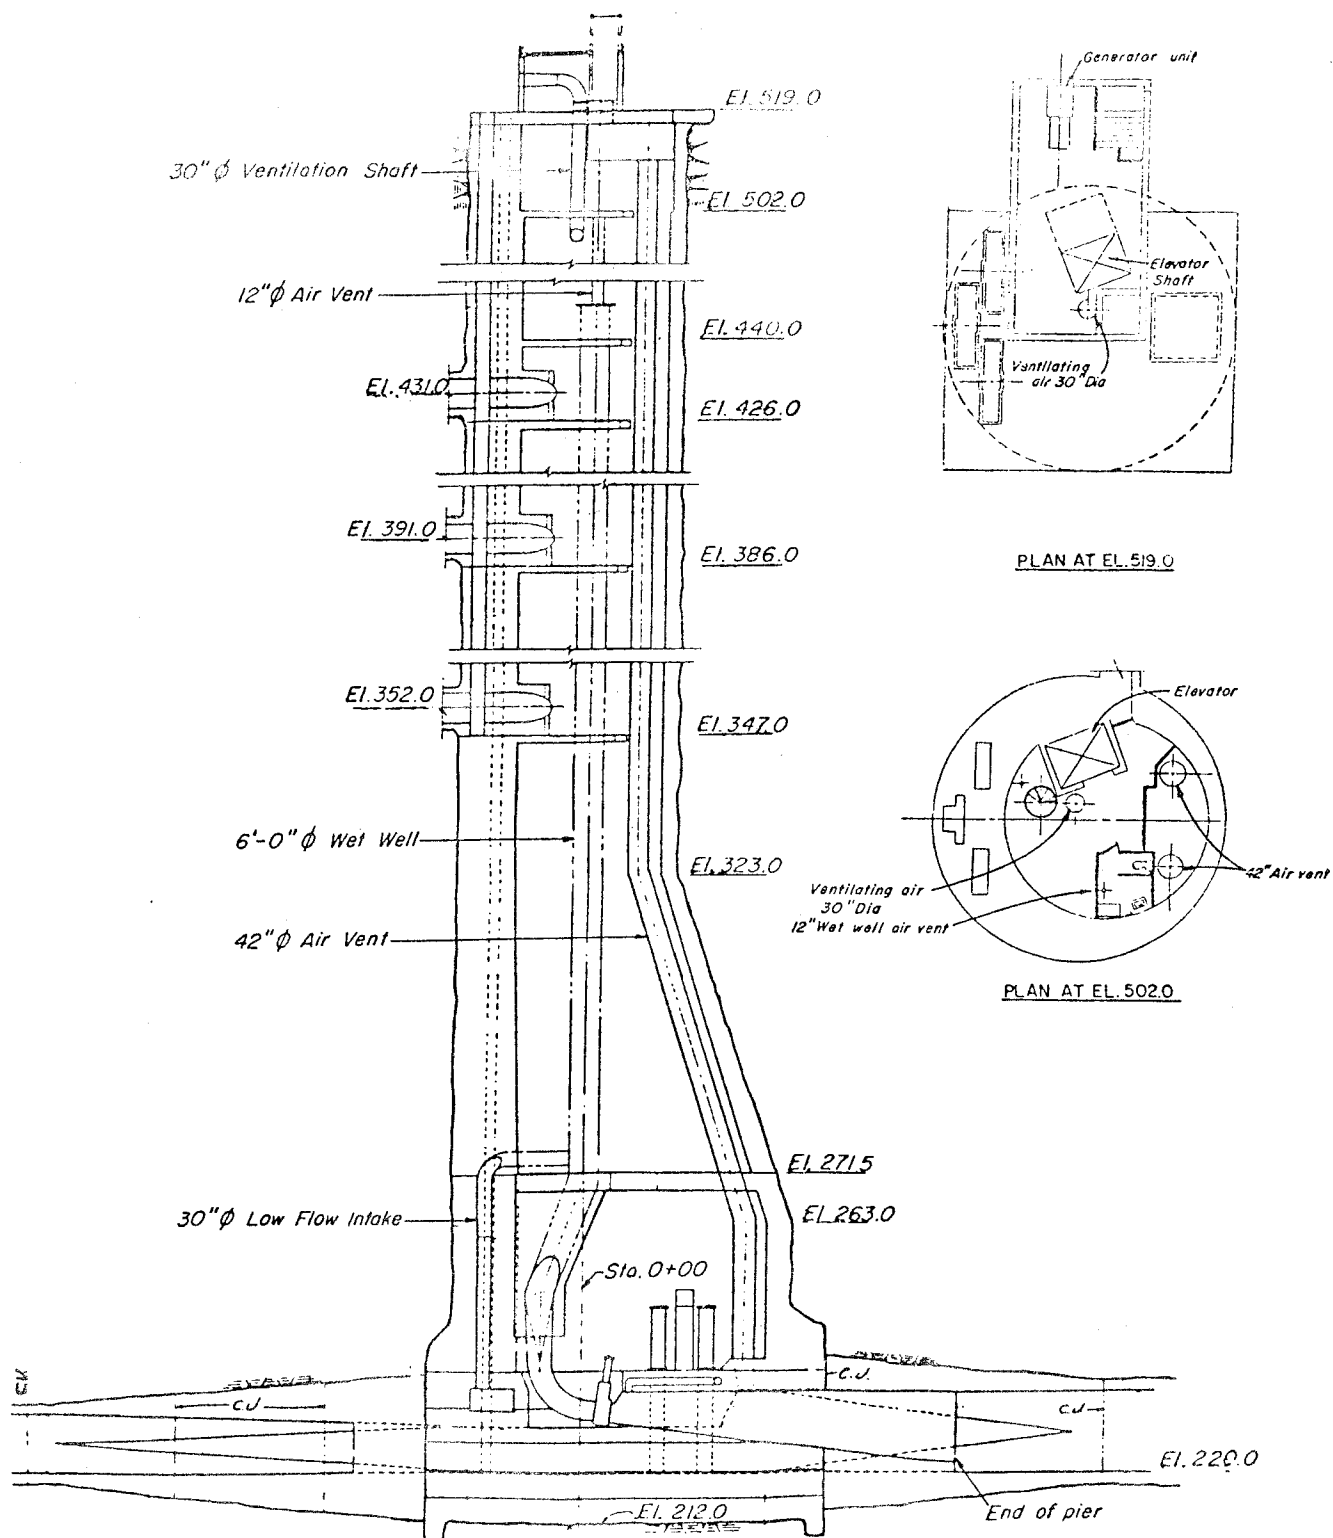
Figure 51. Centerline elevation view of intake control structure, Warm Springs Dam

213. Leakage from horizontal construction joints and vertical cracks in the wall of the intake control structure was noted during the first periodic inspection in November of 1982. Groundwater was the leakage source since the embankment of the dam had just been completed and no water had been impounded. The extent of the leakage at the joints was highly variable, ranging from very slight, isolated flows covering 0.5 ft to 3 ft of the joint to much heavier flows wetting virtually the entire joint circumference. Many of the vertical cracks were essentially continuous across horizontal construction joints and extended over 100 ft in length. At the lower levels substantial portions of the interior surface were continuously wet and at many locations covered with mineral deposits and efflorescence. The floors at these levels were ponding water.

214. The leakage posed no threat to the structures safety, but was threatening the structure's ability to perform as designed. The leakage was resulting in significant reductions in the reliability and performance of the electrical systems and increased corrosion of the operating machinery and appurtenances.

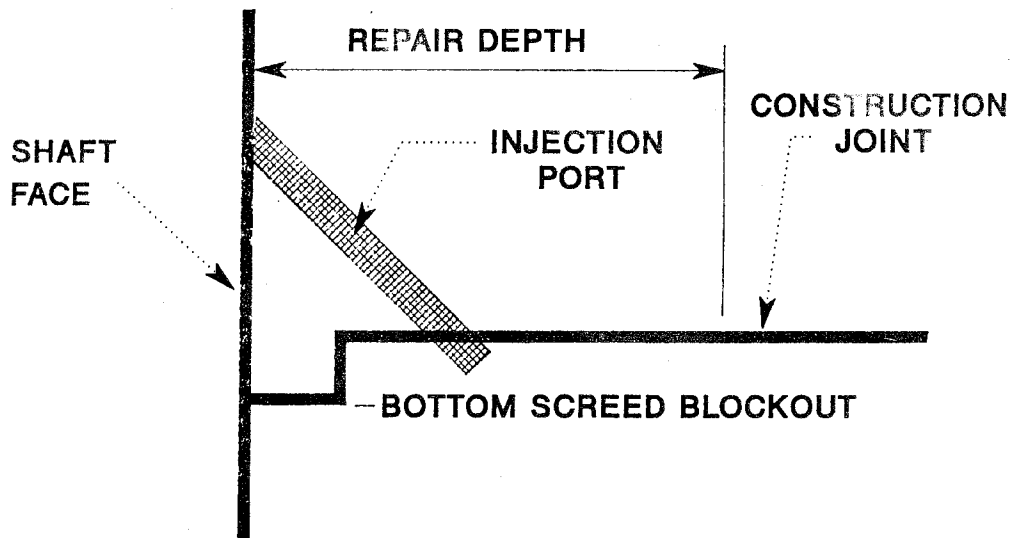
Figure 52. Sketch of epoxy injection joint detail, Warm Springs Dam

217. The epoxy was injected at 160-psi pressure. At this pressure the patches and cosmetic finishes placed along the joints and cracks during construction were spalled from the concrete face. These spalls revealed that the joints varied significantly in elevation along their lengths and were filled with debris. It was speculated that during construction of the shaft a screed strip was located at the top of each lift (Figure 52) and that the screed strip formed a blockout that functioned as a sump or trap for debris when the top surface was being prepared for the placement of the next lift.

218. Only small volumes of epoxy could be injected at the horizontal ports indicating limited penetration of the epoxy into the joints. The contractor improved the penetration of the epoxy into the joints by drilling 10-in.-deep injection ports at a 45-deg incline to shaft face. These ports were located above each joint such that they intersected the horizontal portion of the joint above the assumed blockout (Figure 52).

219. After the epoxy had cured long enough to preclude its draining out from the injected voids, the pipe nipples were removed and the ports patched with Waterplug. The ports and sealed surfaces were then ground flush with the adjacent concrete surfaces.
