US Army Corps  
of Engineers

# REPAIR, EVALUATION, MAINTENANCE, AND REHABILITATION RESEARCH PROGRAM

TECHNICAL REPORT REMR-CS-4

## REPAIR OF WATERSTOP FAILURES: CASE HISTORIES

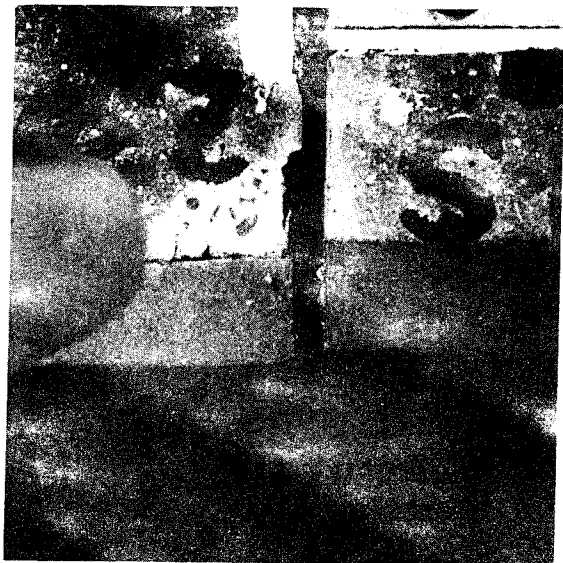
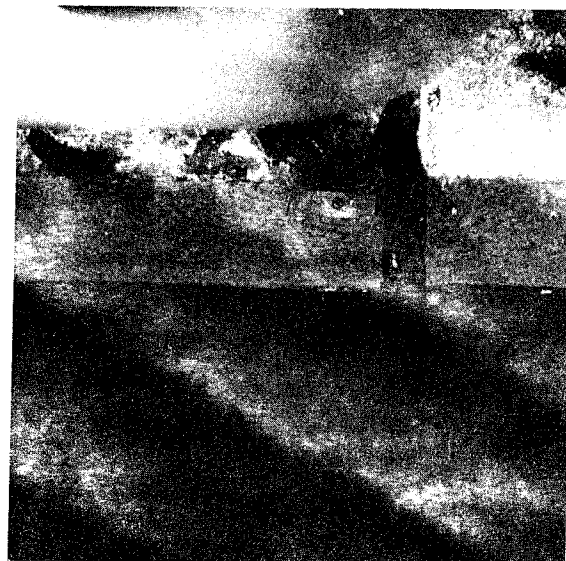
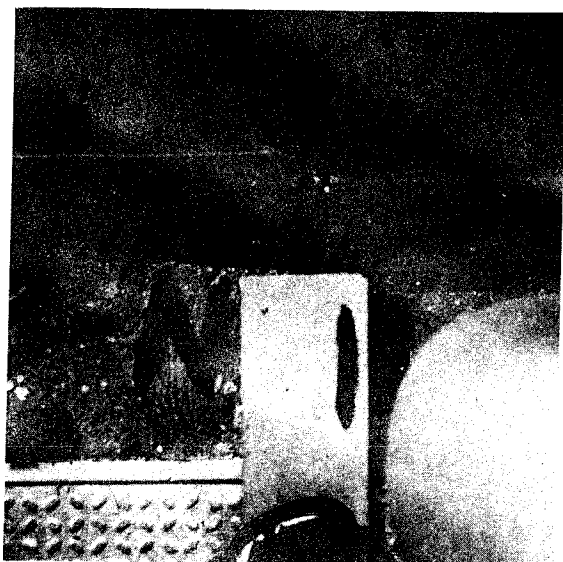
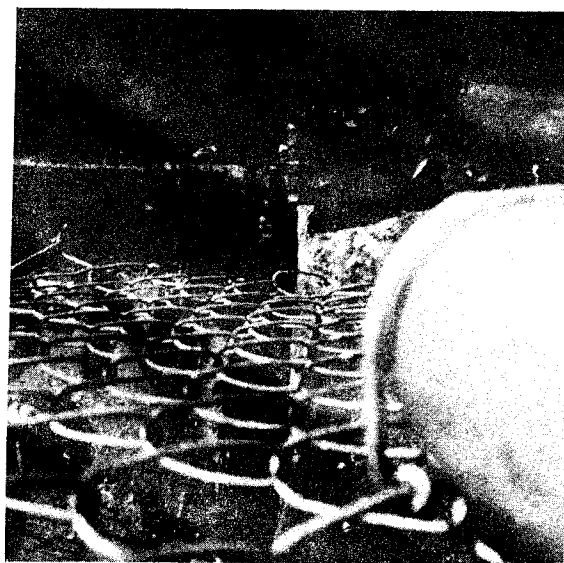
17. The joints between lock chamber monoliths and those between approach monoliths appeared to be in good condition with no unusual openings or offsets when inspected in 1973. However, joints between the gate bay monoliths and adjacent monoliths showed visual evidence of considerable movement (Figures 3 and 4). Also, there were indications that considerable water passed through the joints between the west gate bay monolith and adjacent chamber monoliths during the recent high water (Figure 5). Gate bay joint movements as measured in October 1973 are shown in Figures 6 and 7. No joint repairs were considered necessary at the time; however, repairs during the next scheduled dewatering in 1978 were anticipated.

Figure 3. Movement between east gate bay monolith and adjacent monoliths as viewed from top of lock wall, November 1973, Algiers Lock

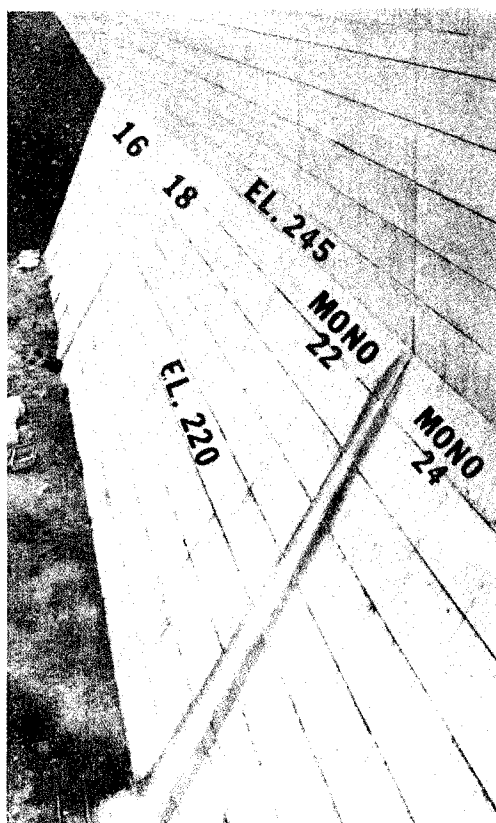
b. Closeup of monolith joint 22/24

Figure 28. Landside lockwall leakage, John Day Lock, October 1972

Leakage from monoliths 16/18 and 22/24 appeared on the surface of the back side of the wall at elevations 220 and 245 ft, respectively. Measured deflections in excess of 1/2 in. were reported for individual lock monoliths (Figure 29).

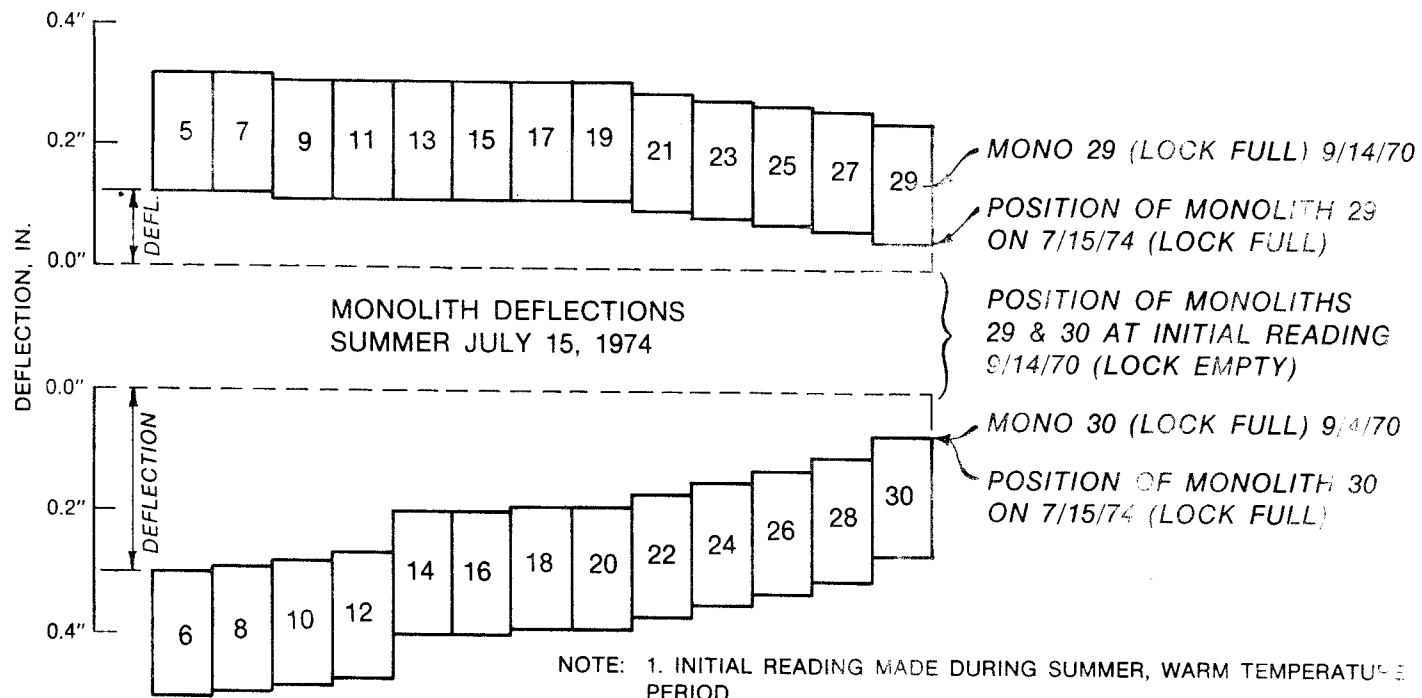
Figure 30. Lock monolith deflections, summer conditions, John Day Lock

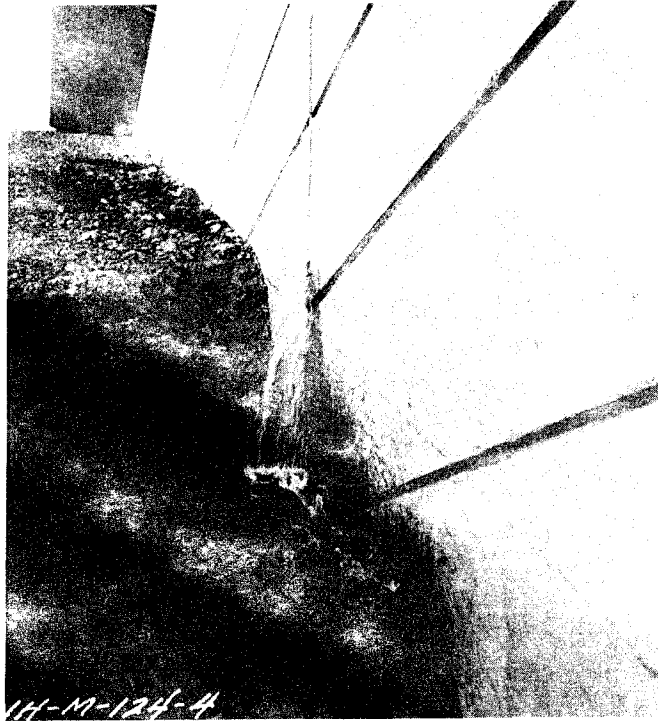
101. Leakage through monolith joint 32/34 was reported during a September 1969 inspection (Figure 37). This joint had been repaired in the spring of 1969 by drilling a 6-in.-diameter vertical hole along the joint and filling it with sand-bentonite mixture. The failure of this repair was attributed in part to the inability to properly place the mixture. Another repair attempt in the spring of 1970 tried placing the sand-bentonite mixture into elongated bags inserted into the drill hole.

Figure 37. Monolith joint 32/34 leakage,  
Ice Harbor Lock, 1969

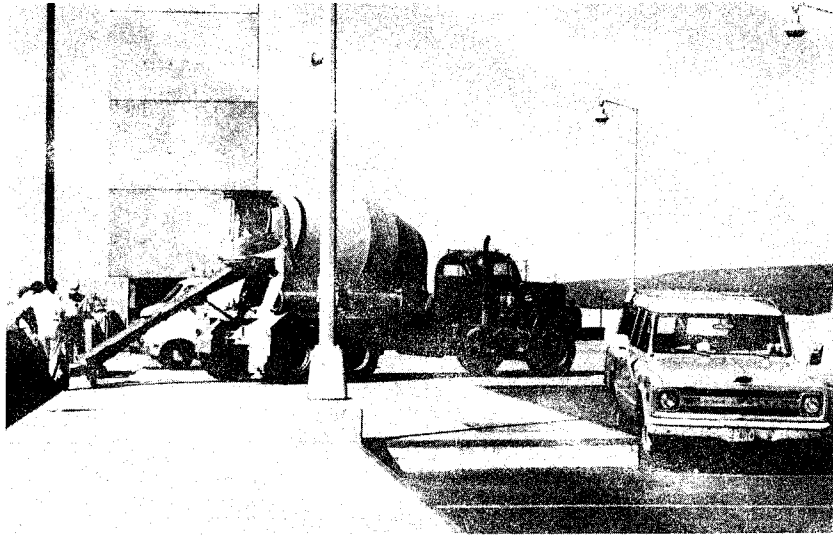
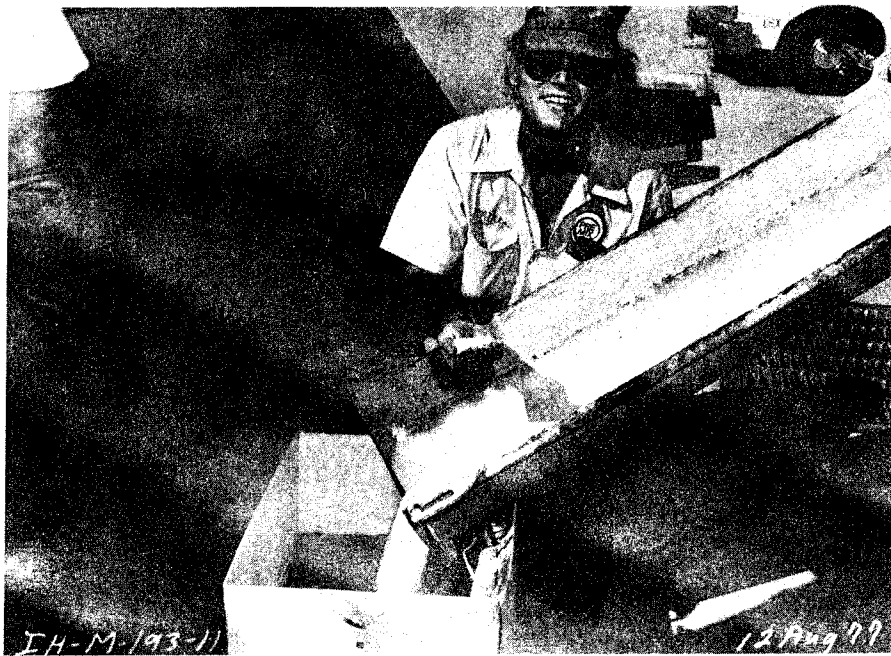
Figure 39. Discharging hydrophobic sand into drill hole, Ice Harbor Lock

111. The drill hole was filled on 12 August 1977 by discharging the hydrophobic sand directly from the transit mixer into the hole (Figure 39). Approximately 35 cu ft of hydrophobic sand was used. Excess sand was stored at the lock. By 17 August, the sand had settled about 5 ft and the hole was refilled. The sand appeared to settle about 1/4 in. with each lockage (Figure 40). On 24 August, the sand was about 5 in. below the surface and the hole refilled. On 2 September, the sand was down about 9 in. and the hole was again refilled. During October 1977, a 6-in.-diameter hole 118 ft deep was drilled 7 ft from the lock face to be used as an observation well to check the effectiveness of the material as a waterstop. On 29 November, the sand was down about 15 ft in the test hole. When the lock was filled, the water in the observation well rose almost as fast as the water in the lock. When the lock was full, the water was within 15 ft of the deck. The water was also running over the top of the sand in the test hole. The water was running fast enough to be clearly heard and seen flowing through the joint looking down both holes from the deck. Since that time, sand has continued to be washed out of the test hole through the joint into the observation hole.

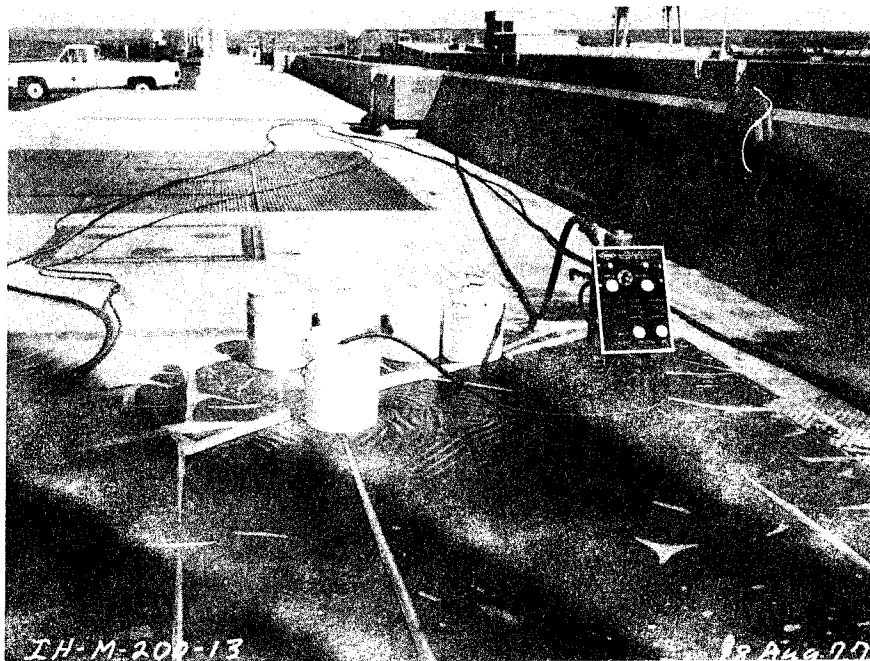
Figure 44. Polyurethane grout installation with proportioning pump, Ice Harbor Lock

The depth of the hole was measured at 44 ft on 2 September.

118. The drill hole was grouted on 18 August 1977 (Figure 44). A 6-in. packer built for this test would not fit into the 6-in. drill hole, so a shorter aluminum sewer grouting nozzle was used. The grouting was started at the bottom of the 120-ft hole and was being raised in stages when a boat lockage through the navigation lock raised the water surface in the hole very quickly. This caused the grout to flow around the packer through the joint and set above the packer. The packer was stuck in the hole about 60 ft from the surface with about 15 ft of the material above the packer. The retrieval equipment would not raise the packer, so the 3/8-in. steel cable and the rubber hoses attached to the packer from the hole and the 3/8-in. cable broke.

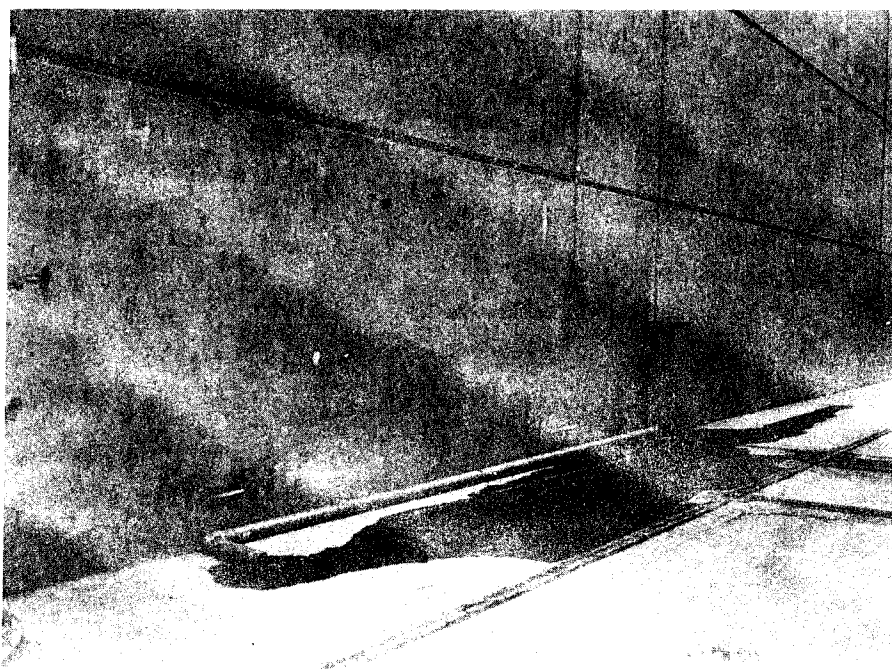
125. Leakage of varying intensities was reported between monolith joints of the different bays in the powerhouse. As would be expected, the amount of leakage varies with the seasons. Garden-type hoses are used at the joints in the powerhouse interior to help divert leakage and control it from flowing onto the generator floor. Joint 1/2 leaks every winter, joint 2/3 has leakage that runs through the hose fairly regularly, and joint 4/5 started leaking when the additional powerhouse units were watered up. Leakage at the outside transformer deck is substantial and is contained in metal troughs and pipes (Figure 47). It was noted that if the pipes were to freeze or if the leakage increased considerably during the winter, a problem of ice buildup and possible flooding of the transformer deck could occur.

Figure 47. Trough and piping to help contain monolith joint leakage in powerhouse, Ice Harbor Dam

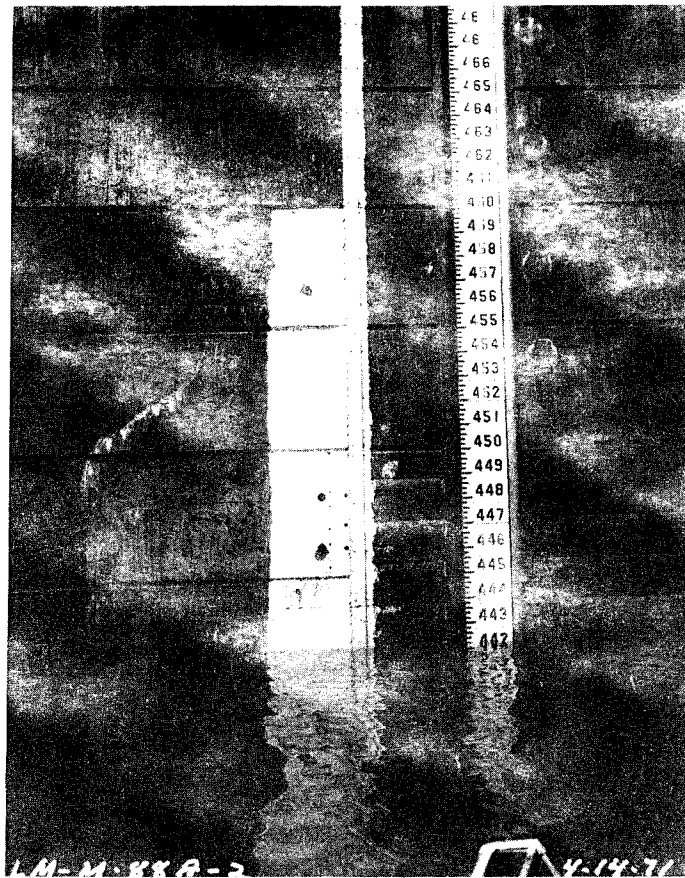
139. Leakage through gate monolith joints 25/27 and 26/28 was repaired by contract while the lock was dewatered in November 1970. A neoprene membrane epoxied to the concrete surface and retained by stainless steel cover plates was used for the repair (Figure 54). The areas which appear gray in Figure 54 have been treated with two coats of an epoxy, Colma-Rote M,

manufactured by Sika Corporation, to form a temporary membrane over areas of deteriorated concrete adjacent to the joint. In September 1971, it was reported that the epoxy showed signs of deterioration and also that the concrete deterioration appeared progressive, as evidenced by increased flows through joints 26/28, 25/27, and 18/20 (Figure 55).

Figure 54. Joint 26/28 repairs,  
Lower Monumental Lock

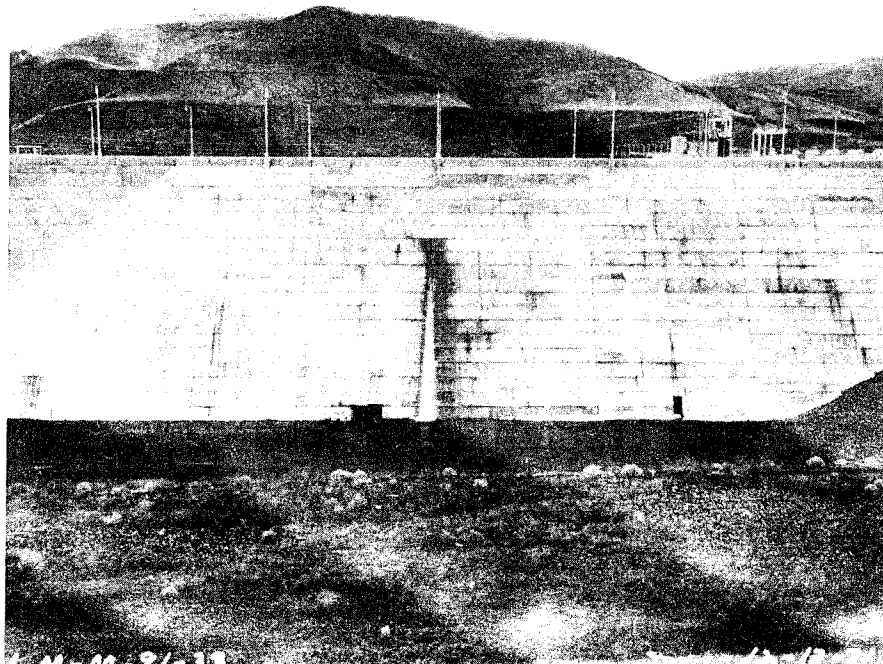
Figure 55. Leakage through joint 18/20 with full lock  
chamber, Lower Monumental Lock, December 1971

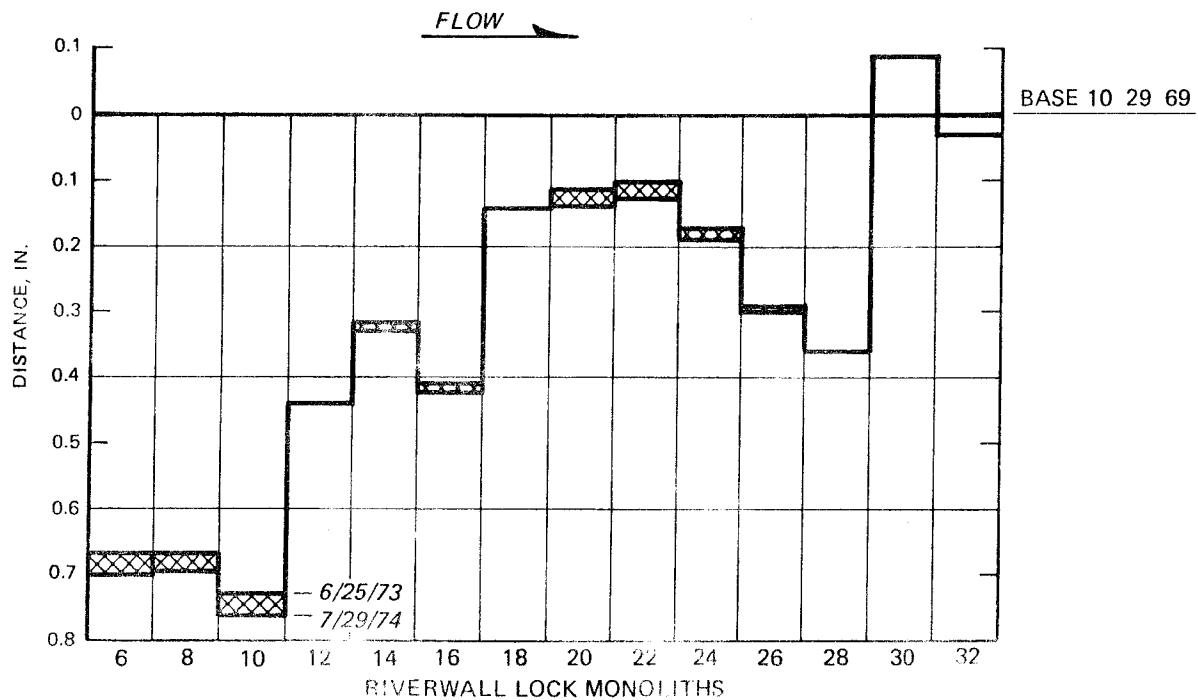
147. Subsequent deflection measurements indicated continued outward tilting of the riverside lock monoliths. Maximum permanent deflections, measured by extensometers, of more than 0.7 in. (Figure 61) were reported in 1974. Displacements were attributed to compression of the relatively weak flow breccia stratum underlying the wall buttresses. The largest relative displacements occurred at monolith joints 4/6, 10/12, 16/18, and 28/30

Figure 61. Permanent deflections measured with lock chamber empty, Little Goose Lock

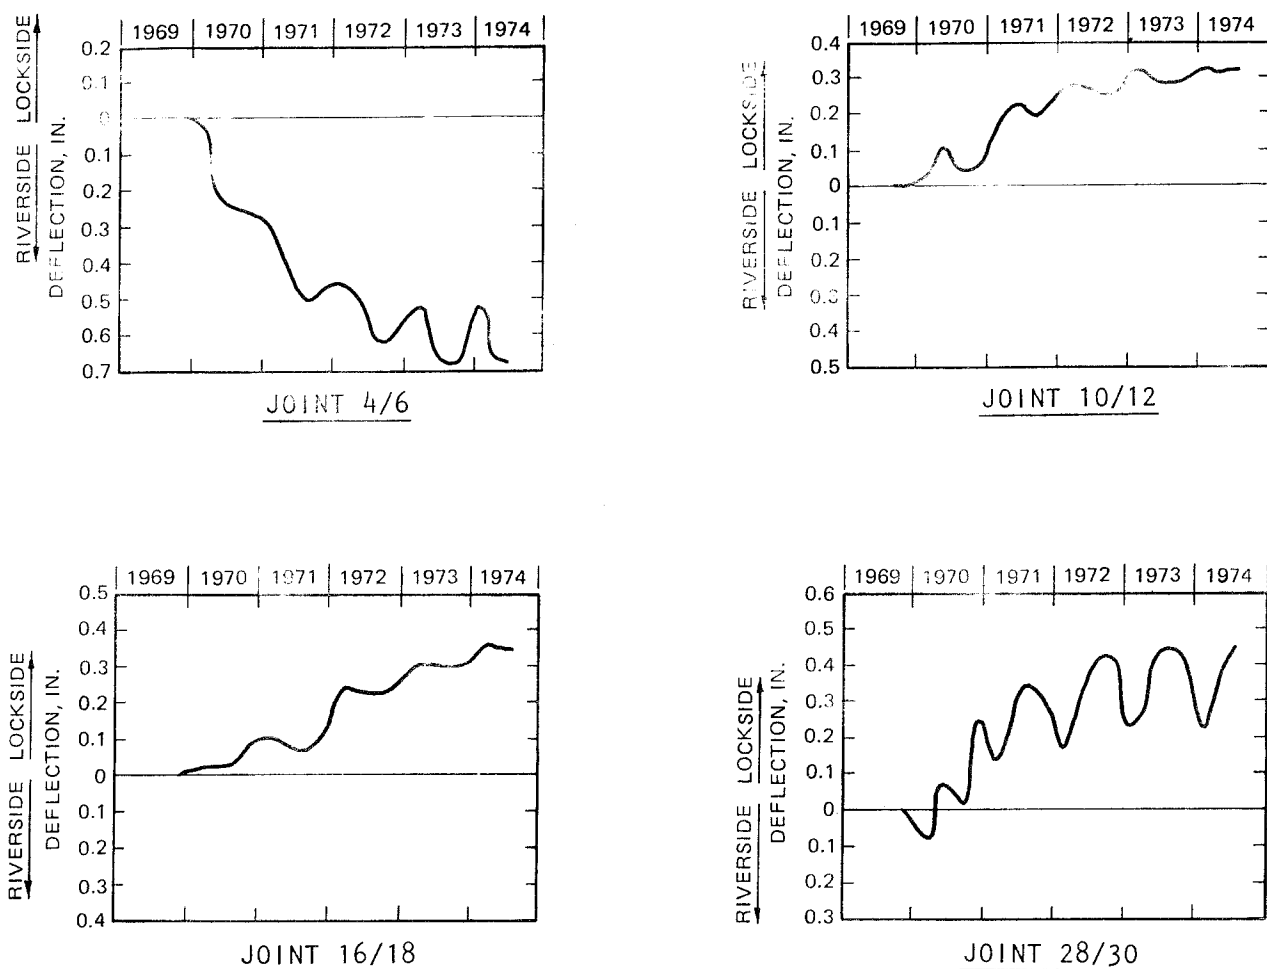
(Figure 62). Total failure of the waterstop at monolith joint 4/6 was reported as a result of the relative displacement between the adjacent monoliths. When the lock was filled, water leaked through the joint and spilled three deep into the parking area near monolith 6 (Figure 63). Most of the other monolith joints exhibited varying rates of leakage.

Figure 62. Maximum relative displacements of lock monoliths, Little Goose Lock

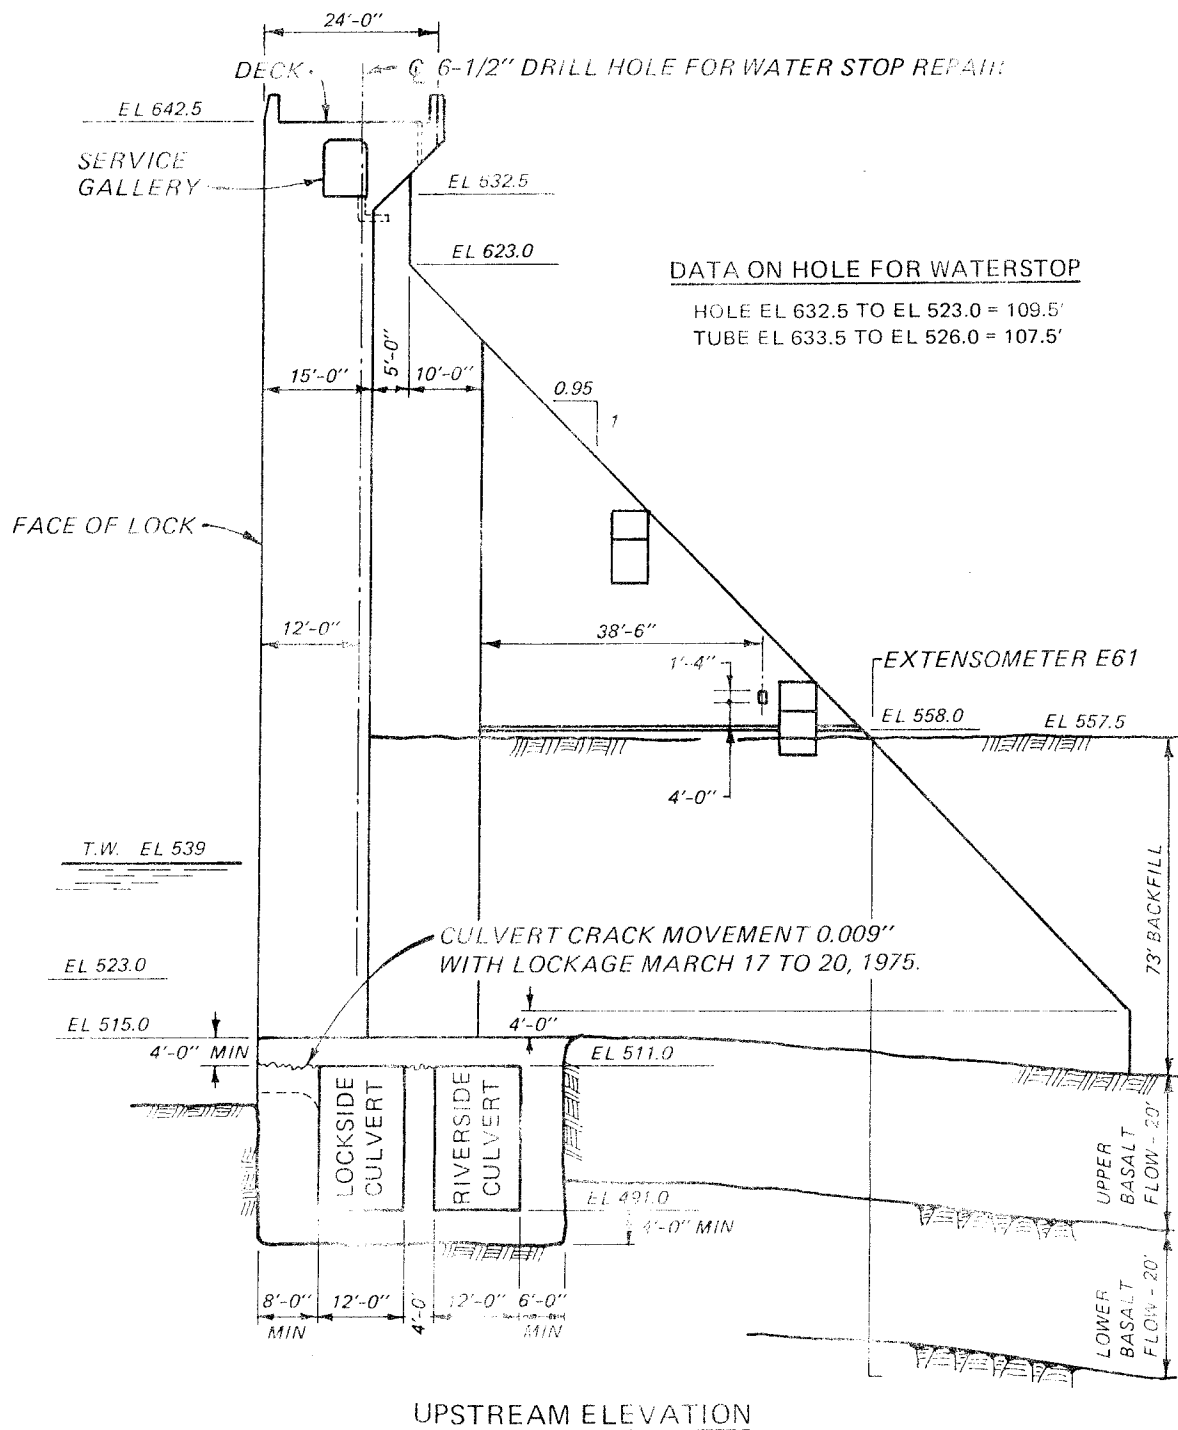
Figure 64. Location of trial waterstop repair, Little Goose Lock

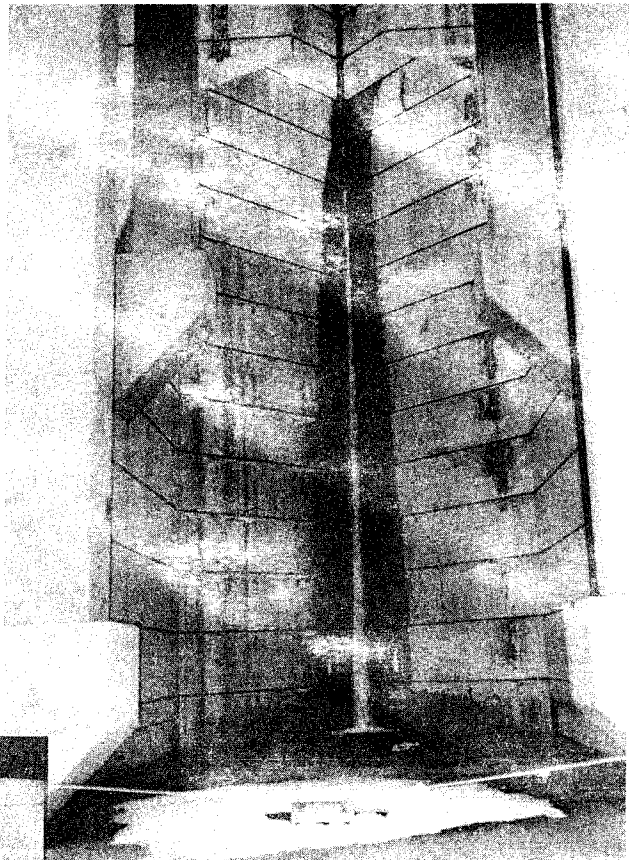
Figure 65. Monolith joint 10/12 leakage before and after repair, Little Goose Lock

152. Based on the Ice Harbor and Little Goose trial repairs, the drill hole with elastic filler method was selected to reestablish monolith joint waterstops at Little Goose Lock. Repairs were accomplished under contract in 1978 by drilling a 6-in.-diameter vertical hole along the joints from the deck to about 5 ft into bedrock and then filling the holes with AM-9 chemical grout to create a cast-in-place waterstop. This repair stopped an estimated 95 percent of the leakage. Leakage at selected joints before and after repair is shown in Figures 65 and 66.

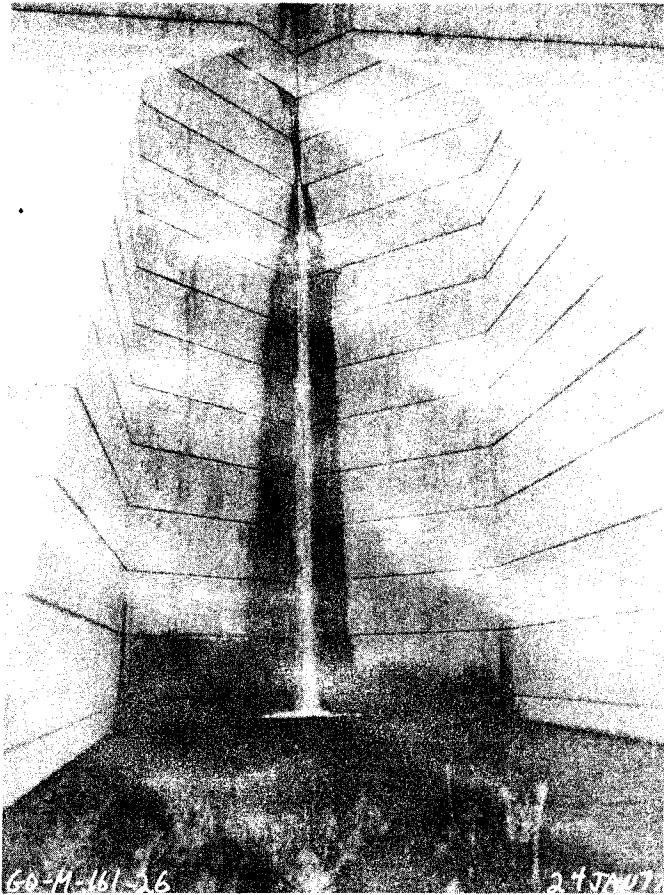
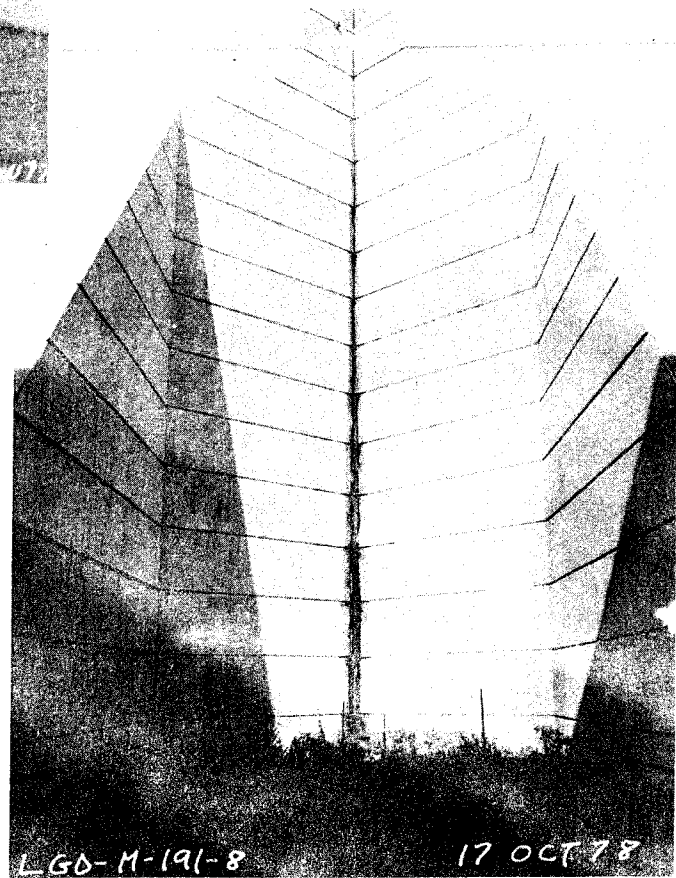
Figure 66. Monolith joint 11/13 leakage before and after repair, Little Goose Lock

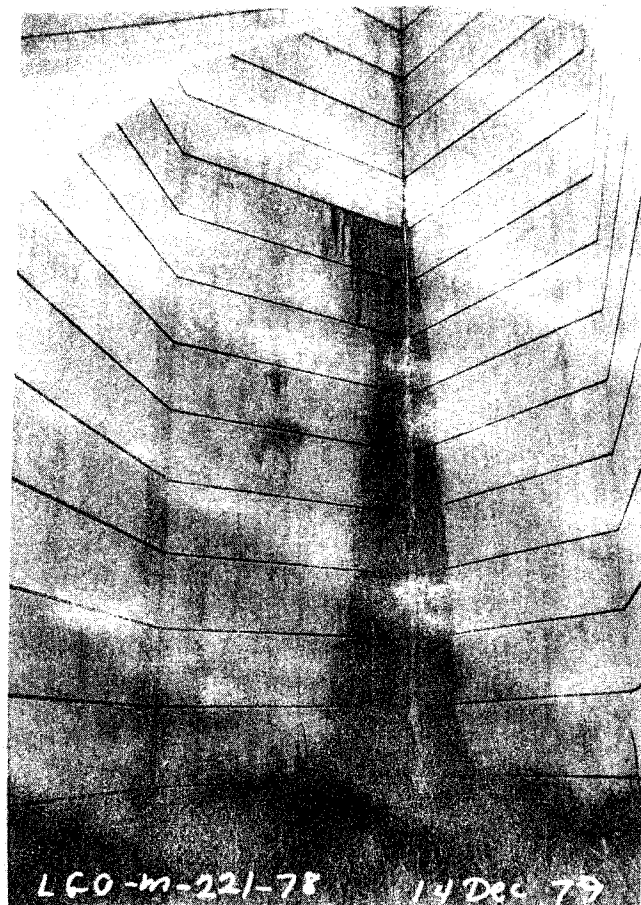
a. Monolith joint 13/15

153. Based on an inspection in August 1979, it was reported that several monolith joints exhibited small amounts of leakage (Figure 67) and would probably require regrouting in the future. It was suggested that one of the advantages of this repair system is that regrouting could be done easily and economically by an experienced chemical grouting crew. Other observations reported during this inspection included:

Figure 67. Monolith joint leakage, Little Goose Lock, December 1979

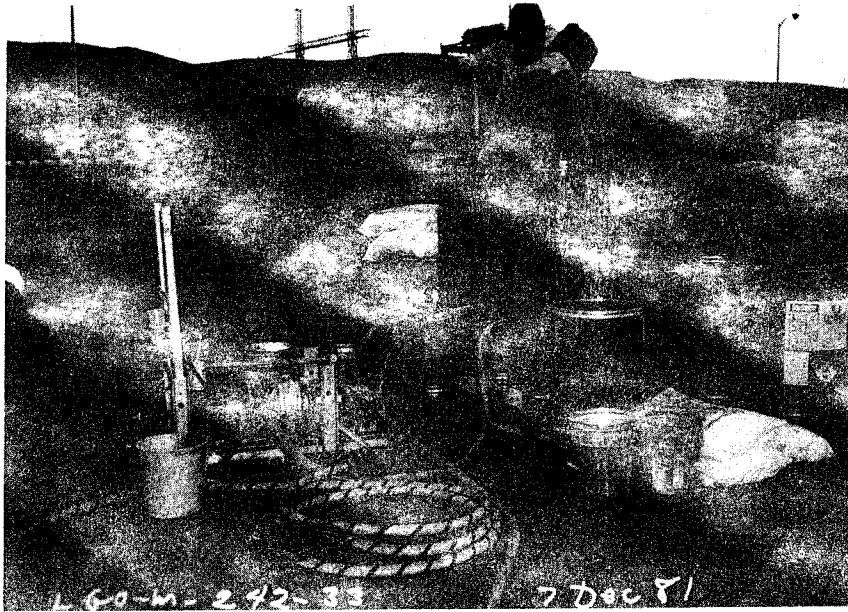
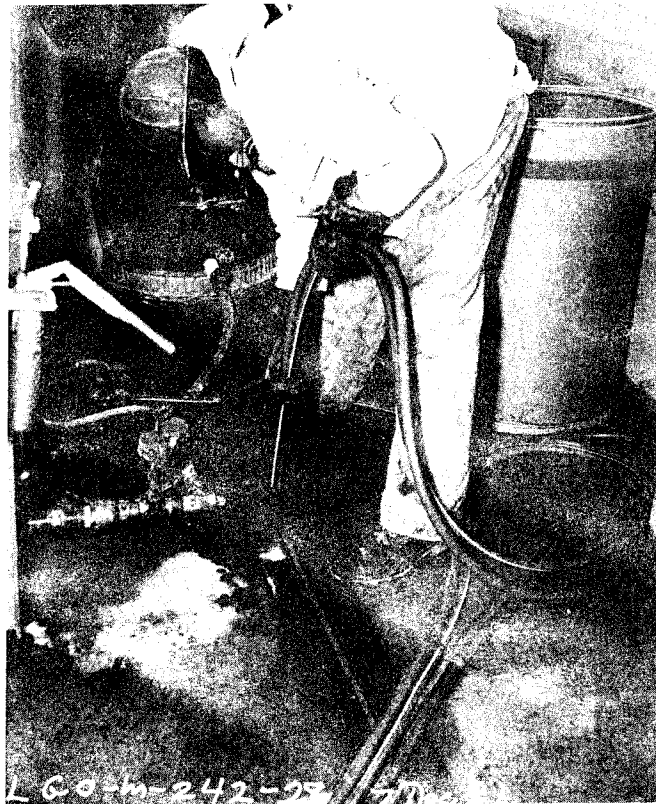
Figure 69. Acrylamide grouting operations, Little Goose Lock

157. Drill holes along monolith joints 15/17, 22/24, and 24/26 were flushed and filled with approximately 300, 350, and 250 gal of acrylamide grout, respectively. Photographs of the grouting operation are shown in Figure 69. At one point, the grout line stuck in the monolith joint 24/26 hole

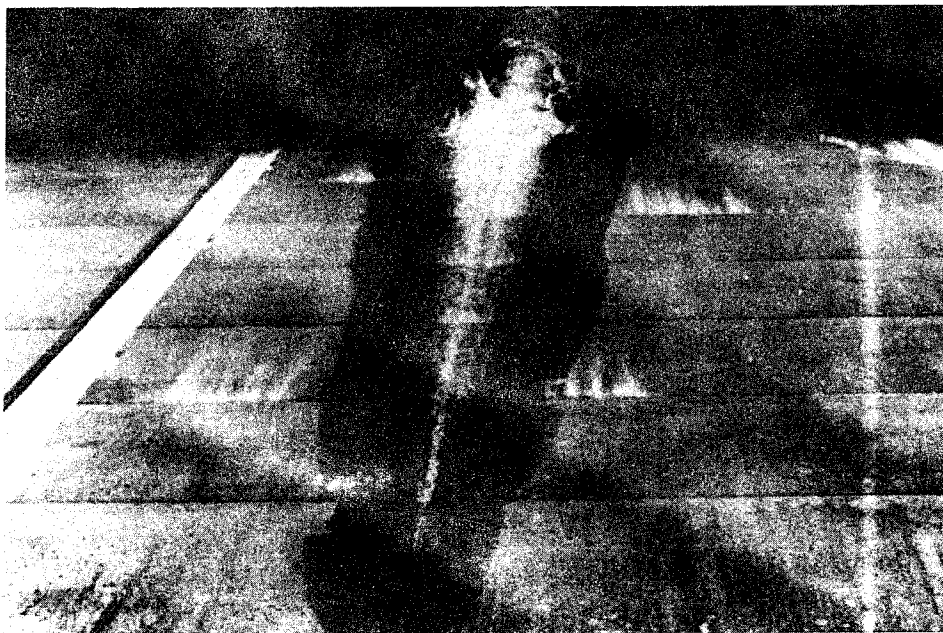
209. The Dardanelle Lock had six vertical monolith joints that had been leaking since 1975. The leakage only occurred during cold wintertime conditions. They were first investigated in January 1977 when the leakage had increased significantly (Figures 113 and 114). Observation and dye tests proved that water from the lock chamber, both at low and full chamber, was passing through the monolith joints. Defective copper waterstops were the probable cause of the leakage. Visual leakage existed at river wall monolith joints R7/8, R8/9, R10/11, R13/14, R18/19, and land wall joint L21/22. Monolith joints R18/19 and L21/22 are located at the lower miter sill and leakage through these joints entered the lock wall grouting galleries and then to the lower miter sill cross-over gallery where sump pumps are located. Total inflow during full lock chamber (wintertime) increased from 75 gal/min in January 1977 to 382.2 gal/min in January 1981. The sump pumps were taxed to the maximum and were modified several times to handle the high inflow.

a. View of riverward lockwall taken from dam looking downstream

b. Close-up of largest leakage

Figure 113. Leakage through monolith joints with lock chamber at upper pool level

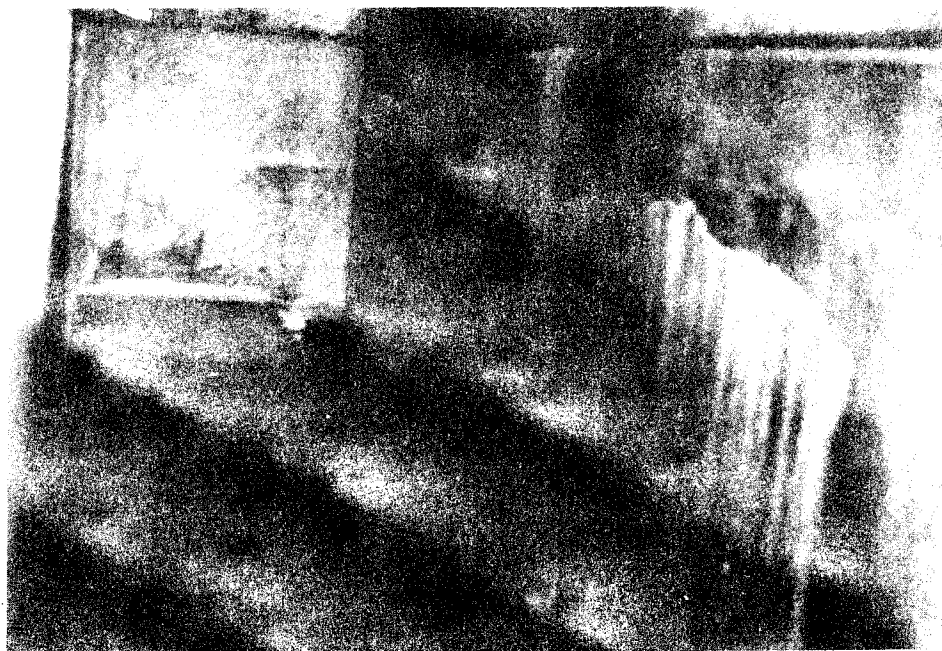
220. The new waterstops reduced the leakage into the galleries by at least 95 percent. Photographs of the leakage before and after waterstop installation are shown in Figures 114 and 119.

Figure 119. View of monolith joint R18/19 after installation of waterstop

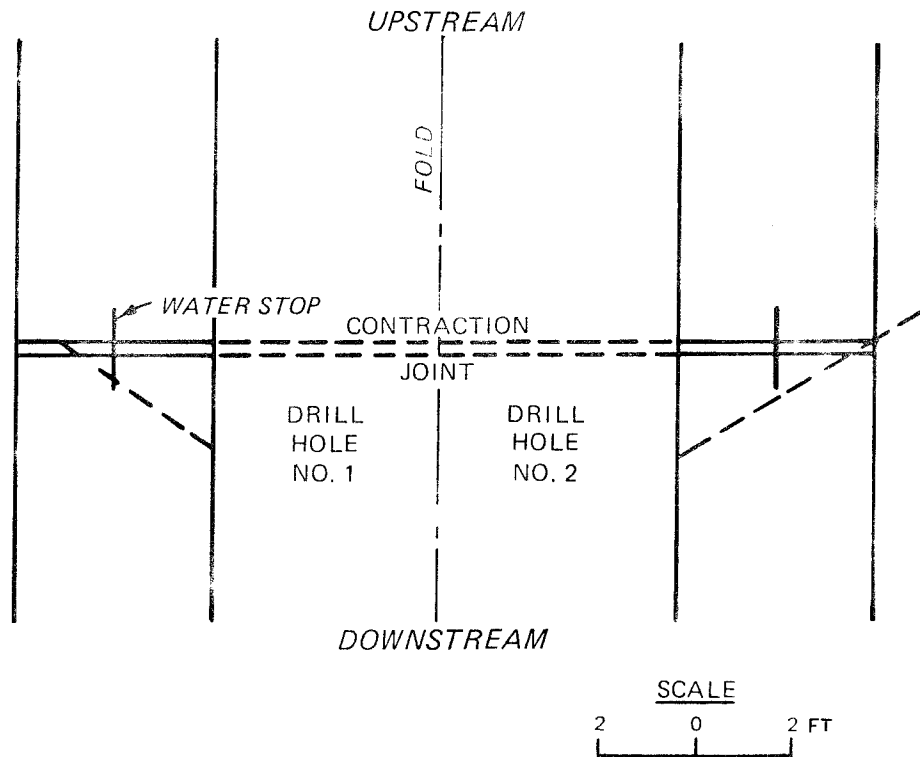
Figure 124. Section through grout holes 1 and 2, Applegate Dam

235. US Army Corps of Engineers crews began mobilizing on Monday, 1 June, and were ready to enter the conduit at the beginning of shift on 3 June. Two holes were drilled, as shown in Figure 123 and 124, and the conduit was made ready for the grouting contractor. Measured flow from the drill holes was 12.5 and 8 gal/min for holes 1 and 2, respectively. Flow through the leak with both drill holes flowing was estimated at 2.5 gal/min.

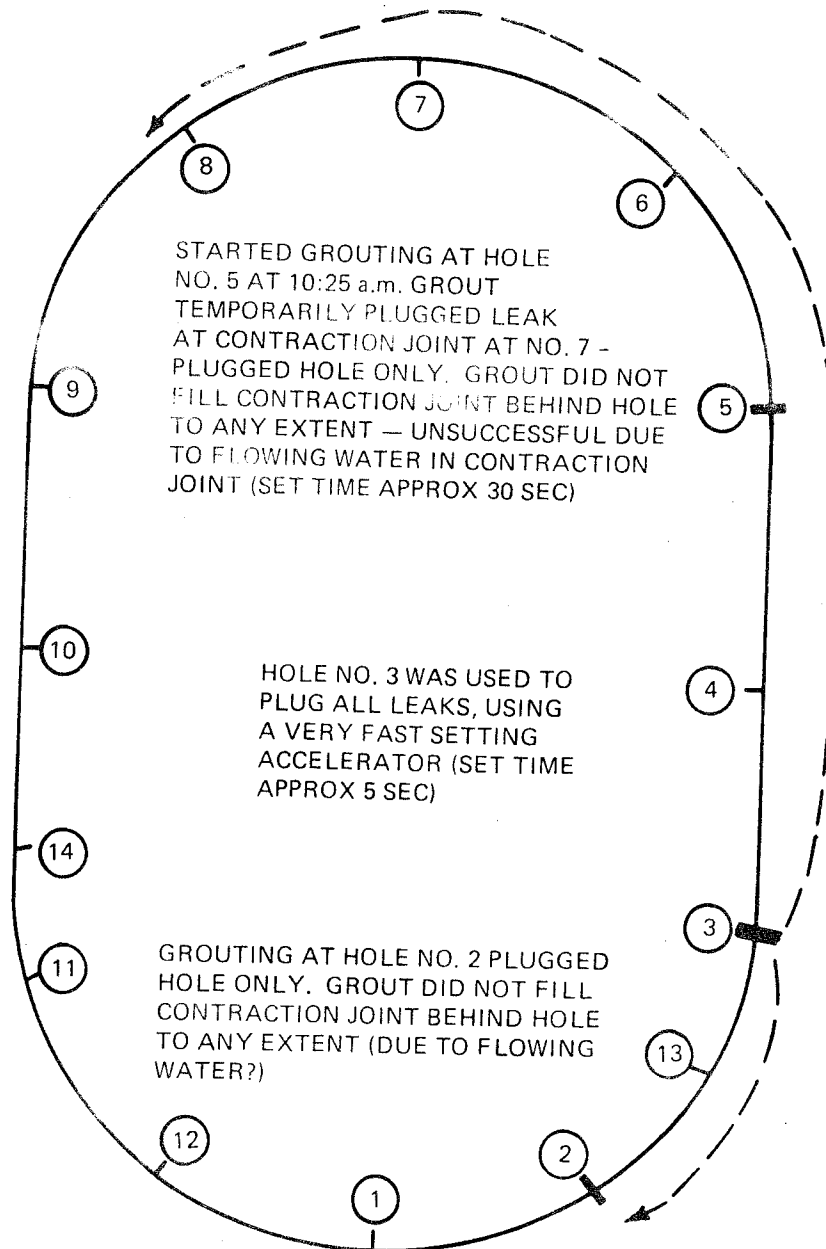
Figure 126. Section at joint 15/16 looking upstream, Applegate Dam

245. Grouting was started on 26 July using a hydrophilic polyurethane gel (CR-250). Grout was pumped into three of the drill holes, starting at hole No. 5 (Figure 126). Grouting at hole No. 5 and 2 apparently plugged those holes but did not fill the joints behind the holes because of flowing water. Hole No. 3 was successfully used to plug all the leaks, because a very fast-setting accelerator was used to shorten the set time of the grout to approximately 5 sec.
