US Army Corps  
of Engineers

# REPAIR, EVALUATION, MAINTENANCE, AND REHABILITATION RESEARCH PROGRAM

TECHNICAL REPORT REMR-CS-4

## REPAIR OF WATERSTOP FAILURES: CASE HISTORIES

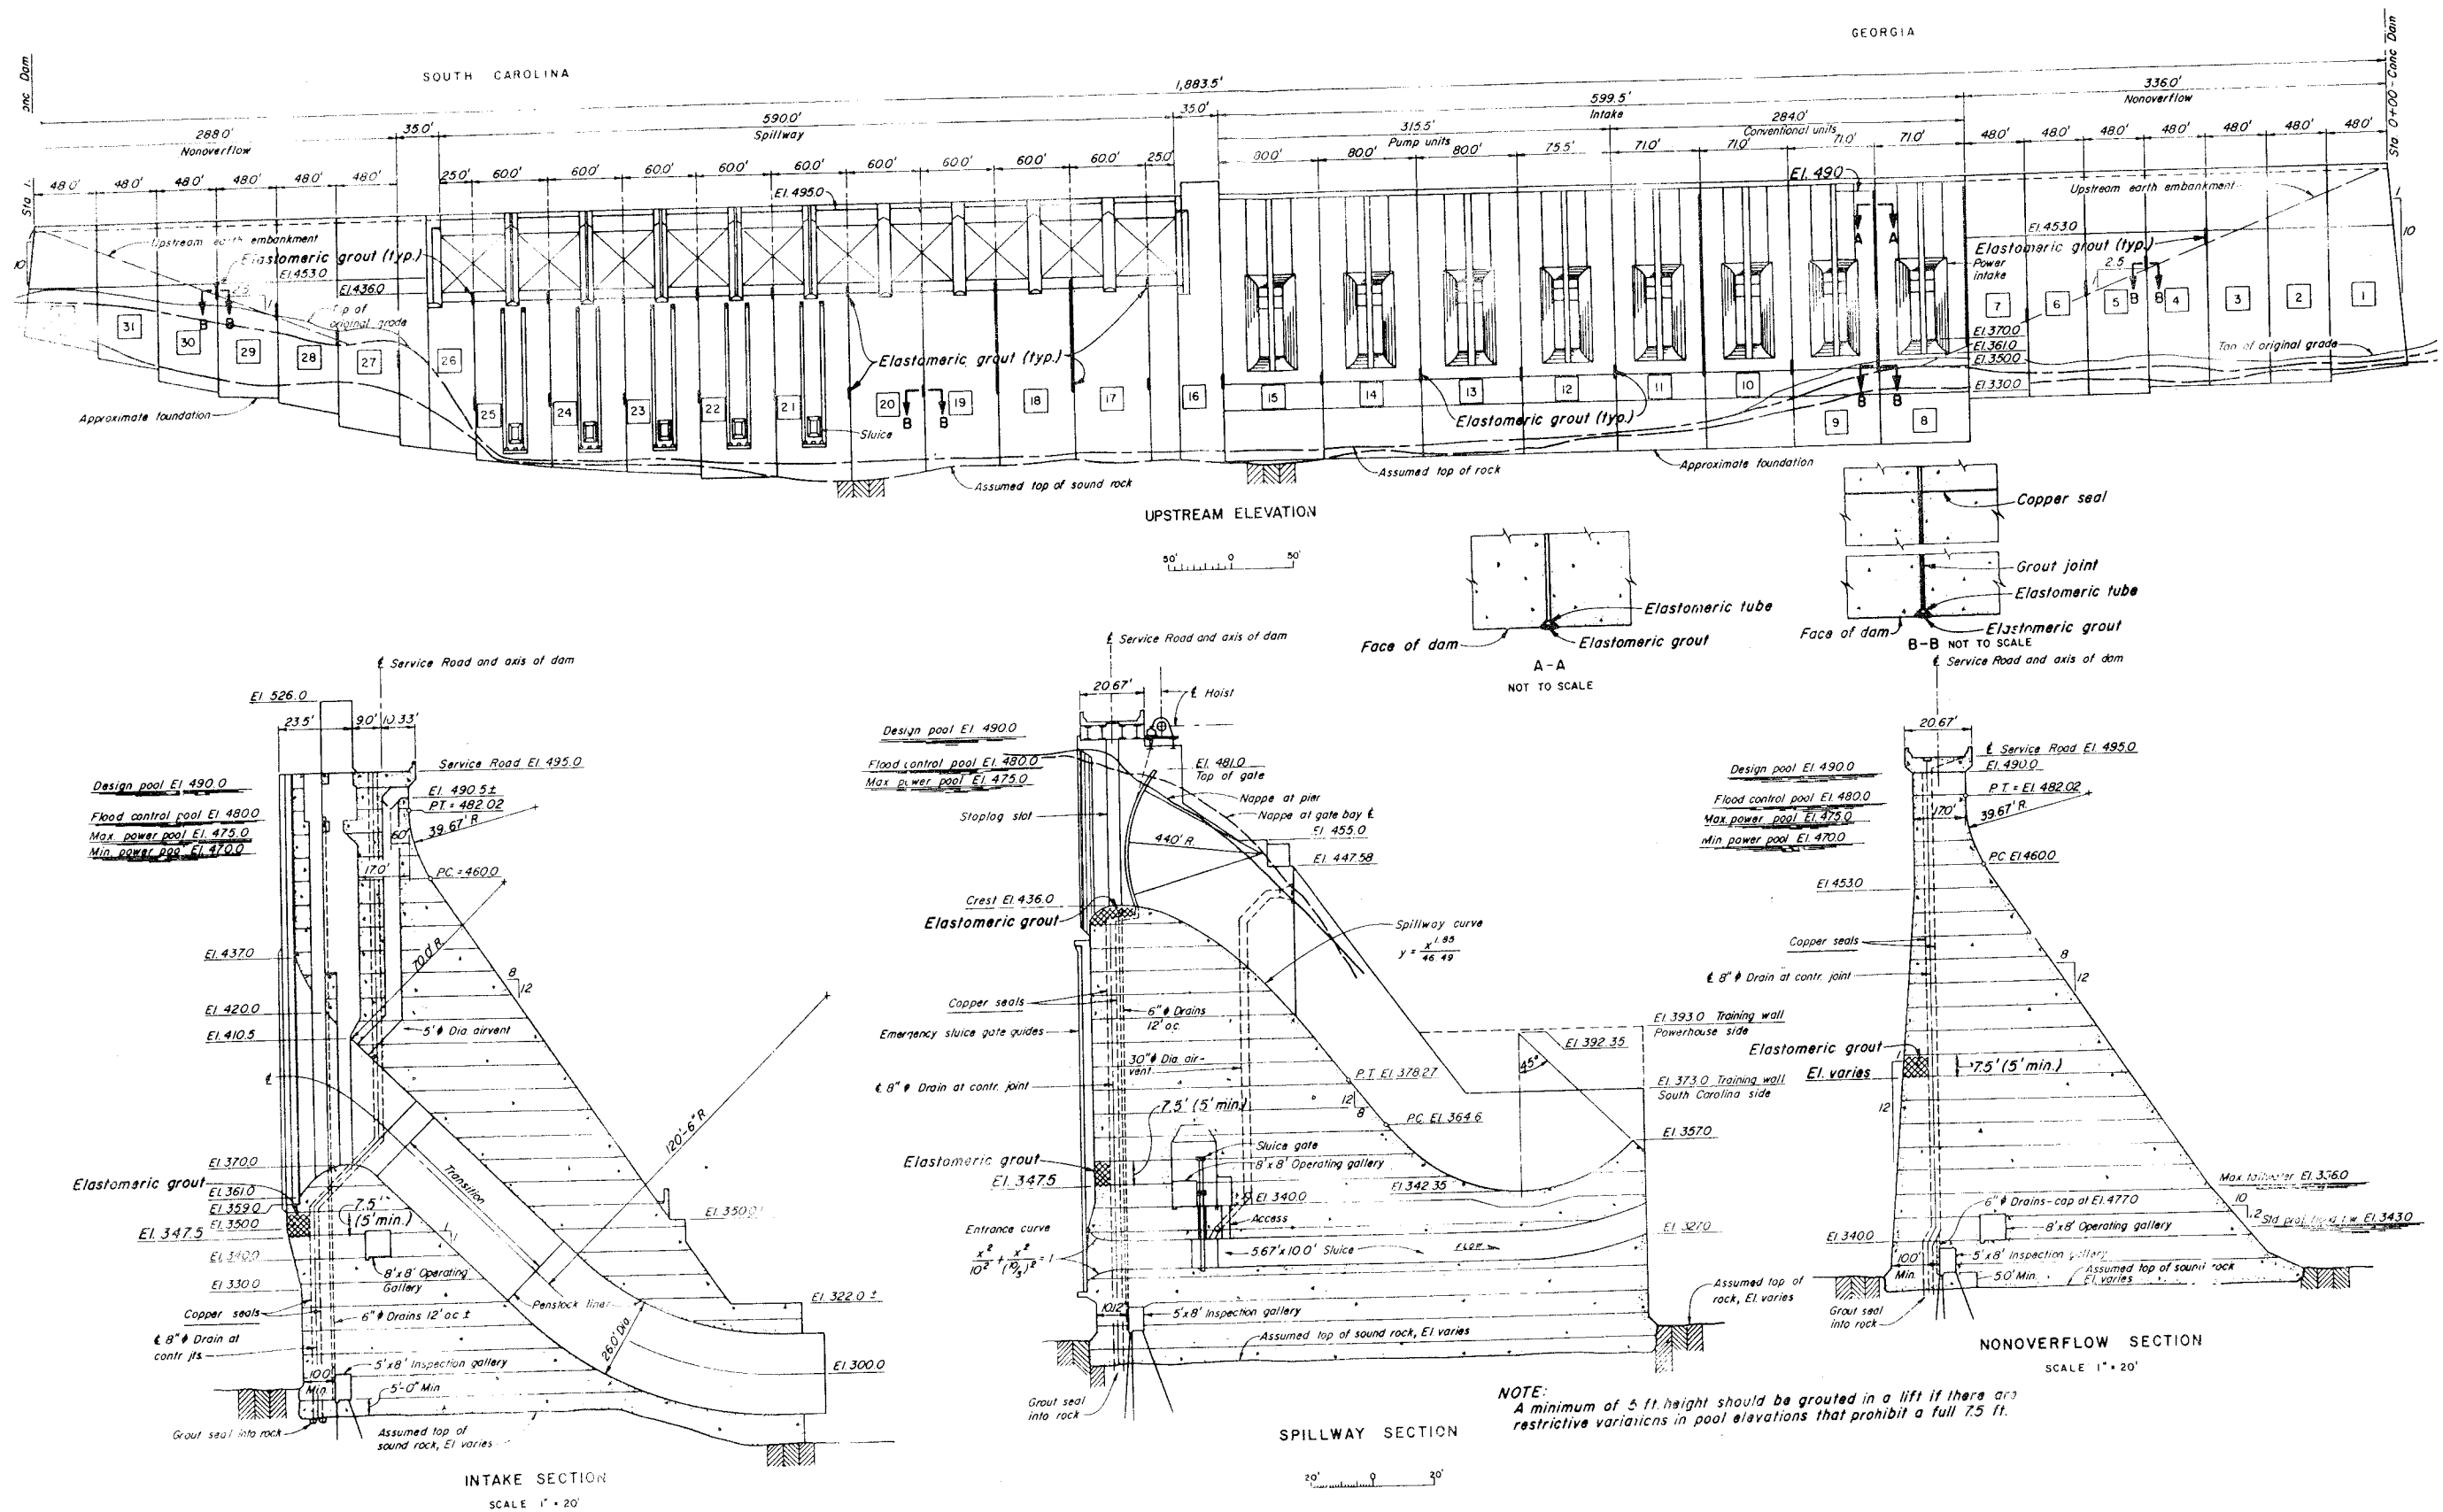
Figure 155. Initial repairs, Richard B. Russell Dam

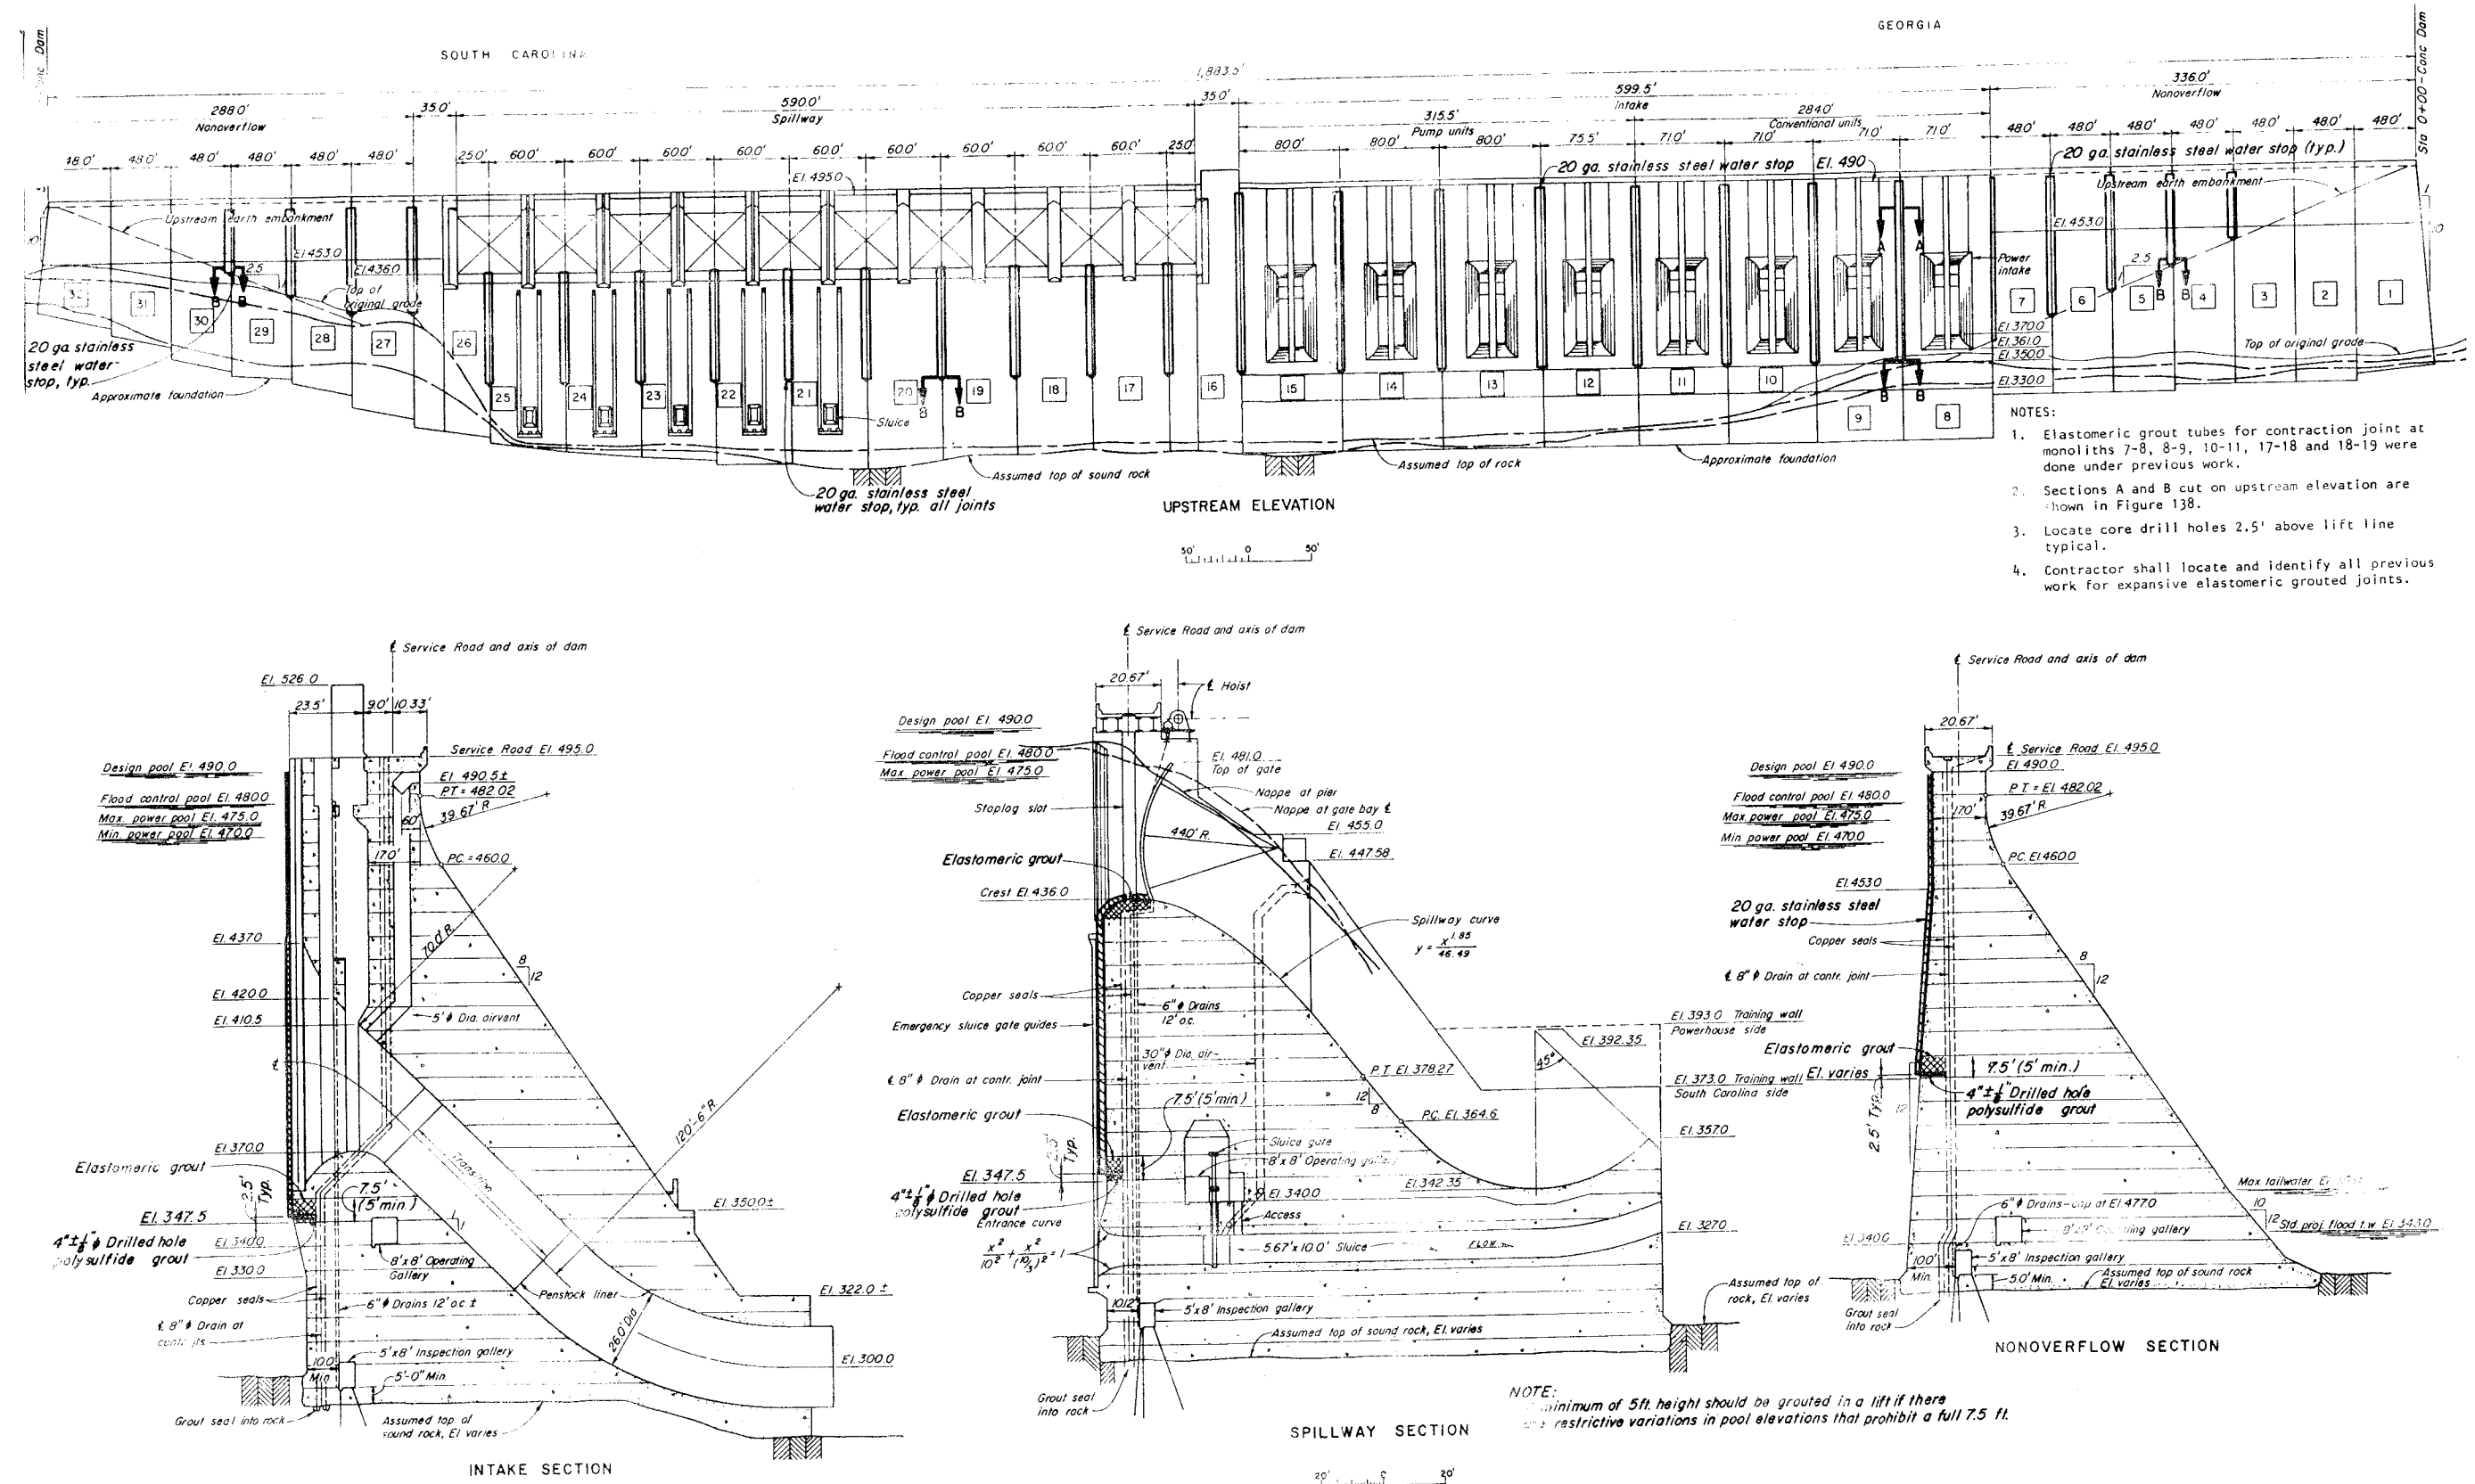
Figure 137. Phase I elastometric grouting of contraction joints, Richard B. Russell Dam

273. Plans and details of the Phase I repairs are shown in Figures 137 and 138. Phase I repair procedures, refinements of the methods used in the initial repair, were as follows:

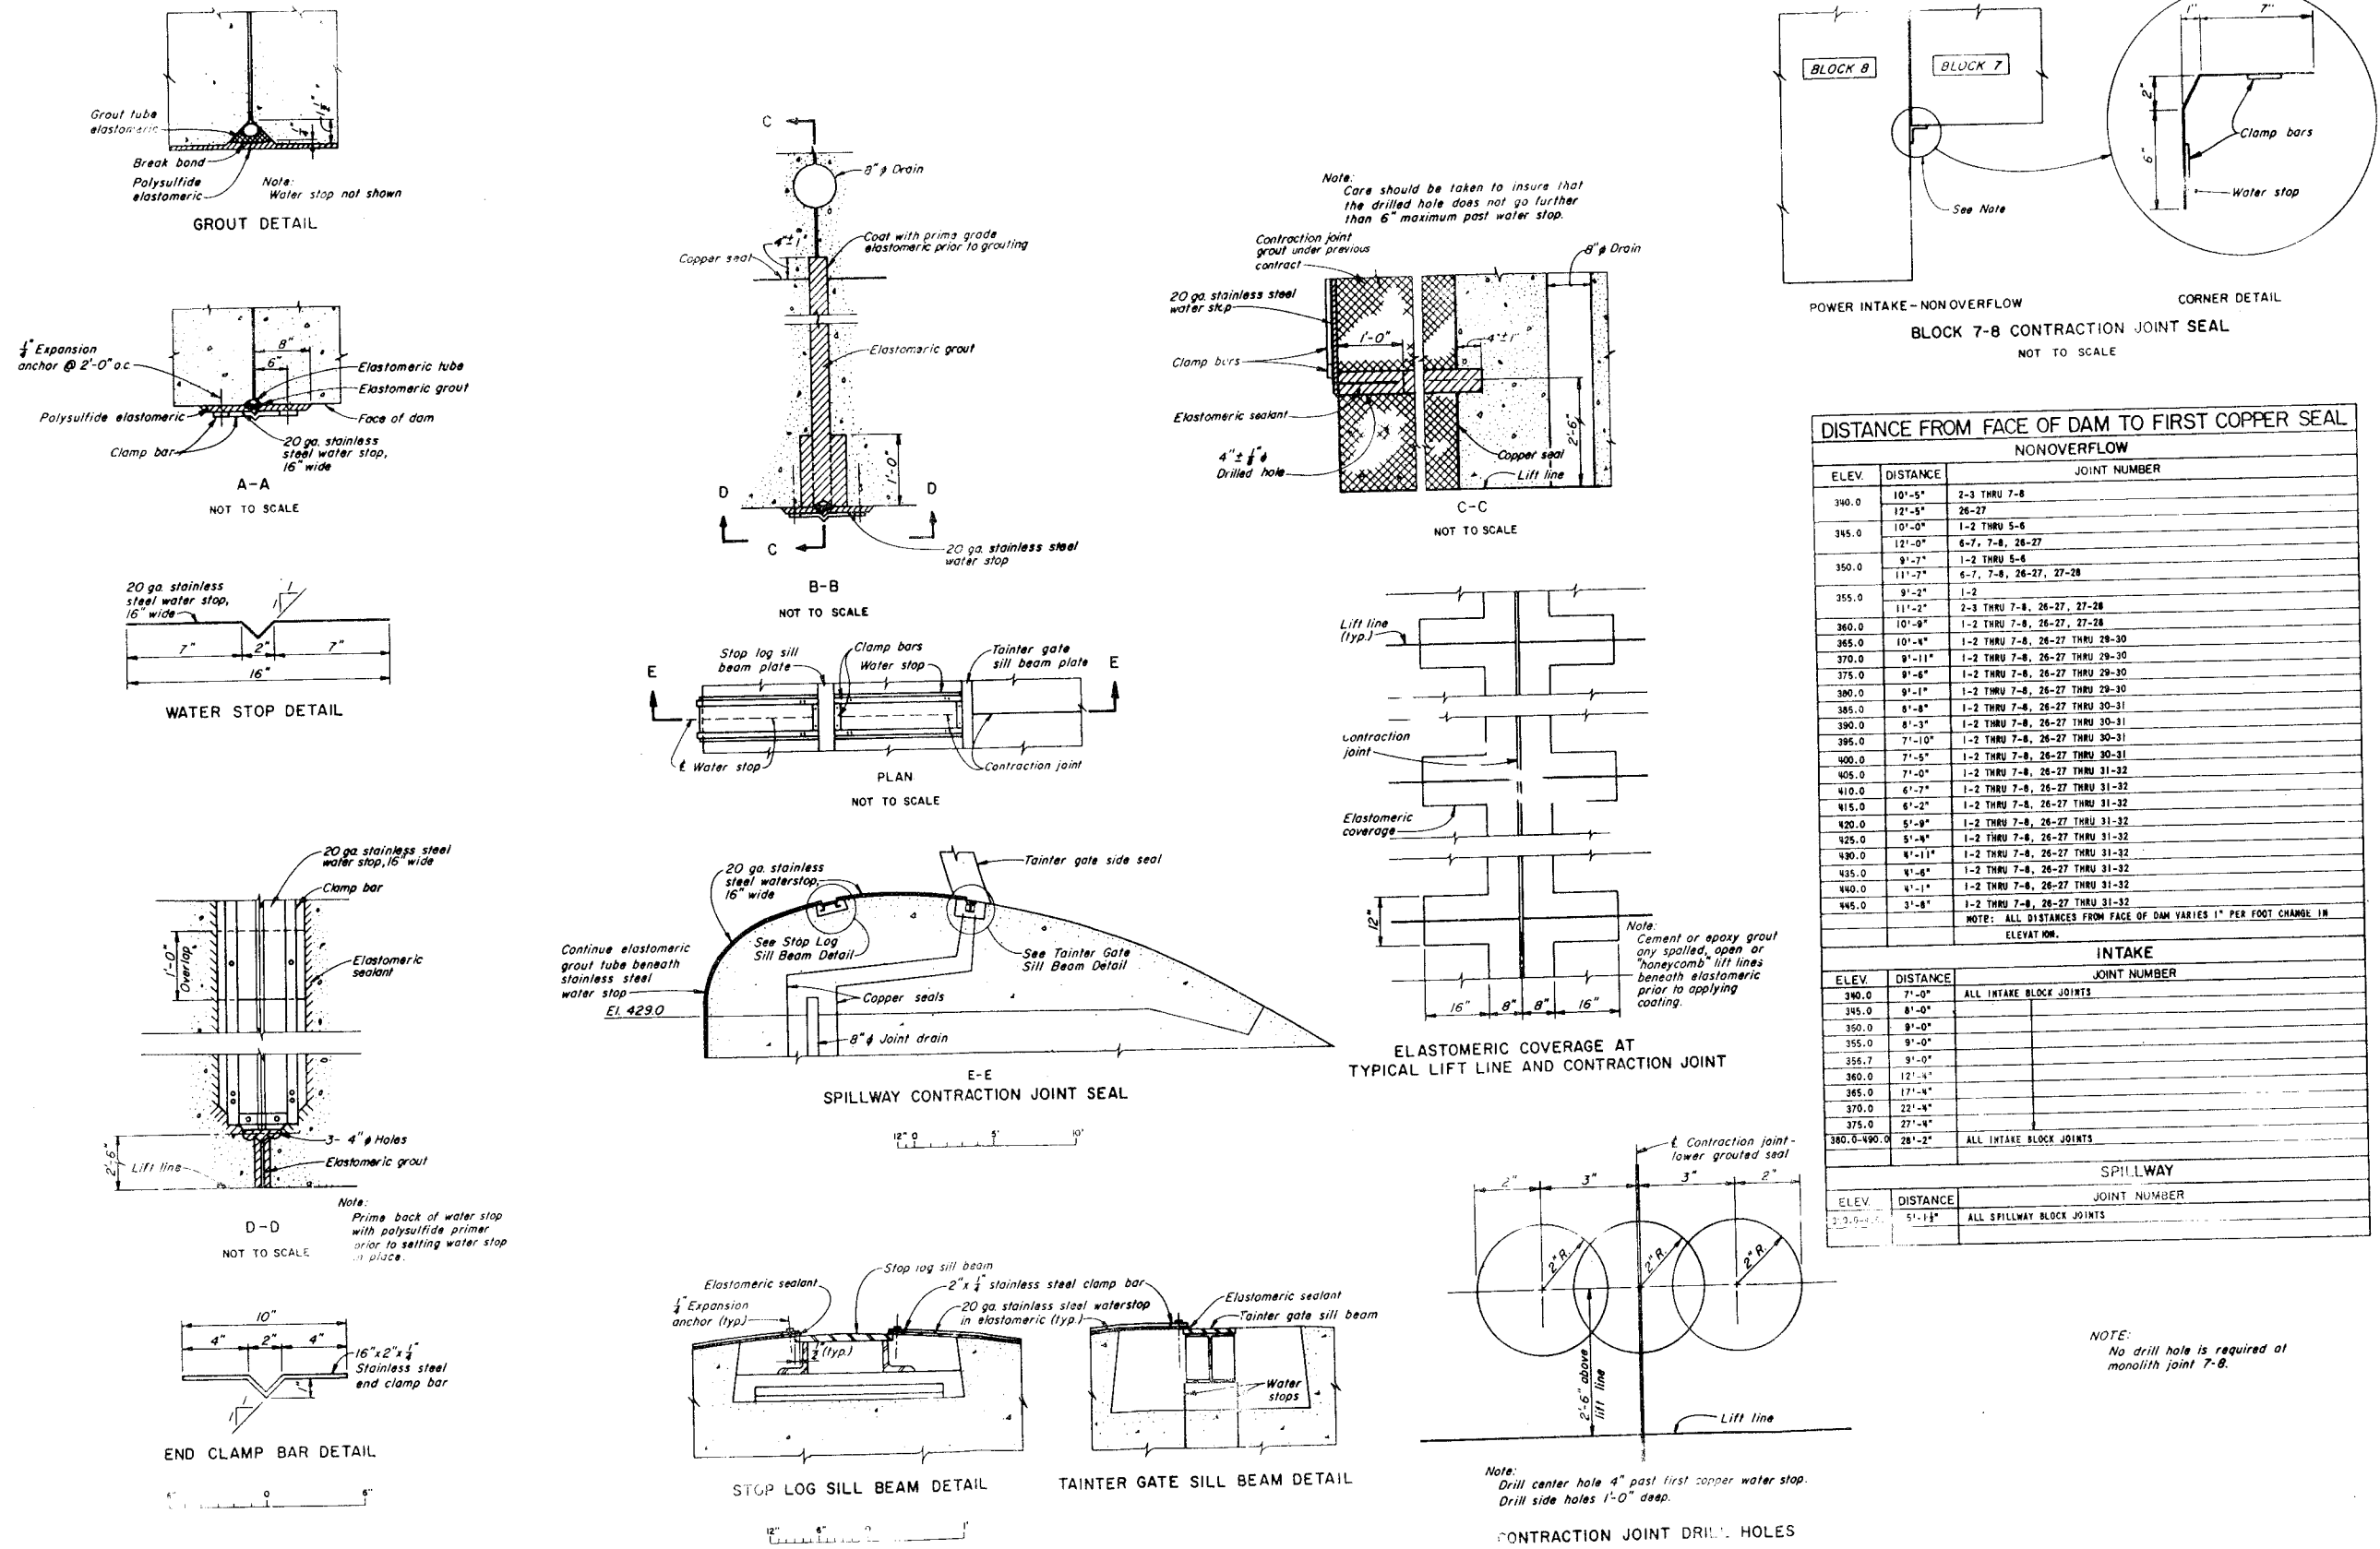
Figure 138. Phase I repair details, Richard B. Russell Dam

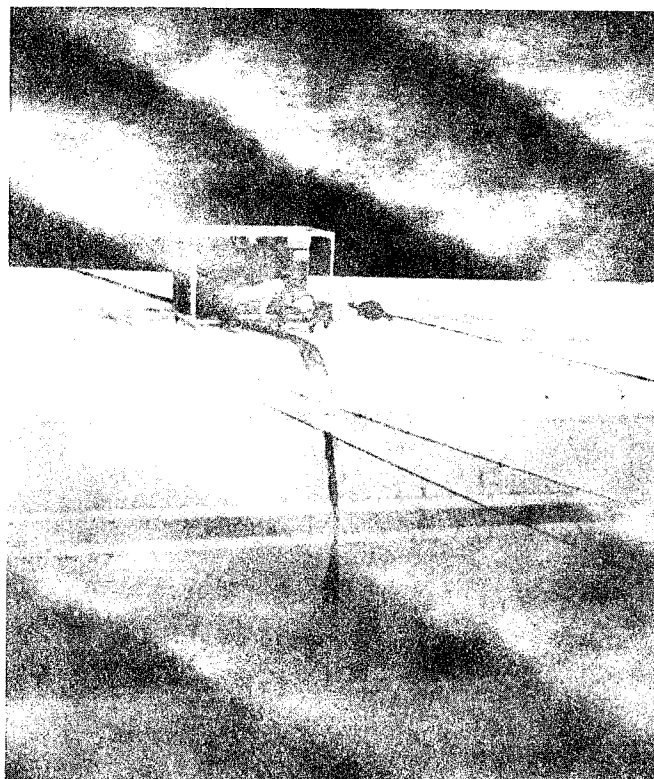
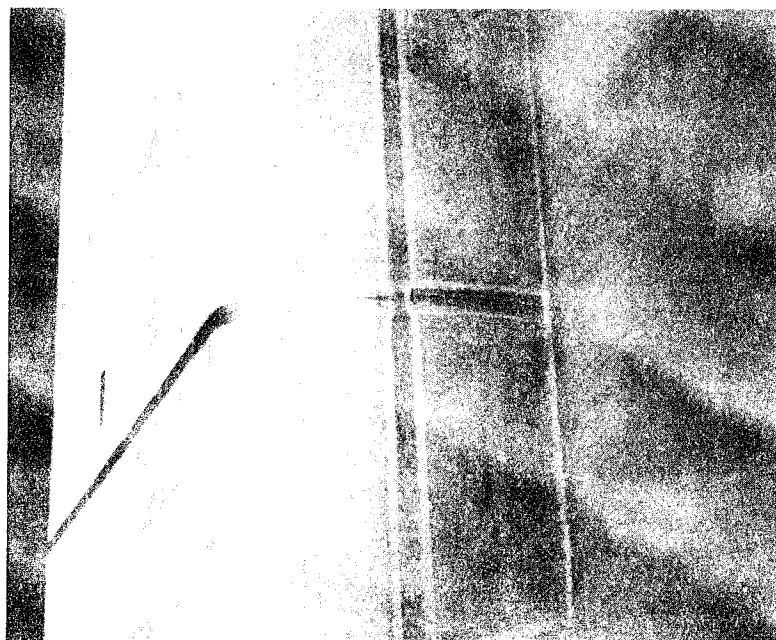
Figure 140. External waterstop, Richard B. Russell Dam

a. During installation

b. Completed waterstop

- c. The remainder of the "V" joint was then filled with a polysulfide sealant that was also spread 8 in. of either side of the joint. Before the sealant set, a stainless steel waterstop, 20-gage thickness and 16 in. wide, was installed over the contraction joints (Figures 140 and 141). The external waterstop was tied into the lower polysulfide grout core and extended upward to elevation 490 ft. Special attention was given to sealing contraction joints in the spillway section. These joints were sealed into the internal copper waterstops on the spillway crest as well as at the lower joint seals.

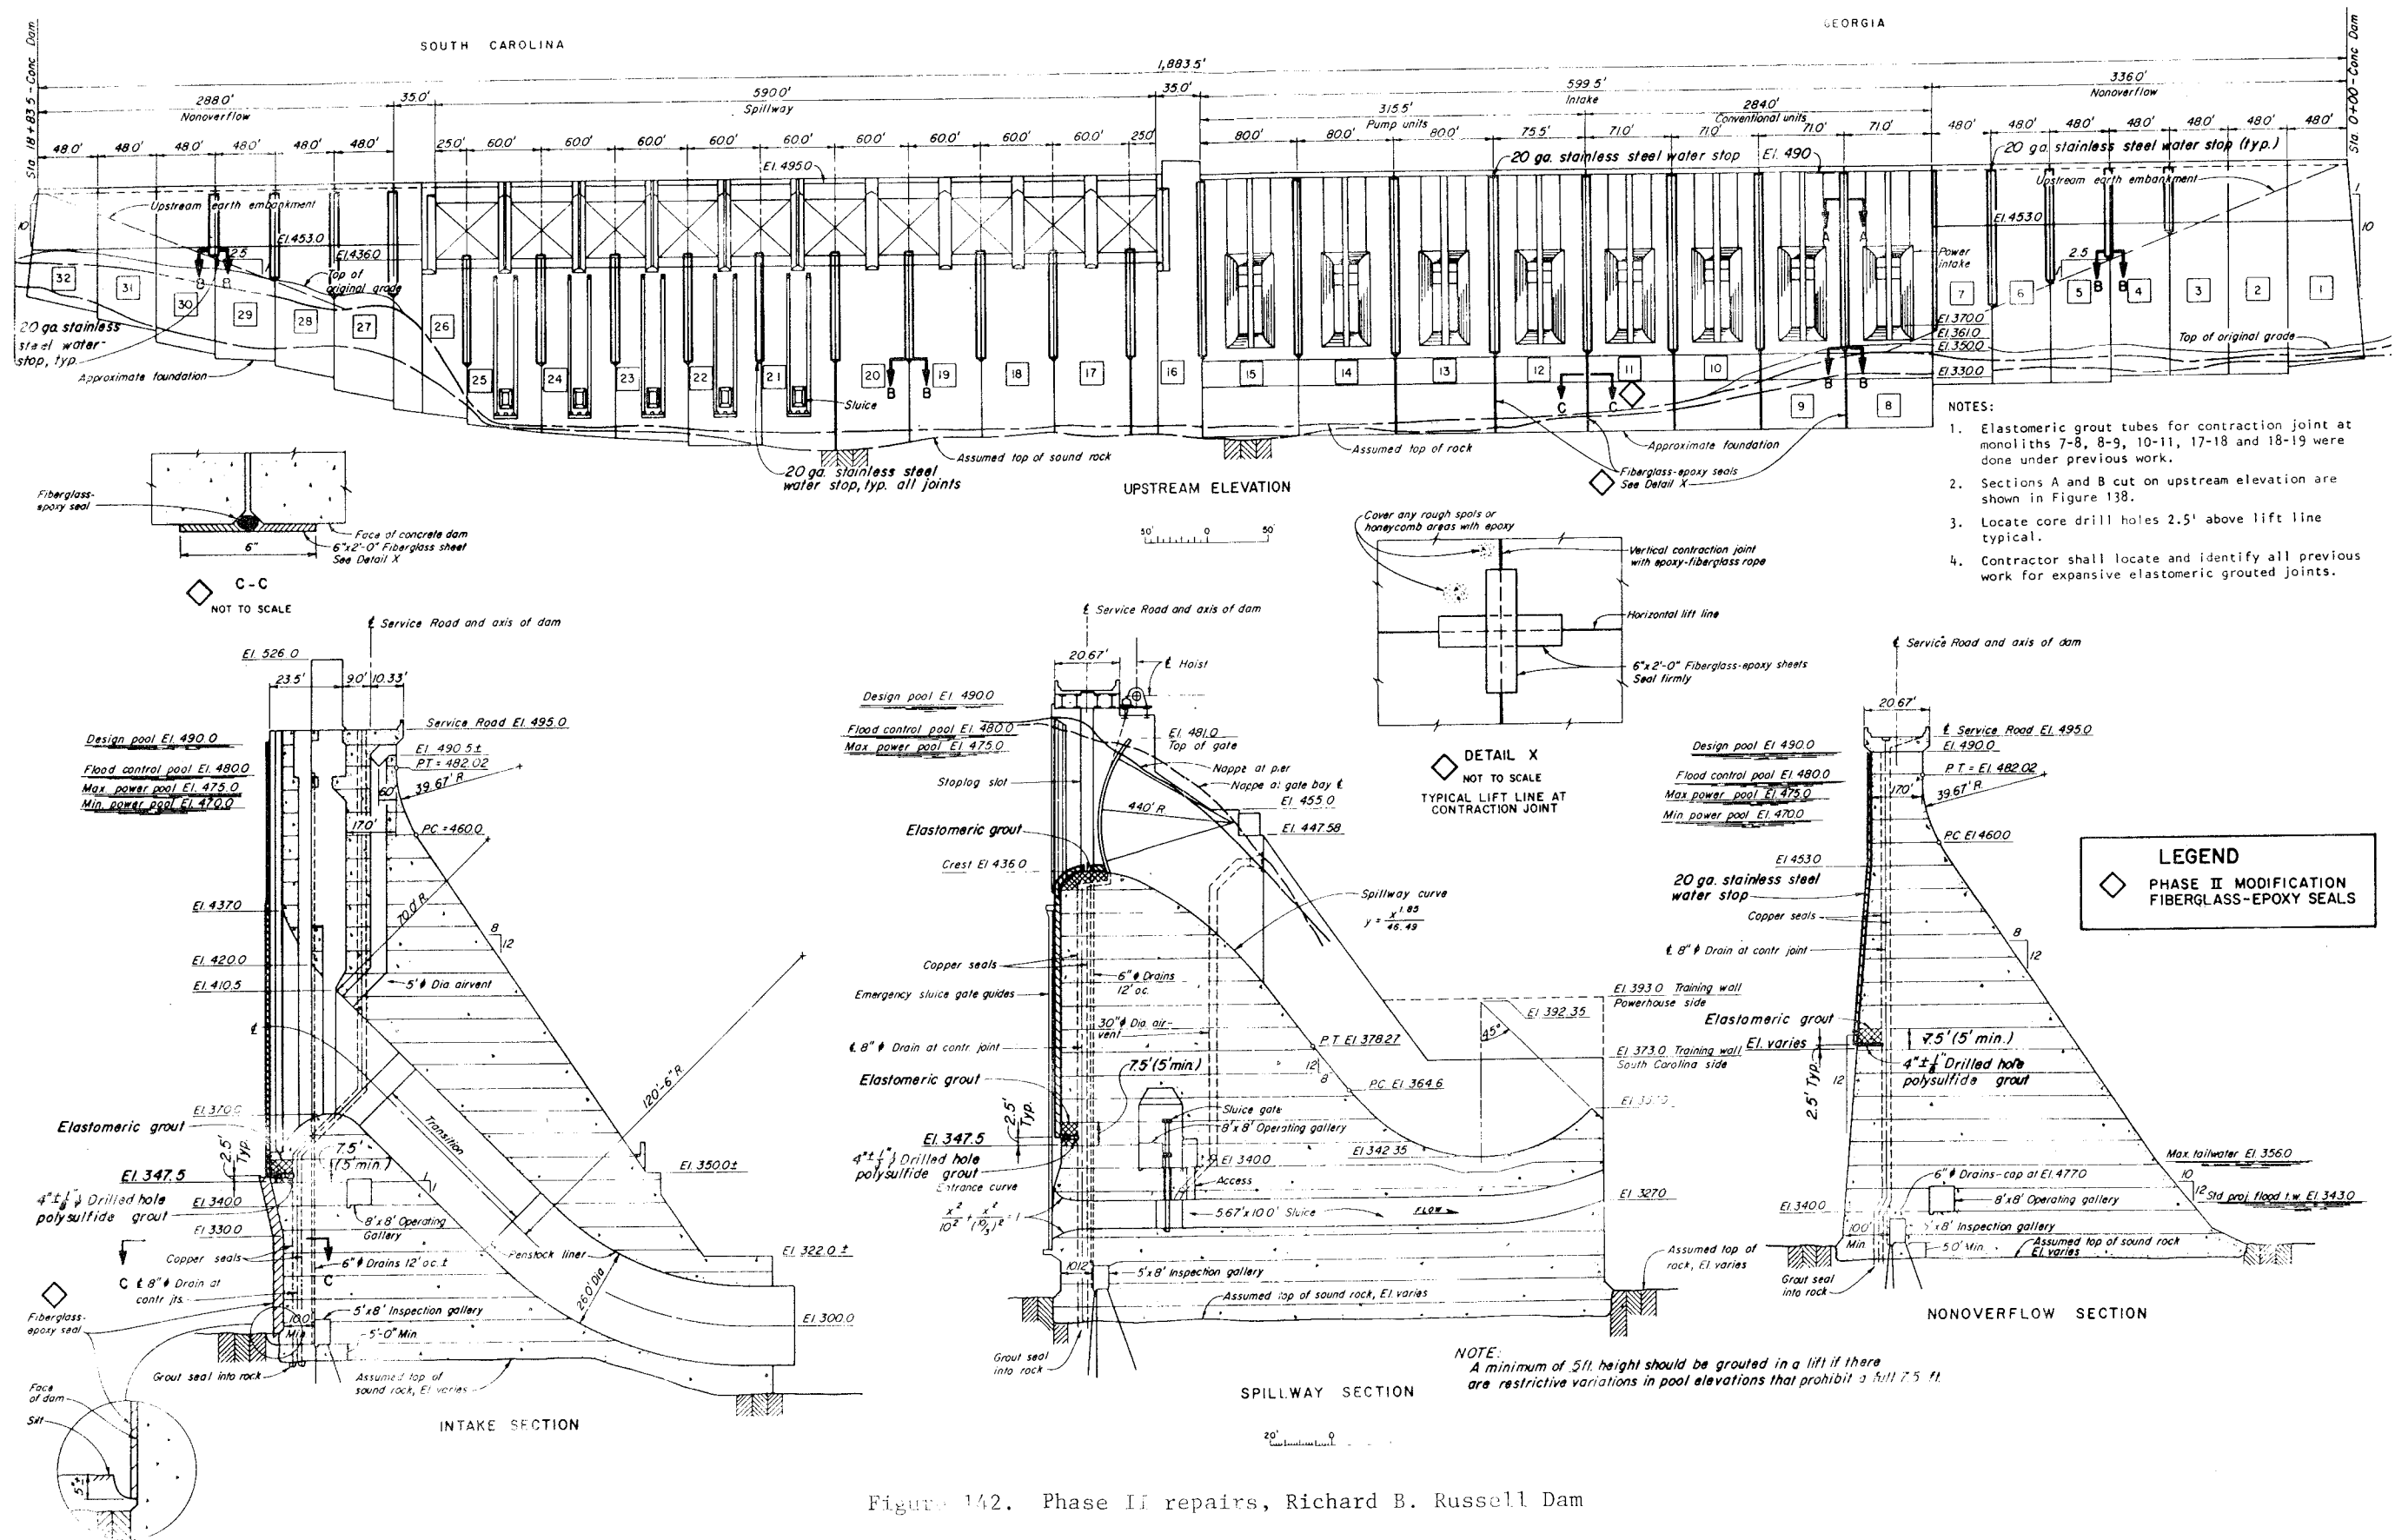
Figure 142. Phase II repairs, Richard B. Russell Dam

283. Phase II repairs, undertaken while the lake rose approximately 75 ft, reduced the leakage from approximately 950 to 350 gal/min. In addition, it is believed that the repair also kept the leakage from increasing substantially as the pool was raised. Therefore, the repairs were considered to be an overall success. Regarding individual repair methods, the use of Silva-Cel wood fibers, cinders, and bentonite had no noticeable effect on stopping the leakage. Application of an external sheet rubber waterstop was only temporarily effective due to failure of the bonding agent. Underwater grouting from the reservoir side was very difficult and only partially effective. The application of fiberglass-epoxy resin strands and patches on the exterior of the concrete dam under water produced very good results. Grouting from the gallery interior was effective, but it was difficult to keep the grout out of the drains. Two drains were clogged, one intentionally.

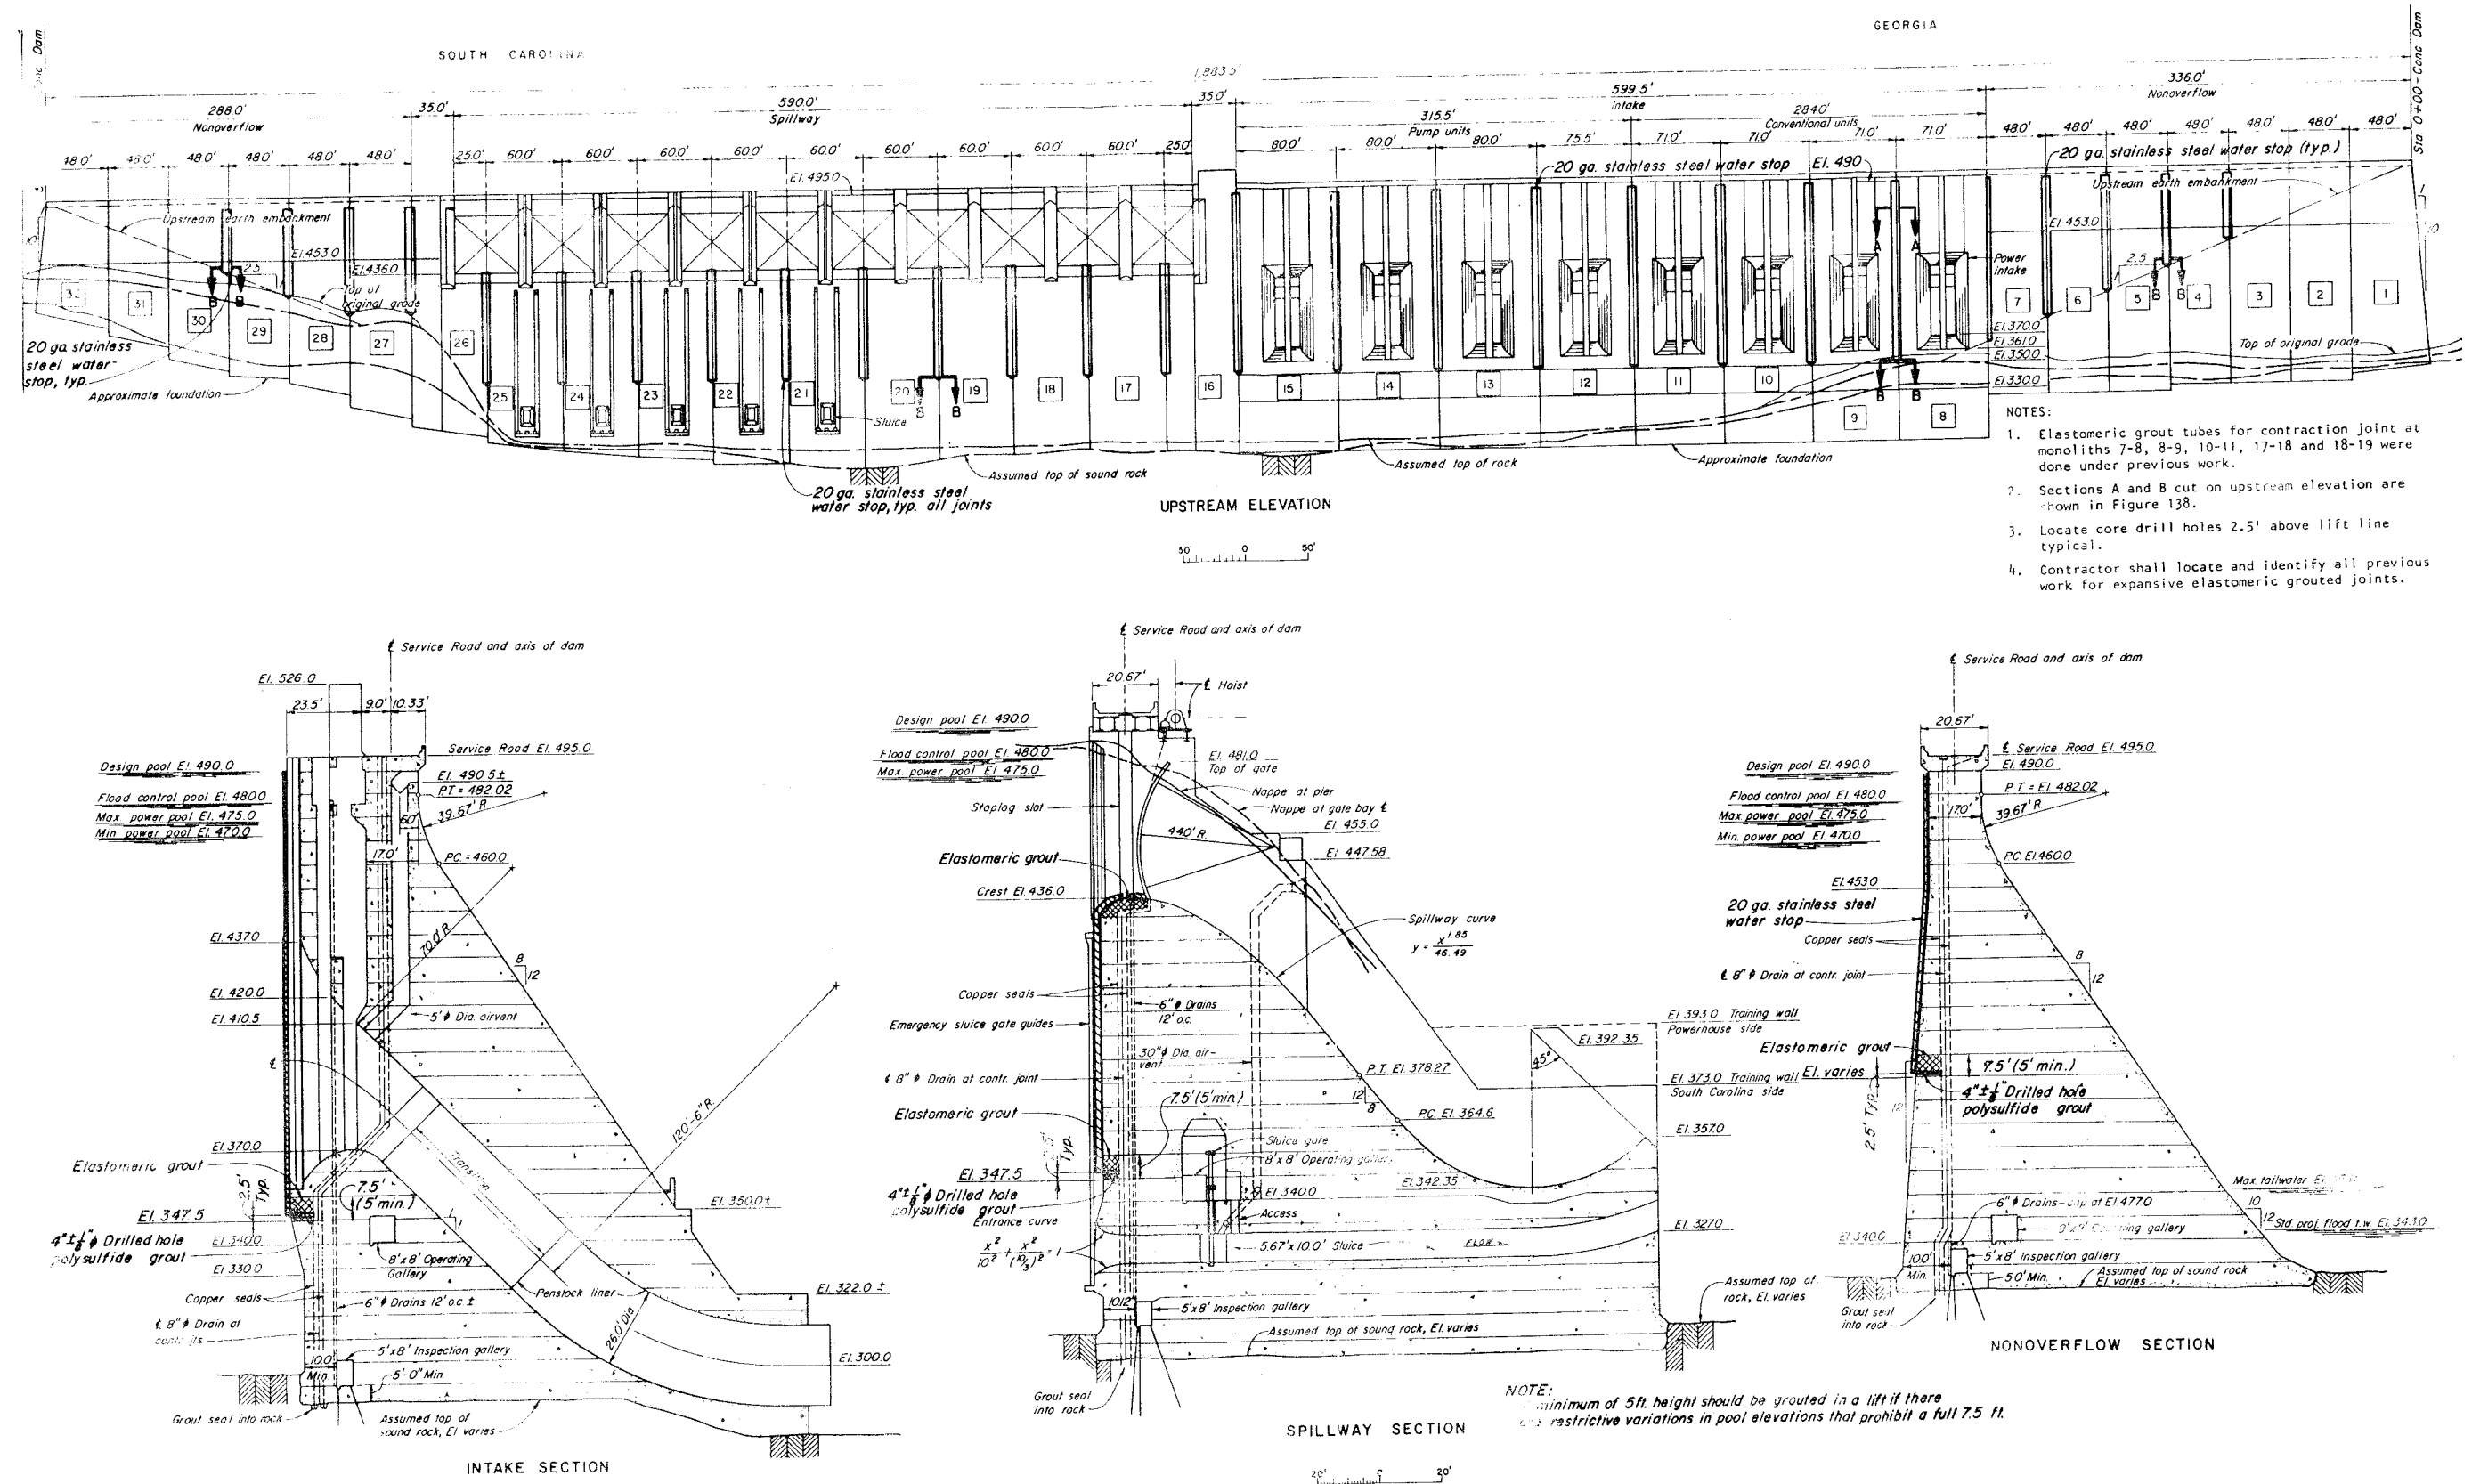
Figure 137. Phase I elastometric grouting of contraction joints, Richard E. Russell Dam

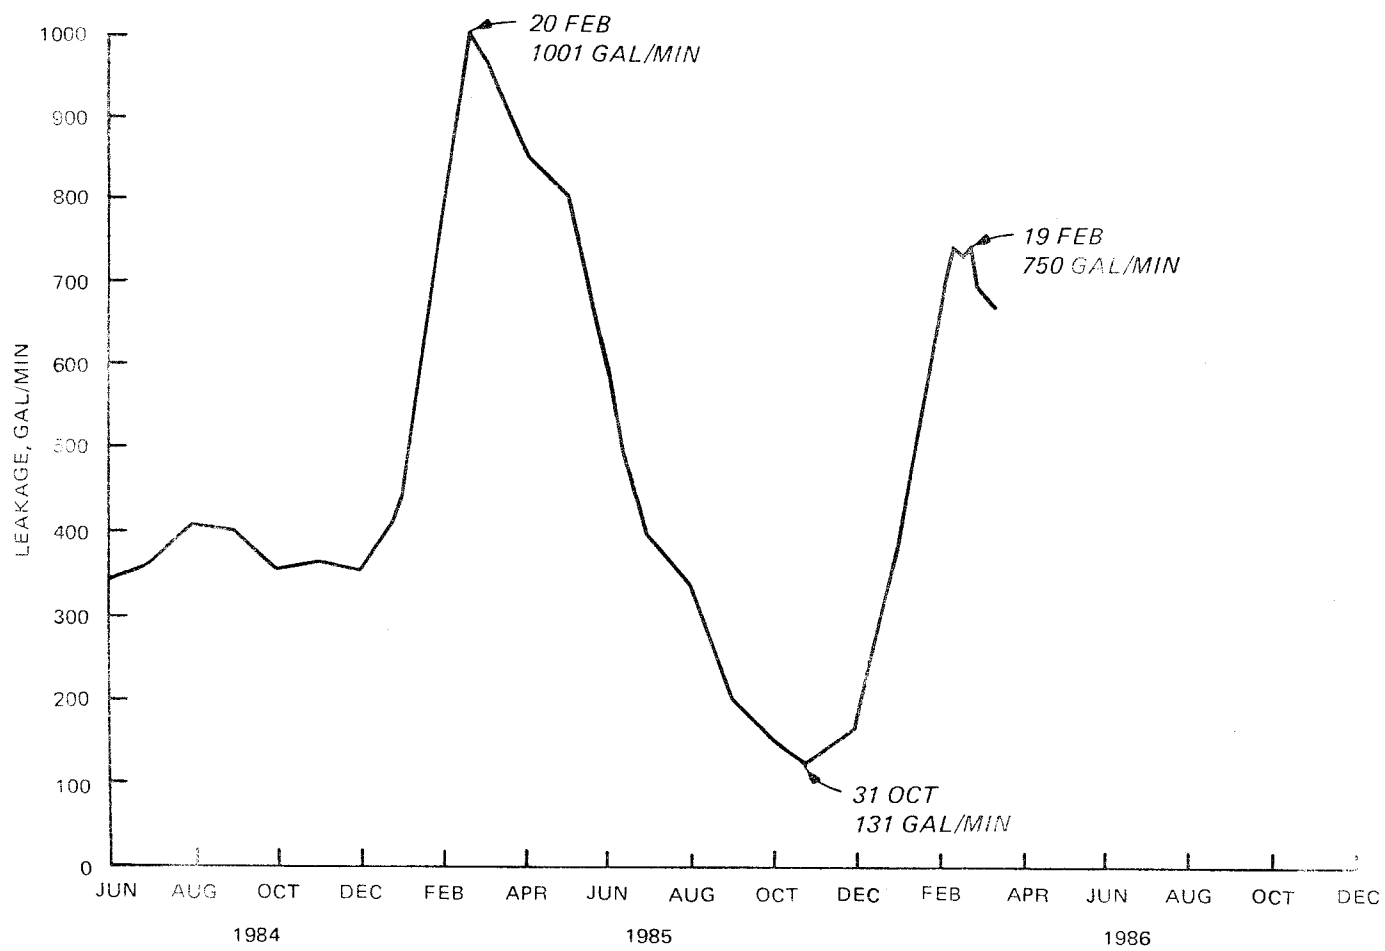
repairs, a maximum leakage of 1,001 gal/min was recorded on February 20, 1985 followed by a steady decline to 131 gal/min on October 31, 1985 (Figure 143). In 1986, the maximum leakage of 750 gal/min was recorded on February 19. Continued measurements and observations are planned through another winter cycle. Based on experience at other dams, it is believed that the formation of calcium carbonate will further reduce the leakage.

Figure 143. Results of leakage measurements, Richard B. Russell Dam

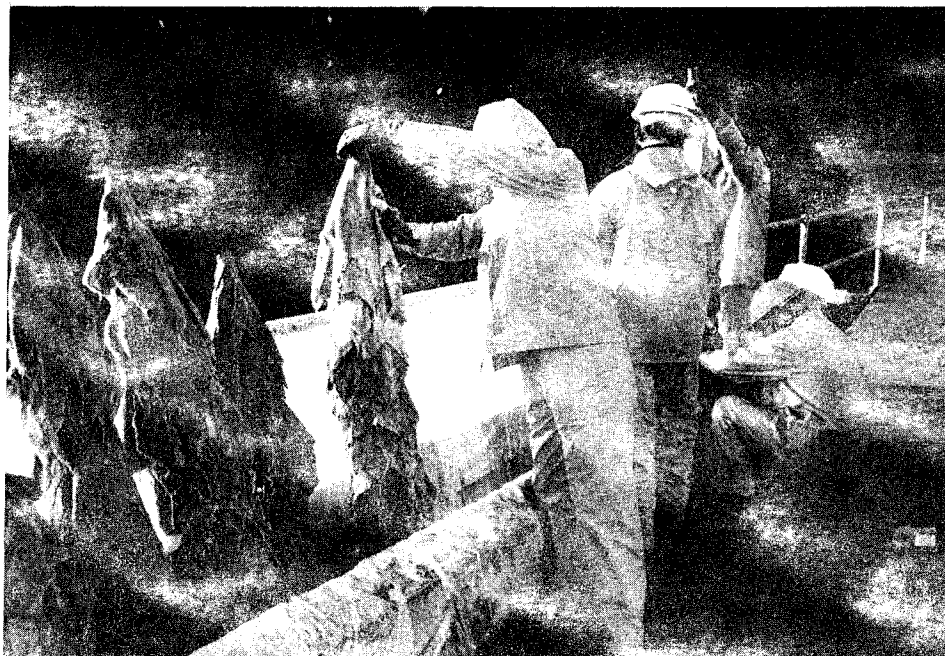
Figure 144. Soaking burlap "Christmas trees" in polyurethane foam grout, Easton Reservoir Dam

287. The grout used was TACSS Flex 44, a polyurethane foam with Environmental Protection Agency (EPA) approval for use around potable water. Because of concerns about the grout being washed through the joint before it set, the grout was not pumped directly into the hole. Burlap was cut into 24-in. squares and attached to a 1-1/2-in.-diameter plastic pipe on approximately 1-in. centers with the pipe through the center of the burlap squares. The pipe sections with the burlap attached were soaked in a long trough filled with the Flex 44 grout (Figure 144). The pipe was removed from the trough and after the excess grout drained off, the pipe was inserted into the hole (Figure 145). The pipe sections were designed to fit together rapidly and lock so the entire 35-ft length of hole could be filled with the burlap and grout
