US Army Corps  
of Engineers

# REPAIR, EVALUATION, MAINTENANCE, AND REHABILITATION RESEARCH PROGRAM

TECHNICAL REPORT REMR-CS-4

## REPAIR OF WATERSTOP FAILURES: CASE HISTORIES

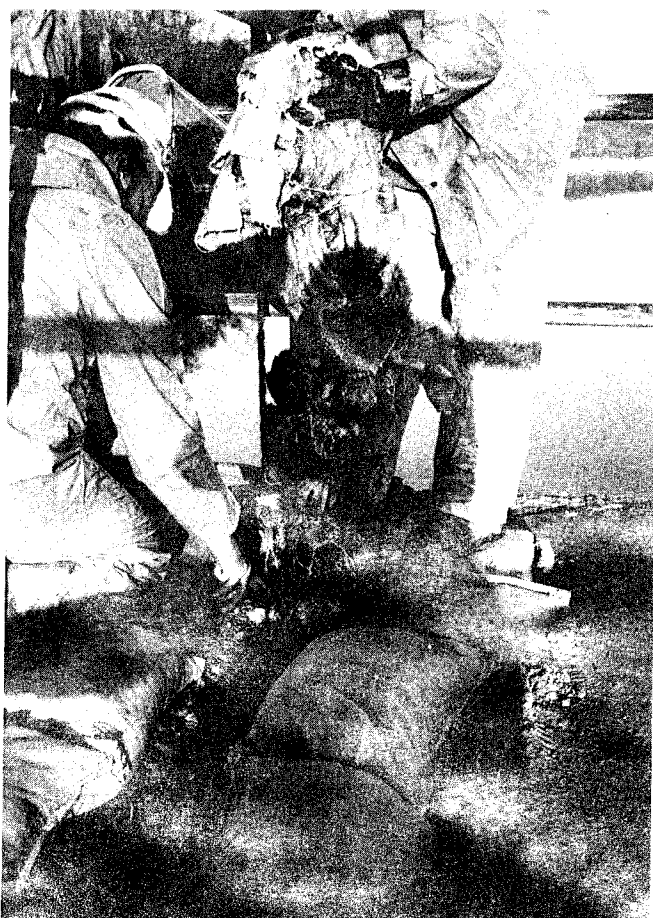
Figure 145. Installing "Christmas tree" in the drill hole, Easton Reservoir Dam

before the grout started to form. This arrangement allowed for positive placement of the grout and removal of the "Christmas tree," if required during installation, before the grout formed. Because most of the holes were dry, water was pumped into the hole after the "Christmas tree" was placed to activate the form. The holes were capped flush with the roadway surface using a concrete plug.

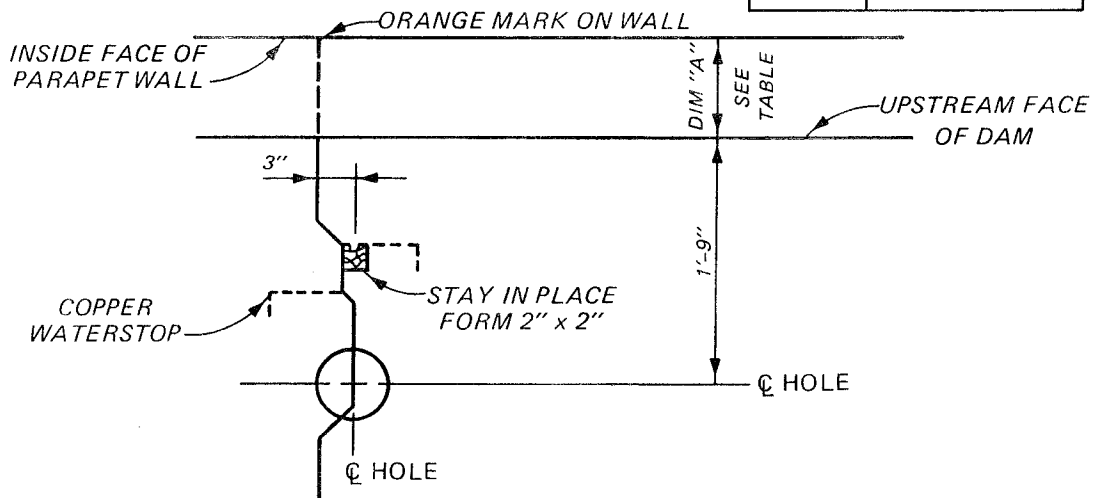
Figure 147. Drill hole locations, Bagnell Dam

291. Construction Drilling, Inc. (CDI), the drilling subcontractor, began mobilizing on 3 April 1984. The mobilization took about a day and a half because numerous patches in the roadway had to be planked and bridged over, a requirement of the Missouri State Highway Department. CDI used an Acker track-mounted drill rig with many modifications specifically for drilling with a down-the-hole hammer. Drilling was accomplished with a 6-in. down-the-hole hammer, a type of rotary/percussion drilling equipment. The head of the hammer pounds as it rotates. At 150 psi, the hammer is operating at approximately 1,000 blows/min. This rate varied as the air pressure at the hammer changed due to depth and frictional losses. In addition to the down-the-hole hammer, a 6-in. core barrel was used to obtain concrete core to verify joint location in the borehole. Drill hole locations are shown in Figure 147.

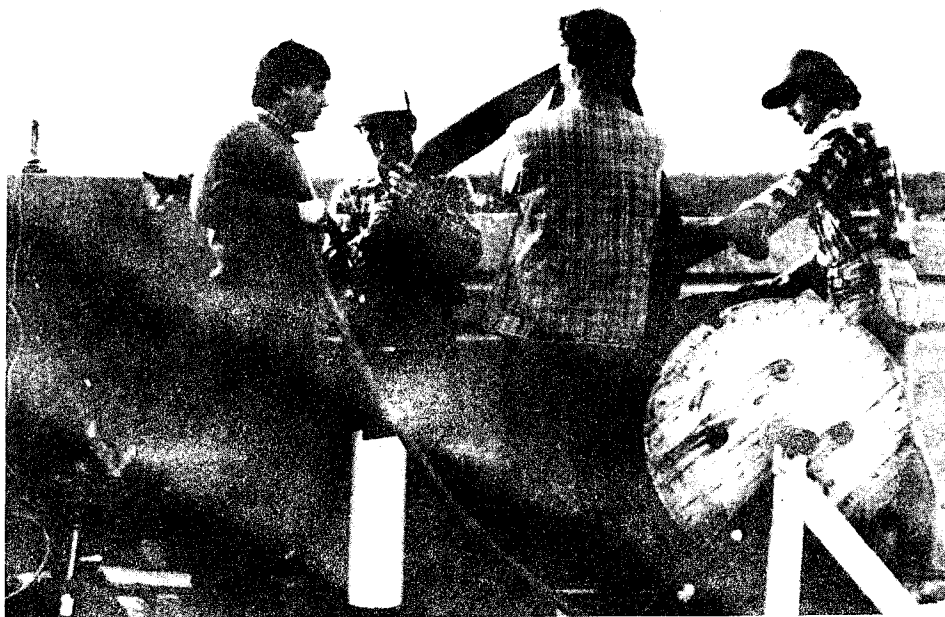
Figure 149. The inversion process underway, Bagnell Dam

302. The intended method of sleeve installation initially was by the inversion process. The inner sleeve was to be delivered inside out to the jobsite. The outer sleeve was to be weighted and lowered into the hole first (Figure 148). Next the inner sleeve was to be attached to a temporary flange at the roadway surface. The inner sleeve would then be inverted down the hole by turning it inside out and filling the annular space with water (Figure 149)

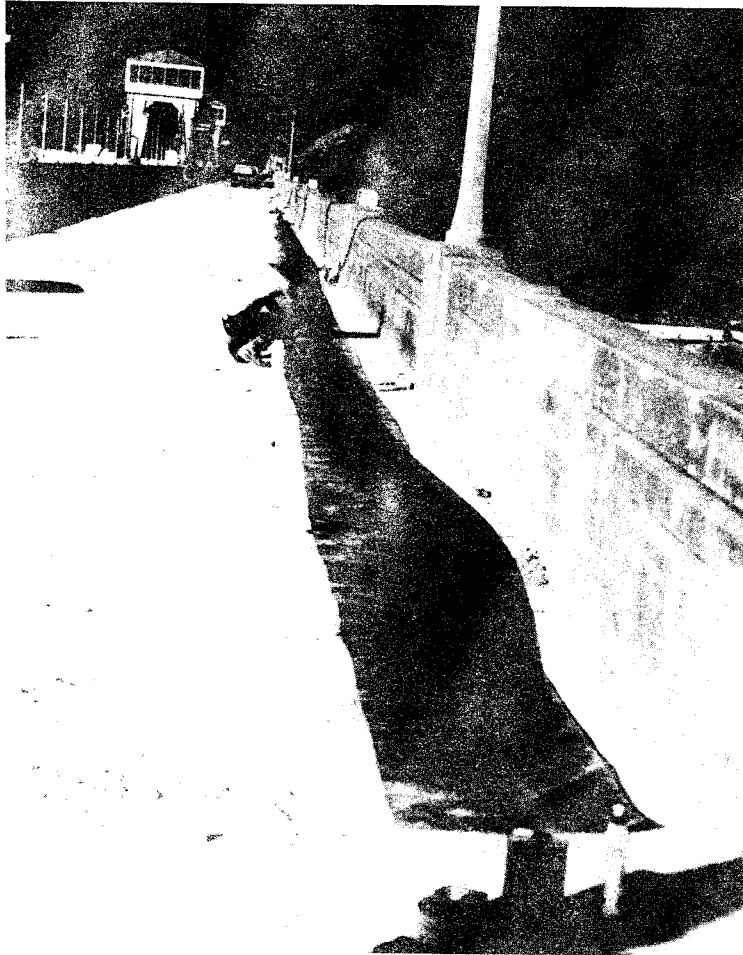
Figure 151. Soap testing the inner sleeve,  
Bagnell Dam

- a. The outer sleeve was rolled out on the roadway deck and cut to the appropriate length. Next, the inner sleeve was placed on the outer sleeve and a packer placed in its open end. Approximately 10 psi of air was then induced into the inner sleeve and it was soap tested for leaks (Figure 151). In the event that any leaks were found, they were repaired by patching with a commercially available tire patch and vulcanizing fluid, a method approved by Rubber Engineer Company.
- b. Once the leak test and any necessary patching was complete, a 10-lb weight was attached to the end of the composite sleeve. The weight consisted of either a piece of 1-1/2-in.-diameter

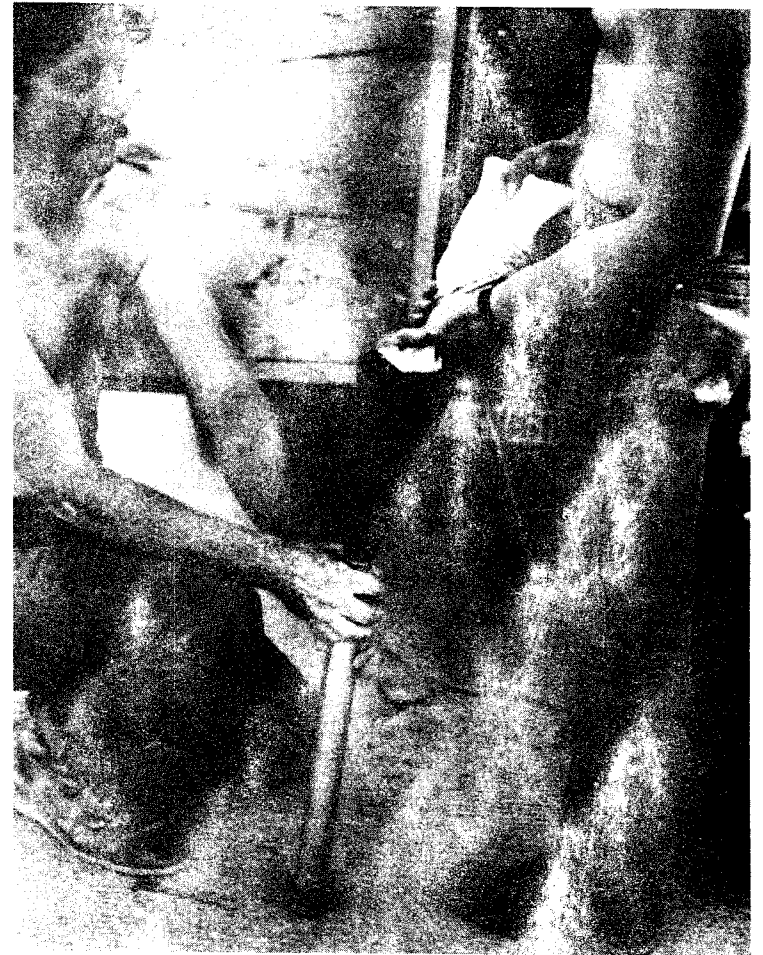
Figure 152. Steel pipe filled with lead shot  
to weight the composite sleeve, Bagnell Dam

steel pipe filled with lead shot, a piece of 2-in.-diameter polyvinyl chloride pipe filled with lead shot, or a lead doughnut 4 in. in diameter (Figure 152).

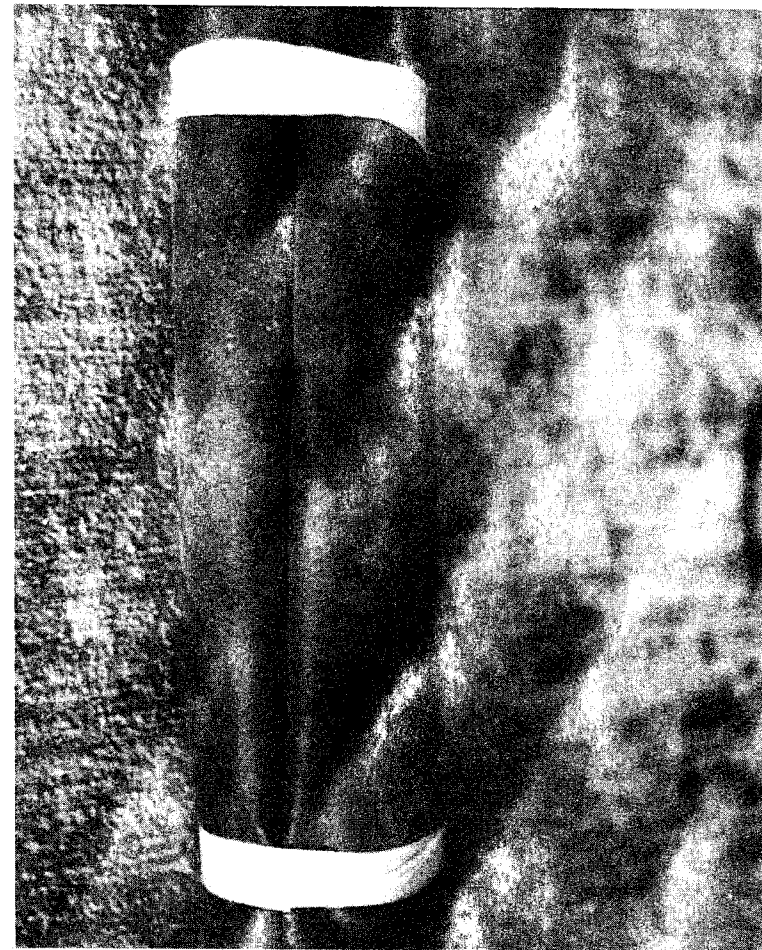
a. Overall view

b. Close-up

Figure 153. Composite sleeve ready for installation, Bagnell Dam

diameter and secured with masking tape bands spaced at approximately 12 in. on center (Figure 153).

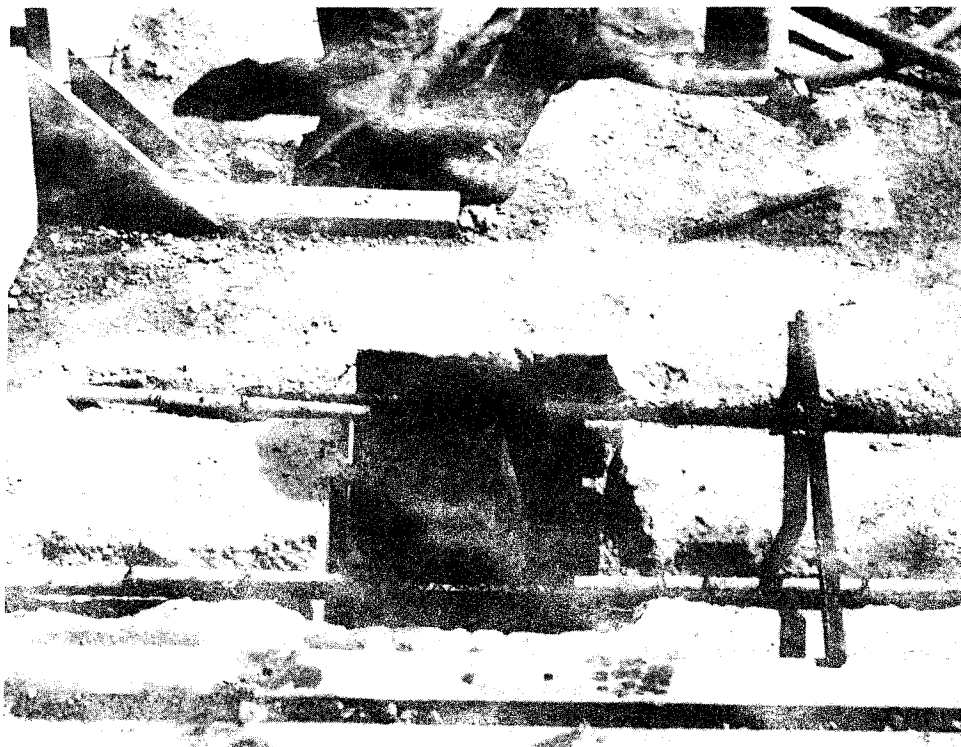
Figure 154. Composite sleeve installed, Bagnell Dam

- e. After the sleeve was prepared and the final video of the borehole completed, the composite system was lowered in the hole, weighted end first. When the composite sleeve was at the bottom, it was rolled over and attached to a temporary flange at the roadway surface (Figure 154). The outer sleeve was marked at 10-ft increments so that it was known that the sleeve was actually lowered to the bottom of the hole.
- f. Once the sleeve was in the bottom of the hole, it was filled with water. Because of the weight of the water and the fact that the adhesive on the masking tape was water soluble, the banding straps would break and the sleeve would seat against the borehole walls.

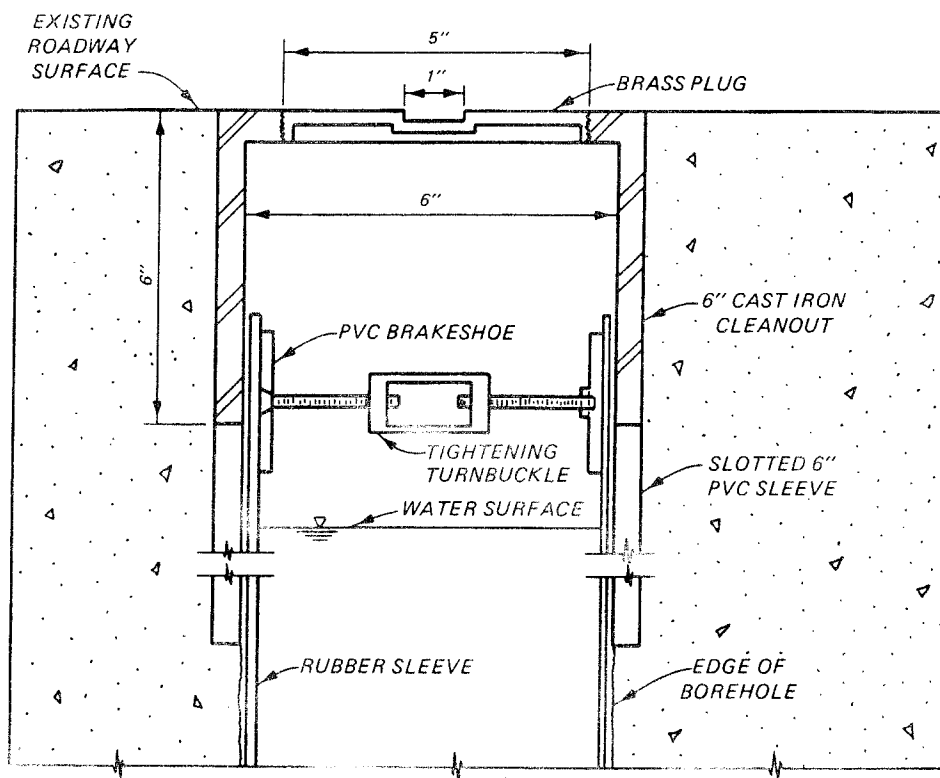
Figure 155. Section through top connection, Bagnell Dam

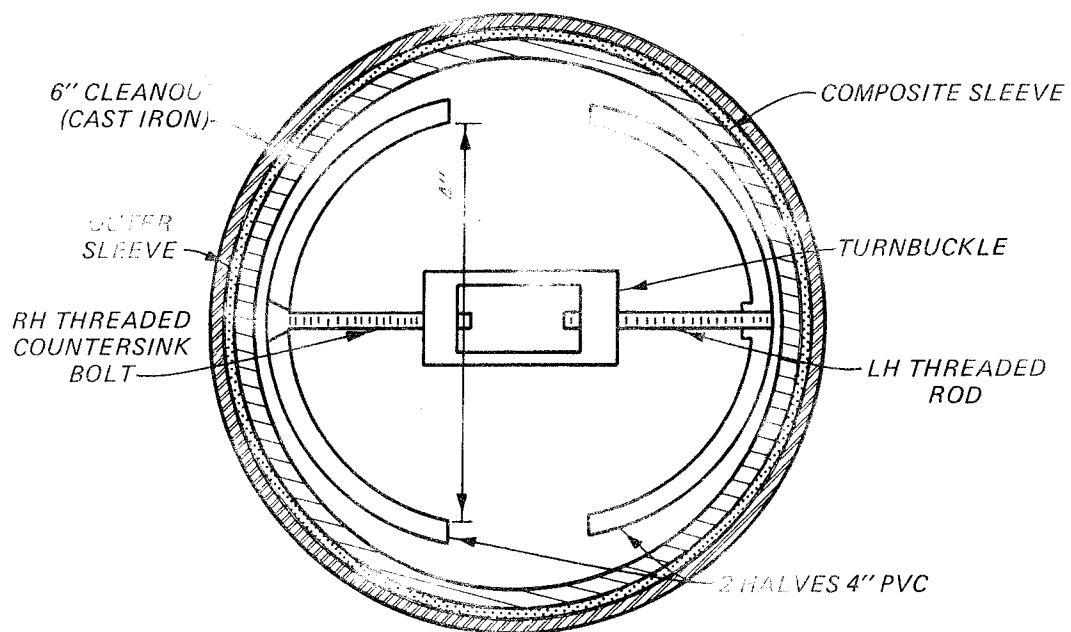
Figure 156. Plan view of top connection, Bagnell Dam

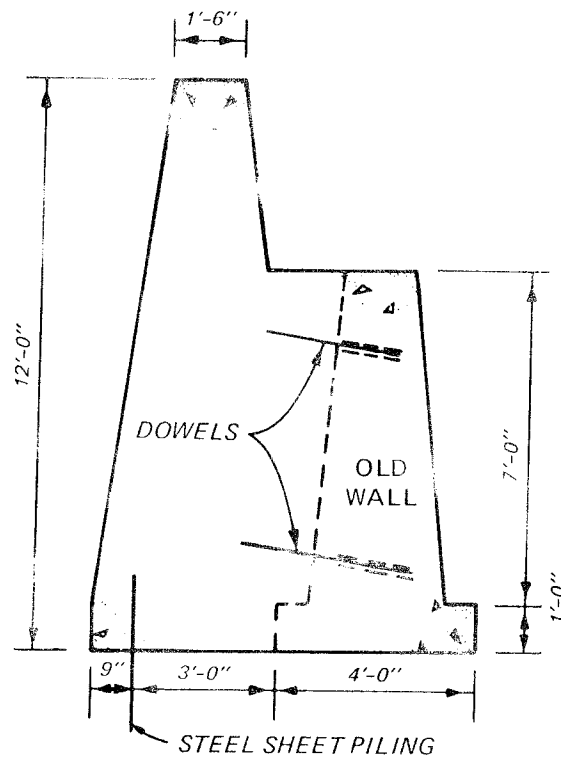
Figure 158. Typical wall section, Caruthersville Floodwall

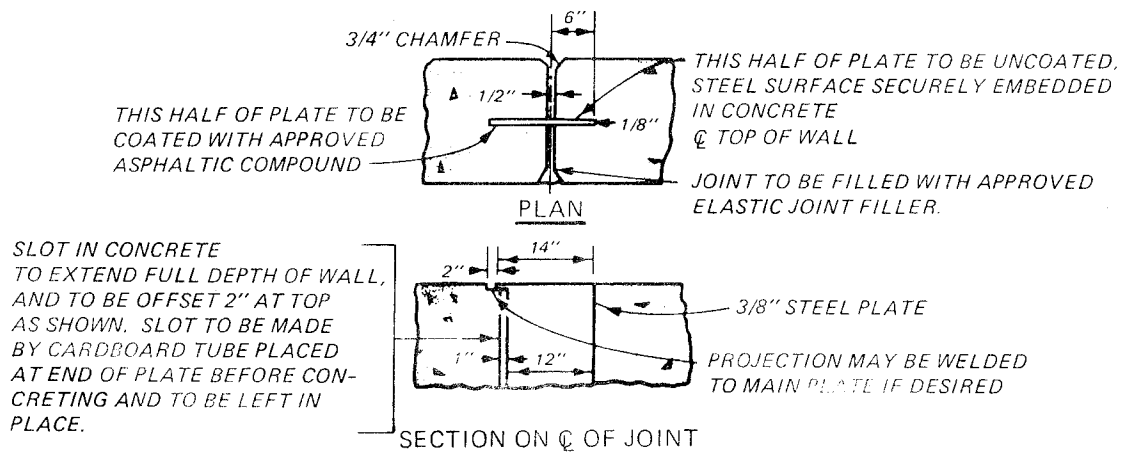
Figure 159. Waterstop detail, Caruthersville Floodwall

310. Concrete cracking and spalling around the monolith joints (Figure 160) was repaired in 1984. Also a new waterstop was installed in 22 of the joints. The center portion of the existing waterstop was removed by drilling a 4-in.-diameter core vertically at the intersection of the steel plate and the joint. A one-piece diamond drill bit 13 ft long was used to core the holes to a depth of 12 ft. The one-piece drill bit was used because the core was divided into four sections by the steel plate and the joint filler and would not stay together in one piece. Also, even if all four pieces of concrete were removed, the drill operators could not free the steel plate until the hole was drilled all the way through the wall. If they had tried to drill deeper after a section of the core was removed, the steel plate probably would have locked up inside the drill bit, causing it to jam. Torque created by such a bit jam could have stripped the threads between the tube sections used to lengthen the drill bit.
