**AIR FORCE FLIGHT  
EVALUATION (SYSTEMS)  
OF THE  
A-10A PROTOTYPE AIRCRAFT**

**TECHNICAL REPORT No. 73-3**

**MARCH 1973**

**AIR FORCE FLIGHT TEST CENTER  
EDWARDS AIR FORCE BASE, CALIFORNIA  
AIR FORCE SYSTEMS COMMAND  
UNITED STATES AIR FORCE**

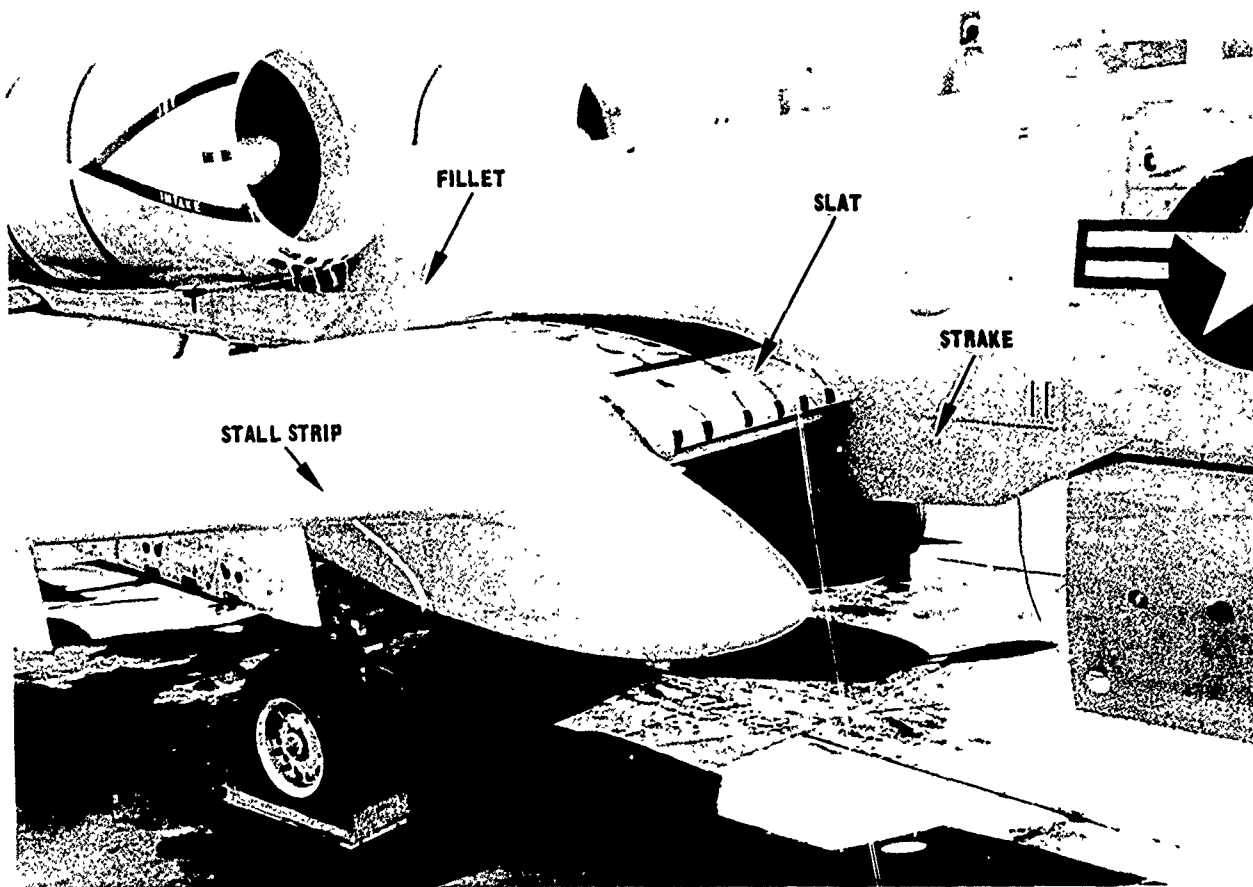
Figure 1

Tests were conducted after completion of Task II to evaluate contractor modification of the A-10A airframe as a solution to the YTF34 engine/A-10A airframe incompatibility problem. This deficiency was documented in the Propulsion-Normal Operations section of the Systems Evaluation Test Results. The modifications consisted of several aerodynamic changes to the A-10A airframe. A fixed, single slotted leading edge siat was installed on the inboard section of each wing between the fuselage and the main landing gear pod. A 24 inch wing leading edge stall strip was located approximately one and a half feet outboard of each gear pod. Also, a filet between the wing and the fuselage at the aft wing root was added. Lastly, a vertical strake was mounted on the fuselage forward of and just below each wing. The complete configuration is shown in Figure 1.
