MTMC REPORT OA 81-4a-27

# ANALYSIS OF MTMC PARTICIPATION IN THE REFORGER 81 EXERCISE

MAY 1982

**MILITARY TRAFFIC MANAGEMENT COMMAND**  
**TRANSPORTATION ENGINEERING AGENCY**  
NEWPORT NEWS, VIRGINIA 23606

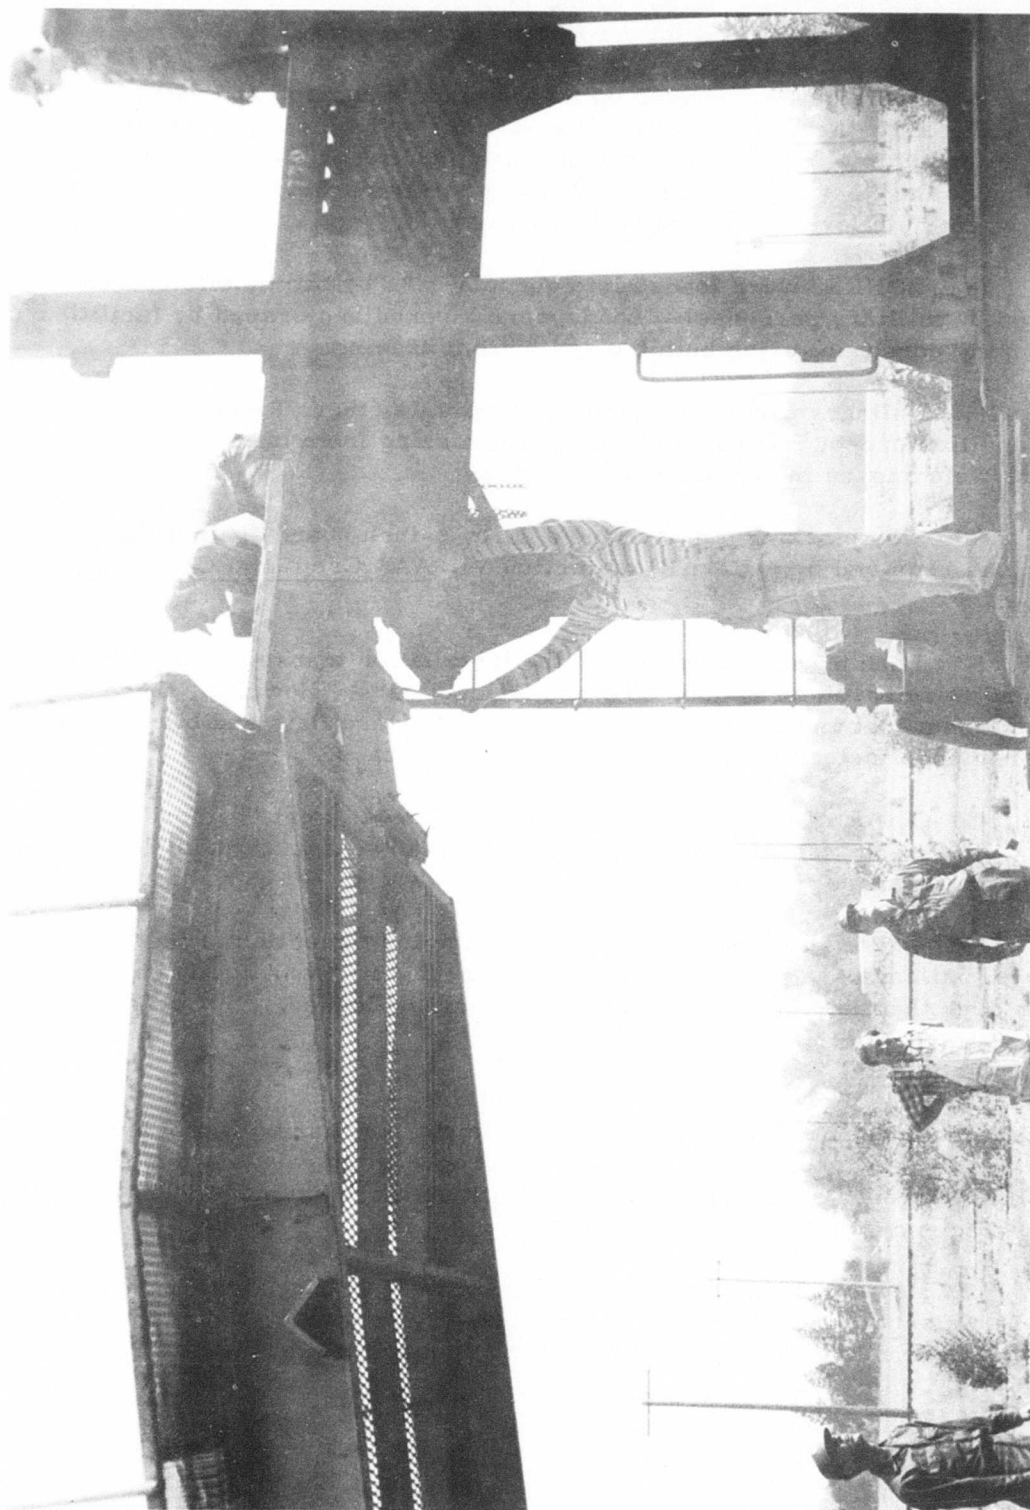
(3) Vehicles were driven up a permanent end ramp and were loaded circus style onto standard flatcars. Bilevel cars were loaded by use of a mobile bilevel ramp. This ramp was not fully functional, requiring some onsite maintenance the first day of loading. Wooden spanners were used to span the gap between the bilevel ramp and railcars (fig 4-1).

Figure 4-1. Fort Lewis bilevel rail-loading ramp.

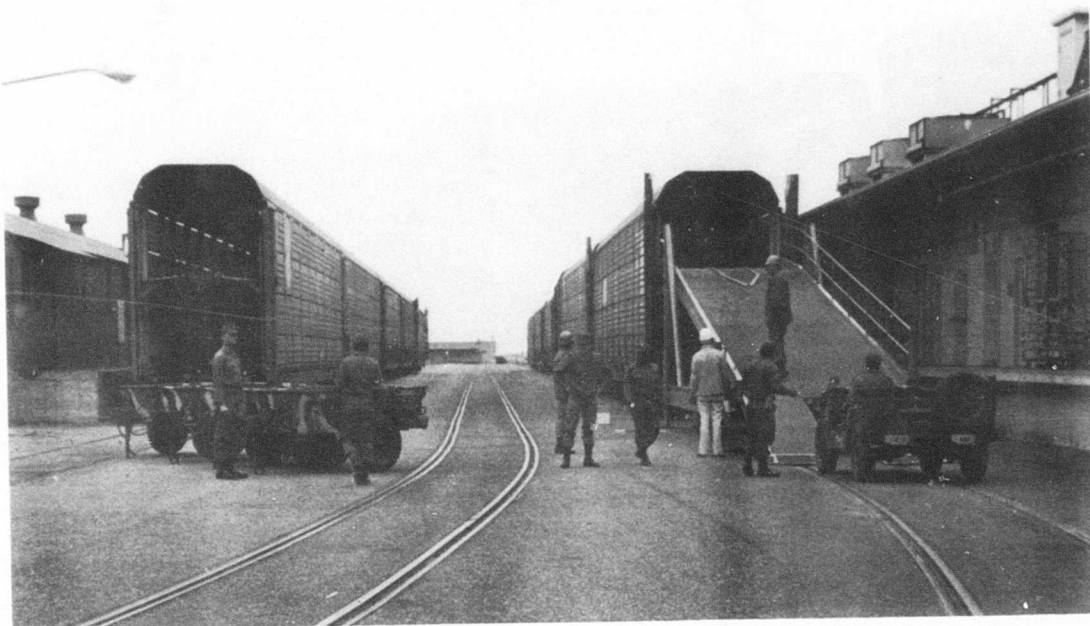
(2) Circus-style loading procedures were used for wheeled vehicles. A new bilevel ramp was used to load the bilevel cars (fig 4-3). Permanent ramps were used at both the balloon spur and the 11th Street spur. Vehicles were called forward to the rail spurs by hand-held radios.

Figure 4-3. Fort Ord bilevel rail-loading ramp.
