AL/CF-TR-1994-0056

**A HUMAN FACTORS EVALUATION OF  
THE MH-60G PAVE HAWK HELICOPTER COCKPIT (U)**

**JANUARY 1994**

**FINAL REPORT FOR THE PERIOD APRIL 1993 TO JANUARY 1994**

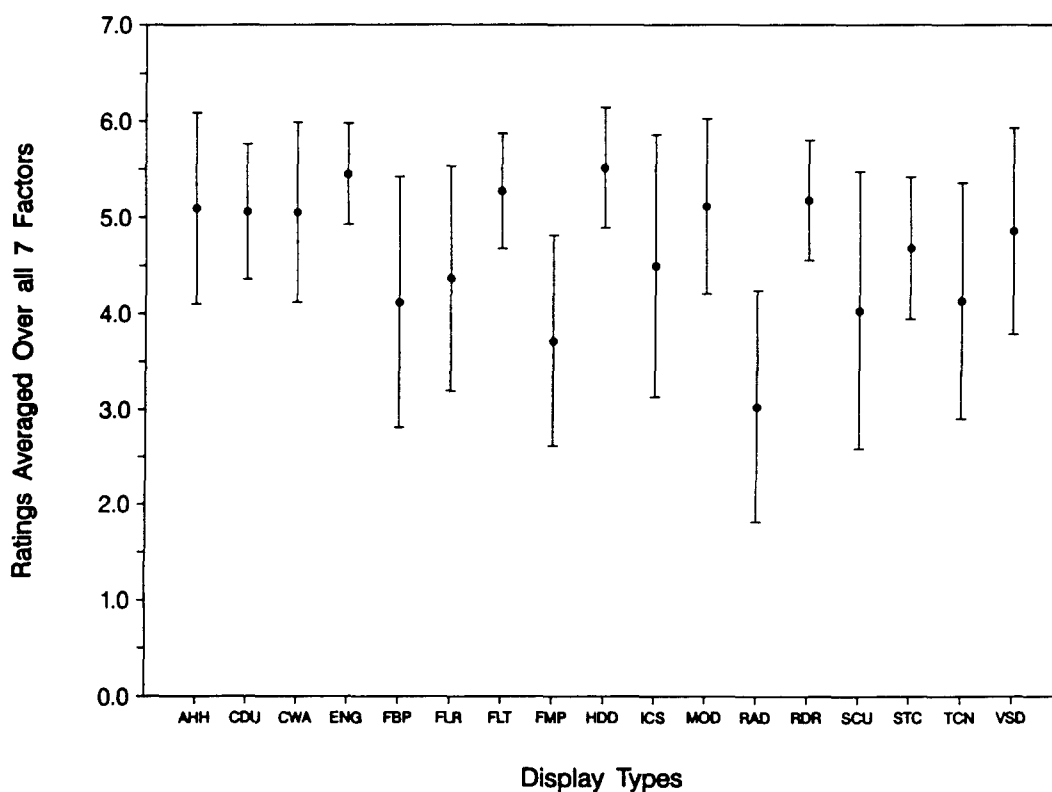
Figure 1. Mean Adequacy Rating for Display Type Averaged Across Display Factor.

The pilots rated some of the Display Types significantly higher than some of the others across all of the Display Factors combined ( $P=0.001$ ). The mean ratings for each Display Type are shown below in Table 2 and are shown graphically in Figure 1. Basically, the Fuel Management Panel and the Radios were rated significantly lower than almost all the other display panels. The SCU, Fuel Boost Pump, TACAN/NAV and FLIR panels were rated as being mildly adequate. The remaining panels were rated as being just under very adequate to close to totally adequate.

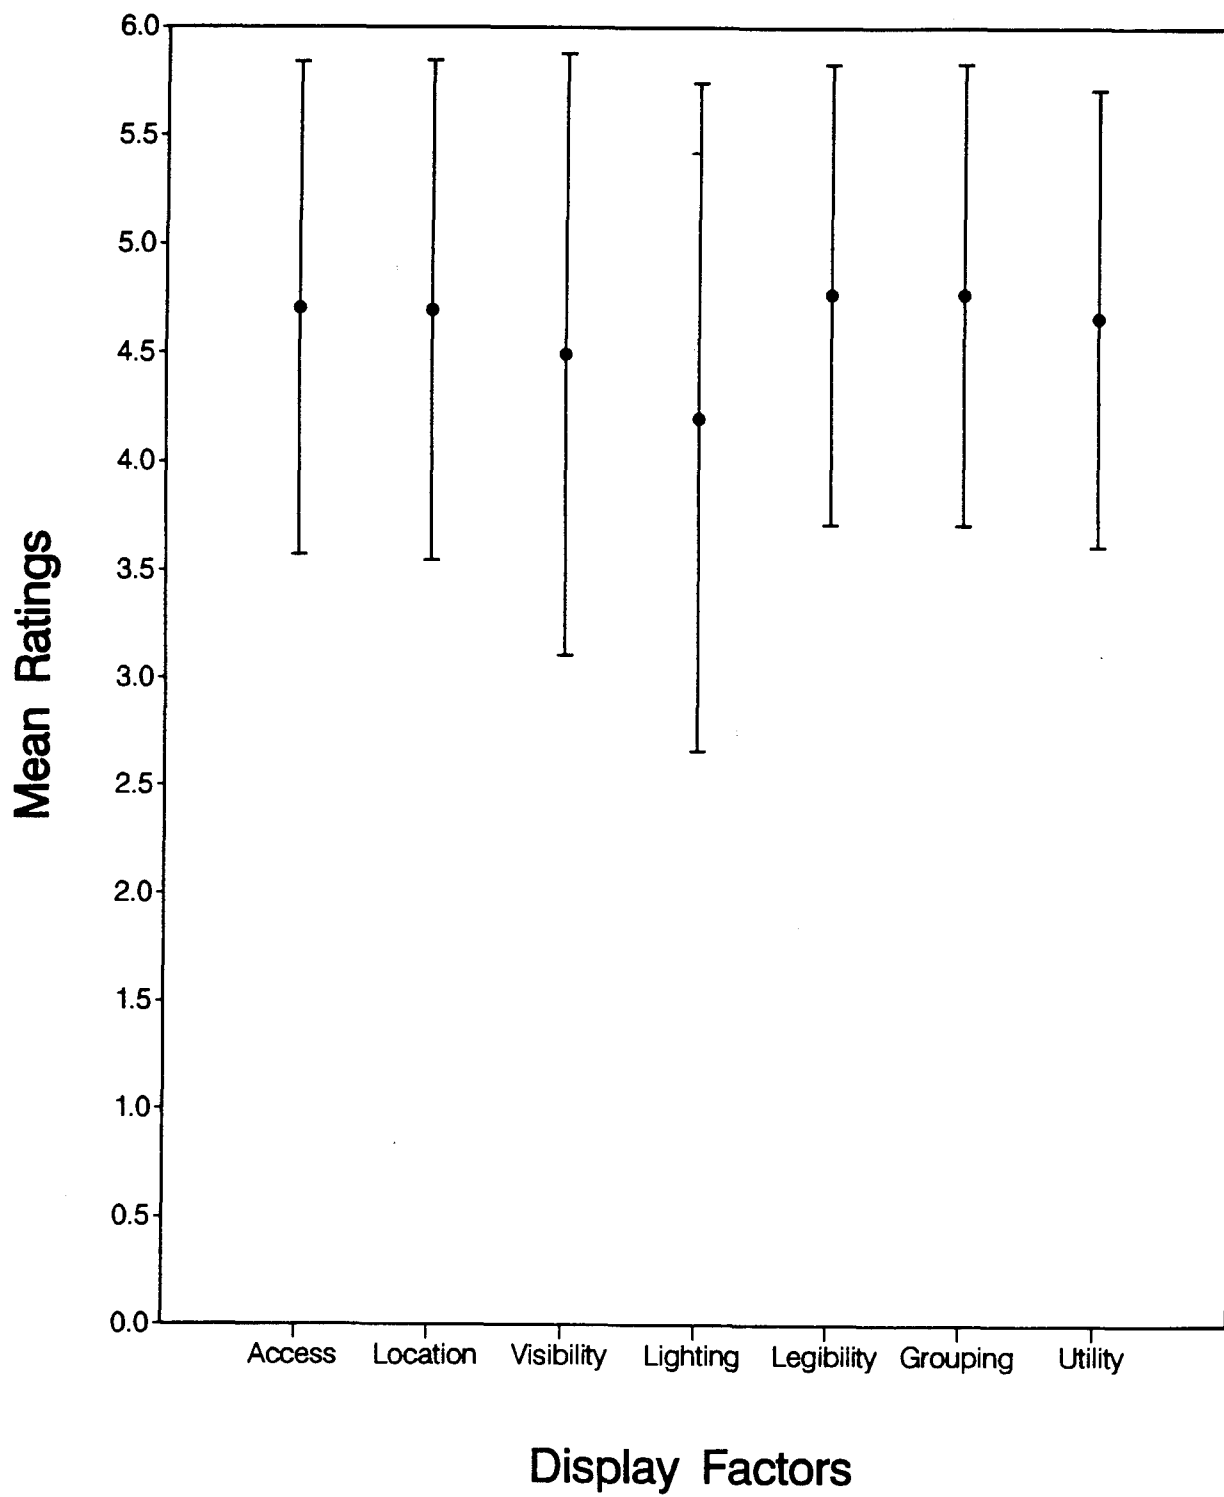
Figure 2. Mean Rating as a Function of Display Factor Averaged Across Display Type

There was a significant effect for the Display Factor variable ( $P=0.0049$ ). The means are shown below in Table 3 and shown graphically in Figure 2. A Tukey post-hoc analysis showed the Lighting factor was significantly lower than all the other Display Factors except Visibility and Utility. No other Display Factors were significantly different from each other. Lighting was consistently rated the lowest across all the display types. The lack of good lighting in the cockpit could be responsible for the low ratings assigned to the Utility and Visibility Factors.
