Advance Restricted Report E5B07

EFFECT OF PROGRESSIVE RING FAILURE ON PISTON DESTRUCTION

By Max J. Tauschek and Lester C. Corrington

Aircraft Engine Research Laboratory  
Cleveland, Ohio

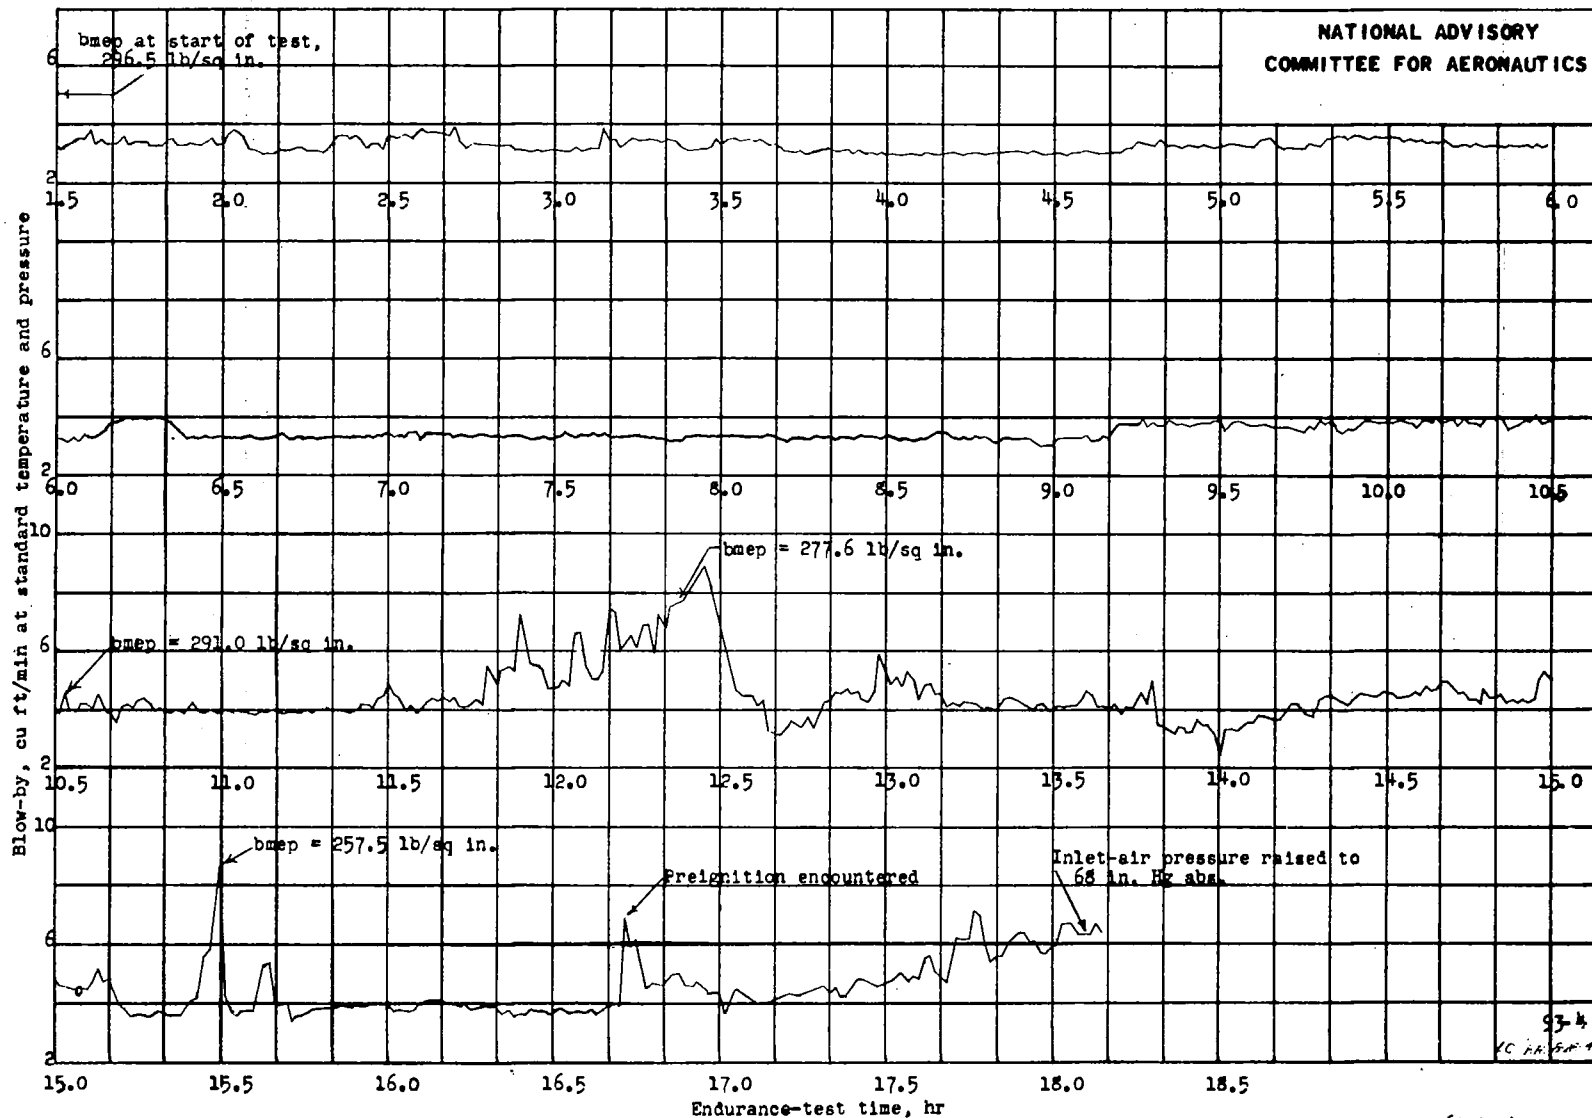
Fig. 4

Blow-by and crankcase pressure. - The curves of the rate of blow-by and the crankcase pressure are shown in figures 4 and 5. Because the crankcase pressure is directly related to the blow-by rate, these curves are similar. It must be borne in mind, in the interpretation of the results of the crankcase-pressure curve, that the magnitudes of the crankcase-pressure values are entirely dependent upon the system used for the removal of the blow-by gases from the crankcase; a system having many restrictions, such as small piping, a flowmeter, and numerous valves, will result in high pressures, whereas a system having fewer obstructions to the gas flow will result in low pressures. The actual pressure in the crankcase was somewhat higher than the values measured because the manometer was connected to the blow-by line some distance from the crankcase.

Figures 4 and 5 indicate that, after failure of the top and second rings had taken place (beginning of endurance test), an increasing degree of failure of the compression rings did not affect the sealing qualities of the piston and ring assembly to any marked extent. The rate of blow-by and the crankcase pressure at the beginning of the test were approximately the same as those values at the

The sudden rise in rate of blow-by at 15.5 hours may also have been caused by preignition although none was detected by the time-pressure diagram on the oscilloscope. The loss in power output recorded at this point is somewhat higher than would be expected from blow-by alone (fig. 6), suggesting that preignition may have advanced only a few degrees, become stable, and shortly afterward disappeared. This type of preignition has been known to occur many times in other tests and would probably be unnoticed on the time-pressure diagram.

Figure 4. - Effect of running time on rate of blow-by for first endurance test. Engine speed, 2600 rpm; inlet-air pressure, 60 inches of mercury absolute (except as noted); inlet-air temperature, 100° F; fuel-air ratio, 0.095; oil flow to piston, 2.0 pounds per minute.

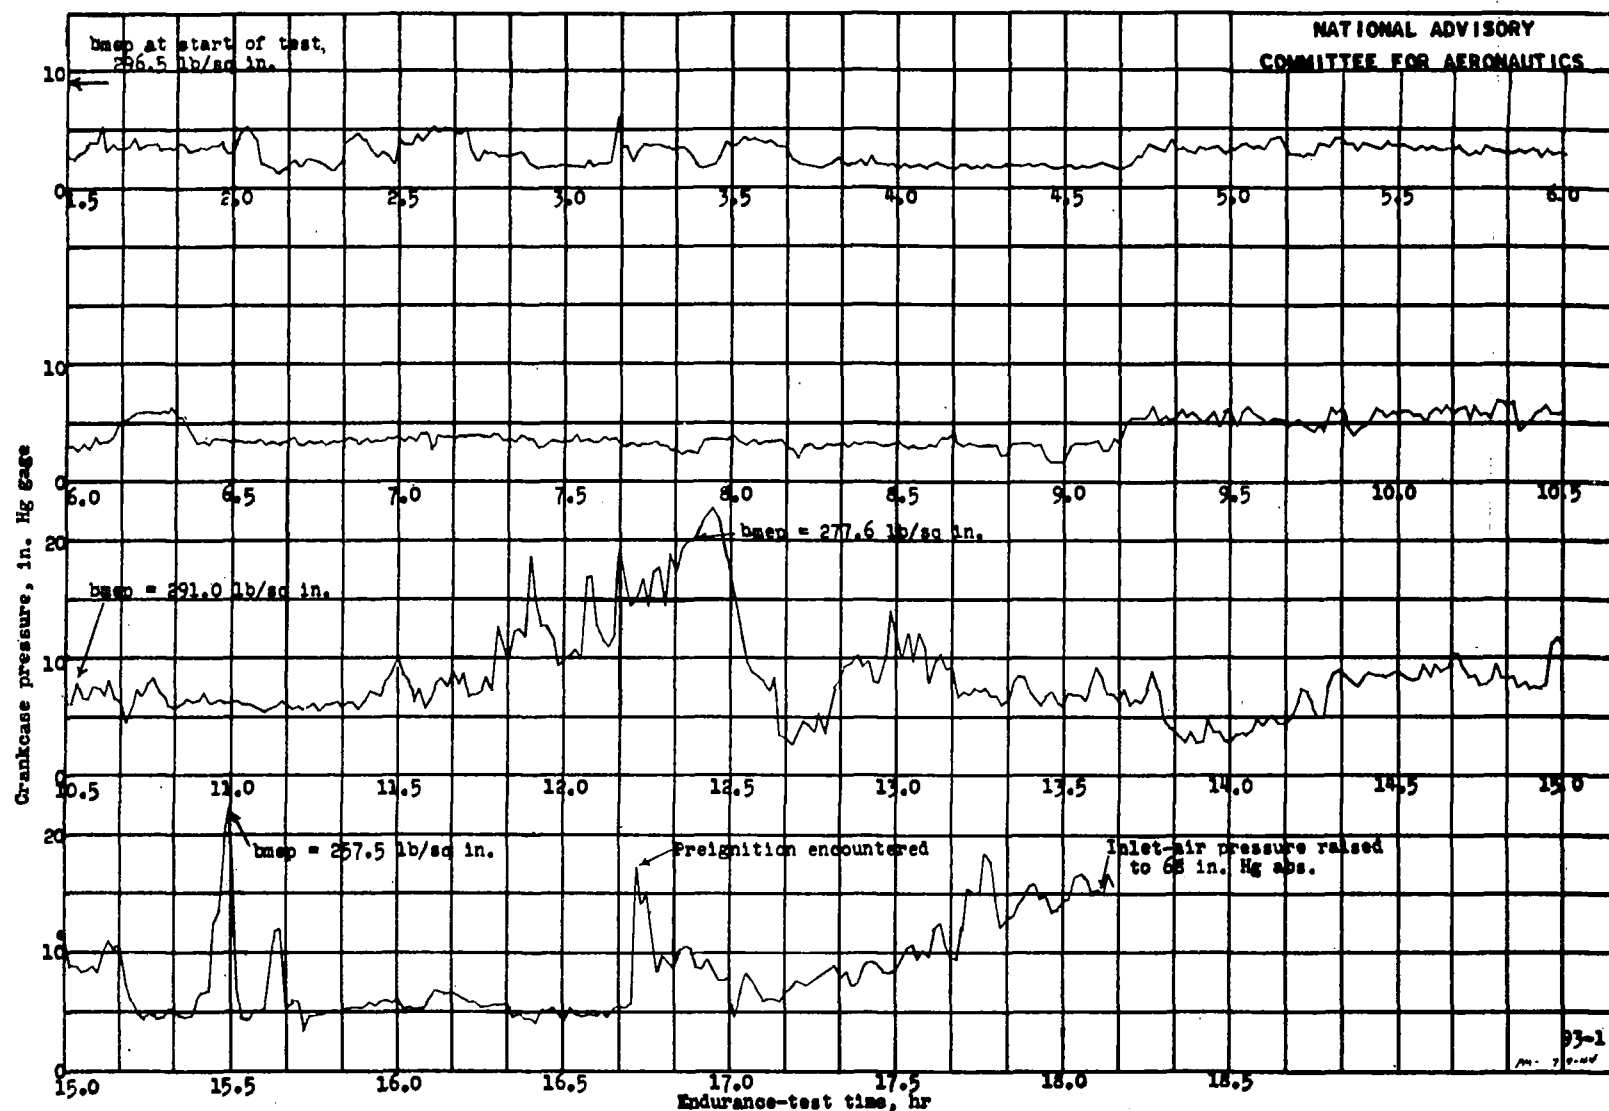
Figure 5. - Effect of running time on crankcase pressure for first endurance test. Engine speed, 2600 rpm; inlet-air pressure, 60 inches of mercury absolute (except as noted); inlet-air temperature, 100° F; fuel-air ratio, 0.095; oil flow to piston, 2.0 pounds per minute.

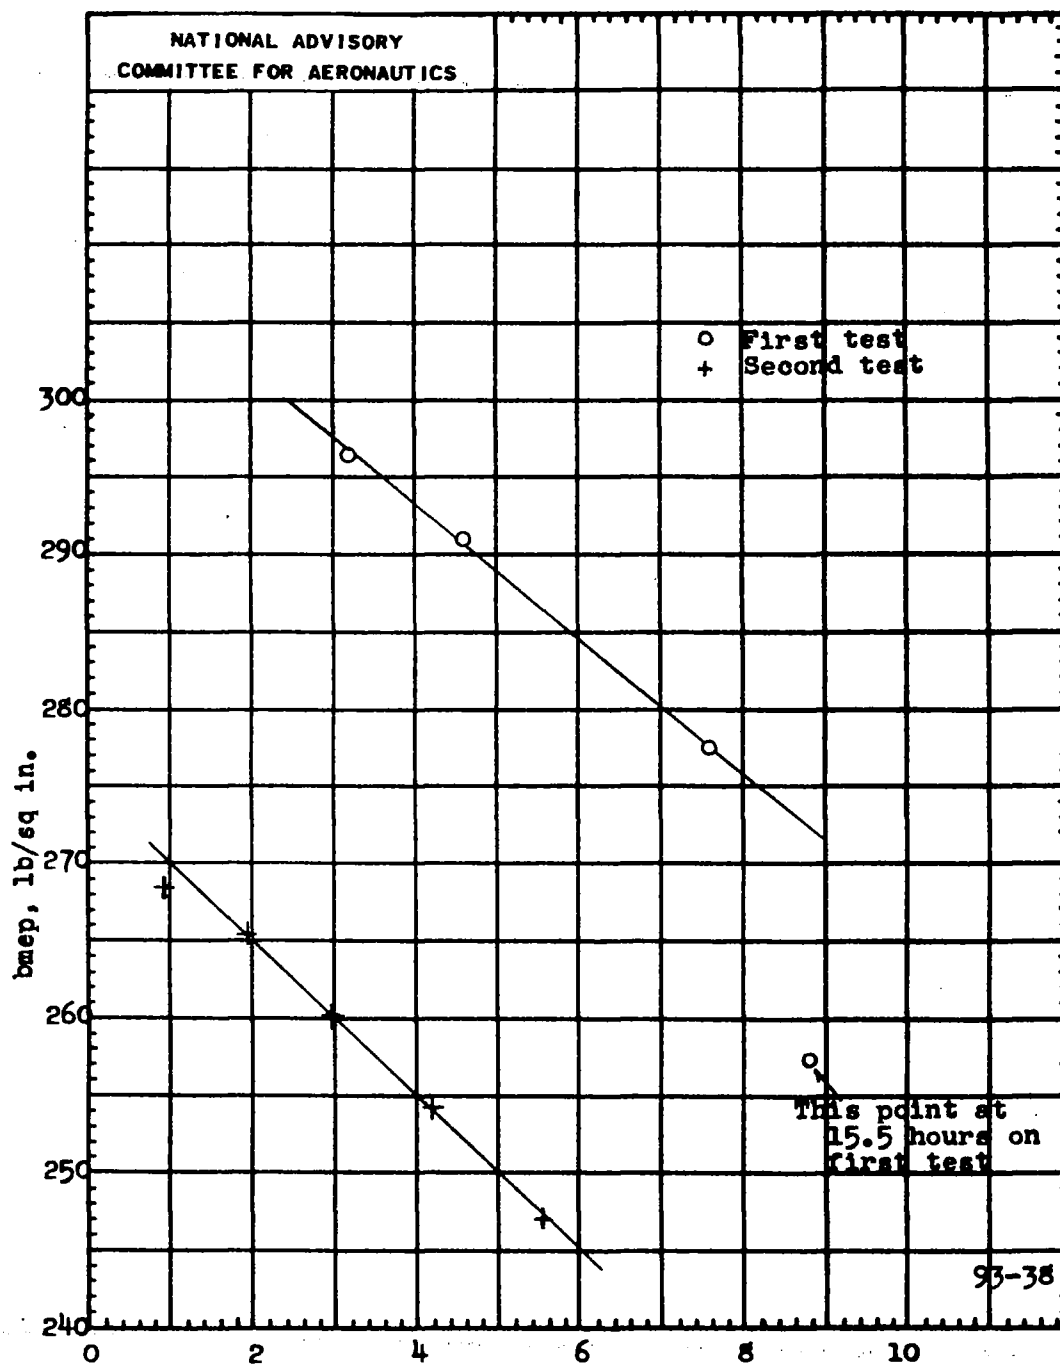
The values of brake mean effective pressure at various times during the two tests (figs. 4 and 12, respectively) are plotted against rate of blow-by in figure 6. The data for the lower curve were taken from the last part of the second test (inlet-air pressure of 56 in. Hg absolute) because the rate of blow-by during the first part of the test was so low that a reasonably accurate curve could not be obtained.

The two curves of figure 6 are straight lines and are roughly parallel. Calculations based on the slopes of these curves indicate that the power loss for a given rate of blow-by is about three times what would be expected if the weight of blow-by gases were considered as an equivalent weight loss of fresh charge. An Orsat analysis of the blow-by gases showed an oxygen content of about 15 percent, and unpublished data taken at this laboratory confirm this value for the

blow-by gases of another engine. The blow-by gases therefore probably consisted of about two-thirds unburned charge and one-third burned charge and the rates of blow-by shown in figure 6 should account for somewhat less than one-third of the power loss on the basis of gas leakage alone. The rest of the power loss can be accounted for only by possible increases in piston and ring friction and by pumping losses caused by the high crankcase pressure.

Blow-by, cu ft/min at standard temperature and pressure  
 Figure 6. - Effect of rate of blow-by on brake mean effective pressure.  
 Engine speed, 2600 rpm; inlet-air temperature, 100° F for first test,  
 200° F for second test; fuel-air ratio, 0.095 for first test, 0.085  
 for second test; oil flow to piston, 2.0 pounds per minute for first  
 test, 0.5 pound per minute for second test.

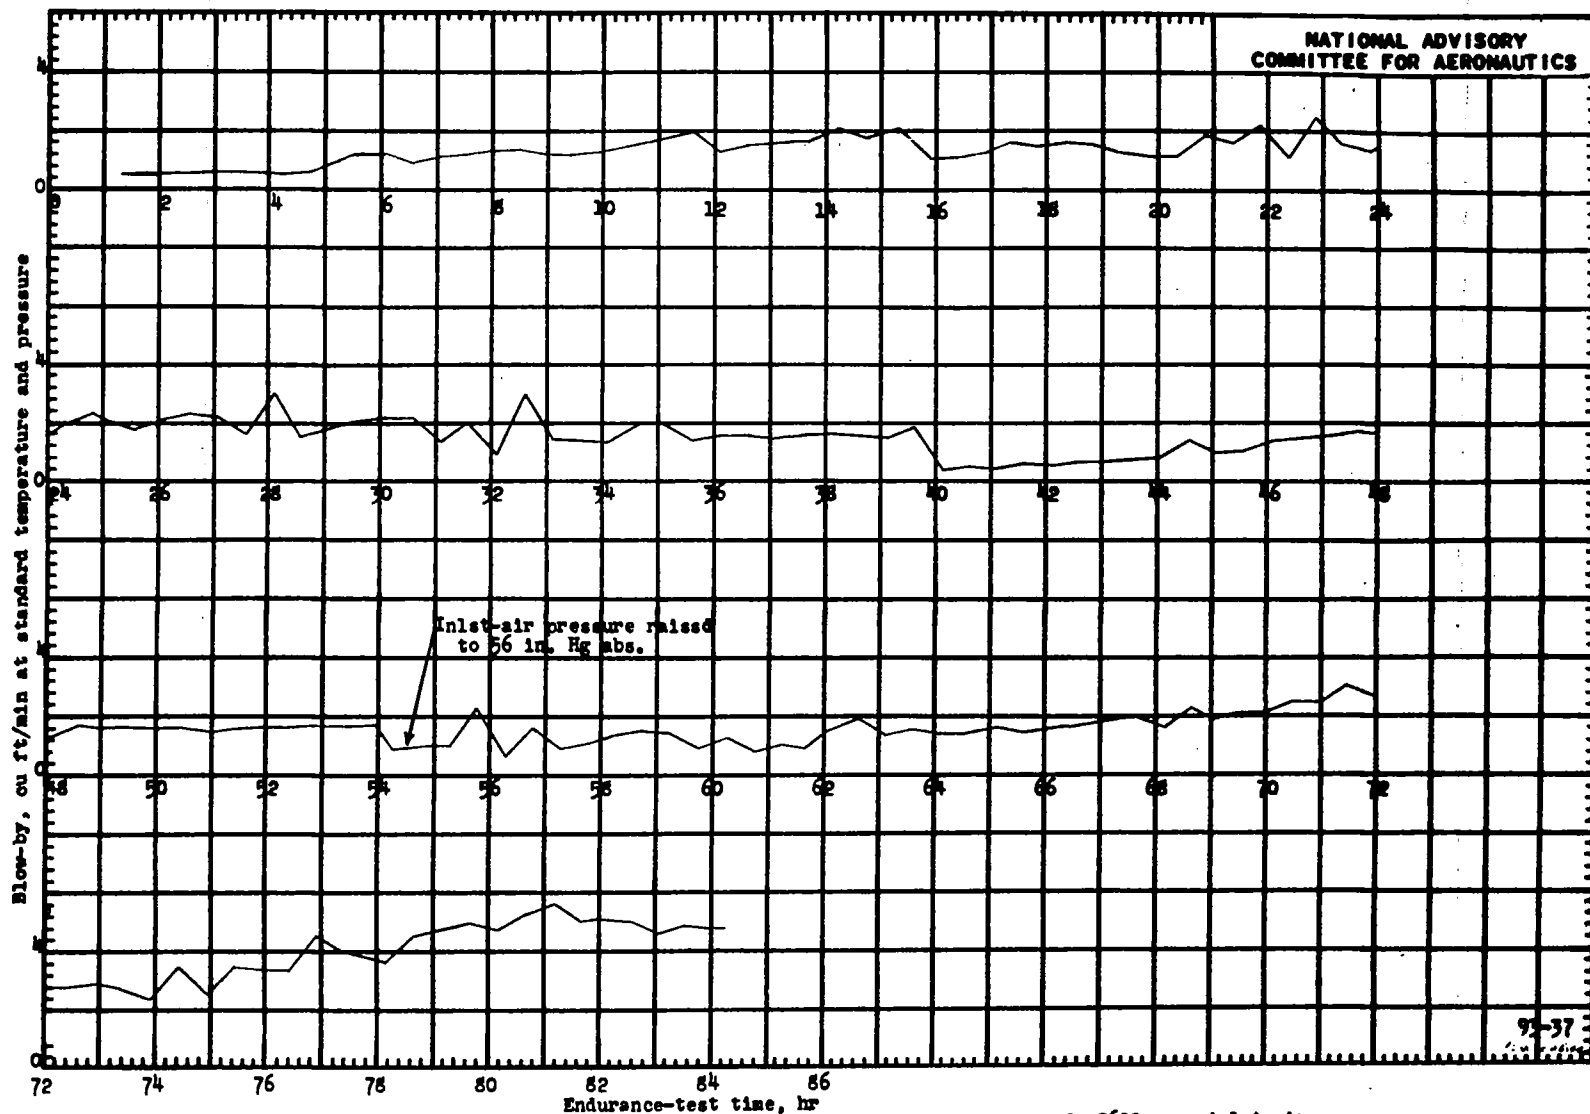
Blow-by and crankcase pressure. - The curves of rate of blow-by and crankcase pressure for the second test are shown in figures 10 and 11. These curves show a marked increase in the blow-by rate and the crankcase pressure after the first 4.5 hours of running, which indicates the beginning of compression-ring failure probably by sticking of the top ring. Unpublished data taken on this engine have shown that 0.5 cubic foot per minute is an average value for the rate of blow-by with a new piston and ring assembly when operating

Figure 10. - Effect of running time on rates of blow-by for second endurance test. Engine speed, 2600 rpm; inlet-air pressure, 50 inches of mercury absolute (except as noted); inlet-air temperature, 200° F; fuel-air ratio, 0.085; oil flow to piston, 0.5 pound per minute.

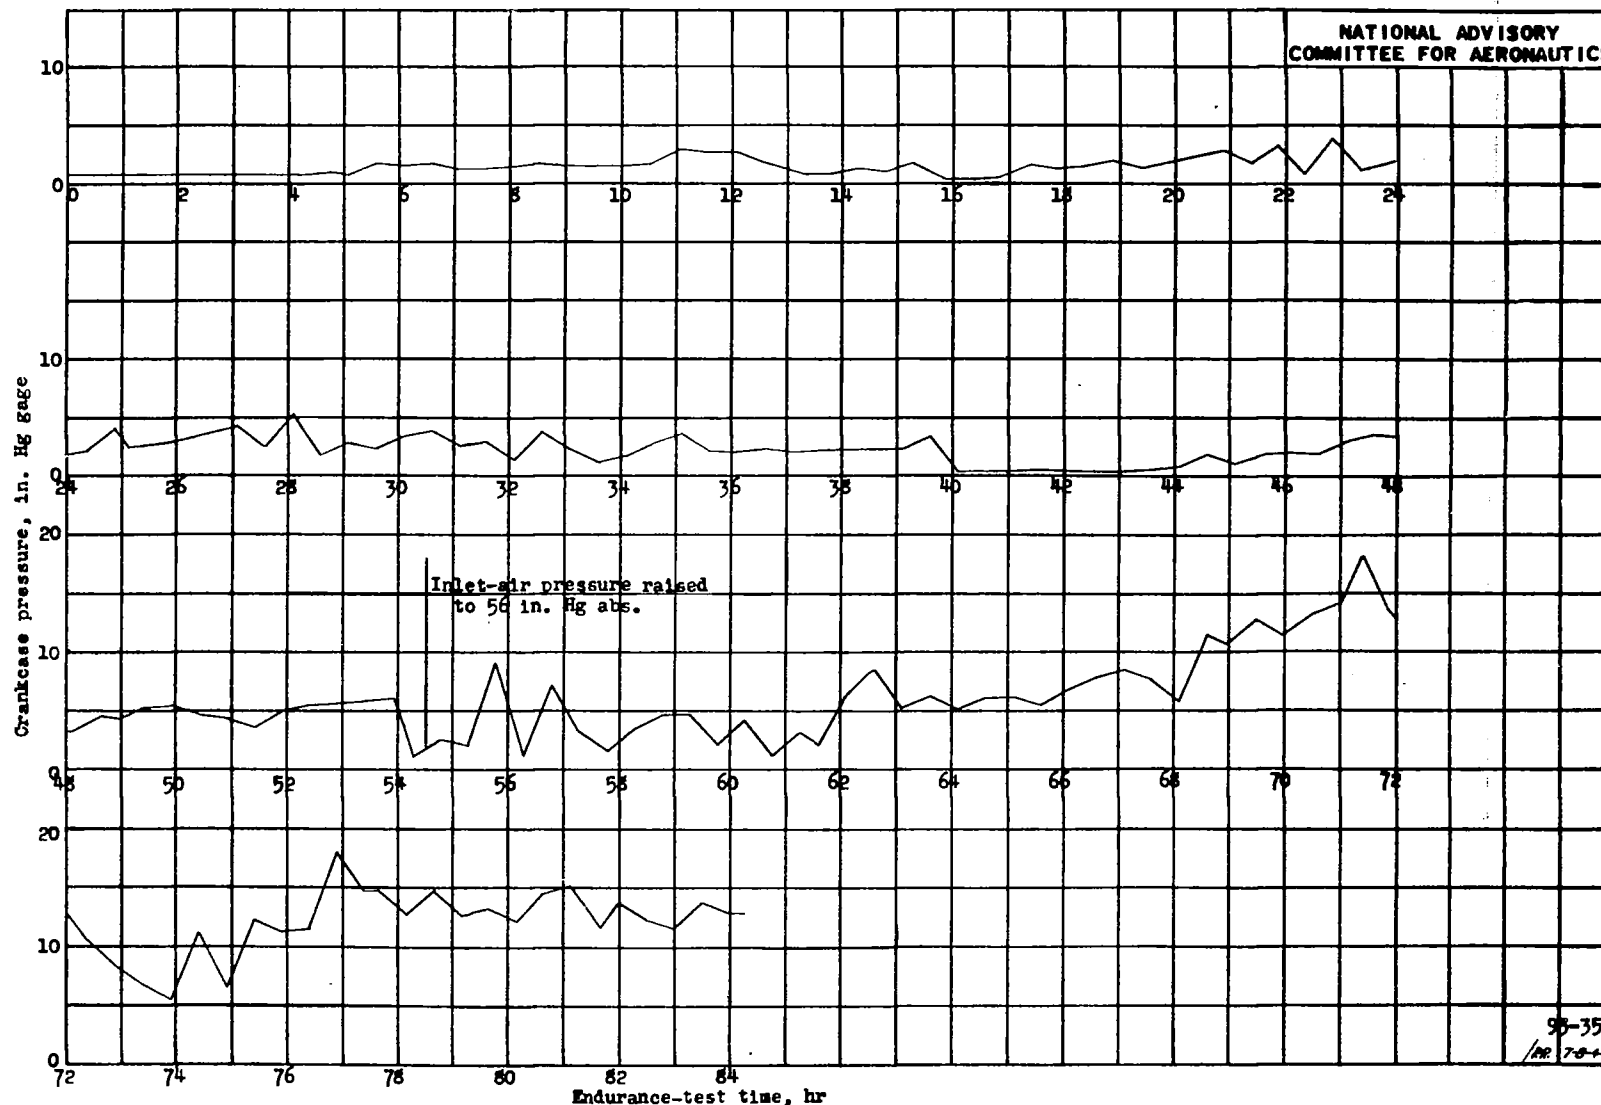
Figure 11. - Effect of running time on crankcase pressure for second endurance test. Engine speed, 2600 rpm; inlet-air pressure, 50 inches of mercury absolute (except as noted); inlet-air temperature, 200° F; fuel-air ratio, 0.085; oil flow to piston, 0.5 pound per minute.

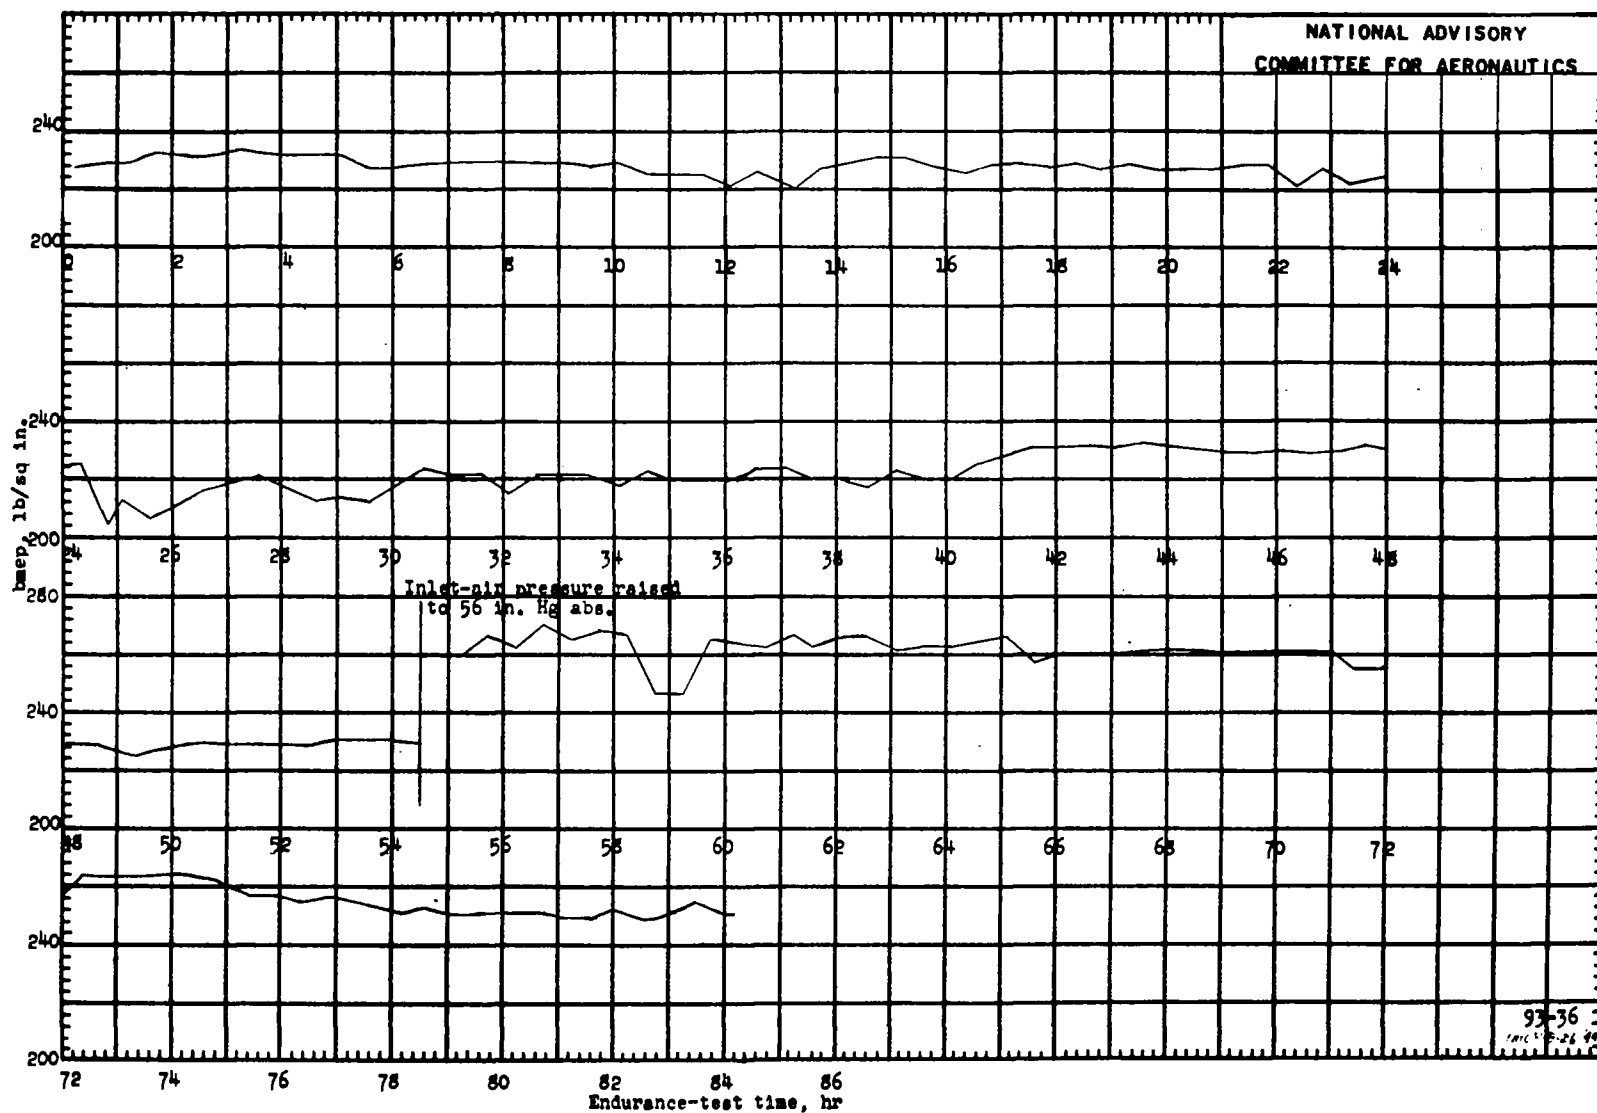
Figure 12. - Effect of running time on brake mean effective pressure for second endurance test. Engine speed, 2600 rpm; inlet-air pressure, 50 inches of mercury absolute (except as noted); inlet-air temperature, 200° F; fuel-air ratio, 0.085; oil flow to piston, 0.5 pound per minute.
