FIRST REPORT ON ASSAULT TANK T14

FIRST REPORT ON ORDNANCE PROGRAM NO. 5621

Feb 44

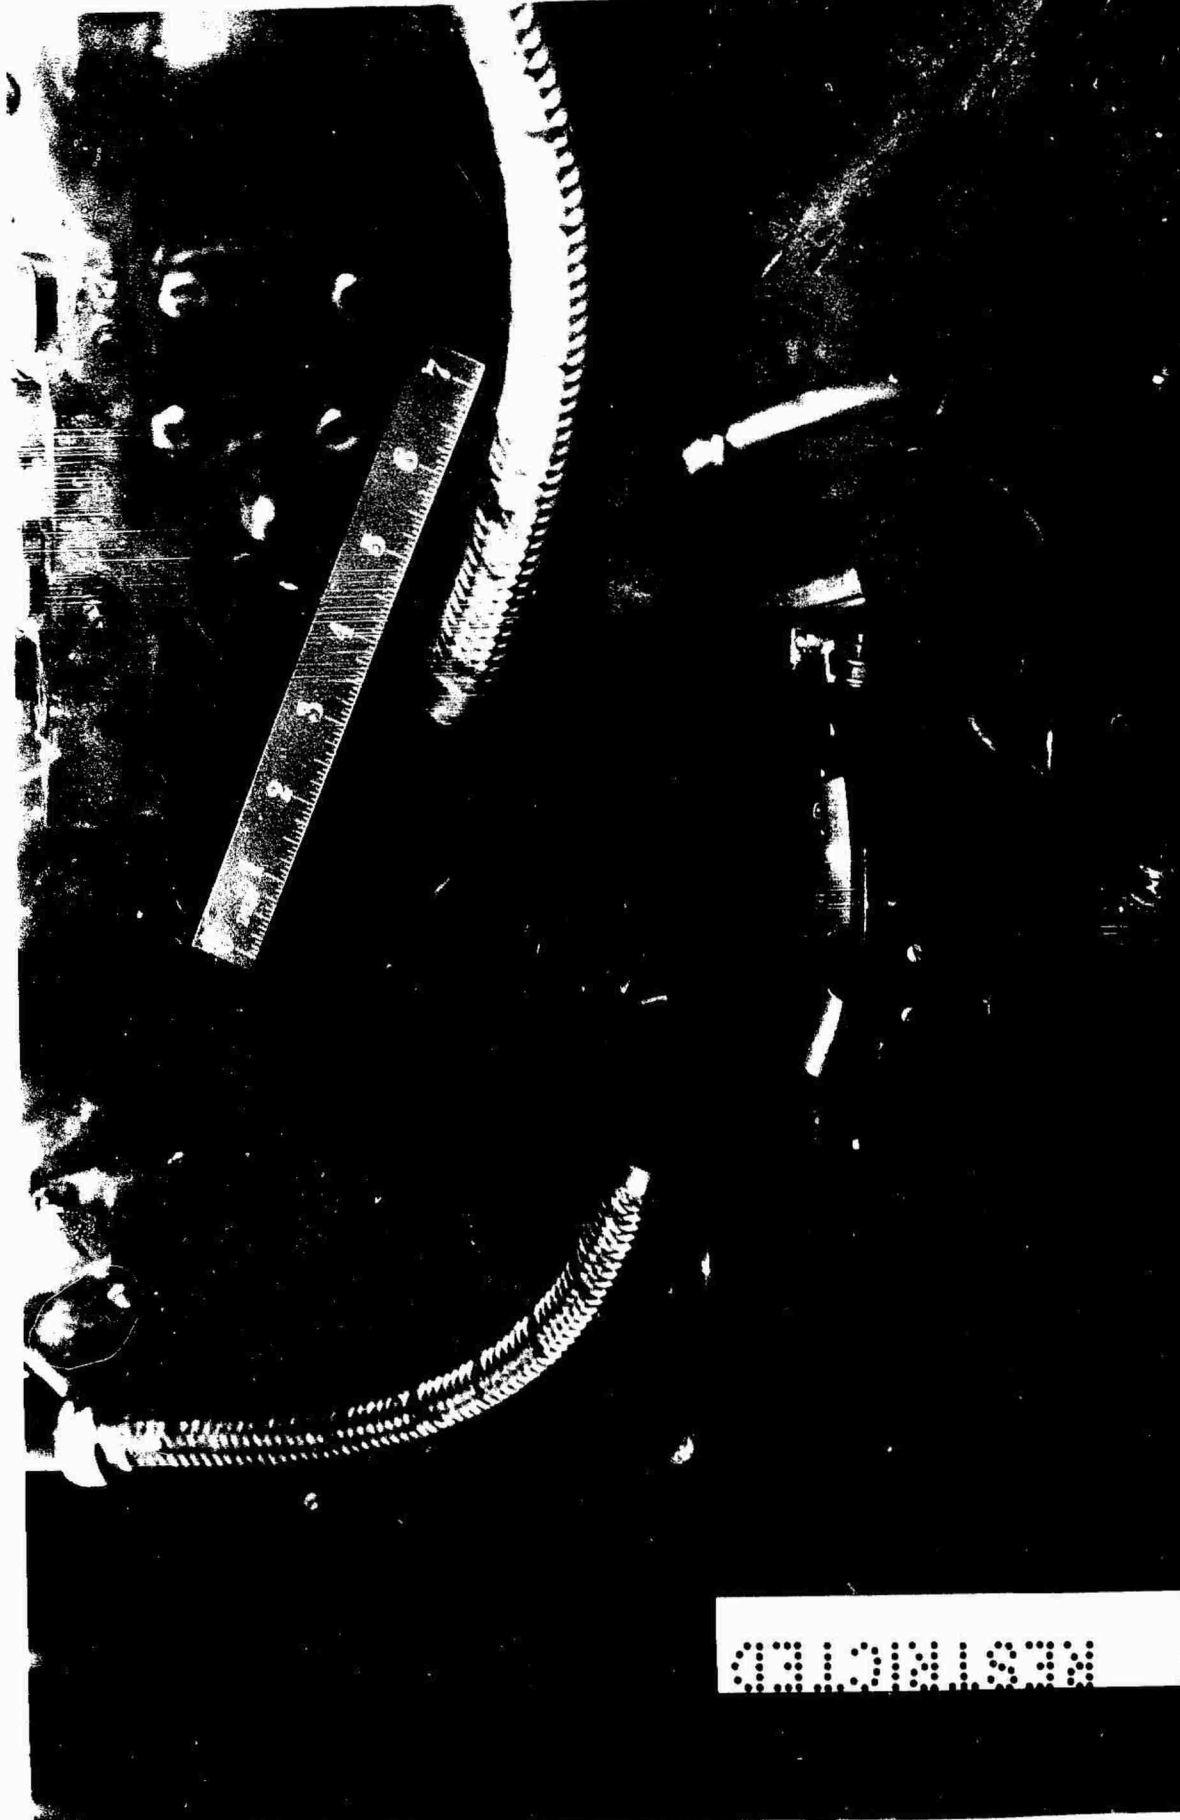
Proj. 3-14-1. Assault Tank, T1, M1 (Pilot). Autolite Dust Proof Distributor for Ford Engine, Model GAZ.
