TITLE: The Inadequacy of Safe-Life Prediction: Aero-Engine Fan and Compressor Disk Cracking

# The Inadequacy of Safe-Life Prediction: Aero-Engine Fan and Compressor Disk Cracking

B.J. Wicks, R.A. Antoniou, S.L. Slater and J. Hou  
Aeronautical and Maritime Research Laboratory  
Defence Science and Technology Organisation  
Department of Defence  
Box 4331 GPO  
Melbourne 3001  
Australia

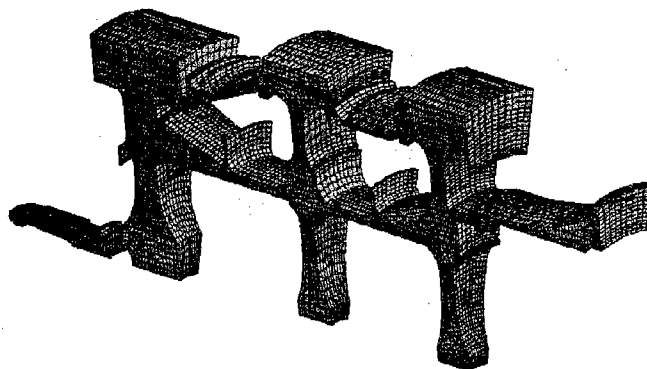
Figure 3: 3D FE model of the assembly.

A 3D cyclic FE assembly model (22.5° sector) was created, consisting of three fan disks, spacers and air seals to determine the global behaviour, as shown in Figure. 3. These components were meshed using 20-noded brick elements. The applied loading includes the centrifugal and thermal loads at maximum power setting (1, 2) Appropriate boundary conditions were applied to the end surfaces of the assembly model. Stress analysis was carried out using ABAQUS software (3) and displacement solutions were obtained.
