EVALUATION AND IMPROVEMENT OF COATINGS
FOR COLUMBIUM ALLOY GAS TURBINE ENGINE COMPONENTS

PRATT & WHITNEY AIRCRAFT
DIVISION OF UNITED AIRCRAFT CORPORATION

Technical Report AFML-TR-66-186, Part II

May 1968

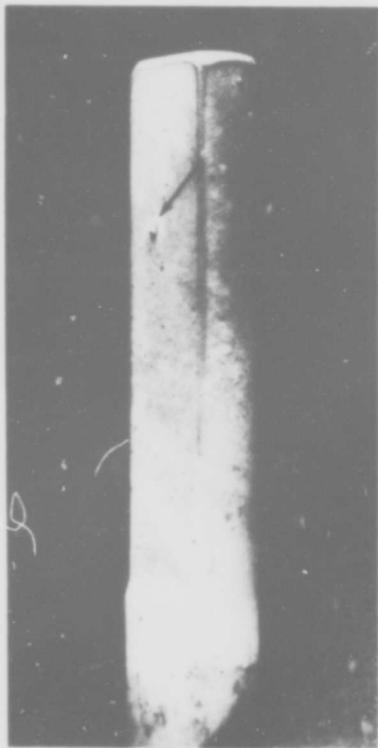
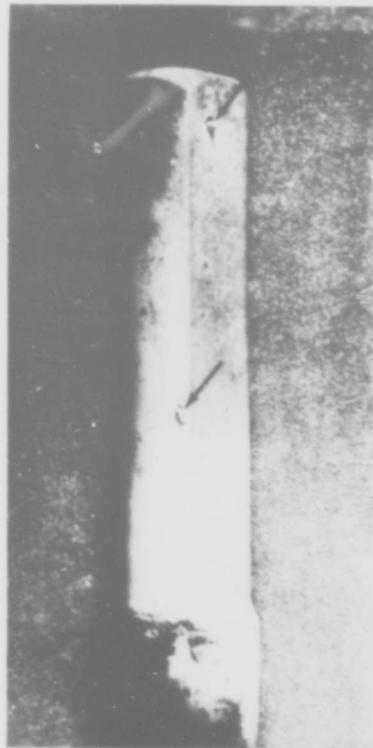
All failures resulted from localized oxidation on specimen airfoil surfaces (Figure 12). These areas of substrate oxidation were confined and occurred at random airfoil locations. Continued testing after failure did not significantly degrade the specimens further after 20 to 100 additional hours. This lack of further degradation was highly temperature dependent, i. e., the higher the test temperature, the shorter the time period during which further specimen degradation occurs.

AFTER 60 HOURS AT 2500°F

AFTER 100 HOURS AT 2400°F

Figure 12. Typical Localized Oxidation-Erosion Failures (Arrows) on Remodified TRW TiCr-Si (Vacuum) Pack Coated Cb-132M Alloy

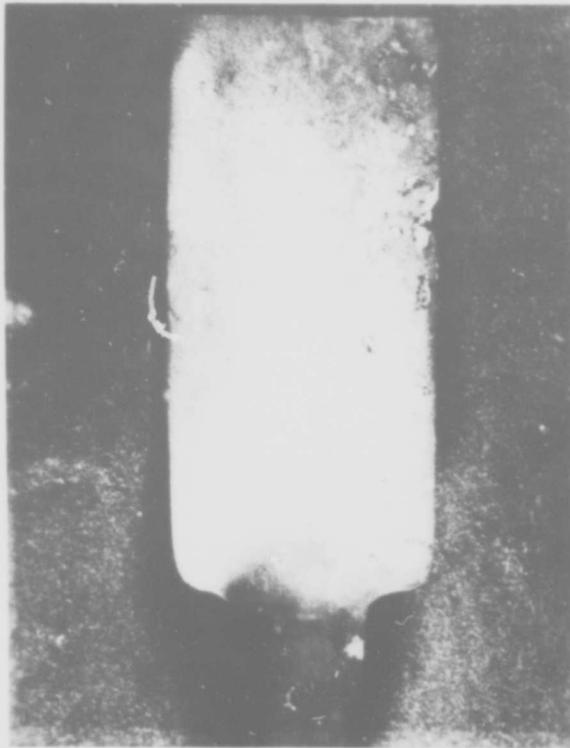
For the 2200°, 2400°, and 2500°F tests, failure occurred by extensive coating spalling and subsequent substrate oxidation along airfoil leading edge surfaces (Figure 15). The 1800° and 2000°F failures were also confined principally to the airfoil leading edge surfaces, but failure was less extensive and resulted from the formation of substrate oxide extending out through coating surface craze cracks.

Figure 15. TRW TiCr-Si (Vacuum) Pack Coated Cb-132M Alloy Specimen (Convex Surface) After Thermal Fatigue Testing for 1000 Cycles to 2200°F

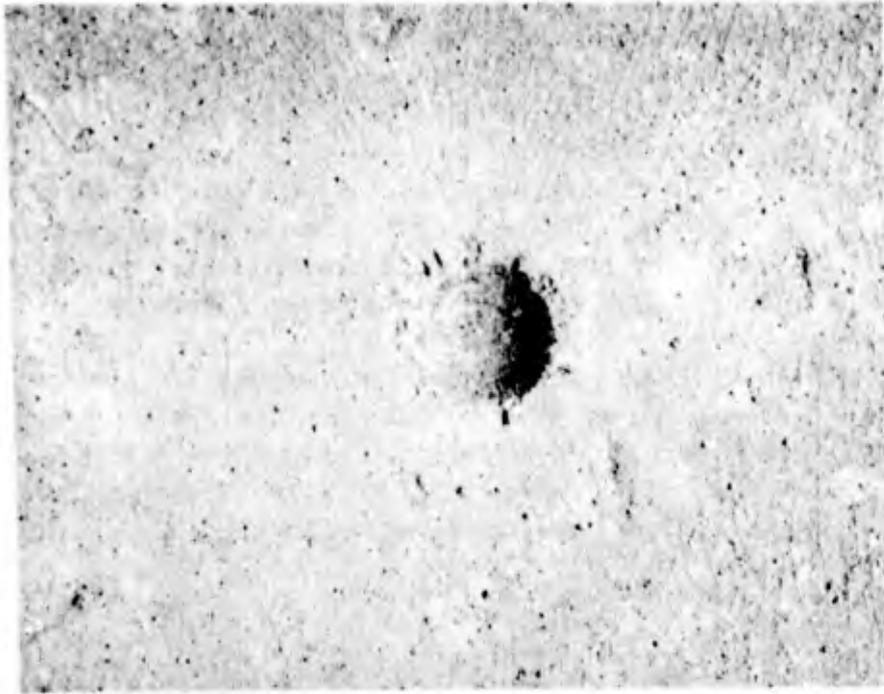
The excellent performance of the system in the 2200° and 2400°F ballistic impact testing indicates a transition between 2000° and 2400°F. Within this region a temperature is reached at which ductility of the coating has increased to the extent that spalling of outer silicide layers and disruption of the coating layer adjacent to the substrate are minimized. The surface appearance of the specimen (Figure 17) and metallographic examination of the impact depression (Figure 18) support this conclusion.

Figure 17. Surface of Remodified TRW TiCr-Si (Vacuum) Pack Coated Cb-132M Alloy After 2200°F Ballistic Impact at 500 Feet Per Second and 20 Hours Subsequent Static Oxidation Exposure at 2200°F

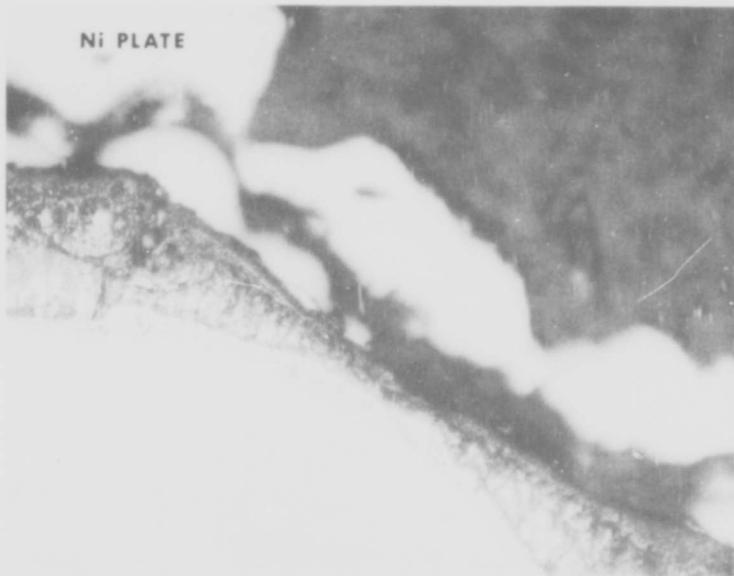
Figure 18. Microstructure of the Transition Area Between the Specimen Surface and Impact Depression for Remodified TRW TiCr-Si (Vacuum) Pack Coated Cb-132M Alloy Showing Coating Integrity

The specimen was impacted at 500 feet per second at 2400°F and subsequently exposed to oxidation at 2200°F for 20 hours with no failure. The specimen surface outside the impact-affected zone continues to the left of photograph; the surface of the impact depression continues down and to the right.

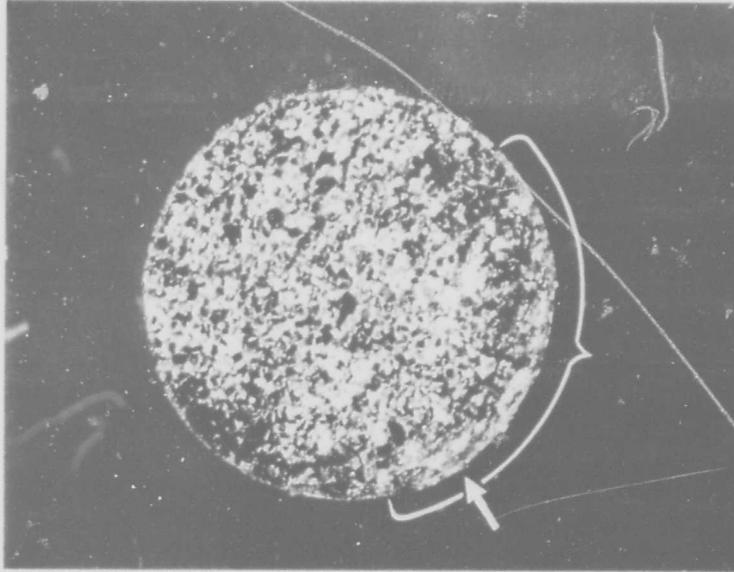
The fracture surfaces of the specimens tested at 40,000 and 50,000 psi revealed a predominantly granular surface, with a very small outer region of fatigue progression (Figure 21). The fatigue limit of 35,000 psi for 10^7 cycles reflects a stress level of approximately 50 percent of the ultimate tensile strength for uncoated Cb-132M alloy at 2200°F.

Figure 21. Fracture Surface of Remodified TRW TiCr-Si (Vacuum) Pack Coated Cb-132M Alloy After Fatigue Testing in Air at 2200°F

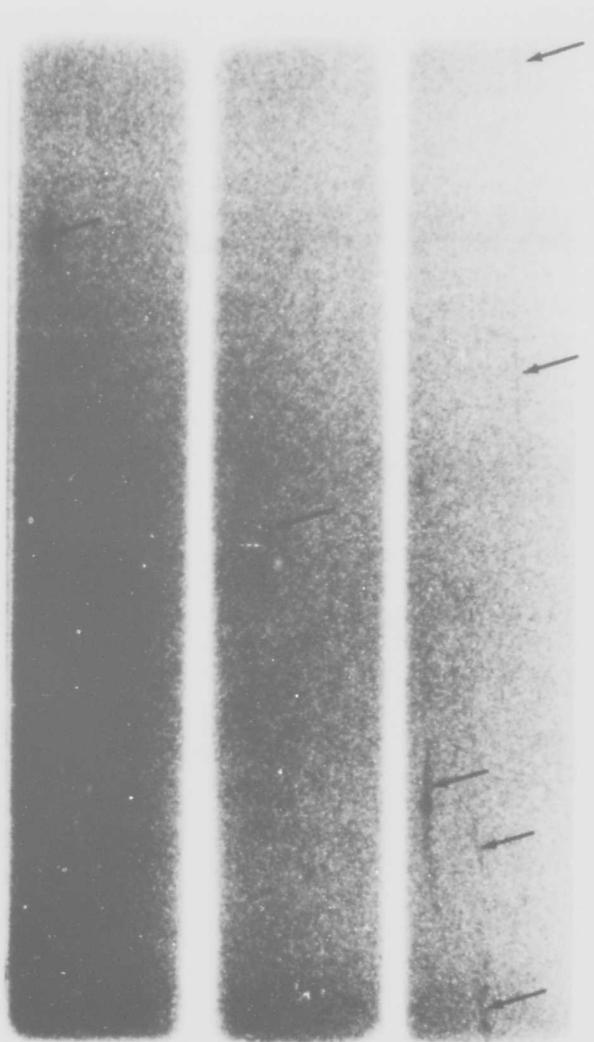
Inspection of XB-88 alloy test specimens utilizing radiographic techniques revealed occasional high-density stringers within the alloy (Figure 27). The stringers, believed to be tungsten rich, were isolated and oriented parallel to the swaging direction. Stringer locations for all inspected test specimens were documented should premature coating failures occur where these areas are in contact with the coating. Care was also utilized to avoid stringers in the gage sections of the creep and fatigue test specimens.

Figure 27. Radiograph (Positive Print) of XB-88 Columbian Alloy Bars Showing Typical Stringers (Arrows)

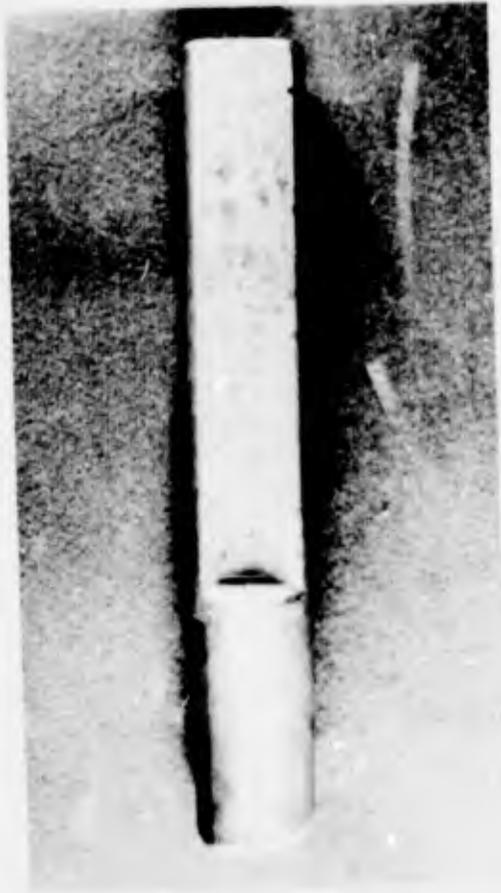
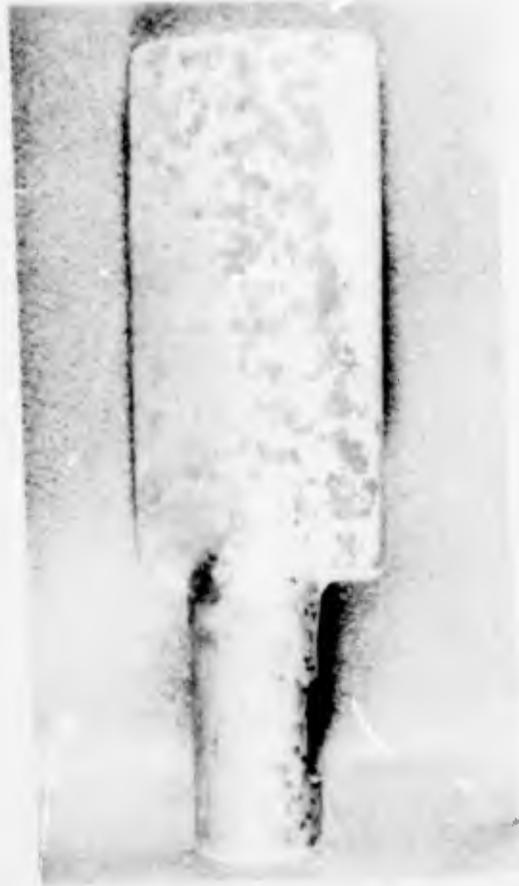
Figure 29. As-Coated TRW TiCr-Si/XB-88 Alloy Oxidation-Erosion Bar (Left) and Thermal Fatigue Paddle (Right)

The coating had an extremely mottled surface appearance (Figure 29). Discussions with TRW, Inc. revealed that these darker surface areas were high in chromium. Metallographic examination showed that coating thickness varied from 3.2 to 3.6 mils. Poor uniformity of the (Cb, Ti)Cr₂-type Laves phase and outer silicide coating layers was noted (Figure 30). No solid solution zone beneath the coating-substrate interface was apparent.

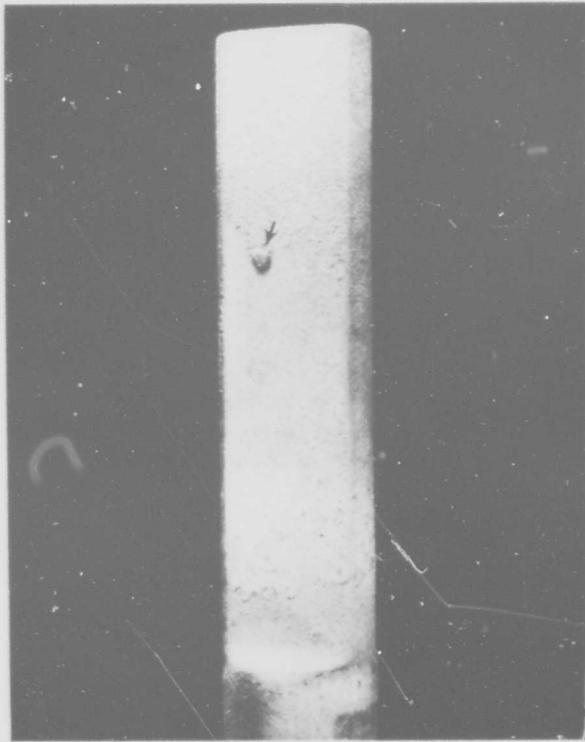
Figure 36. Sylvania SiCrTi Slurry Coated B-66 Alloy Bar After Oxidation-Erosion Testing for 100 Hours at 2200°F Plus 100 Hours at 2400°F Plus 20 Hours at 2500°F

Sylvania SiCrTi Slurry/B-66. Failure was observed for the Sylvania SiCrTi/B-66 system within a range from 100 hours at 2200° F plus 40 hours at 2400° F to 100 hours at 2200° F plus 100 hours at 2400° F plus 20 hours at 2500° F. Failure generally occurred by localized oxidation at random airfoil locations (Figure 36). In two instances, however, oxidation occurred in areas used for specimen support during coating

Localized failure after 20 hours at 2500°F is indicated by arrow.

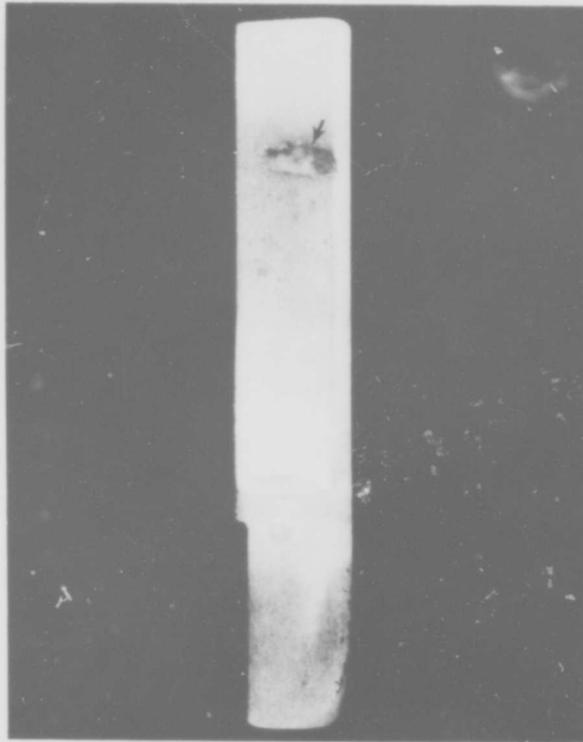
Figure 37. Sylvania SiCrTi Slurry Coated B-66 Alloy Bar After Oxidation-Erosion Testing for 100 Hours at 2200°F Plus 60 Hours at 2400°F

application (Figure 37). These support areas were evidenced prior to testing by a slightly different coloration of the coating.

Failure occurred after 140 hours in area at which specimen was supported during coating application (arrow).

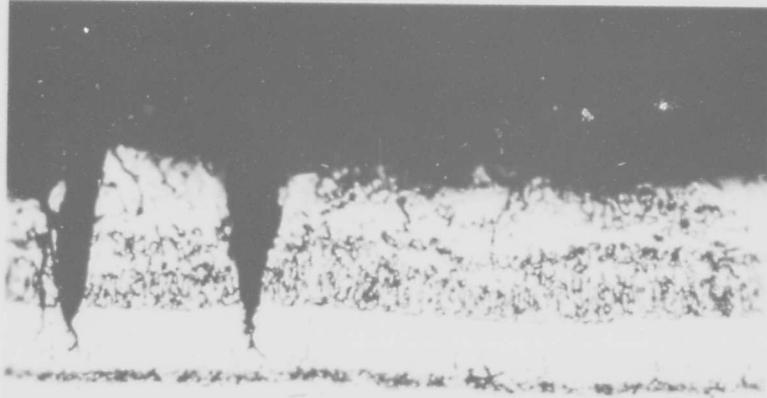
Metallographic examination of the coating after erosion testing revealed numerous areas of oxide penetration through the outer coating layers (Figure 38). Substrate attack, however, was absent except in those areas where oxidation was visible on the specimen surfaces.

Figure 38. Oxide Penetration Through the Outer Coating Layers of Sylvania SiCrTi Slurry Coated B-66 Alloy Specimen After Oxidation-Erosion Testing for 100 Hours at 2200°F Plus 60 Hours at 2400°F

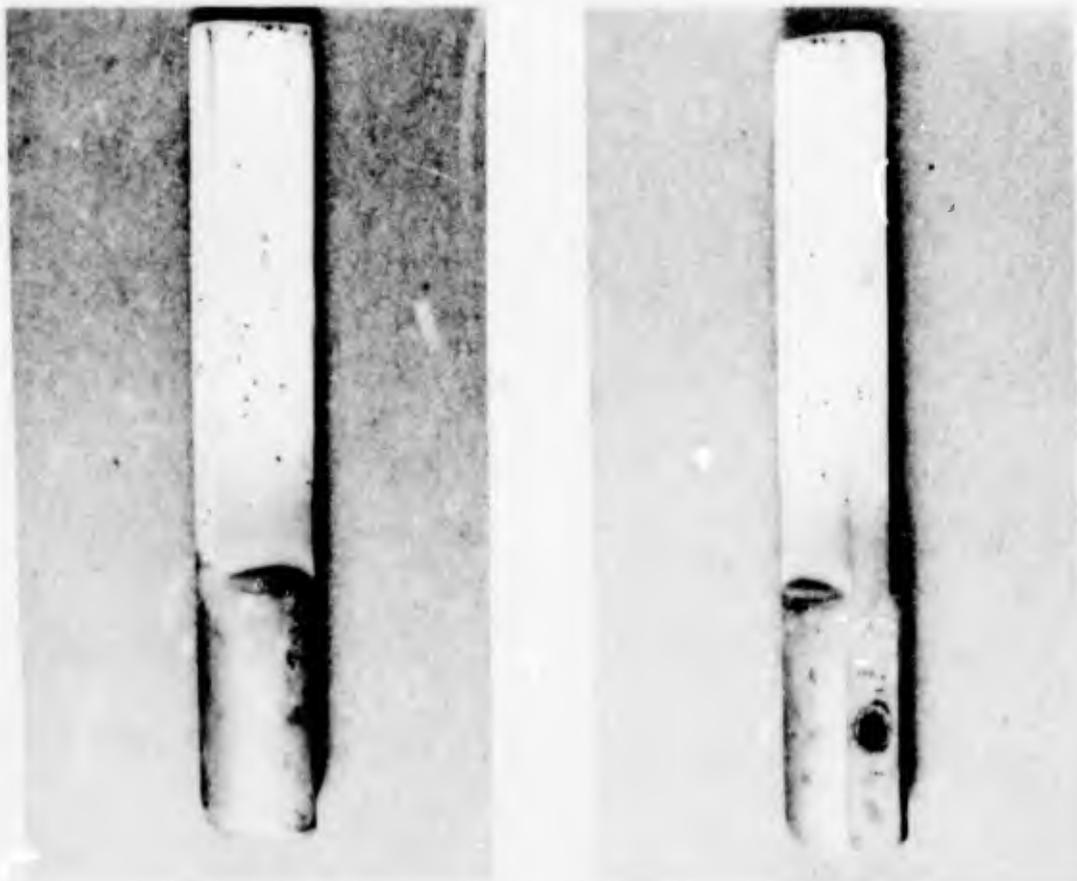
Figure 39. TRW TiCr-Si Coated XB-88 Alloy Bars After Oxidation-Erosion Testing for 20 Hours at 2200°F

TRW TiCr-Si (Vacuum) Pack/XB-88. Failure of four specimens, as judged by visible substrate oxide (Figure 39), was observed for the TRW TiCr-Si/XB-88 system after 20 hours at 2200° F. Metallographic examination revealed complete oxygen penetration of the coating in areas of surface craze cracking. Subsequent oxidation occurred along the coating-substrate interface (Figure 40).

Note numerous localized oxidation failures on airfoil surfaces.

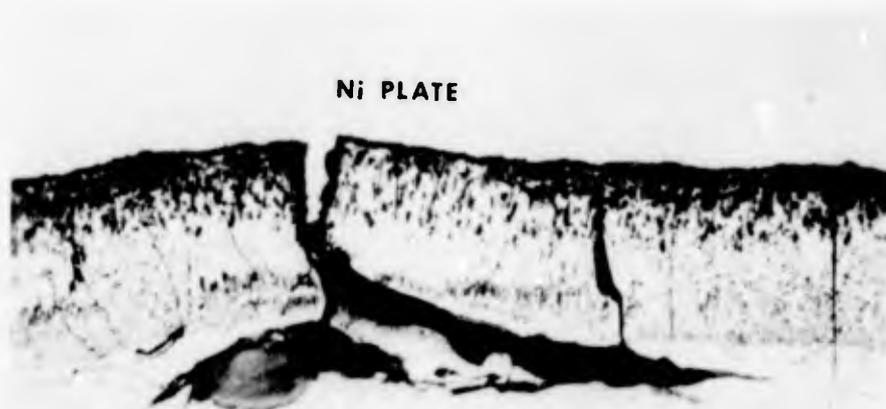
Figure 40. Typical Oxidation Failure on TRW TiCr-Si Coated XB-88 Alloy Specimen Oxidation-Erosion Tested for 20 Hours at 2200°F

were observed on airfoil surfaces (Figure 57). Composite microstructure after failure was similar to that observed for the system after failure in oxidation-erosion (see Figure 40); i.e., oxide penetration within coating craze cracks led to rupture of the coating and subsequent substrate oxidation.

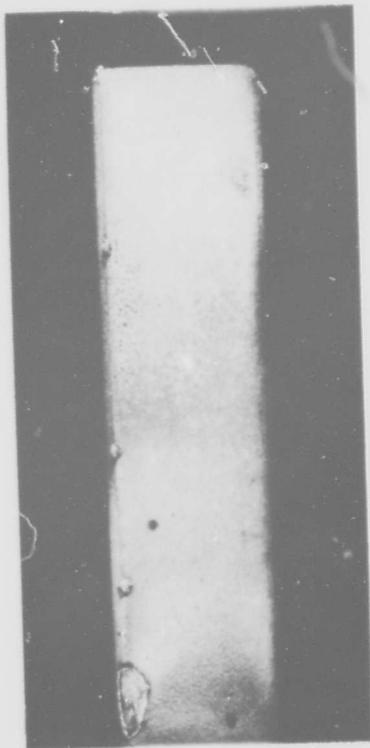
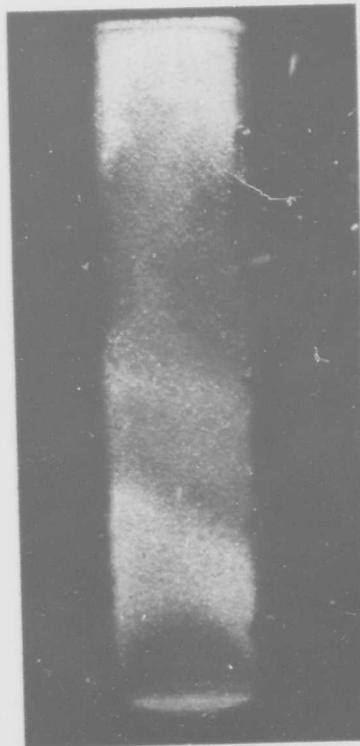
Figure 41. Typical Solar V-CrTi-Si Coated Cb-132M Alloy Erosion Bars After 80 Hours of Oxidation-Erosion Testing at 2200°F

Solar V-CrTi-Si/Cb-132M. Failure was detected after 20 hours at 2200° F for three of the Solar V-CrTi-Si/Cb-132M specimens and after 100 hours at 2200° F plus 20 hours at 2400° F for the fourth specimen. Those specimens exhibiting failure after 20 hours were tested for an additional 60 hours at 2200° F to determine whether the areas of local oxidation represented coating defects or signified the onset of general failure. Although progressive extension of the local oxidation occurred, no additional areas of failure were observed. Local oxidation generally occurred along the trailing edge and airfoil tip surfaces (Figure 41).

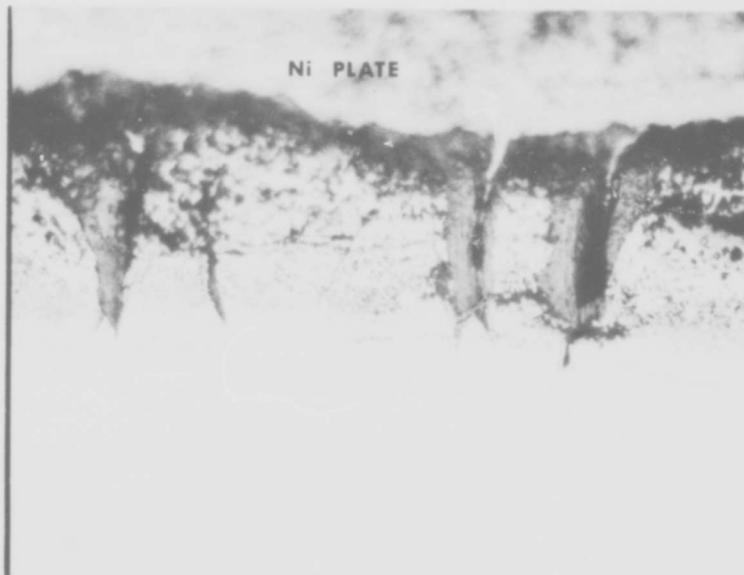
Metallographic examination of the specimens after test revealed general oxide penetration through coating cracks to the coating-substrate diffusion zone (Figure 42). The areas of local failure showed appreciable amounts of substrate oxide (Figure 43), and, in some cases, oxygen enrichment along grain boundaries extended for an appreciable distance (2 to 3 mils) beneath the oxide layer (Figure 44).

Figure 42. Typical Microstructure of Solar V-CrTi-Si Coated Cb-132M Alloy After 80 Hours of Oxidation-Erosion Testing at 2200°F

No external failure was noted in this area.

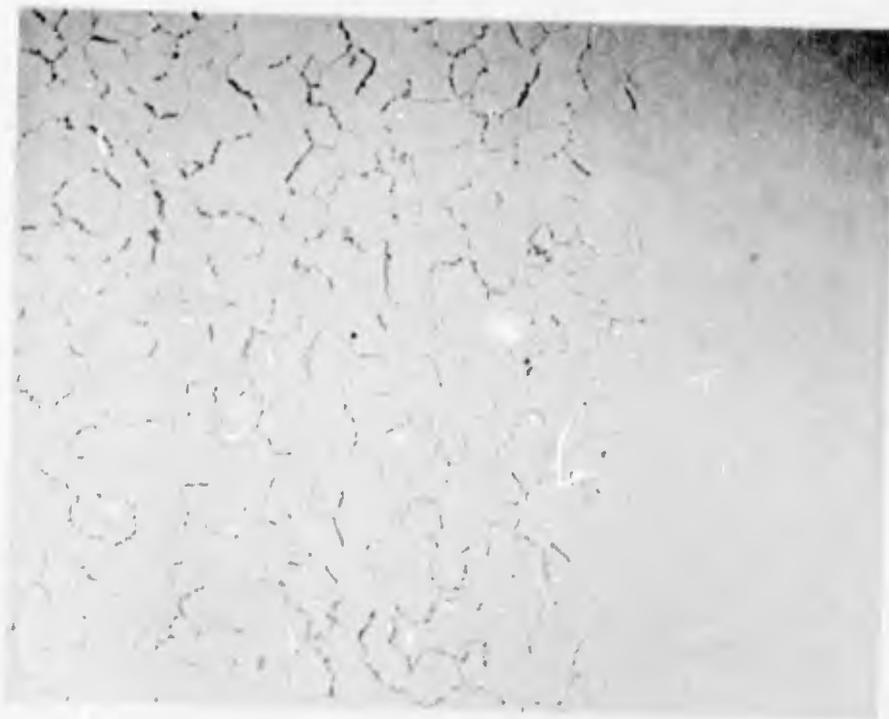
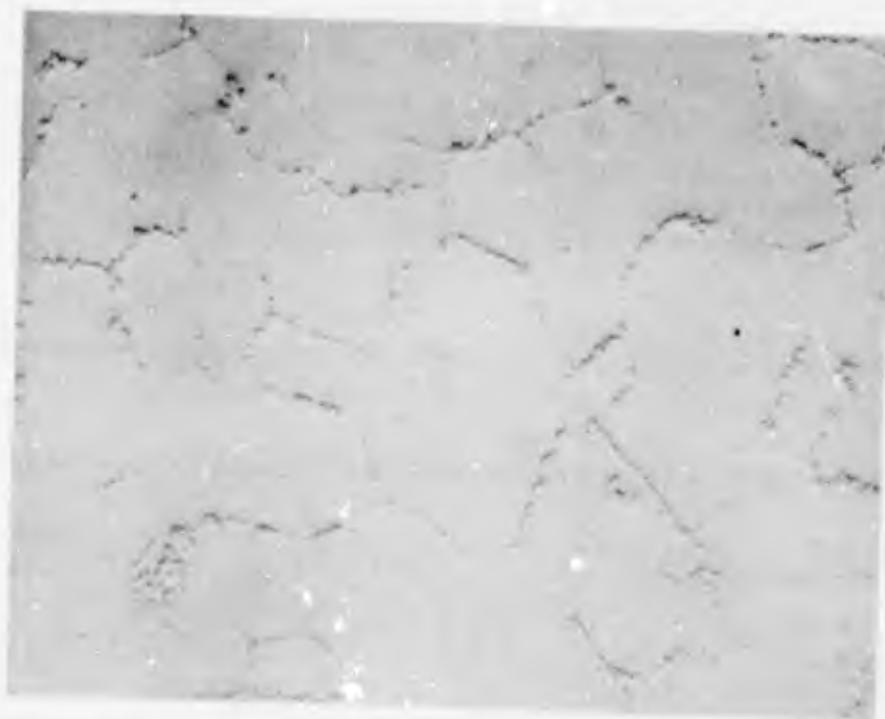
Figure 44. Microstructure of Cb-132M Alloy Substrate Showing Grain Boundary Oxygen Enrichment Beneath a Typical Solar V-CrTi-Si Coating Failure in 2200°F Oxidation-Erosion

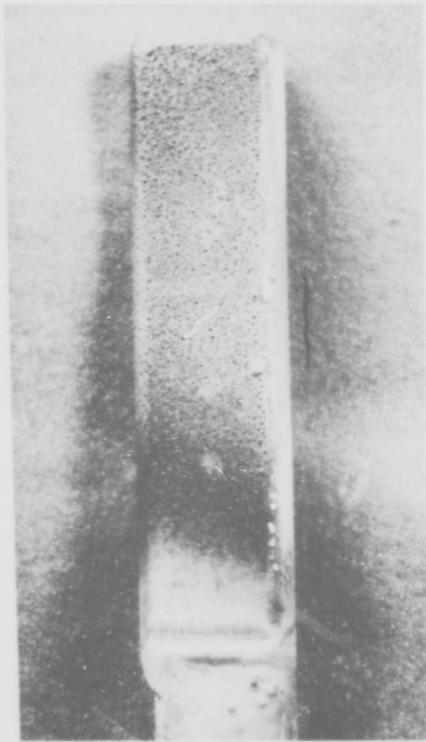
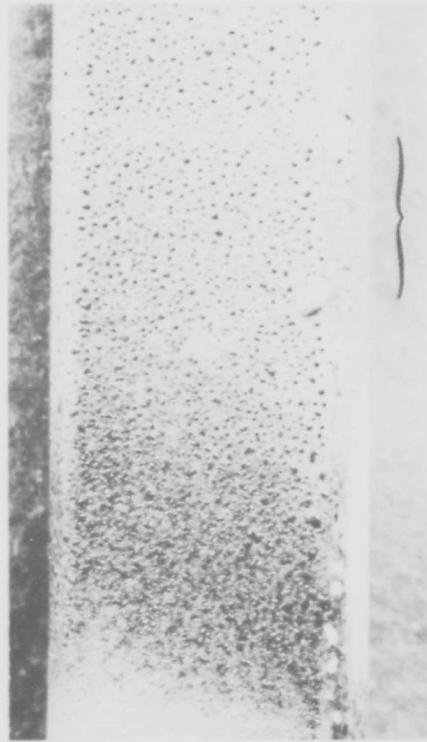
Figure 46. Solar MoTi-Si Coated Cb-132M Alloy Bar After Oxidation-Erosion Testing for 100 Hours at 2200°F Plus 100 Hours at 2400°F Plus 40 Hours at 2500°F

- After 100 hours each at 2200° and 2400° F plus 40 hours at 2500° F: Substrate oxidation was observed along the trailing edge surface as shown in Figure 46. In other specimen airfoil areas, subcoating substrate oxidation appeared to be imminent as shown in Figure 47.

Note oxidation along trailing edge surface (bracket).

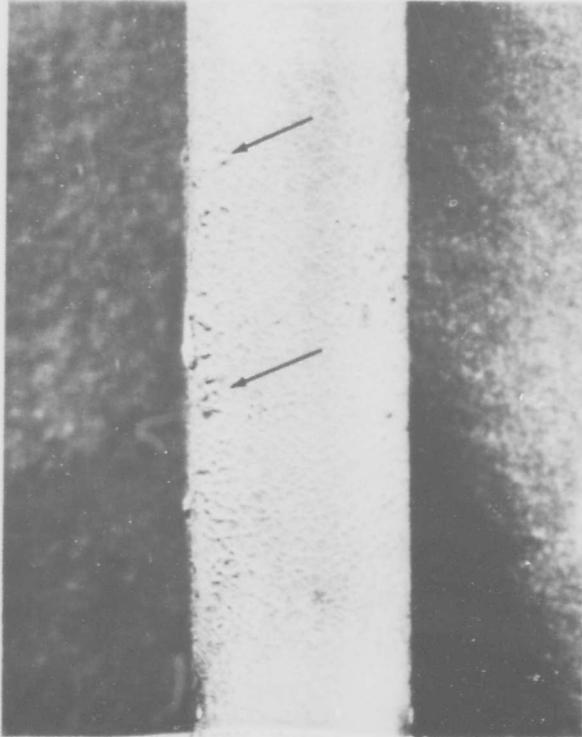
Figure 47. Solar MoTi-Si Coated Cb-132M Alloy Bar After Oxidation-Erosion Testing for 100 Hours at 2200°F Plus 100 Hours at 2400°F Plus 40 Hours at 2500°F

Note area of apparent subcoating oxidation (arrows).

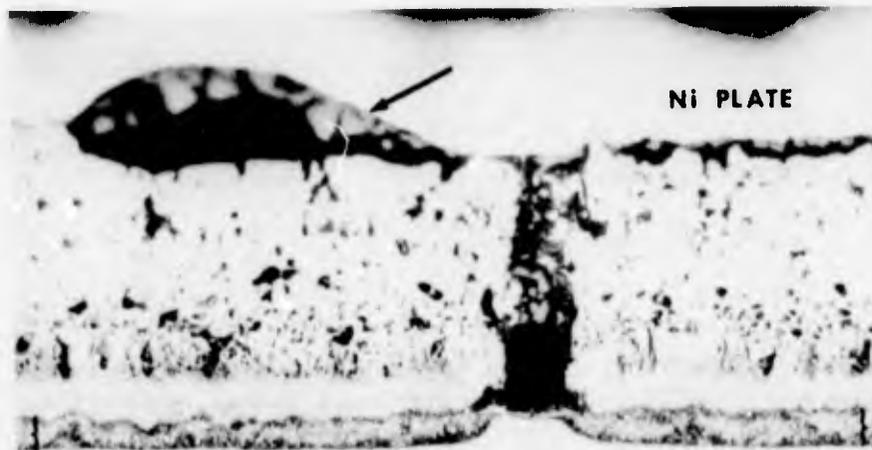
Metallographic examinations confirmed that surface beads were glassy formations. The glassy spots which were dark gray in color indicated glass devitrification on specimen cooling (Figure 48); the milky white spots, however, retained an amorphous structure (Figure 49). Coating structure beneath these glassy surface formations consisted of craze cracks extending to the coating-substrate interface. These cracks were filled with devitrified glass. During testing, an additional coating layer was formed at the coating-substrate interface. This layer also appeared glassy in nature. Additional layer formation was notably absent in substrate regions immediately beneath the glass-filled craze cracks (Figure 48). At failure, the glassy areas were bisque-colored in appearance, denoting substrate oxidation (Figure 50).

Figure 48. Microstructure of Solar MoTi-Si Coated Cb-132M Alloy After Oxidation-Erosion Testing for 100 Hours at 2200°F Plus 100 Hours at 2400°F Plus 40 Hours at 2500°F

Note devitrified glassy spot on coating surface (arrow) and the formation and penetration of second phase into the alloy substrate (brackets).

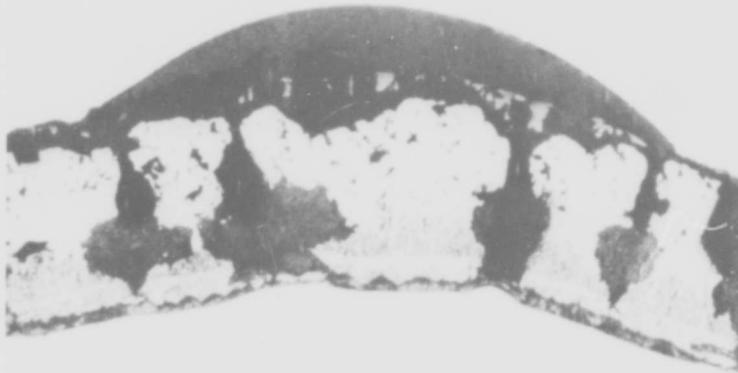
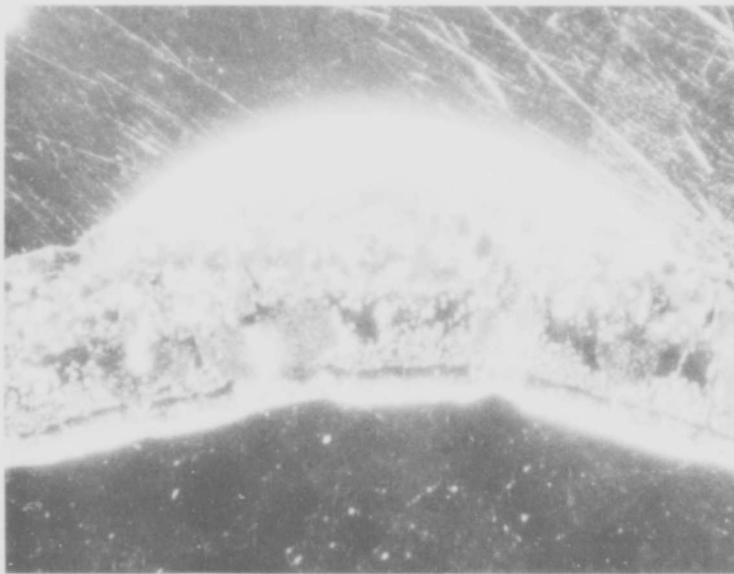
Figure 49. Microstructure of Solar MoTi-Si Coated Cb-132M Alloy Showing Formation of Amorphous and Devitrified Glassy Structures During Oxidation-Erosion Testing

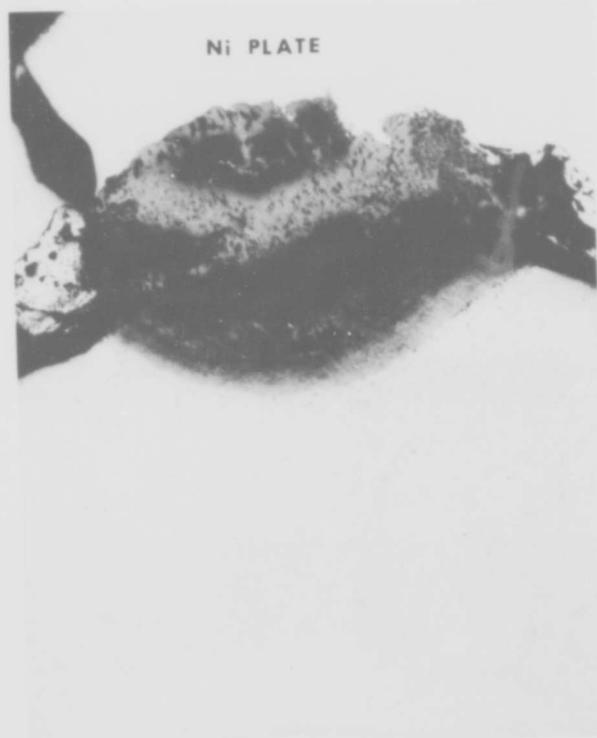
Figure 50. Microstructure of Solar MoTi-Si Coated Cb-132M Alloy Showing Substrate Oxidation Beneath Bisque-Colored Glassy Areas After Oxidation-Erosion Testing

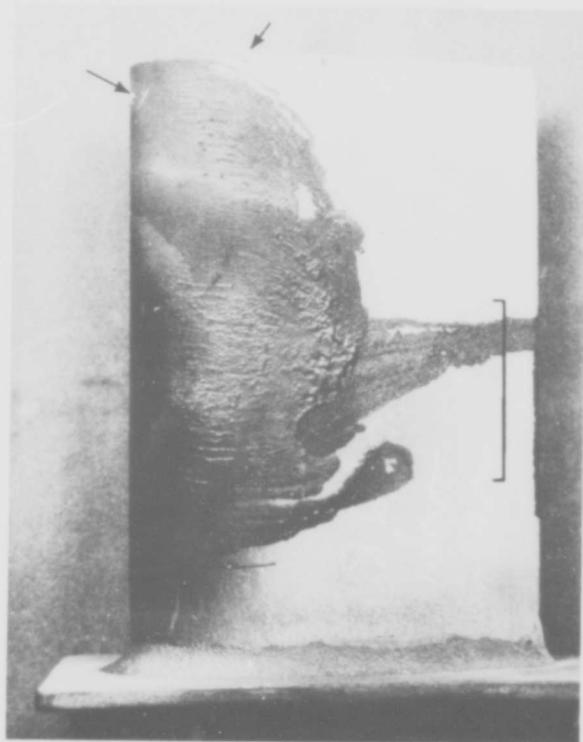
Figure 53. Sylvania SiCrTi Slurry Coated B-66 Alloy Vane Airfoil After 600 Thermal Fatigue Cycles to 2200°F Plus 400 Cycles to 2400°F Plus a 30-Minute Exposure at 2500°F

On the first of the two specimens, separation occurred after the 30-minute stabilization period at 2500° F prior to cycling. The coating on the airfoil (Figure 53) was damaged, and testing was necessarily terminated. Metallographic examination of the airfoil section revealed craze cracking and subsequent oxide penetration through outer coating layers (Figure 54). Substrate oxidation, however, was not observed in these areas.

Note localized coating and specimen damage (arrow). Bracket denotes location of a hairline crack.

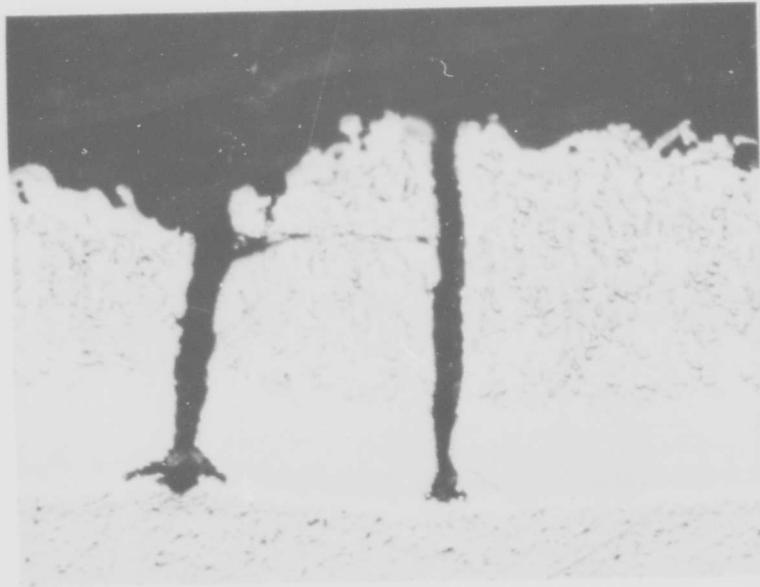
Figure 54. Craze Cracking and Oxide Penetration Through Outer Coating Layers of Sylvania SiCrTi Slurry Coated B-66 Alloy After 600 Thermal Fatigue Cycles to 2200°F Plus 400 Cycles to 2400°F Plus a 30-Minute Exposure at 2500°F

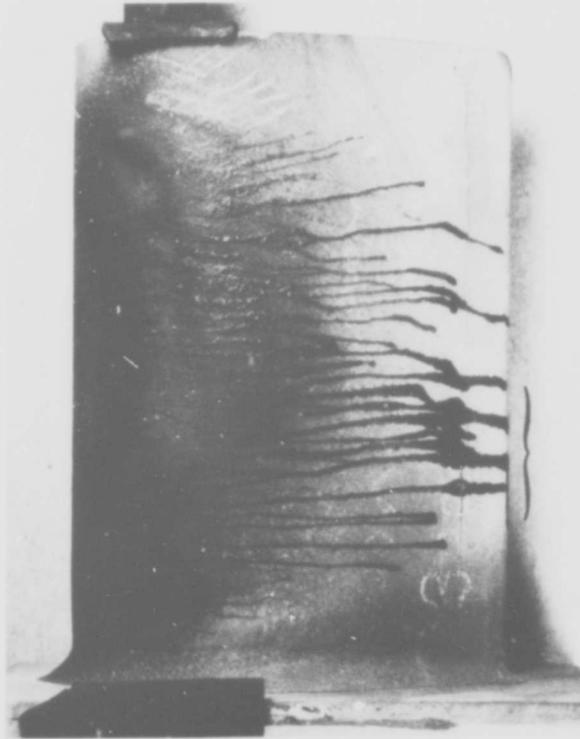
Figure 55. Sylvania SiCrTi Slurry Coated B-66 Alloy Vane Airfoil Convex Surface After 600 Thermal Fatigue Cycles to 2200°F Plus 400 Cycles to 2400° F Plus 500 Cycles to 2500°F; No Coating Failure

The second specimen was tested further at 2500° F for the stabilization period plus 100 cycles. Testing was discontinued immediately prior to handle-airfoil separation. Since the airfoil coating areas remained in good condition, a suitable fixturing technique was devised to allow continued testing at 2500° F. An additional 400 cycles to 2500° F (500 cycles total at 2500° F) was accumulated before airfoil cracking (convex surface) was observed along a line parallel to the trailing edge (Figure 55). Although an additional 200 cycles to 2500° F (700 cycles total at 2500° F) resulted in continued oxidation along the cracked surface and additional crack formation along the concave surface, the airfoil leading edge remained in good condition (Figure 56). The leading edge exhibited local coating depletion, but coating failure and leading edge oxidation did not occur.

Bracket locates hairline crack.

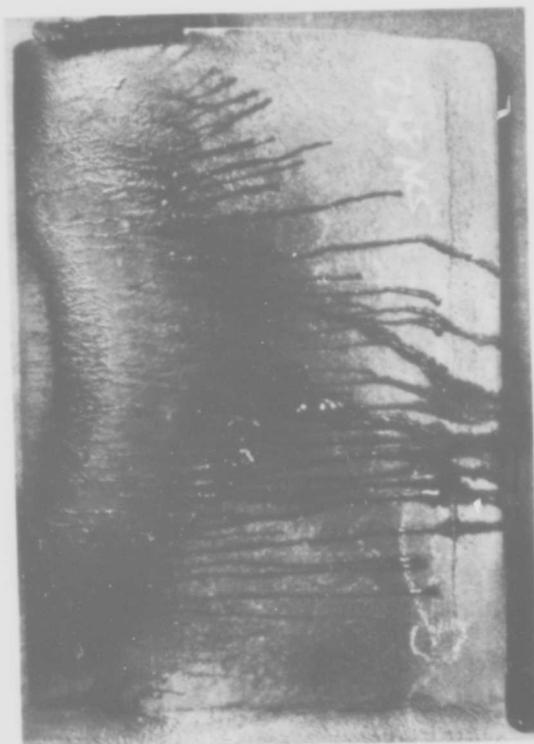
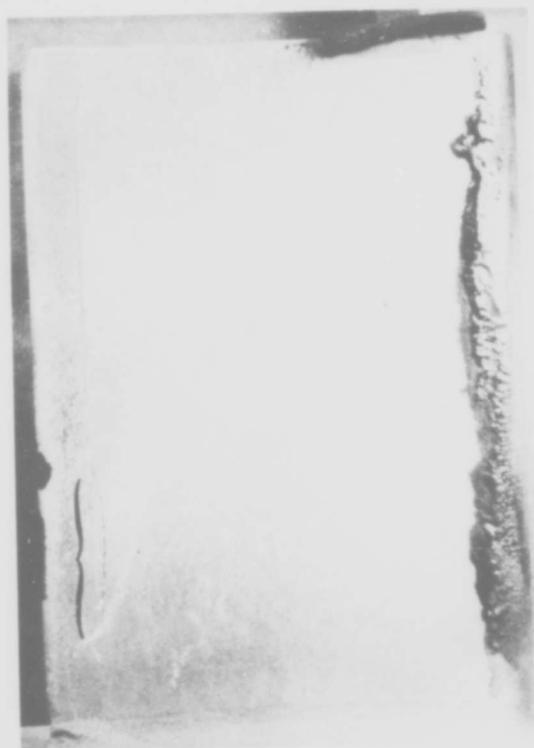
Figure 56. Sylvania SiCrTi Slurry Coated B-66 Alloy Vane Airfoil After 600 Thermal Fatigue Cycles to 2200°F Plus 400 Cycles to 2400°F Plus 700 Cycles to 2500°F; No Coating Failure

Brackets locate hairline cracks.

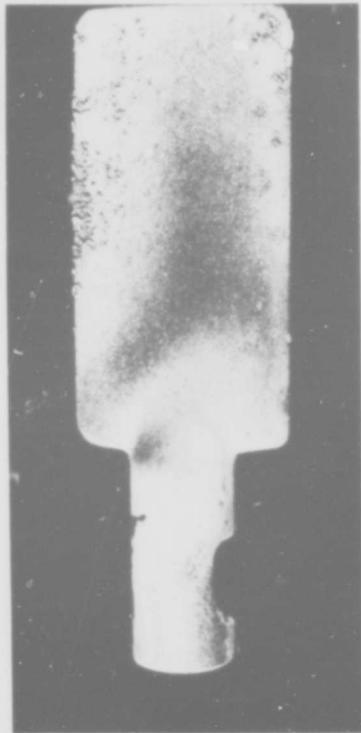
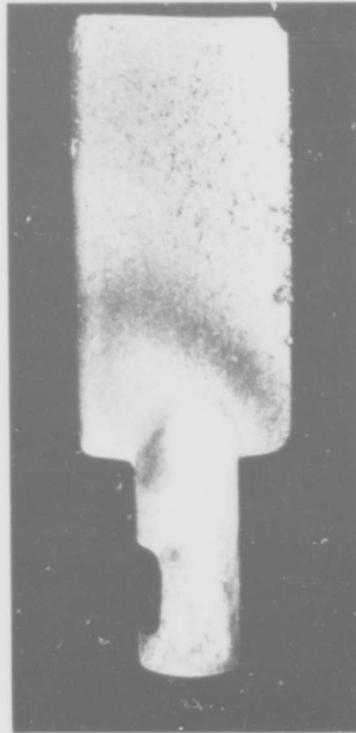
Figure 59. Solar V-CrTi-Si Coated Cb-132M Alloy Thermal Fatigue Specimens
After 400 Cycles to 2200°F

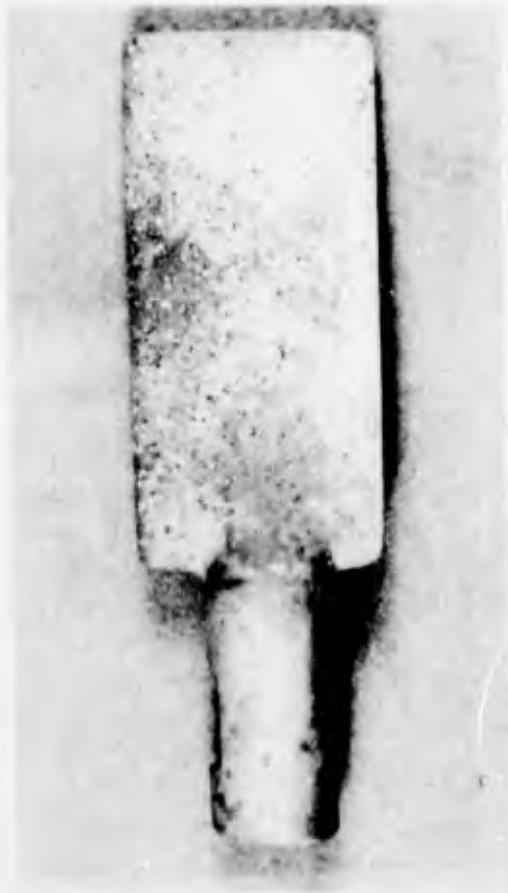
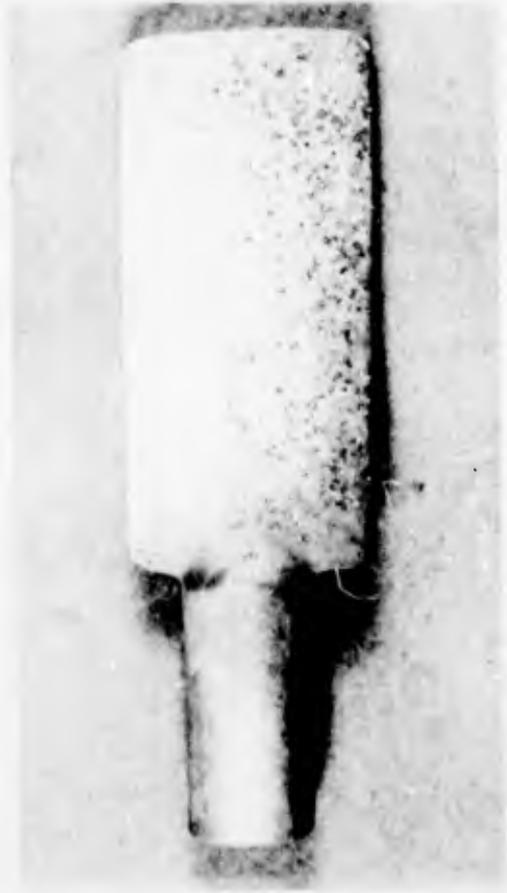
Figure 57. TRW TiCr-Si Coated NB-88 Alloy Specimens After 200 Thermal Fatigue Cycles to 2200°F

Note numerous airfoil oxidation failures.

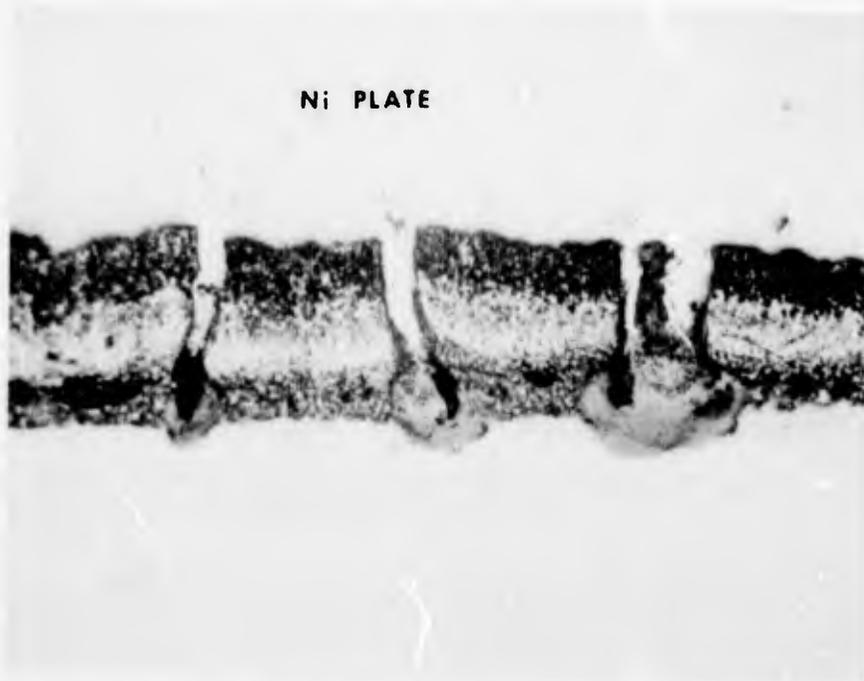
Figure 60. Typical Microstructure of Solar V-CrTi-Si Coated Cb-132M Alloy After 400 Thermal Fatigue Cycles to 2200°F

No external failure was noted in this area.

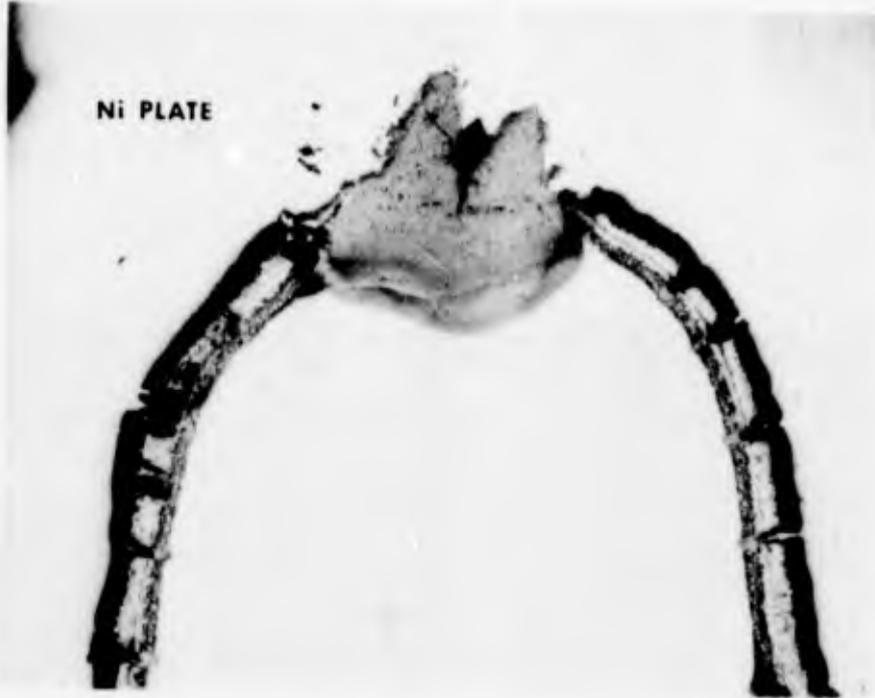
Figure 62. Microstructure of Solar V-CrTi-Si Coated Cb-132M Alloy in Area of 2200°F Thermal Fatigue Failure at the Airfoil Trailing Edge

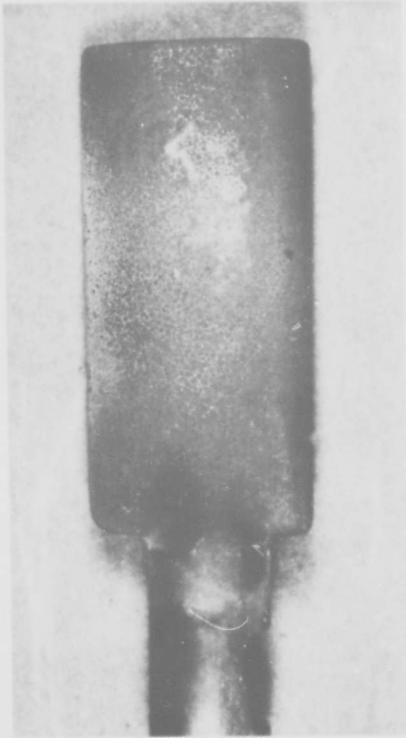
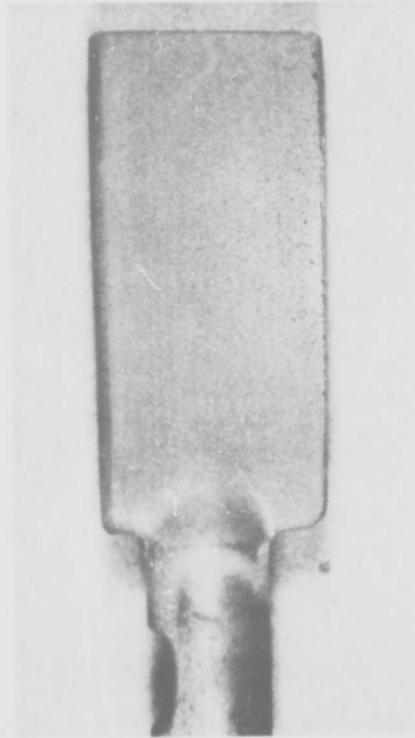
Figure 63. Solar MoTi-Si Coated Cb-132M Alloy Specimen After 600 Thermal Fatigue Cycles to 2200°F Plus 400 Cycles to 2400°F Plus 1200 Cycles to 2500°F

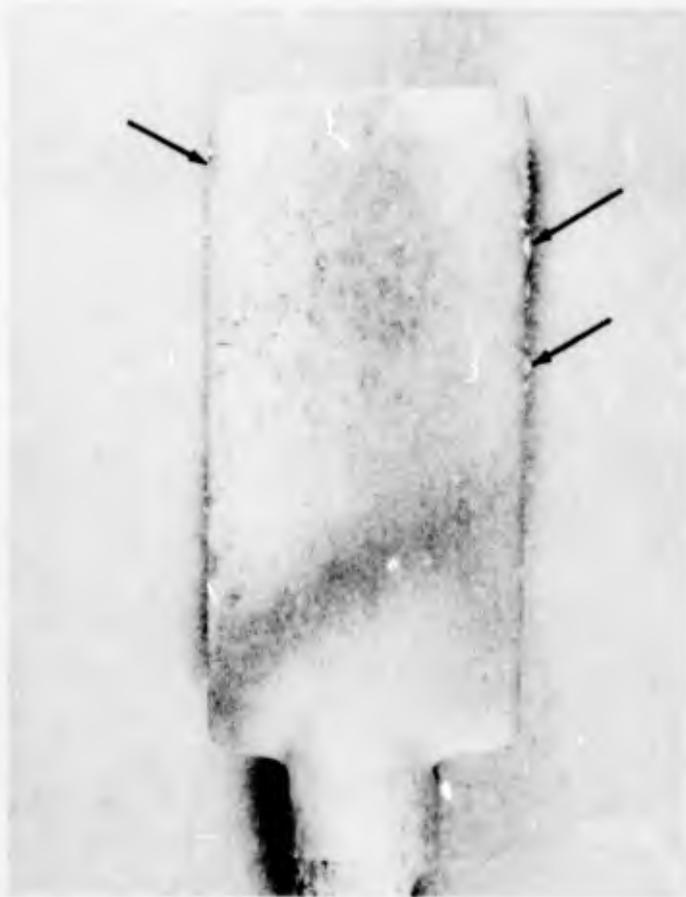
Figure 64. Solar MoTi-Si Coated Cb-132M Alloy Specimen (Convex Surface)
After Thermal Fatigue Testing for 600 Cycles to 2200°F Plus 400
Cycles to 2400°F Plus 1400 Cycles to 2500°F

Note areas of localized oxidation on leading and trailing edge surfaces (arrows).

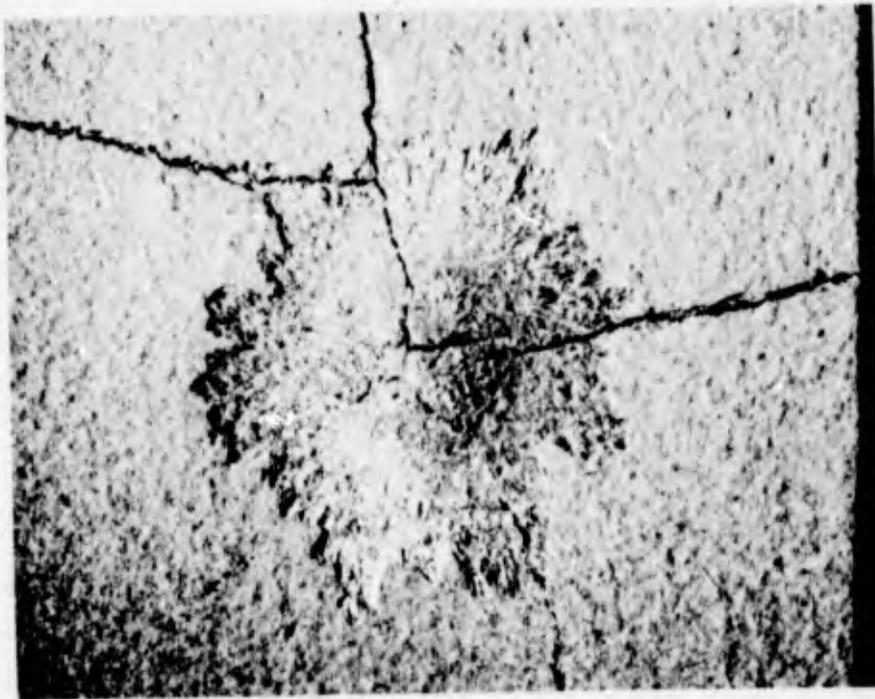
A summary of the ballistic impact test results on all four coating-substrate systems is presented in Table VIII, with the observed condition after oxidation exposure stated for various periods at 2200° F. In all cases, failures were first noted in the scabbed areas (either Zone II or Zone V). Oxidation was generally more prevalent on the impact sides of the specimens. The 500-ft/sec, 70° F impact condition was particularly severe for the Sylvania SiCrTi slurry/B-66 vane system. Both impacts resulted in fracture of the coating-alloy composite (Figure 66).

Figure 66. Surfaces of Sylvania SiCrTi Slurry Coated B-66 Alloy After Room Temperature Impact Testing at 500 Feet Per Second (No Oxidation Exposure)

Note coating-alloy composite cracking.

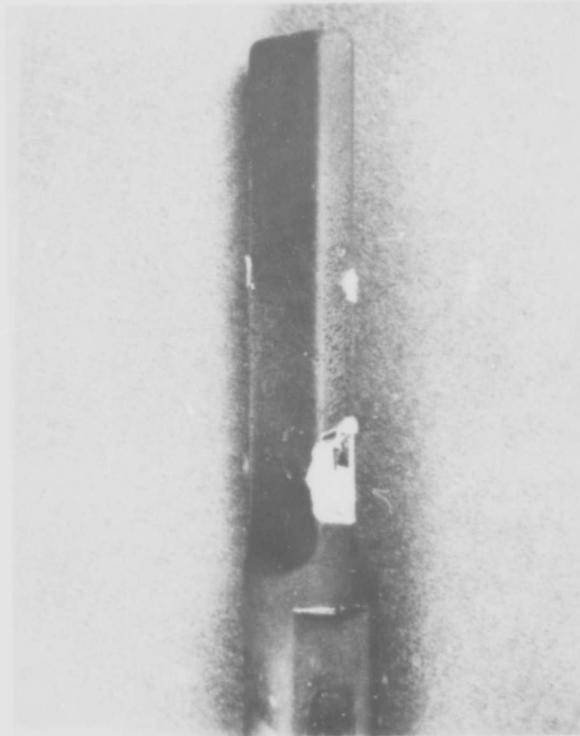
Though not part of contract requirements, oxidation-erosion testing was performed on these test specimens using parameters identical to those described for the Phase V preliminary screening tests (paragraph 3.3.1.1). Failure as determined by localized oxide formations occurred for all Solar TNV-7SE4 coated Cb-132M alloy specimens after 100 hours at 2200° F plus 40 hours at 2400° F (Figure 67). Oxidation-erosion failures of the Solar V-(CrTi)-Si coated Cb-132M alloy occurred on one specimen after 100 hours at 2200° F plus 60 hours at 2400° F and for two remaining specimens after 100 hours at 2200° F plus 100 hours at 2400° F plus 20 hours at 2500° F. Localized substrate oxide formations on specimen airfoil surfaces were considered to indicate a failure of the coating (Figure 68).

Figure 67. Solar (WMoVTi)-Si (TNV-7SE4) Coated Cb-132M Alloy Bar After Oxidation-Erosion Testing for 100 Hours at 2200°F Plus 40 Hours at 2400°F
