EVALUATION AND IMPROVEMENT OF COATINGS
FOR COLUMBIUM ALLOY GAS TURBINE ENGINE COMPONENTS

PRATT & WHITNEY AIRCRAFT
DIVISION OF UNITED AIRCRAFT CORPORATION

Technical Report AFML-TR-66-186, Part II

May 1968

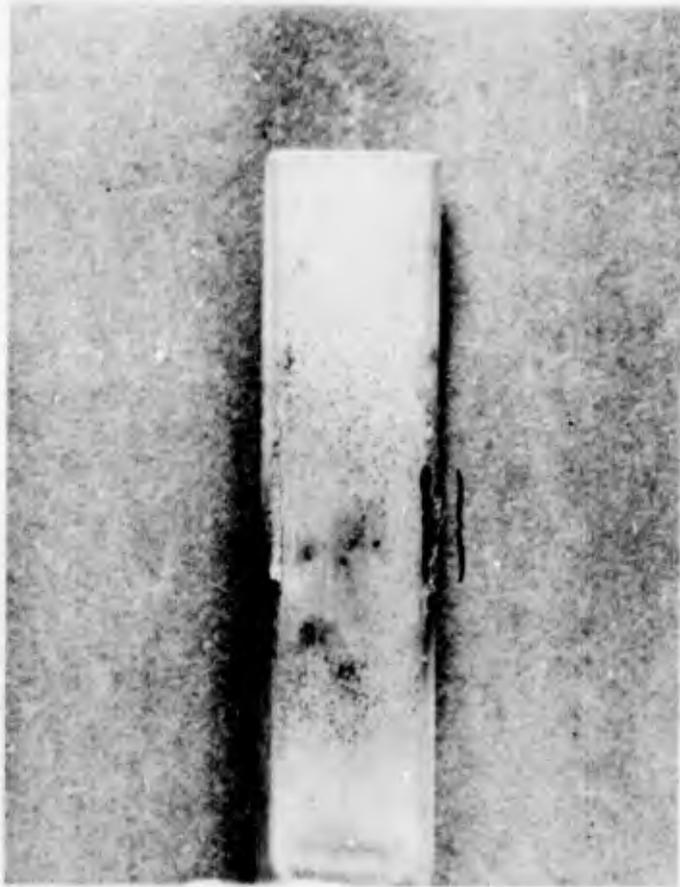
Though not part of contract requirements, oxidation-erosion testing was performed on these test specimens using parameters identical to those described for the Phase V preliminary screening tests (paragraph 3.3.1.1). Failure as determined by localized oxide formations occurred for all Solar TNV-7SE4 coated Cb-132M alloy specimens after 100 hours at 2200° F plus 40 hours at 2400° F (Figure 67). Oxidation-erosion failures of the Solar V-(CrTi)-Si coated Cb-132M alloy occurred on one specimen after 100 hours at 2200° F plus 60 hours at 2400° F and for two remaining specimens after 100 hours at 2200° F plus 100 hours at 2400° F plus 20 hours at 2500° F. Localized substrate oxide formations on specimen airfoil surfaces were considered to indicate a failure of the coating (Figure 68).

Figure 68. Solar V-(CrTi)-Si Coated Cb-132M Alloy Bar After Oxidation-Erosion Testing for 100 Hours at 2200°F Plus 100 Hours at 2400°F Plus 20 Hours at 2500°F

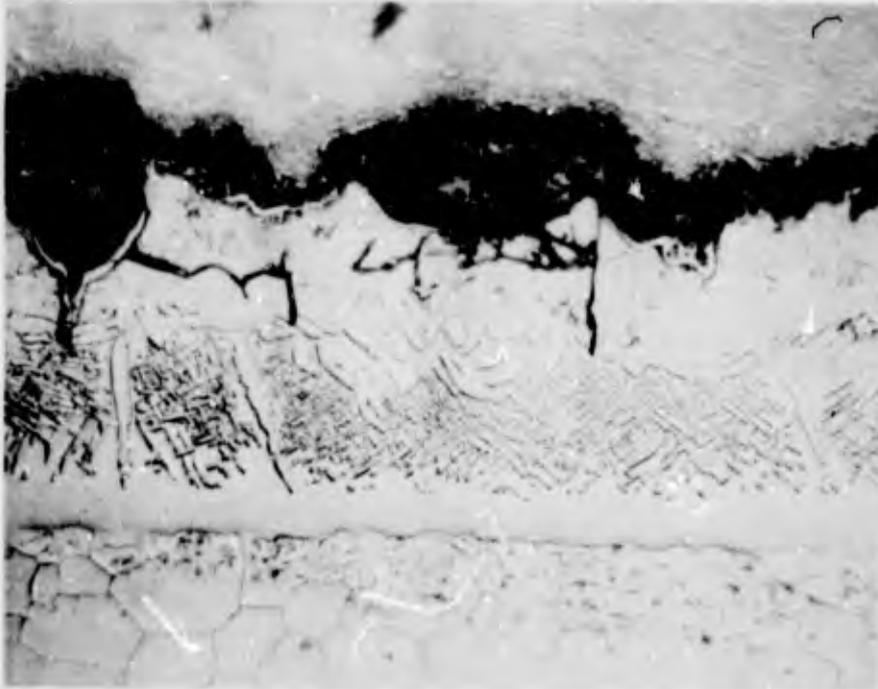
No 1300° or 1600°F failures were noted for the TRW TiAl/Cb-132M system after 400 hours. Metallographic examination of the coating after 1600°F testing revealed good coating continuity, particularly near the coating-substrate interface, and no surface crack penetration to the substrate (Figure 80). Extensive intergranular and intragranular precipitation occurred during exposure within a region extending into the substrate for approximately 1.0 mil (see Figure 80).

Figure 80. Typical Microstructure of TRW TiAl (Vacuum) Pack Coated
Cb-132M Alloy After 400 Hours Oxidation Exposure at 1600°F

Note precipitation in substrate region immediately beneath the coating.

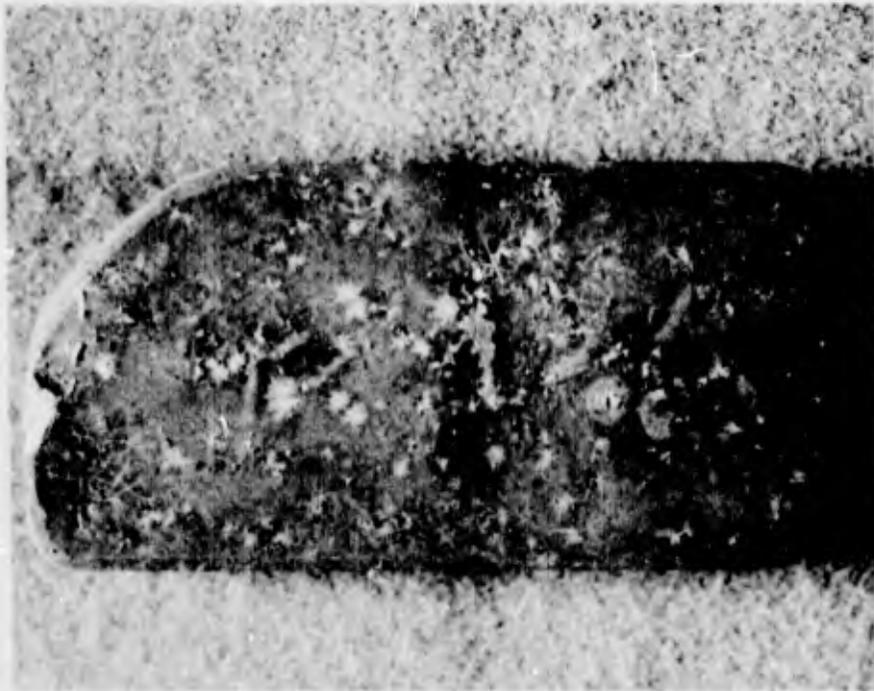
The 1600°F failures for the TRW TiCr-Al coating were confined to corners and edges. In other areas, however, the specimen surfaces were rough and appeared nonhomogeneous (Figure 81). No failures occurred after 400 hours at 1300°F.

Figure 81. TRW TiCr-Al (Vacuum) Pack Coated Cb-132M Alloy Specimen Showing Edge Failure After 54 Hours Oxidation Exposure at 1600°F

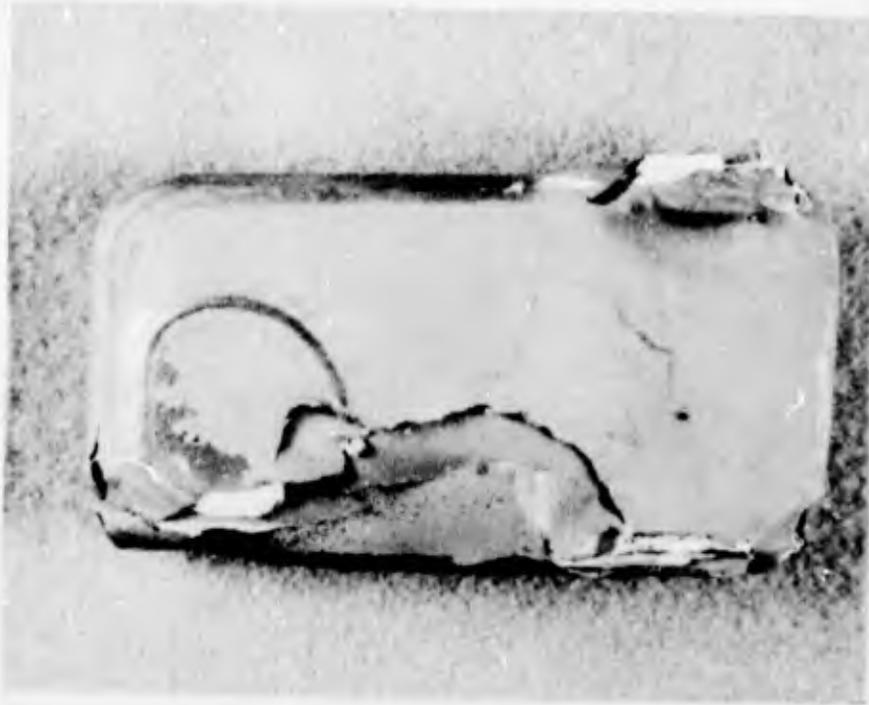
Failure of the electroplated NiCr coatings followed a distinct pattern. Where oxygen had apparently penetrated the NiCr coating layers, continued substrate oxidation buckled the surrounding coating extensively (Figure 83). Failures initially occurred along specimen edges. Metallographic examination of intact coating regions revealed extensive diffusion, coating separation, and oxide formations beneath the outer NiCr layers (Figure 84). In contrast, the vacuum deposited NiCr coating failed only by localized oxidation. Both the NiPt and the PtRh coatings failed by localized oxidation, principally at specimen edges. At failure, oxygen had apparently penetrated the coating and led to the formation of surface irregularities by substrate oxidation (Figure 85). Areas away from the failure points remained in good condition. Very good coating homogeneity was noted metallographically for the NiPt coating, which did not fail after 290 hours at 1300°F (Figure 86).

Figure 83. Electroplated NiCr Coated Cb-132M Alloy Specimen Showing Typical Coating Failure After 8 Hours Oxidation Exposure at 1600°F

Note undermining and rupture of intact coating regions.

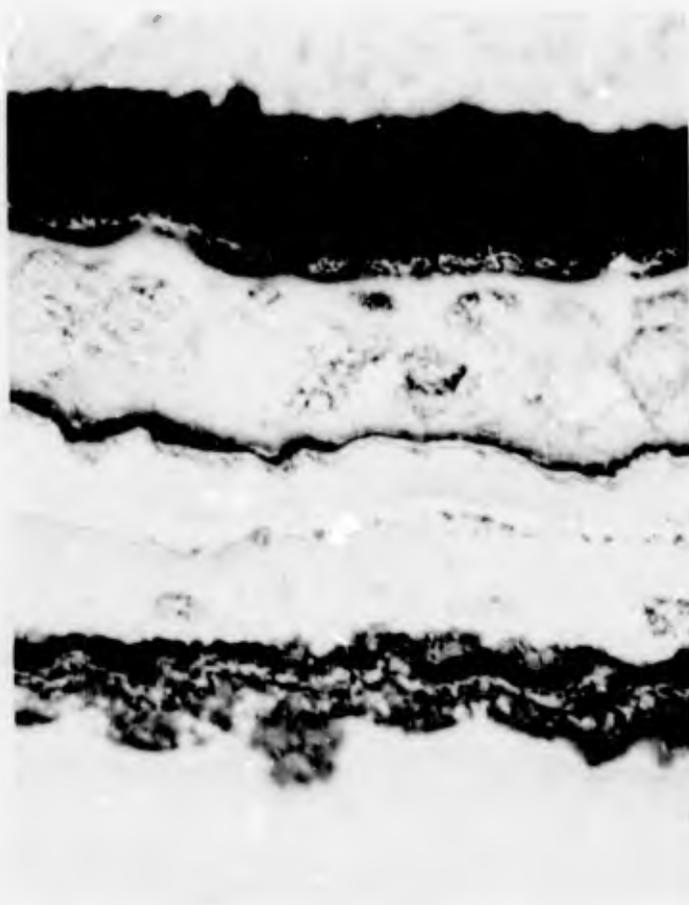
Figure 84. Microstructure of Electroplated NiCr Coated Cb-132M Alloy Showing Coating Separation and Oxide Formation at the Coating-Substrate Interface

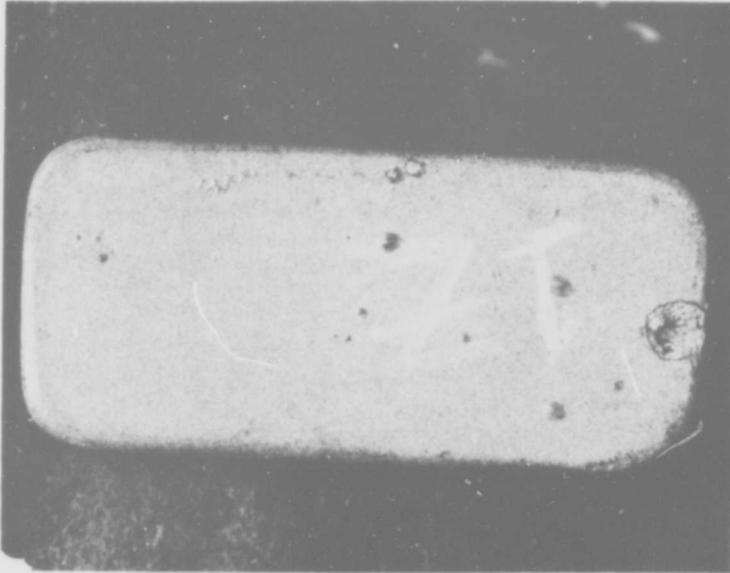
Figure 85. PtRh Coated Cb-132M Alloy Specimen After 8 Hours Oxidation Exposure at 1300°F

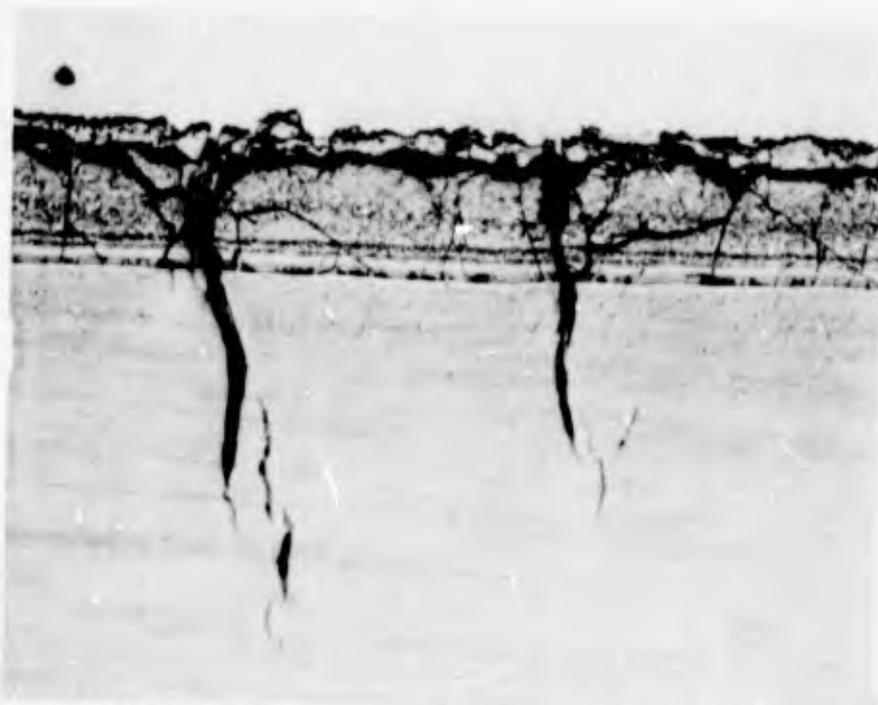
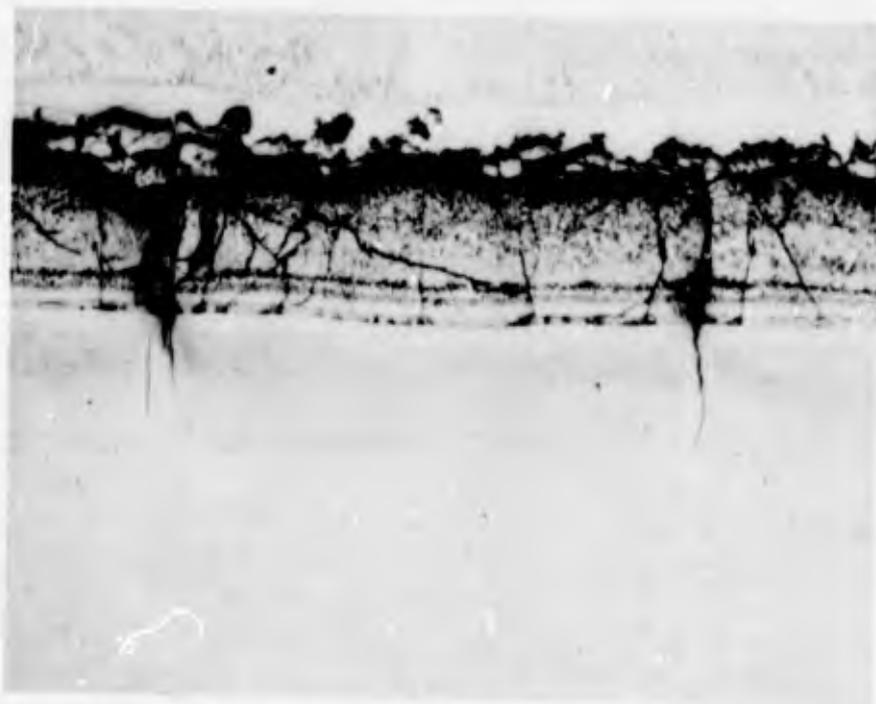
- Although the tensile strain data were relatively good for the Sylvania SiCrFe coating, metallographic examination of specimen gage sections after failure revealed numerous cracks originating at the coating surface and extending into the substrate (Figure 88).

Figure 88. Typical Microstructure of Sylvania SiCrFe Slurry Coated Cb-132M Alloy After Tensile Testing in Air at 1300°F

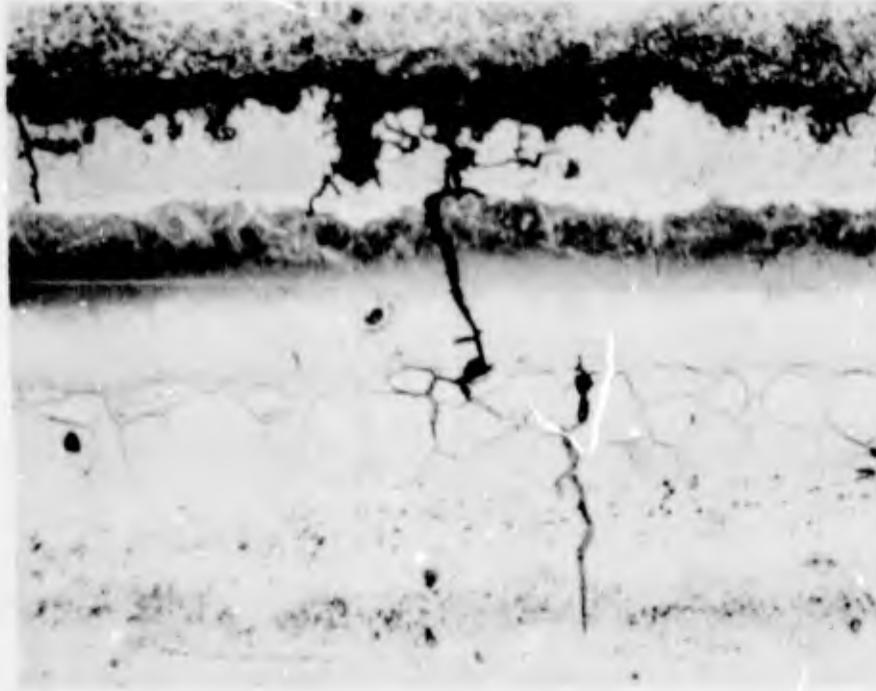
- One of the TRW TiAl coated tensile specimens failed in the elastic region. A second specimen tested at 70°F, however, developed plastic strain. Metallographic examination of the gage section showed some coating cracks (Figure 89), but more extensive cracking at the center of the specimen diameter suggests that the coating may not be responsible for the tensile failure.

Figure 89. Microstructure of TRW TiAl (Vacuum) Pack Coated Cb-132M Alloy After Tensile Failure at 70°F

No other areas contained coating cracks extending into the substrate.

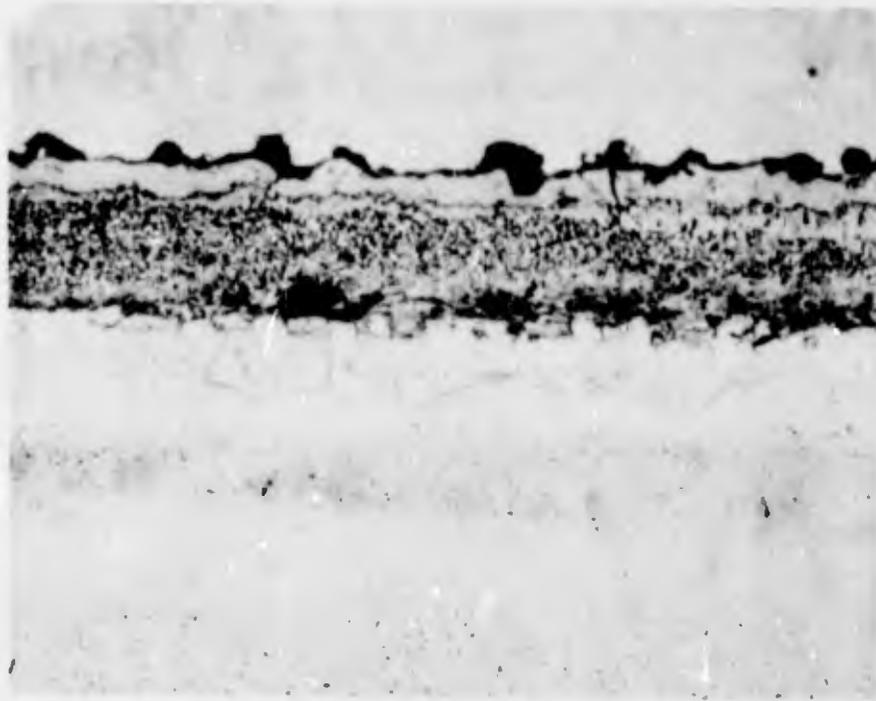
- The TRW TiCr and TiCr-Al coatings resulted in severe embrittlement. However, metallographic examination suggests that cracks did not originate in the coating (Figure 90).

Figure 90. Typical Microstructure of TRW TiCr-Al (Vacuum) Pack Coated Cb-132M Alloy After Tensile Testing at 70°F

Note absence of crack penetration from the coating into the substrate.

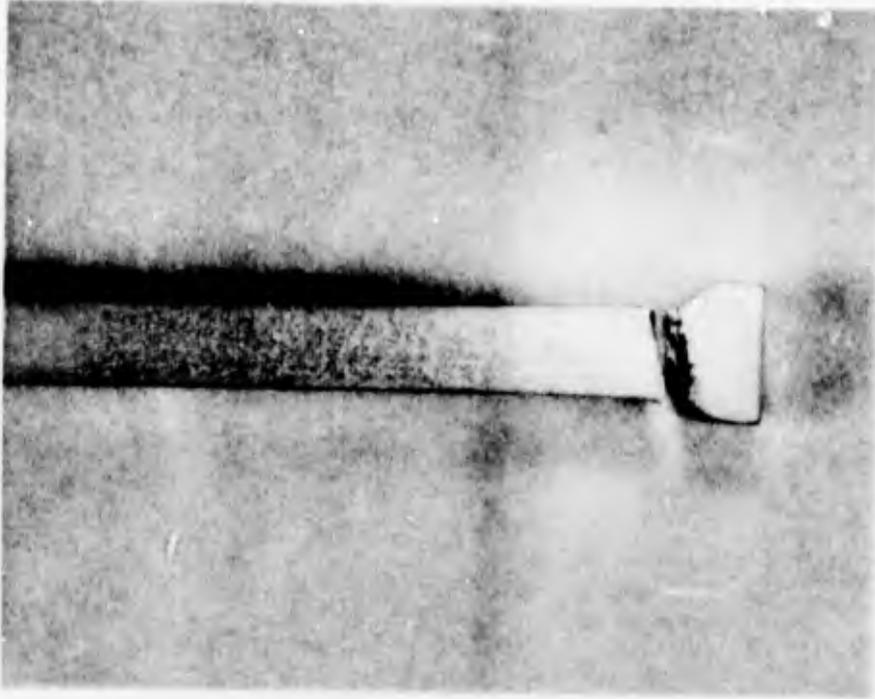
Figure 92. Sylvania SiCrFe Slurry Coated Cb-132M Alloy Wear-Galling Specimen Showing Failure Within Dovetail Radius Area After 97,000 Cycles at 1300°F

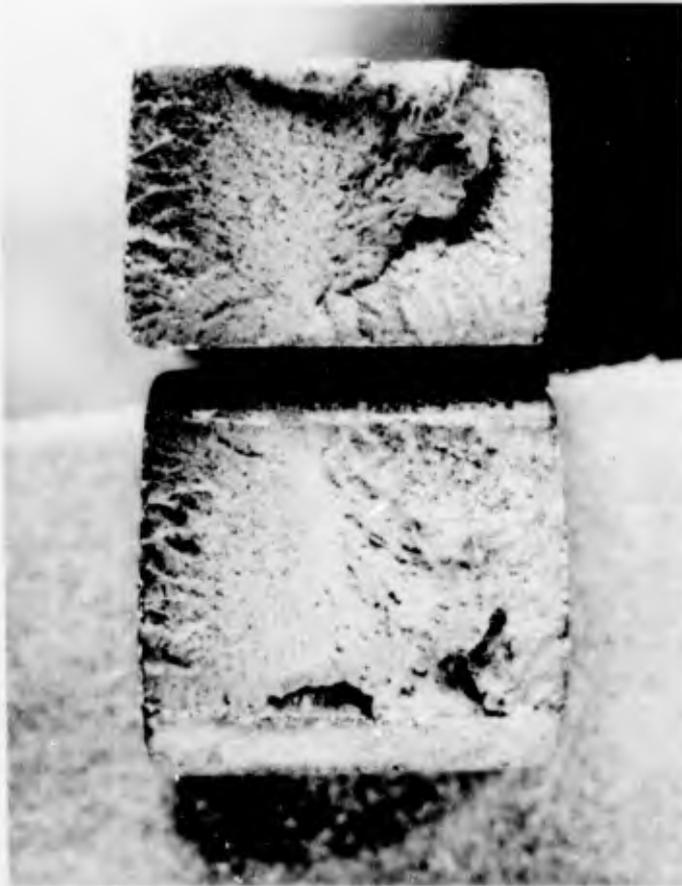
Figure 93. Fracture Surface of Failed Sylvania SiCrFe Slurry Coated Cb-132M Alloy Wear-Galling Specimen After 97,000 Cycles at 1300°F and a Tensile Stress of 30,000 Psi

Surface indicates brittle fracture.

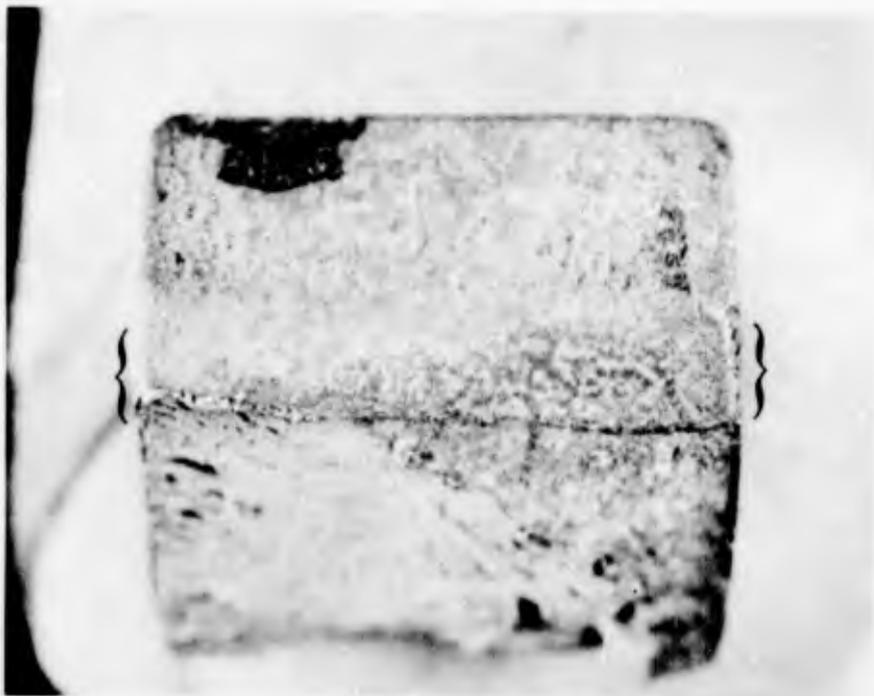
Figure 94. Sylvania SiCrFe Slurry Coated Cb-132M Alloy Wear-Galling Specimen Showing Wear Surface (Brackets) After 97,000 Cycles at 1300°F and a Tensile Stress of 30,000 Psi

Note absence of distress in contact area.

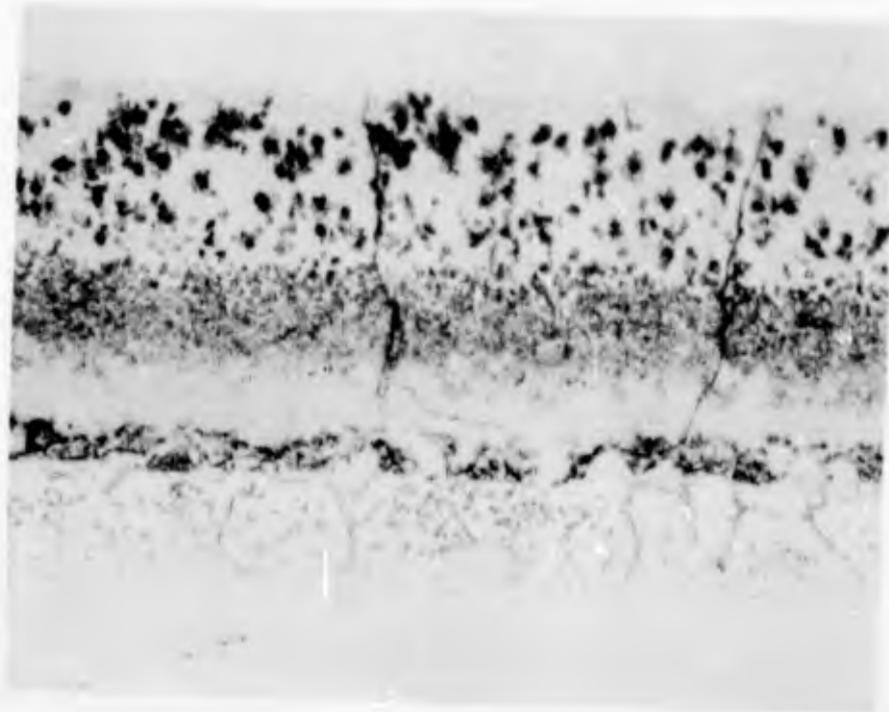
A metallographic examination of the 3.5-mil-thick metallic-gray coating produced with this modified process revealed three microstructurally different layers in addition to a solution zone extending approximately 0.5 mil into the XB-88 substrate (Figure 100). Precipitation of a second phase within this solid solution zone had occurred in a continuous fashion along the substrate grain boundaries. Precipitation was discontinuous within substrate grains. The coating layer adjacent to the substrate was discontinuous and poorly defined in thickness (Figure 100). The continuous intermediate layer was approximately 1.3 mils thick and was fairly homogeneous except for the outer 0.8 mil, which contained discontinuous regions similar in appearance to portions of the outer layer. The 2.0-mil-thick outer layer was continuous although regions of second phase were present at random locations. Numerous coating cracks extended from the surface through the coating to the coating-substrate layer.

Figure 100. Typical Microstructure of As-Applied Modified TRW TiCr-Si (Vacuum) Pack Coating on XB-88 Alloy

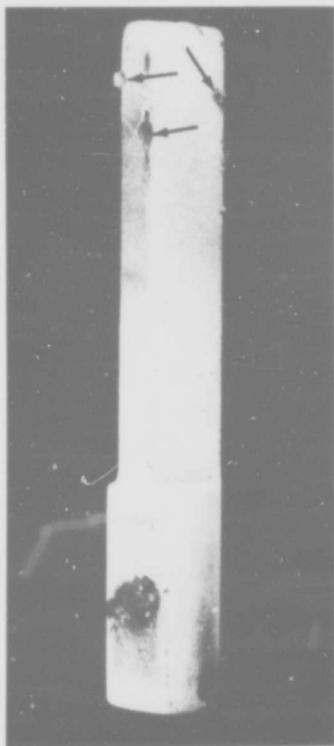
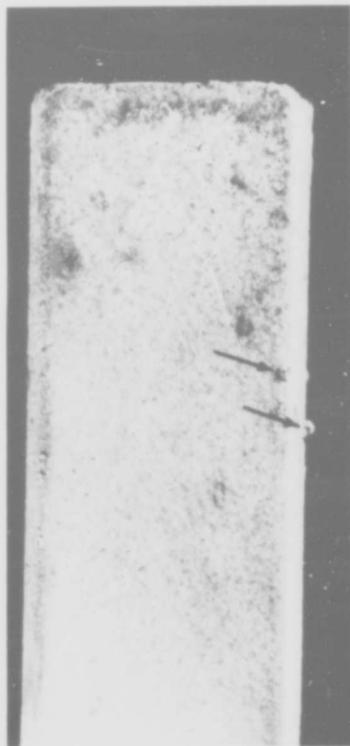
Modified Sylvania SiCrTi Slurry/B-66. For all four test specimens, the modified (thicker) SiCrTi slurry coating on B-66 alloy exhibited a protective life of 100 hours at 2200°F plus 100 hours at 2400°F plus 20 hours at 2500°F. Failure occurred by local oxide formation on specimen airfoil surfaces (Figure 103). Comparison of these results with the Phase V results for the 2.6-mil-thick coating indicates that the greater coating thickness does not extend the maximum oxidation-erosion life, but does increase the reliability of the system. Characteristics of failure, determined metallographically, were similar to those reported for the Phase V coating. Oxide penetration through surface craze cracks led to eventual substrate oxidation at random airfoil locations.

Figure 103. Modified Sylvania SiCrTi Slurry Coated B-66 Alloy After Oxidation-Erosion Testing for 100 Hours at 2200°F Plus 100 Hours at 2400°F Plus 20 Hours at 2500°F

Note areas of local oxidation (arrows).

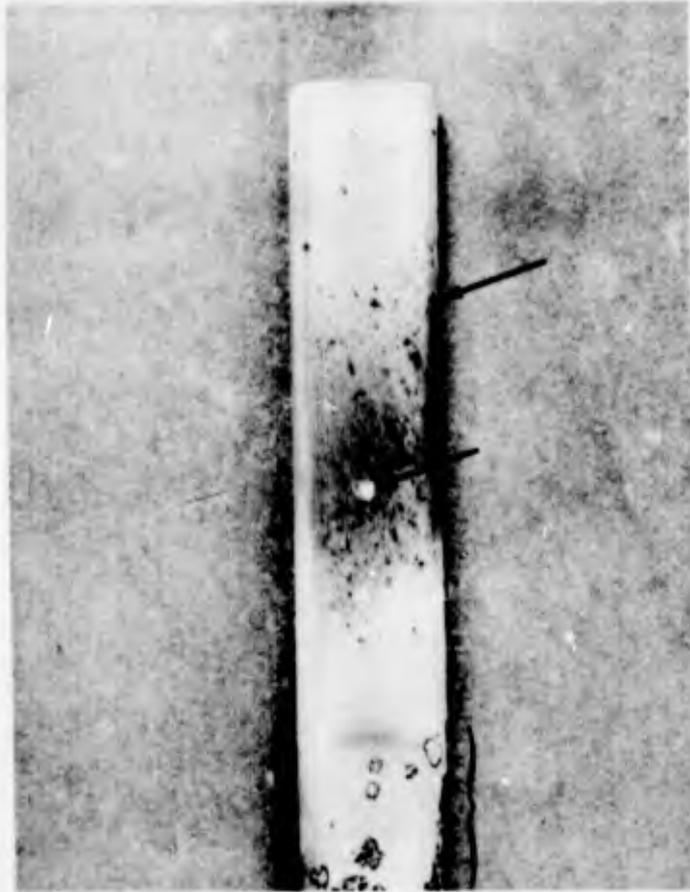
Modified TRW TiCr-Si (Vacuum) Pack/XB-88. During oxidation-erosion testing of the modified TRW TiCr-Si/XB-88 system, failure occurred on four separate test specimens after 100 hours at 2200°F plus 40, 60, 80, and 100 hours, respectively, at 2400°F. Localized formations of substrate oxide penetrating the coating at random locations on specimen airfoil surfaces constituted failure (Figure 104). The progressive failure of these specimens as observed metallographically was similar to that described for the Phase V TRW TiCr-Si/XB-88 oxidation-erosion specimens in paragraph 3.3.2.1.

Pest, or low-temperature (1500°-2000°F), oxidation occurred on specimen grip sections after 100 hours of testing. The holder or grip portions of the specimens operate 200° to 500°F cooler than the airfoil, this temperature difference depending on the airfoil temperature. Oxidation appeared independent of specimen-holder contact locations and progressed continuously during subsequent 2400°F testing of specimen airfoils (see Figure 104).

Figure 104. Modified TRW TiCr-Si (Vacuum) Pack Coated XB-88 Alloy Bar After Oxidation-Erosion Testing for 100 Hours at 2200°F Plus 100 Hours at 2400°F

Airfoil failures resulted from local oxidation (arrows). Note pest oxidation in specimen grip section (brackets) which was first observed after 100 hours at 2200°F.

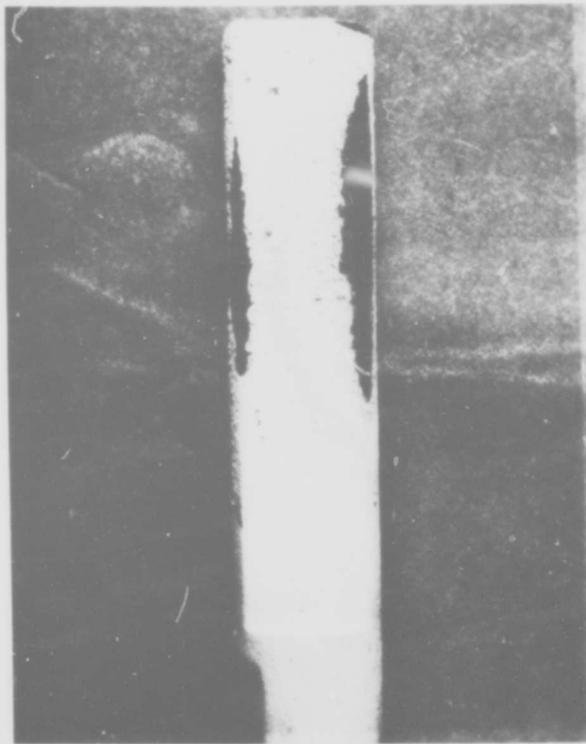
Sylvania SiCrV Slurry/Cb-132M. During testing of Sylvania SiCrV/Cb-132M in oxidation-erosion at 2200°F, some erosion of outer silicide coating layers occurred. Partial removal of the outer coating layer appeared to be strictly a surface effect and did not immediately affect performance of the specimens. Failure of all test specimens occurred after 100 hours at 2200°F plus 60 hours at 2400°F. Oxidation along airfoil edge surfaces was extensive (Figure 105) compared to the localized oxidation observed for most of the other systems.

Figure 105. Sylvania SiCrV Slurry Coated Cb-132M Alloy Bar Showing Edge Oxidation After Oxidation-Erosion Testing for 100 Hours at 2200°F Plus 60 Hours at 2400°F

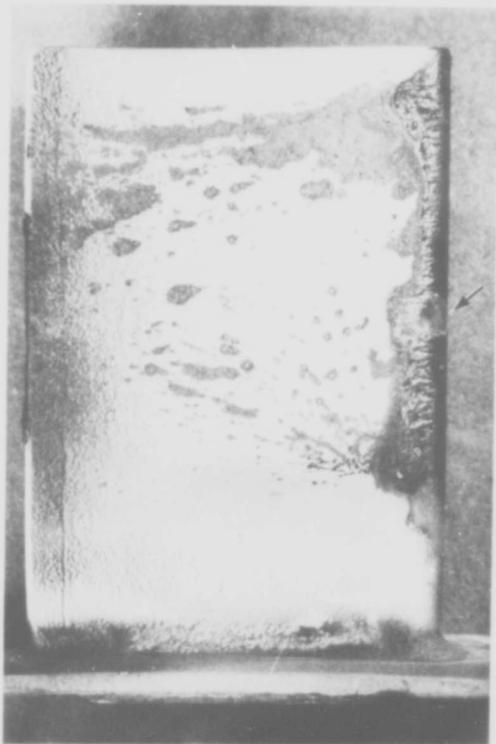
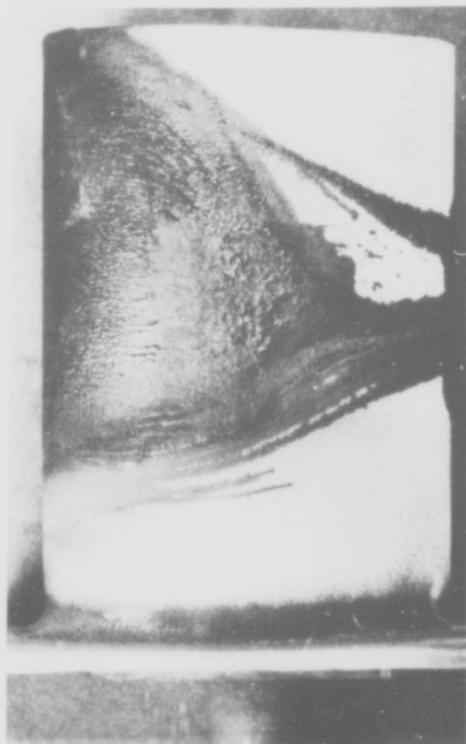
Modified Sylvania SiCrTi Slurry/B-66. The thicker SiCrTi coating exhibited a thermal fatigue life of 600 cycles to 2200°F plus 400 cycles to 2400°F plus 300 and 400 cycles to 2500°F for two specimens. Failure, occurring on airfoil leading edge surfaces, resulted from coating depletion due to viscous flow of the outer coating layers during testing. In areas away from this localized oxidation, however, the coating appeared to be in good condition.

Figure 106. Modified Sylvania SiCrTi Slurry Coated B-66 Alloy Vane Airfoil After Thermal Fatigue Testing for 600 Cycles to 2200°F Plus 400 Cycles to 2400°F Plus 300 Cycles to 2500°F

Arrow locates area of coating failure on leading edge.

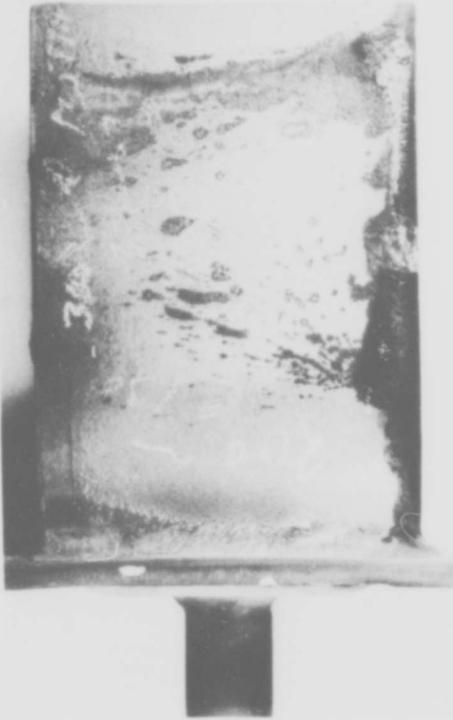
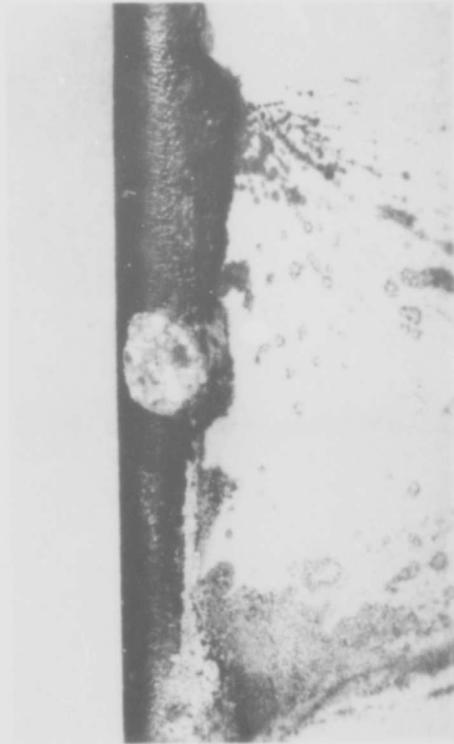
To determine the rapidity of specimen deterioration after localized failure on the leading edge, one of the two test airfoils (Figure 106) was subjected to additional thermal fatigue cycles to 2200°F. After 300 additional cycles, oxidation produced only a pinhole through the leading edge (50-mil-thick sheet prior to coating) within the initial failure region (Figure 107). An additional 100 cycles to 2200°F led to continued penetration and enlargement of the oxidized region (Figure 108).

Figure 107. Modified Sylvania SiCrTi Slurry Coated B-66 Alloy Vane Airfoil (Same Airfoil Shown in Figure 106) After 300 Additional Thermal Fatigue Cycles to 2200°F (Total Cycles in Order: 600 to 2200°F, 400 to 2400°F, 300 to 2500°F, and 300 to 2200°F)

Note that substrate oxidation has progressed but has not penetrated the 0.050-inch-thick airfoil wall.

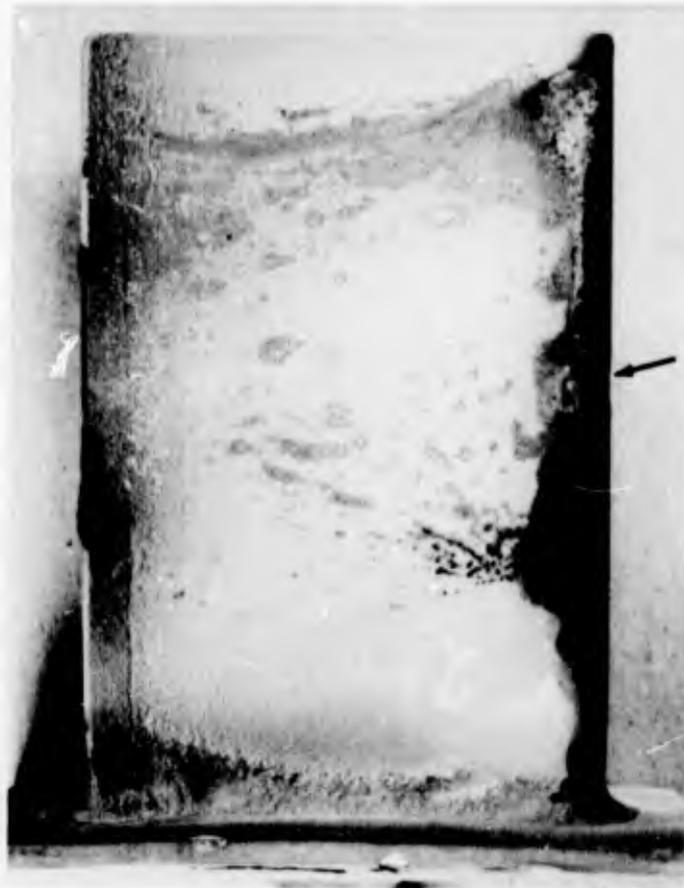
Figure 108. Concave Surface of Modified Sylvania SiCrTi Slurry Coated B-66 Alloy Vane Airfoil (Same Airfoil Shown in Figures 106 and 107) After 100 Additional Thermal Fatigue Cycles to 2200°F (Total Cycles in Order: 600 to 2200°F, 400 to 2400°F, 300 to 2500°F, and 400 to 2200°F)

Note oxidation through leading edge wall (arrow) 400 cycles after detection of initial coating failure.

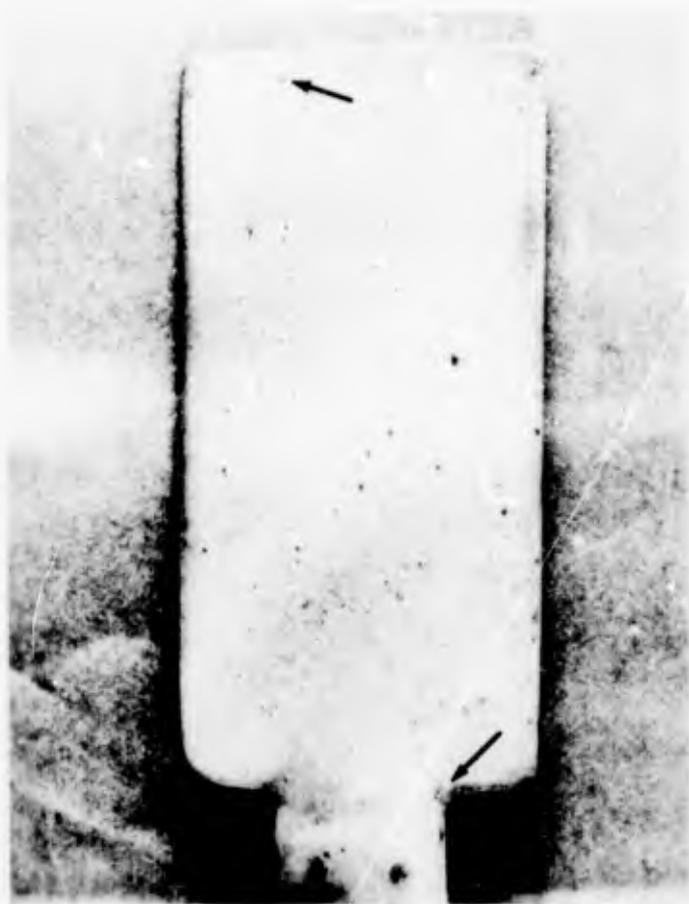
Sylvania SiCrV Slurry/Cb-132M. Local failures at random airfoil locations occurred on one of two specimens after 600 cycles to 2200°F plus 400 cycles to 2400°F plus 600 cycles to 2500°F (Figure 110). These isolated failures progressed only

Figure 110. Convex Airfoil Surface of Sylvania SiCrV Slurry Coated Cb-132M Alloy Specimen Showing Spot Failures (Arrows) After Thermal Fatigue Testing for 600 Cycles to 2200°F Plus 400 Cycles to 2400°F Plus 600 Cycles to 2500°F

The areas of localized oxidation for both thermal fatigue specimens coincided with those spots of high vanadium content visible as surface asperities on the as-coated specimens. Metallographic examination showed no nonuniformity in the 0.35-mil-thick intermediate coating layer in the failure regions.

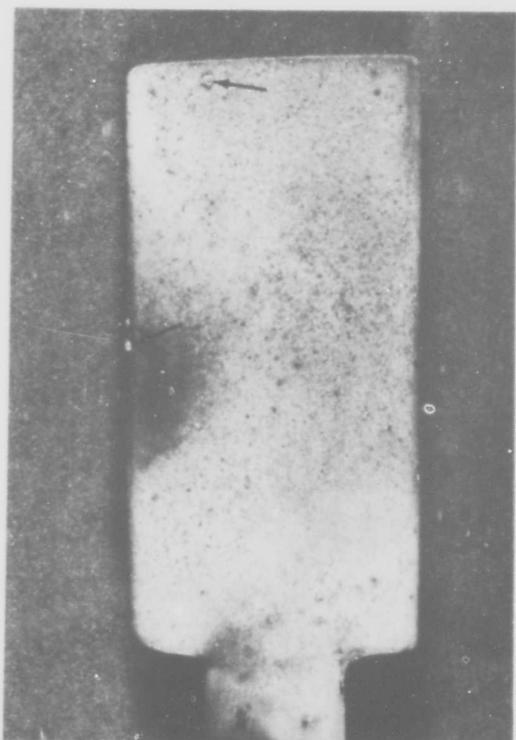
slightly during 600 additional thermal fatigue cycles to 2500°F (Figure 111). The second test specimen exhibited failure after 600 cycles to 2200°F plus 400 cycles to 2400°F plus 1400 cycles to 2500°F. Localized failures were similar to those observed for the first test specimen.

Figure 111. Convex Airfoil Surface of Sylvania SiCrV Slurry Coated Cb-132M Alloy Specimen Showing Progression of Spot Failure Deterioration (Arrows) After 600 Additional Cycles to 2500°F

Spot failure occurred initially after 600 cycles to 2200°F plus 400 cycles to 2400°F plus 600 cycles to 2500°F (see Figure 110).

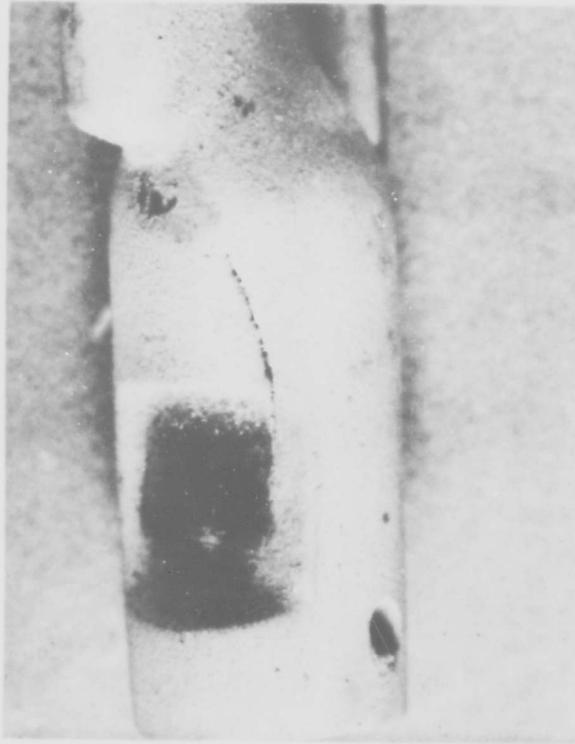
It is considered significant that a forging lap or crack present in the handle of the second specimen after paddle forging and prior to coating application was protected throughout testing for 600 cycles to 2200°F plus 400 cycles to 2400°F plus 1400 cycles to 2500°F (Figure 112). It is projected that specimen temperature at the defect was in the 1400° to 1900°F temperature range during the 2200°, 2400°, and 2500°F peak temperature portions of the thermal cycles.

Figure 112. Sylvania SiCrV Slurry Coated Cb-132M Alloy Thermal Fatigue Specimen Showing Handle Defect

Defect was present prior to coating.

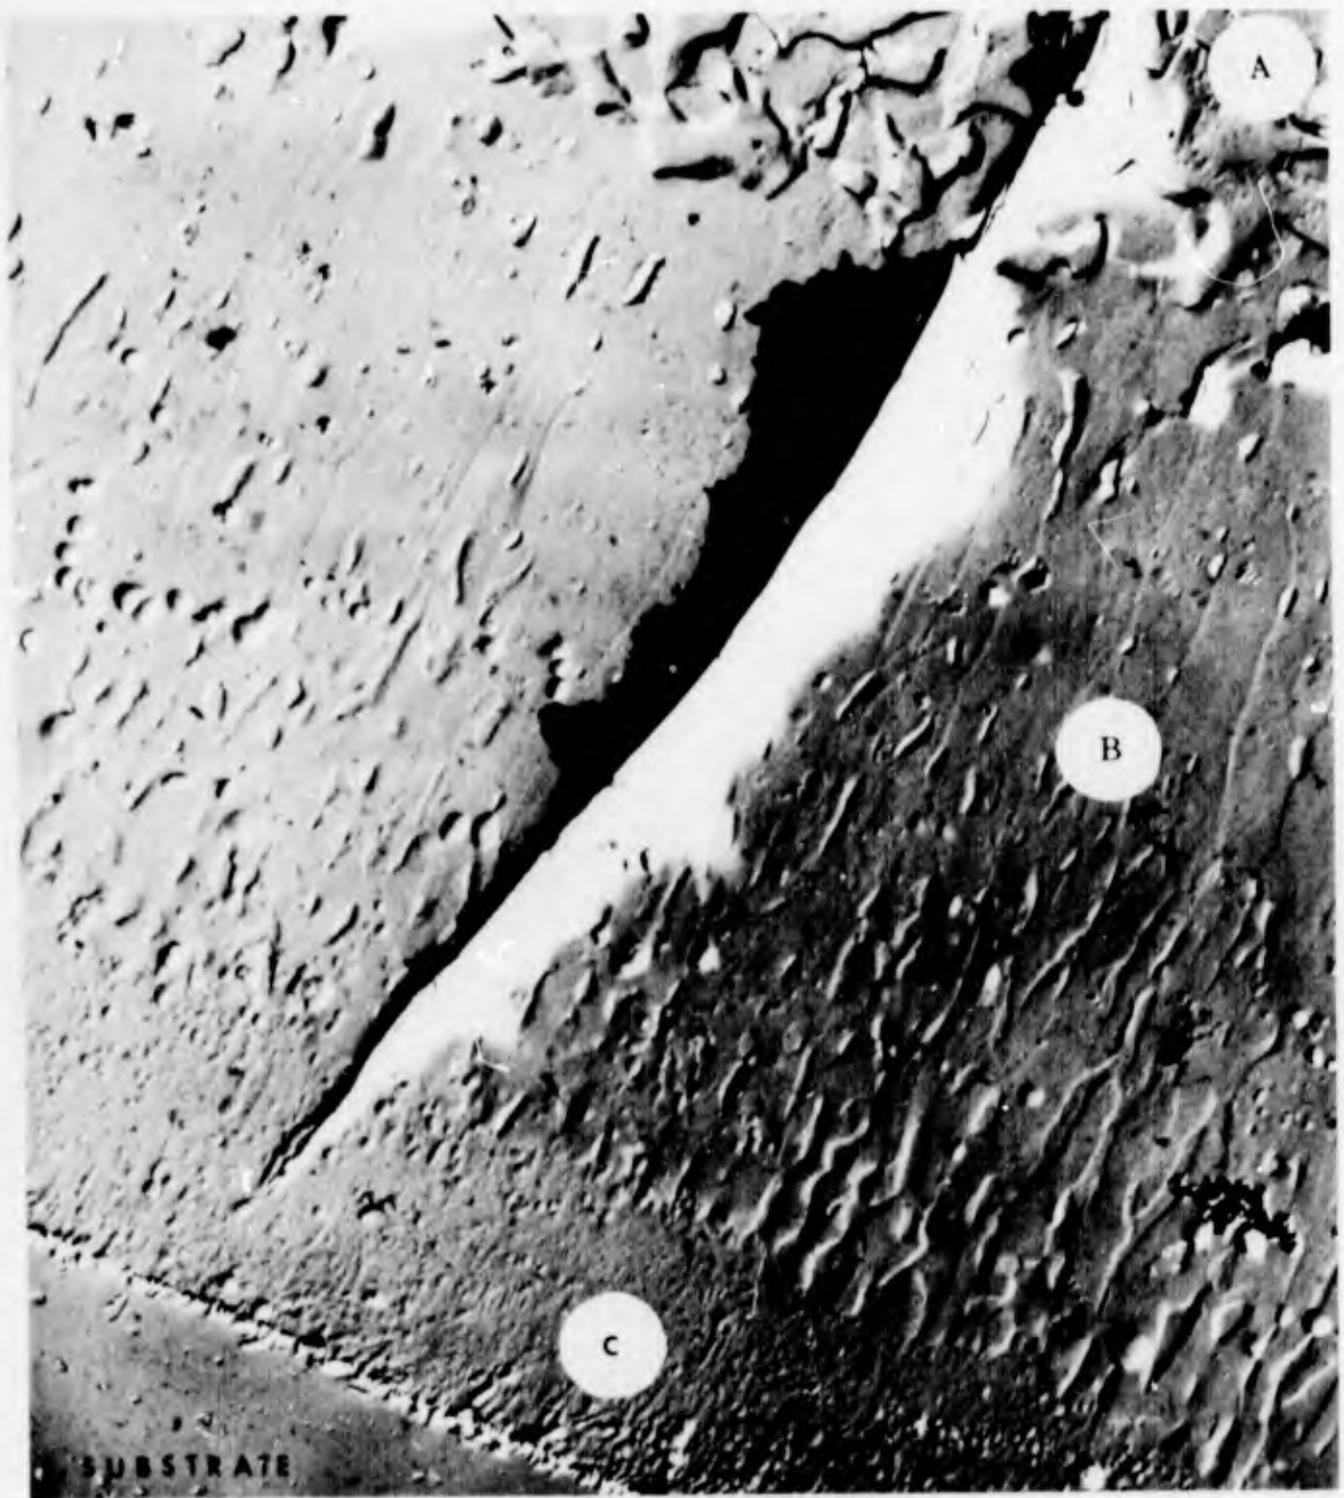
- Radial cracks: These separations were quite extensive and in some cases extended from the surface to the coating-substrate interface (Figure 122).
- Lateral cracks: Separations propagating parallel to the coating-substrate interface were of short length and appeared to be confined to the outer coating region (Figure 123).

Figure 122. Structure of As-Applied Phase VII Sylvania SiCrTi Slurry Coating on NB-88 Alloy Showing Surface Crack Penetration Through the Outer (A) and Intermediate (B) Coating Layers Into the Diffusion Zone (C)

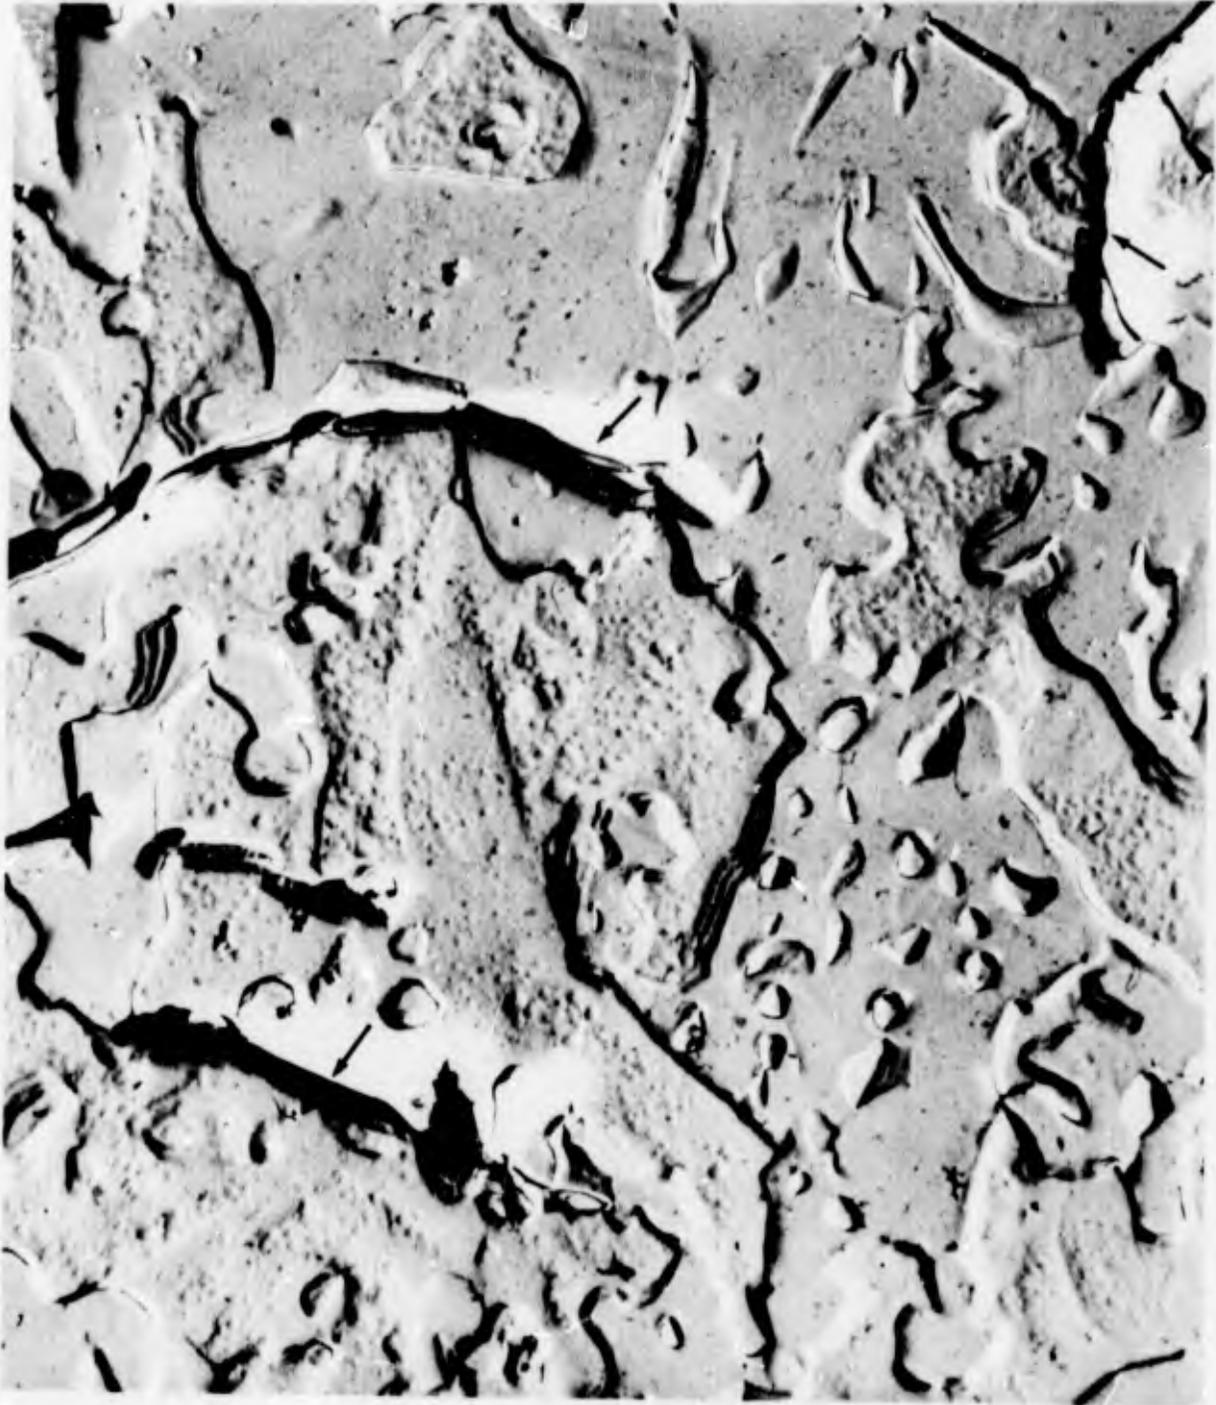
A third dissimilarity was the absence of distinct diffusion envelopes encompassing the second-phase particles in the outer coating region (Figure 123). These envelopes, believed to be transition regions between silicide compounds, were observed in the SiCrTi coating on B-66 alloy (see Figure 118).

Figure 123. Electron Micrograph of As-Applied Phase VII Sylvania SiCrTi Slurry Coating on XB-88 Alloy Showing Lateral Microcracks (Arrows) and the Absence of Diffusion Surrounding Precipitated Particles in the Outer Coating Region

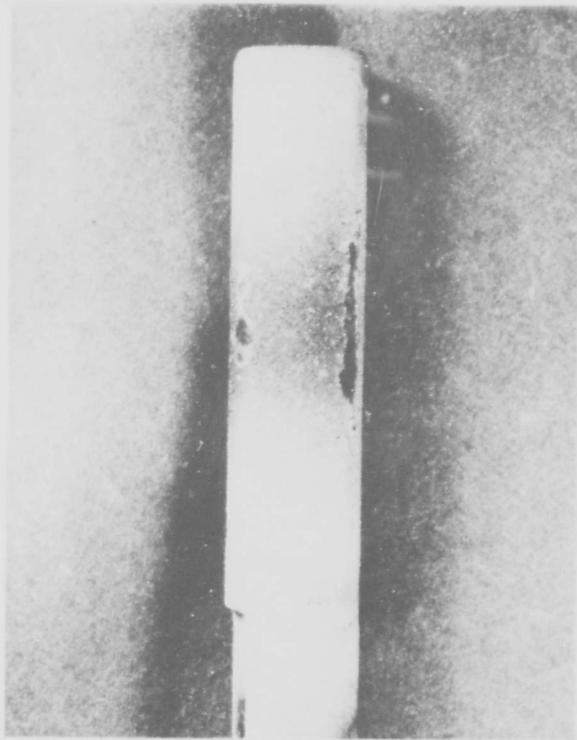
Figure 126. Phase VII Sylvania SiCrTi Slurry Coated B-66 Alloy Bar After Oxidation-Erosion Testing for 220 Hours at 2200°F

Failure resulted from oxidation along airfoil edge surfaces.

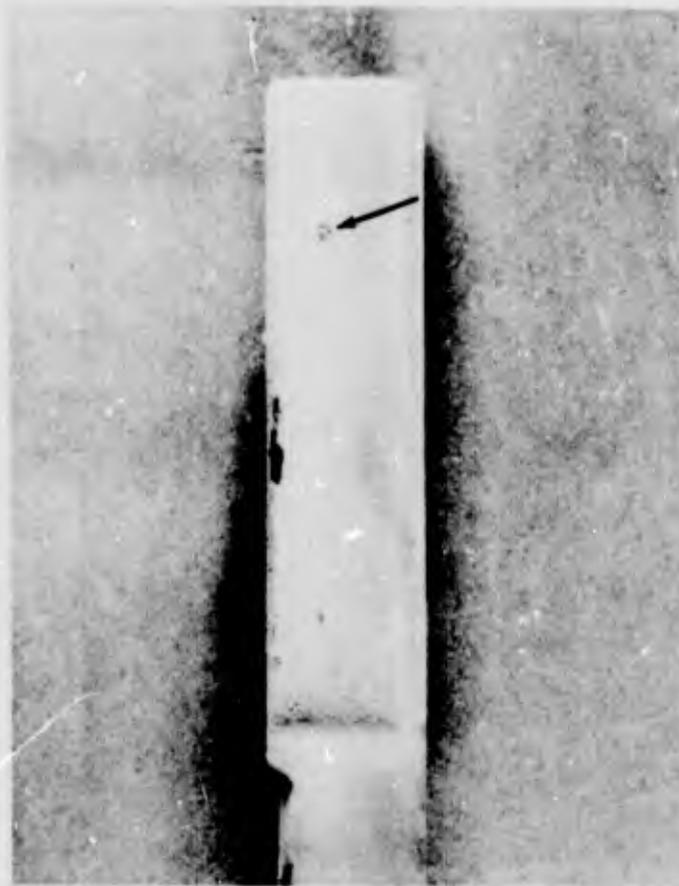
Figure 127. Phase VII Sylvania SiCrTi Slurry Coated B-66 Alloy Bar After Oxidation-Erosion Testing for 140 Hours at 2400°F

Substrate oxidation occurred along leading edge surfaces and on flat airfoil regions (arrow).

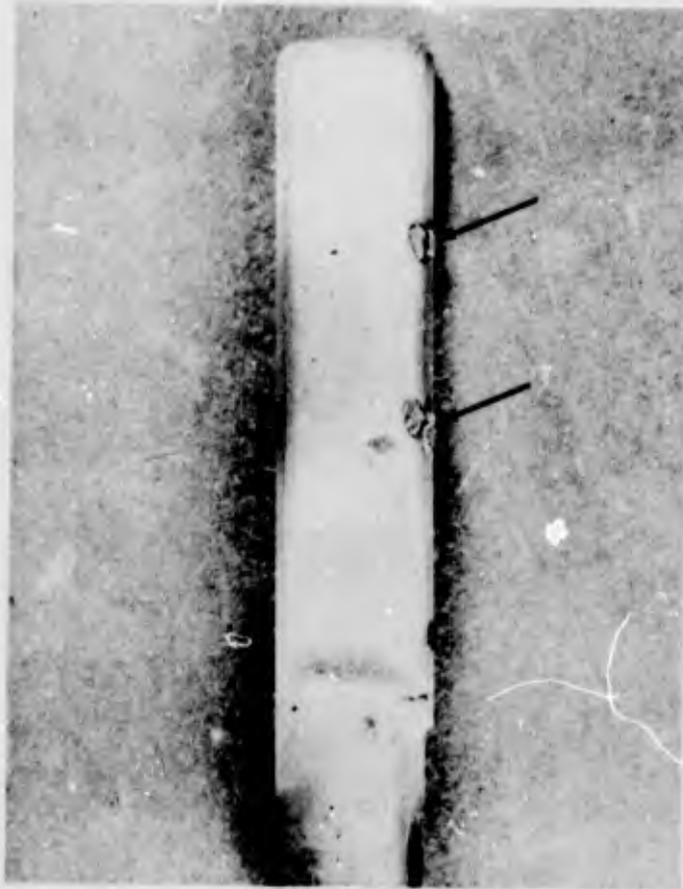
Figure 128. Phase VII Sylvania SiCrTi Slurry Coated B-66 Alloy Bar After Oxidation-Erosion Testing for 53 Hours at 2500°F

Failure resulted from localized substrate oxidation at the specimen leading edge surface (arrows).
