EVALUATION AND IMPROVEMENT OF COATINGS
FOR COLUMBIUM ALLOY GAS TURBINE ENGINE COMPONENTS

PRATT & WHITNEY AIRCRAFT
DIVISION OF UNITED AIRCRAFT CORPORATION

Technical Report AFML-TR-66-186, Part II

May 1968

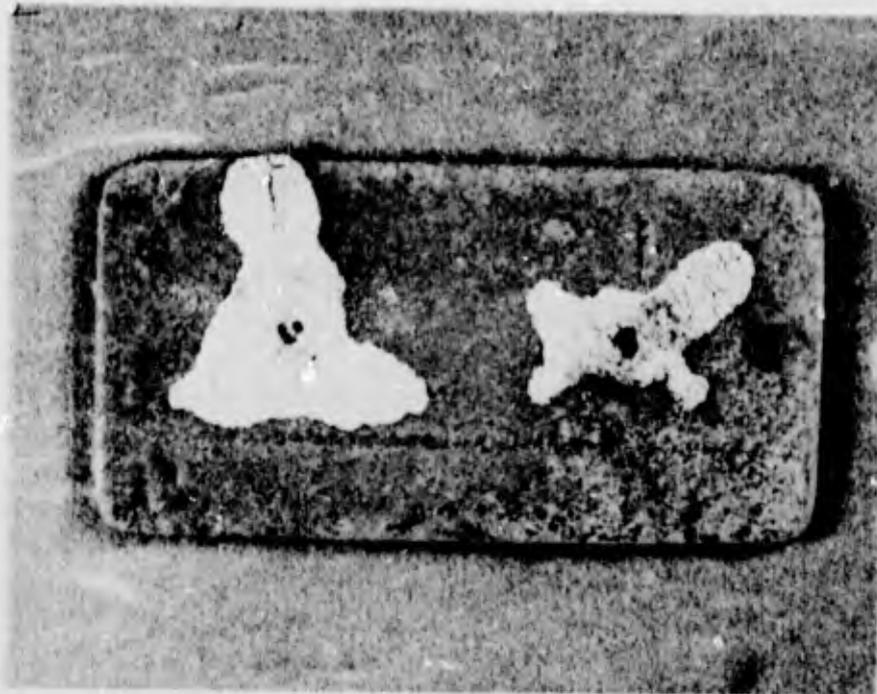
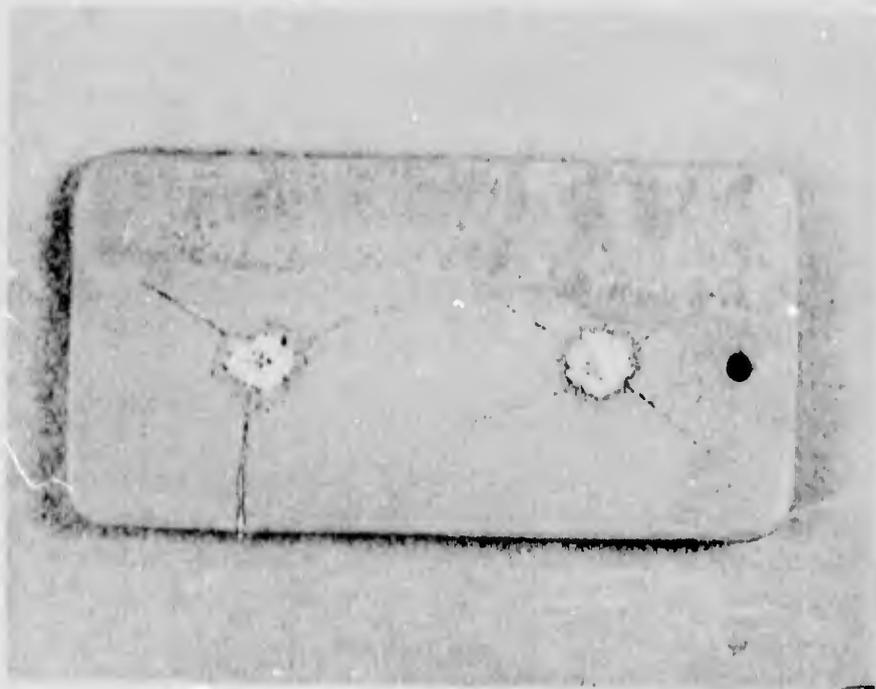
Oxidation surrounding all impact depressions occurred after a 1-hour exposure at 2200°F. Substrate oxidation radiating outward along surface cracks, which was severe for the 70°F, 500-ft/sec impacts on both the front and rear specimen surfaces at and directly behind the impact depressions (Figure 131), also occurred during the impact tests at 1600°F. Failure of the 2000°, 2200°, 2400°, and 2600°F impact areas, however, was confined to the front specimen surfaces in regions surrounding the impact

Figure 131. Surfaces of Phase VII Sylvania SiCrTi Slurry Coated B-66 Alloy Test Specimens After Room Temperature Impacting at 500 Feet Per Second and Subsequent Static Oxidation Exposure For 1 Hour at 2200°F

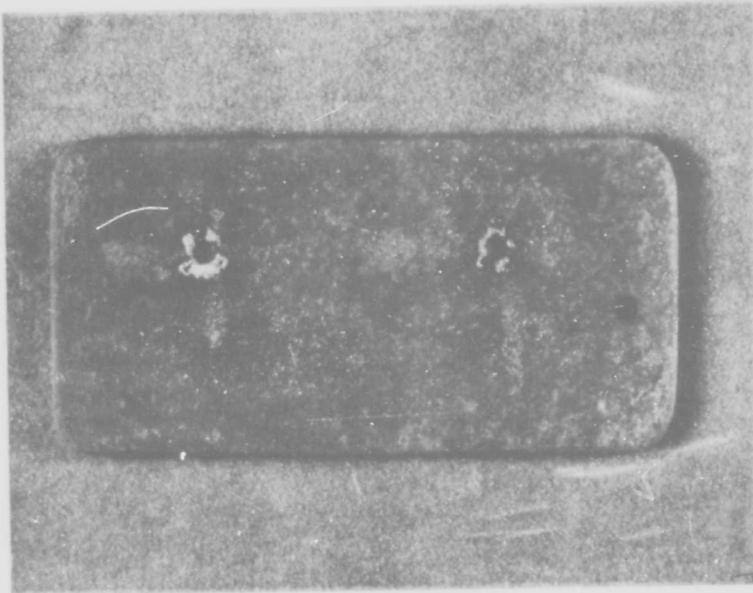
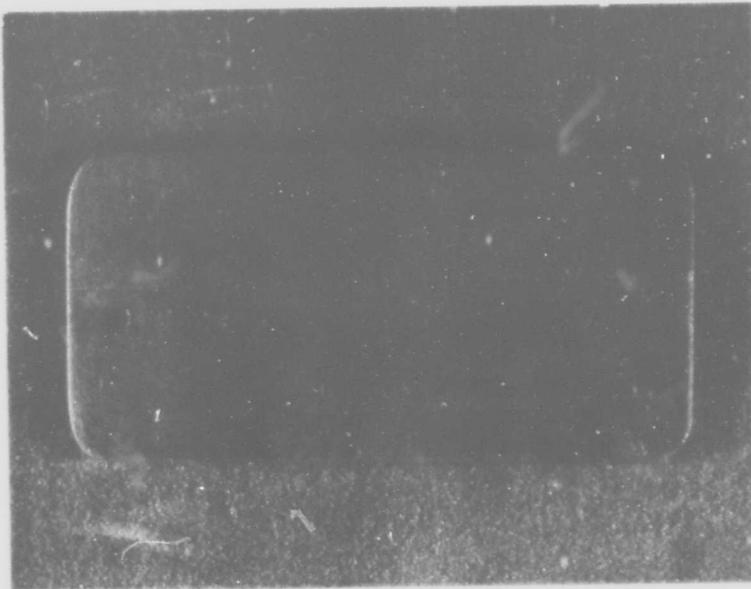
depressions. Further exposure of the 2000°, 2200°, 2400°, and 2600°F impact specimens for 2 hours additional (total 3 hours) at 2200°F did not significantly degrade the test specimens further. This behavior appeared to be due to the adherent nature of the oxide surrounding the impact depression (Figure 132).

Figure 132. Surfaces of Phase VII Sylvania SiCrTi Slurry Coated B-66 Alloy After 2200°F Impacting at 500 Feet Per Second and Subsequent Static Oxidation Exposure for 3 Hours at 2200°F

Oxidation surrounding impact depressions (upper photograph) were first observed after 1 hour at 2200°F oxidation exposure.

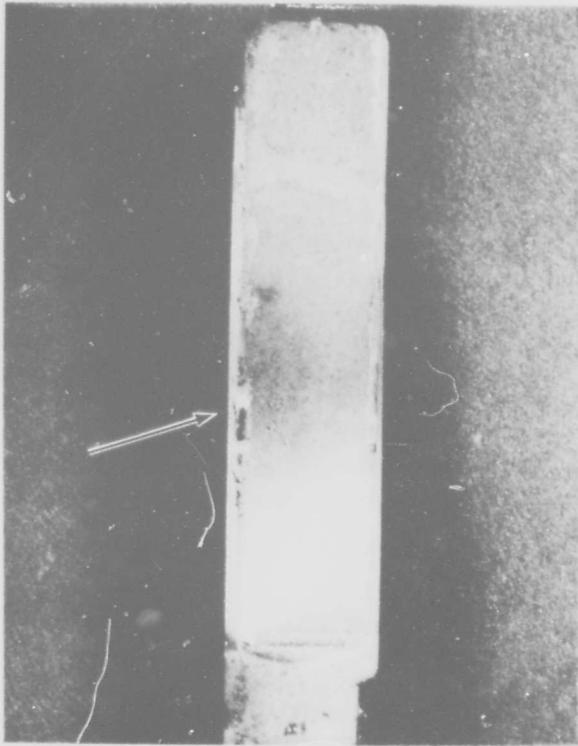
Up to 2400°F, failure occurred predominantly by localized oxidation along the airfoil trailing edge surfaces (Figure 136) and, in some cases, by the formation of point areas of substrate oxide (Figure 137). However, after 60 hours at 2500°F, more general oxidation occurred on airfoil edge surfaces (Figure 138). Erosion of outer coating layers during early stages of testing was observed at all temperatures. This condition remained through specimen failure as shown in Figure 137. Erosion was confined principally to the extreme outer regions of the coating, these regions containing numerous void areas and entrapped oxides (refer to paragraph 5.2.2, where coating application of the Sylvania SiCrTi coating on XB-88 alloy is discussed). Since coating removal was evident particularly at specimen corners and edges and since these were the predominant failure areas (Figures 136 through 138), coating erosion appears to have been the limiting factor for coating life.

Figure 136. Typical Surface Appearance of Phase VII Sylvania SiCrTi Slurry Coated XB-88 Alloy Bar After Oxidation-Erosion Testing for 180 Hours at 2200°F

Note coating erosion and failure (arrow) along airfoil edge surfaces.

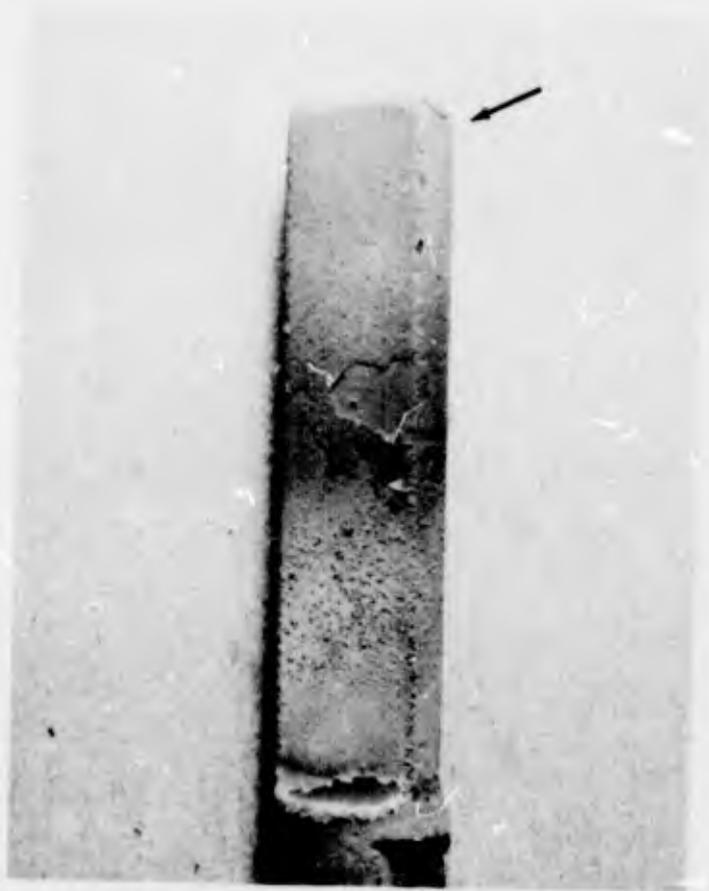
Figure 137. Typical Surface Appearance of Phase VII Sylvania SiCrTi Slurry Coated XB-88 Alloy Bar After Oxidation-Erosion Testing for 380 Hours at 2000°F

Note area of local oxidation at leading edge tip (arrow).

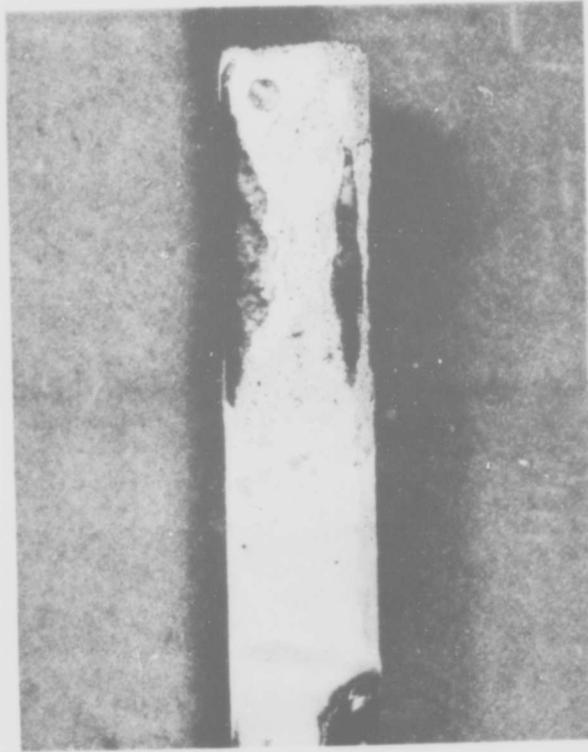
Figure 138. Surface Appearance of Phase VII Sylvania SiCrTi Slurry Coated XB-88 Alloy Bar After Oxidation-Erosion Testing for 60 Hours at 2500°F

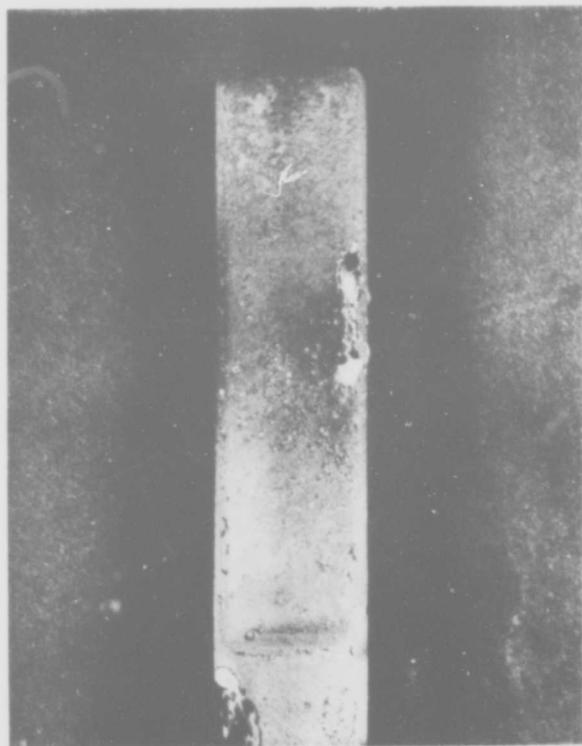
Oxidation-erosion testing at 2200°F with transient temperature overshoots to 2600°F was performed using the procedure described in paragraph 2.3.3. The Sylvania SiCrTi/XB-88 system demonstrated a performance of 140 hours at 2200°F plus 35 minutes total transient time to 2600°F for one specimen and 160 hours at 2200°F plus 40 minutes total transient time to 2600°F for three remaining specimens. Failure in all cases resulted from the formation of localized oxide on specimen airfoil surfaces (Figure 139).

Figure 139. Typical Surface Appearance of Phase VII Sylvania SiCrTi Slurry Coated XB-88 Alloy Bar After Melting (Transient Temperature Overshoot) Testing for 160 Hours at 2200°F Plus 40 Minutes Total Transient Time to 2600°F

Failure in all cases resulted from depletion of the coating and substrate oxidation along airfoil trailing edge surfaces.

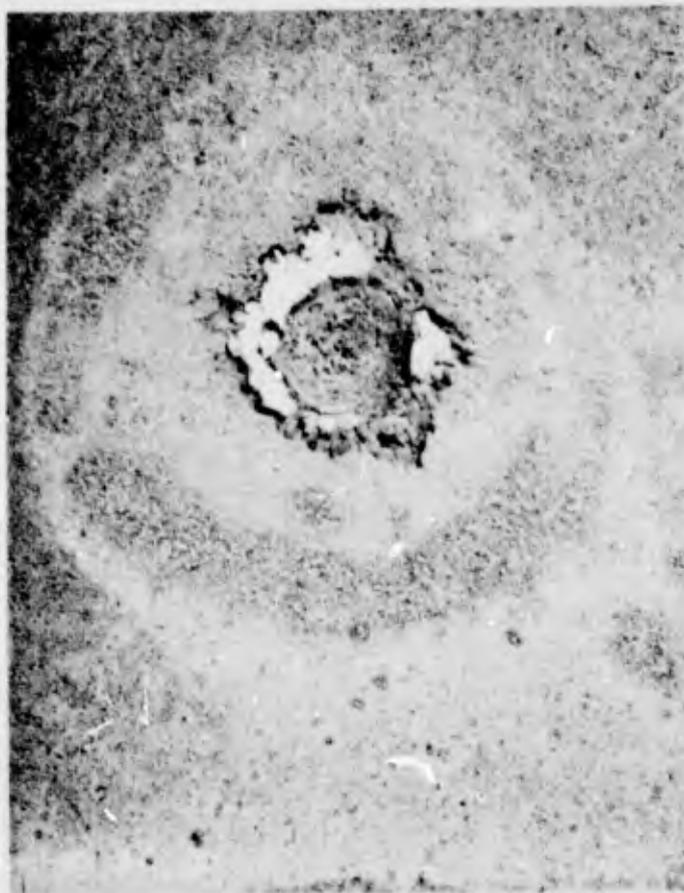
Test specimens (two per temperature) were impacted at 500 feet per second with a 0.75-gram steel pellet at 70°, 1600°, 2000°, 2200°, 2400°, and 2600°F. Impact procedure is described in paragraph 2.3.4. After impact and subsequent inspection, 2200°F oxidation exposure in static air resulted in failure for each test specimen after 1 hour exposure. Surface characteristics of the specimens after failure (Figure 140) were identical to those described for the Phase VII Sylvania SiCrTi slurry/B-66 vane system in paragraph 5.3.1.4.

Figure 140. Typical Surface Appearance of Phase VII Sylvania SiCrTi Slurry Coated XB-88 Alloy After 2000°F Impact Testing at 500 Feet Per Second and Subsequent Oxidation Exposure for 1 Hour at 2200°F

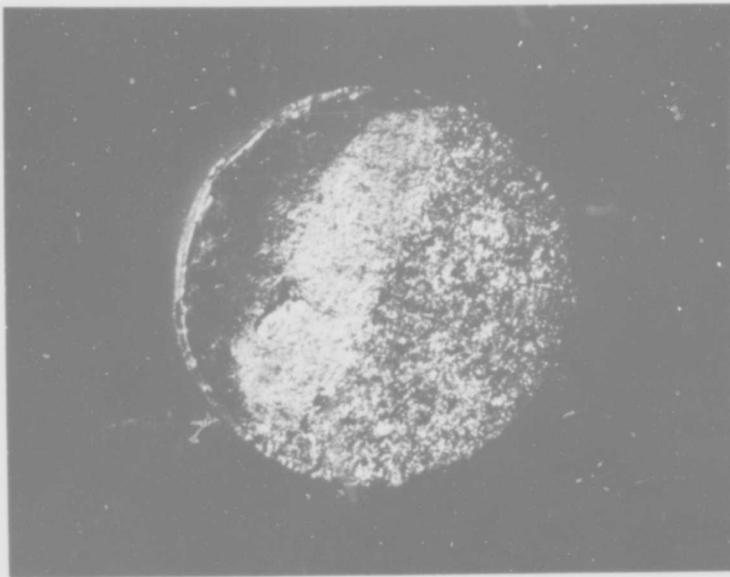
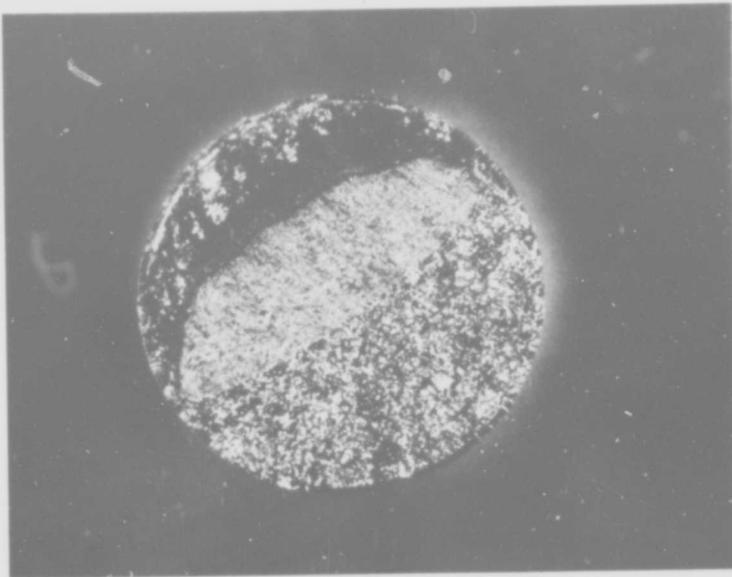
The fatigue test results (Table XVI) indicate a fatigue limit between 45,000 and 50,000 psi. This stress level is approximately 65 percent of the ultimate strength for XB-88 alloy at 2200°F. The fracture surfaces of the two specimens which failed at a load of 50,000 psi had burnished and smooth areas indicative of fatigue failure (Figure 142).

Figure 142. Fracture Surfaces of Phase VII Sylvania SiCrTi Slurry Coated XB-88 Alloy After Fatigue Testing at 50,000 Psi Stress in Air at 2200°F

Failure occurred after 0.54×10^7 cycles for the specimen in the upper photograph and after 0.81×10^7 cycles for the lower specimen.

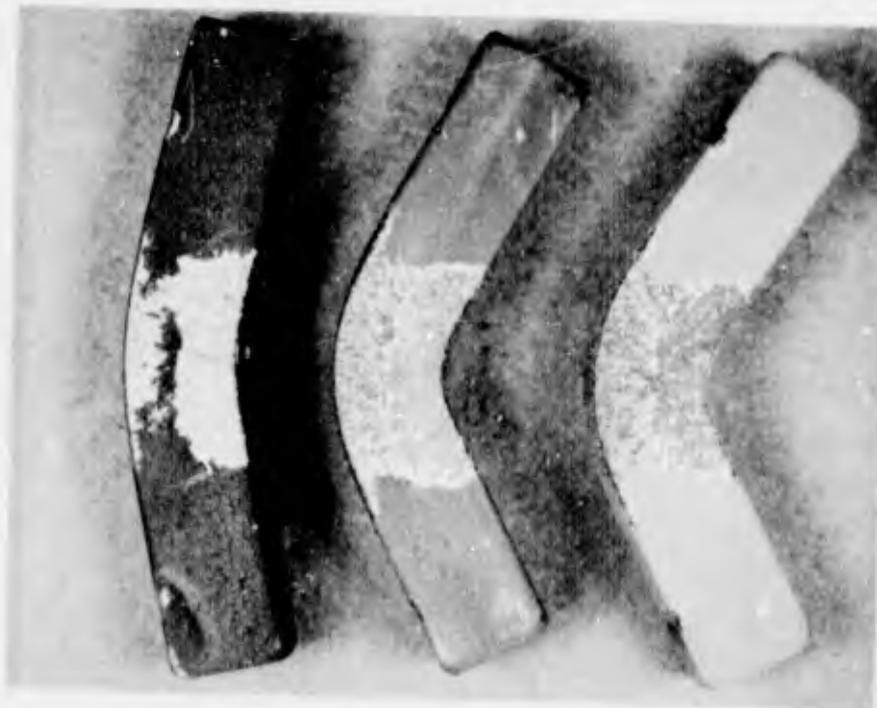
Smooth Charpy impact testing of Sylvania SiCrTi coated XB-88 columbium alloy was performed in air at 70°, 1400°, 1700°, and 2000°F. Two uncoated specimens were also impacted at 70°F. Impact test results (Table XVII) indicate a ductile-brittle transition between 70°F and 1400°F. Very good toughness was indicated at 1400°, 1700°, and 2000°F; no failures were noted (Figure 143).

Figure 143. Appearance of Phase VII Sylvania SiCrTi Slurry Coated XB-88 Alloy After Charpy Impact Testing at 1400°F, 60 Ft-Lb (Left); 1700°F, 120 Ft-Lb (Center); and 2000°F, 120 Ft-Lb (Right)

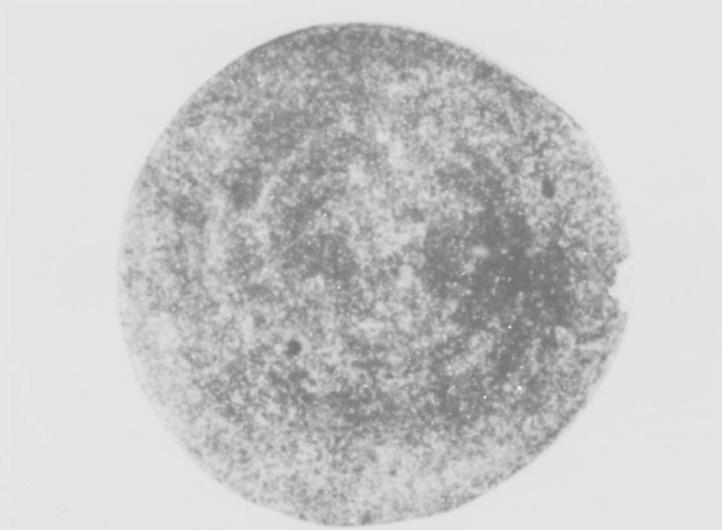
The SiCrFe coating performed adequately for the intended application, with the first failure occurring at 571 hours of test. In addition, only one of the remaining specimens failed during testing, and that after 960 test hours. The TiAl coating did not perform as well, with the initial failure occurring at 77 hours and only five of the ten test coupons surviving the total exposure. Failures of the SiCrFe and the TiAl coatings on XB-88 are shown in Figures 146 and 147.

Figure 146. Sylvania SiCrFe Slurry Coated XB-88 Alloy Specimen Showing Edge Failure After 571 Hours Static Oxidation Exposure at 1600°F

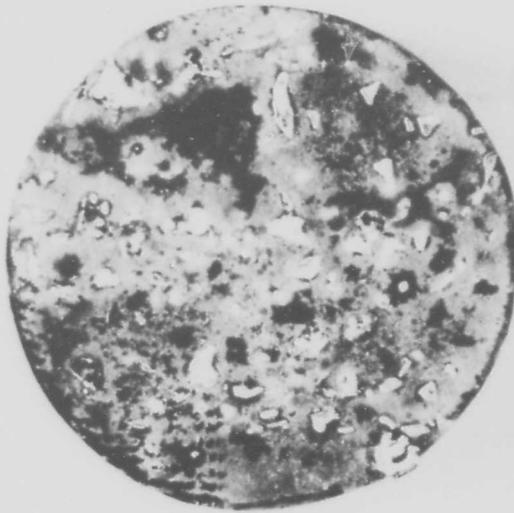
Figure 147. TRW TiAl (Vacuum) Pack Coated XB-88 Alloy Specimen Showing Edge Failure After 77 Hours Static Oxidation Exposure at 1600°F

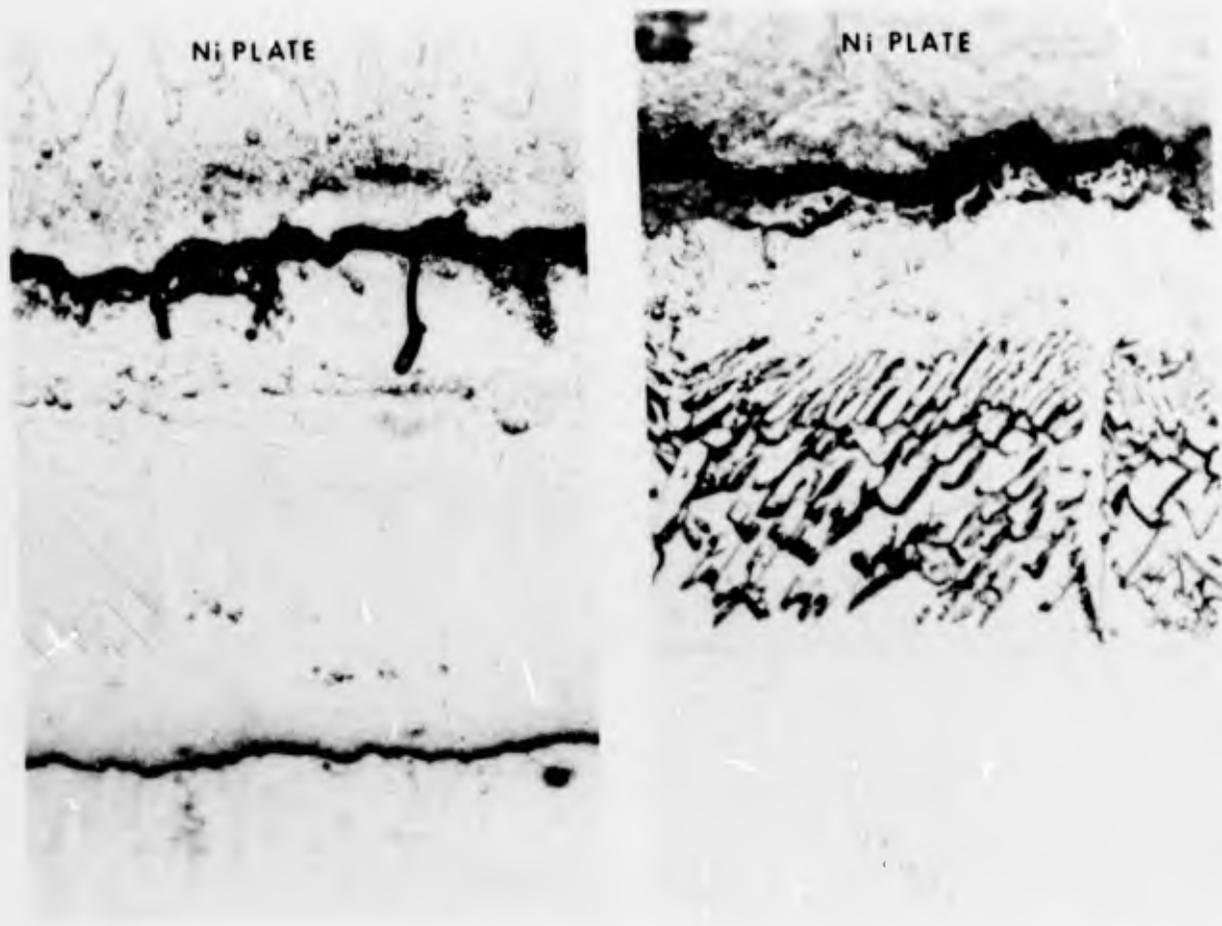
Stability of both the SiCrFe and the TiAl coatings was evaluated by metallographic examination of specimens exposed in excess of 1100 hours at 1600°F. The TiAl coating developed a substantial precipitate in the intermediate coating layer (Figure 148), but no significant depletion of the coating was observed. The SiCrFe coating exhibited

Figure 148. Typical Microstructure of As-Applied (Left) and Exposed (Right) TRW TiAl (Vacuum) Pack Coated XB-88 Alloy

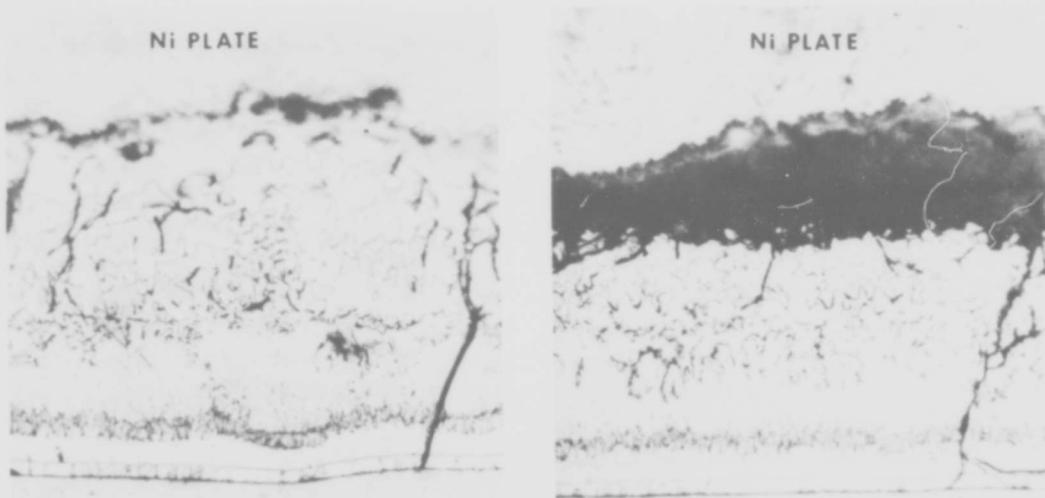
oxidation of approximately 1 mil of the outer coating layer (Figure 149), but no significant microstructural changes in the coating-substrate composite were evident.

Figure 149. Typical Microstructure of As-Applied (Left) and Exposed (Right) Sylvania SiCrFe Slurry Coated XB-88 Alloy

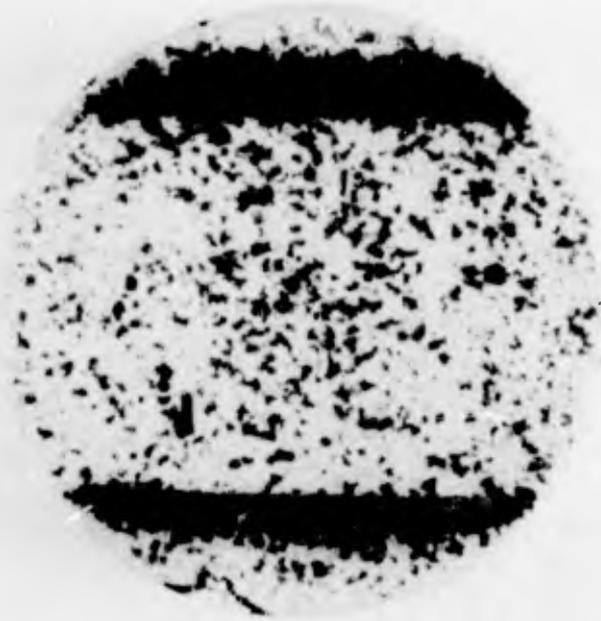
Although there was an edge failure after 24 hours of test at 1600°F on one of the SiCrFe coated specimens (Figure 150), this system performed well, with the remaining nine specimens all surviving the test period. The TiAl coated specimens did not perform satisfactorily, with failure occurring at 24, 48, and 96 hours and only one of the ten specimens surviving the test period. Figures 151 and 152 illustrate failures of the TiAl coating at 1400° and 1600°F exposure, respectively.

Figure 150. Sylvania SiCrFe Slurry Coated XB-88 Alloy Specimen Showing Edge Failure After 24-Hour Postcyclic Exposure at 1600°F

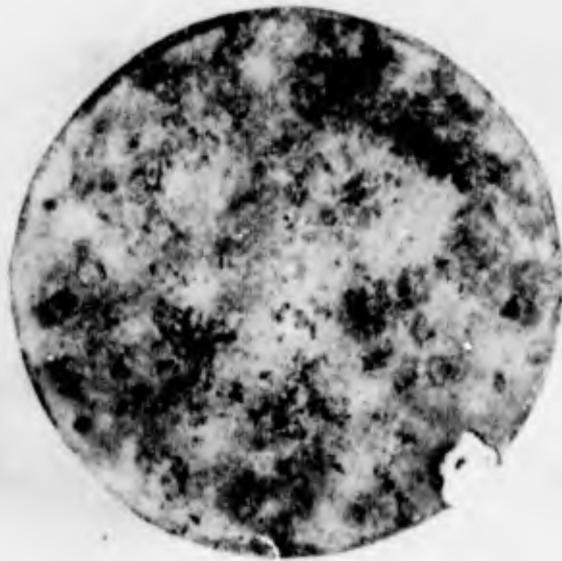
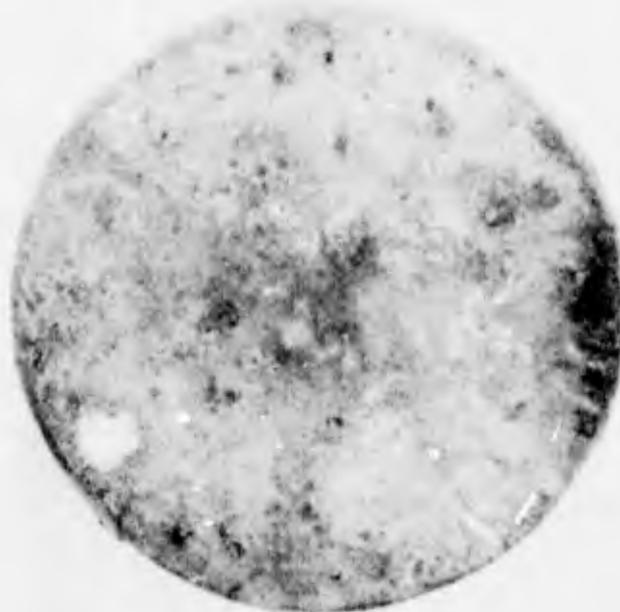
Figure 151. TRW TiAl (Vacuum) Pack Coated XB-88 Alloy Specimens Showing Edge and Surface Failures After Postcyclic Exposure at 1400°F

The specimen at top failed after 168 hours exposure; the specimen at bottom failed after 96 hours exposure.

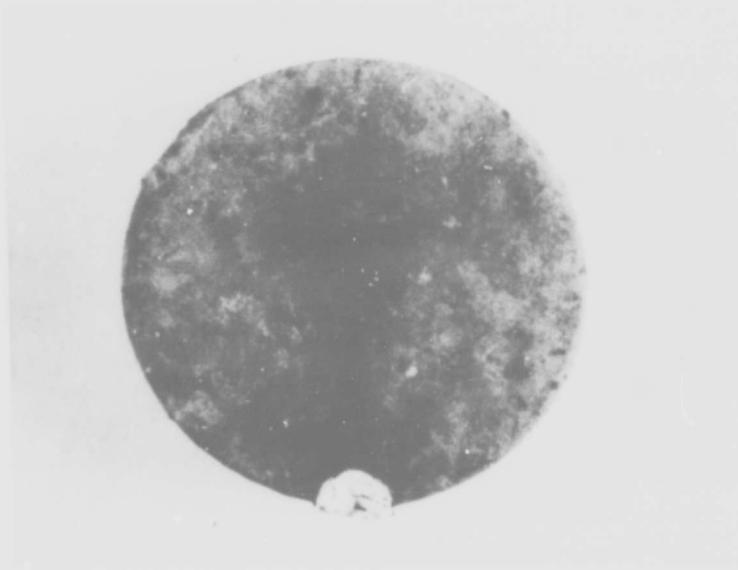
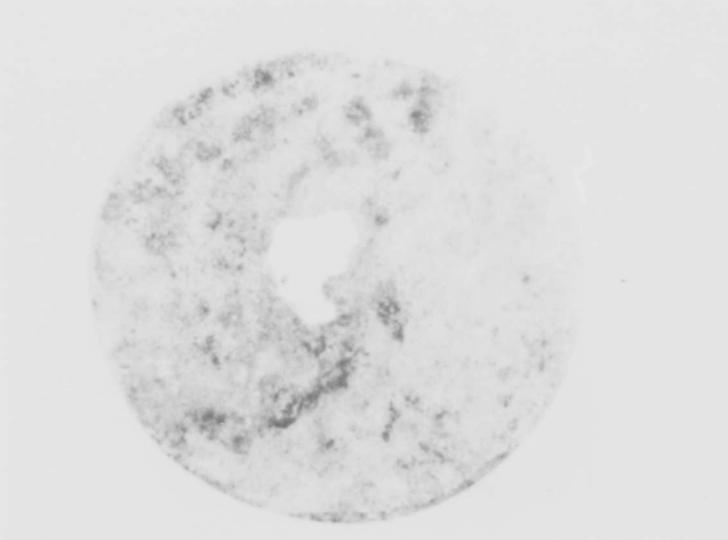
Figure 152. TRW TiAl (Vacuum) Pack Coated XB-88 Alloy Specimens Showing Typical Edge and Surface Failures After Postcyclic Exposure at 1600°F

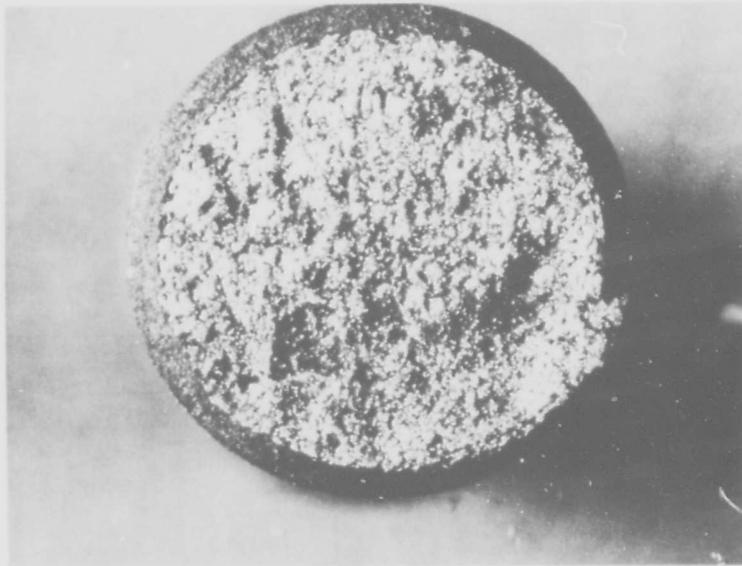
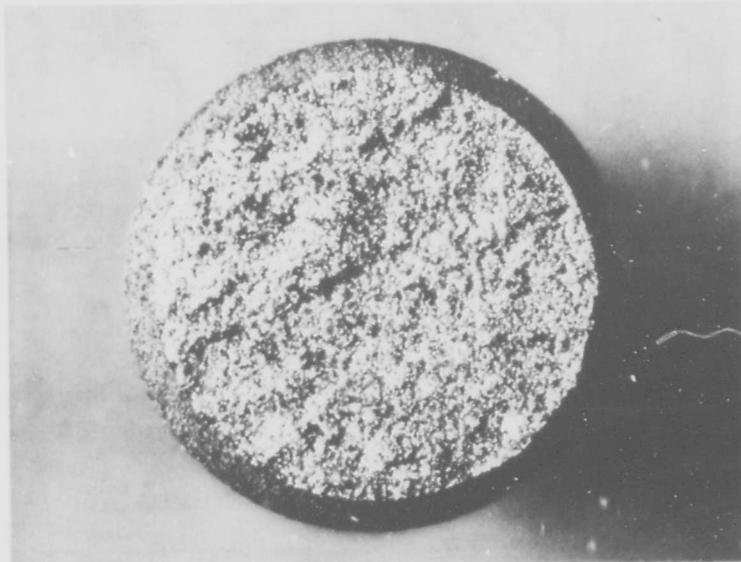
At 1200°F the Sylvania SiCrFe coated notched XB-88 alloy specimens exhibited a fatigue limit of about 49,000 psi, which is approximately 90 percent of the 0.2-percent yield strength of uncoated XB-88 at 1250°F. After test, all specimens were fractured and examined for evidence of fatigue. The fracture surfaces of specimens which had been fatigue tested for 10^7 cycles are shown in Figure 154.

Figure 154. Sylvania SiCrFe Slurry Coated XB-88 Alloy Notched ($K_t = 3.2$) Fatigue Specimens Showing Room Temperature Fracture Surface After Testing in Air at 1250°F

Neither specimen had failed after 1.0×10^7 cycles. The specimen at top ran at a stress of 49,000 psi; the specimen at bottom ran at a stress of 42,500 psi.

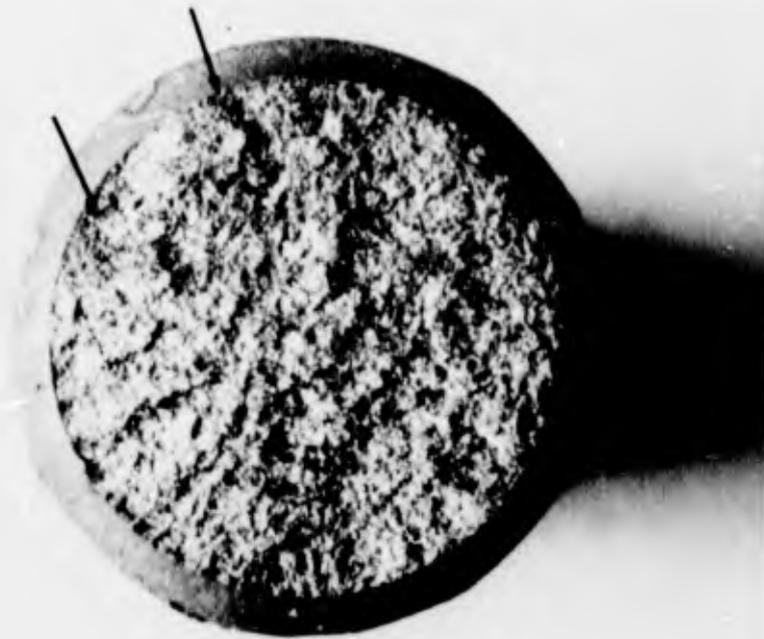
At 1250°F the TRW TiAl coated notched XB-88 alloy specimen exhibited a fatigue limit of less than 30,000 psi, while the smooth specimens had a fatigue limit greater than 55,000 psi, which is approximately equal to the yield strength of the uncoated alloy. The fracture surfaces of the notched specimens after test and room temperature fracture showed small oxidized areas of fatigue progression (Figure 155).

Figure 155. TRW TiAl (Vacuum) Pack Coated XB-88 Alloy Notched ($K_t = 3.2$) Fatigue Specimen Showing Room Temperature Fracture Surface After Testing at 30,000 Psi in Air at 1250°F
