# TECHNICAL MEMORANDUM

EVALUATION OF RUBBER-ASPHALT BINDER FOR SEAL COATING ASPHALTIC CONCRETE, NPTR EL CENTRO, CALIFORNIA, MARCH 1974 - JULY 1977, by

R.B. BROWNIE,

AUGUST 1977.

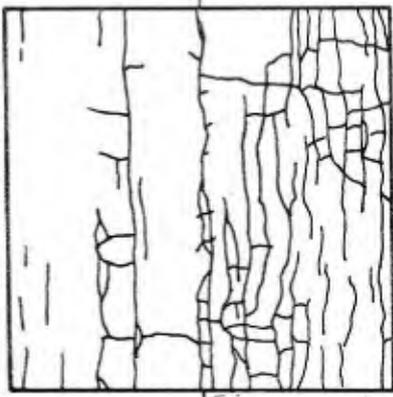
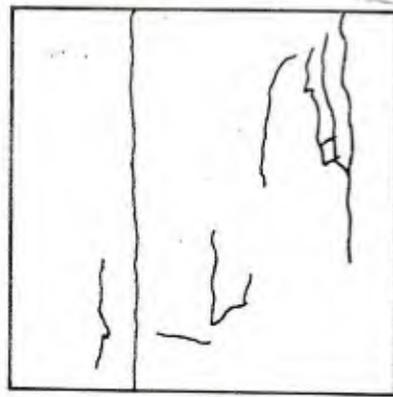
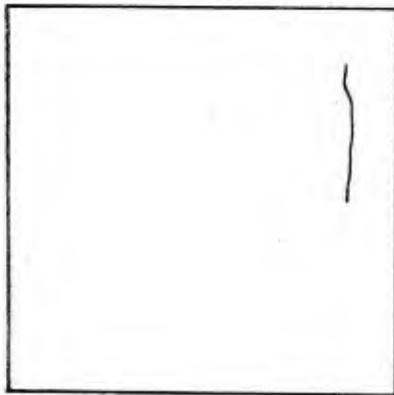
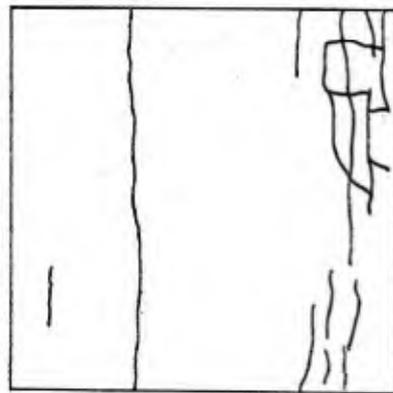
Figure 3. Crack Survey Plots, Taxiway A  
NPTR El Centro, California

Plot 2  
Taxiway A  
Seal Coated 14-15 October 1975

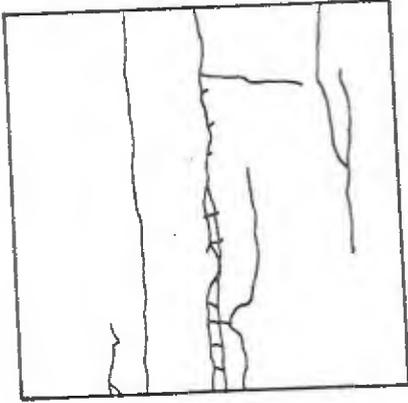
Figure 3a. Crack Survey Plots, Taxiway A  
NPTR El Centro, California

Plot 2  
Taxiway A  
Seal Coated 14-15 October 1975

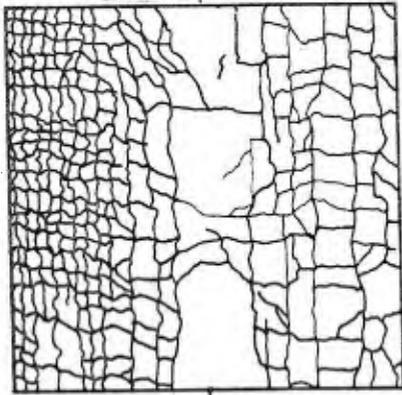
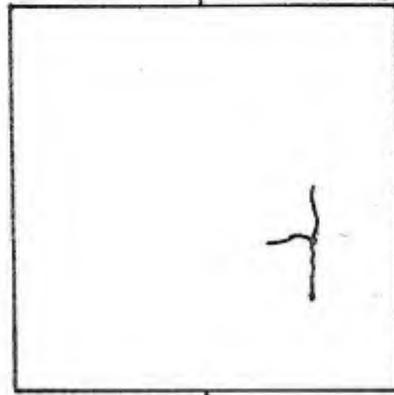
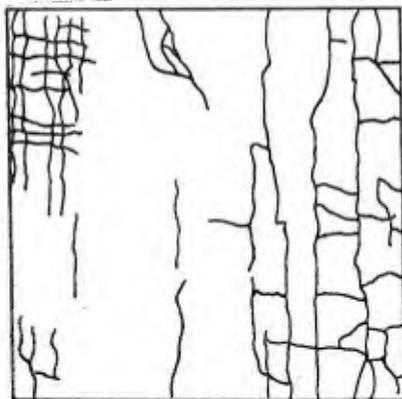
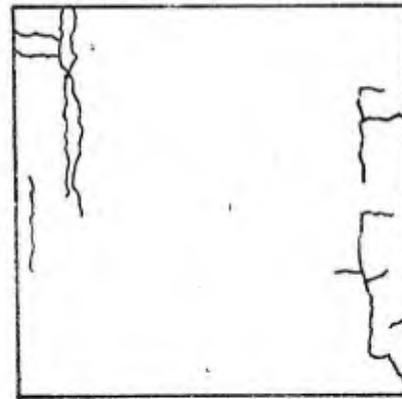
Figure 4. Crack Survey Plots, Taxiway B  
NPTR El Centro, California

Note: No cracks visible on  
7 November 1974

Plot 1  
Taxiway B  
Seal Coated 25 March 1974

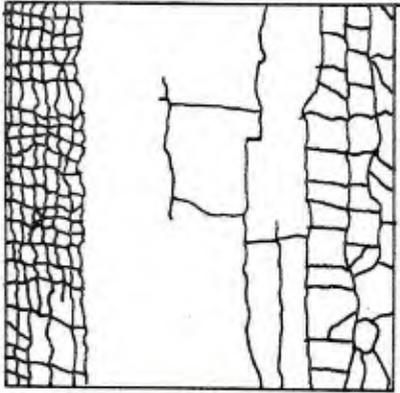
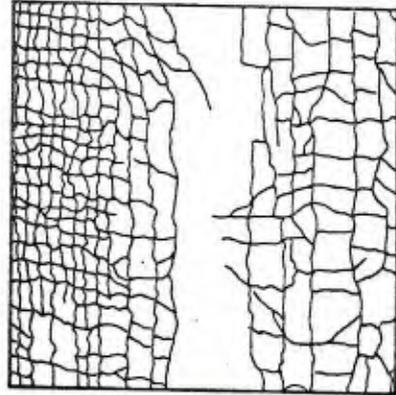
Figure 4a. Crack Survey Plots, Taxiway B  
NPTR El Centro, California

Plot 1  
Taxiway B  
Seal Coated 25 March 1974

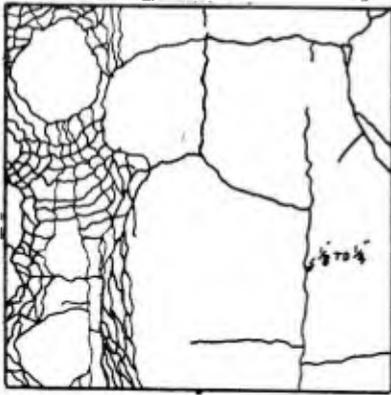
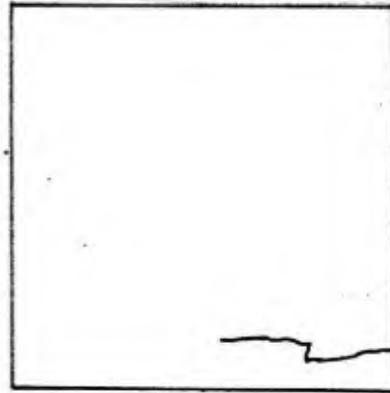
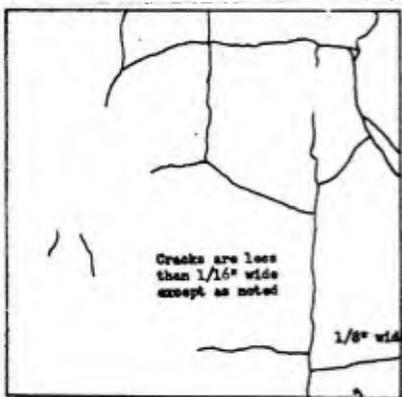
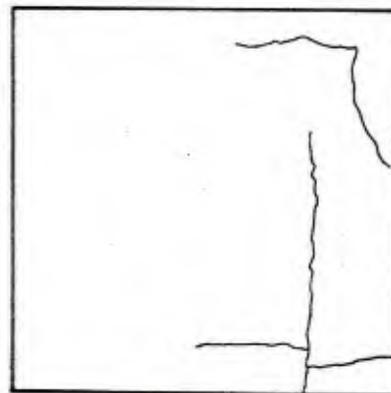
Figure 5. Crack Survey Plots, Taxiway B  
NPTR El Centro, California

Note: No cracks visible on  
7 November 1974

Plot 2  
Taxiway B  
Seal Coated 25 March 1974

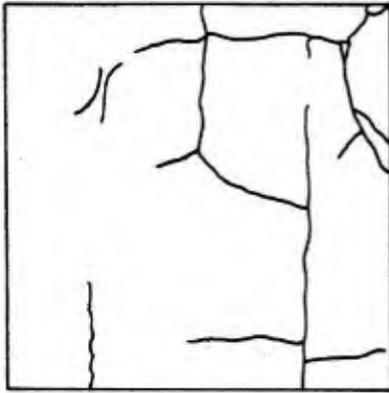
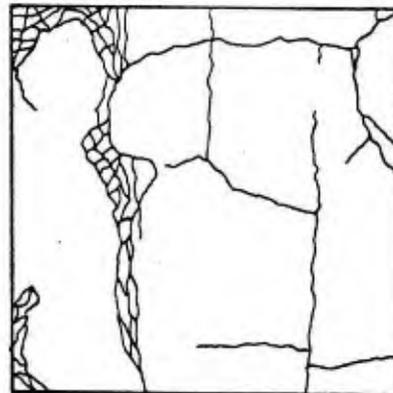
Figure 5a. Crack Survey Plots, Taxiway B  
NPTR El Centro, California

Plot 2  
Taxiway B  
Seal Coated 25 March 1974

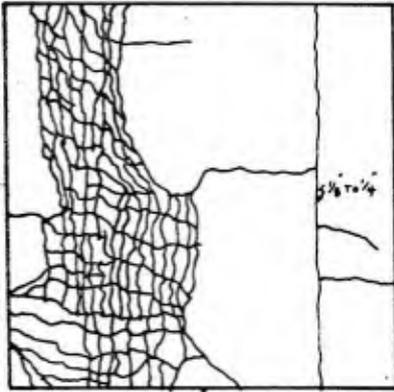
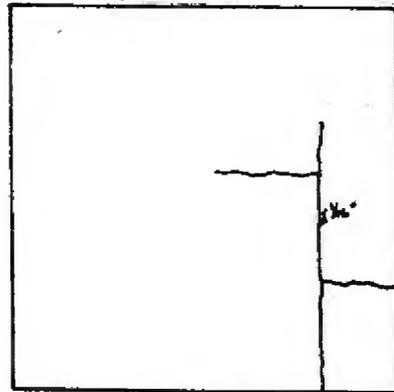
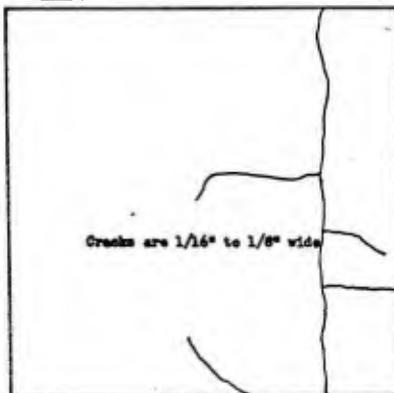
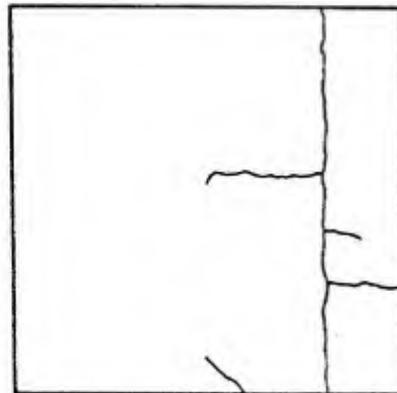
Figure 6. Crack Survey Plots, Taxiway B  
NPTR El Centro, California

Note: No cracks visible on  
7 November 1974

Plot 3  
Taxiway B  
Seal Coated 25 March 1974

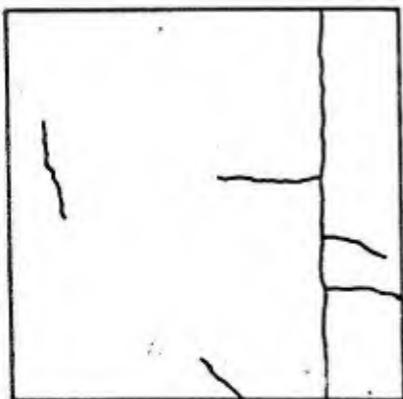
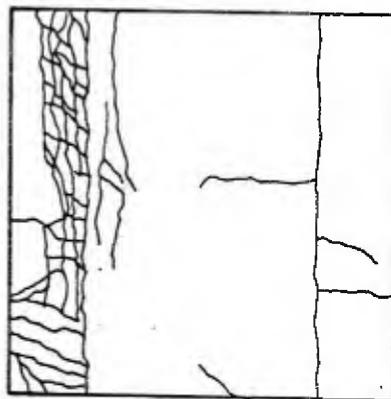
Figure 6a. Crack Survey Plots, Taxiway B  
NPTR El Centro, California

Plot 3  
Taxiway B  
Seal Coated 25 March 1974
