**US Army Corps
of Engineers®**
Engineer Research and
Development Center

Alternatives for Large Crater Repairs using Rapid Set Concrete Mix®

Lulu Edwards, Haley P. Bell, and Marcus L. Opperman

June 2021

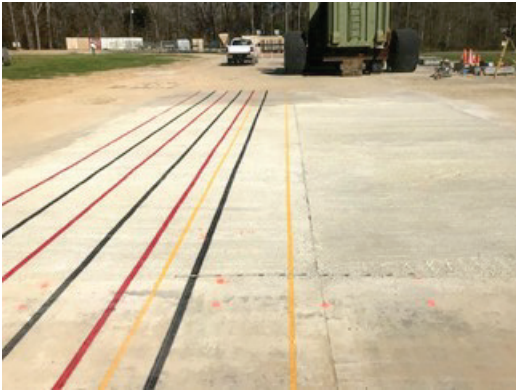
Figure 39. Repair 2 progression of distresses.

The rapid-setting concrete surface and crushed limestone base course thicknesses were 10 and 14 in., respectively, for Repair 2. Failure of the repair occurred after approximately 100 passes (85 coverages) due to a high-severity joint spall on the western edge. The repair was also close to failure on the eastern edge due to a high-severity joint spall. The progression of distresses with increasing traffic can be found in Figure 39.

The repair had a few shrinkage cracks on the surface that were observed prior to trafficking (Figure 40). The shrinkage cracks appeared on the surface soon after each quadrant was placed. Linear cracks and interior corner breaks were observed on the surface after just 18 passes (15 coverages). After 112 passes (96 coverages), the repair was shattered in three of the four quadrants, and high-severity joint spalling was observed on the trafficked edges; the repair exceeded the failure criteria. A tire hazard was not present, so the repair was trafficked beyond failure for assessment. After 224 passes (191 coverages), the dimensions of the joint spalls had not progressed from dimensions measured at 112 passes (96 coverages). However, spalling on the parent slabs along the western edge of the repair had occurred (Figure 41). The center of the repair was cracked in a circular shape (interior corner breaks) at 224 passes (191 coverages), as shown in Figure 42. The interior corner breaks indicate that the combination of the slab thickness and foundation strength/thickness was inadequate to support the heavy load.

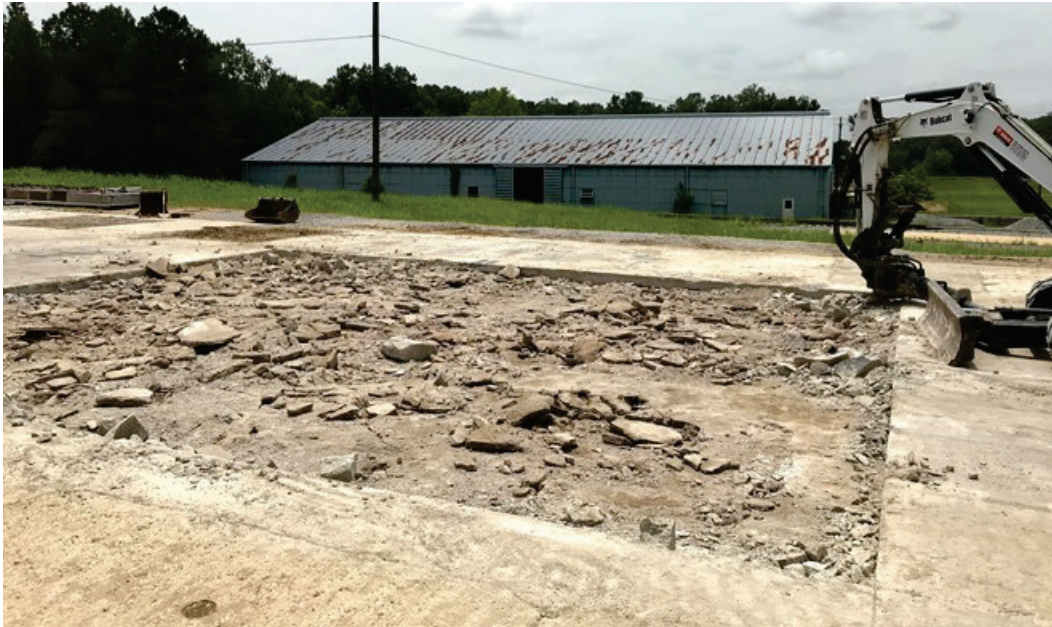
Figure 44. Rapid-setting flowable fill during the backfill breaking and removal process.

The rapid-setting flowable fill was placed in 2-in.-thick lifts for Repair 2, rather than the typical 3- to 4-in.-thick lifts. This was done in an attempt to increase the water percolation into the flowable fill. However, as can be seen in Figure 44, after excavation, each lift of the

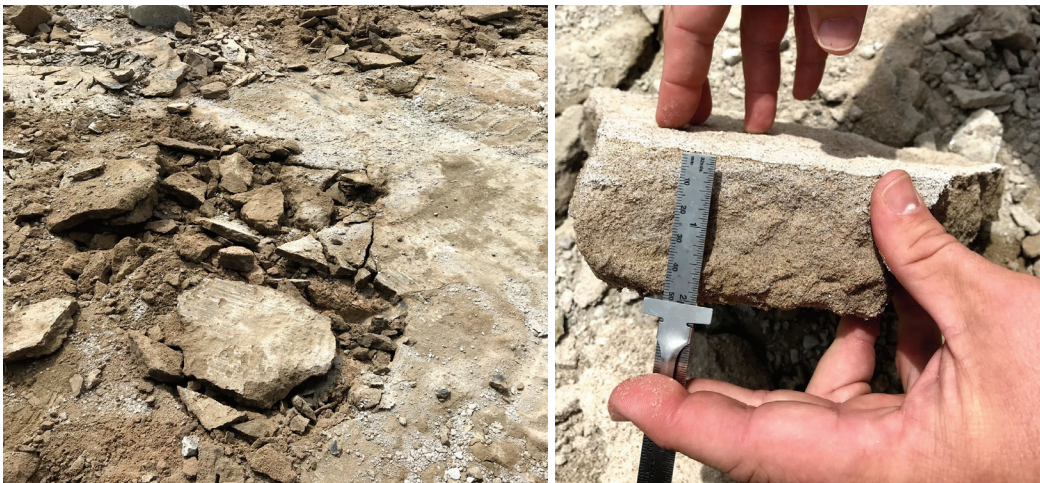
Figure 45. Close-up of flowable fill layers during removal.

material appeared to be delaminated. Figure 45 shows that the layers delaminated in the same thickness it was placed.

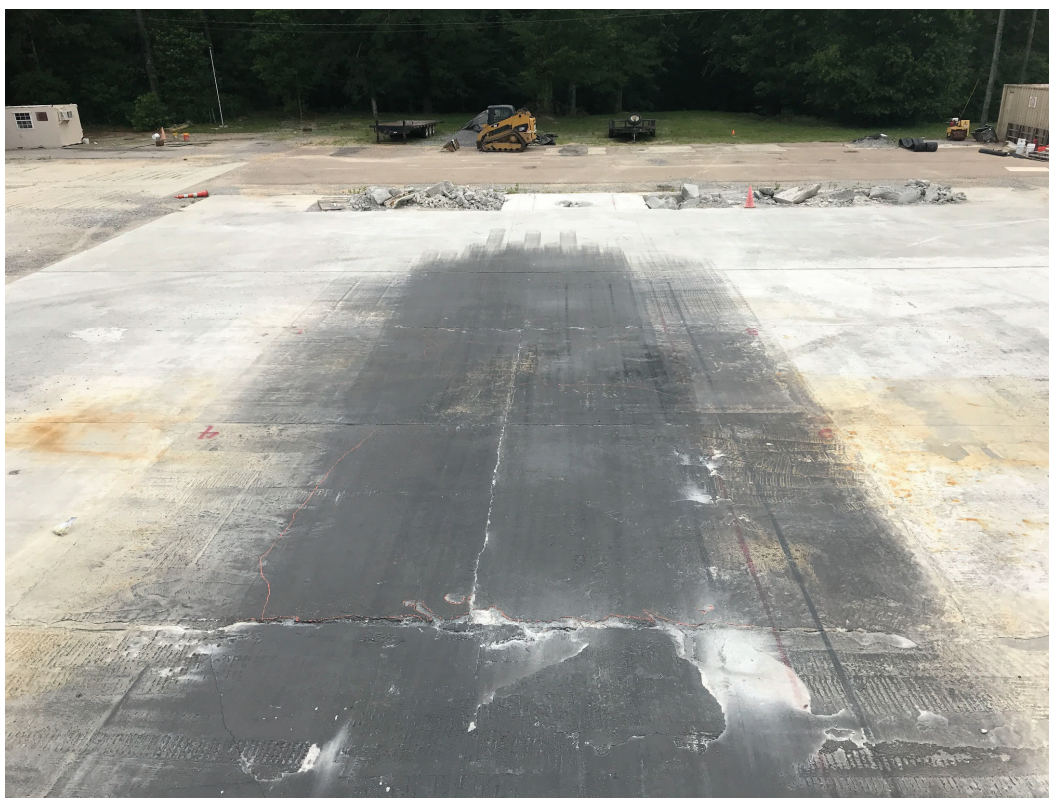
Figure 52. Overview of Repair 6 at 2,112 passes.

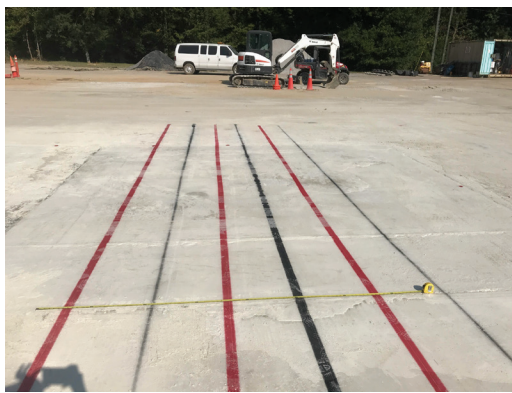
Figure 53. Repair 7 progression of distresses.

Repair 7 was conducted after the replaced parent slabs had cured for at least 28 days. Repair 7 consisted of 10 in. of Rapid Set Concrete Mix[®] over 13.5 in. of cement-stabilized silty sand. The repair failed at approximately 896 passes (766 coverages) with high-severity joint spalling exceeding the failure criteria in two locations. The progression of distresses with increasing traffic can be found in Figure 53.
