**SIGAR 20-21 Inspection Report**

## Kajaki Dam Irrigation Tunnel: The \$27.3 Million Tunnel Is Not Operating Properly Due to Construction Deficiencies and a Maintenance Issue

**JANUARY  
2020**

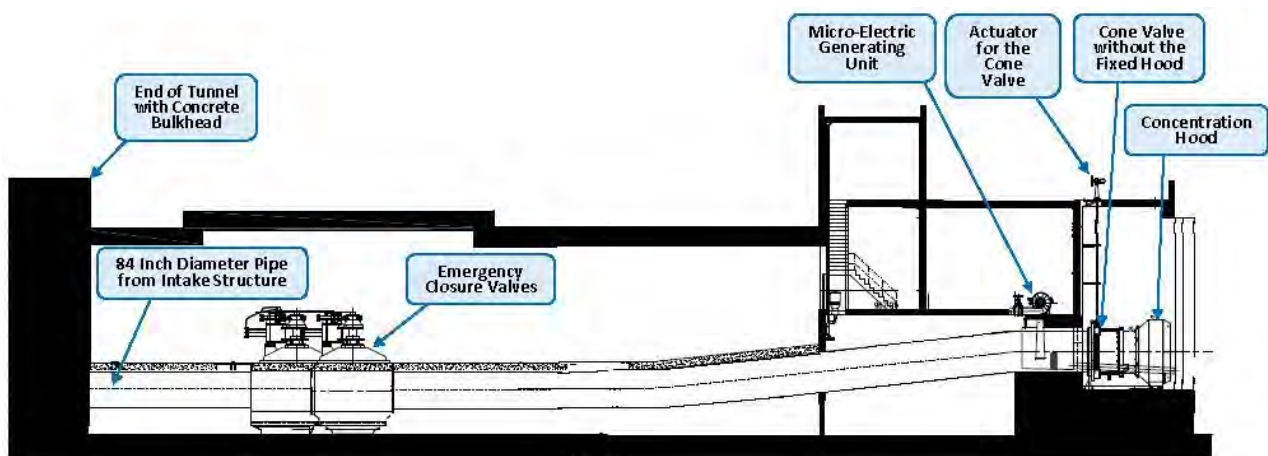
**Figure 1 - Cross Sectional Schematic View of the Kajaki Dam Irrigation Tunnel**

On January 30, 2013, the U.S. Army Corps of Engineers (USACE) awarded a \$25.6 million firm-fixed-price contract to Metag Insaat Ticaret A.S. (METAG), a Turkish firm, to repair the irrigation tunnel's intake structure, refurbish the emergency closure valve, replace the cone valve, and replace the micro-electric generating unit (see figure 1).<sup>2</sup>
