ERDC/CHL CHETN-IX-63 March 2023

## Underwater Carbon Fiber–Reinforced Polymer (CFRP)–Retrofitted Steel Hydraulic Structures (SHS) Fatigue Cracks

by Guillermo A. Riveros and Hussam Mahmoud

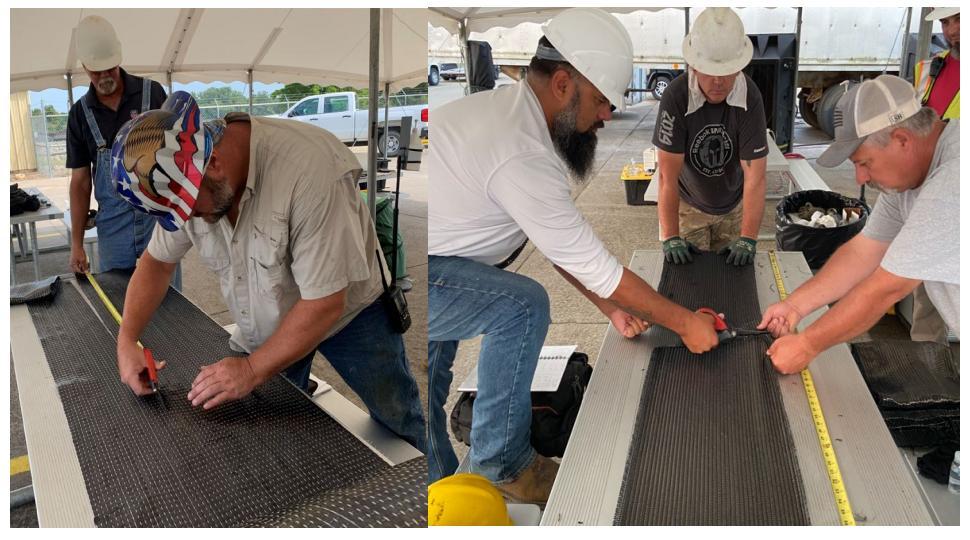
Figure 7. Cutting fibers to specific lengths. At left, CFRP.At right, basalt fibers.

- a. Fabric preparation. After inspection, precut all fabrics before mixing any epoxy. Cutting fiber 24 in to 36 in long (Figure 7) is preferred.
- b. Surface preparation. The required surface preparation is largely dependent on the type of element being repaired and strengthened. In general, the surface must be clean, dry, and free of protrusions or cavities, which may cause voids behind the Tyfo composite. Discontinuous wrapping surfaces (beams) typically require a sandblast, grinding, or other approved method to prepare for bonding. For SHS, the surface must be clear to the base metal. This can be accomplished either by grinding or sandblasting (preferable method) the surface and cleaning with acetone (Figure 8).

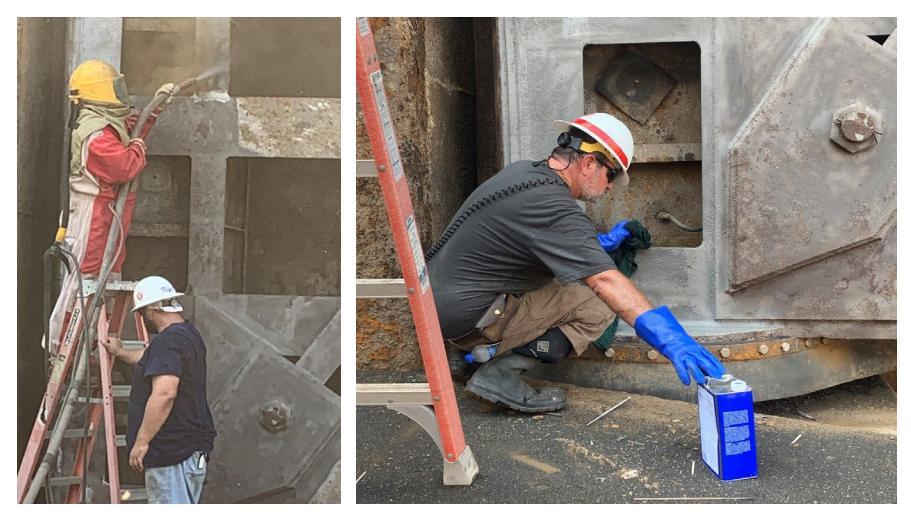
Figure 8. Sandblasting and cleaning the surface with acetone.

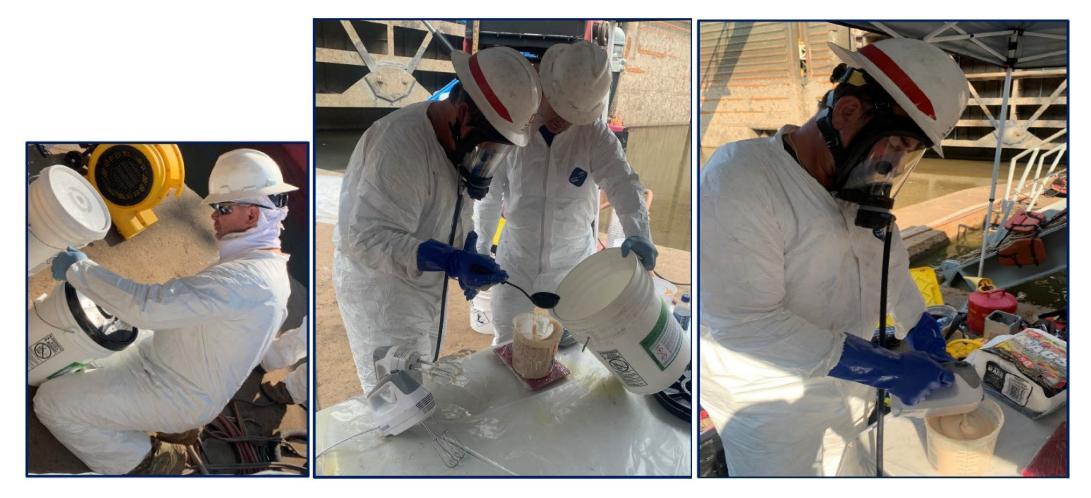
Figure 9. Mixing epoxy and adhesive.

- c. Mixing FYFE Tyfo S Epoxy. FYFE Tyfo S Epoxy is a two-component epoxy. The A component color is normally clear to amber with a thick consistency and slight resin smell. The B component is normally clear to yellow with a very thin consistency similar to water and has an ammonia-like smell. The FYFE Tyfo S Epoxy matrix material is combined with the FYFE Tyfo fabrics to provide a wet-layup composite system for strengthening structural members. Premix each component: 100 parts of component A to 34.5 parts of component B by weight. Mix thoroughly for 5 minutes with a low-speed mixer at 400 to 600 RPM until uniformly blended (Figure 9).

parts of component B by weight. Mix thoroughly for 5 minutes with a low-speed mixer at 400 to 600 RPM until components are thoroughly dispersed. Excessive mixing will shorten pot life (Figure 9).

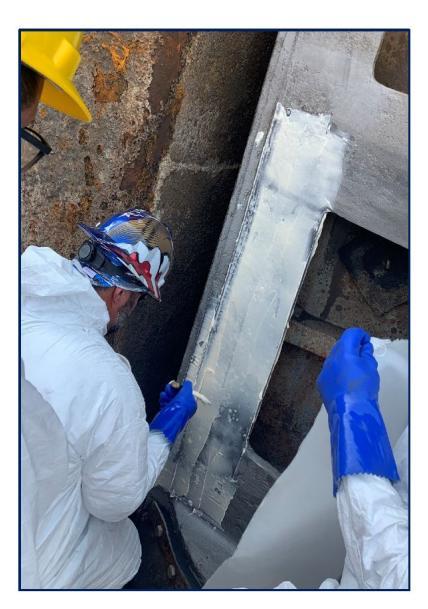
Figure 10. Adhesive application.

- 1. Apply adhesive to the clean surface (Figure 10).
  - 2. Install one layer of glass fiber (FYFE Tyfo WEB glass fabric) (Figure 11).
  - 3. Apply adhesive to the glass fiber.

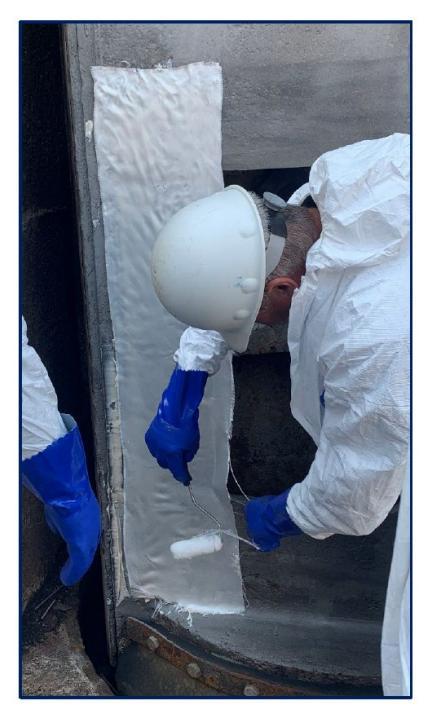
Figure 11. Glass fiber installation.

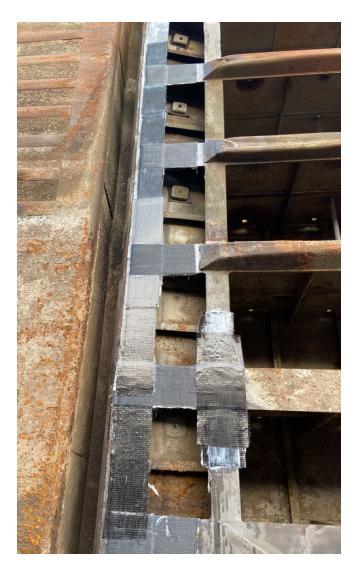
Figure 12. CFRP installation.

- 5. If a second layer of carbon fiber is needed, apply adhesive to the carbon fiber already installed, and apply Tyfo S to one side of the new carbon fiber layers with a roller. Once the carbon fiber is installed to the carbon fiber, use a roller to complete saturation of the carbon fiber (Figure 12).
