José María Gil Adobe

Historic Context, Maintenance Issues, Measured Drawings,
and Adaptive Reuse

October 2023

Final Report

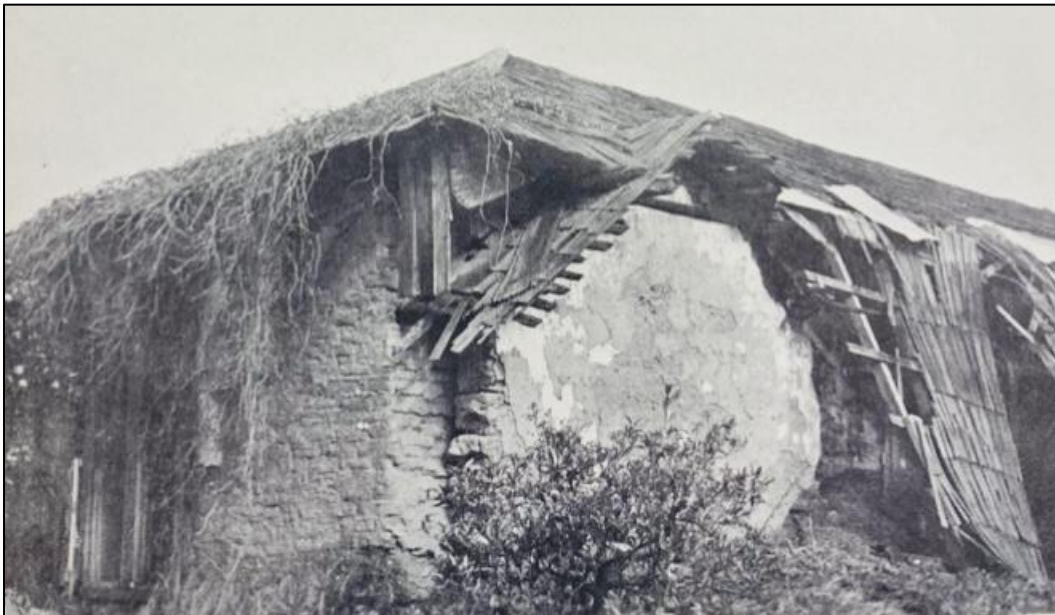
Figure 17. Roofing material crumbling at the corner of the Ignacio Palomares Adobe and plants growing into the wooden roof, no date. (Image reproduced from Giffen 1955, 84. Public domain.)

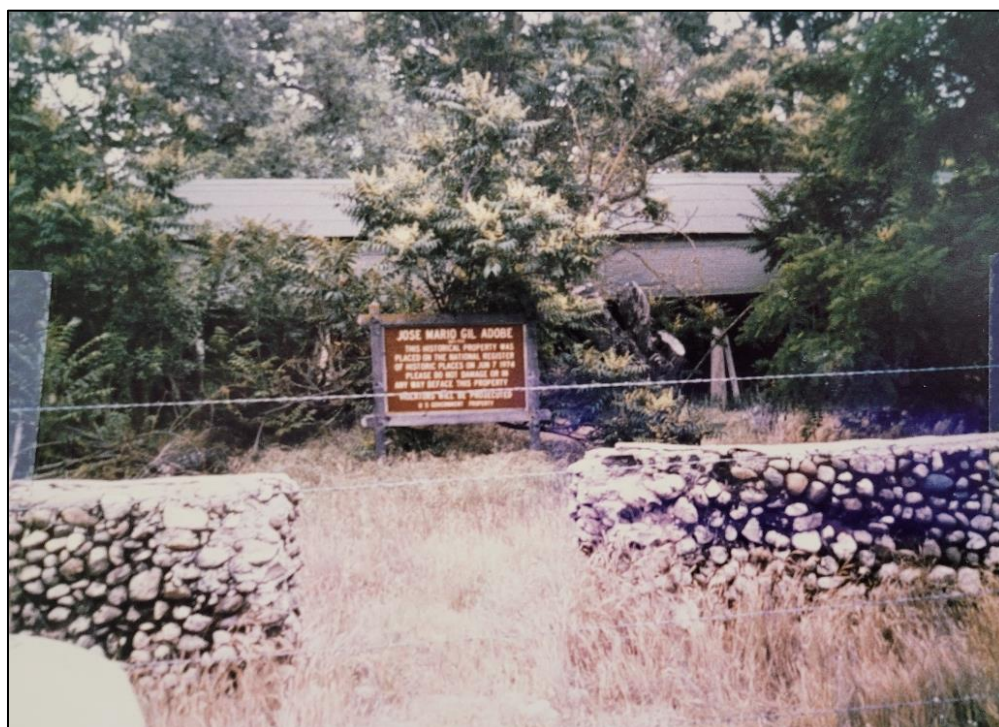
Figure 28. Major limbs and overgrowth on the east side of the José María Gil Adobe, 1993. (FHL real property file record.)

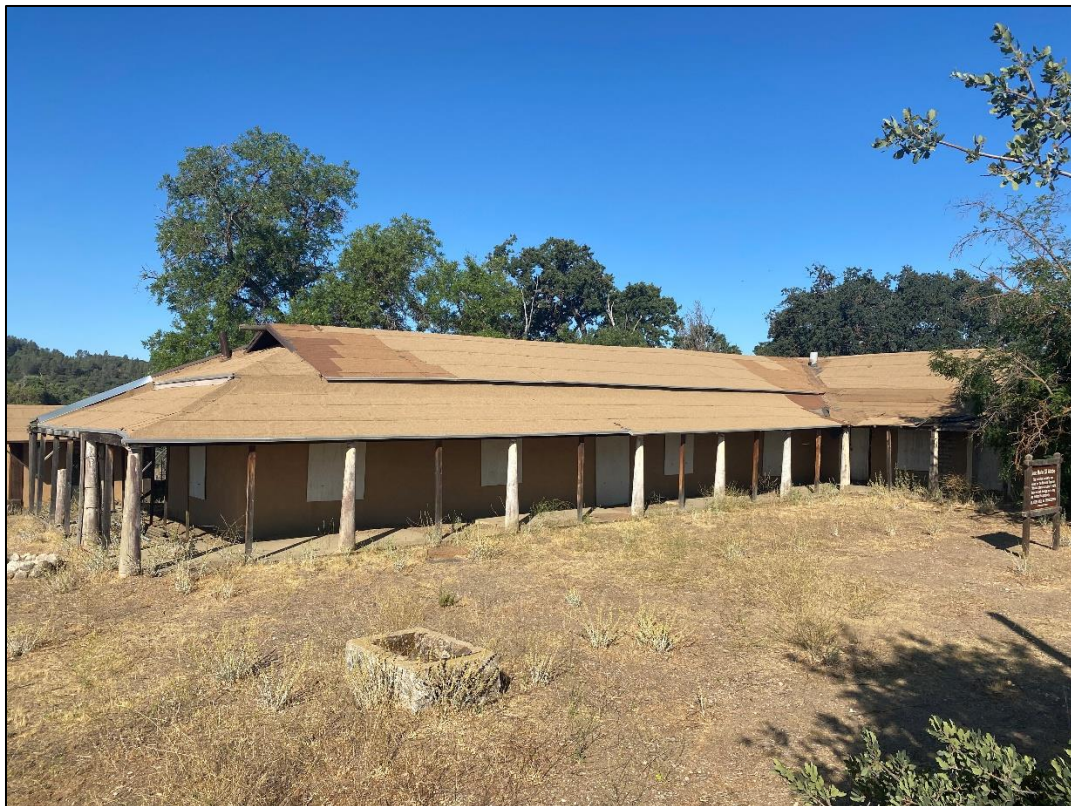
Figure 29. José María Gil Adobe in its present condition and how it was left in 1993, 2021.
(ERDC-CERL.)

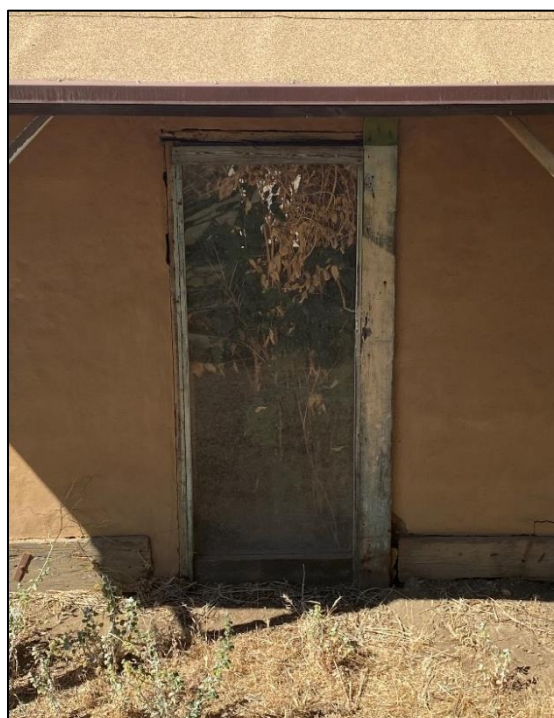
Figure 40. Plexiglass in the door opening on the northeast side of the cold storage building, 2021. (ERDC-CERL.)

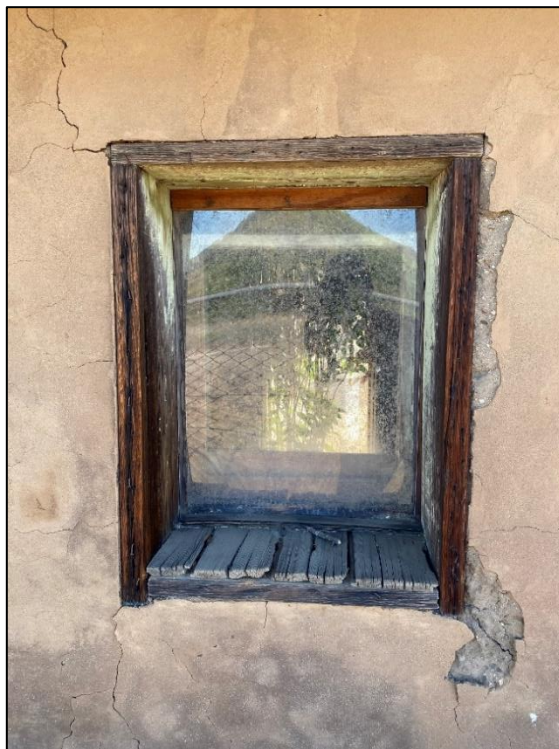
Figure 41. Plexiglass in the window opening on the southwest side of the cold storage building, 2021. (ERDC-CERL.)

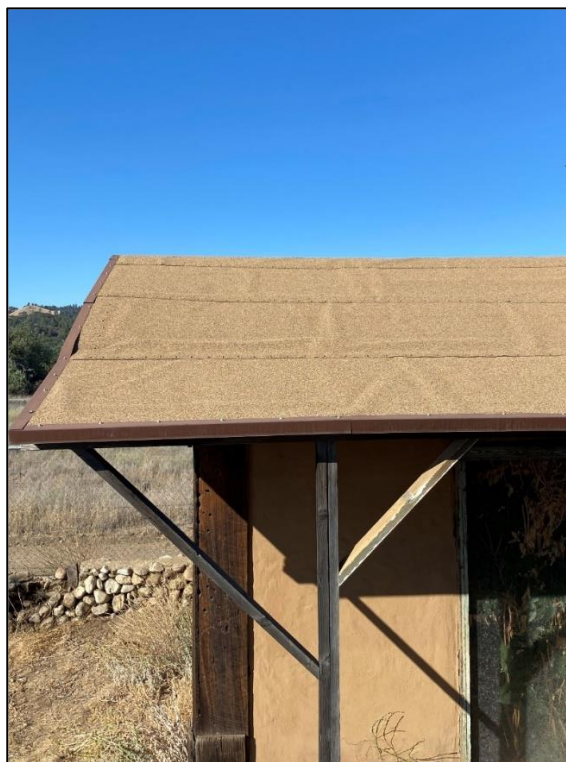
Figure 42. Brown asphalt paper on the roof of the cold storage building, 2021. (ERDC-CERL.)

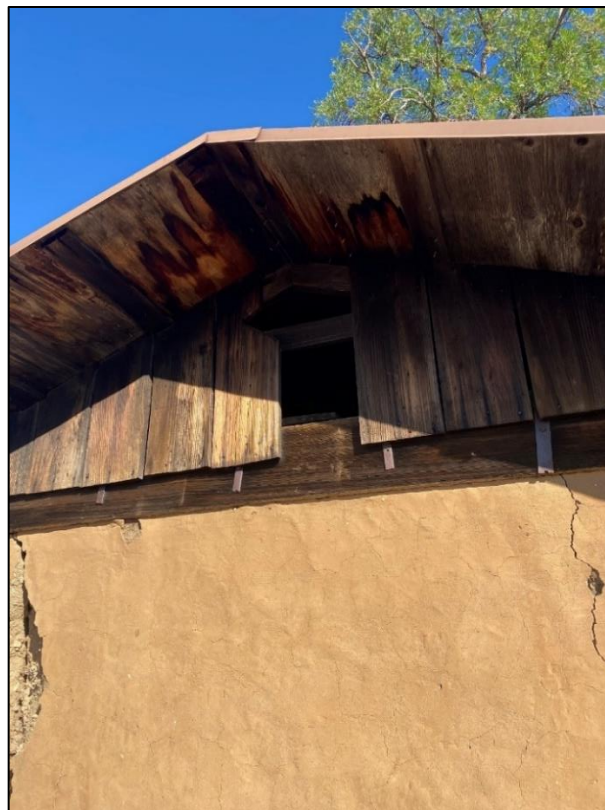
Some wooden elements remain on the exterior of the cold storage building. All wooden elements are in “POOR” condition. In the north and south gable openings there are 1 × 10 in. wooden boards vertically placed (Figure 45). The rammed earth walls do not extend up to the peak of the roof. Under the 22 in. overhang along all but the northeast side are wooden soffits (Figure 46). The northeast side consists of the door opening and a wooden veranda that extends outward 46 in., supported by two wooden posts. The two posts are strengthened by angled brace members in a Y shape that extend in either direction of the posts toward the roof’s middle and edge (Figure 47). The posts are resting on concrete blocks. There are approximately 1 × 10 in. wooden trim boards that line the top and base of the rammed earth structure as well as the vertical corner edges (Figure 48). Some of the wooden trim boards have split, which causes them to appear narrower in some areas. The window on the southwest side of the building has 2 to 3 in. wooden trim boards and sill boards (Figure 49). The door opening on the southwest side of the building has missing and deteriorating wood trim (Figure 47). See Section 10 for the analysis of the outbuilding materials.

Figure 45. Vertically placed boards cladding the gable opening on the north and south sides of the cold storage building, 2021. (ERDC-CERL.)

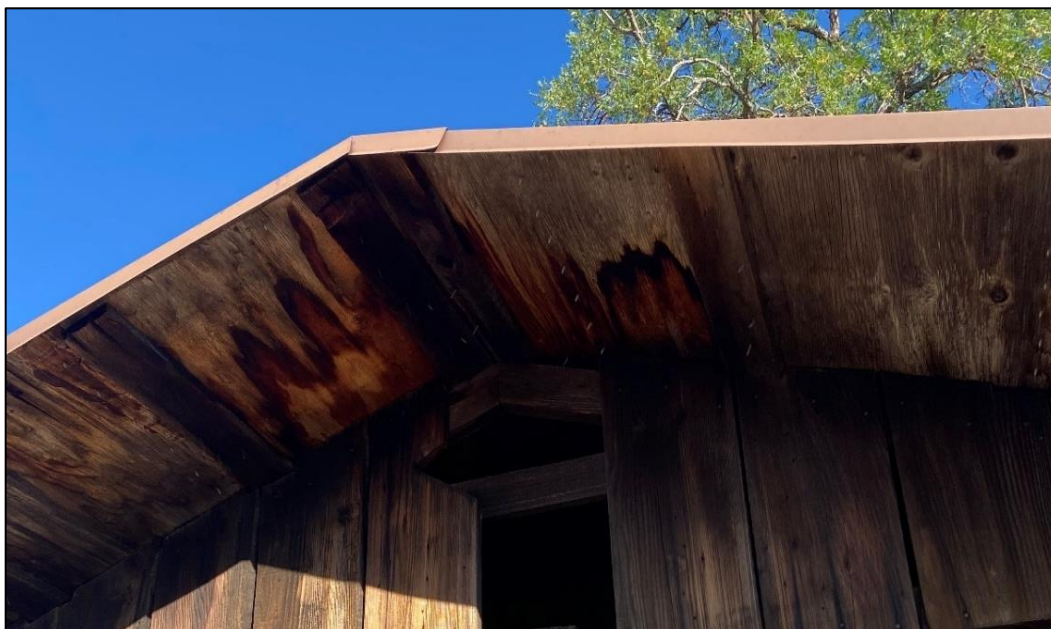
Figure 46. Wooden soffits under the roof overhang of the cold storage building, 2021. (ERDC-CERL.)

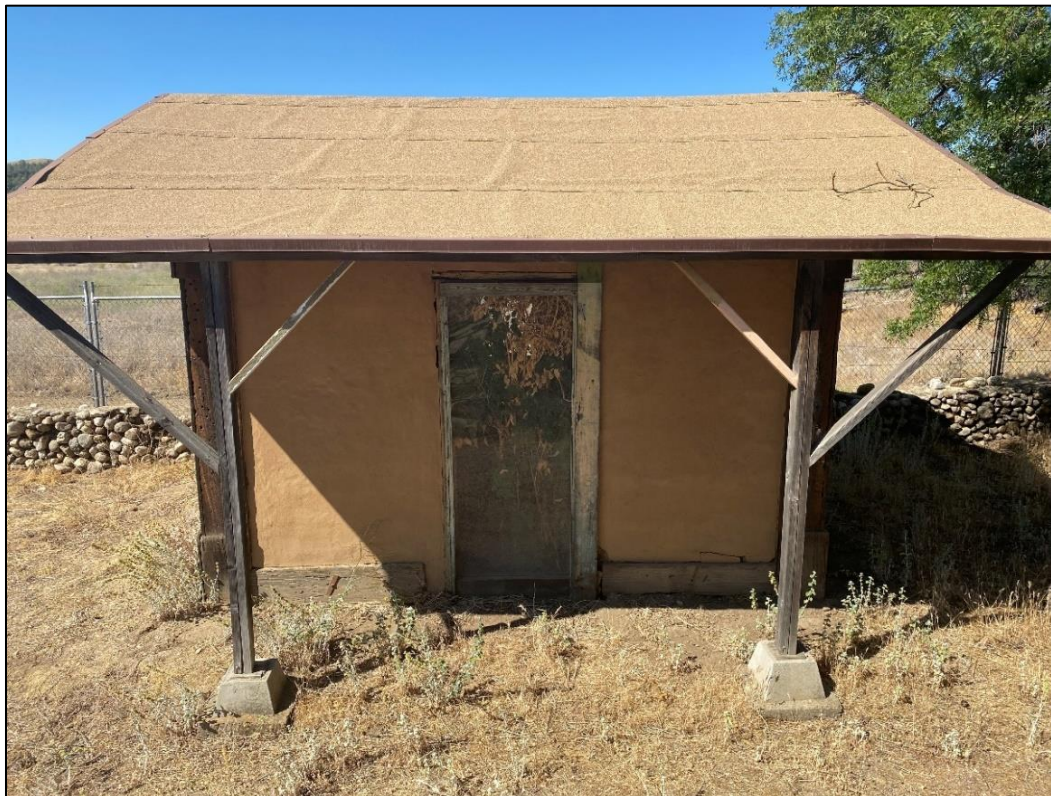
Figure 47. Wooden posts supporting front veranda of the cold storage building, 2021. (ERDC-CERL.)

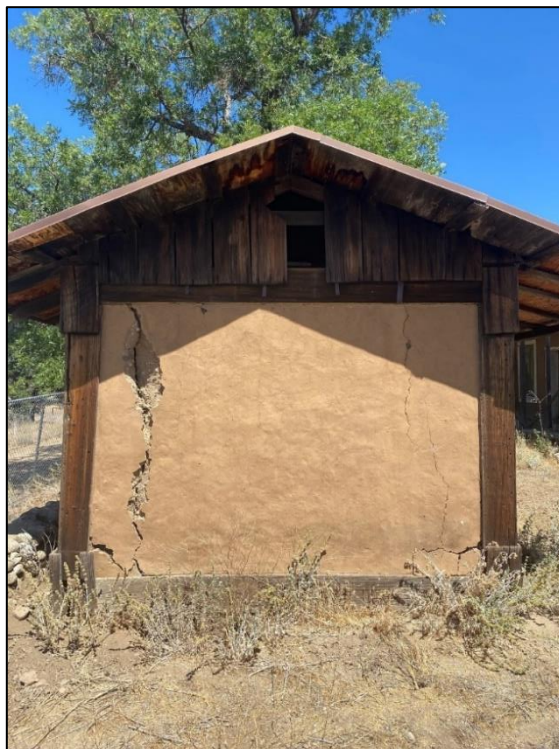
The rammed earth material seen in Figure 43 has been exposed due to a large crack on the southeast side of the cold storage building. The crack was most likely caused by a past earthquake and can be fully seen in Figure 48. The remainder of the rammed earth structure is coated in a plaster that was added during the same time period and of the same kind as the José María Gil Adobe (Figure 44).

Figure 48. Wooden trim boards along base and corners of the cold storage building, 2021.
(ERDC-CERL.)

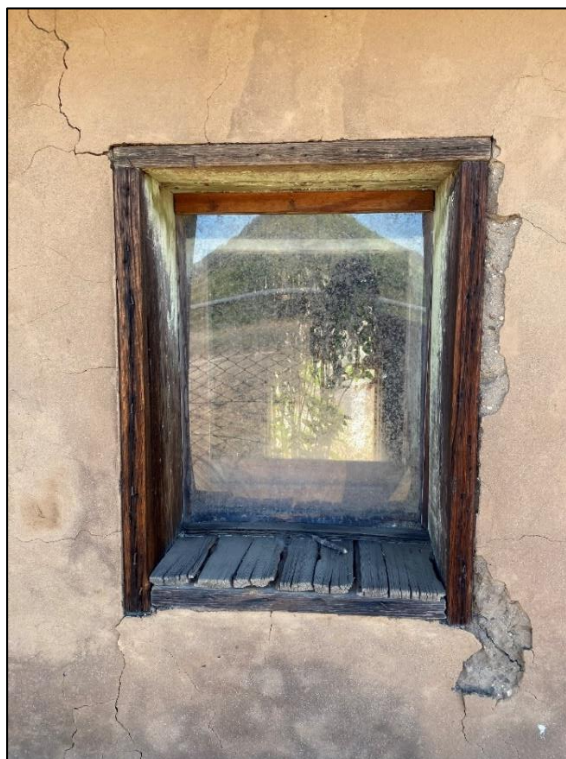
Figure 49. Wooden window trim and sill boards on the cold storage building, 2021. (ERDC-CERL.)

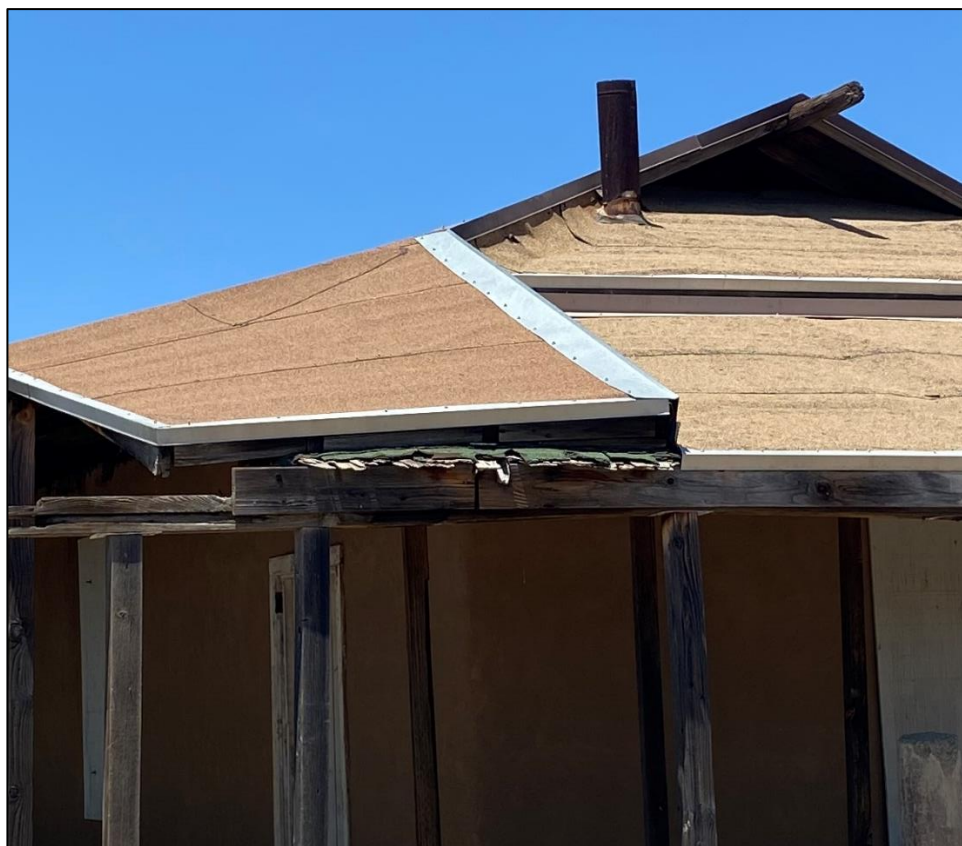
Figure 55. Multiple roof layers showing green asphalt shingles and brown asphalt paper on the south corner of the José María Gil Adobe, 2021. (ERDC-CERL.)

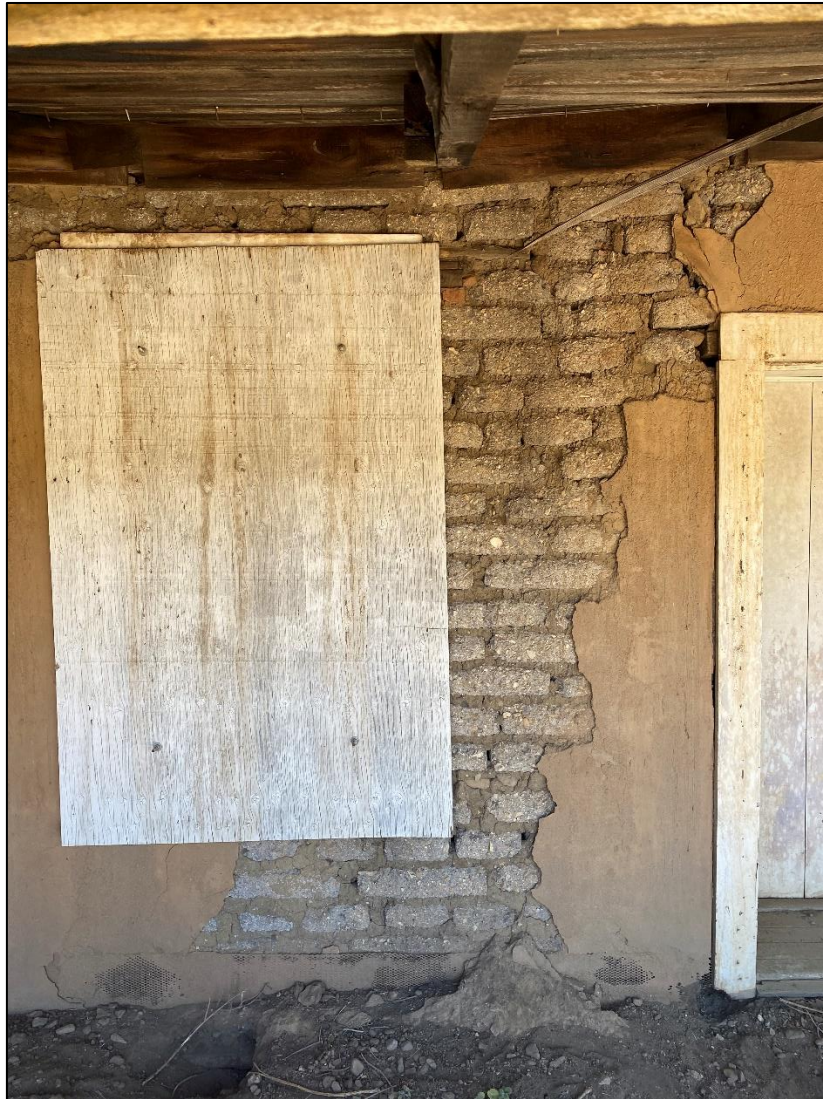
The building is constructed of adobe bricks currently coated in brown plaster (Figure 60). There are many areas on all elevations that the plaster has deteriorated, which has exposed the adobe bricks. The walls were created by hand, resulting in unique and uneven surfaces, a strong characteristic of vernacular architecture (Figure 61).

Figure 60. Plaster coating and exposed adobe brick on the north wing of the José María Gil Adobe, 2021. (ERDC-CERL.)

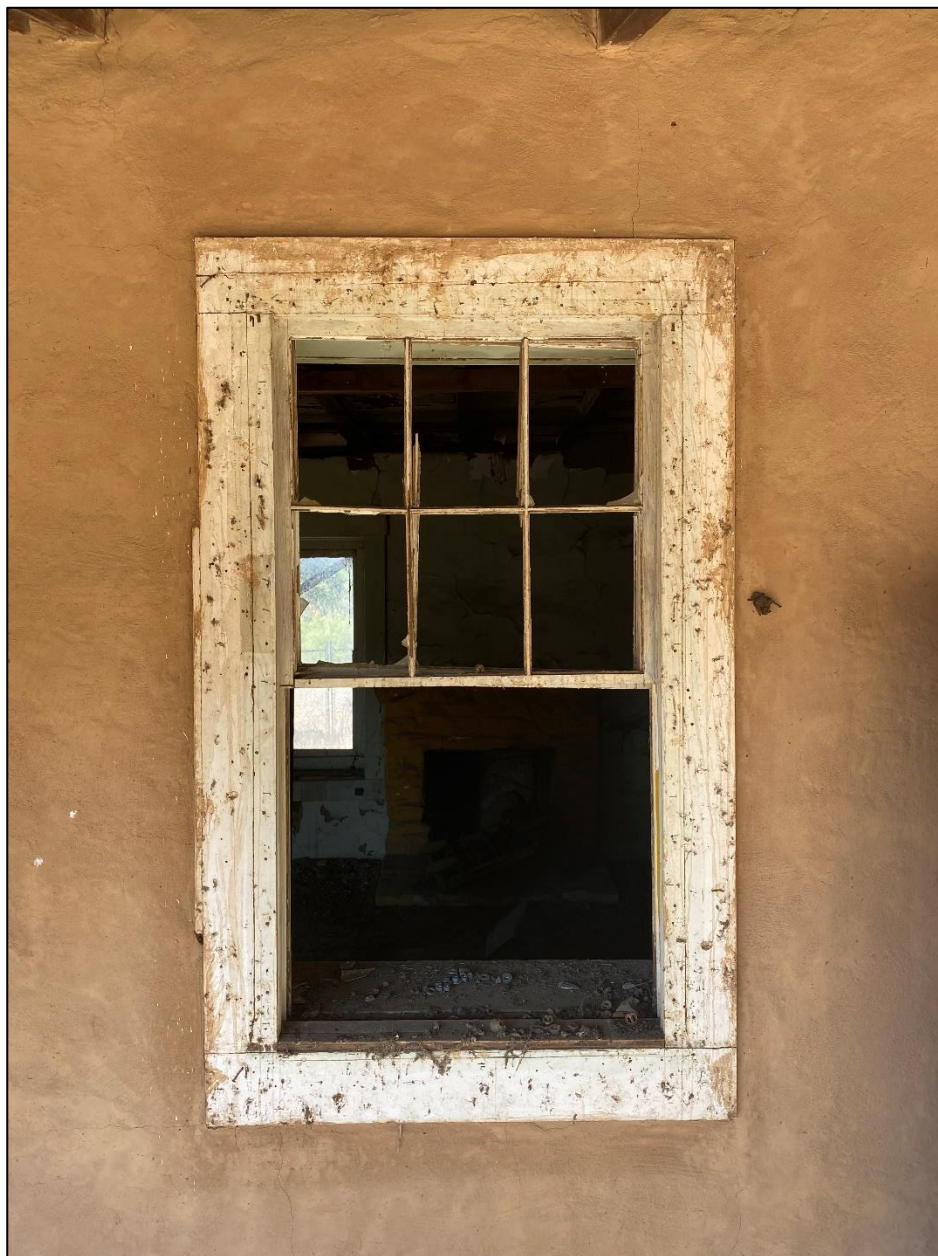
Figure 62. Example of a six-over-six, wood-sash, double-hung wood window that is missing muntins on the east side of the José María Gil Adobe, 2021. (ERDC-CERL.)

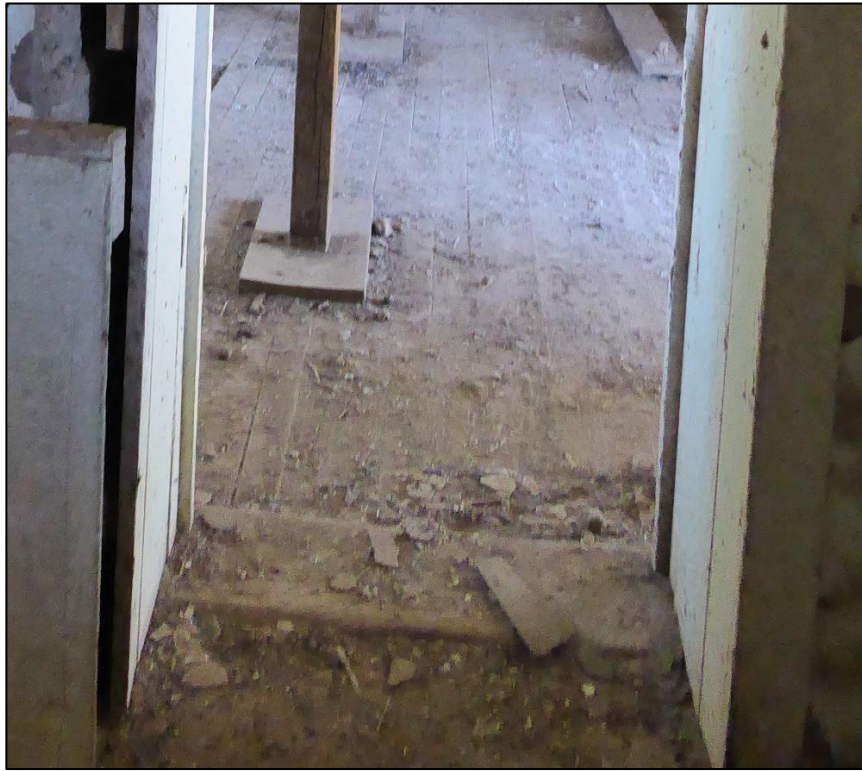
Figure 66. Wooden floor with extensive dirt and guano in the south wing of the José María Gil Adobe, 2021. (ERDC-CERL.)

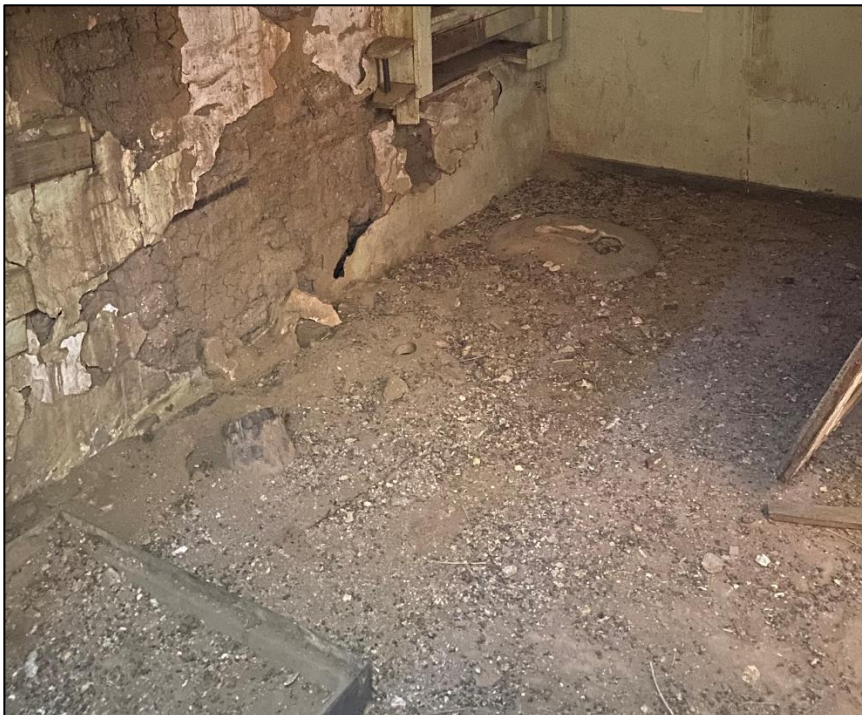
Figure 67. Floor that appears to be dirt due to excessive coverage of dirt and guano in the north wing of the José María Gil Adobe, 2021. (ERDC-CERL.)

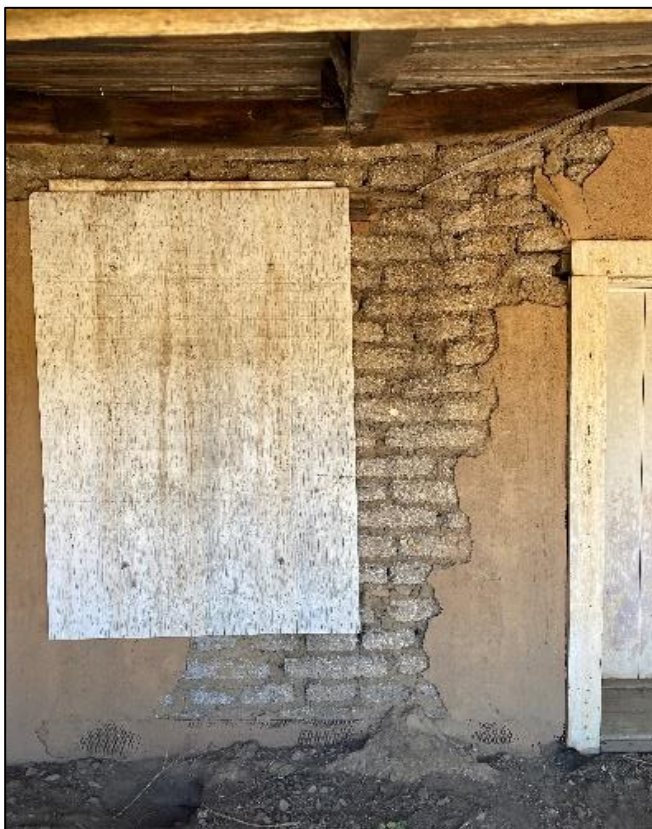
Adobe as a construction material is made entirely from natural elements. The José María Gil Adobe is constructed in adobe bricks of various sizes, some appearing smaller due to breakage. Because the adobe bricks are coated in plaster as a protective layer, the bricks were not laid based on aesthetics. Due to neglect, there are areas of the building where plaster has deteriorated, exposing adobe brick (Figure 85, Figure 86, and Figure 87).

Figure 86. Large section of adobe brick between a door and window on the southeast side of the José María Gil Adobe, 2021. (ERDC-CERL.)

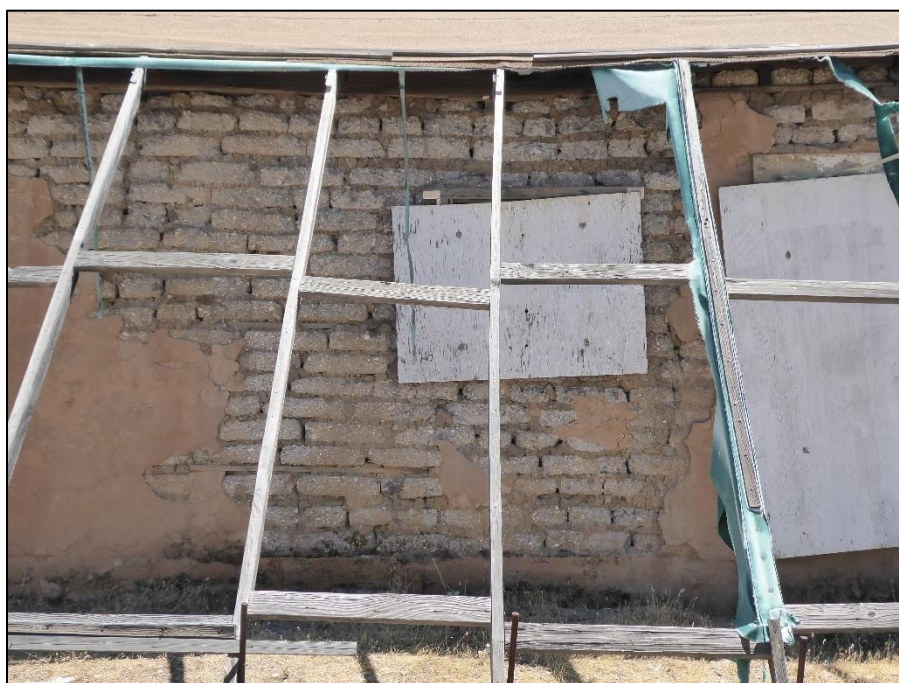
Figure 87. Large section of adobe brick around two windows on the northwest side of the José María Gil Adobe, 2021. (ERDC-CERL.)

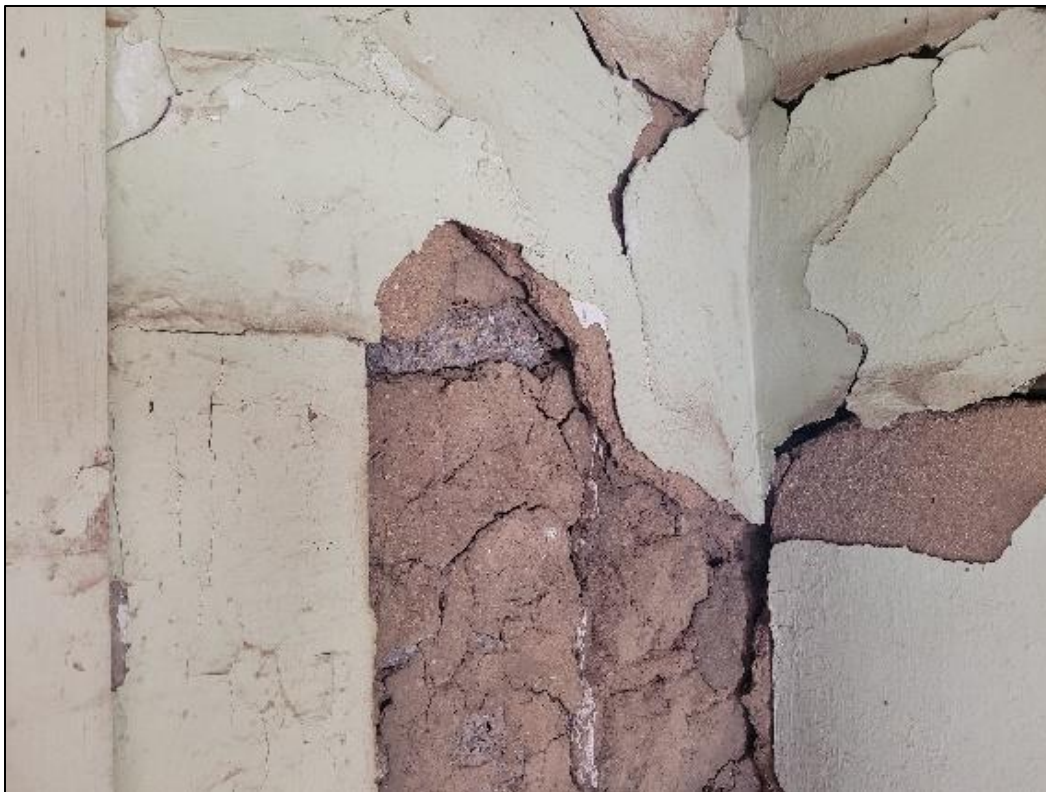
The José María Gil Adobe has interior plaster that coats the adobe brick. Much of the plaster has been painted a pale green. The plaster and paint are in “POOR” condition. The paint and plaster are cracked and peeling in many locations, exposing interior adobe and wooden features (Figure 89 and Figure 90). Some plaster walls are still intact on the interior and are exposed by peeling paint (Figure 91).

Figure 89. Cracked plaster and paint exposing adobe brick in the south wing of the José María Gil Adobe, 2021. (ERDC-CERL.)

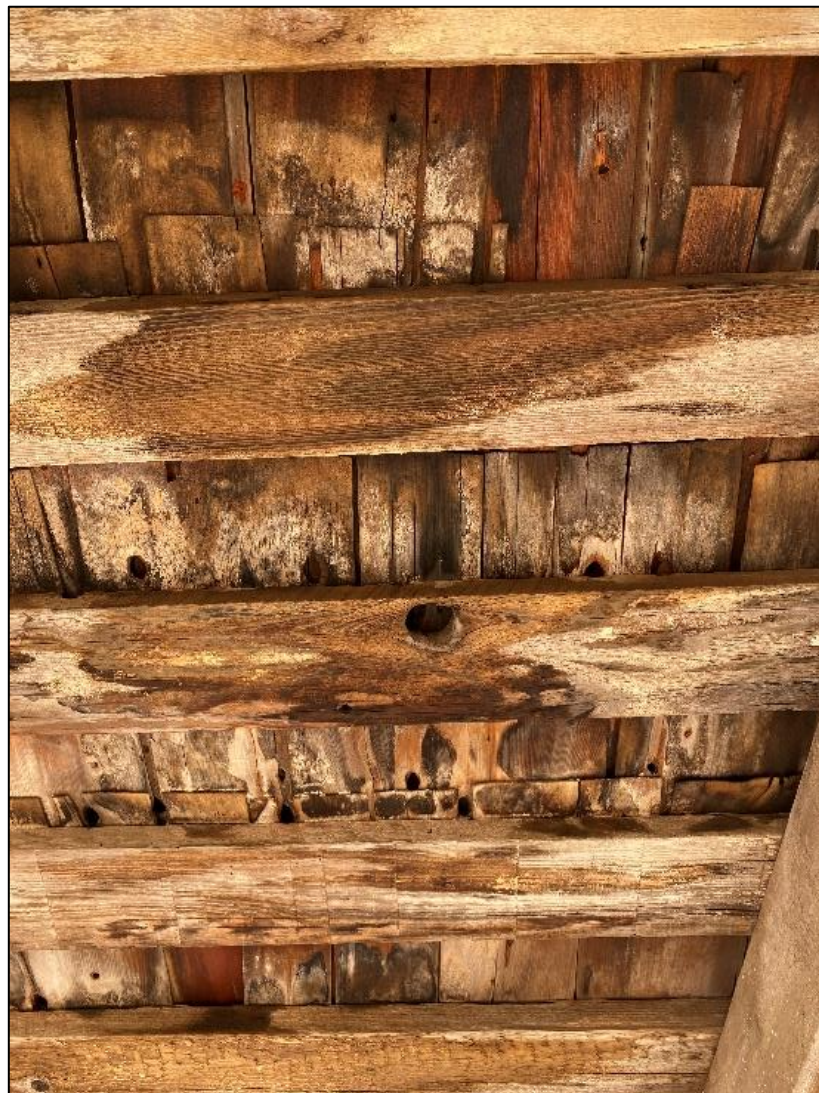
The underside of some portions of the existing veranda of the José María Gil Adobe are wooden shingles that are in “POOR” condition. These shingles are visible when standing under the veranda looking up. Figure 94 shows the shingles resting on the wooden frame without any roof sheathing, which is historically accurate for a wood-shingled roof built during the 19th century.

Figure 94. Looking up at wooden shingles under the south veranda roof of the José María Gil Adobe, 2021. (ERDC-CERL.)

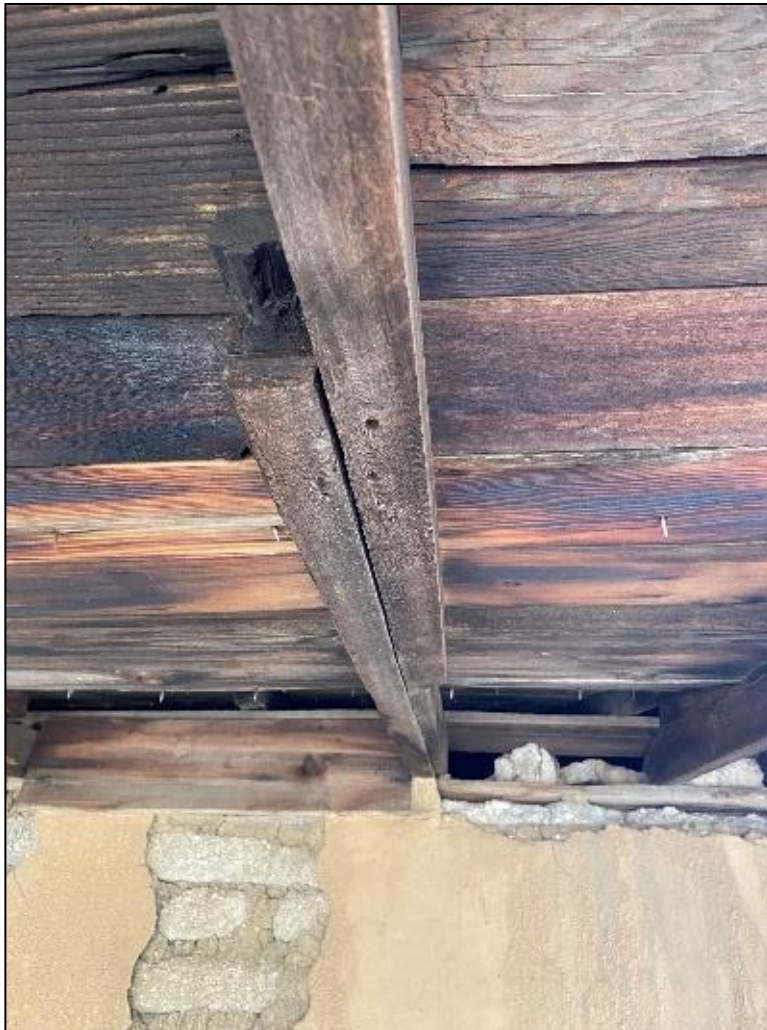
In some areas, the veranda roof is not original and was added by connecting the rafters (Figure 95). The boards extending from the structure itself may be part of the original roof overhang. The wooden members with a notch at their ends may be part of the original roof.

Figure 95. Looking at the connection between the veranda roof to the roof of the José María Gil Adobe, 2021. (ERDC-CERL.)

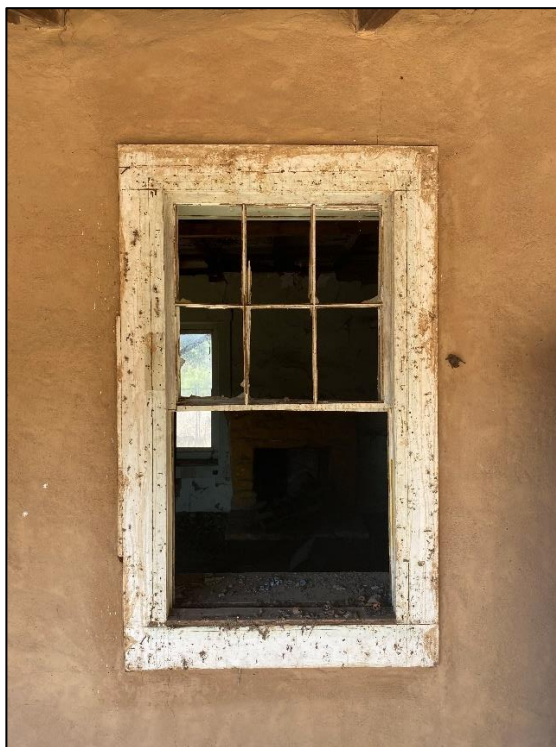
Figure 98. White-painted window trim surrounding a window on the west side of the José María Gil Adobe, 2021. (ERDC-CERL.)

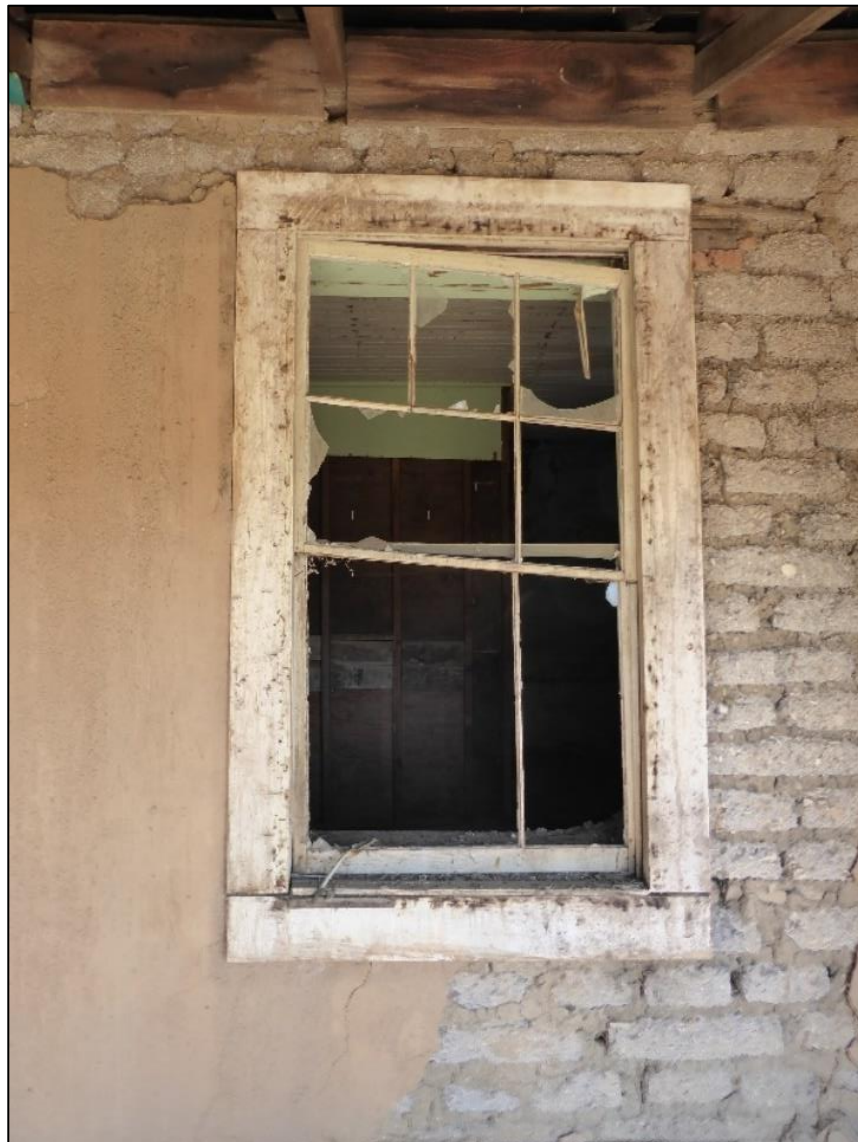
Wooden trim lines the exterior windows and doors of the José María Gil Adobe (Figure 97 and Figure 98). The trim varies in sizes from 3 to 5 in. within and between windows, meaning a single window could have a 5 in. piece of trim on the left side and a 4 in. piece of trim on the right. In some cases, the edges of the wood have split and broken off. The trim is missing in some areas, and it is also very crooked due to lack of fasteners as many have rusted away. It is important to remember that no two doors or windows are alike on this structure. This is due to the uniqueness of the adobe building, resulting in multisized window and door openings, as well as the fact that some are of different materials and ages. The windows were originally six-over-six, double-hung wood windows. Many windows are missing either some or all of their muntins (Figure 99).

Figure 99. Sagging windows and missing muntins on the west side of the José María Gil Adobe, 2021. (ERDC-CERL.)

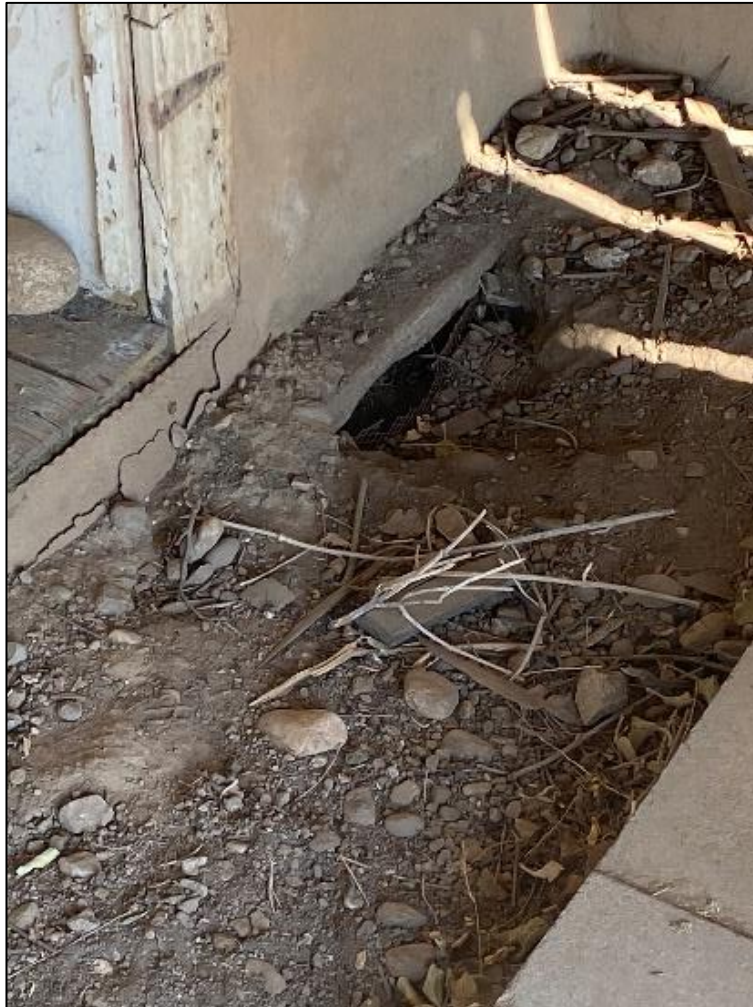
Animals digging along the perimeter of the José María Gil Adobe led to the exposure of the wooden base of the adobe wall (Figure 103). It was common for builders to use wooden members or stones to act as a foundation, though some adobes had little to no foundation.

Figure 103. Wooden sill supporting the base of the adobe wall at grade level of the José María Gil Adobe, 2021. (ERDC-CERL.)

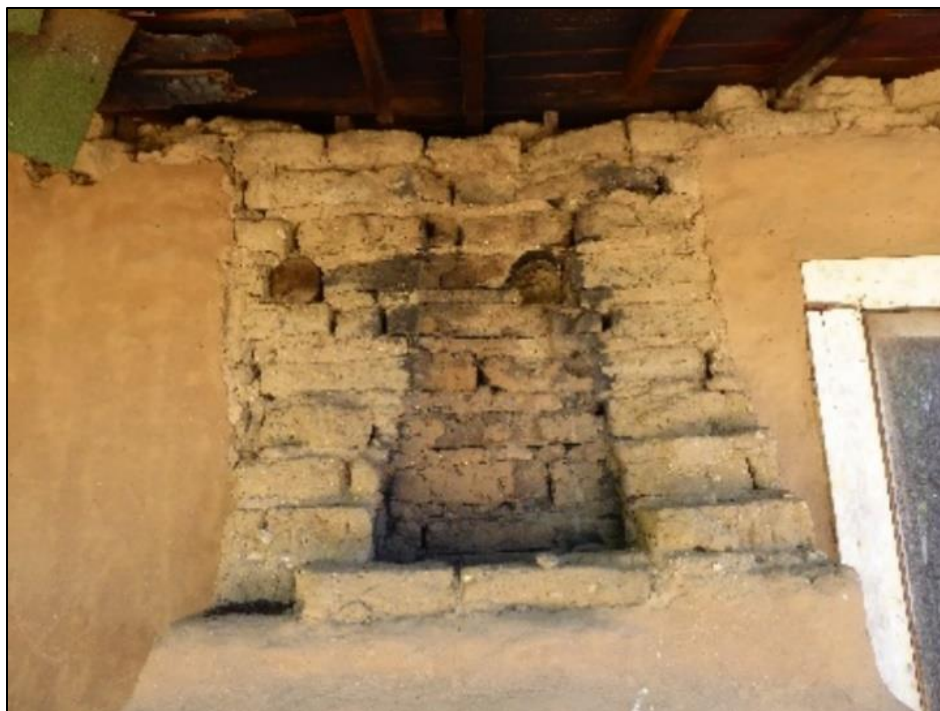
Due to the erosion on the exterior portion of the south chimney, two circular wooden posts horizontally placed into the chimney are now exposed (Figure 107). It was common to place wooden shims within adobe walls for leveling and strengthening purposes. These wooden pieces are not visible on the interior of the building.

Figure 107. Circular posts imbedded into the south chimney of the José María Gil Adobe, 2021. (ERDC-CERL.)

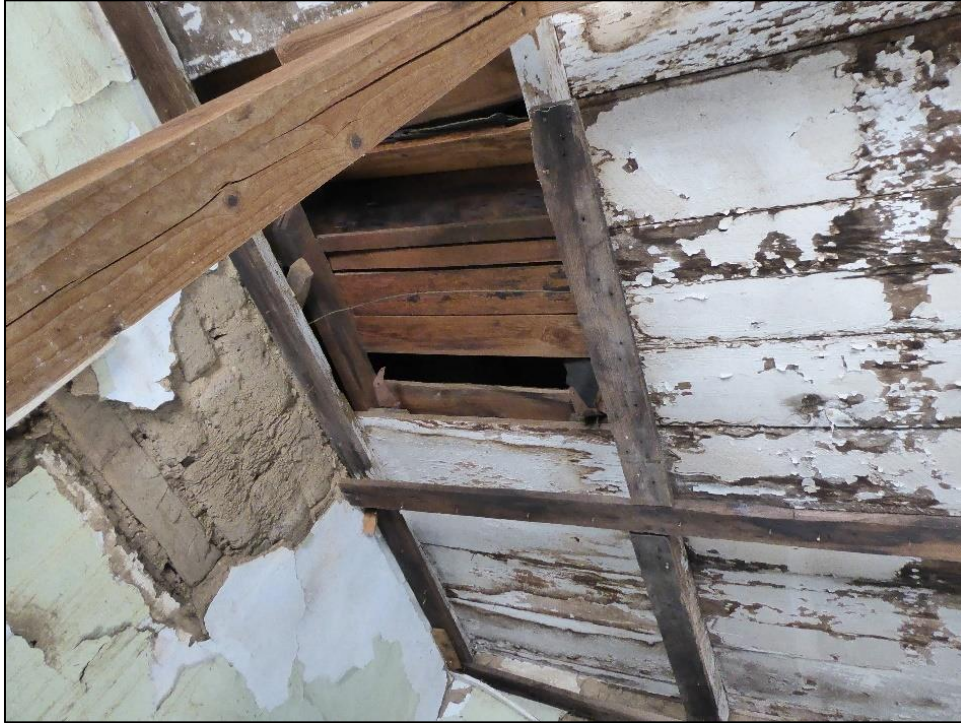
The ceiling boards are multisized planks (Figure 108 and Figure 109), and some are beadboard (Figure 110). Some boards appear to be much newer than others, specifically the studs supporting the middle of the ceiling (Figure 111). All of the paint on the ceiling boards is peeling.

Figure 108. Multisized and multiaged wooden members supporting the ceiling within the José María Gil Adobe, 2021. (ERDC-CERL.)

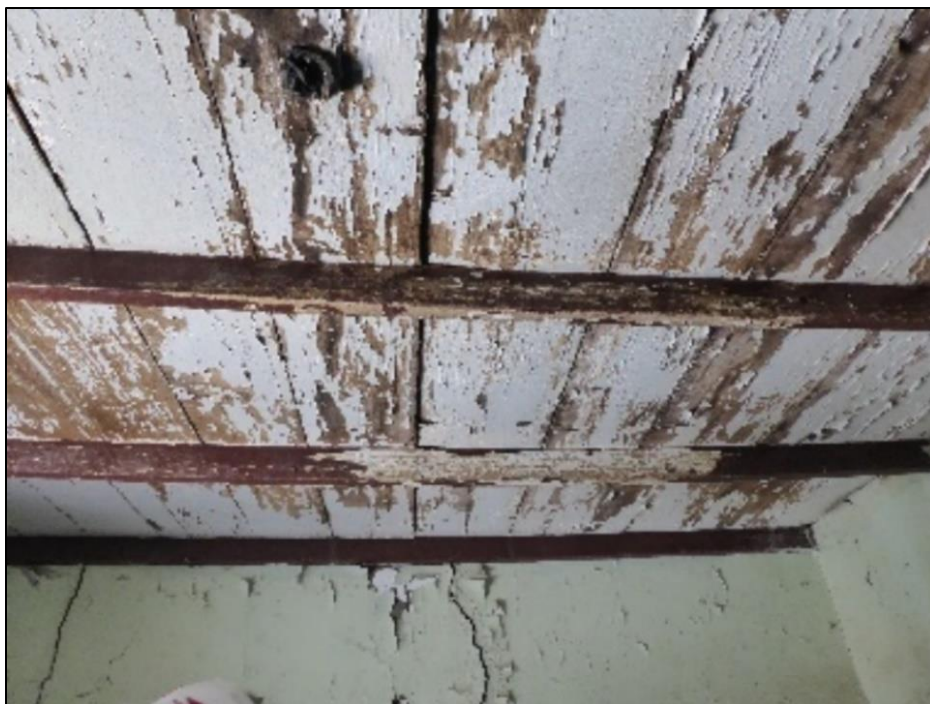
Figure 109. Wooden ceiling joists, 2 × 4 in., supporting wooden ceiling boards in the José María Gil Adobe, 2021. (ERDC-CERL.)

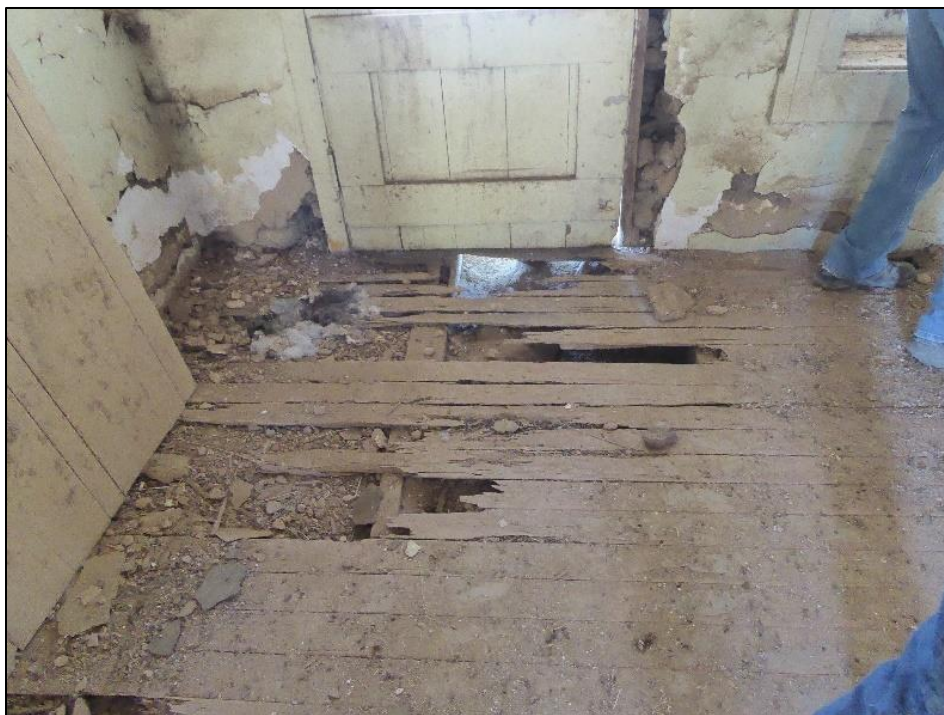
The floor of the José María Gil Adobe is wood strip flooring in some rooms and dirt in others. The wooden floors are in “POOR” condition. The majority of the floorboards are rotten due to their age and exposure to the elements due to roof leaks and wildlife. The floor is missing boards in some areas due to breakage (Figure 112, Figure 113, and Figure 114).

Figure 112. Wood strip flooring with breakthrough areas near an exterior door of the José María Gil Adobe, 2021. (ERDC-CERL.)

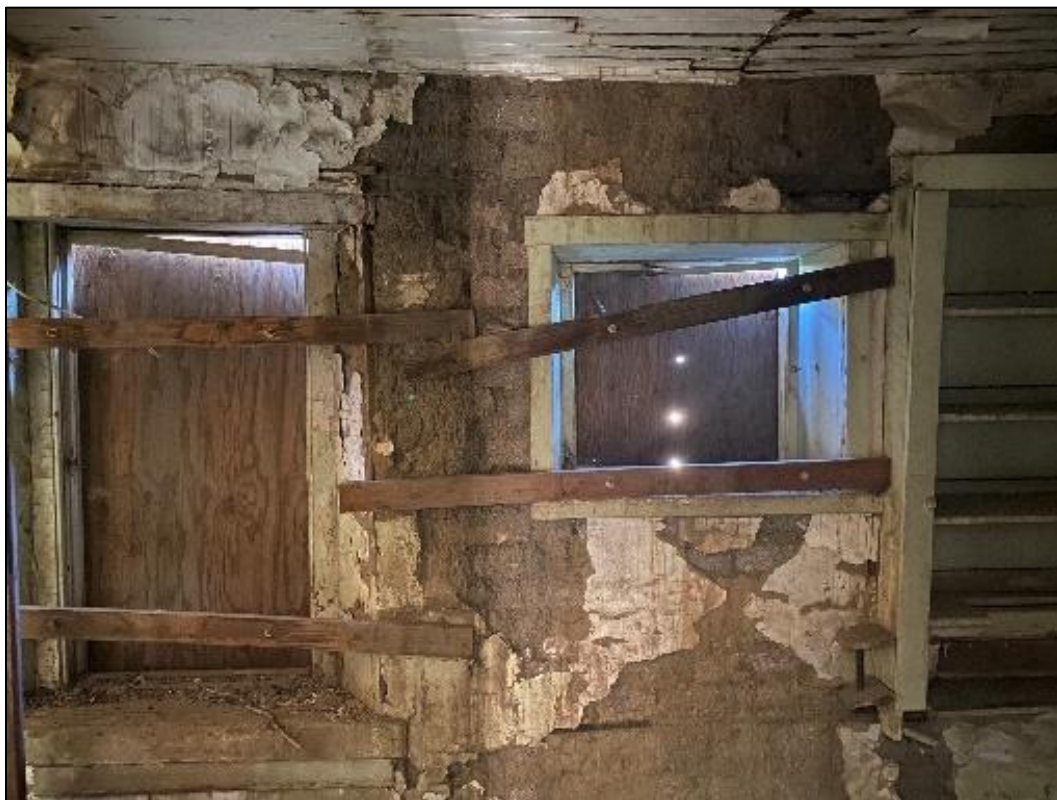
The interior wooden window and door trim has various sizes, measuring in the range of 3 to 5 in. The trim is in “POOR” condition. Many trim boards are rotten or out of place (Figure 118 and Figure 119).

Figure 118. Crooked and various-sized window trim in the north wing of the José María Gil Adobe, 2021. (ERDC-CERL.)

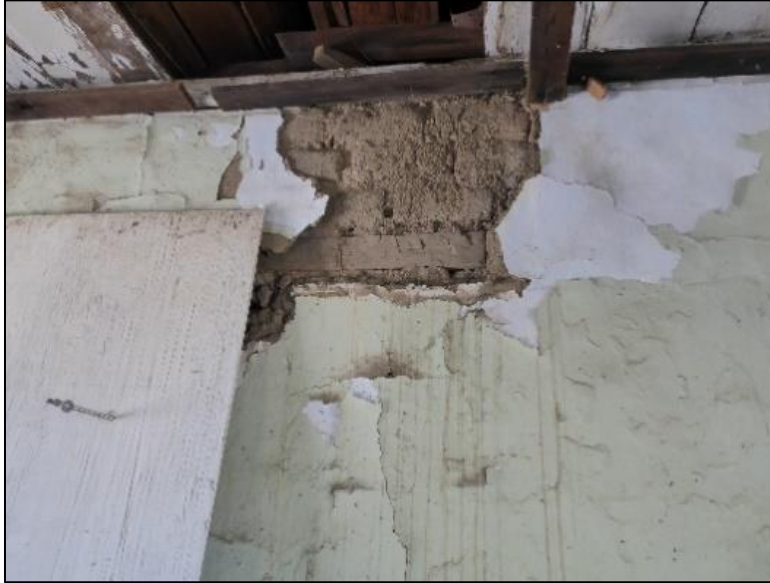
Figure 125. Wooden element embedded within the adobe wall in the south wing of the José María Gil Adobe, 2021. (ERDC-CERL.)

The wooden elements are used for structural or leveling purposes to act as a frame to help the handmade blocks rise to a consistent height. The wooden elements are placed horizontally between rows of adobe bricks (Figure 125).
