José María Gil Adobe

Historic Context, Maintenance Issues, Measured Drawings,
and Adaptive Reuse

October 2023

Final Report

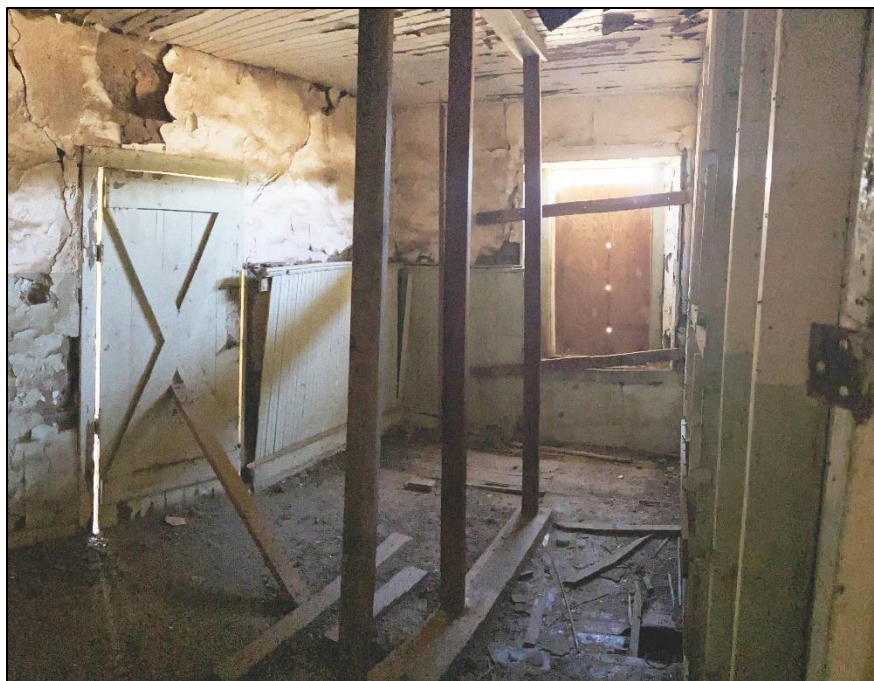
Figure 126. Beadboard wainscoting in the north wing of the José María Gil Adobe, 2021. (ERDC-CERL.)

On the interior walls of the José María Gil Adobe are wooden wainscoting, (some with chair rails) of various board forms and dimensions. In the north wing of the building is approximately 3 in. beadboard wainscoting that was painted olive green (Figure 126). Some rooms have wainscoting built of larger boards of various sizes, shown in Figure 127.

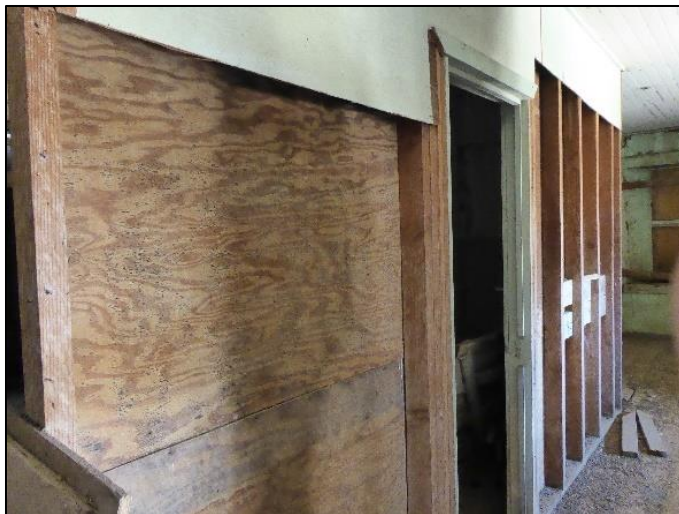
Figure 129. Wooden partition wall using plywood and studs, framing the bathroom space in the north wing of the José María Gil Adobe, 2021. (ERDC-CERL.)

The north wing of the José María Gil Adobe was heavily modified after the building was acquired by the Army during World War II. Wooden cabinets and counters as well as partition walls were added to create kitchen and bathroom space in this wing. The wooden kitchen elements remain in “POOR” condition (Figure 128). The addition of wooden walls served a double purpose of creating the bathroom space as well as supporting roof loads in this wing. The walls were constructed using a 2 × 4 in. frame with a mixture of plywood and wood plank sheathing (Figure 129 and Figure 130). The wooden materials appear to be in “FAIR” condition.

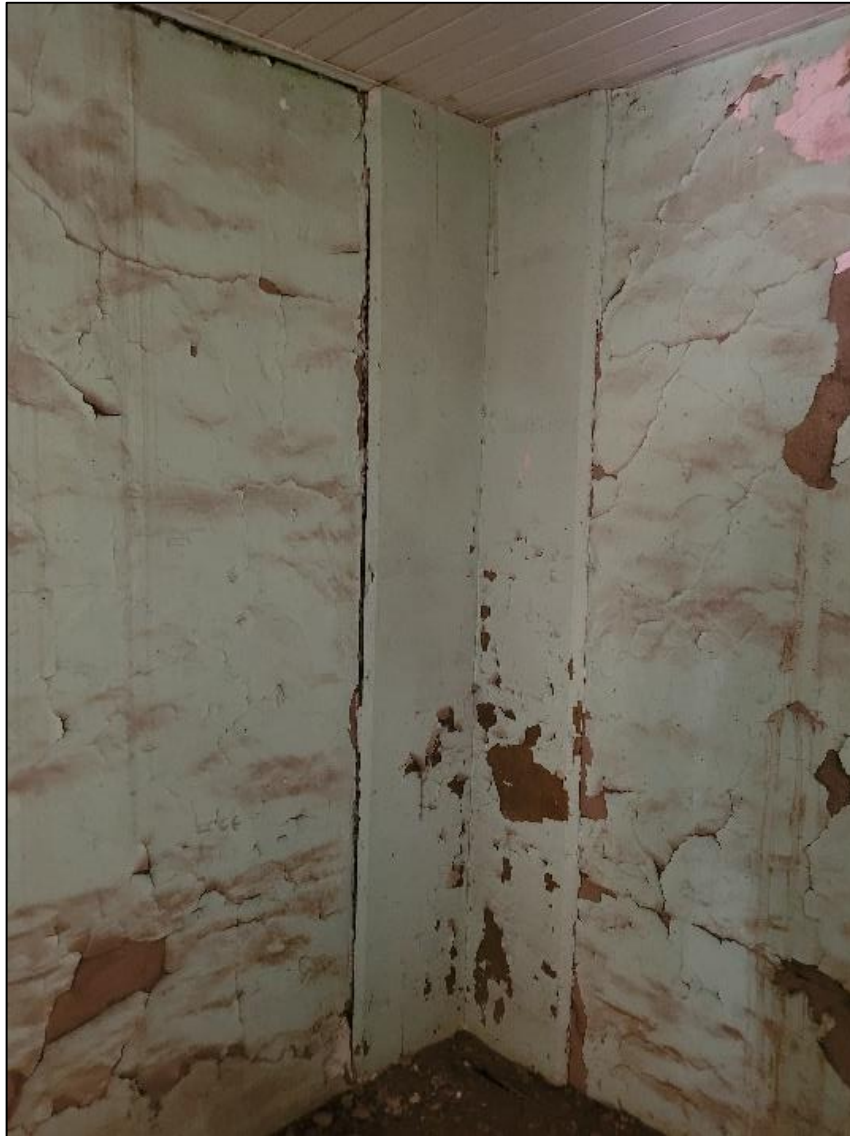
Figure 131. Floor to ceiling wooden element in the northmost corner of the José María Gil Adobe, 2021. (ERDC-CERL.)

In the northmost corner of the building's north wing is a wooden element that extends from the floor to the ceiling (Figure 131). The element is painted olive green to match the painted interior plaster. The purpose of this element is unknown.

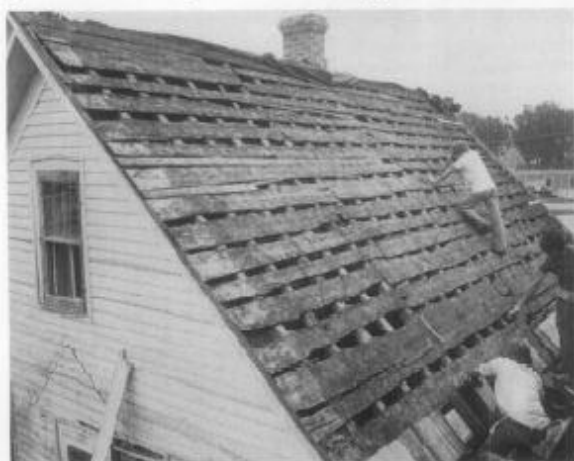
7. The reshingling of the circa 1856 Stovewood House in Decorah, Iowa, revealed the original open sheathing boards and pole rafters. Sawn cedar shingles were used as a replacement for the historic cedar shingles seen still in place at the ridge. A new starter course is being laid at the eaves. Photo: Norwegian-American Museum, Decorah, Iowa.

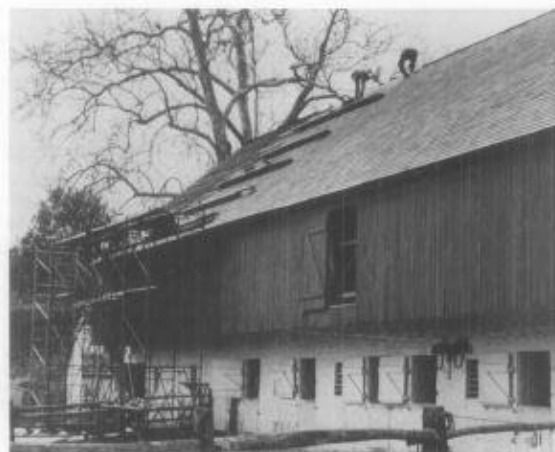
11. The replacement sawn red cedar shingles matched the deteriorated shingles exactly for this barn re-roofing. The old shingles, seen to the far left, were removed as the new shingles were installed. Even the horizontal coursing matched because the exposure length for both old and new shingles was the same. Photo: Williamsport Preservation Training Center.

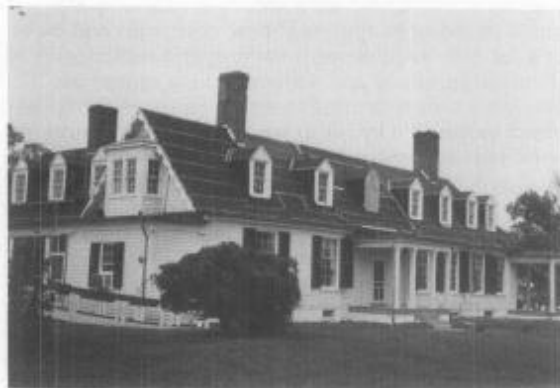
A. The later non-historic shingles were removed from Appomattox Manor (circa 1840 with later additions) and roofing paper was installed for temporary protection during the re-shingling.

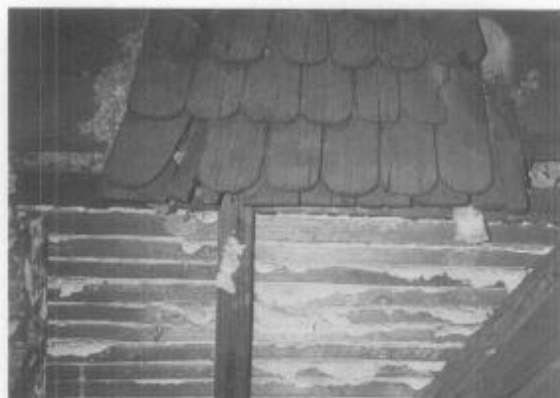
B. These weathered historic 19th-century handsplit and dressed shingles were found in place under a later altered roof. Note the straight butt eave shingles under the curved butts of the historic dormer shingles.

14. Original 19th-century handsplit and dressed wooden shingles 18" long, 3"-4" wide, and 5/8" thick were found in place on the Appomattox Manor at Hopewell, Virginia. The butts were curved and evidence of a red stain remained. The specifications and details were researched so that the appearance of the historic shingles and installation patterns could be matched in the re-shingling project. Photos: John Ingle.

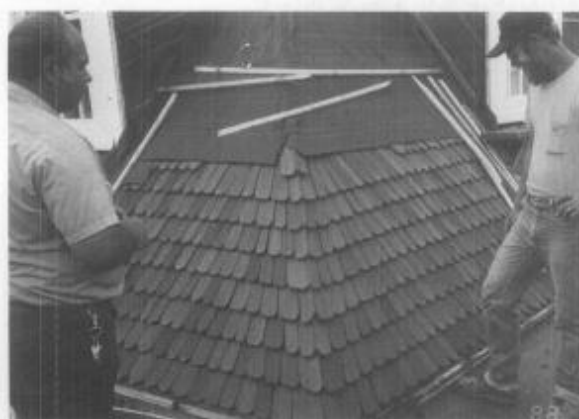
D. The fanned hips (seen here), swept valleys, and projecting ridge combs were installed as part of the re-roofing project. Special features, when documented, should be reproduced when re-shingling historic roofs.

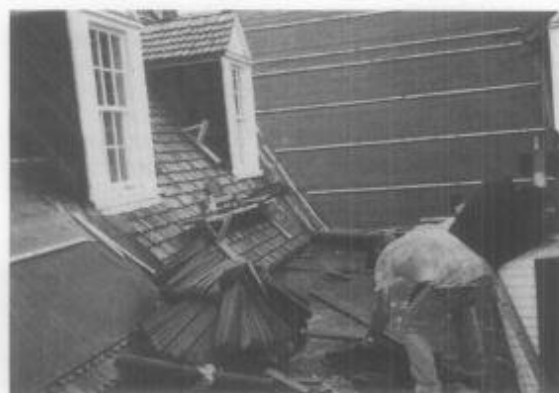
C. The replacement shingles (see specifications above), matched the historic shingles and were of such high quality that little hand dressing was needed at the site. The building paper, a temporary protection, was removed as the shingles were installed on the sheathing boards.

Type of nails and flashing: double hot dipped galvanized nails sized to penetrate sheathing totally; metal flashing to be 20 oz. lead-coated copper, or terne-coated stainless steel; additional flashing reinforcement to be aluminum foil type with fiber backing to use at hips, ridges, eaves, and valleys.

Type of sheathing: uninsulated attic, any deteriorated 3/4" sheathing boards, spaced 1/2"-3/4", to be replaced in kind.

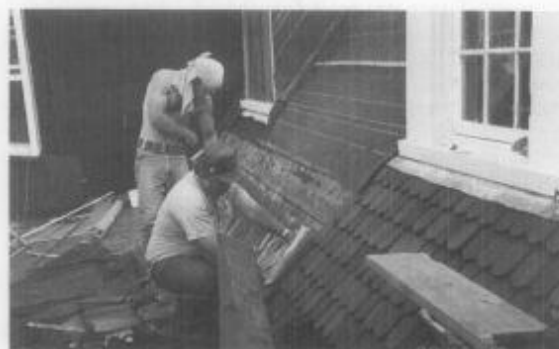
E. In order to achieve a "Class B" fire-rating, the shingles were dipped in fire-retardant chemicals and allowed to dry prior to installation. Iron oxide was added to this chemical dip to stain the shingles to match the historic red color. These coatings will need periodic reapplication.

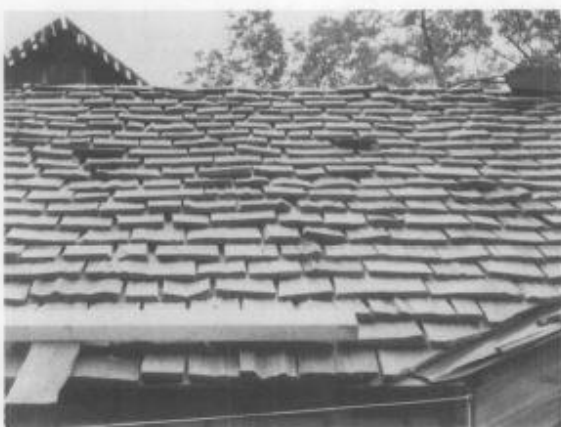
15. These commercially available roofing products with rustic split faces are not appropriate for historic preservation projects. In addition to the inaccurate appearance, the irregular surfaces and often wide spaces between shingles will allow wind-driven moisture to penetrate up and under them. The excessively wide boards will tend to cup, curl and crack. Moss, lichens and debris will have a tendency to collect on these irregular surfaces, further deteriorating the roofing. Photo: Sharon C. Park.

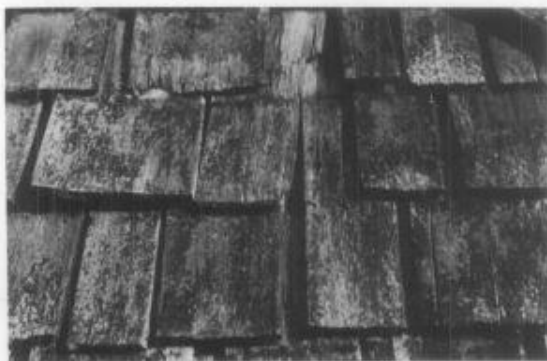
16. Routine maintenance is necessary to extend the life of the roof. On this roof, the shingles have not seriously eroded, but the presence of lichens and moss is becoming evident and there are a few cracked and missing shingles. The moss spores should be removed, missing shingles replaced, and small pieces of metal flashing slipped under cracked shingles to keep moisture from penetrating. Photo: Williamsport Preservation Training Center.

Periodic maintenance inspections of the roof may reveal loose or damaged shingles that can be selectively replaced before serious moisture damage occurs (see illus. 16). Keeping the wooden shingles in good condition and repairing the roof, flashing and guttering, as needed, can add years of life to the roof.

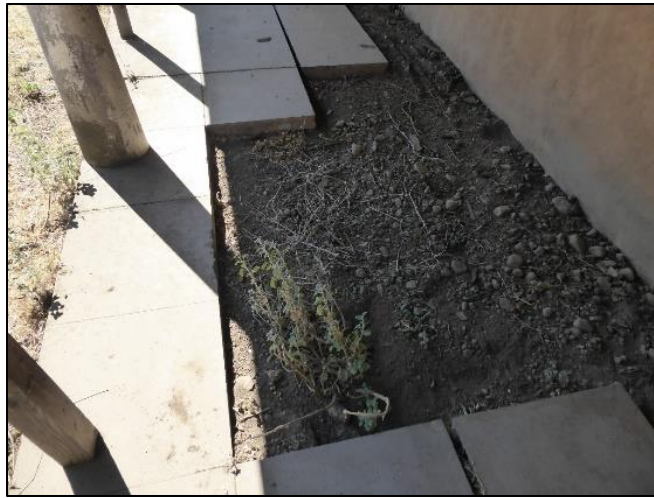
The south portion of the site of the José María Gil Adobe decreases in elevation. The porch floor on the south side of the building is leveled off with concrete to allow for a level surface along the building's immediate edge.

Figure 134. Raised concrete porch floor on the southwest side of the José María Gil Adobe, 2021. (ERDC-CERL.)

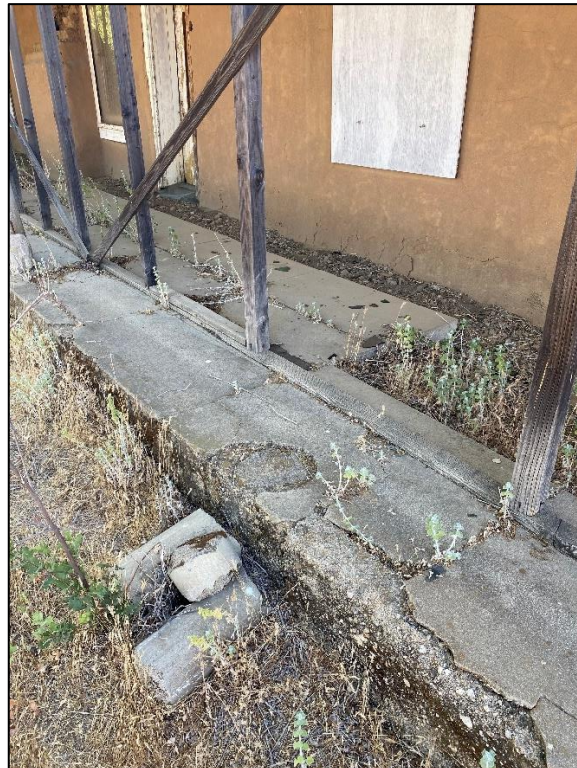
The José María Gil Adobe veranda has a concrete paver floor, each paver measuring approximately 2 × 2 ft. The pavers line the building's perimeter on all but the northwest side of the building (Figure 132). Many pavers have been removed for archeological reasons, discussed previously in Section 3.4 (Figure 133). Most of the square concrete pavers appear to be in “FAIR” condition; however, the connections and raised porch floor are spalling and cracking due to settling (Figure 134 and Figure 135).

Figure 135. Spalling and cracking of concrete on the south side of the porch floor of the José María Gil Adobe, 2021. (ERDC-CERL.)

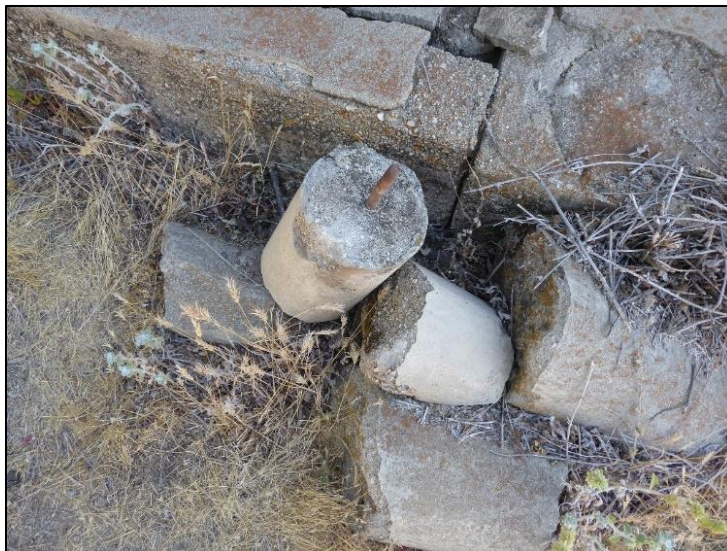
The José María Gil Adobe has concrete columns that support the veranda roof on all but the northwest side of the building (Figure 136). The intact columns are topped with wooden disks, possibly for leveling purposes of the roof. Many columns have cracked and failed, exposing metal reinforcements (Figure 137). Some columns have completely separated from their square concrete bases (Figure 138), while some have completely tipped over (Figure 139).

Figure 138. Concrete base with separated concrete column on the south corner of the José María Gil Adobe, 2021. (ERDC-CERL.)

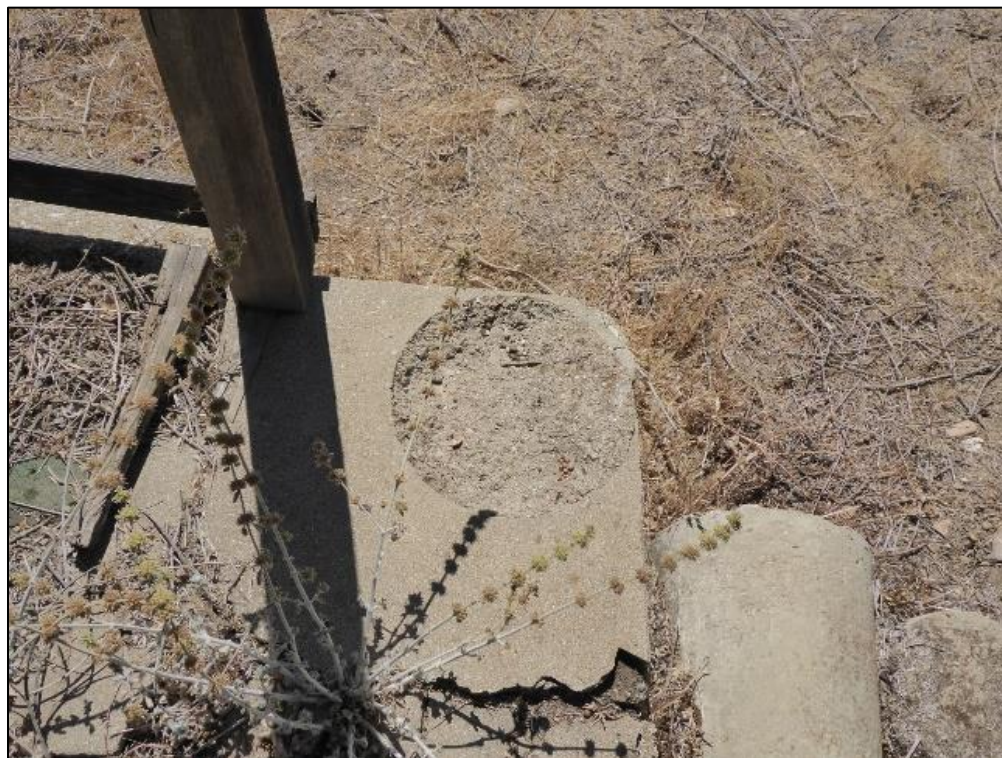
Figure 139. Concrete column tipped over with base still attached on the northwest corner of the José María Gil Adobe, 2021. (ERDC-CERL.)

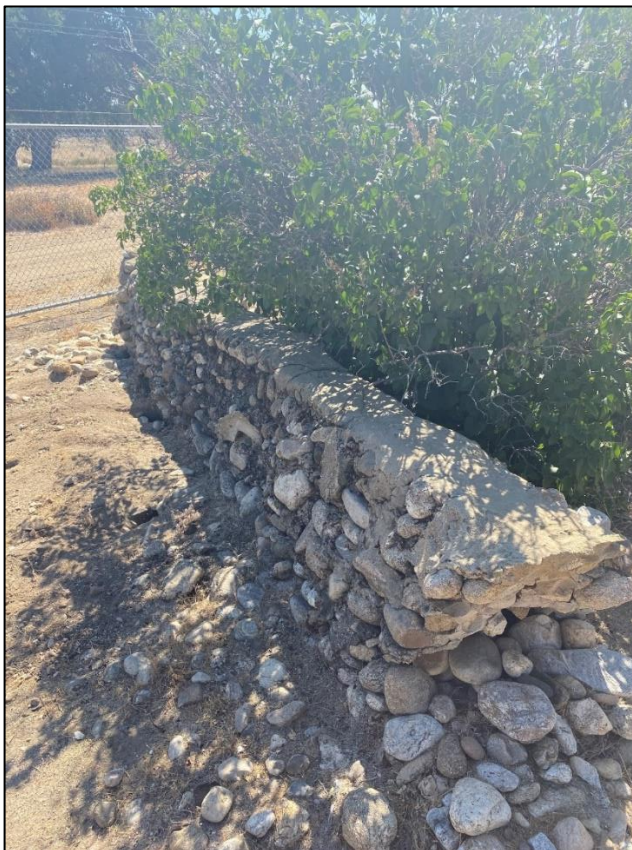
Figure 147. Crumbling cobblestone wall on the north side of the site of the José María Gil Adobe, 2021. (ERDC-CERL.)

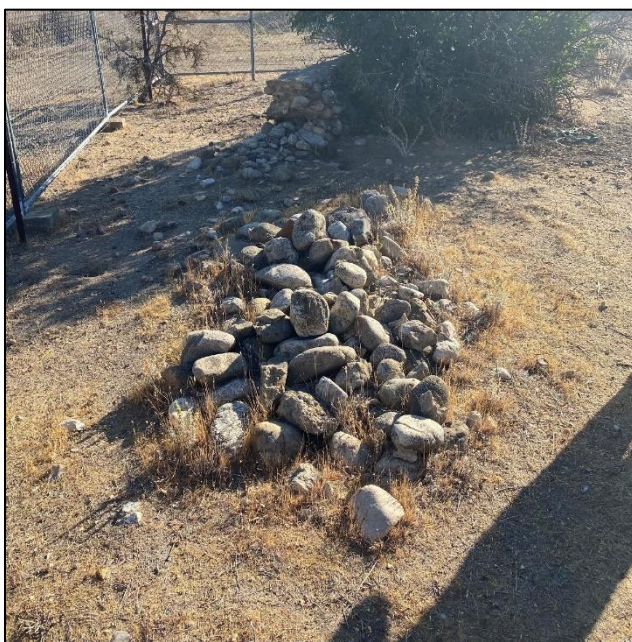
Figure 148. Smeared concrete surface on top of the cobblestone wall along the perimeter of the site of the José María Gil Adobe, 2021. (ERDC-CERL.)

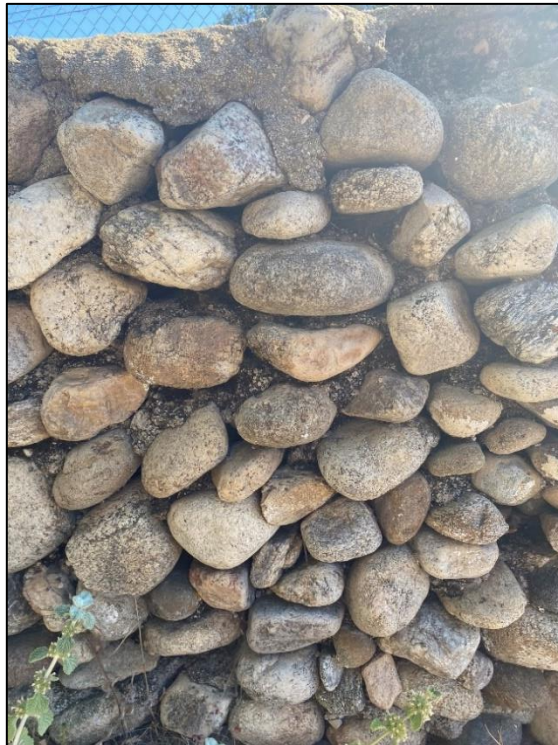
Within the site of the José María Gil Adobe are piles of cobblestone left over from the wall as it has eroded over the years (Figure 150 and Figure 151), as well as other small stones that are scattered throughout the site in no clear relation to the location of the wall (Figure 152).

Figure 150. Crumbled and scattered cobblestone wall on the east side of the site of the José María Gil Adobe, 2021. (ERDC-CERL.)

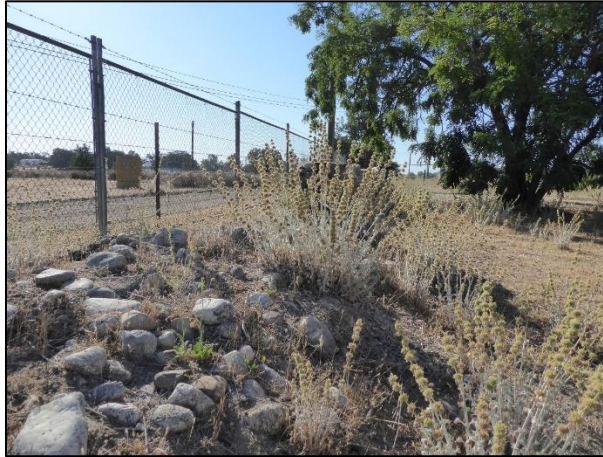
Figure 151. Crumbled and scattered cobblestone wall on the north side of the site of the José María Gil Adobe, 2021. (ERDC-CERL.)

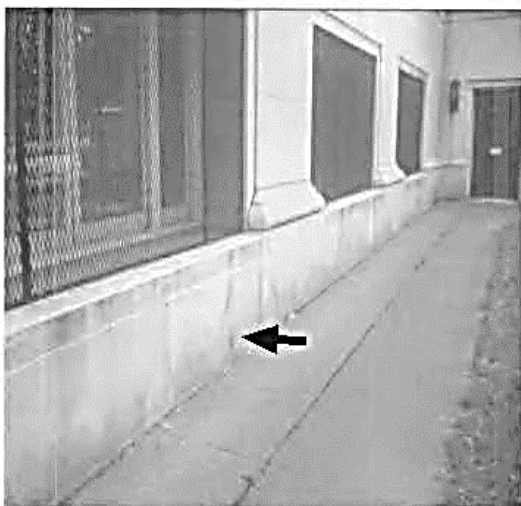
Figure 2. Biological growth as shown on this marble foundation can usually be removed using a low-pressure water wash, possibly with a non-ionic detergent added to it, and scrubbing with a natural or synthetic bristle brush.

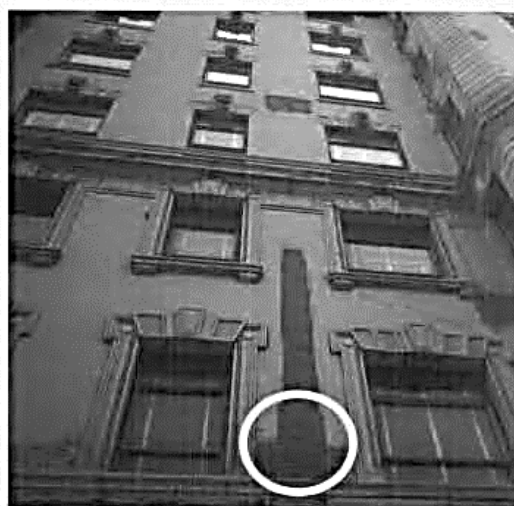
Figure 3. This small test area has revealed a red brick patch that does not match the original beige brick. This may explain why the building was painted, and may suggest to the owner that it may be preferable to keep it painted.

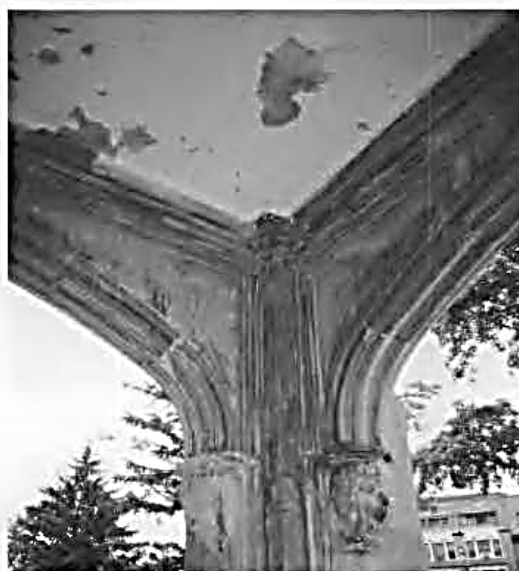
Figure 5. Repeated water washing did not remove the staining inside this limestone porte cochere. Upon closer examination, it was determined to be a water-repellent coating that had been applied many years earlier. An alkaline cleaner may be effective in removing it.

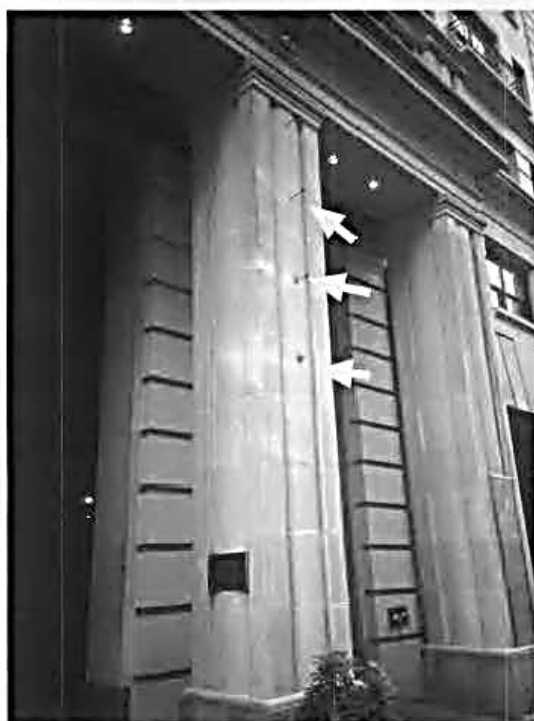
Figure 10. High-pressure water washing too close to the surface has abraded and, consequently, marred the limestone on this early-20th century building.

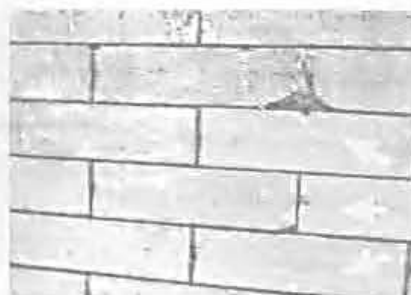
Figure 11. Rinsing with high-pressure water following chemical cleaning has left a horizontal line of abrasion across the bricks on this late-19th century row house.

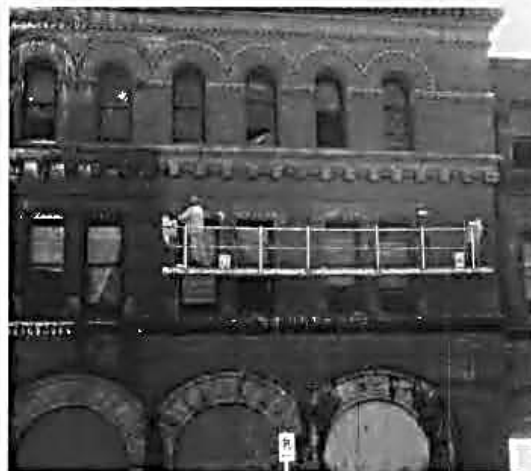
Figure 12. A mild acidic cleaning agent is being used to clean this heavily soiled brick and granite building. Additional applications of the cleaner and hand-scrubbing, and even poulticing, may be necessary to remove the dark stains on the granite arches below. Photo: Sharon C. Park, FAIA.

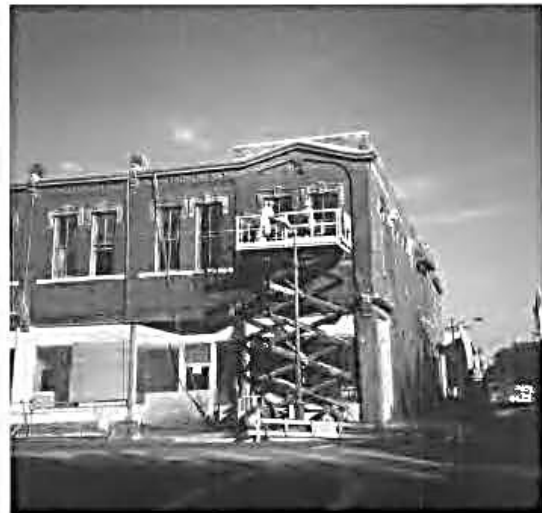
Figure 14. Chemical removal of paint from this brick building has revealed that the cornice and window hoods are metal rather than masonry.

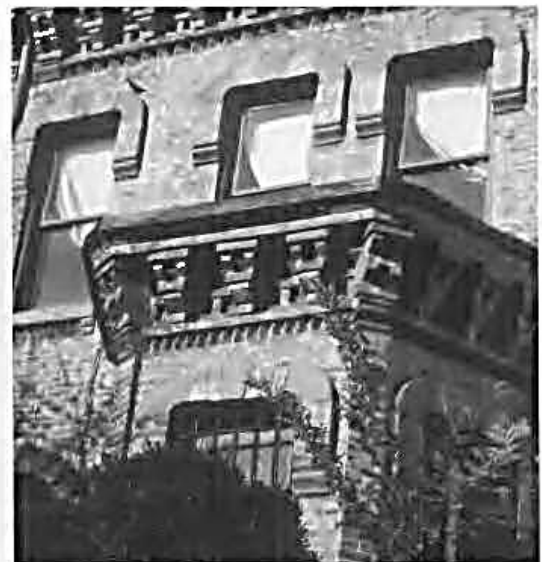
Figure 15. The whitish deposits left on the brick by a chemical paint remover may have resulted from inadequate rinsing or from the chemical being left on the surface too long and may be impossible to remove.

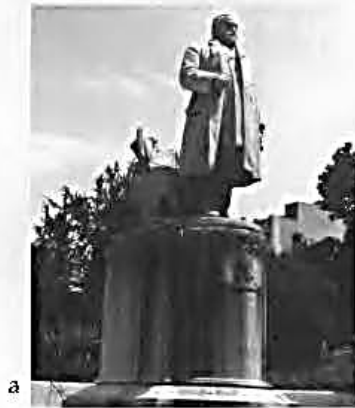
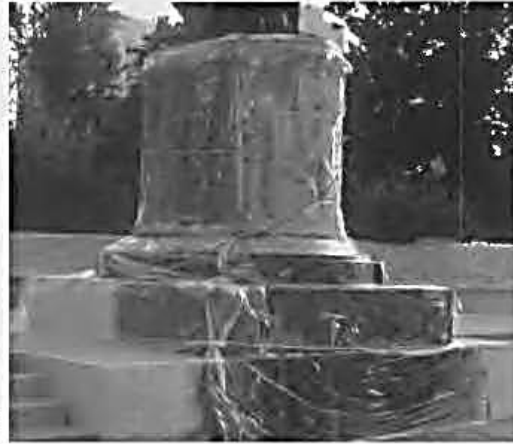
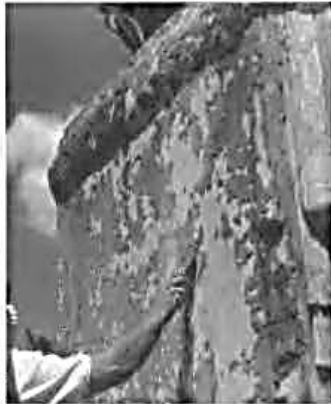
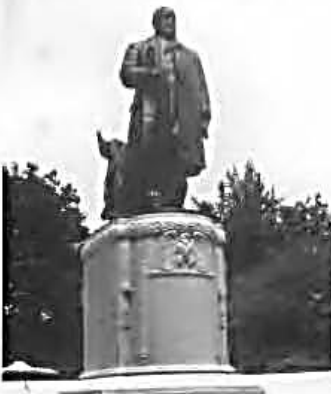
Figure 16. (a) The limestone base was heavily stained by runoff from the bronze statue above. (b) A poultice consisting of copper stain remover and ammonia mixed with fuller's earth was applied to the stone base and covered with plastic sheeting to keep it from drying out too quickly. (c) As the poultice dried, it pulled the stain out of the stone. (d) The poultice residue was removed carefully from the stone surface with wooden scrapers and the stone was rinsed with water. Photos: John Dwyer.

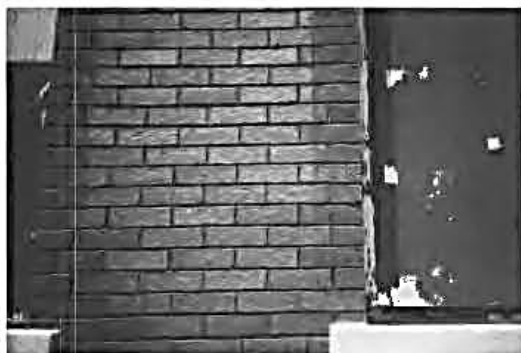
Figure 18. The glazed bricks in the center of the pier were covered by a signboard that protected them from being damaged by the sandblasting which removed the glaze from the surrounding bricks.

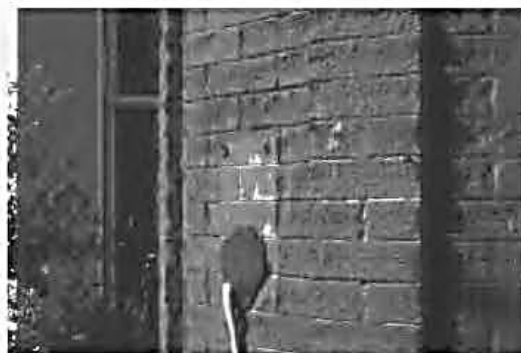
Figure 19. A comparison of undamaged bricks surrounding the electrical conduit with the rest of the brick facade emphasizes the severity of the erosion caused by sandblasting.

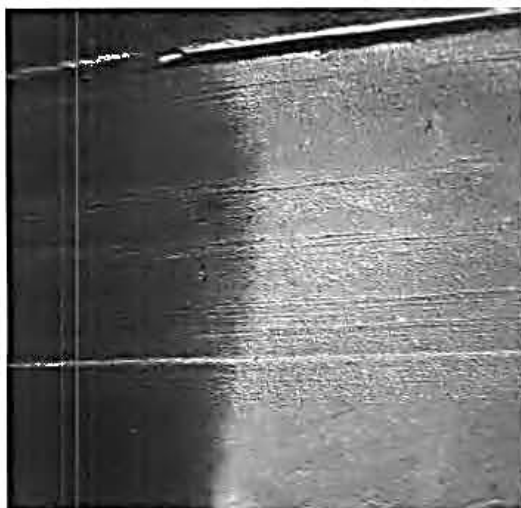
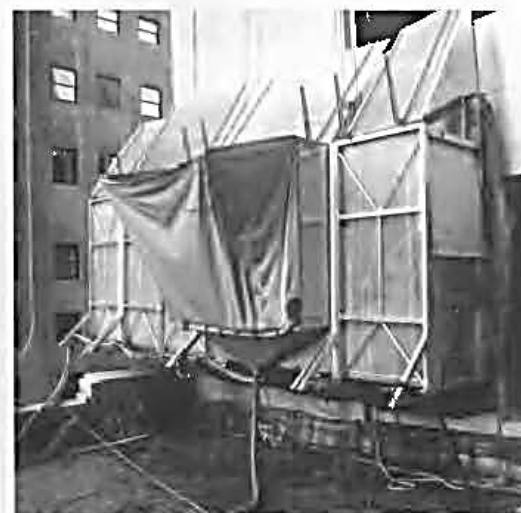
Figure 20. (Left) A comparison of the limestone surface of a 1920s office building before and after “cleaning” with a proprietary abrasive process using fine glass powder clearly shows the effectiveness of this method. But this is an abrasive technique and it has “cleaned” by removing part of the masonry surface with the dirt. Because it is abrasive, it is generally not recommended for large-scale cleaning of historic masonry, although it may be suitable to use in certain, very limited cases under controlled circumstances. (Right) A vacuum chamber where the used glass powder is collected for environmentally safe disposal is a unique feature of this particular process. The specially-trained operators in the chamber wear protective clothing, masks and breathing equipment. Photos: Tom Keohan.

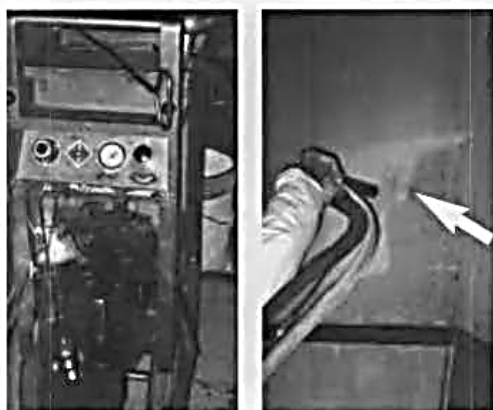
Figure 21. Low-pressure blasting with ice pellets or ice crystals (left) is an abrasive cleaning method that is sometimes recommended for use on interior masonry because it does not involve large amounts of water. However, like other abrasive materials, ice crystals "clean" by removing a portion of the masonry surface with the dirt, and may not remove some stains that have penetrated into the masonry without causing further abrasion (right). Photos: Audrey T. Tepper.

Ice particles, or pelletized dry ice (carbon dioxide or CO_2), are another medium used as an abrasive cleaner (Fig. 21). This is also too abrasive to be used on most historic masonry, but it may have practical application for removing mastics or asphaltic coatings from some substrates.

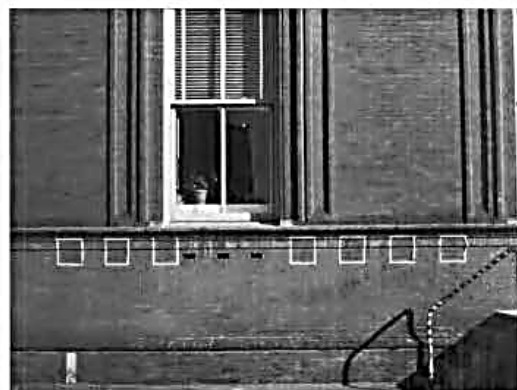
Figure 22. Cleaning test areas may be quite small at first and gradually increase in size as testing determines the "gentlest means possible". Photo: Frances Gale.

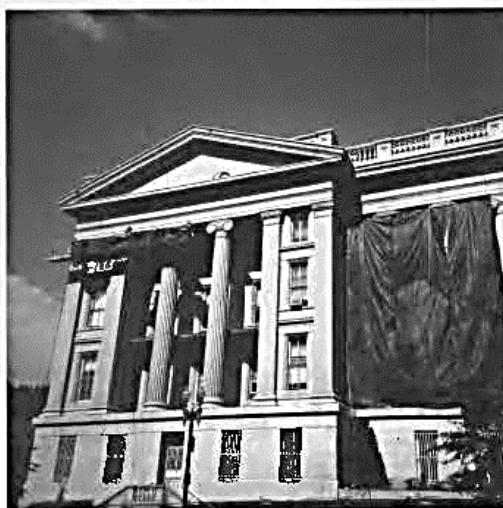
Figure 23. A tarpaulin protects and shields pedestrians from potentially harmful spray while chemical cleaning is underway on the granite exterior of the U.S. Treasury Building, Washington, D.C.

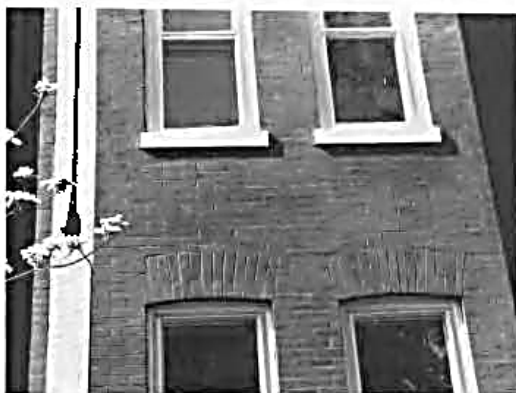
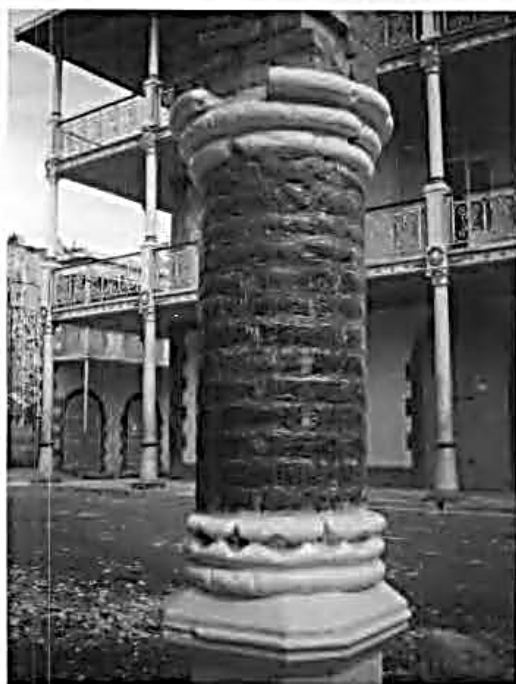
Figure 24. Although the application of a water-repellent coating was probably not needed on either of these buildings, the coating on the brick building (above), is not visible and has not changed the character of the brick. But the coating on the brick column (below), has a high gloss that is incompatible with the historic character of the masonry.

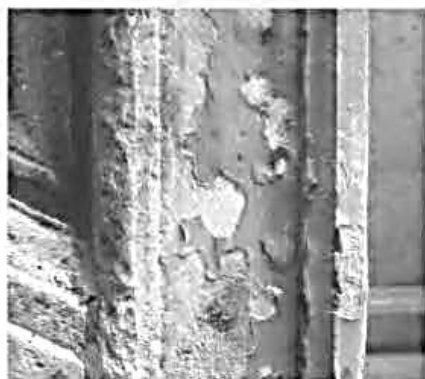
Some modern water-repellent coatings which contain a binder intended to replace the natural binders in stone that have been lost through weathering and natural erosion are described in product literature as both a water repellent and a consolidant. The fact that newer water-repellent coatings penetrate beneath the masonry surface instead of just forming a layer on top of the surface may indeed convey at least some consolidating properties to certain stones. However, a water-repellent coating cannot be considered a consolidant. In some instances, a water-repellent or "preservative" coating, if applied to already damaged or spalling stone, may form a surface crust which, if it fails, may exacerbate the deterioration by pulling off even more of the stone (Fig. 25).

Figure 25. The clear coating applied to this limestone molding has failed and is taking off some of the stone surface as it peels. Photo: Frances Gale.

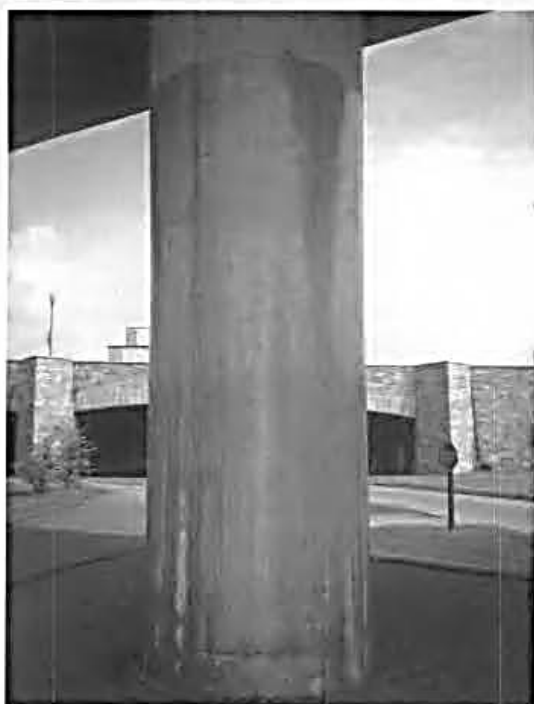
Figure 26. The anti-graffiti or barrier coating on this column is very shiny and would not be appropriate to use on a historic masonry building. The coating has discolored as it has aged and whitish streaks reveal areas of bare concrete where the coating was incompletely applied.

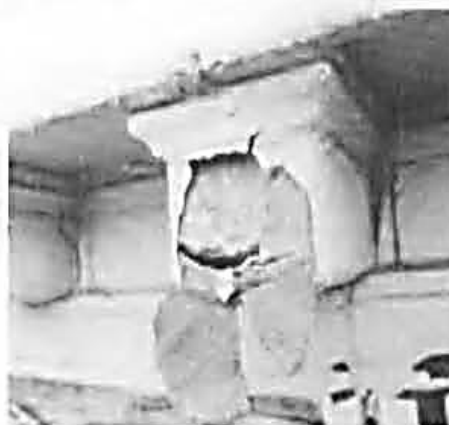
In addition, the water eventually will get out by the path of least resistance. If this path is toward the interior, damage to interior finishes can result; if it is toward the exterior, it can lead to damage to the masonry caused by built-up water pressure (Fig. 27).

Figure 27. Instead of correcting the roof drainage problems, an elastomeric coating was applied to the already saturated limestone cornice. An elastomeric coating holds moisture in the masonry because it does not "breathe" and does not allow liquid moisture to escape. If the water pressure builds up sufficiently it can cause the coating to break and pop off as shown in this example, often pulling pieces of the masonry with it. Photo: National Park Service Files.

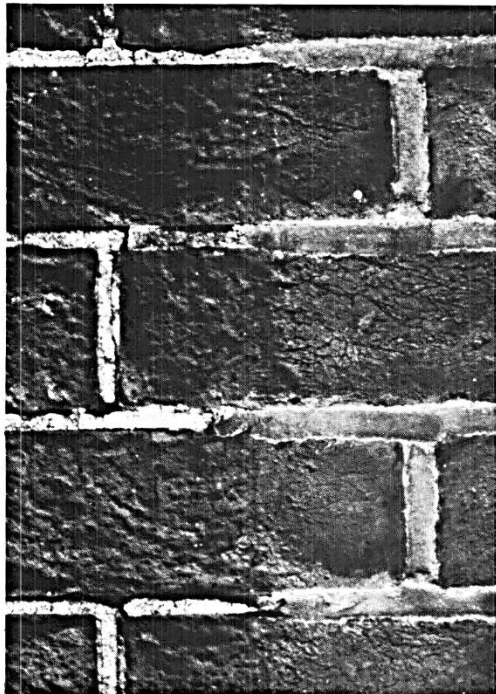
Abrasively Cleaned vs. Untouched Brick. Two brick rowhouses with a common façade provide an excellent point of comparison when only one of the houses has been sandblasted. It is clear that abrasive blasting, by removing the outer surface, has left the brickwork on the left rough and pitted, while that on the right still exhibits an undamaged and relatively smooth surface. Note that the abrasive cleaning has also removed a considerable portion of the mortar from the joints of the brick on the left side, which will require repointing.

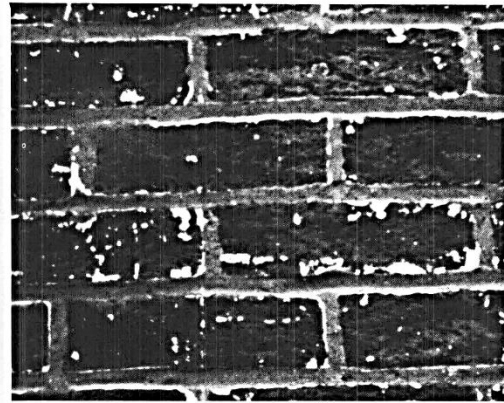
Abrading the Surface without Removing the Paint. Even though the entire outer surface layer of the brick has been sandblasted off, spots of paint still cling to the masonry. Sandblasting or other similarly abrasive methods are not always a successful means of removing paint.

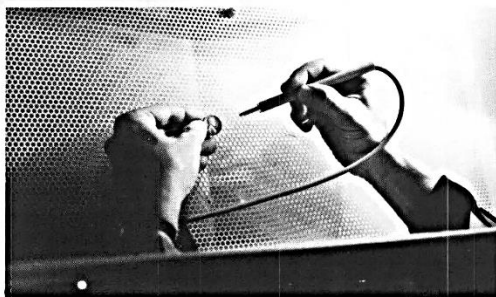
Micro-Abrasive Cleaning. This small, pencil-sized micro-abrasive unit is used by some museum conservators to clean small objects. This particular micro-abrasive unit is operated within the confines of a box (approximately 2 cubic feet of space), but a similar and slightly larger unit may be used for cleaning larger pieces of sculpture, or areas of architectural detailing on a building. Even a pressure cleaning unit this small is capable of eroding a surface, and must be carefully controlled.

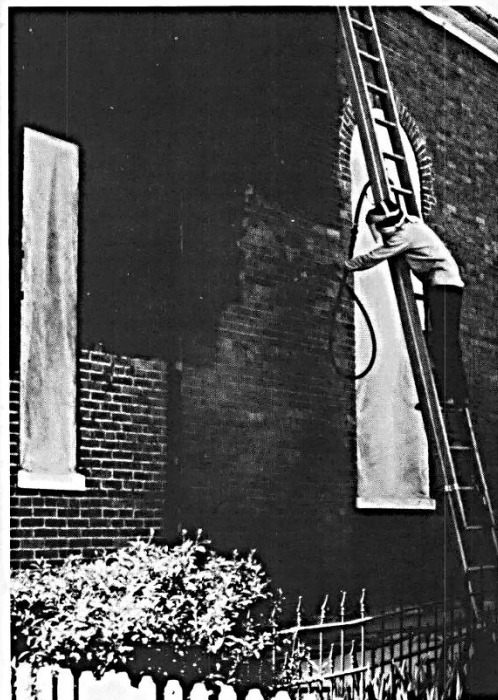
"Line Drop." Even though the operator of the sandblasting equipment is standing on a ladder to reach the higher sections of the wall, it is still almost impossible to have total control over the pressure. The pressure of the sand hitting the lower portion of the wall will still be greater than that above, because of the "line drop" in the distance from the pressure source to the nozzle. (Hugh Miller)

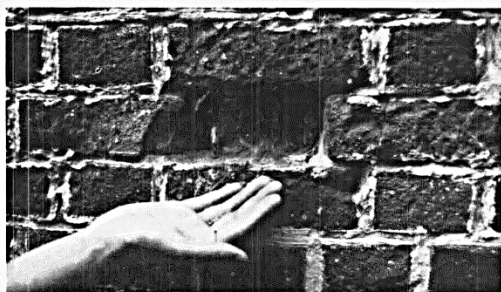
Spalling Brick. This soft, early 19th-century brick was sandblasted in the 1960s; consequently, severe spalling has resulted. Some bricks have almost totally disintegrated, and will eventually have to be replaced. (Robert S. Gamble)

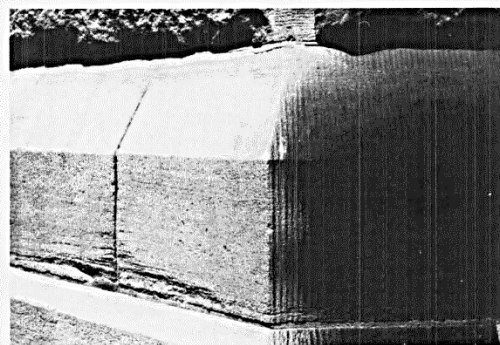
Abrasive Cleaning of Tooled Granite. Even this carefully controlled "wet grit" blasting has erased vertical tooling marks in the cut granite blocks on the left. Not only has the tooling been destroyed, but the damaged stone surface is now more susceptible to accelerated weathering.

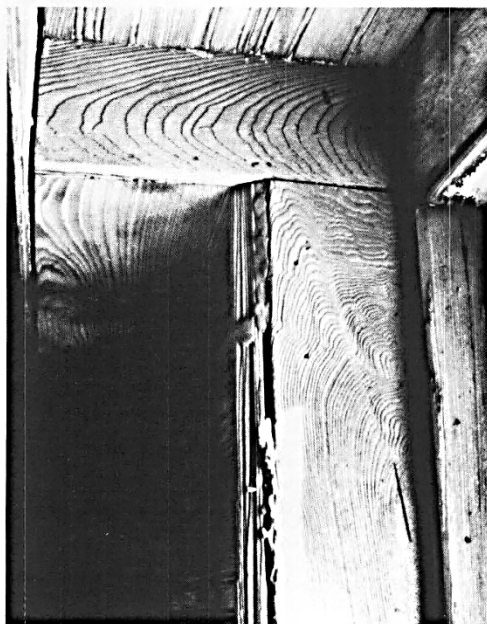
Abrasive Cleaning of Wood. This wooden windowsill, molding and paneling have been sandblasted to remove layers of paint in the rehabilitation of this commercial building. Not only is some paint still embedded in cracks and crevices of the woodwork, but more importantly, grit blasting has actually eroded the summer wood, in effect raising the grain, and resulting in a rough surface.

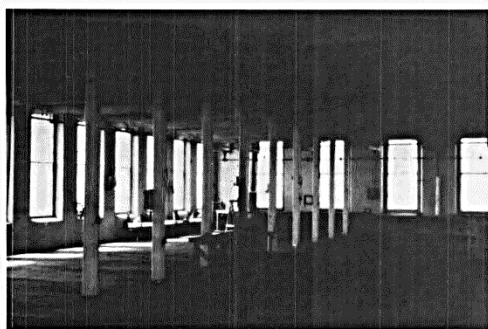
Permissible Abrasive Cleaning. In accordance with the Secretary of the Interior's Guidelines for Rehabilitation Projects, it may be acceptable to use abrasive techniques to clean an industrial interior space such as that illustrated here, because the masonry surfaces do not have significant design, detailing, tooling or finish, and the wooden architectural features are not finished, molded, beaded or worked by hand.

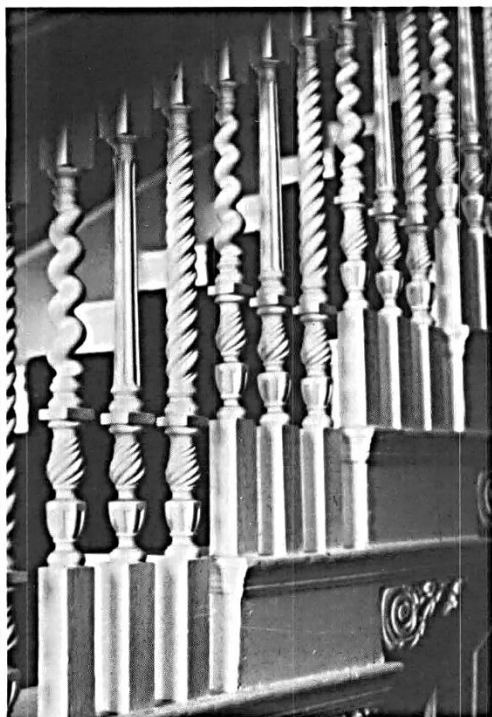
Do not Abrasively Clean these Interiors. Most historic residential and some commercial interior spaces contain finished plaster and wooden elements such as this stair balustrade and paneling which contribute to the historic and architectural character of the structure. Such interiors should not be subjected to abrasive techniques for the purpose of removing paint, dirt, discoloration or plaster.

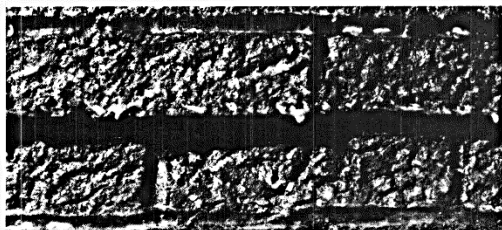
Hazards of Sandblasting and Surface Coating. In order to "protect" this heavily sandblasted brick, a clear surface coating or sealer was applied. Because the air temperature was too cold at the time of application, the sealer failed to dry properly, dripping in places, and giving the brick surface a cloudy appearance.

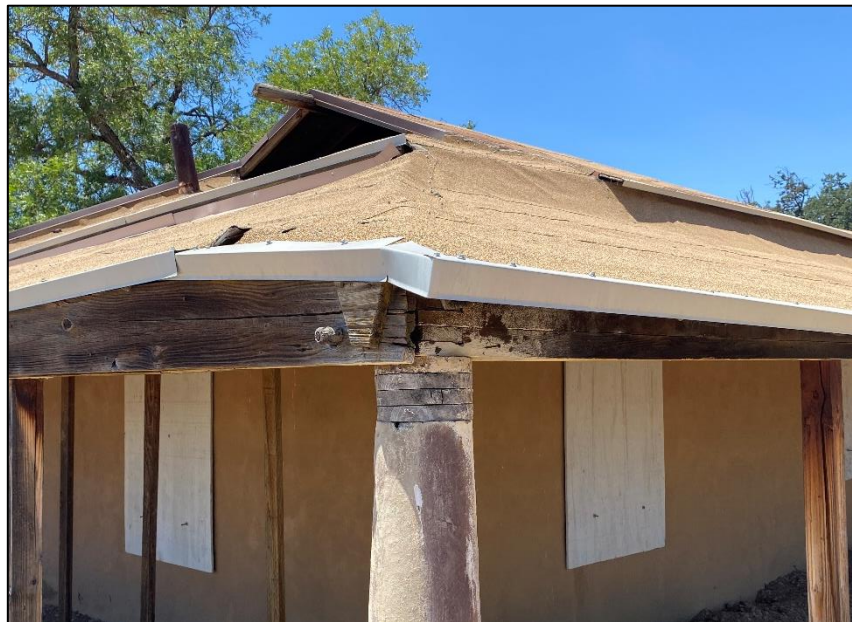
Figure 156. Aluminum drip edge that lines the edge of the roof of the José María Gil Adobe, 2021. (ERDC-CERL.)

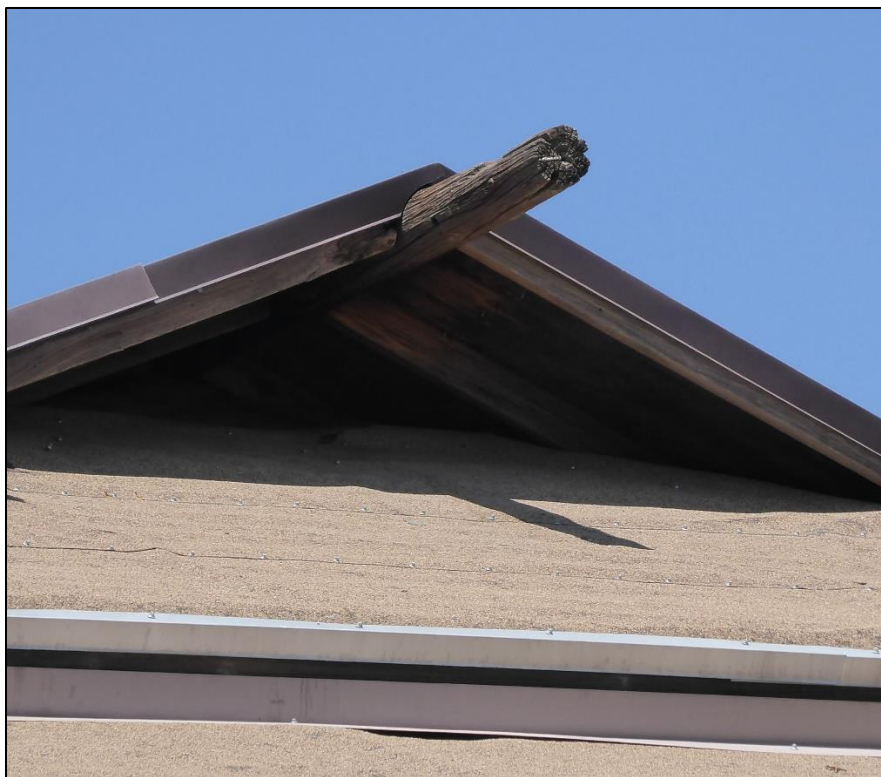
Figure 157. Brown aluminum fascia cladding on the upper layers of the roof of the José María Gil Adobe, 2021. (ERDC-CERL.)

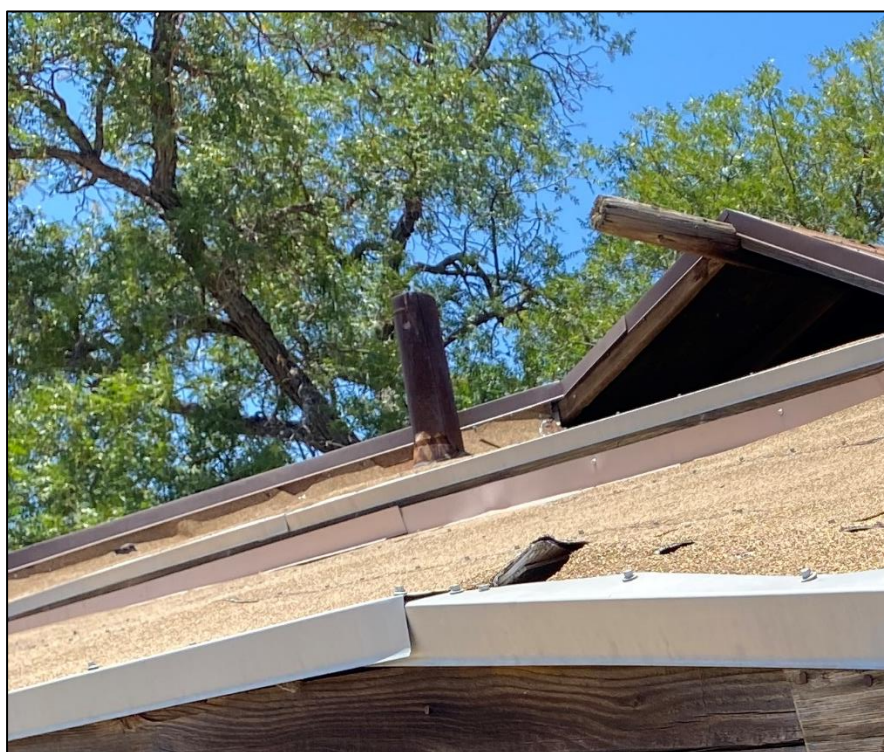
Figure 158. Metal stovepipe on the south wing of the José María Gil Adobe, 2021. (ERDC-CERL.)
