José María Gil Adobe

Historic Context, Maintenance Issues, Measured Drawings,
and Adaptive Reuse

October 2023

Final Report

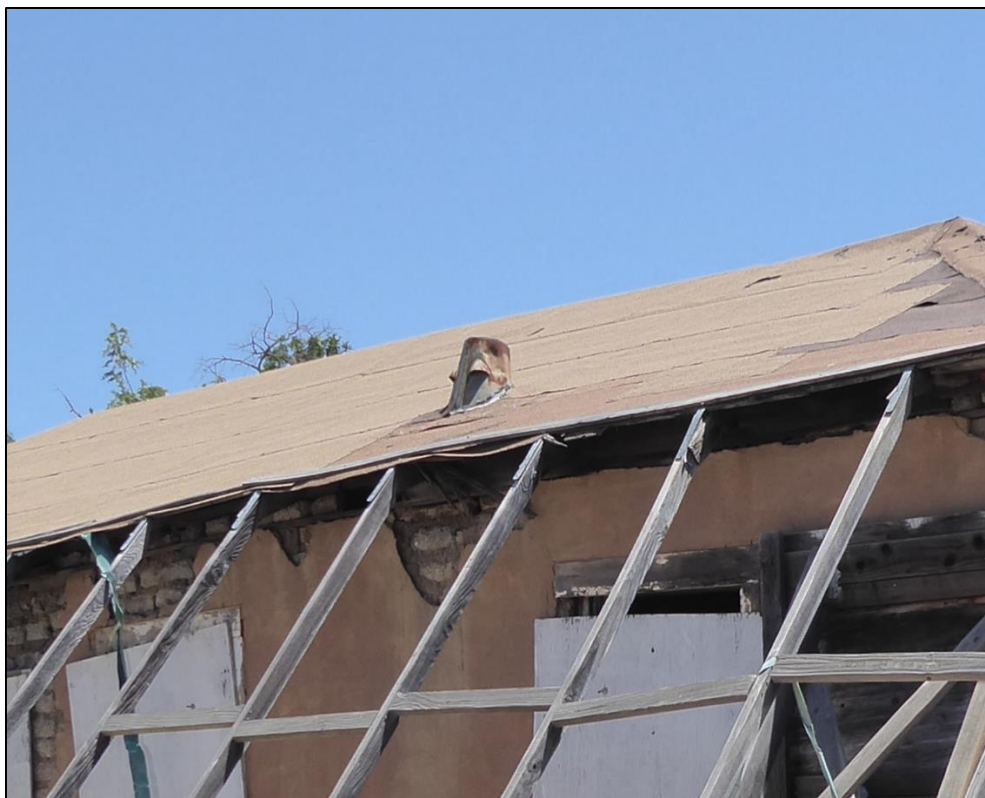
Figure 159. Metal stovepipe on the north wing of the José María Gil Adobe, 2021.
(ERDC-CERL.)

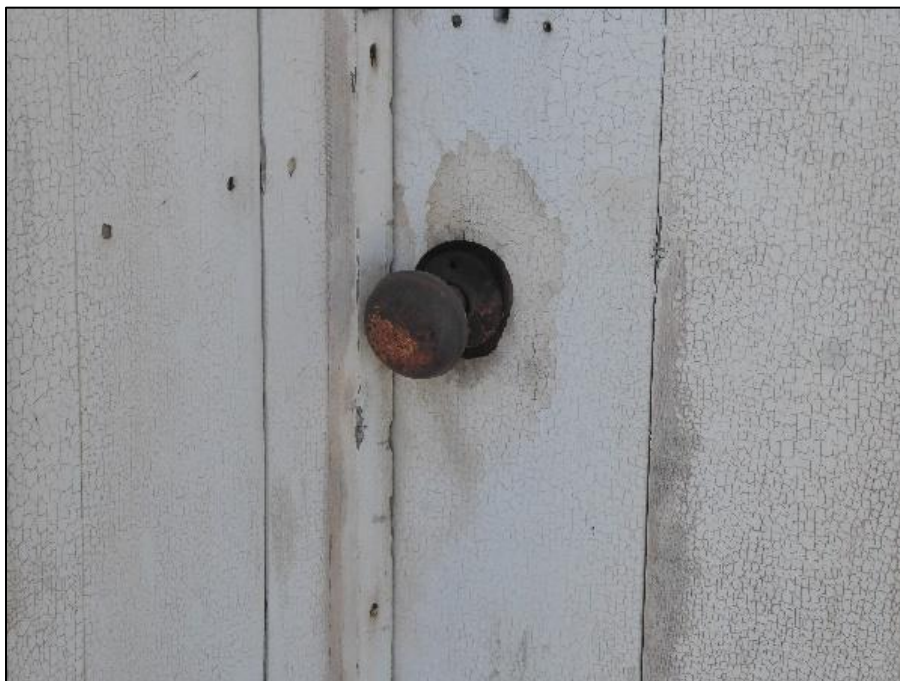
Figure 163. Brass doorknob on an exterior door on the north wing of the José María Gil Adobe, 2021. (ERDC-CERL.)

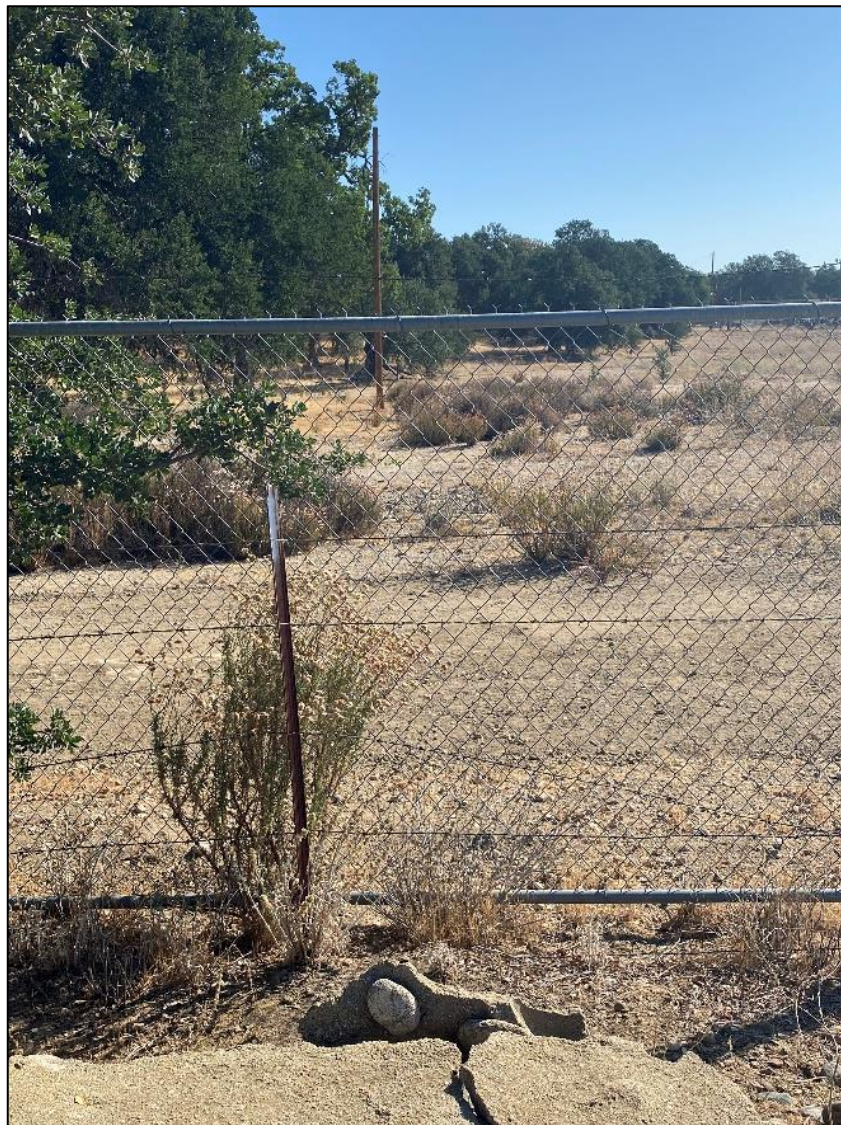
Figure 165. Metal heavy corner on the south side of the site of the José María Gil Adobe, 2021. (ERDC-CERL.)

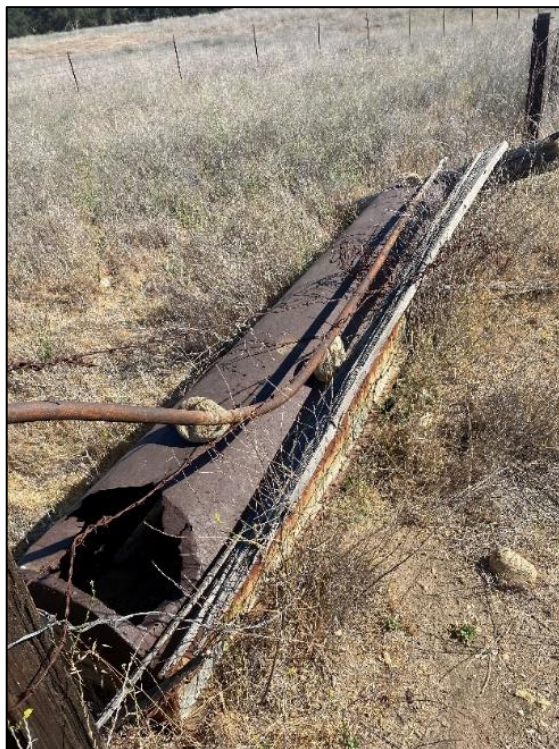
Figure 167. Metal trough and fencing material piled northwest of the José María Gil Adobe, 2021. (ERDC-CERL.)

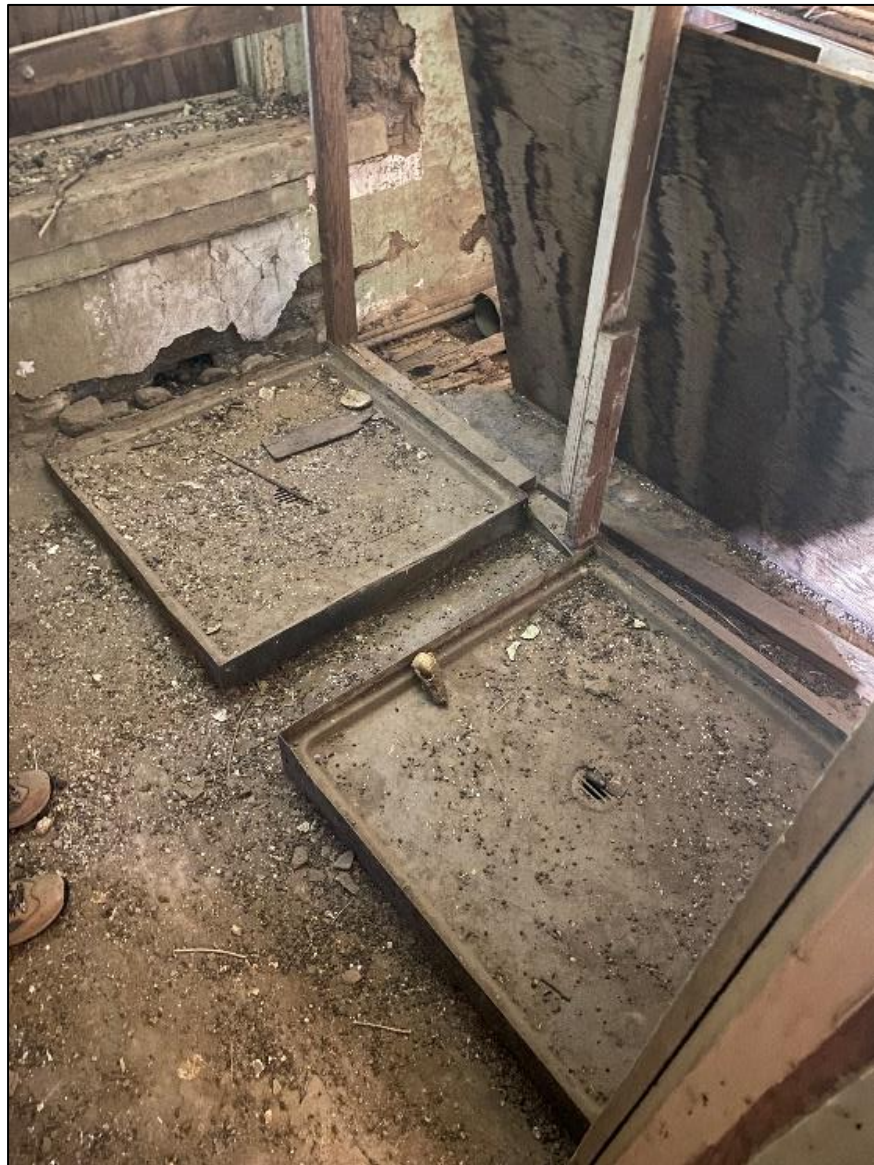
In the north wing of the building are two square, metal shower floors (Figure 169). The shower squares as well as the floor itself is saturated in dirt and guano (Figure 170). In the same room are metal toilet plumbing connections (Figure 171).

Figure 170. Square, metal shower floor covered in guano in the north wing of the José María Gil Adobe, 2021. (ERDC-CERL.)

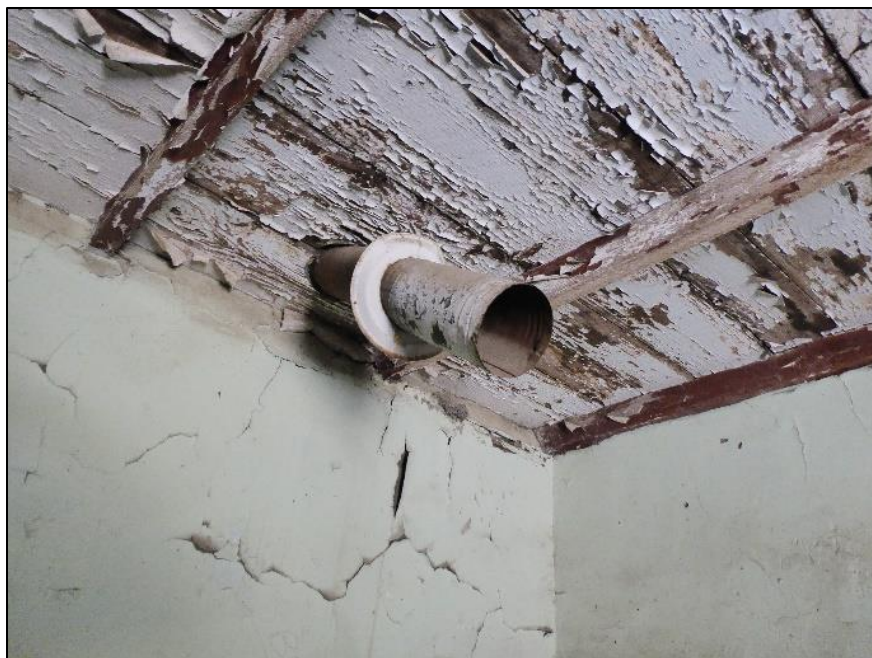
The connections for the metal stovepipes and chimney pipes remain on the interior of the building despite there being no remaining stoves in the building. The pipes protrude from the ceiling and the wall in multiple locations (Figure 176, Figure 177, and Figure 178). Some stovepipes have been removed and are now stacked inside the building (Figure 179).

Figure 176. Metal stovepipe connection remaining in the south wing of the José María Gil Adobe, 2021. (ERDC-CERL.)

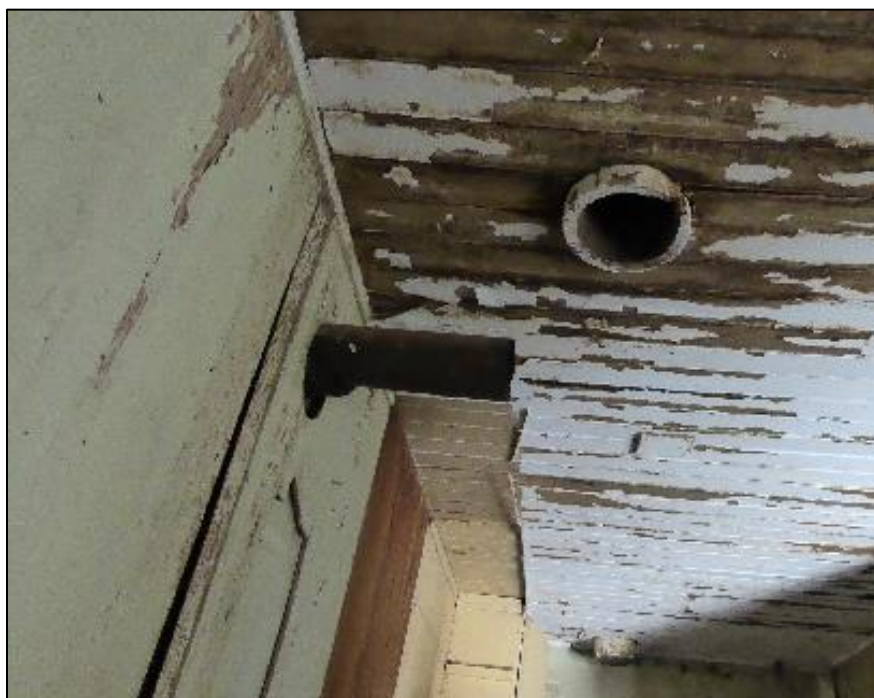
Figure 177. Metal stovepipe connection remaining on a wall and a chimney pipe remaining in the ceiling in the north wing of the José María Gil Adobe, 2021. (ERDC-CERL.)

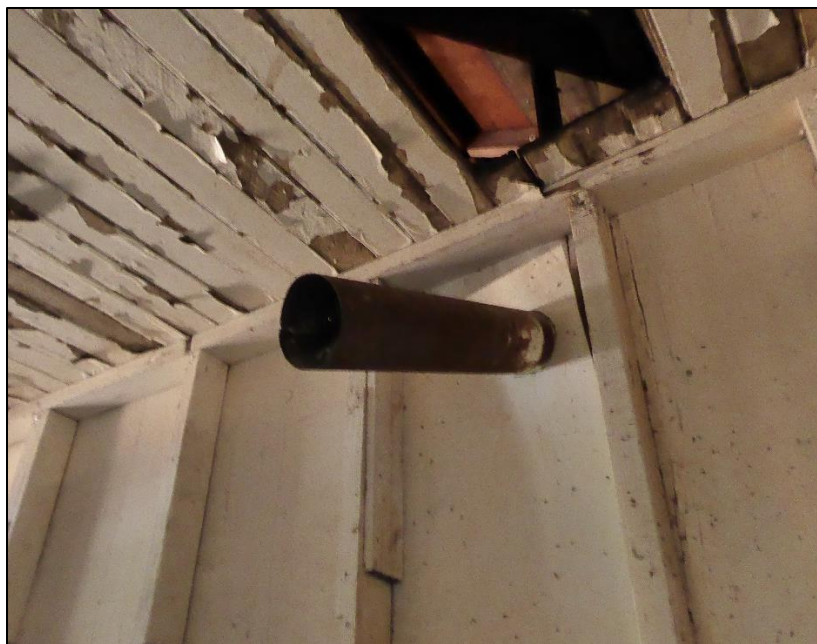
Figure 178. Metal stovepipe protruding from the wall in the north wing of the José María Gil Adobe, 2021. (ERDC-CERL.)

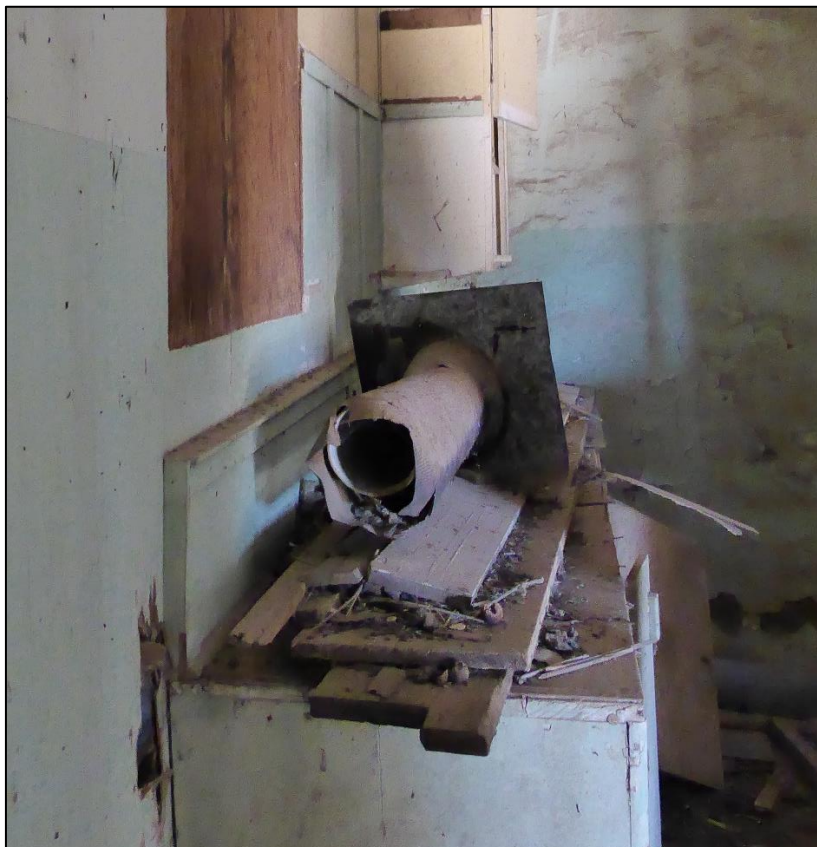
Figure 179. Metal stovepipe now on counter in the north wing of the José María Gil Adobe, 2021. (ERDC-CERL.)

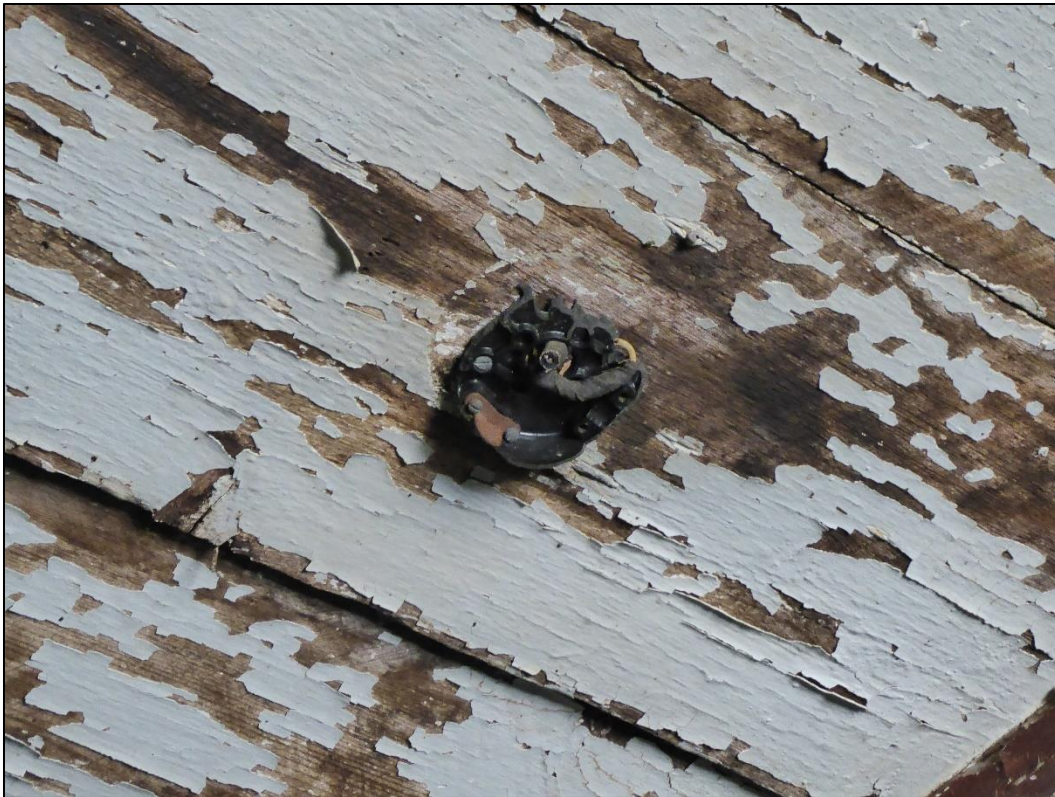
In various locations on the ceiling, there are light fixture attachments that remain. None of these attachments are intact. These were most likely added during the Army's ownership of the property, around the same time when the bathroom fixtures were installed. See a light fixture attachment in Figure 180.

Figure 180. Remaining light fixture attachment in the south wing of the José María Gil Adobe, 2021. (ERDC-CERL.)

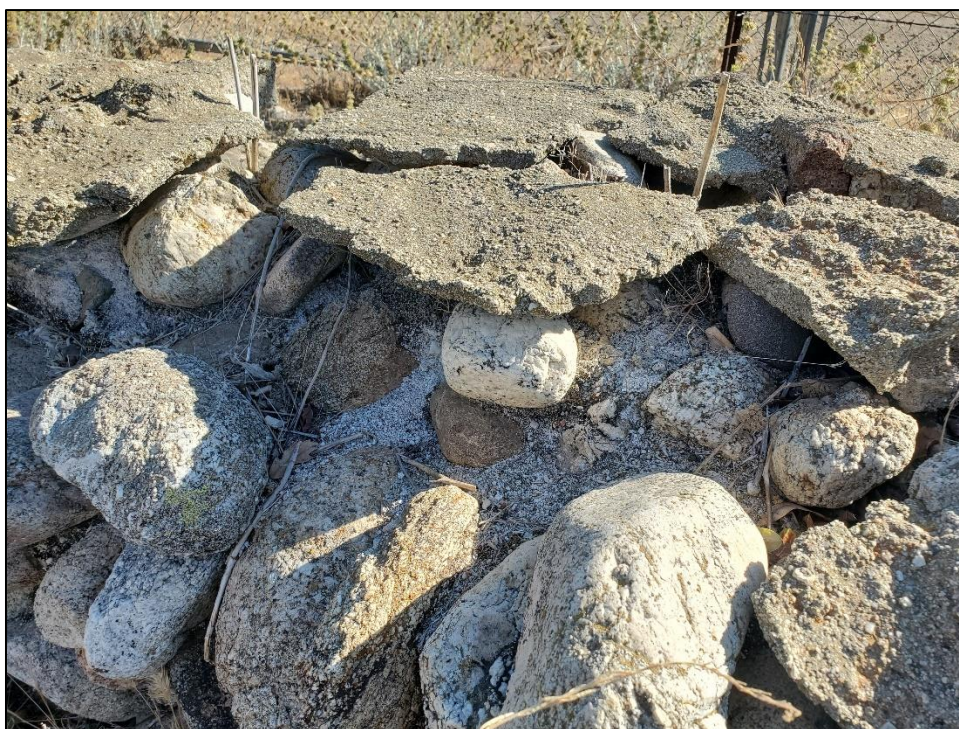
Figure 183. Broken top pieces of perimeter wall (sample 1).

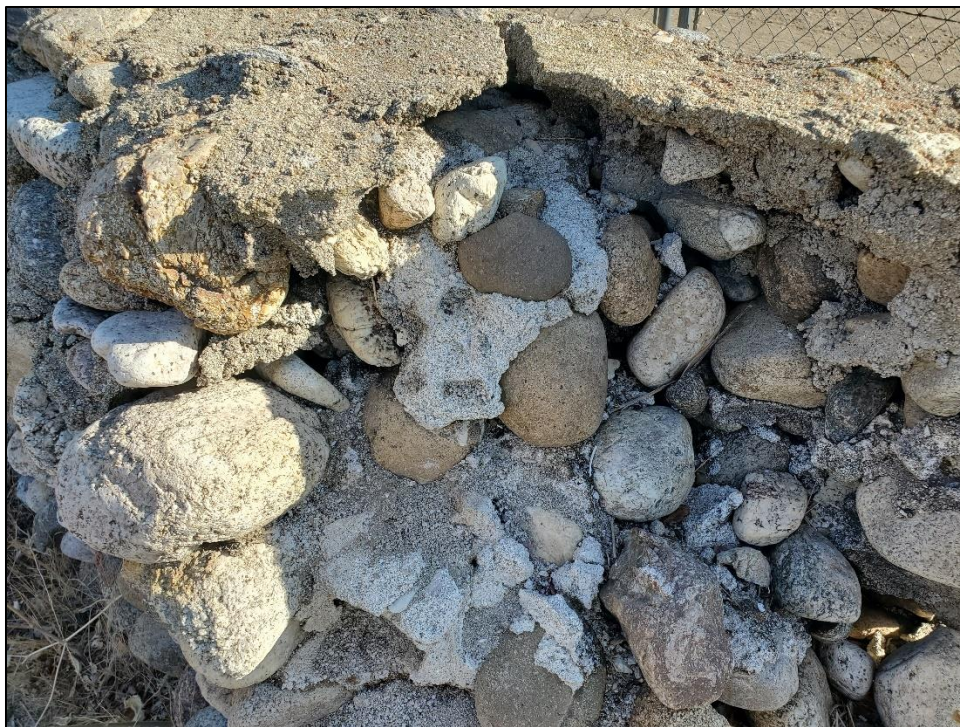
The collection sites for samples 1, 2, and 3 are shown in Figure 183–Figure 185. Sample 2 had a mostly uniform gradation between the no. 16 and no. 100 sieves that was heavy on the no. 30 sieve (Table 15). The sand was primarily a light tan or cream color, though this may be imparted by the binder phase.

Figure 184. Inner mortar within stone wall (sample 2).

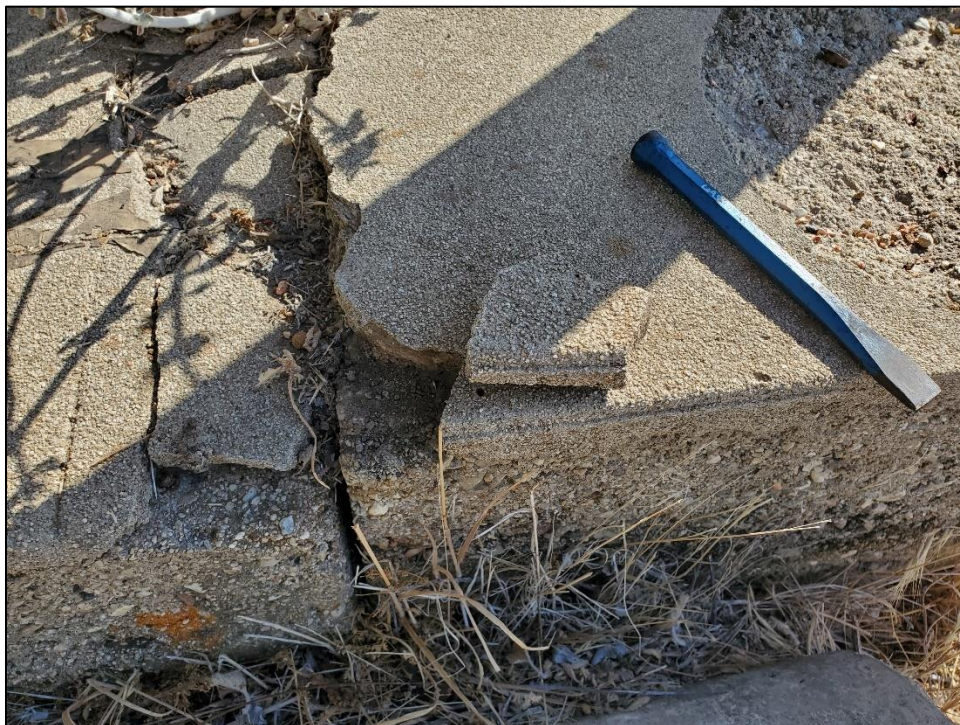
Figure 185. Tile surrounding main structure (sample 3).

Samples 3 and 16b came from the concrete tile on the veranda and one of the concrete columns, respectively. A steel rod protrudes from the top of each column to transfer horizontal loads from the veranda roof down to the foundation.

Due to the surface characteristics of the broken floor sections, it appears that the concrete tile was poured monolithically with the underlying

After the appropriate aggregates are selected by the architect, concrete and mortar mixture designs for veranda rehabilitation should follow the guidance of American Concrete Institute (ACI) PRC-211.1, *Selecting Proportions for Normal-Density and High Density-Concrete-Guide*, or ASTM C270, *Standard Specification for Mortar for Unit Masonry*. The contractor should also heed the guidance of ACI PRC-546, *Guide to Concrete Repair*, and ACI PRC-303, *Guide to Cast-in-Place Architectural Concrete Practice*.

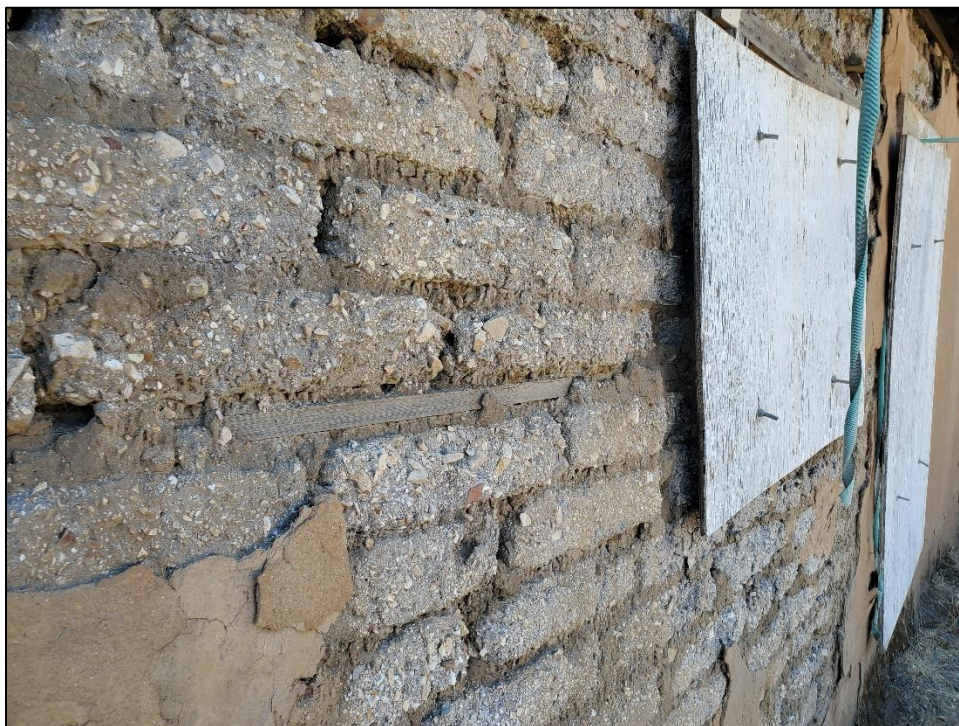
Figure 186. West exterior wall bricks (sample 15) and mortar (sample 13.)

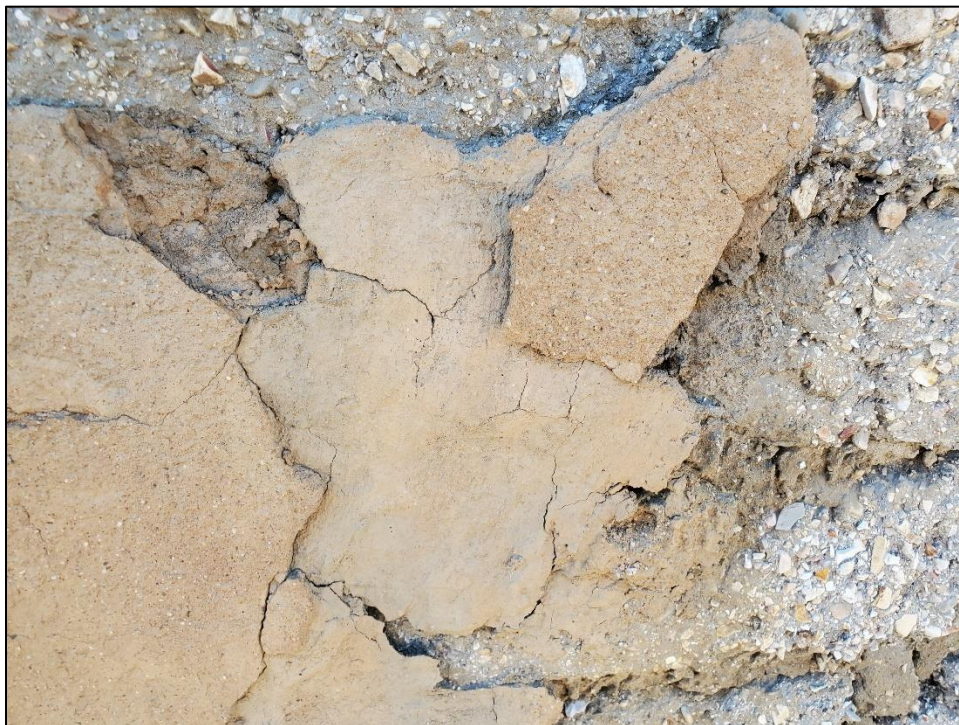
Figure 190. West exterior wall stucco (sample 14.)

Our recommended recipe for a historically accurate rehabilitation of the exterior stucco, similar to the interior plaster, would borrow from the brick-and-mortar recipe. Portland cement should not be used. The plasterer or stucco mason might use a similar clay-based binder, but for the filler, they should use only a well-graded river sand with a nominal maximum particle size of no. 16 (1.18 mm). A finer, poorly graded mason sand would not allow adequate moisture transfer for the underlying soil-based structural components. It may be difficult to commercially procure large quantities of natural river sand for construction purposes due to environmental restrictions in the region. The filler-to-binder ratio by weight should range between 2.75 to 3.25 in order to achieve a rough yet spreadable consistency that will not slough under self-weight. This increase in filler fraction above the interior plaster recipe will provide a slightly rougher surface finish. Water should be added slowly and carefully; the mixture will rapidly become unworkable with too much water added. Using less water for the exterior stucco than the interior plaster should produce a harder, more resilient coating.

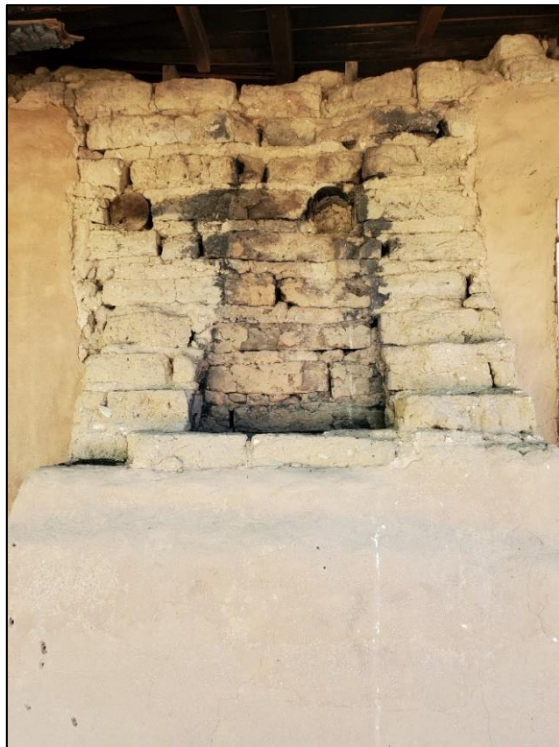
Figure 191. Two stuccos (*top and bottom*) (samples 17b and 18) of different color and edge quality on the south exterior wall, indicating different time periods of application.

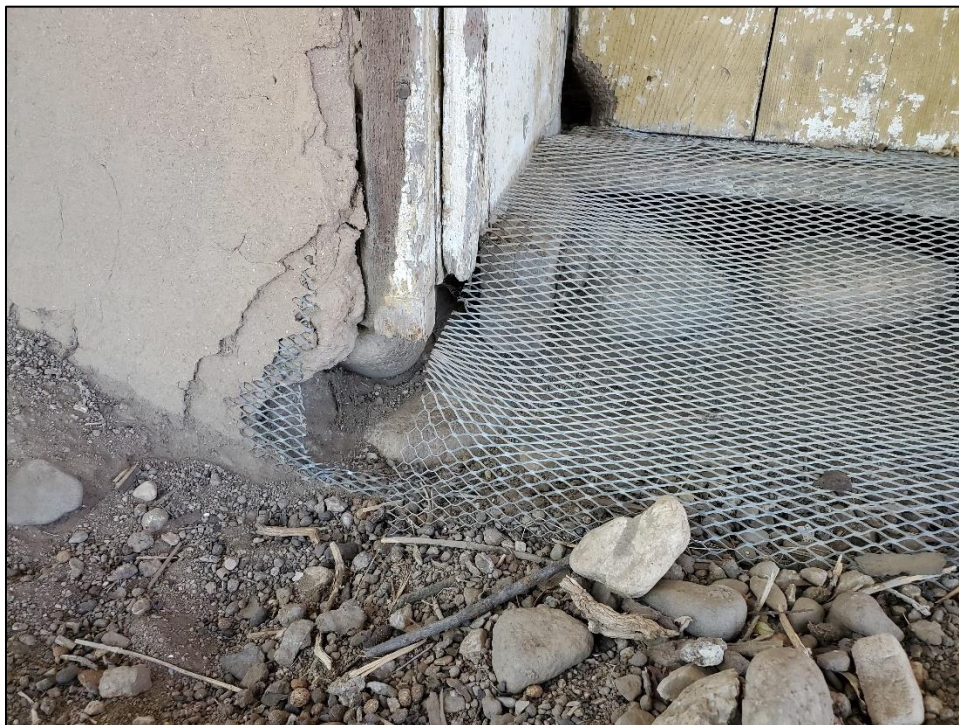
The collection sites for samples 17b and 18 are shown in Figure 191 and Figure 192. Sample 17b had a dense gradation between the no. 16 and no. 100 sieves that was well graded across all sieves (Table 17). The sand was primarily light tan. The no. 200 sieve and pan materials were combined for analysis in XRF to determine calcium content of the binder phase.

Figure 192. Stucco on wire lath (sample 17b) over different color stucco having better edge quality (sample 18.)

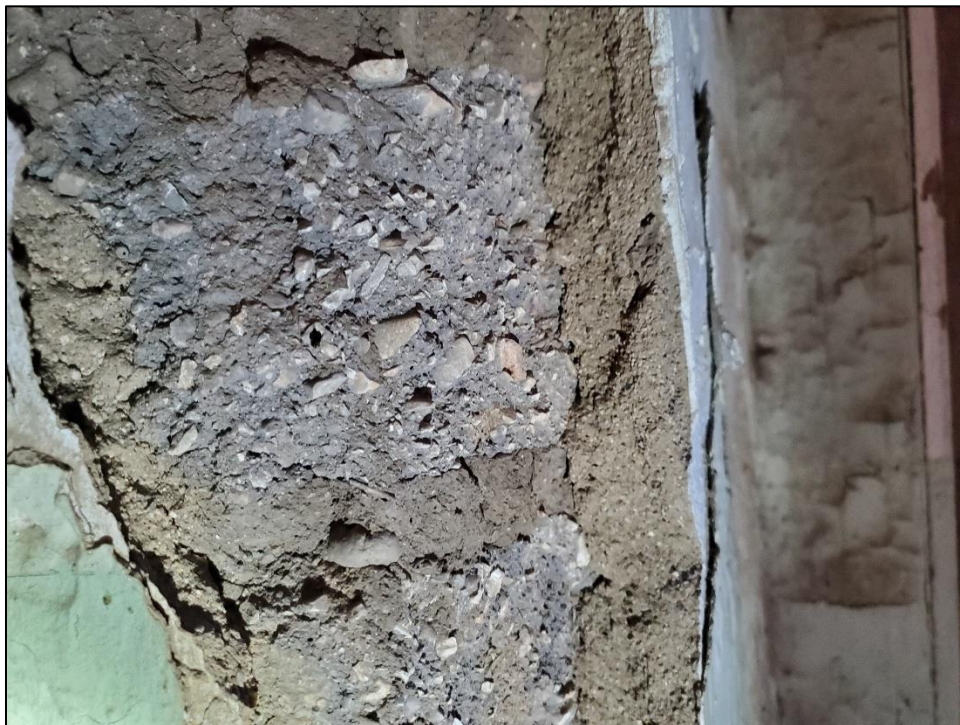
Figure 193. Bricks (sample 9) on the west side of the main structure, having light-gray color with angular aggregates and lacking straw reinforcement.

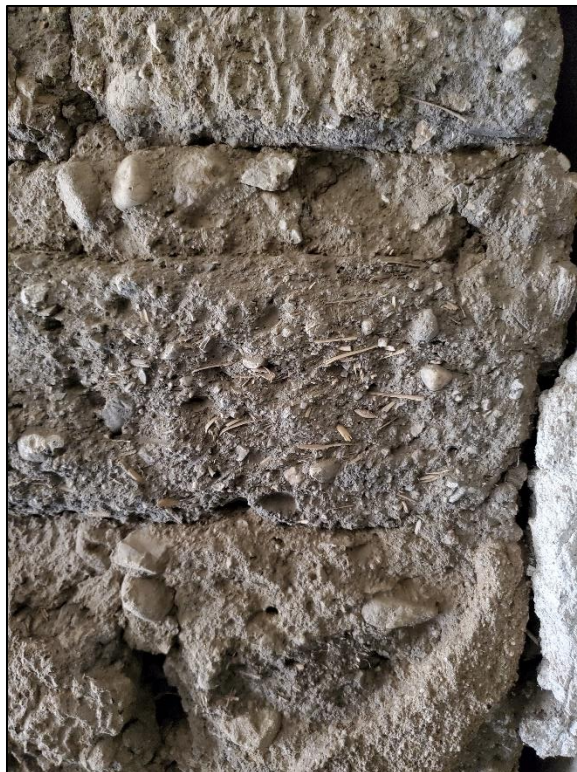
Figure 196. Bricks having dark gray color with rounded aggregates and a high fraction of straw reinforcement.

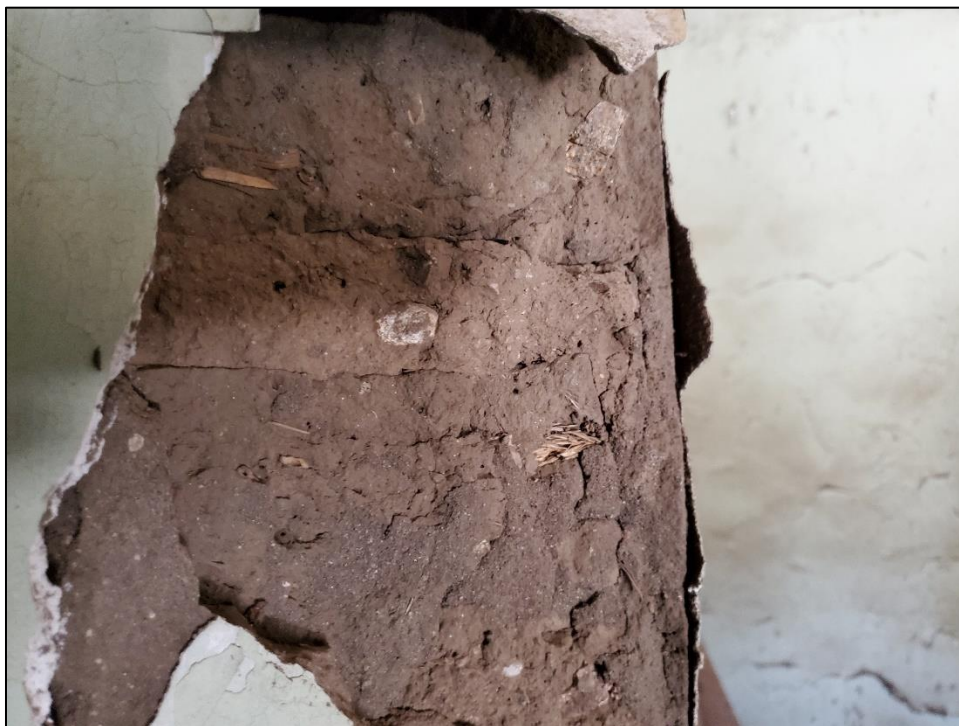
Figure 197. Bricks (sample 16a) in the east room having brown color and a low fraction of straw reinforcement.

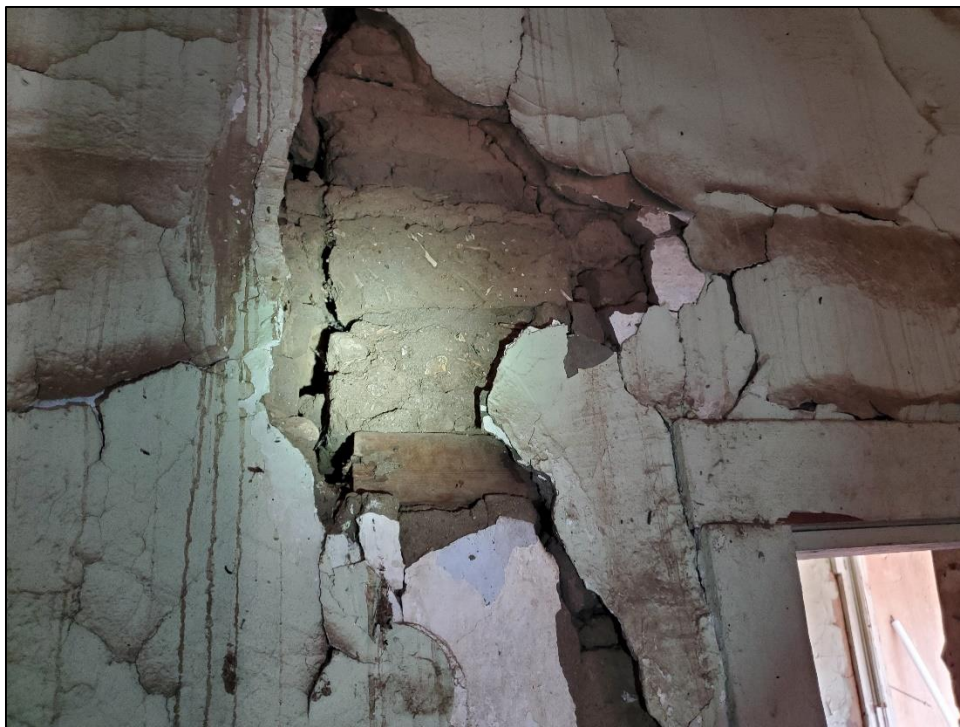
Figure 201. Stucco (sample 5) and coatings (sample 6) in the entry room.

We performed Fourier transform infrared (FT-IR) spectroscopy on samples 6, 7, and 8 to determine the material composition of the green coating. An automatic search-match function returned results for ethylene propylene rubber (EPR), butyl rubber, chlorobutyl, and neoprene. We conclude that this is a rubberized coating, but we could not determine why this type of coating was selected for use in this application, as it is uncommon to use such coatings for the walls of interior living spaces.

Our recommended recipe for a historically accurate rehabilitation of the interior plaster would borrow from the brick-and-mortar recipe. Portland cement should not be used. The plasterer or stucco mason might use a similar clay-based binder, but for the filler, they should use a well-graded river sand with a nominal maximum particle size of no. 16 (1.18 mm). If a smoother surface finish is desired by the architect, it would be acceptable to use a coarse masonry sand gradation with a large fraction retained on no. 100. It may be difficult to commercially procure large quantities of natural river sand for construction purposes due to environmental restrictions in the region. The filler-to-binder ratio by weight should range between 2.25 to 2.75 in order to achieve a smooth, spreadable consistency that will not slough under self-weight. Water should be added slowly and carefully; the mixture will rapidly become unworkable with too much water added.

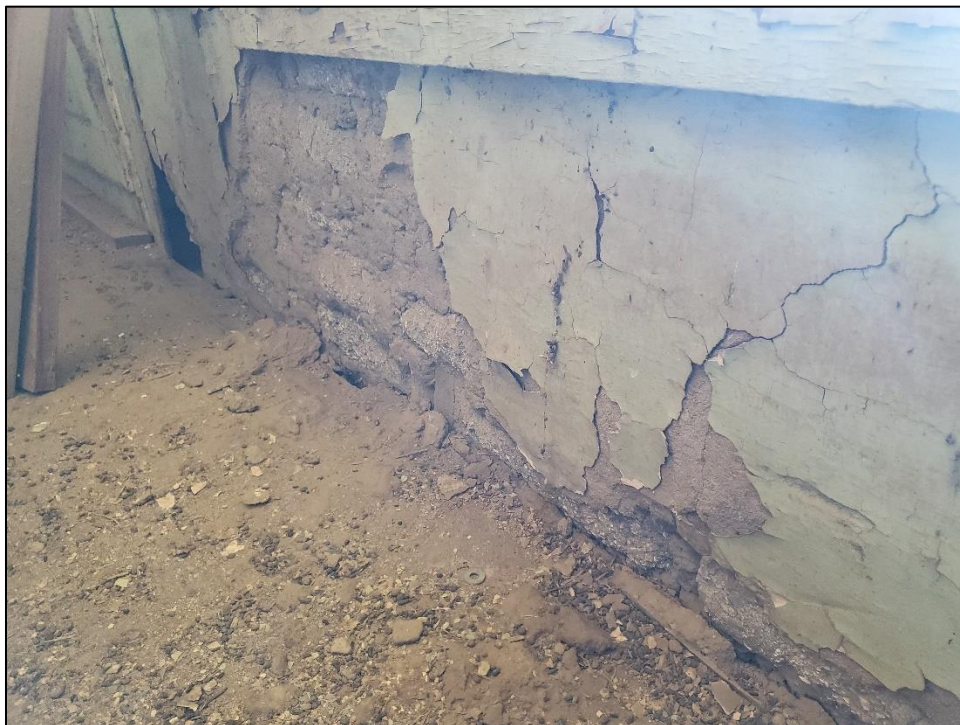
Figure 202. Coating, stucco (sample 11), and bricks in the west rooms.

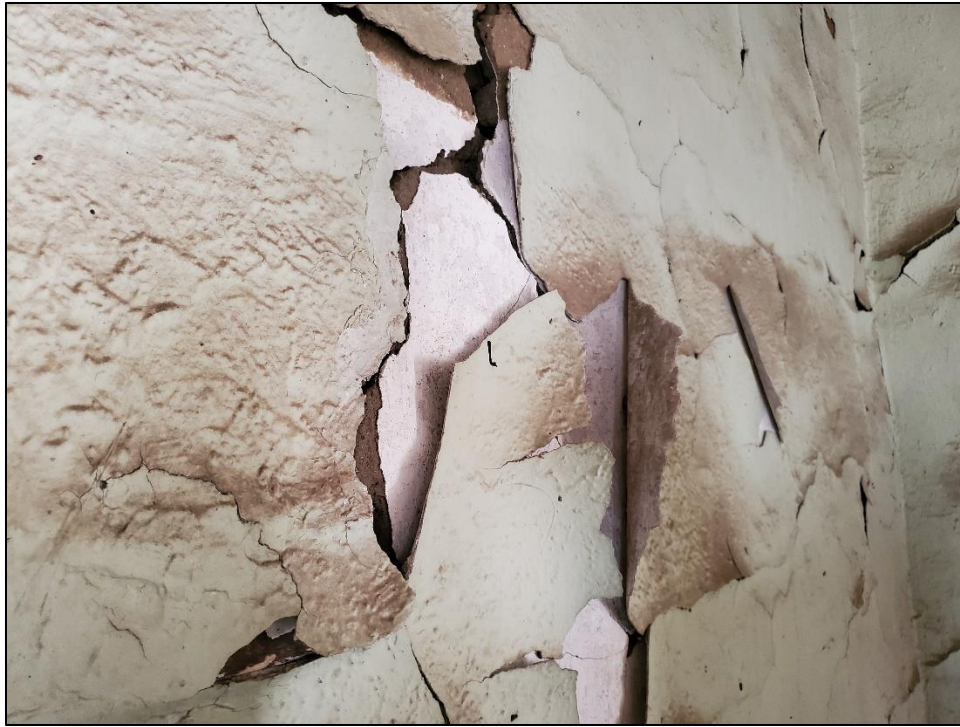
Samples 6 (Figure 201) and 8 (Figure 204) are similar coating materials from the same room. Sample 7 may be the same material as sample 4, which we infer from the data is a modern gypsum or slaked lime plaster. We also found what appears to be a whitewash coating on sample 5, but we did not perform deeper composition analysis on this sample.

Figure 204. Underlying (sample 7) and peeling (sample 8) coatings in the entry room.

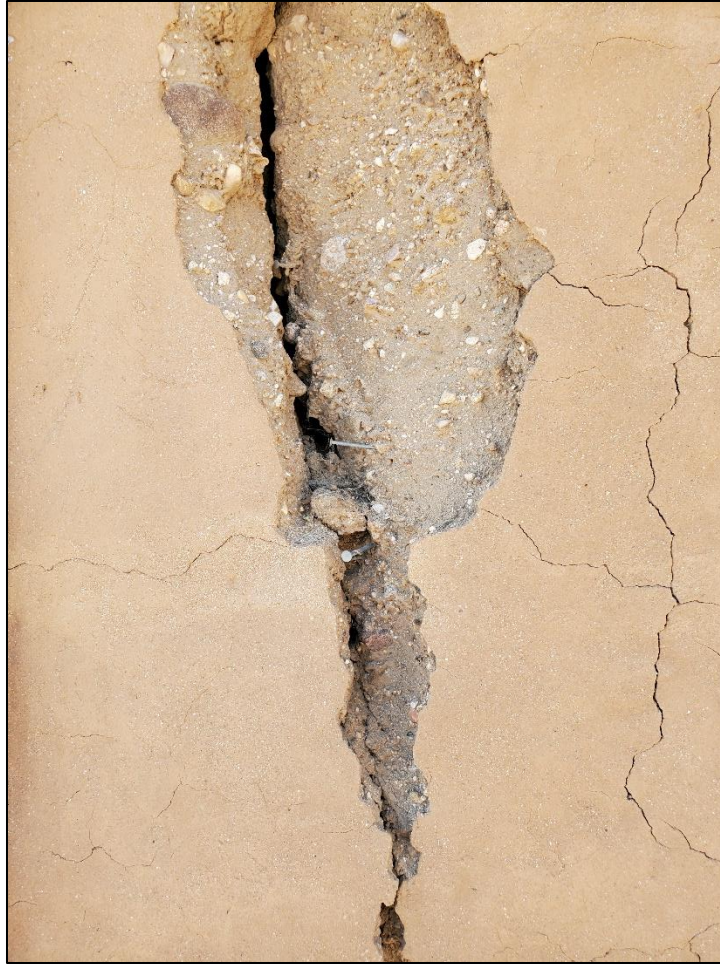
We collected four samples from the exterior of the outbuilding. Both walls sampled are of similar construction with a monolithic fill material and stucco of similar color as sample 15 taken from the west exterior wall. Nails are visible, used for either original reinforcements or repairs (Figure 205). The TGA of wall sample 21 shows slightly less water dehydration than the bricks in the main structure, which could indicate the presence of different clays in the mixture. Sample 21 also shows a slight decarboxylation of calcium carbonate at 650°C, indicating the presence of a small quantity of either slaked lime or limestone in the mix.

Figure 205. Outbuilding earthen wall and stucco with reinforcing nails.
