Review of Regressive Channel Erosion and Grade Control Options on the Rio Coca, Ecuador

by Chris Haring, Tom Darby, David May, and Paul Boyd

PURPOSE: The US Army Corps of Engineers (USACE) is assisting the Ecuadorian state-run Corporación Eléctrica del Ecuador (CELEC) in addressing a water resource issue involving regressive channel erosion on the Rio Coca. Reconnaissance of the site was completed the week of 21 February 2022; parts of the river system were viewed to determine if improvements could be made to the current grade control structure (GCS) mitigation plan for reducing channel erosion and stabilizing the river system downstream of the Coca Coda Sinclair (CCS) Dam.

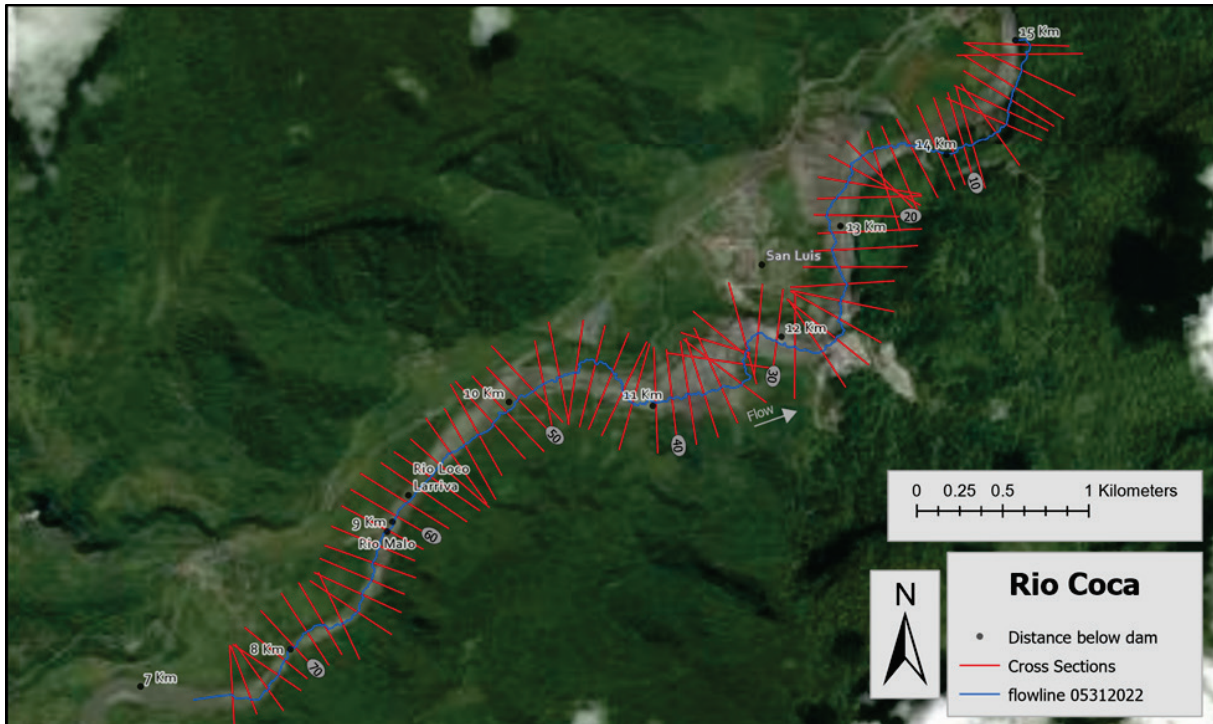
The Rio Coca's longitudinal profile has changed drastically since the waterfall-failure event in February of 2020 (Figure 5 and Figure 6). Figure 5 illustrates the Rio Coca cross-section locations. To further assess the spatial and temporal changes to the channel and valley profile (Figure 6), FluvialGeomorph (FG; Haring et al. 2020; Haring and Biedenharn 2021) was used to plot lidar provided by CELEC. The purple profile illustrates the with-waterfall slope prior to the failure event in early February 2020. The red profile shows the effects of the regressive erosion, with the baselevel lowering by more than 114.3 m (375 ft) at San Rafael and by approximately 3.1–4.6 m (i.e., 10–15 ft) upstream, close to the mouth of the Rio Malo.

Figure 5. Rio Coca FluvialGeomorph (FG) cross-section locations starting downstream at the San Rafael waterfall (*upper right*) and progressing upstream to the Rio Malo (*lower left*) confluence.

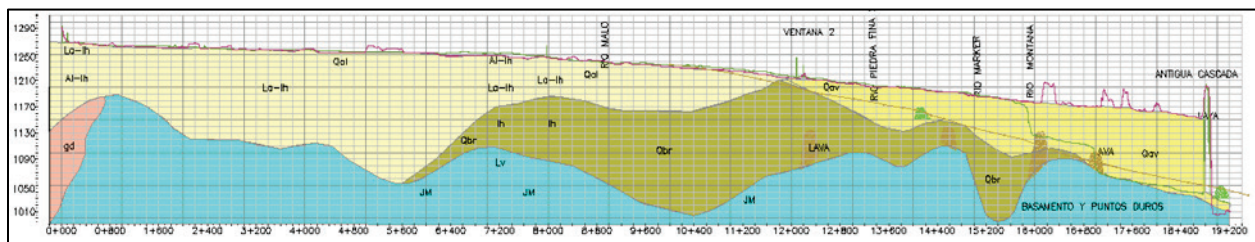
of avalanche deposits (between Km 12 and Km 19), fluvio-lake character deposits (between Km 0+0 and Km 12), and deposits of gap volcanic underlying the deposits of avalanche to the fluvio-lacustrine (between Km 5.6 and 16.8; CELEC 2021). Figure 11 illustrates the general geological profile. There have been some additional updates to the geologic mapping, especially in the area upstream and downstream of the Rio Malo tributary confluence (approximate stations Km 7–12). The newer mapping and field observations monitoring the progress of the regressive erosion front have located important resistive materials present in the form of surface outcrops acting as hard points. The main hard point locations are at Km 7.8 (Walking Bridge), 12 (San Luis Bridge knick zone) and 14 (downstream of San Luis). All three hard points are located where the Rio Coca encounters the right valley wall. The hard points are areas where consistent fluvial erosion has weathered valley wall materials (i.e., bedrock) from the adjacent and underlying strata and provided larger, concentrated, erosion-resistant bed materials (Figure 12).

Figure 11. Rio Coca geologic profile from CCS Dam (0+00 m) to the San Rafael Waterfall (19+200 m). Image adapted from CELEC (2021).

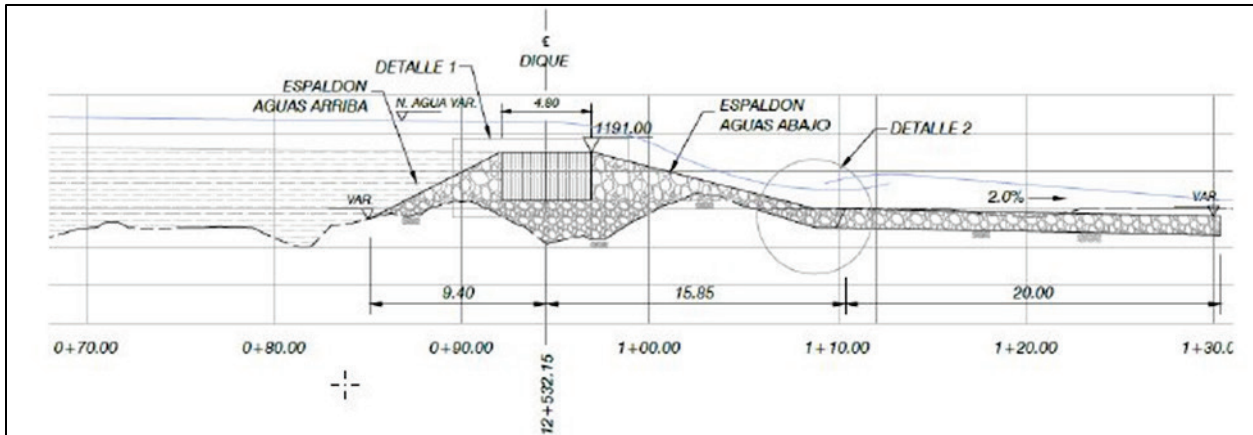
A third CDS (Figure 15) was constructed upstream of the pinch-point at approximate station 9+550 (upstream of La Loma Camp). This structure was viewed during the site visit on 22 February 2022 and appeared to be functioning well (Figure 16). From design information, it appears that the structure was installed as a linear structure perpendicular to flow and did not have a solid core (CELEC 2021). The structure will be tested with the upcoming rainy season (Spring/Summer 2022).

Figure 15. Rio Malo control dam structure (CDS) profile (*left* is upstream to *right* downstream). Image reproduced with permission from CELEC (2021).

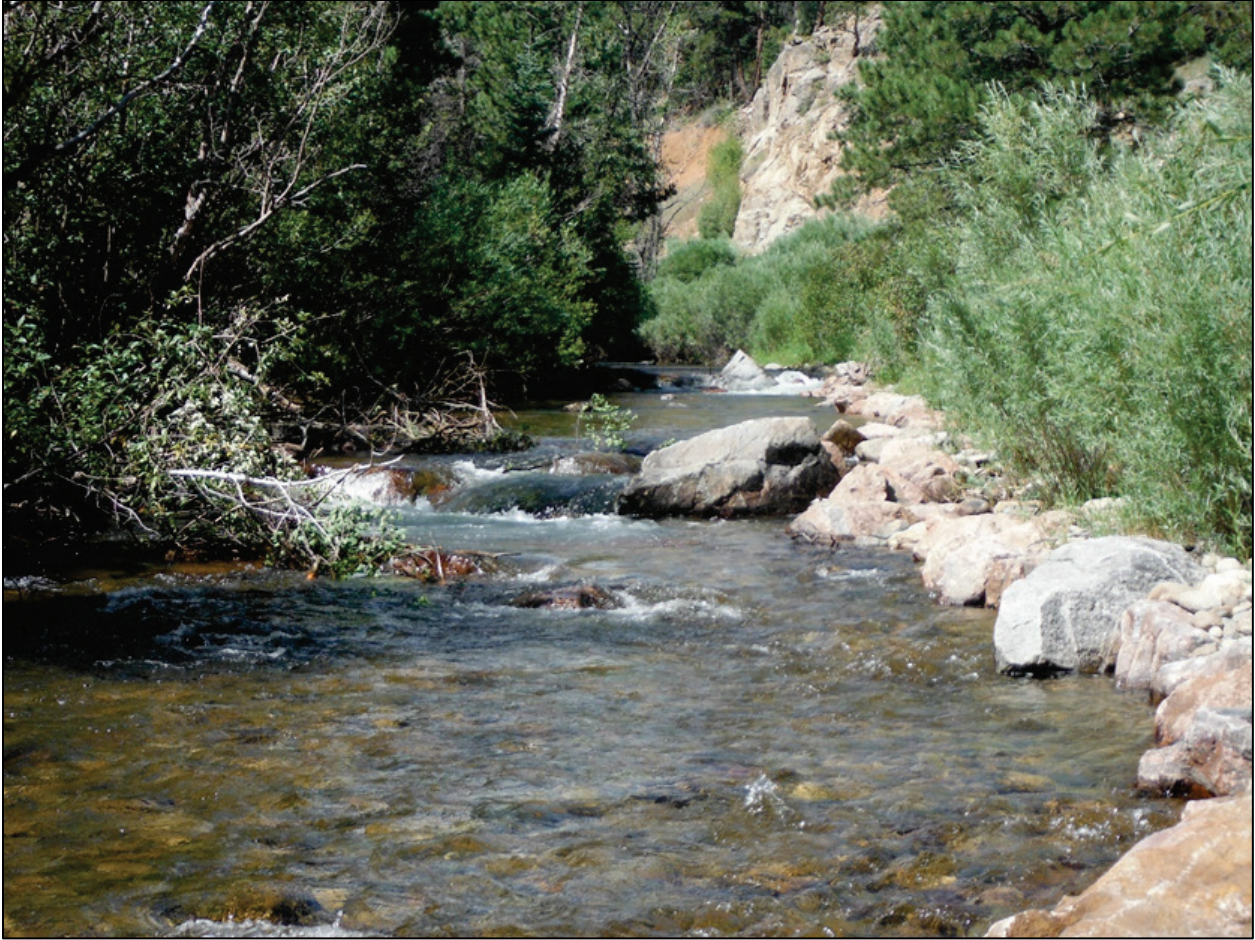
Figure 19. The Boulder Creek, Colorado, stabilization project was completed using onsite large boulders and well-graded finer materials to reestablish cascades, falls, pools, and revegetation.

3. Using local materials with limited size and gradation to continue to construct the CDS would provide some local protection but would only slow down, rather than halt, the channel degradation. Some enhancements to the structure design would be to slightly V-shape the structure upstream, with a lower elevation at the center of the V. This would allow upstream flow to concentrate in the center of the channel and away from the potential of flanking at the bank lines. If using large boulder materials (i.e., well-graded material sizes based on velocity/shear stress calculations), the center could be built with an invert elevation notch, with increasing elevation in the direction of each bank line. This would provide some level of protection as the knickpoints migrate upstream, concentrating the degradation in the center of the channel and not around the sides where it will encounter less-resistant alluvial and terrace deposits. The V-shape could be modified to either side of the channel, depending on planform characteristics or promoting channel locations away from the alluvial terraces. Best practice would be to reinforce the center, where the velocities and shear stresses are high, with larger materials in the crest and the downstream plunge pool. The more rock placed on the backslope of the structure, the better as degradation progresses upstream to the structure apron. Mimicking natural cascades and falls at the structure locations would provide the greatest energy dissipation and a local stable slope. Examples of reestablishing high-gradient channel stability after flood events or for wildfire recovery are common in the Western United States (Figure 19). Concepts and designs from these stabilization projects could be applied on the Rio Coca.

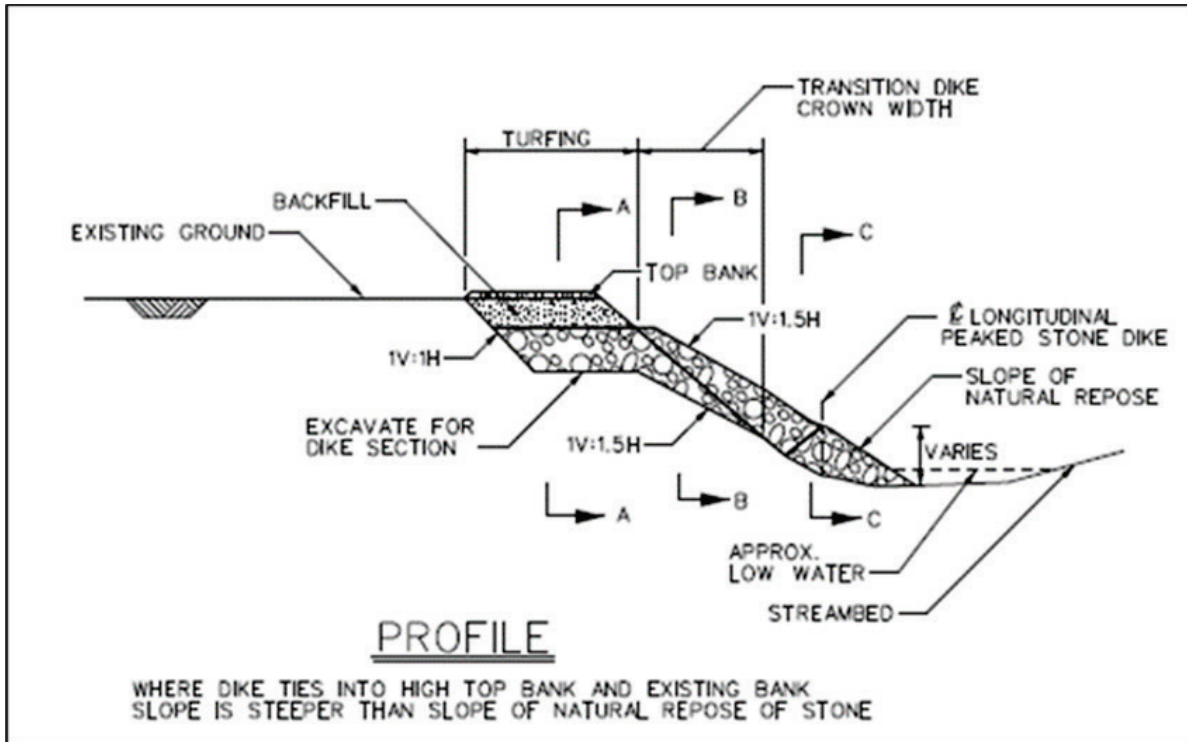
Figure 20. Example revetment key or tieback to prevent structure flanking.

4. Keys or tiebacks into both bank lines should be extensive at each structure (Figure 20 and Figure 21). If there is a high terrace at the revetment location, the tieback can be lowered so that construction does not have to be completed to three-fourths of bank height. Each site will likely have different characteristics and should be assessed independently.

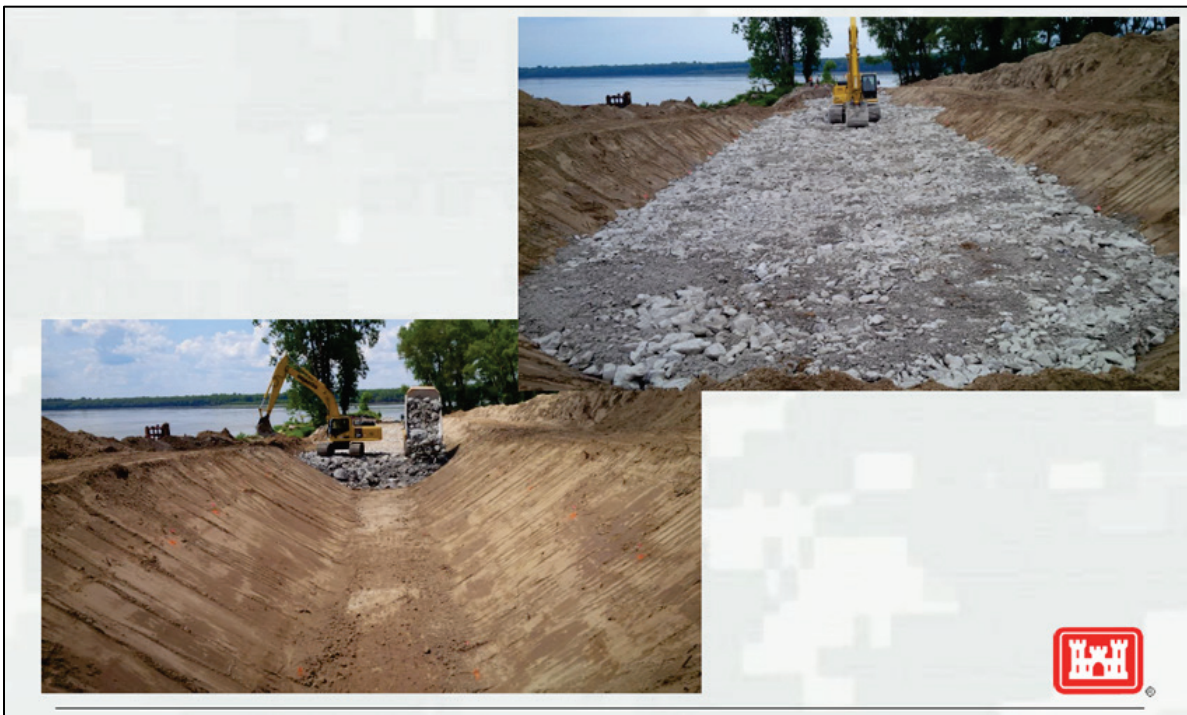
Figure 21. Example revetment key on the Mississippi River. Images reproduced from USACE Vicksburg District (n.d.).
